# LEVEL II SCOUR ANALYSIS FOR BRIDGE 39 (STOWTH00160039) on TOWN HIGHWAY 16, crossing MOSS GLEN BROOK, STOWE, VERMONT

Open-File Report 97-794

By MICHAEL A. IVANOFF AND ROBERT E. HAMMOND

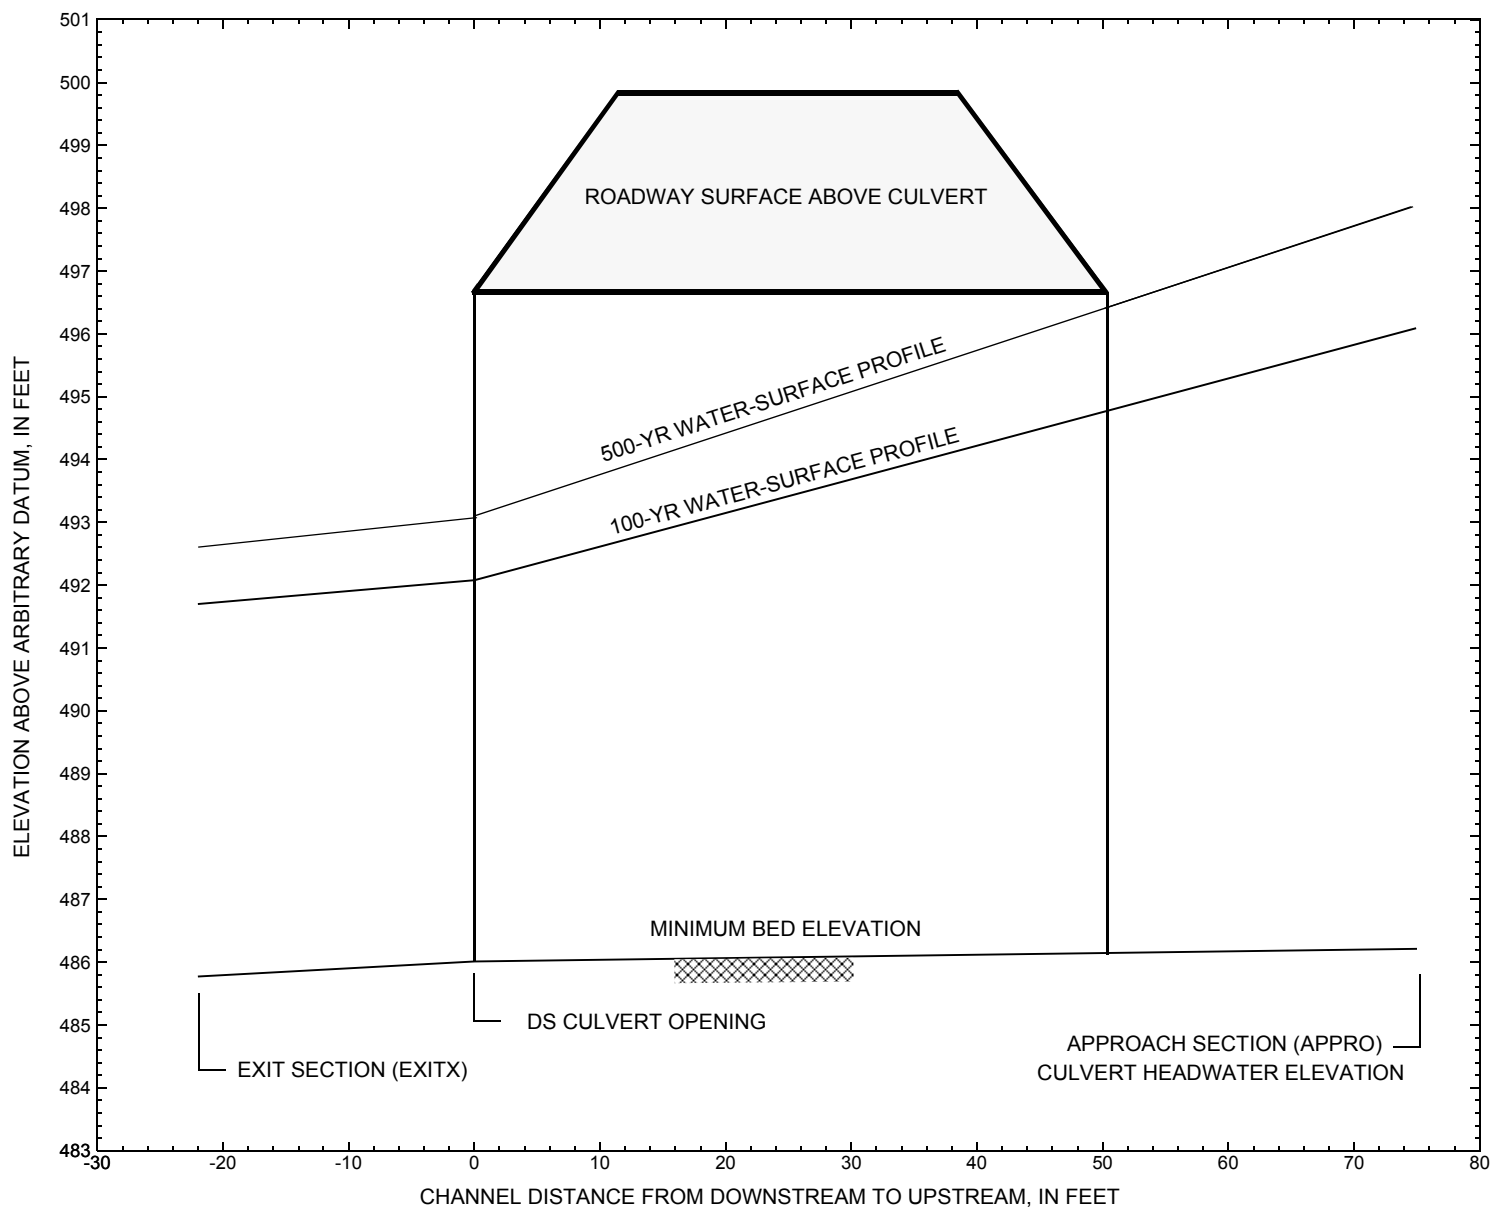
Figure 7. Water-surface profiles for the 100- and 500-yr discharges at structure STOWTH00160039 on Town Highway 16, crossing Moss Glen Brook, Stowe, Vermont.

Hydraulic analyses of the reach were done by use of the Federal Highway Administration's WSPRO step-backwater computer program (Shearman and others, 1986, and Shearman, 1990). The analyses reported herein reflect conditions existing at the site at the time of the study. Furthermore, in the development of the model it was necessary to assume no accumulation of debris or ice at the site. Results of the hydraulic model are presented in the Bridge Hydraulic Summary, Appendix B, and figure 7.

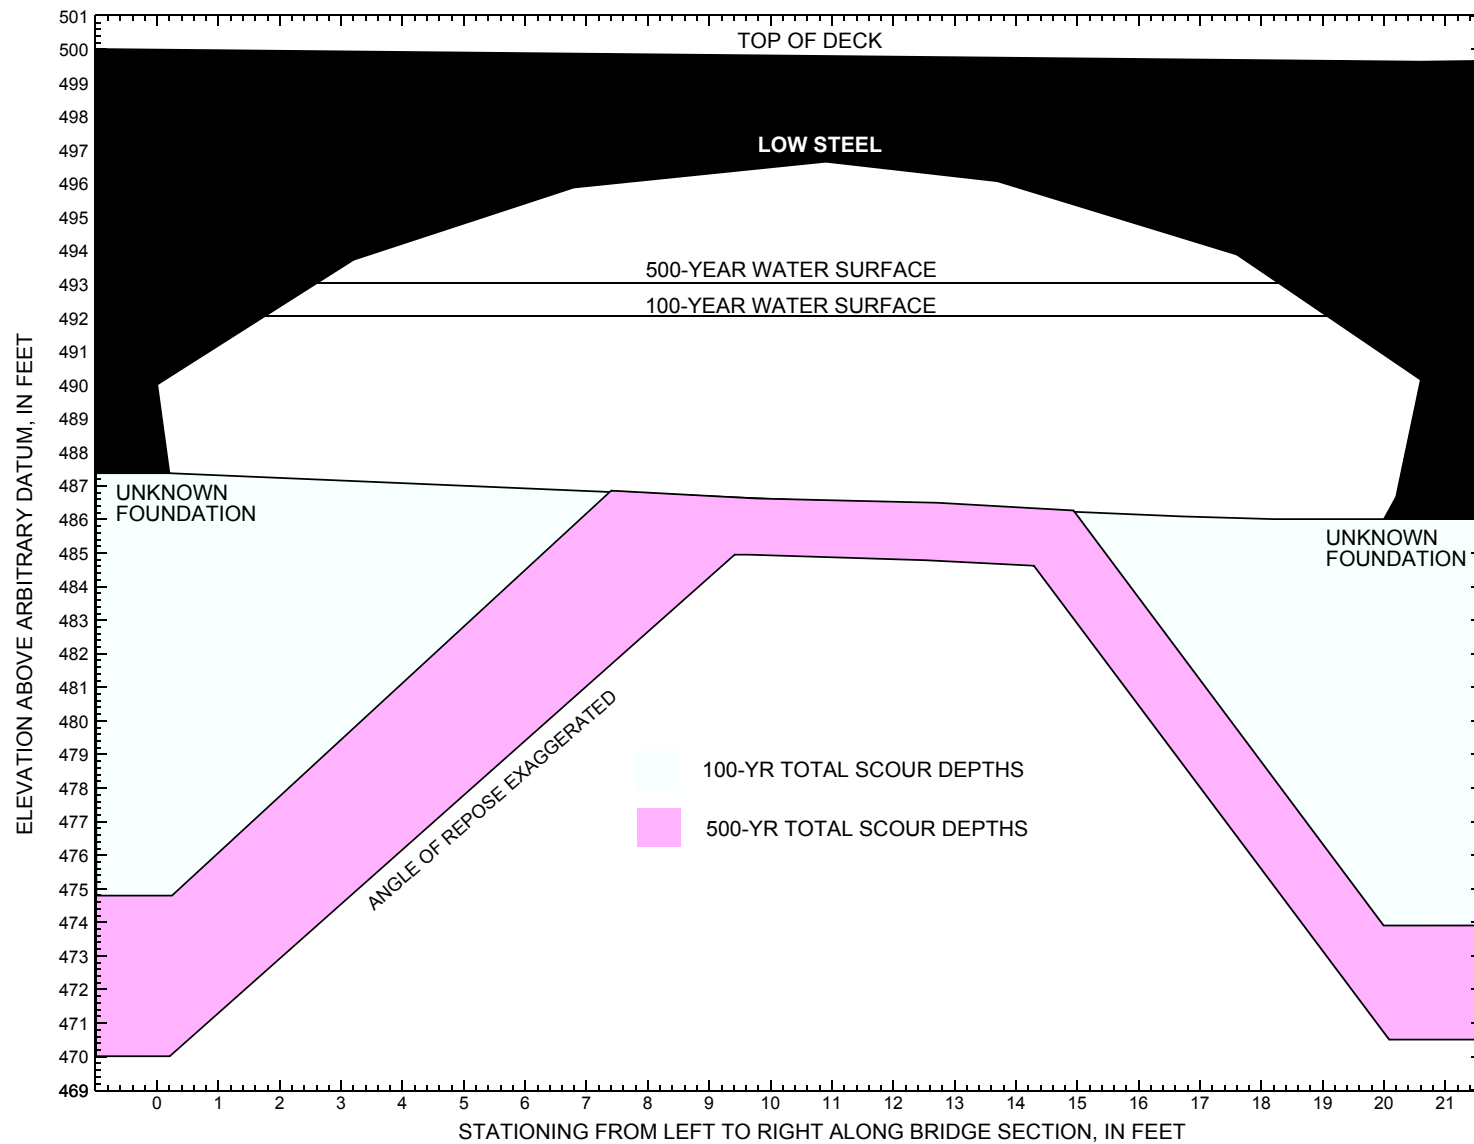
Figure 8. Scour elevations for the 100-yr and 500-yr discharges at structure STOWTH00160039 on Town Highway 16, crossing Moss Glen Brook, Stowe, Vermont.

Contraction scour for all modelled flows ranged from 0.0 to 1.2 ft. The worst-case contraction scour occurred at the 500-year discharge. Left abutment scour ranged from 12.6 to 16.2 ft. Right abutment scour ranged from 12.1 to 14.3 ft. The worst-case abutment scour occurred at the 500-year discharge. Additional information on scour depths and depths to armoring are included in the section titled “Scour Results”. Scoured-streambed elevations, based on the calculated scour depths, are presented in tables 1 and 2. A cross-section of the scour computed at the bridge is presented in figure 8. Scour depths were calculated assuming an infinite depth of erosive material and a homogeneous particle-size distribution.

Scour depths were computed using the general guidelines described in Hydraulic Engineering Circular 18 (Richardson and others, 1995). Scour depths were calculated assuming an infinite depth of erosive material and a homogeneous particle-size distribution. The results of the scour analysis are presented in tables 1 and 2 and a graph of the scour depths is presented in figure 8.
