LEVEL II SCOUR ANALYSIS FOR BRIDGE 55 (WILMTH00230055) on TOWN HIGHWAY 23, crossing BEAVER BROOK, WILMINGTON, VERMONT

Open-File Report 98-007

U.S. Geological Survey
Open-File Report 98-007

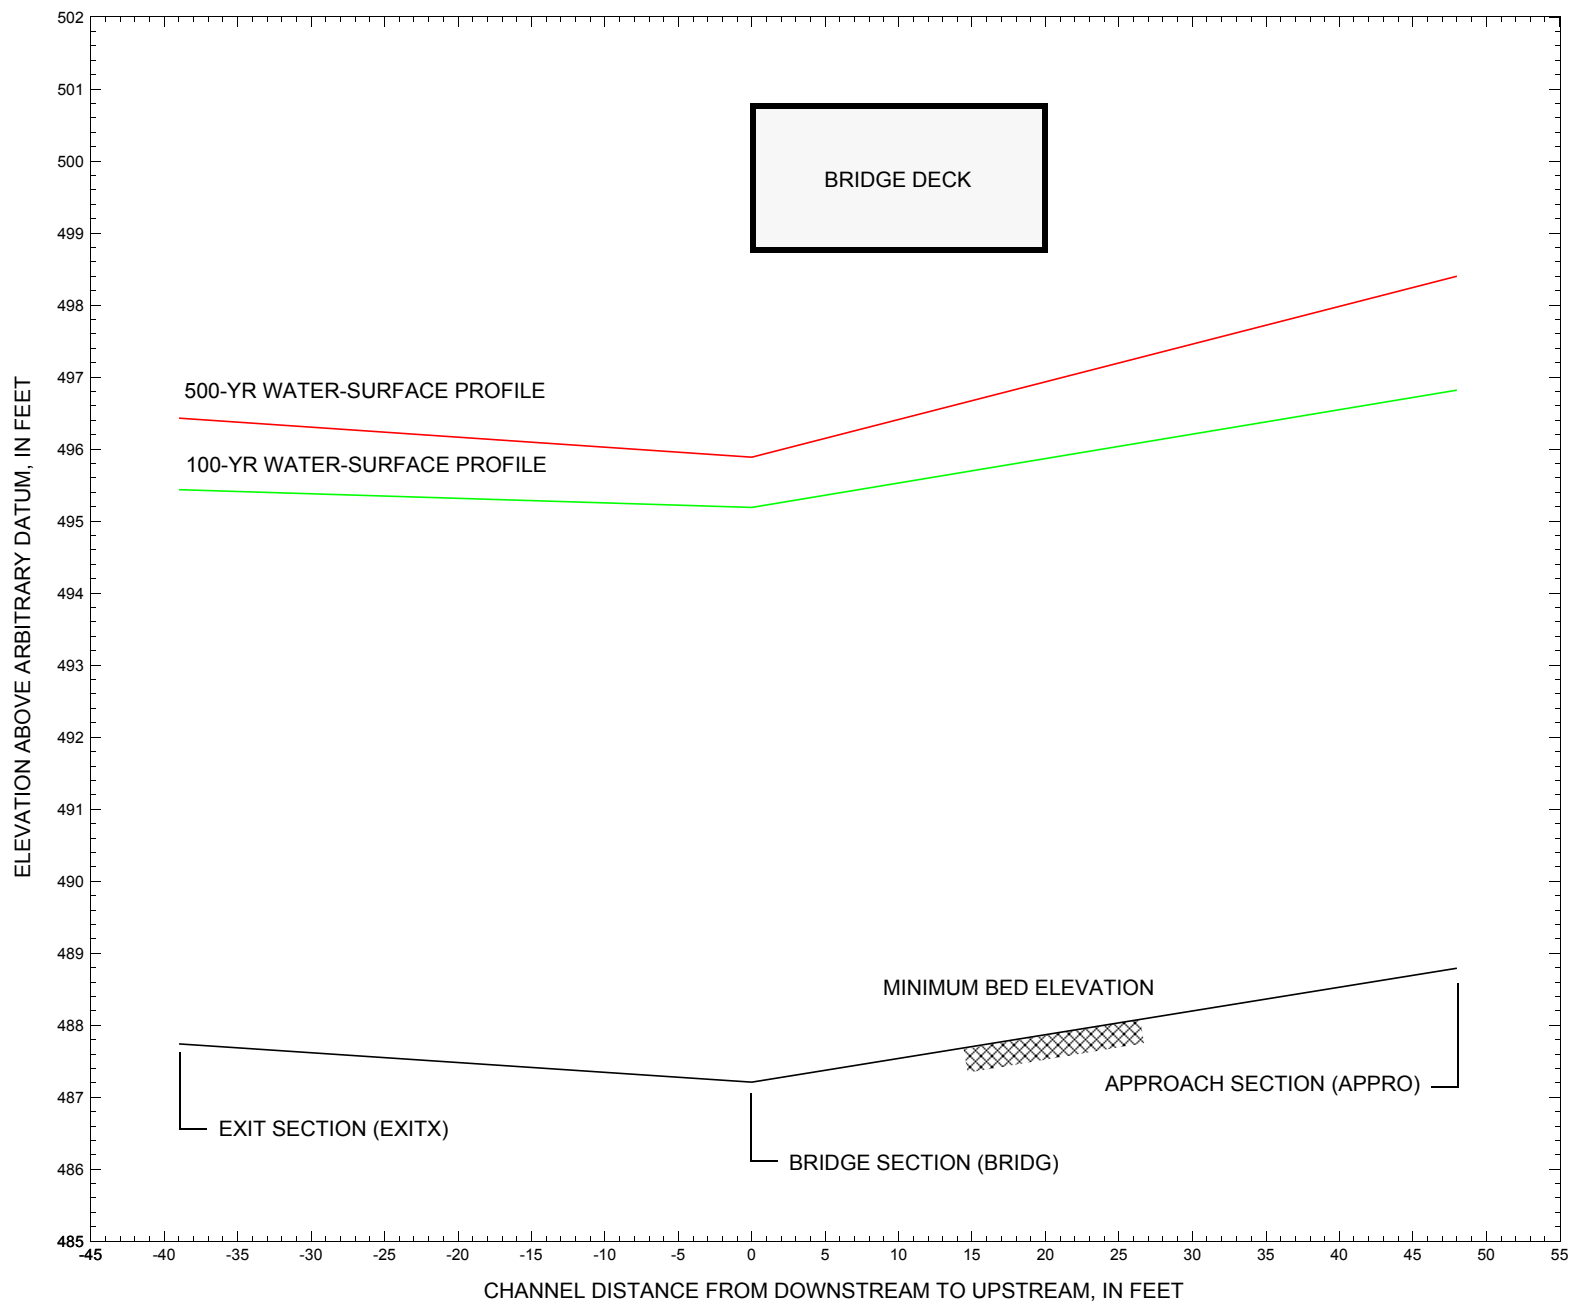
Figure 7. Water-surface profiles for the 100- and 500-yr discharges at structure WILMTH00230055 on Town Highway 23, crossing Beaver Brook, Wilmington, Vermont.

Hydraulic analyses of the reach were done by use of the Federal Highway Administration's WSPRO step-backwater computer program (Shearman and others, 1986, and Shearman, 1990). The analyses reported herein reflect conditions existing at the site at the time of the study. Furthermore, in the development of the model it was necessary to assume no accumulation of debris or ice at the site. Results of the hydraulic model are presented in the Bridge Hydraulic Summary, Appendix B, and figure 7.

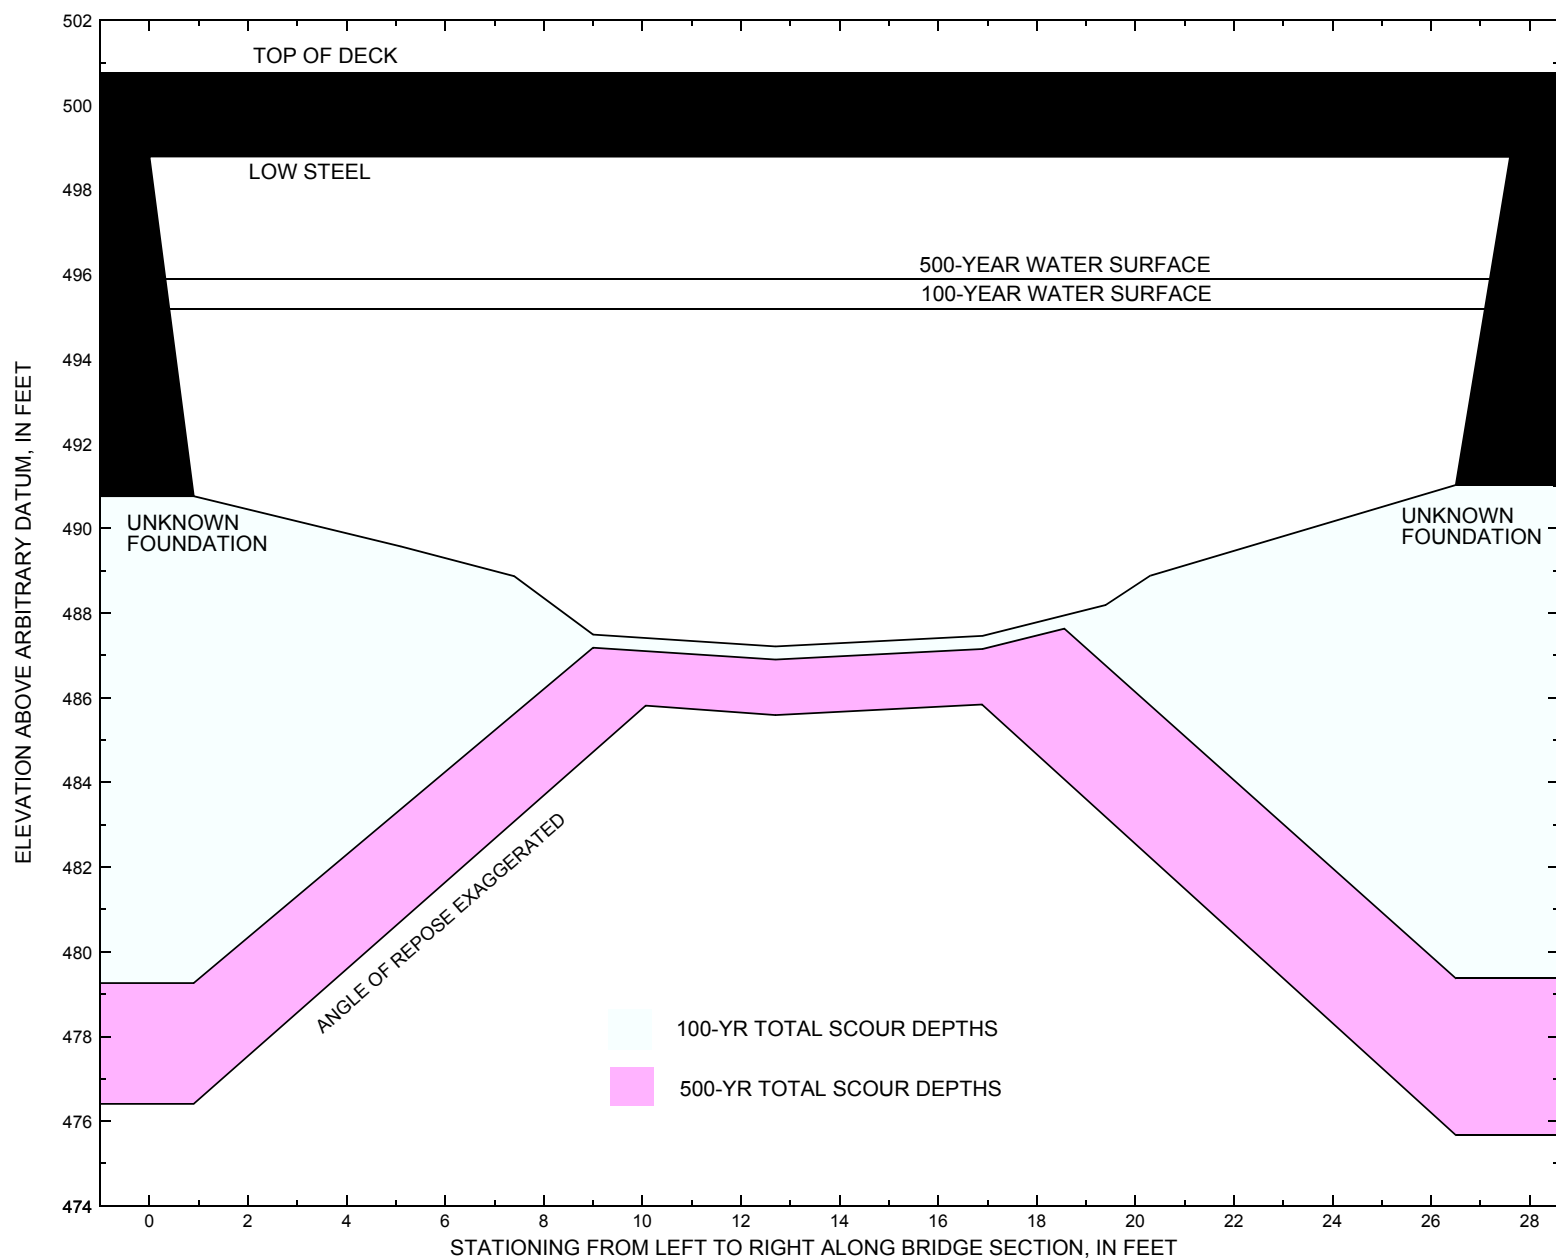
Figure 8. Scour elevations for the 100-yr and 500-yr discharges at structure WILMTH00230055 on Town Highway 23, crossing Beaver Brook, Wilmington, Vermont.

Contraction scour for all modelled flows ranged from 0.3 to 1.6 ft. The worst-case contraction scour occurred at the 500-year discharge. Abutment scour ranged from 11.2 to 13.7 ft. The worst-case abutment scour occurred at the 500-year discharge. Additional information on scour depths and depths to armoring are included in the section titled “Scour Results”. Scoured-streambed elevations, based on the calculated scour depths, are presented in tables 1 and 2. A cross-section of the scour computed at the bridge is presented in figure 8. Scour depths were calculated assuming an infinite depth of erosive material and a homogeneous particle-size distribution.

Scour depths were computed using the general guidelines described in Hydraulic Engineering Circular 18 (Richardson and Davis, 1995). Scour depths were calculated assuming an infinite depth of erosive material and a homogeneous particle-size distribution. The results of the scour analyses for the 100- and 500-year discharges are presented in tables 1 and 2 and the scour depths are shown graphically in figure 8.
