EVALUATION OF THE LANDSLIDE POTENTIAL IN CAPULIN CANYON FOLLOWING THE DOME FIRE, BANDELIER NATIONAL MONUMENT, NEW MEXICO

Open-File Report 98-42

U.S. Geological Survey
Denver, CO 80225

1998

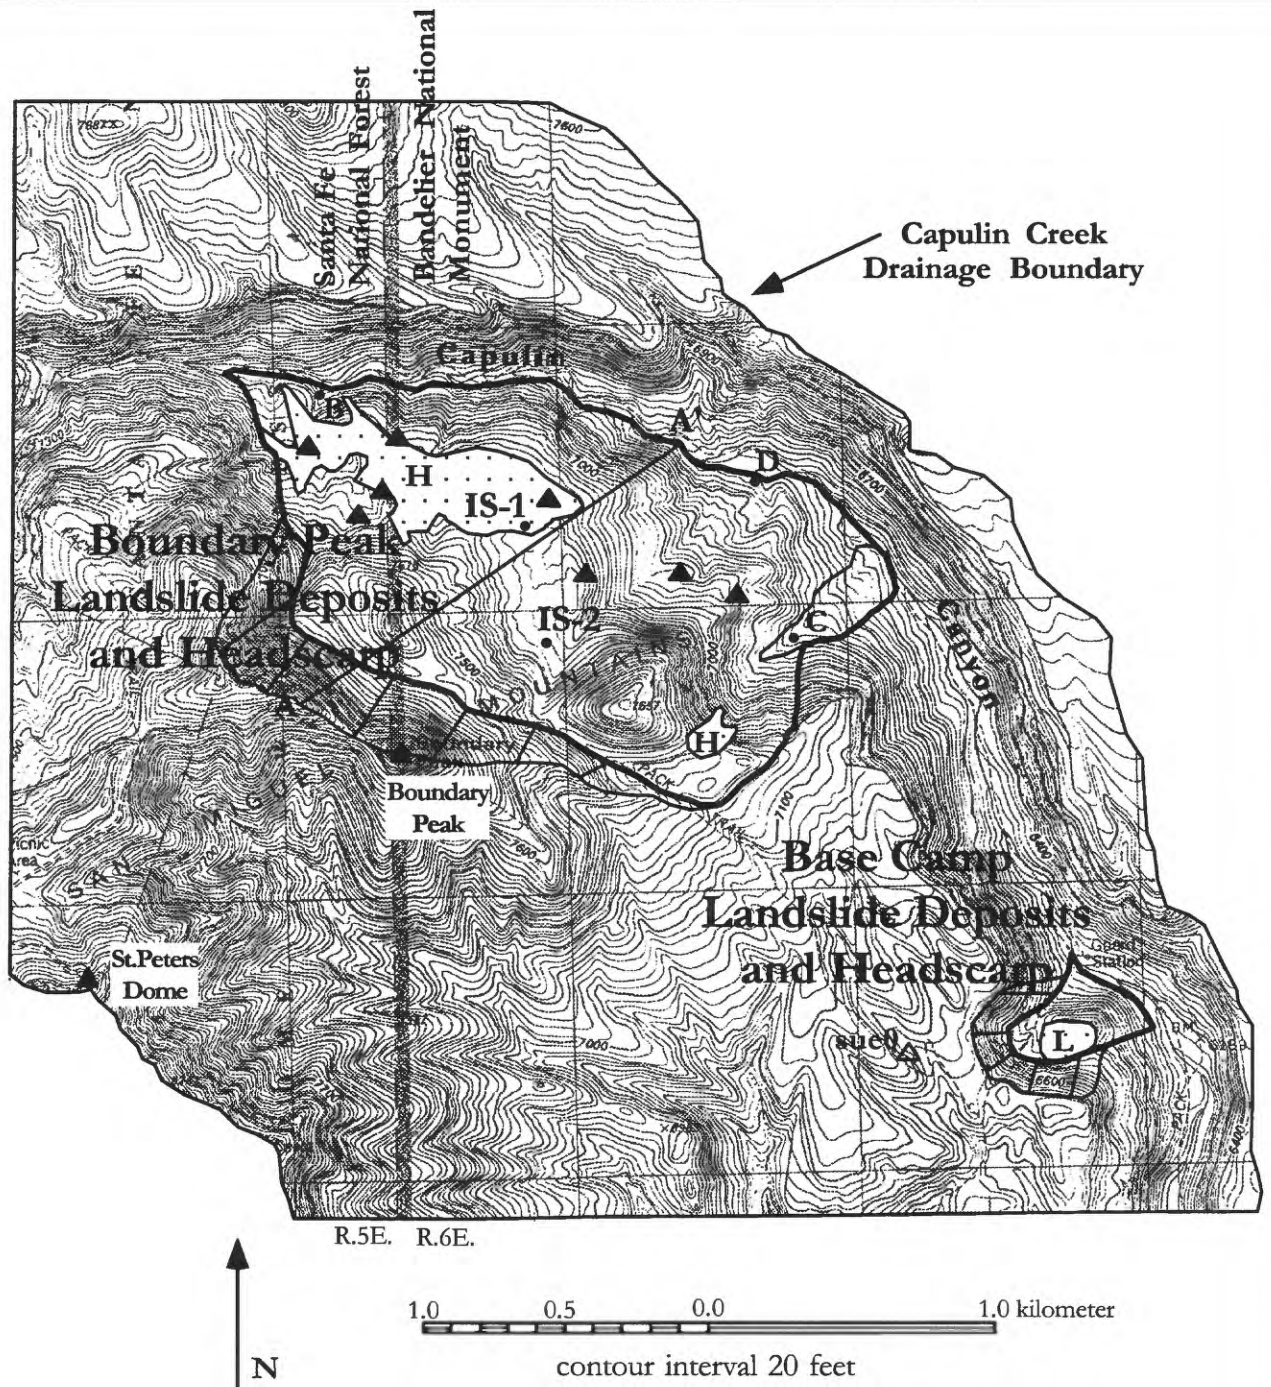
Figure 1. Topographic map of portion of Capulin Canyon in Bandelier National Monument showing locations of Boundary Peak and Base Camp landslide deposits, burn intensity, instrumentation sites, GPS survey monuments, and other locations discussed in the text. Stippled areas denote area of high (H) burn intensity on the Boundary Peak landslide deposits, and an area of low (L) burn intensity on the Base Camp landslide deposits. Instrument site IS-1 is within the burned area, and IS-2 is in the unburned. Filled triangles show locations of GPS survey monuments; open triangle (sue0) shows location of reference base station. Letter B marks the location of a possible basal slip surface. Letter C denotes the location of the alluvial fan where ^{14}C -dated samples were obtained. Letter D shows the location of surficial raveling of the landslide toe. Base is from U.S. Geological Survey Frijoles, New Mexico, 7.5' quadrangle.

Deposits from the Boundary Peak landslide, as outlined in Figure 1, extend a distance of 1.2 km from the base of the headscarp to Capulin Canyon, and are approximately 2.4 km wide in the canyon. Delineation of the landslide deposits was accomplished through examination of the 1:8000-scale color IR aerial photographs taken on May 5, 1996, and field examination. The western and south-western boundaries of the deposits were easily delineated based on topographic expression; the landslide deposits are generally smoother, and have gentler slopes than the adjacent undisturbed ground. The south-eastern boundary, however, required a little more investigation. The 7657-foot-high peak located near the south margin of the landslide deposits is composed of Paliza Canyon Formation hornblende dacite that dips 55 degrees to the south with a N10W strike. This dip is considerably greater than that measured for the same unit to the south (Goff and others, 1990), and is oriented back toward the headscarp, suggesting that this peak is not in-place material, but rather a back-tilted rotational block that has moved downslope. The southeastern boundary of the landslide deposits was further located by what might possibly be the remnants of a flank ridge, a feature commonly found along the margins of actively moving landslides (Fleming and Johnson, 1989). In addition, a contact between the Bandelier Tuff and landslide material was observed just east of this flank ridge, and the remnants of rotational slump blocks in landslide material were observed on the slopes below. The northeast margin of the deposits was delineated based on the topographic expression of a steep landslide toe in Capulin Canyon.

What appears to be a basal failure zone of the Boundary Peak landslide is exposed in the west wall of a stream cut at map location B (fig. 1). This zone was measured to be 84-cm thick, is inclined at 3 degrees to the north, and consists of a plastic, silty clay of variable color. Laboratory determination of the Atterburg limits obtained a liquid limit of 61.5%, plastic limit of 41.1% and a plasticity index of 20.4. This material would thus be classified using the Unified Soil Classification System as a silt of high plasticity (Craig, 1987). This possible failure surface rests on what appears to be red Galisteo sandstone. Given the location and geometry of the failure surface, and the slope of the headscarp, a possible location of the failure surface beneath the landslide can be inferred, as shown in cross-section A-A' (fig. 2). This reconstruction indicates that the deposits may be about 150 m thick. Given the impre-

One area of low burn intensity that covers approximately 0.03 km², or one-sixth, of the deposits is shown on the U.S. Forest Service map of fire intensity (fig. 1).

- The steep section of the landslide toe in Capulin Canyon (between points B and D on Figure 1) should be monitored for signs of steepening or erosion by the creek.
- Formation of cracks and shears within the deposits, particularly in the areas of stepped topography on the lateral margins of the primary block could indicate reactivation.
- The presence of new seeps or springs, or increased flow in existing seeps or springs along the toe of the landslide deposits in Capulin Creek or at the heads of channels on the deposits, could indicate increased groundwater flow through the deposits in response to increased infiltration into the burned area.
- The development of areas with numerous tilted trees should be noted.

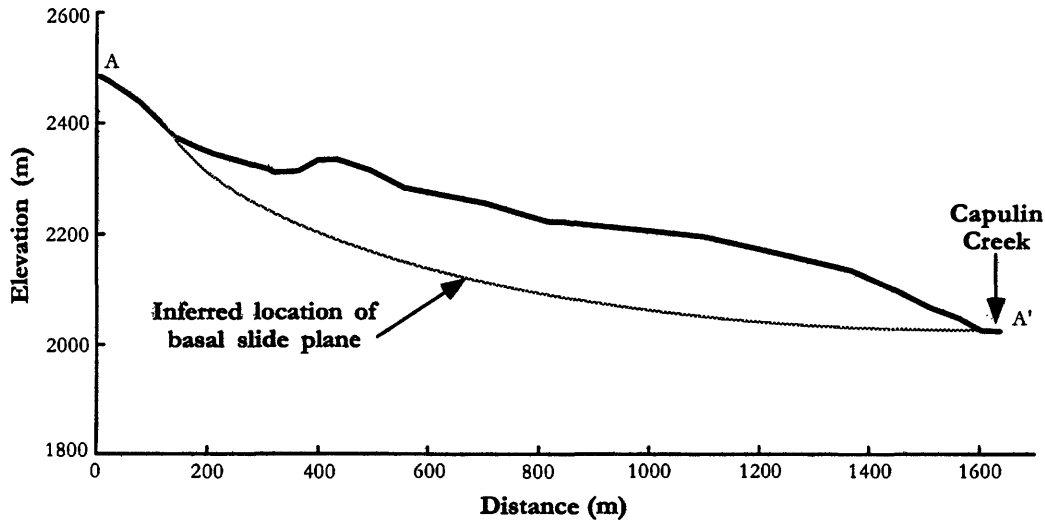
Figure 2. Cross section through Boundary Peak landslide deposits. Topography is from U.S. Geological Survey Frijoles 7.5' quadrangle.

cise values for the width and length of the deposits, a volume of the landslide deposits of approximately 530,000,000 m³ is calculated.

Movement of the Boundary Peak landslide likely occurred along a deep-seated, convex-upward failure surface, which resulted in a rotational transfer of material downslope and out onto the valley floor. Material did not travel down Capulin Canyon for any distance. The topography of the landslide suggests that it moved primarily as one unit, although it appears that the main rotational block broke into a number of smaller, nested blocks at its lateral margins, resulting in a stepped topography on either side of the main block. No sedimentologic or geomorphic evidence was observed upstream from the landslide deposit that would indicate that the landslide ever dammed Capulin Creek, suggesting that the rates of movement into Capulin Creek were sufficiently slow to allow the creek to maintain a channel.

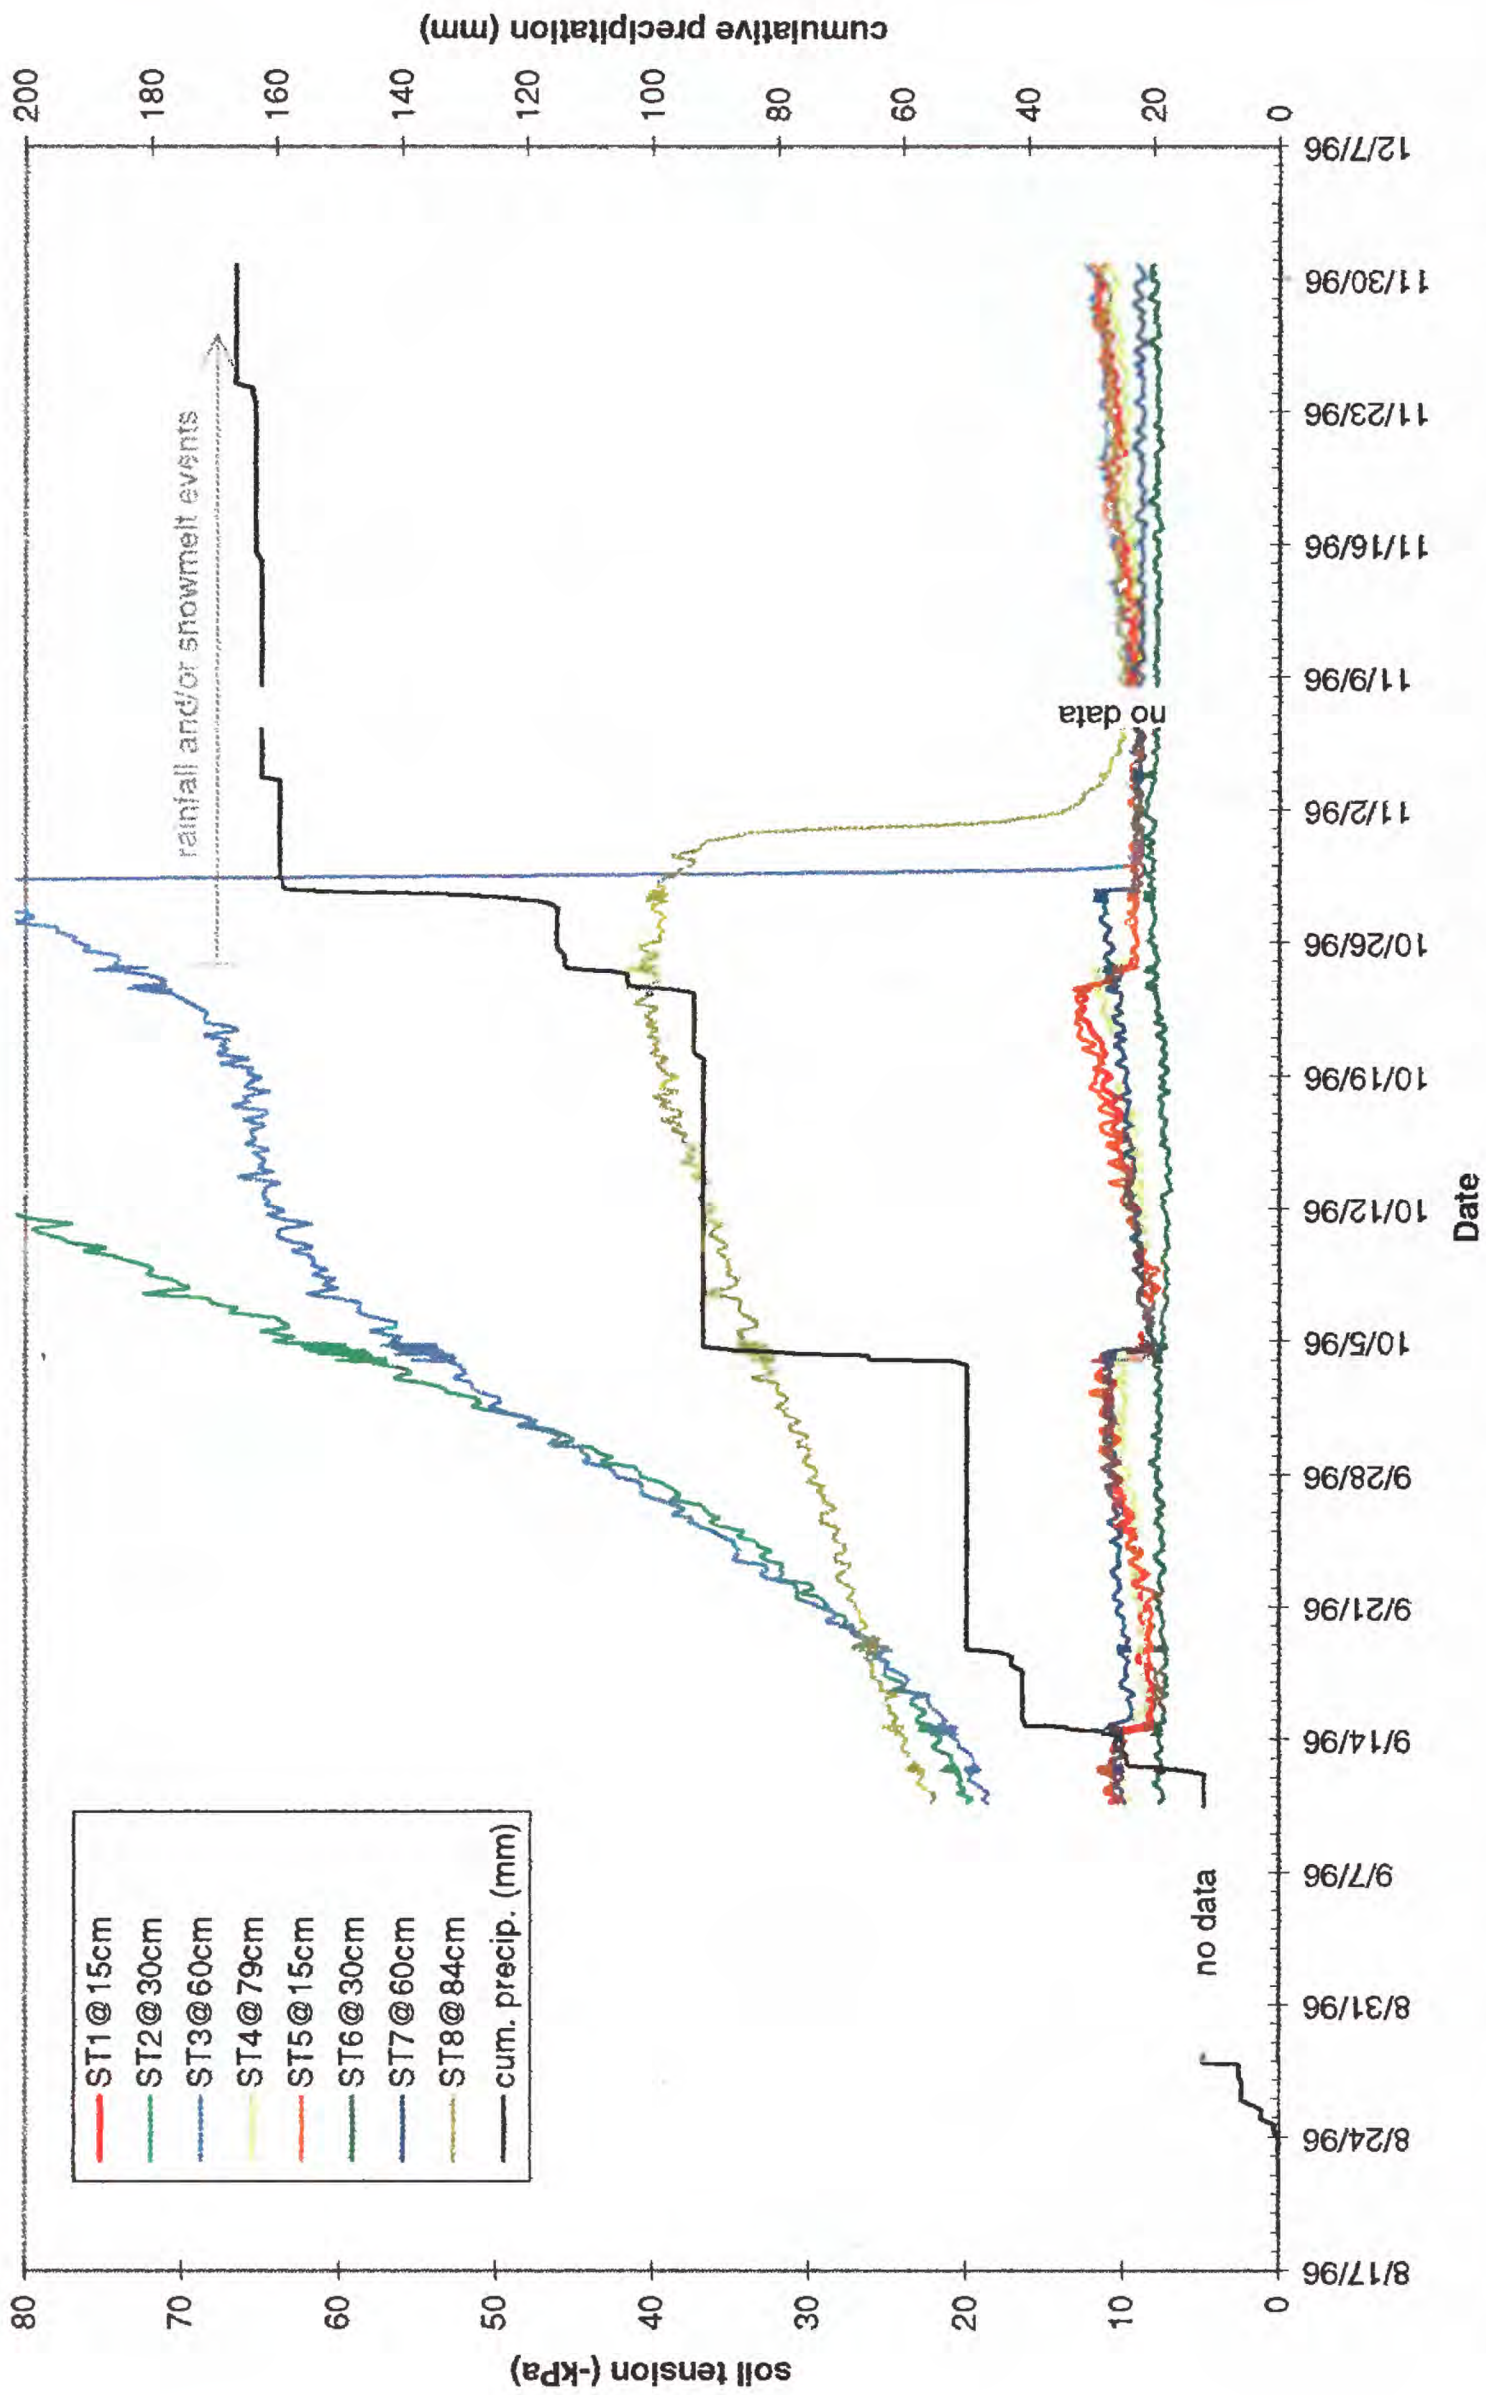
Burned Site Response: The record for 1996, as shown in figure 5A, reflects a gradual movement of soil moisture to greater depths with a continued application of rainfall. In response to the second period of rainfall (starting on September 14th) during the September event, both of the 15 cm sensors show a rapid wetting, which was then followed by a period of gradual drying. The remaining sensors either continued to dry, or did not respond. The October 4-5 event was characterized by an immediate wetting of both the 15 cm sensors, followed about 12 hours later by sensor ST-7 at 60 cm. Again, this response was followed by a gradual drying, and the remaining sensors continued to dry or did not respond. The October 23-29 rainfall and snowmelt event showed an immediate wetting of the two 15 cm sensors, followed about 4 days later by wetting of sensor ST-7 at 60 cm, which was followed one day later by sensor ST-3 at 60 cm, and lastly, two days later, by the 84 cm sensor. The remaining sensors showed no response.

Figure 5A. Plot of cumulative precipitation and soil-tension measurements with time for IS-1 (burned site) in 1996. ST refers to soil-moisture sensors. Cumulative precipitation totals do not include events that occurred between August 29 and September 10, 1996. 13.55 mm of rainfall was measured at IS-2 between those dates.

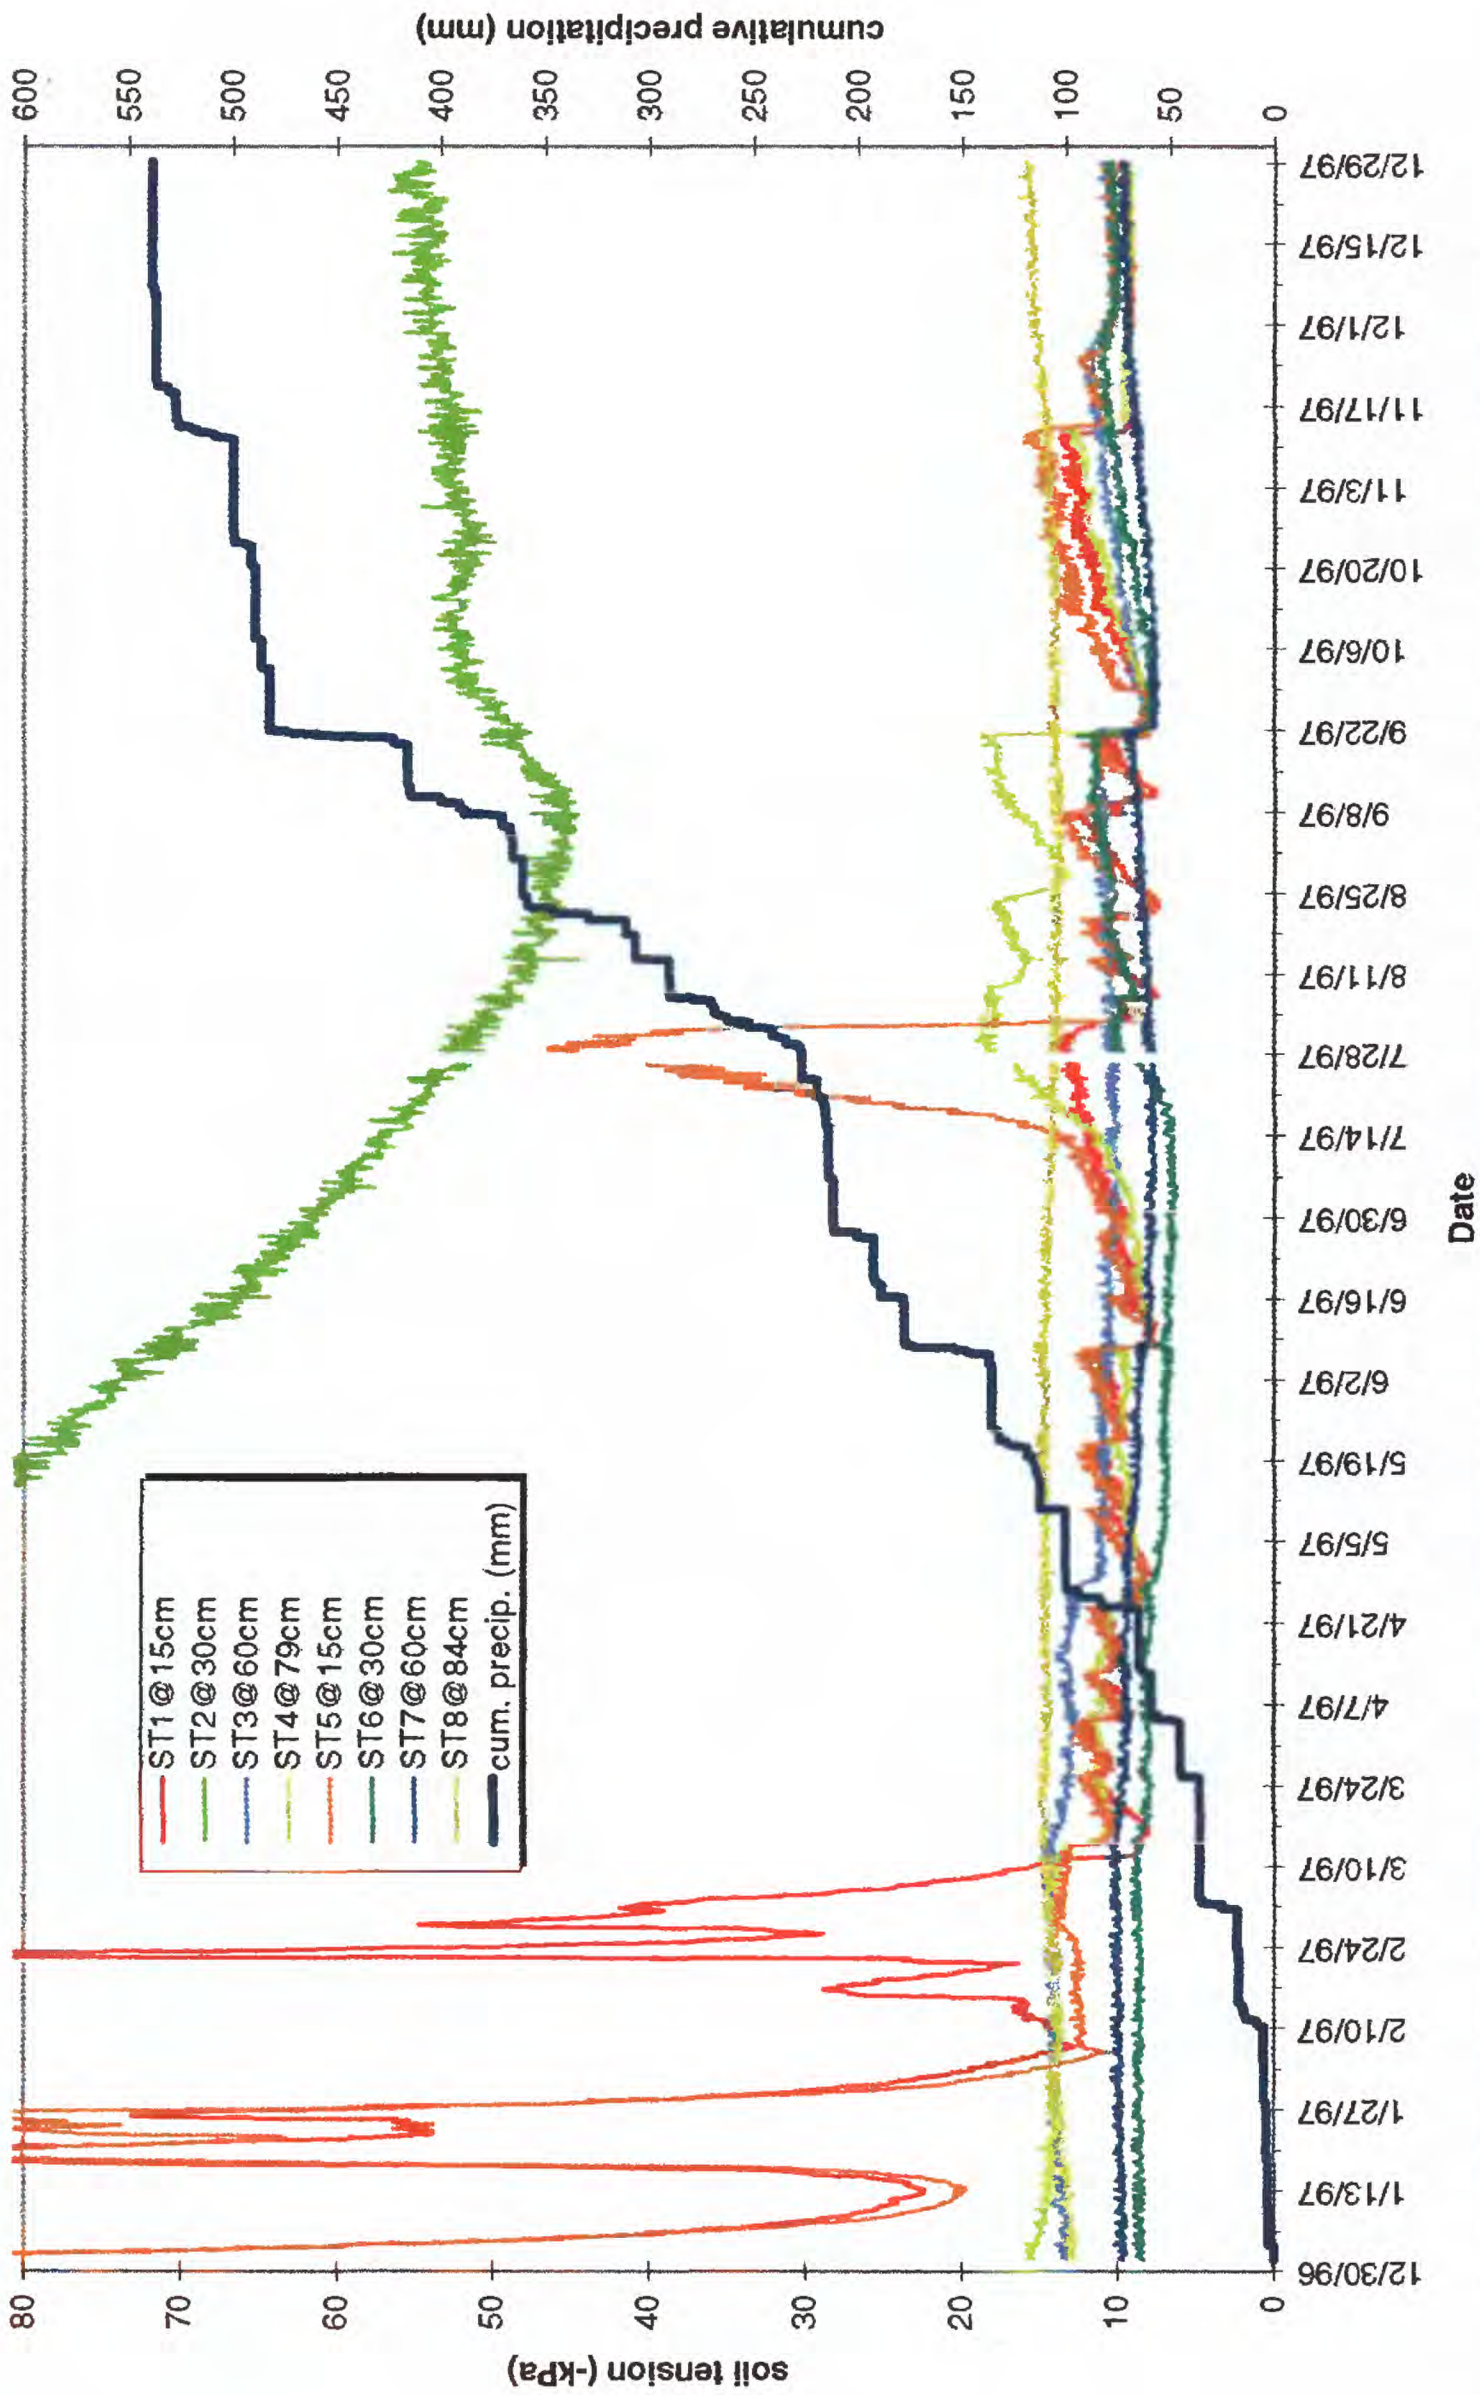
The soil-moisture data for 1997, shown in Figure 5B, also reflects a gradual infiltration of soil moisture to depth with the continued application of rainfall. From the start of the record until early March, the record is characterized by the drying and wetting of both the 15 cm sensors that accompanied freezing and thawing of the upper soil surface. The deeper sensors did not show this effect. Then, starting in mid-March and continuing until late June, both 15 cm sensors showed immediate wetting at the onset of each small rainfall event, followed by a more gradual period of drying. Sensor ST-6 at 30 cm remained constant through this period, and the other was extremely dry. Of the 60 cm sensors, ST-7 remained constant, while ST-3 showed a wetting response in late April. Oddly, although neither of the 30 cm sensors registered any effects of these rainfall events, the 79 cm sensor does show a wetting response. There are two possible explanations for this phenomenon: either the wiring was switched during installation and the channel thought to be reading the 79 cm sensor is actually reading the 30 cm sensor, or an inter-soil channel is directing moisture to this deeper sensor. This issue can possibly be resolved when the sensors are removed from the ground. Continuing on,

Figure 5B. Plot of cumulative precipitation and soil-tension measurements with time for IS-1 (burned site) in 1997. ST refers to soil-tension sensors.

during the dry period between late June and mid-July, the two 15 cm sensors and the presumed-79 cm sensor, followed by sensor ST-6 at 30 cm, show a gradual drying. The onset of the rainy period in mid-July is accompanied by an immediate wetting of both 15 cm sensors, which then continue to gradually dry and then wet up in response to lulls and periods of rainfall accumulation. Sensor ST-6 at 30 cm showed a gradual drying during this period, followed by a constant value. The dry period between late August and early September shows a gradual drying of the sensors that had wetted during the preceding rainy period. The September 6-10 storm resulted in the re-wetting of both the 15 cm sensors, but no response of the deeper sensors. Even the errant 79 cm sensor did not register this event. However, the September 20-22 storm resulted in an immediate wetting of both 15 cm sensors, sensor ST-6 at 30 cm, both 60 cm sensors, and the 79 cm sensor. This was again followed by a period of gradual drying until the final storm of the season in mid-November. Both the 15 cm sensors responded immediately to this event, followed a few days later by sensor ST-3 at 60 cm and a little later still, by sensor ST-6 at 30 cm.

The drying responses of the sensors described above also reflect an important characteristic of the burned site. Although the sensors show a gradual drying between rainfall events, the minimum values of soil-water tension attained are, in general, around -15 kPa. This fact that this minimum value is small relative to those measured at the unburned site (described below), indicates that this site remains relatively moist throughout the summer. This is a particularly interesting result given that the burned site is relatively open and exposed to direct sunlight, while the unburned site is well shaded.

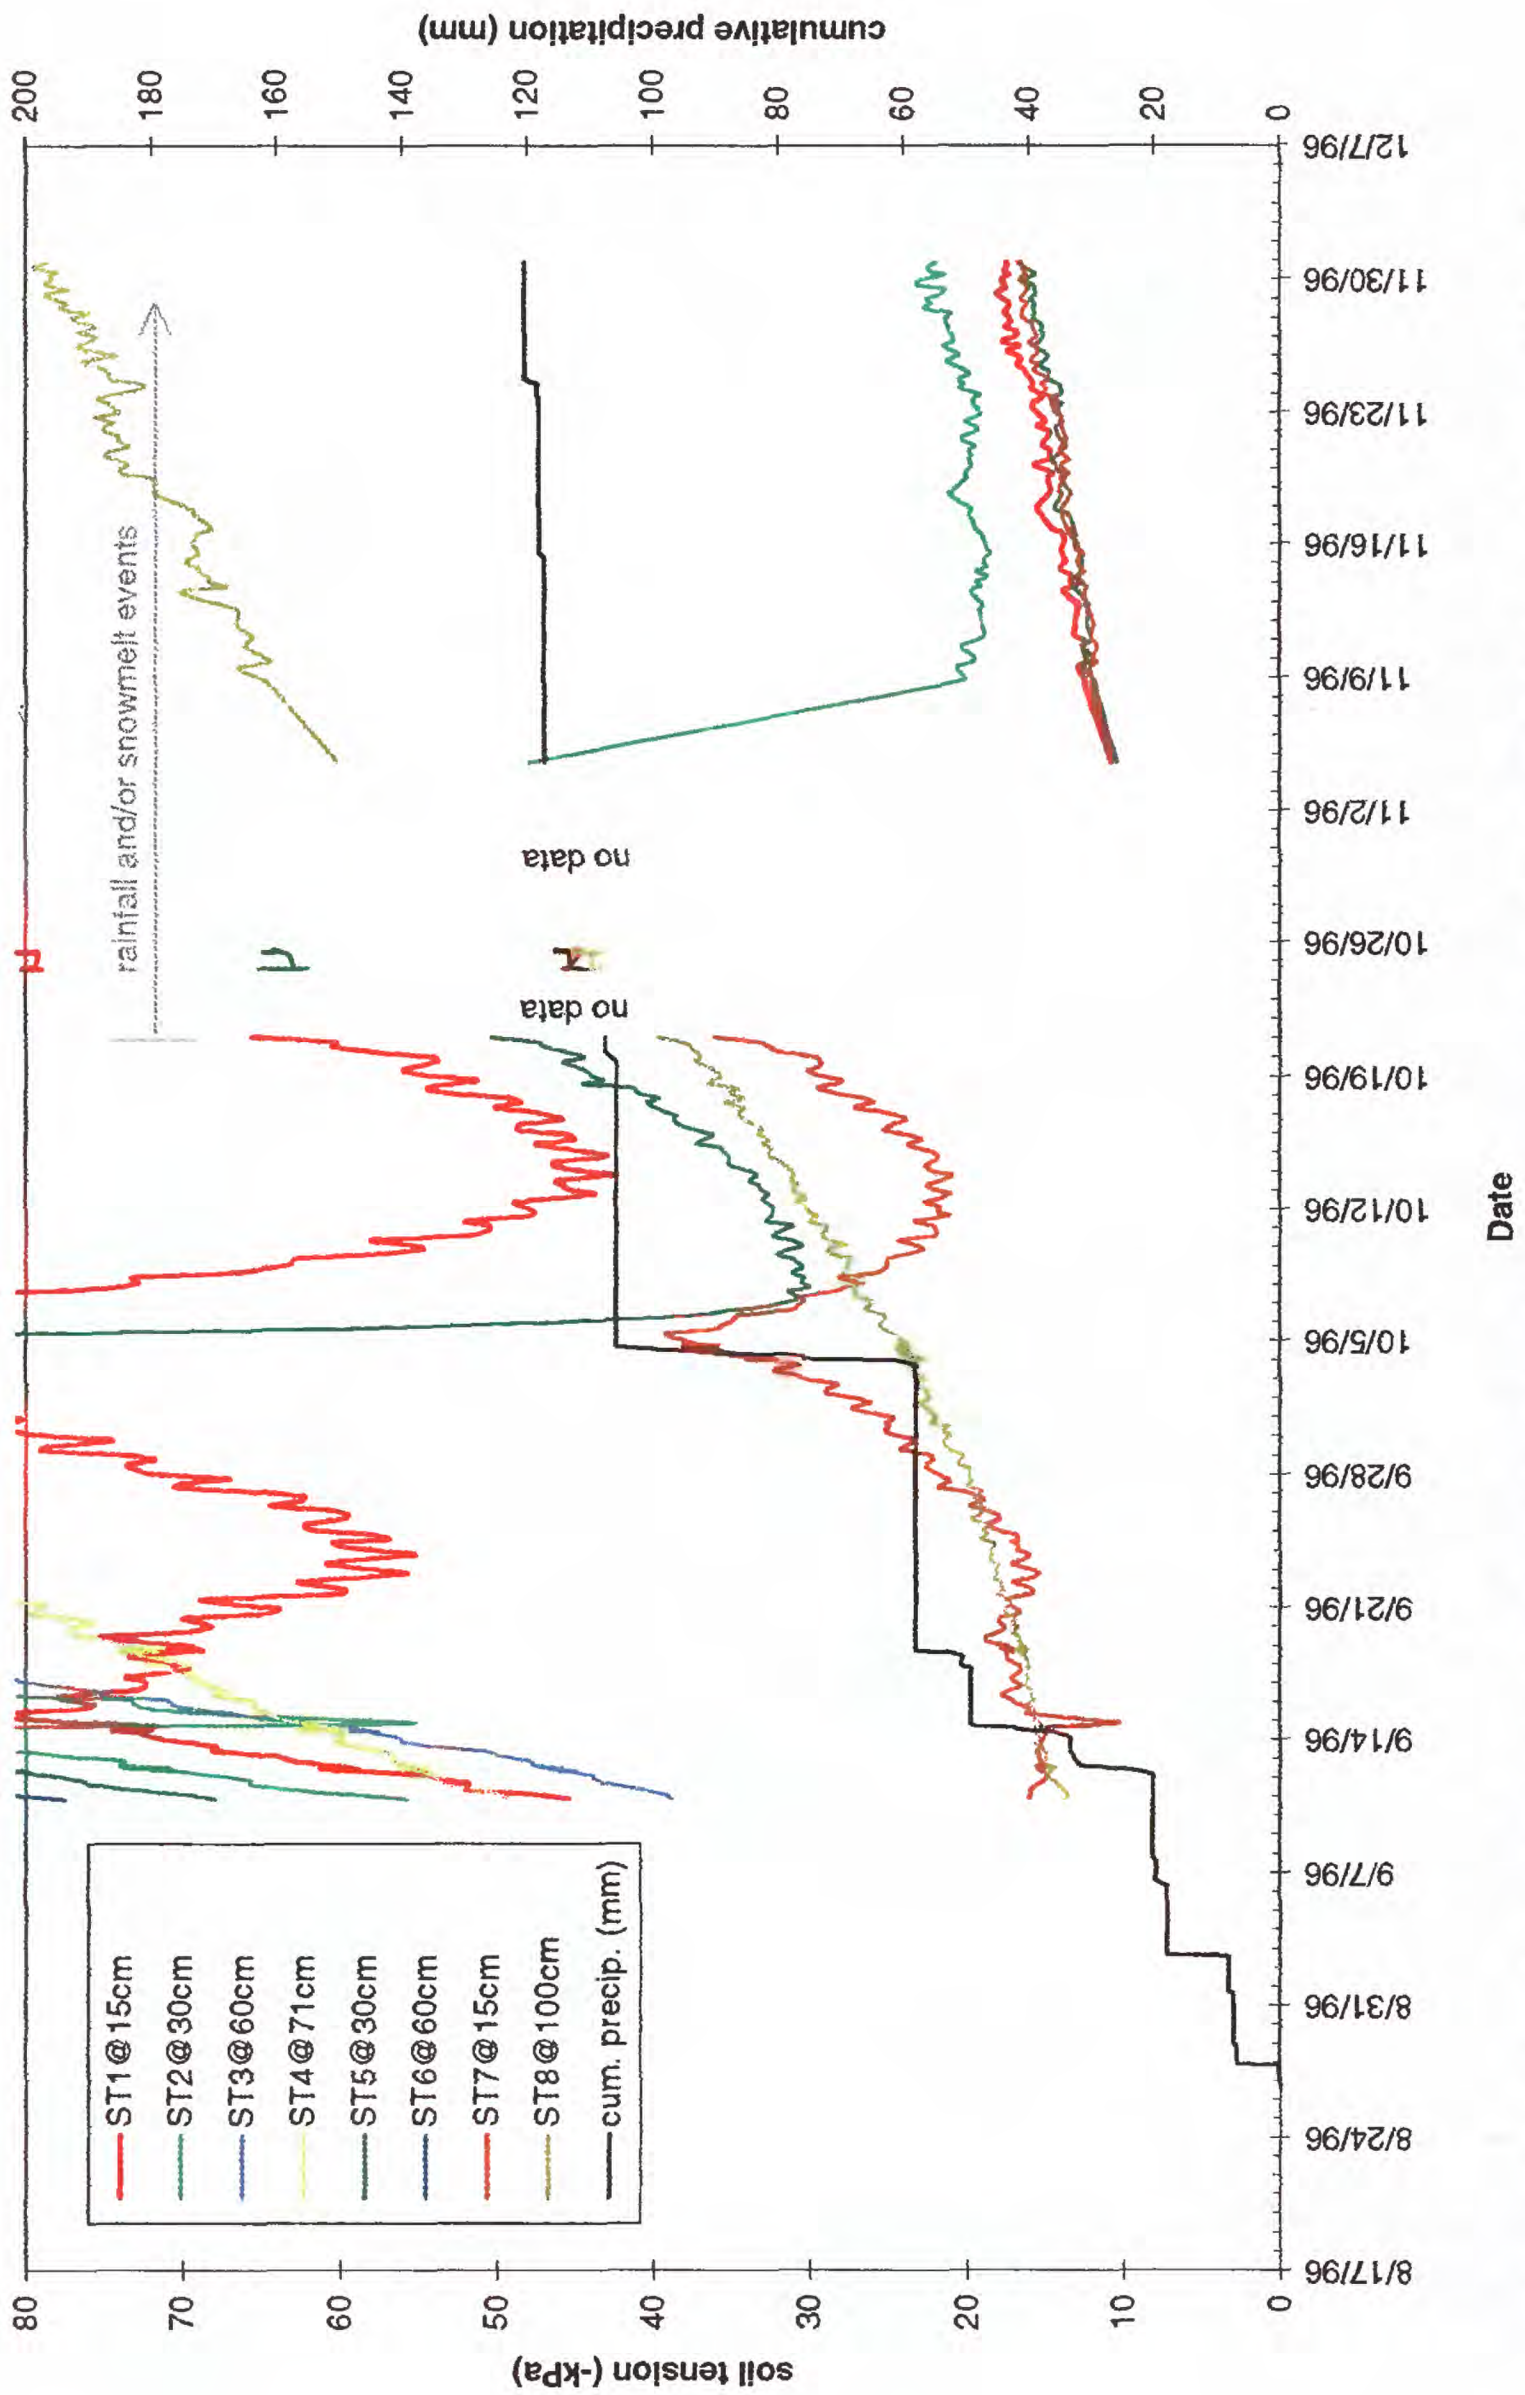
Figure 6A. Plot of cumulative precipitation and soil-tension measurements with time for IS-2 (unburned site) in 1996. ST refers to soil-moisture sensors. Cumulative precipitation totals do not include events that occurred between October 20 and November 8, 1996. A total of 67.5 mm of rainfall was measured at IS-1 during this time.

Unburned Site Response: Data from the soil-moisture sensors through 1996, shown in figure 6A, illustrate a response to rainfall events quite different from that of the burned site. During the second period of rainfall within the September 12-19 event, sensor ST-7 at 15 cm showed a relatively rapid wetting. A period of gradual drying was then

ended by a rather gradual wetting of both the 15 cm sensors and sensor ST-5 at 30 cm in response to the early October rainfall. A gap in the data exists due to power difficulties in mid-October. However, when data acquisition resumed, both 15 cm sensors and sensor ST-5 at 30 cm were relatively moist. The soil-moisture data for the unburned site from 1997, shown in figure 6B, show a response remarkably different from that of the burned site. The record again shows a response to repeated freezing and thawing by both 15 cm sensors from the start of the record to mid-March. The two 30 cm sensors did not respond to this effect, and the remaining sensors are so dry as to be off the vertical axis. As with the burned site, both 15 cm sensors show a rapid wetting followed by a more gradual drying response to rainfall starting in mid-March. In contrast with the burned site, however, both 30 cm sensors also show this response, although it is less rapid and uniform than is that of the 15 cm sensors. More importantly, however, and again in contrast with the burned site, at the end of April all four sensors start to dry out quickly and stay dry for the rest of the summer (with the brief exception of dramatic responses to rainfall events in late September and mid-November). Values for soil-water tension are considerably drier than the average value of -15 kPa measured at the burned site.

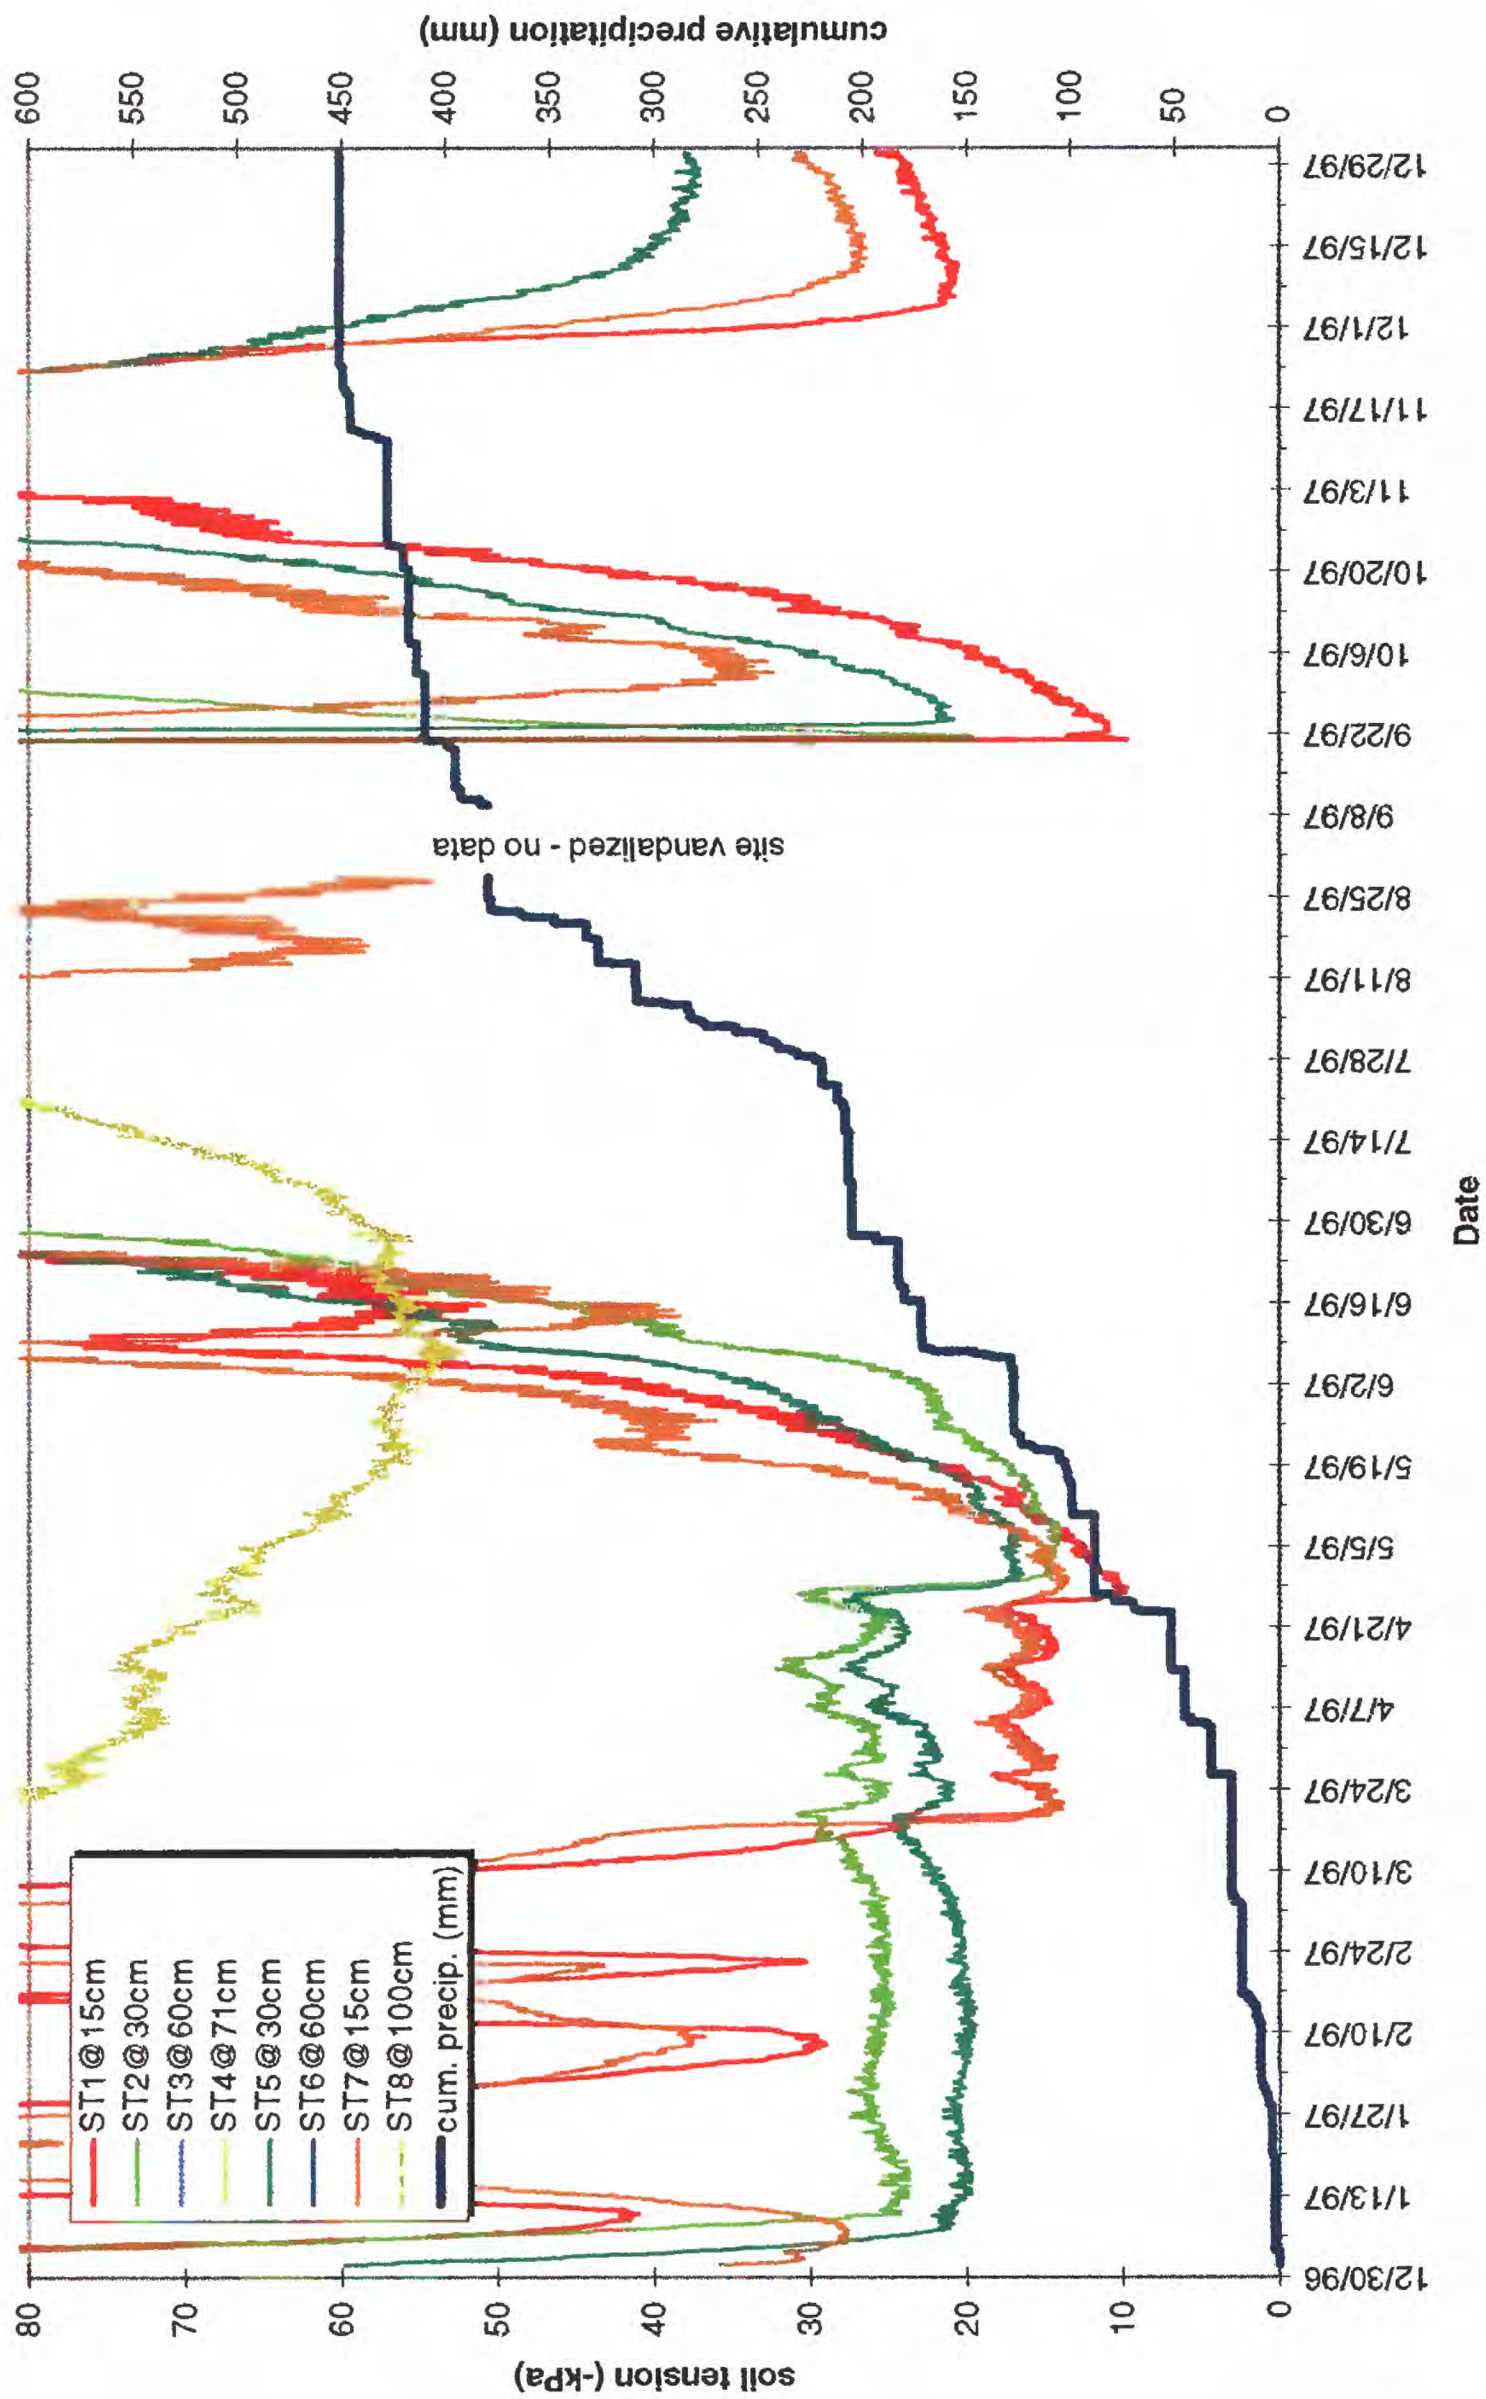
Figure 6B. Plot of cumulative precipitation and soil-tension measurements with time for IS-2 (unburned site) in 1997. ST refers to soil-moisture sensors. Data was not collected for a week in early September. Further, in late September, a rainfall accumulation of about 60 mm was measured at IS-1 which was not recorded at this site.
