LEVEL II SCOUR ANALYSIS FOR BRIDGE 64 (STOWTH00340064) on TOWN HIGHWAY 34, crossing RANCH BROOK, STOWE, VERMONT

Open-File Report 98-081

U.S. Geological Survey
Open-File Report 98-081

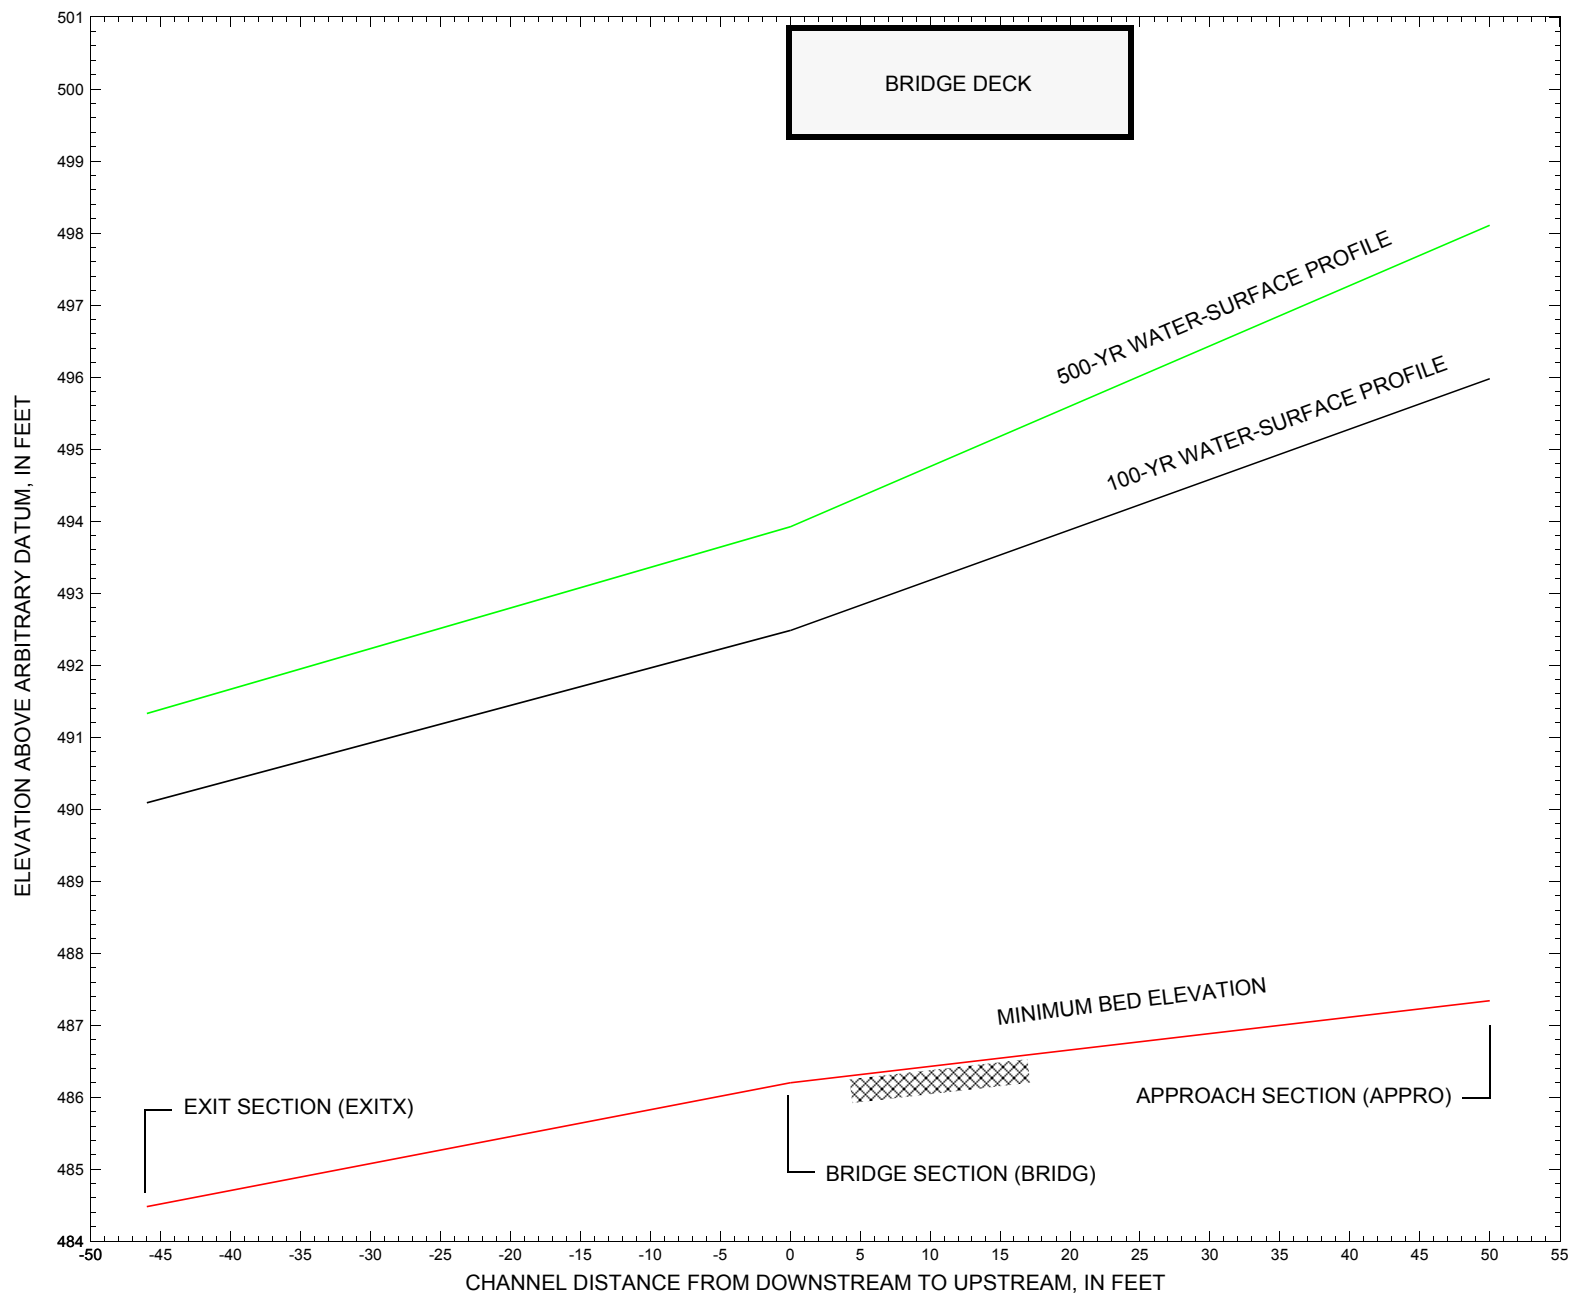
Figure 7. Water-surface profiles for the 100- and 500-yr discharges at structure STOWTH00340064 on Town Highway 34, crossing Ranch Brook, Stowe, Vermont.

Hydraulic analyses of the reach were done by use of the Federal Highway Administration's WSPRO step-backwater computer program (Shearman and others, 1986, and Shearman, 1990). The analyses reported herein reflect conditions existing at the site at the time of the study. Furthermore, in the development of the model it was necessary to assume no accumulation of debris or ice at the site. Results of the hydraulic model are presented in the Bridge Hydraulic Summary, appendix B, and figure 7.

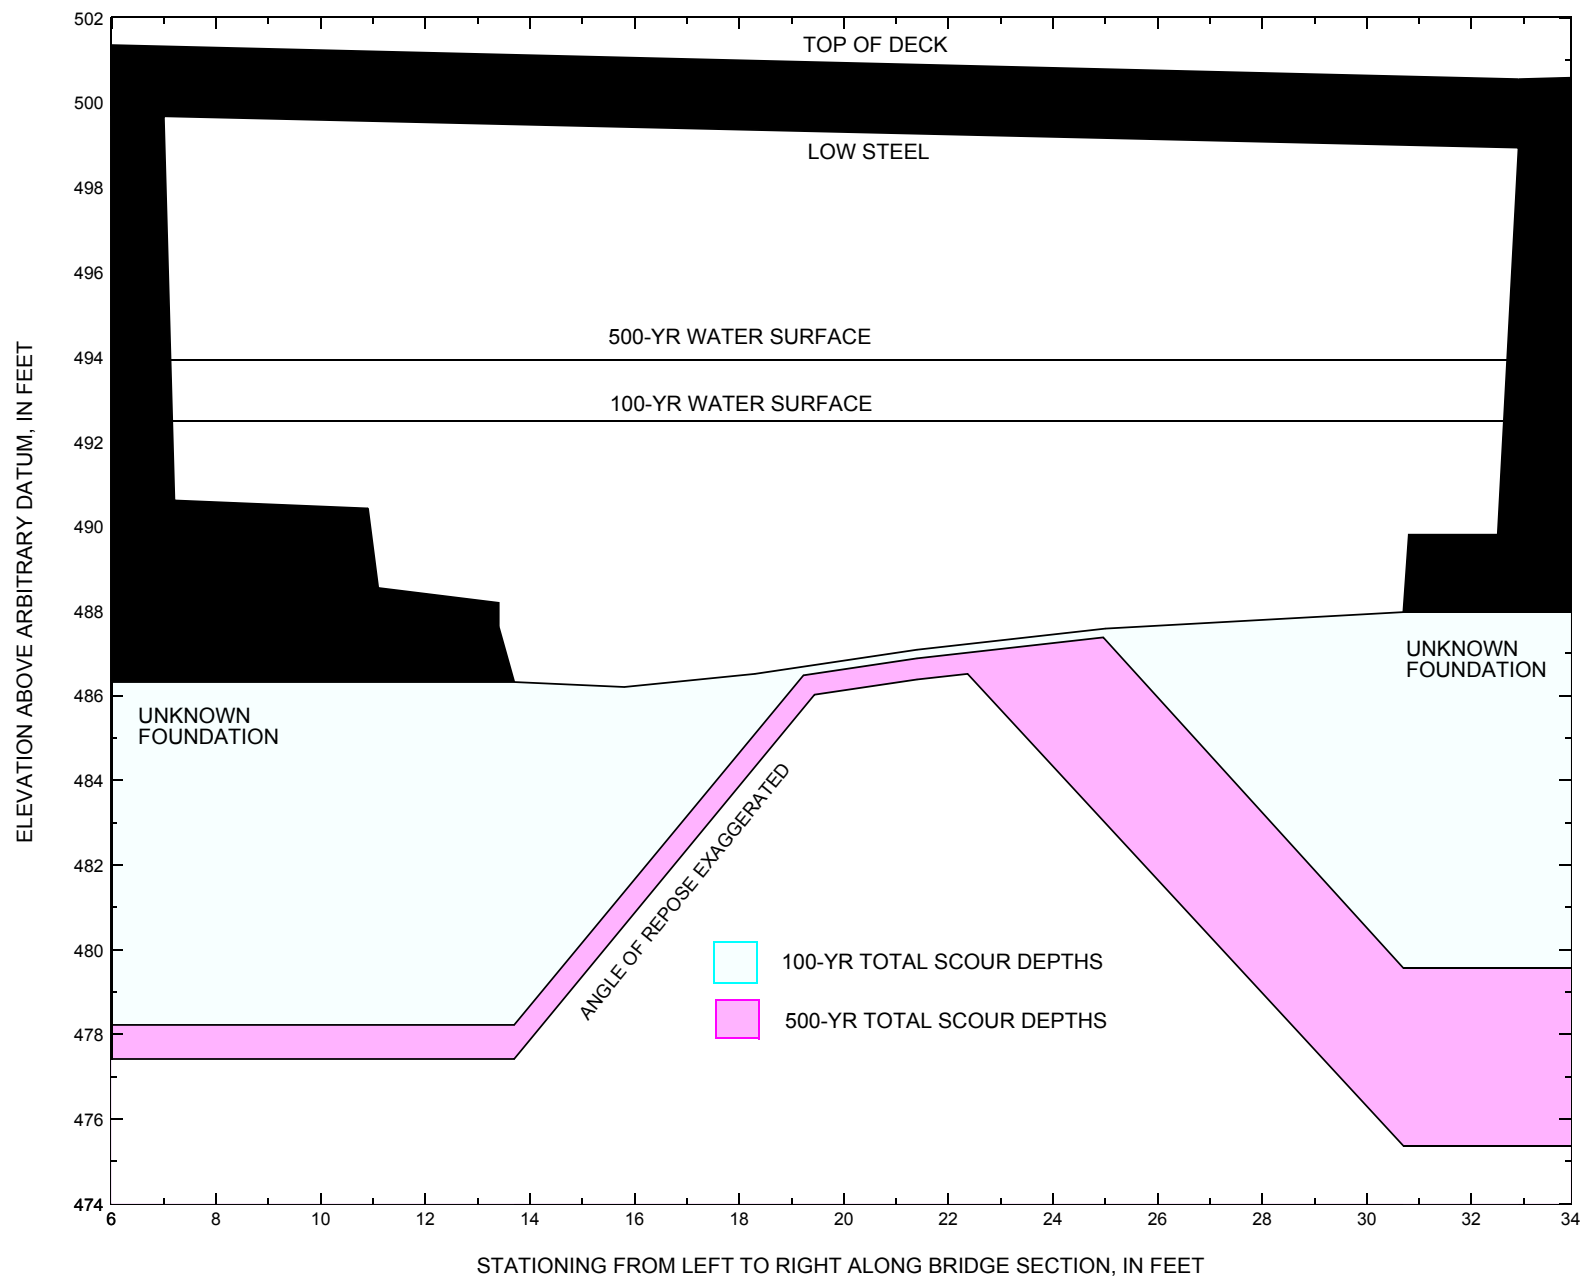
Figure 8. Scour elevations for the 100- and 500-yr discharges at structure STOWTH00340064 on Town Highway 34, crossing Ranch Brook, Stowe, Vermont.

Contraction scour for all modelled flows ranged from 0.2 to 0.7 ft. The worst-case contraction scour occurred at the 500-year discharge. Abutment scour ranged from 7.9 to 11.9 ft. The worst-case abutment scour occurred at the 500-year discharge. Additional information on scour depths and depths to armoring are included in the section titled “Scour Results”. Scoured-streambed elevations, based on the calculated scour depths, are presented in tables 1 and 2. A cross-section of the scour computed at the bridge is presented in figure 8. Scour depths were calculated assuming an infinite depth of erosive material and a homogeneous particle-size distribution.

Scour depths were computed using the general guidelines described in Hydraulic Engineering Circular 18 (Richardson and Davis, 1995). Scour depths were calculated assuming an infinite depth of erosive material and a homogeneous particle-size distribution. The results of the scour analysis for the 100- and 500- year discharges are presented in tables 1 and 2 and the scour depths are shown graphically in figure 8.
