LEVEL II SCOUR ANALYSIS FOR BRIDGE 29 (JAMATH00300029) on TOWN HIGHWAY 30, crossing BALL MOUNTAIN BROOK, JAMAICA, VERMONT

Open-File Report 98-88

Prepared in cooperation with
VERMONT AGENCY OF TRANSPORTATION
and
FEDERAL HIGHWAY ADMINISTRATION

U.S. Geological Survey
Open-File Report 98-88

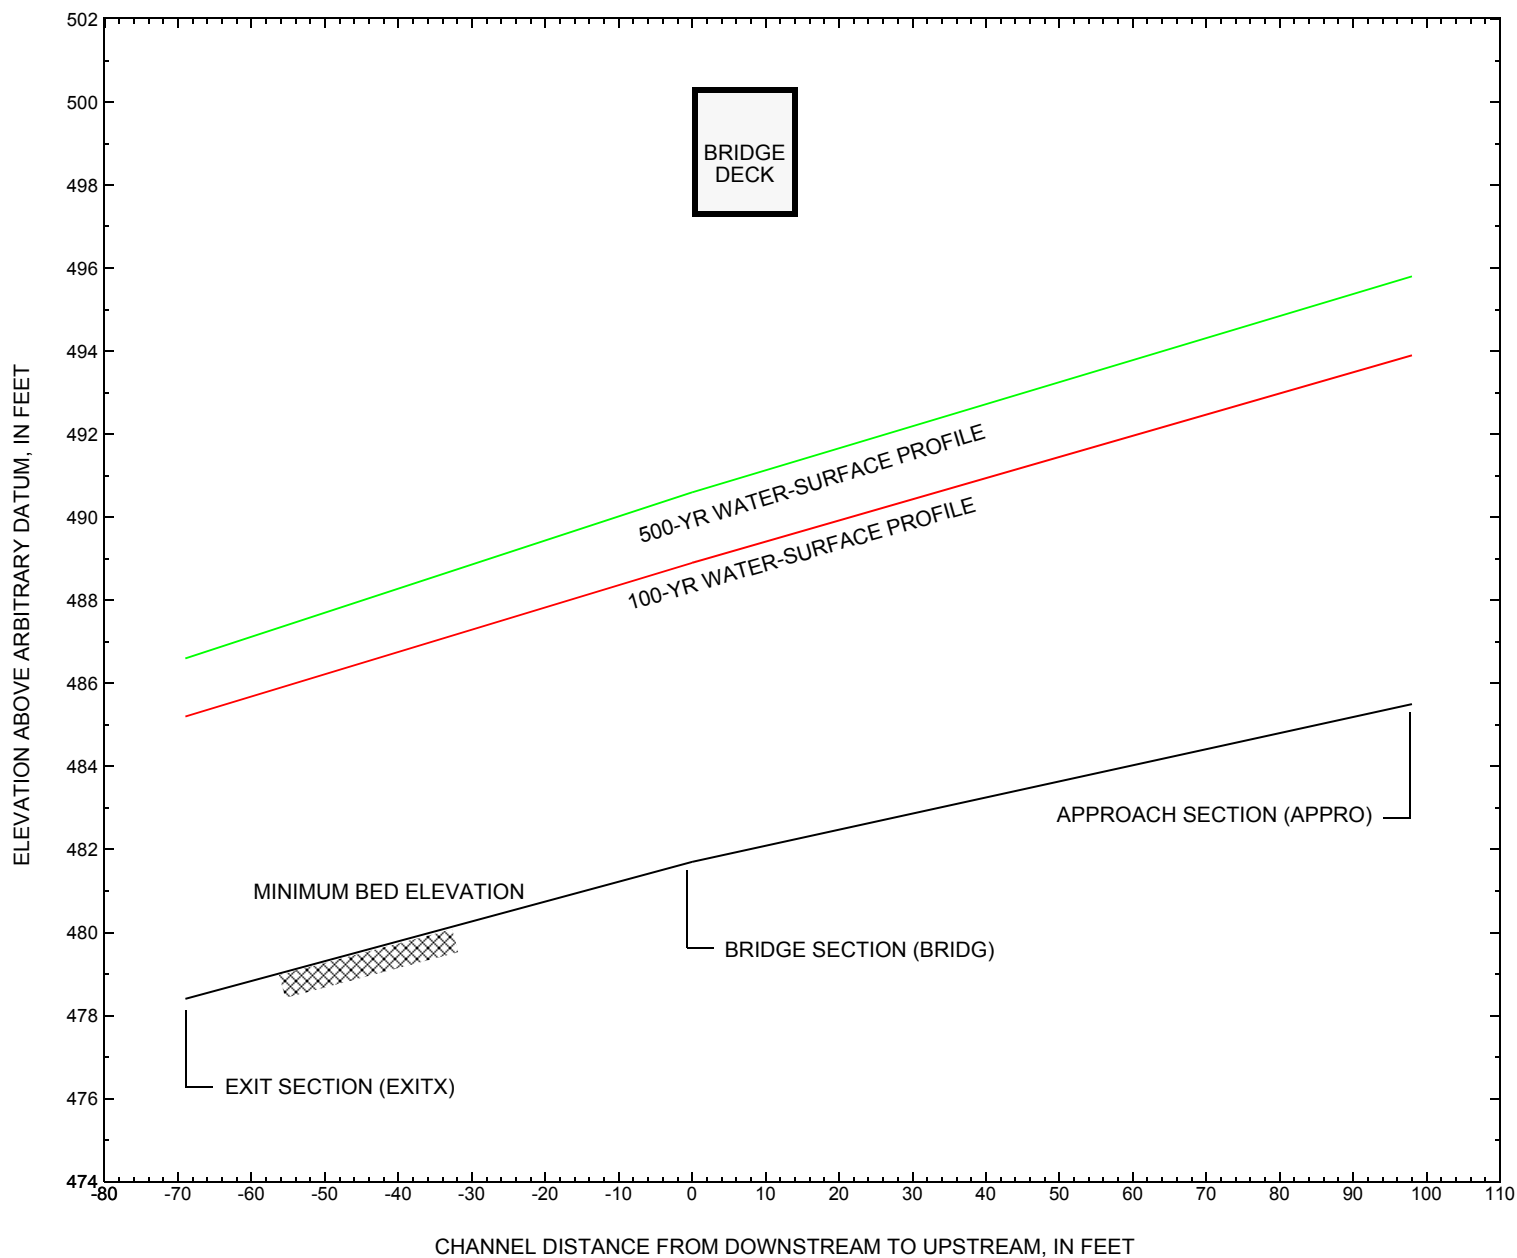
Figure 7. Water-surface profiles for the 100- and 500-yr discharges at structure JAMATH00300029 on Town Highway 30, crossing Ball Mountain Brook, Jamaica, Vermont.

100-year discharge 3,470 *ft³/s*
Water-surface elevation in bridge opening 488.9 *ft*
Road overtopping? No *Discharge over road* -- *ft³/s*
Area of flow in bridge opening 282 *ft²*
Average velocity in bridge opening 12.3 *ft/s*
Maximum WSPRO tube velocity at bridge 15.6 *ft/s*

Water-surface elevation at Approach section with bridge 493.9
Water-surface elevation at Approach section without bridge 491.8
Amount of backwater caused by bridge 2.1 *ft*

500-year discharge 5,200 *ft³/s*
Water-surface elevation in bridge opening 490.6 *ft*
Road overtopping? No *Discharge over road* -- *ft³/s*
Area of flow in bridge opening 383 *ft²*
Average velocity in bridge opening 13.6 *ft/s*
Maximum WSPRO tube velocity at bridge 17.4 *ft/s*

Water-surface elevation at Approach section with bridge 495.8
Water-surface elevation at Approach section without bridge 493.1
Amount of backwater caused by bridge 2.7 *ft*

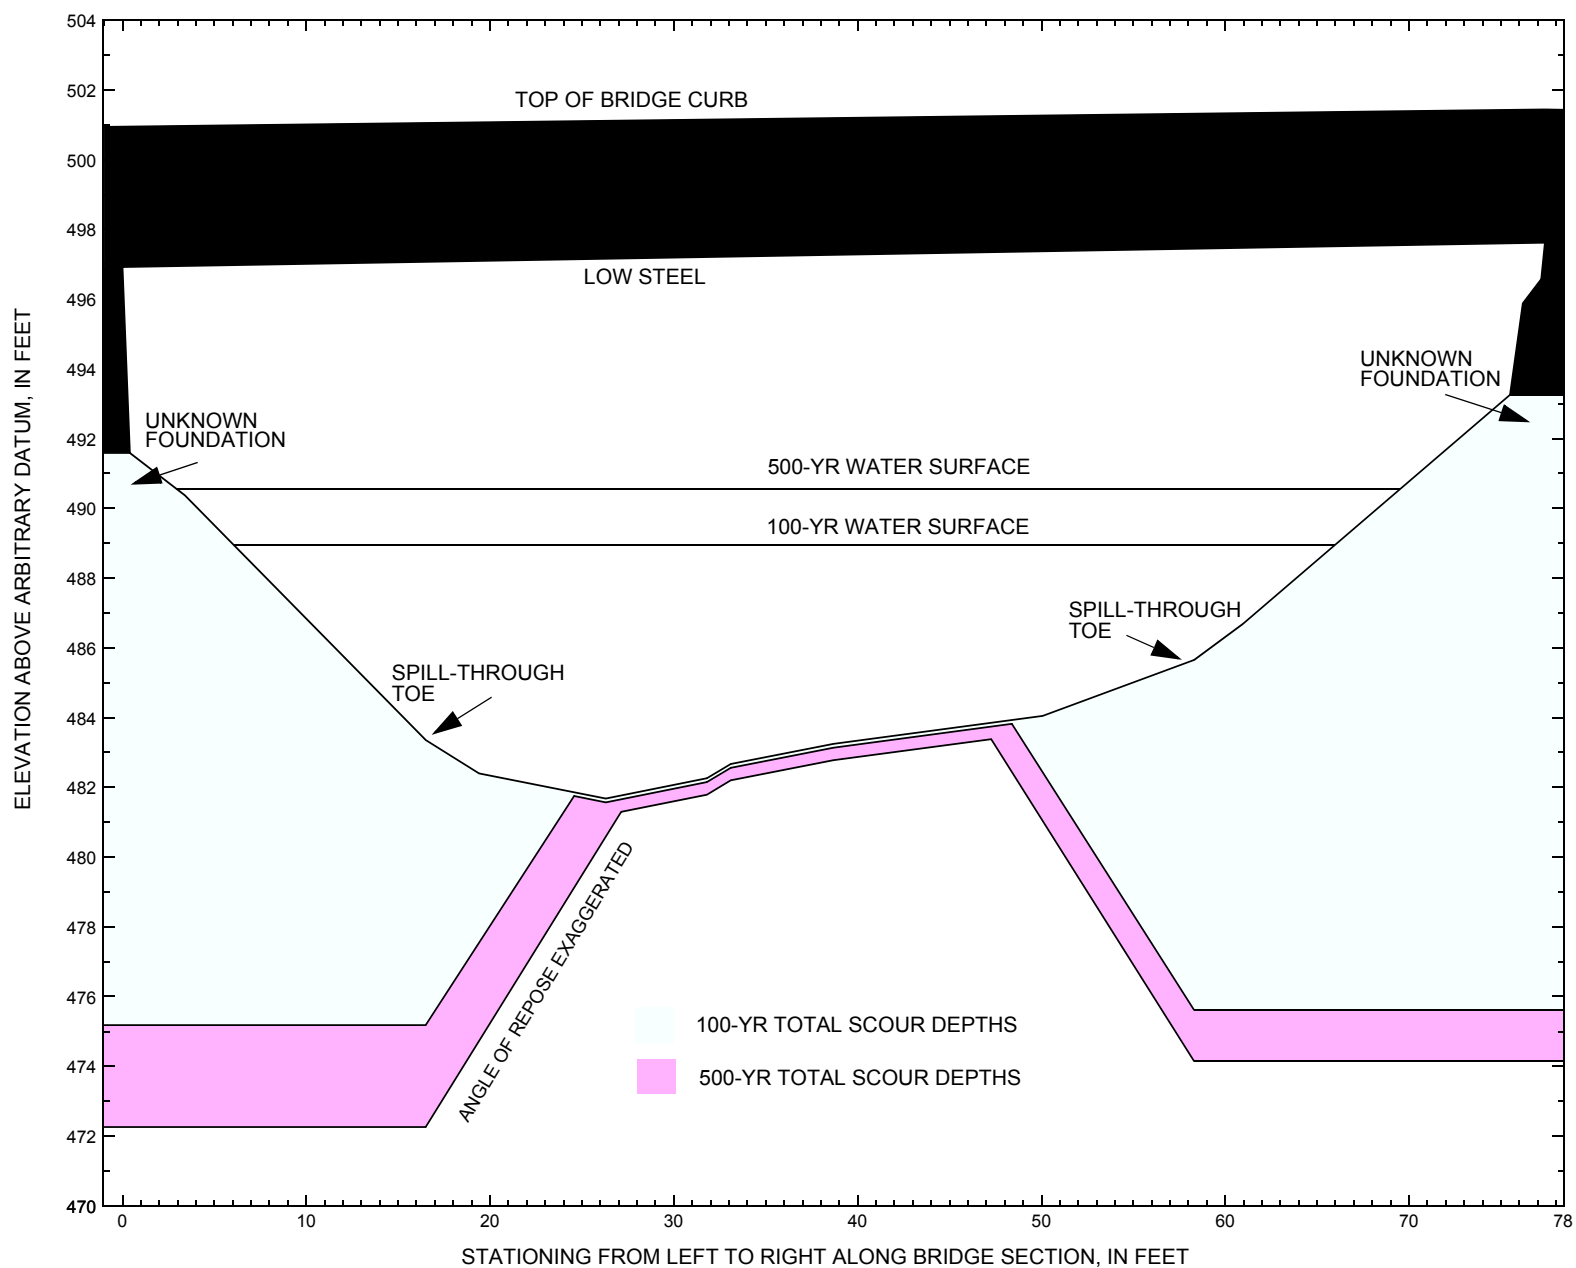
Figure 8. Scour elevations for the 100- and 500-yr discharges at structure JAMATH00300029 on Town Highway 30, crossing Ball Mountain Brook, Jamaica, Vermont.

Contraction scour for all modelled flows ranged from 0.1 ft to 0.5 ft. The worst-case contraction scour occurred at the 500-year discharge. Abutment scour ranged from 8.1 to 11.0 ft. The worst-case abutment scour occurred at the 500-year discharge. Additional information on scour depths and depths to armoring are included in the section titled “Scour Results”. Scoured-streambed elevations, based on the calculated scour depths, are presented in tables 1 and 2. A cross-section of the scour computed at the bridge is presented in figure 8. Scour depths were calculated assuming an infinite depth of erosive material and a homogeneous particle-size distribution.

Because the influence of scour processes on the spill-through embankment material is uncertain, the scour depth at the vertical laid-up stone abutment walls is unknown. Therefore, the total scour depth computed at the toe of the embankment was applied for the entire spill-through embankment, as shown in figure 8.

<i>Abutment scour</i>	8.1	10.6	--
<i>Left abutment</i>	9.9	11.0	--
<i>Right abutment</i>	--	--	--
<i>Pier scour</i>	--	--	--
<i>Pier 1</i>	--	--	--
<i>Pier 2</i>	--	--	--
<i>Pier 3</i>	--	--	--

<i>100-yr discharge</i>	<i>500-yr discharge</i>	<i>Incipient overtopping discharge</i>
	<i>(D₅₀ in feet)</i>		
<i>Abutments:</i>	2.1	2.7	--
<i>Left abutment</i>	2.1	2.7	--
<i>Right abutment</i>	--	--	--
<i>Piers:</i>	--	--	--
<i>Pier 1</i>	--	--	--
<i>Pier 2</i>	--	--	--
