LEVEL II SCOUR ANALYSIS FOR BRIDGE 65 (MTHOTH00120065) on TOWN HIGHWAY 12, crossing FREEMAN BROOK, MOUNT HOLLY, VERMONT

Open-File Report 98-161

U.S. Department of the Interior
U.S. Geological Survey

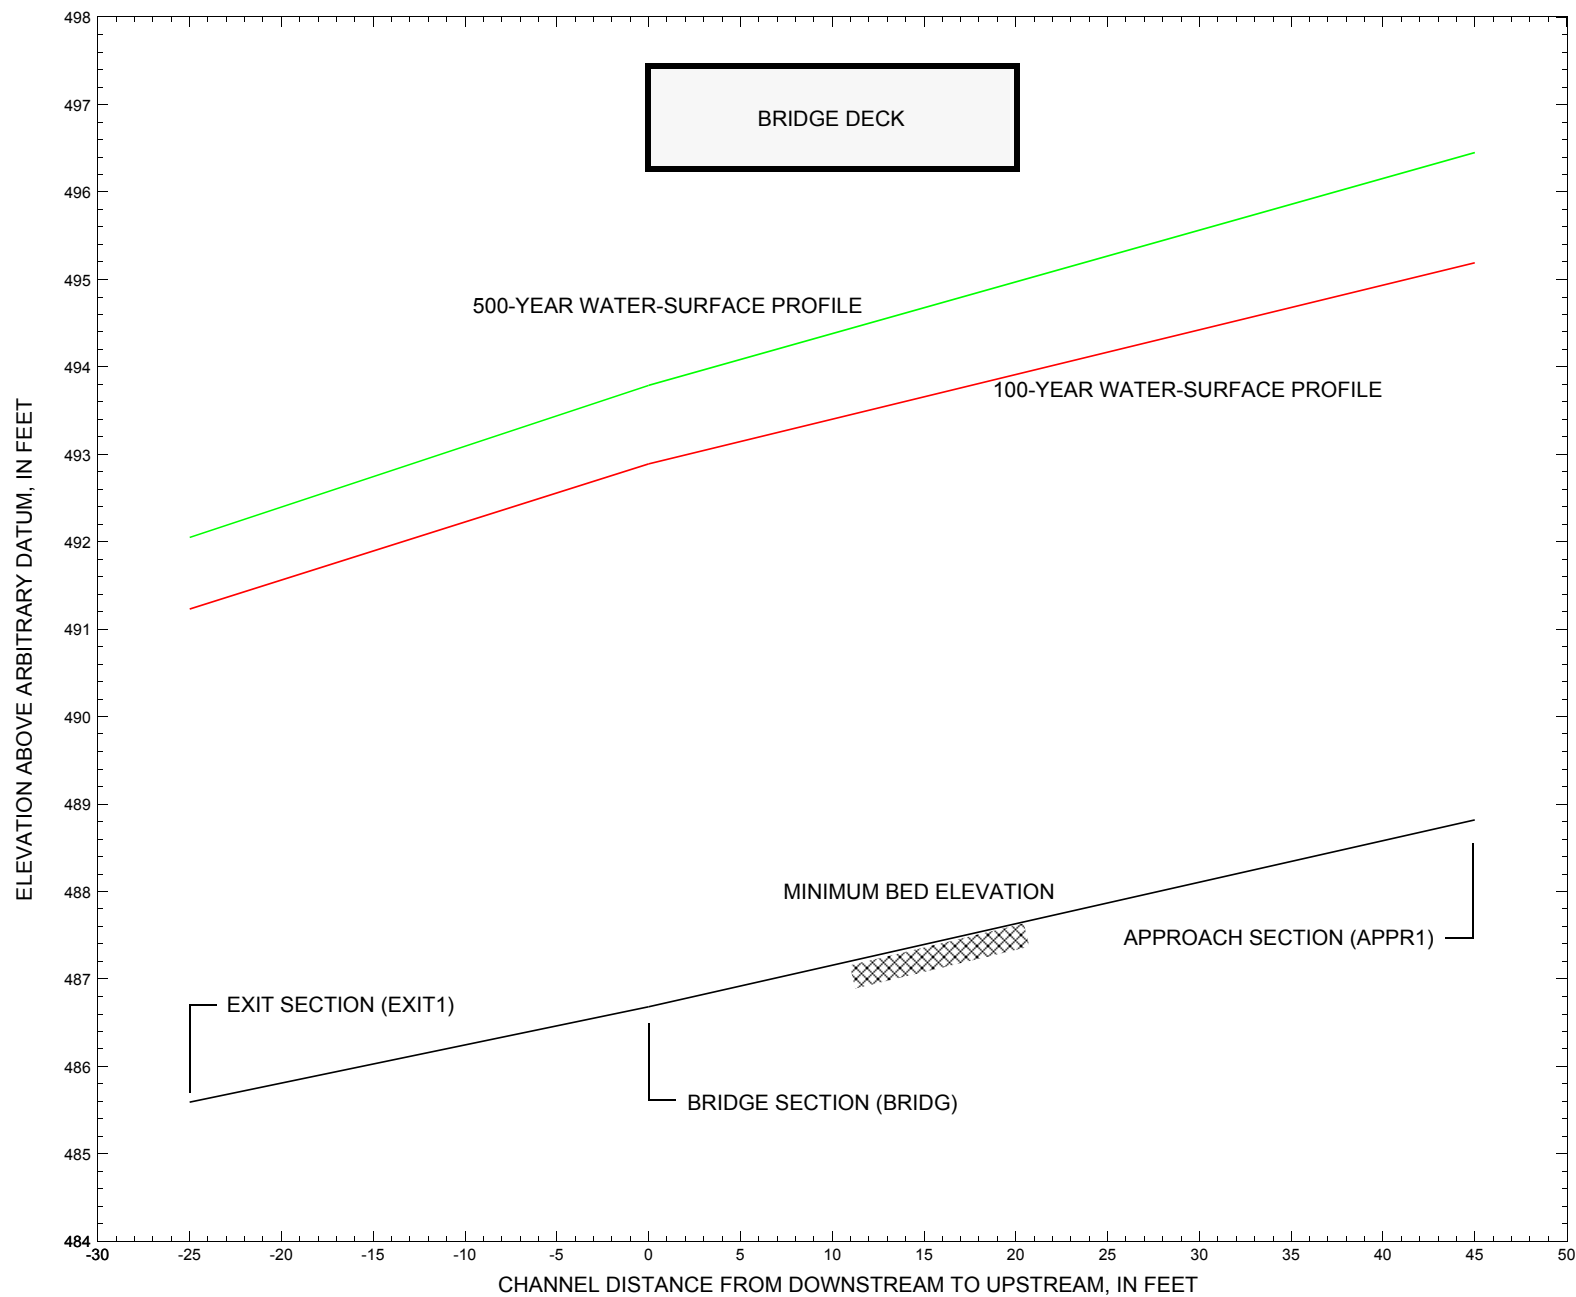
Figure 7. Water-surface profiles for the 100- and 500-year discharges at structure MTHOTH00120065 on Town Highway 12, crossing Freeman Brook, Mount Holly, Vermont.

100-year discharge 1,120 *ft³/s*
Water-surface elevation in bridge opening 492.9 *ft*
Road overtopping? No *Discharge over road* -- *ft³/s*
Area of flow in bridge opening 97 *ft²*
Average velocity in bridge opening 11.5 *ft/s*
Maximum WSPRO tube velocity at bridge 15.1 *ft/s*

500-year discharge 1,500 *ft³/s*
Water-surface elevation in bridge opening 493.8 *ft*
Road overtopping? No *Discharge over road* -- *ft³/s*
Area of flow in bridge opening 119 *ft²*
Average velocity in bridge opening 12.6 *ft/s*
Maximum WSPRO tube velocity at bridge 16.7 *ft/s*

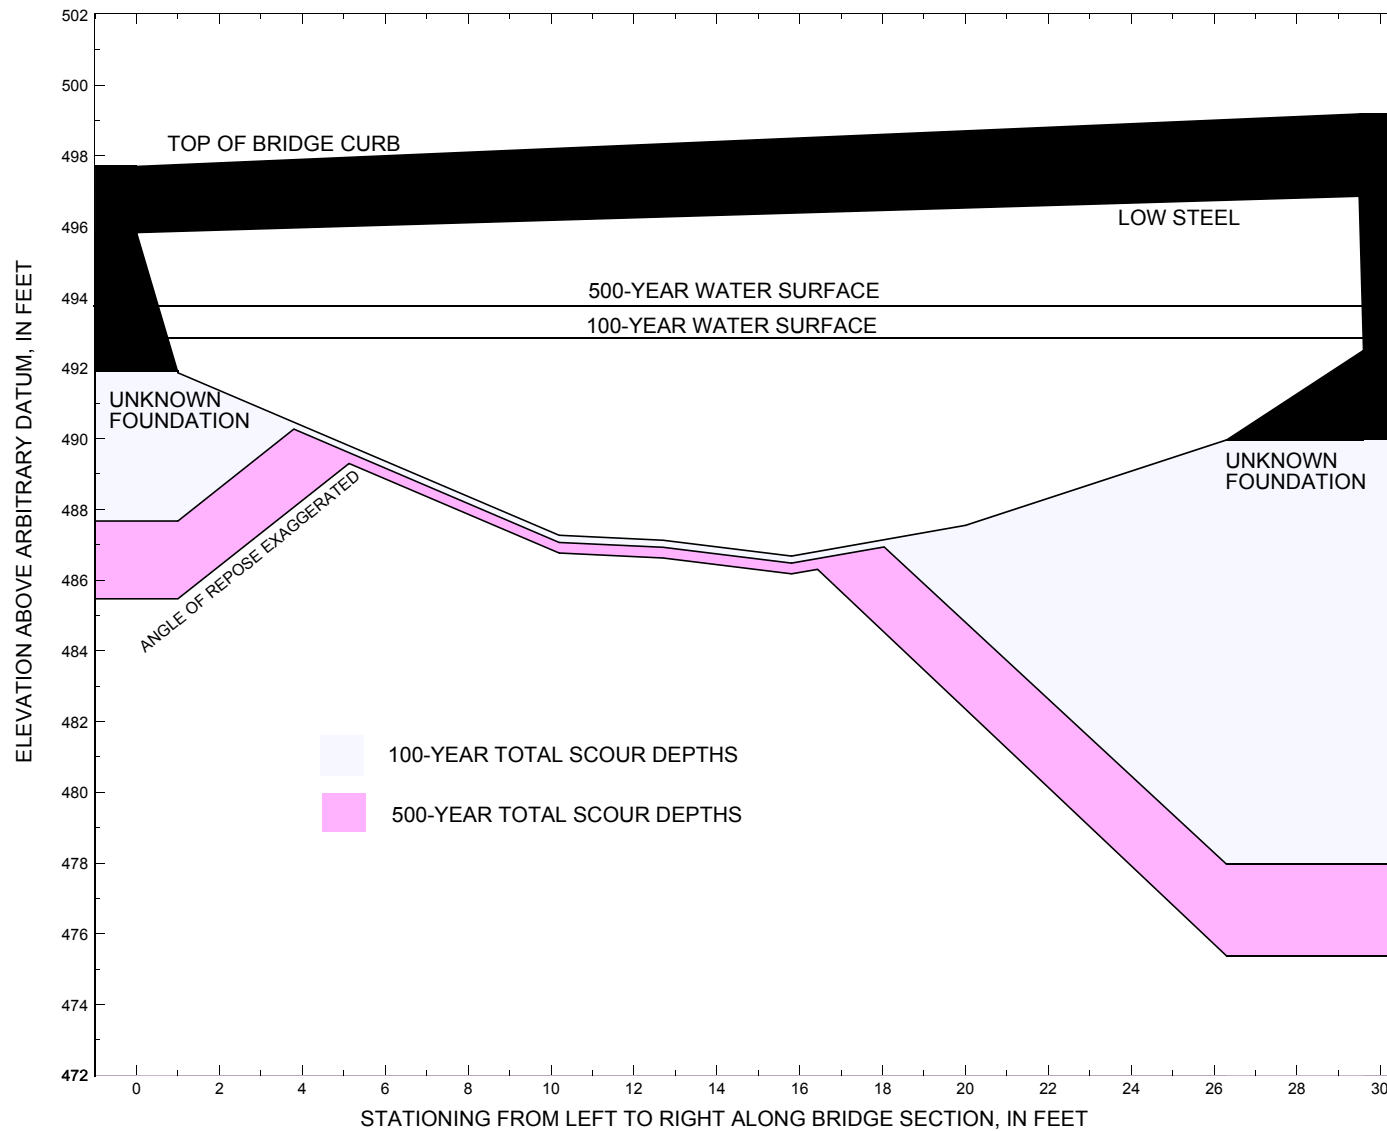
Figure 8. Scour elevations for the 100- and 500-year discharges at structure MTHOTH00120065 on Town Highway 12, crossing Freeman Brook, Mount Holly, Vermont.

Scour depths were computed using the general guidelines described in Hydraulic Engineering Circular 18 (Richardson and Davis, 1995). Scour depths were calculated assuming an infinite depth of erosive material and a homogeneous particle-size distribution. The results of the scour analyses for the 100- and 500-year discharges are presented in tables 1 and 2 and the scour depths are shown graphically in figure 8.

<i>Abutment scour</i>	4.0	5.9	--
<i>Left abutment</i>	11.8	14.1	--
<i>Right abutment</i>			
<i>Pier scour</i>	--	--	--
<i>Pier 1</i>	--	--	--
<i>Pier 2</i>	--	--	--
<i>Pier 3</i>

<i>100-year discharge</i>	<i>500-year discharge (D₅₀ in feet)</i>	<i>Incipient overtopping discharge</i>
<i>Abutments:</i>	1.7	2.1	--
<i>Left abutment</i>	1.7	2.1	--
<i>Right abutment</i>	--	--	--
<i>Piers:</i>	--	--	--
<i>Pier 1</i>	--	--	--
<i>Pier 2</i>
