# LEVEL II SCOUR ANALYSIS FOR BRIDGE 57 (NEWFTH00690057) on TOWN HIGHWAY 69, crossing HUNTER BROOK, NEWFANE, VERMONT

Open-File Report 98-193

By RONDA L. BURNS

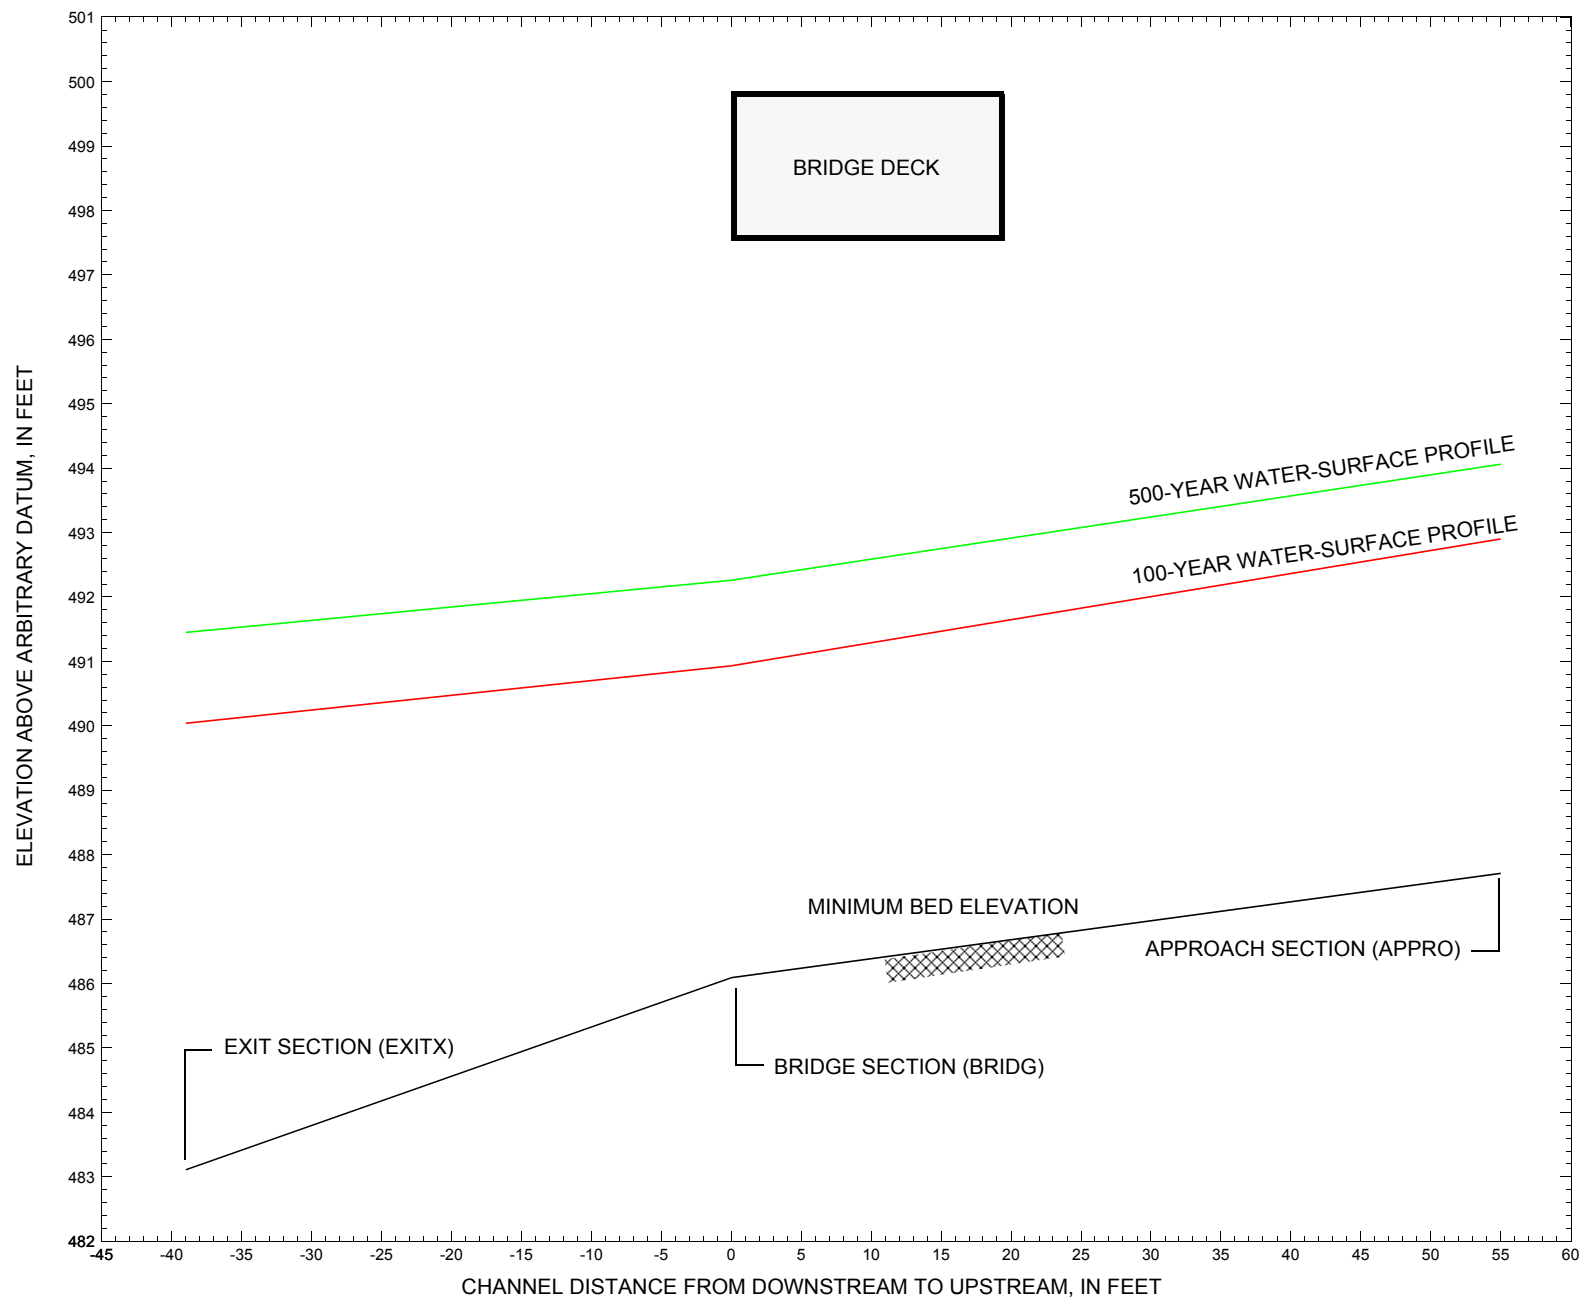
Figure 7. Water-surface profiles for the 100- and 500-year discharges at structure NEWFTH00690057 on Town Highway 69, crossing Hunter Brook, Newfane, Vermont.

For all modelled flows, the bridge was not a significant constriction in the channel. The WSPRO bridge routines failed to find a solution which balanced the total discharge and energy at the APPRO section with the sum of the discharges and energy over the roadway and through the bridge opening. Therefore, the bridge sections at the upstream and downstream faces were modelled as open channel sections. This allowed the model to evaluate flow conditions through the bridge and at the approach section as unconstricted.

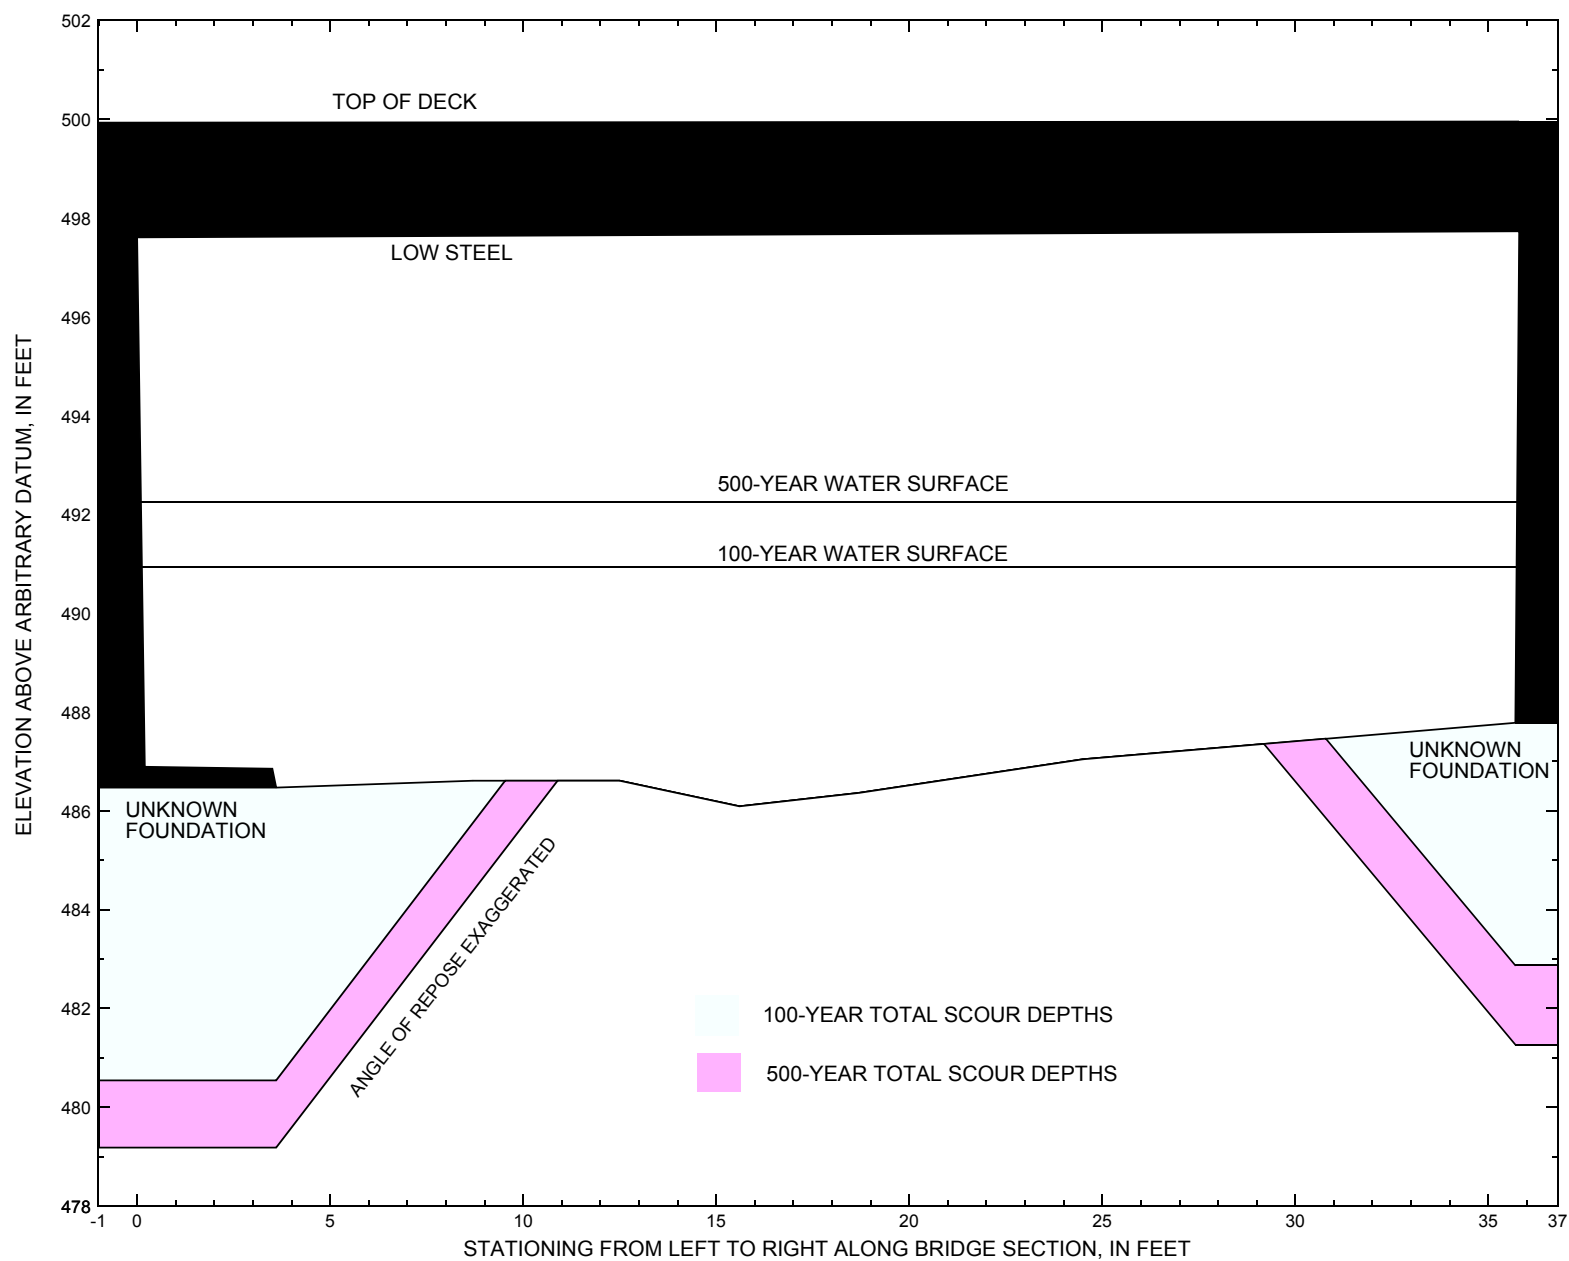
Figure 8. Scour elevations for the 100- and 500-year discharges at structure NEWFTH00690057 on Town Highway 69, crossing Hunter Brook, Newfane, Vermont.

Contraction scour computed for all modelled flows was zero ft. Abutment scour ranged from 4.9 to 7.3 ft. The worst-case abutment scour occurred at the 500-year discharge. Additional information on scour depths and depths to armoring are included in the section titled “Scour Results”. Scoured-streambed elevations, based on the calculated scour depths, are presented in tables 1 and 2. A cross-section of the scour computed at the bridge is presented in figure 8. Scour depths were calculated assuming an infinite depth of erosive material and a homogeneous particle-size distribution.

Scour depths were computed using the general guidelines described in Hydraulic Engineering Circular 18 (Richardson and Davis, 1995). Scour depths were calculated assuming an infinite depth of erosive material and a homogeneous particle-size distribution. The results of the scour analyses for the 100- and 500-year discharges are presented in tables 1 and 2 and the scour depths are shown graphically in figure 8.
