# LEVEL II SCOUR ANALYSIS FOR BRIDGE 67 (MTHOTH00120067) on TOWN HIGHWAY 12, crossing FREEMAN BROOK, MOUNT HOLLY, VERMONT

Open-File Report 98-401

By EMILY C. WILD and TIMOTHY SEVERANCE

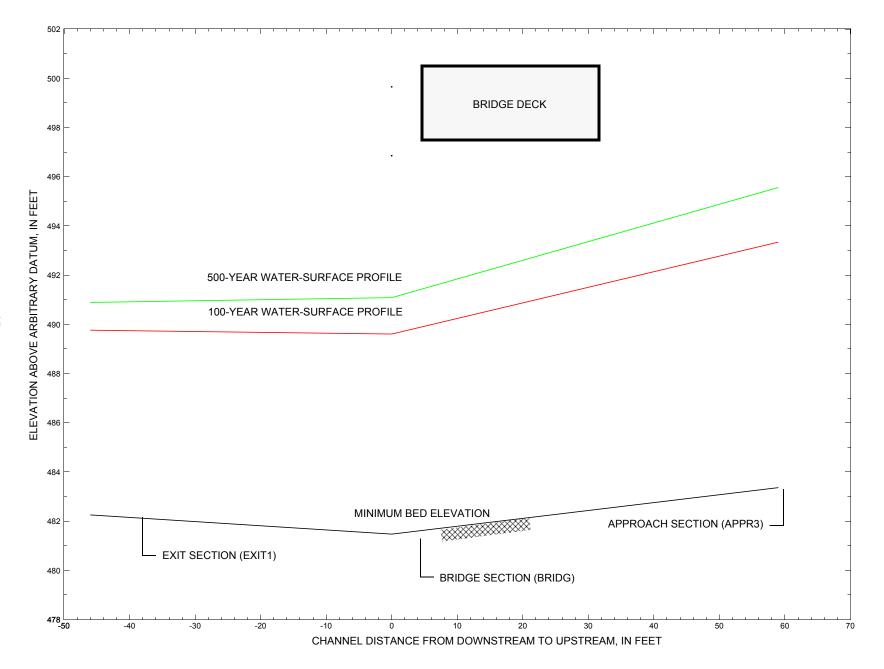
Figure 7. Water-surface profiles for the 100- and 500-year discharges at structure MTHOTH00120067 on Town Highway 12, crossing Freeman Brook, Mount Holly, Vermont.

Hydraulic analyses of the reach were done by use of the Federal Highway Administration's WSPRO step-backwater computer program (Shearman and others, 1986, and Shearman, 1990). The analyses reported herein reflect conditions existing at the site at the time of the study. Furthermore, in the development of the model it was necessary to assume no accumulation of debris or ice at the site. Results of the hydraulic model are presented in the Bridge Hydraulic Summary, appendix B, and figure 7.

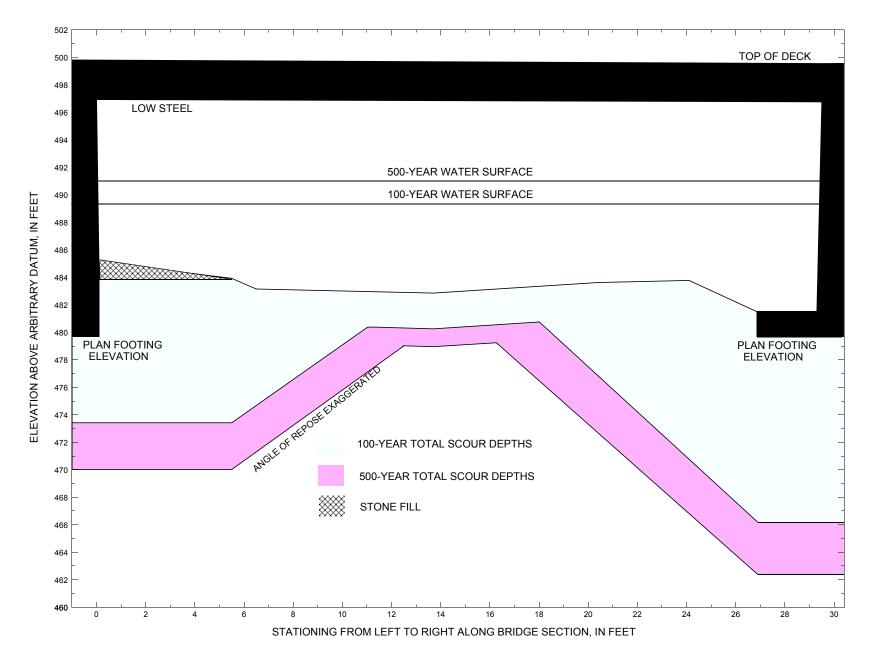
Figure 8. Scour elevations for the 100- and 500-year discharges at structure MTHOTH00120067 on Town Highway 12, crossing Freeman Brook, Mount Holly, Vermont.

Contraction scour for all modelled flows ranged from 2.6 to 3.9 ft. The worst-case contraction scour occurred at the 500-year discharge. Left abutment scour ranged from 7.9 to 10.0 ft. Right abutment scour ranged from 12.7 to 15.2 ft. The worst-case abutment scour occurred at the 500-year discharge. Additional information on scour depths and depths to armoring are included in the section titled "Scour Results". Scoured-streambed elevations, based on the calculated scour depths, are presented in tables 1 and 2. A cross-section of the scour computed at the bridge is presented in figure 8. Scour depths were calculated assuming an infinite depth of erosive material and a homogeneous particle-size distribution.

It is generally accepted that the Froehlich equation (abutment scour) gives "excessively conservative estimates of scour depths" (Richardson and Davis, 1995, p. 46). Usually, computed scour depths are evaluated in combination with other information including (but not limited to) historical performance during flood events, the geomorphic stability assessment, existing scour protection measures, and the results of the hydraulic analyses. Therefore, scour depths adopted by VTAOT may differ from the computed values documented herein.
