# LEVEL II SCOUR ANALYSIS FOR BRIDGE 47 (LYNDTH00360047) on TOWN HIGHWAY 36, crossing the EAST BRANCH PASSUMPSIC RIVER, LYNDON, VERMONT

Open-File Report 98-406

By LORA K. STRIKER AND TIMOTHY A. SEVERANCE

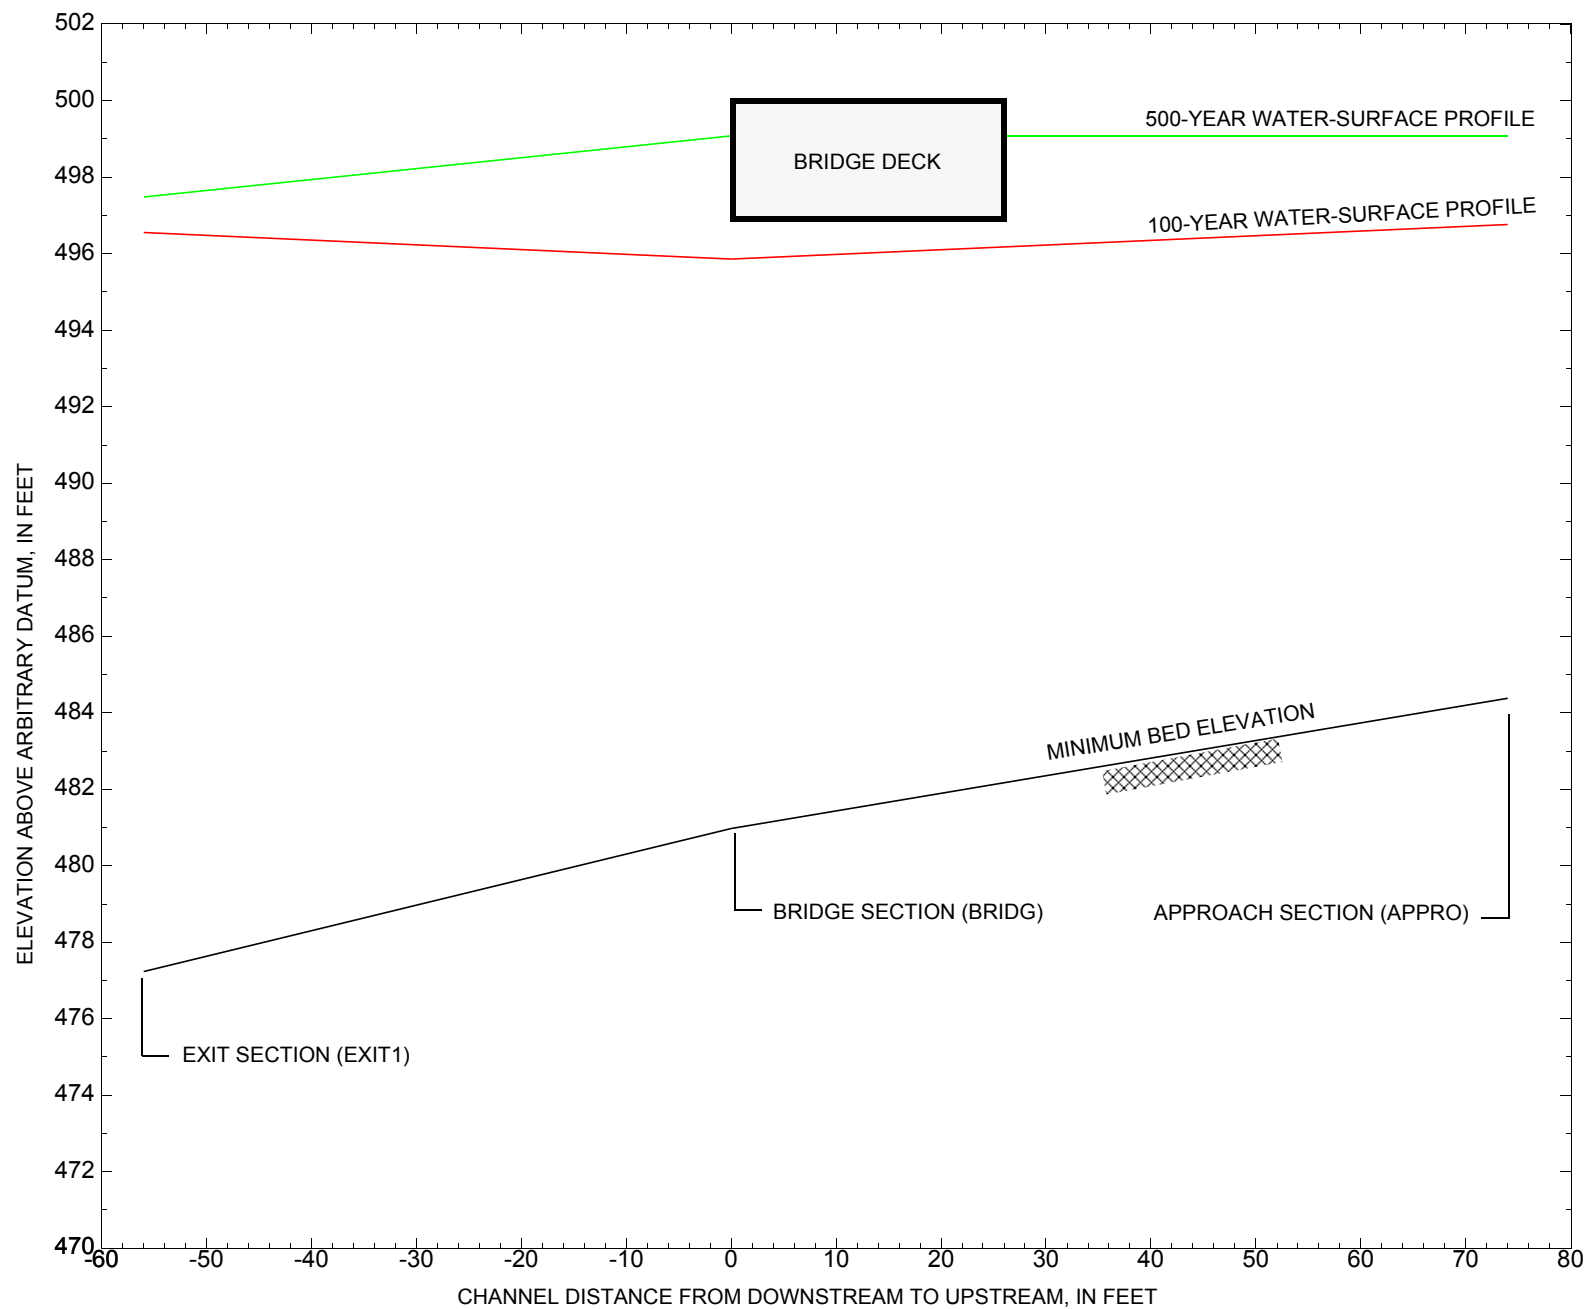
Figure 7. Water-surface profiles for the 100- and 500-year discharges at structure LYNDTH00360047 on Town Highway 36, crossing the East Branch Passumpsic River, Lyndon, Vermont.

Water-surface elevation at Approach section with bridge 496.8  
 Water-surface elevation at Approach section without bridge 496.4  
 Amount of backwater caused by bridge 0.4 ft

Water-surface elevation at Approach section with bridge 499.1  
 Water-surface elevation at Approach section without bridge 497.2  
 Amount of backwater caused by bridge 1.9 ft

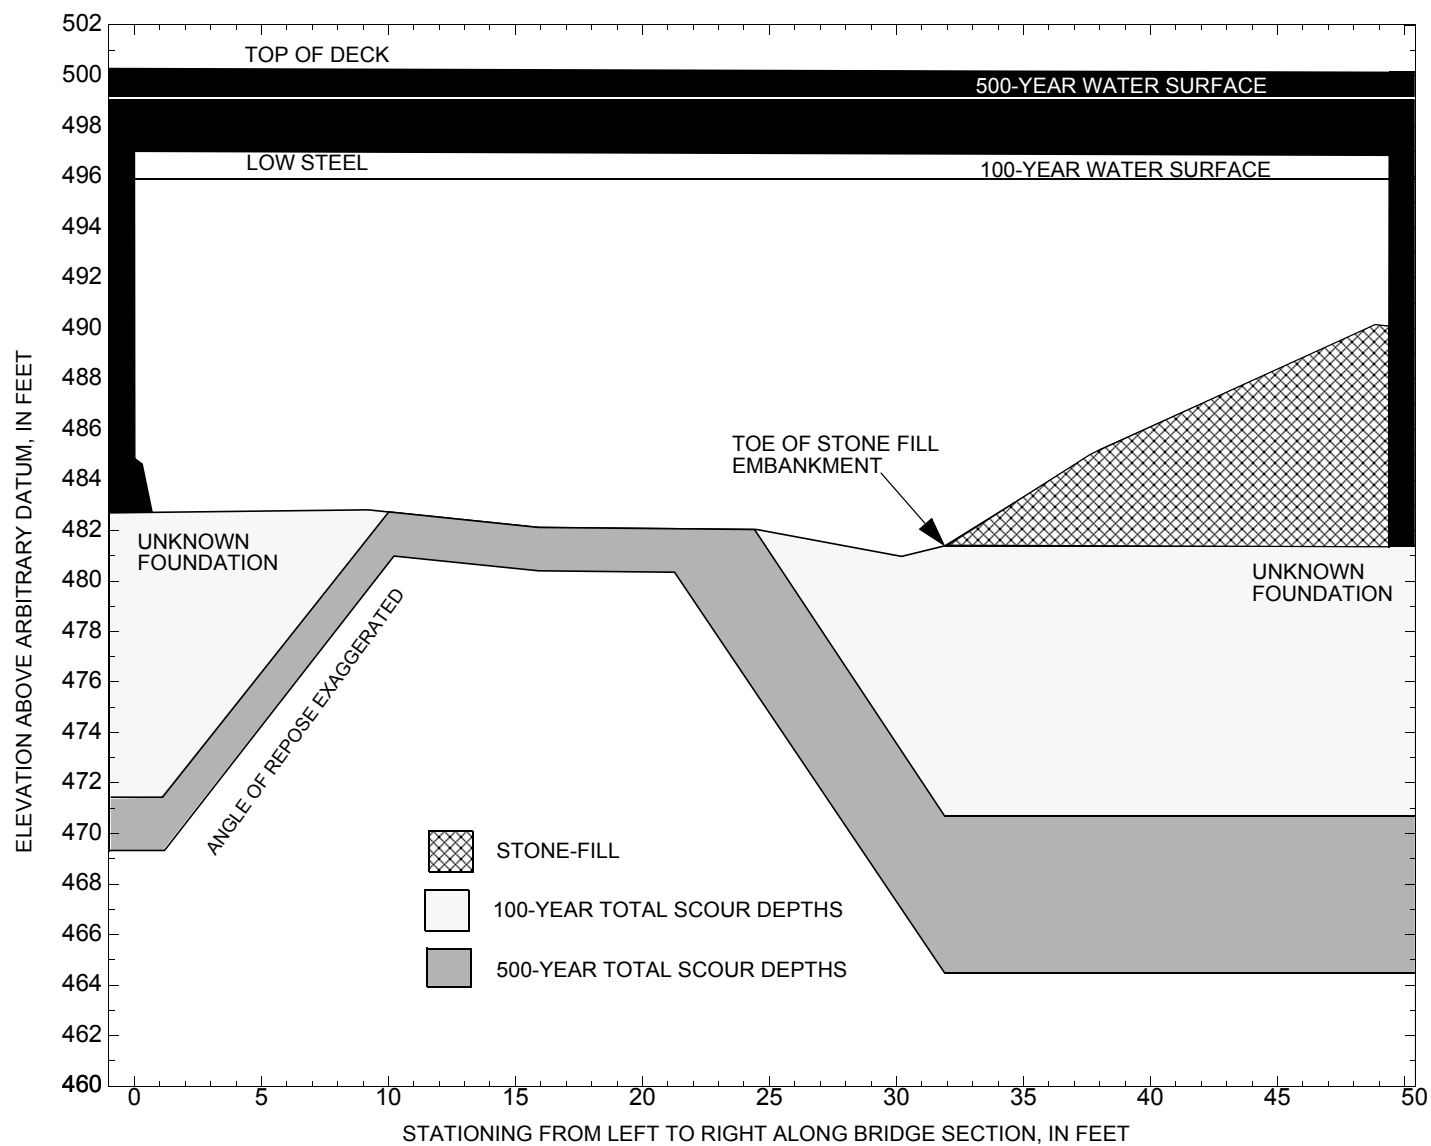
Figure 8. Scour elevations for the 100- and 500-year discharges at structure LYNDTH00360047 on Town Highway 36, crossing the East Branch Passumpsic River, Lyndon, Vermont.

Because the influence of scour processes on the stone fill embankment material at the right abutment is uncertain, the scour depth at the vertical concrete abutment wall is unknown. Therefore, the scour depth was applied for the entire stone fill embankment on the right abutment below the elevation at the toe of the embankment, as shown in figure 8.

<i>Abutment scour</i>	13.3	13.6	13.9
<i>Left abutment</i>	10.7	15.2	11.3
<i>Right abutment</i>			
<i>Pier scour</i>	--	--	--
<i>Pier 1</i>	--	--	--
<i>Pier 2</i>	--	--	--
<i>Pier 3</i>
