LEVEL II SCOUR ANALYSIS FOR
BRIDGE 32 (BURKTH00440032) on
TOWN HIGHWAY 44, crossing
ROUNDY BROOK,
BURKE, VERMONT

Open-File Report 98-554

U.S. Geological Survey
Open-File Report 98-554

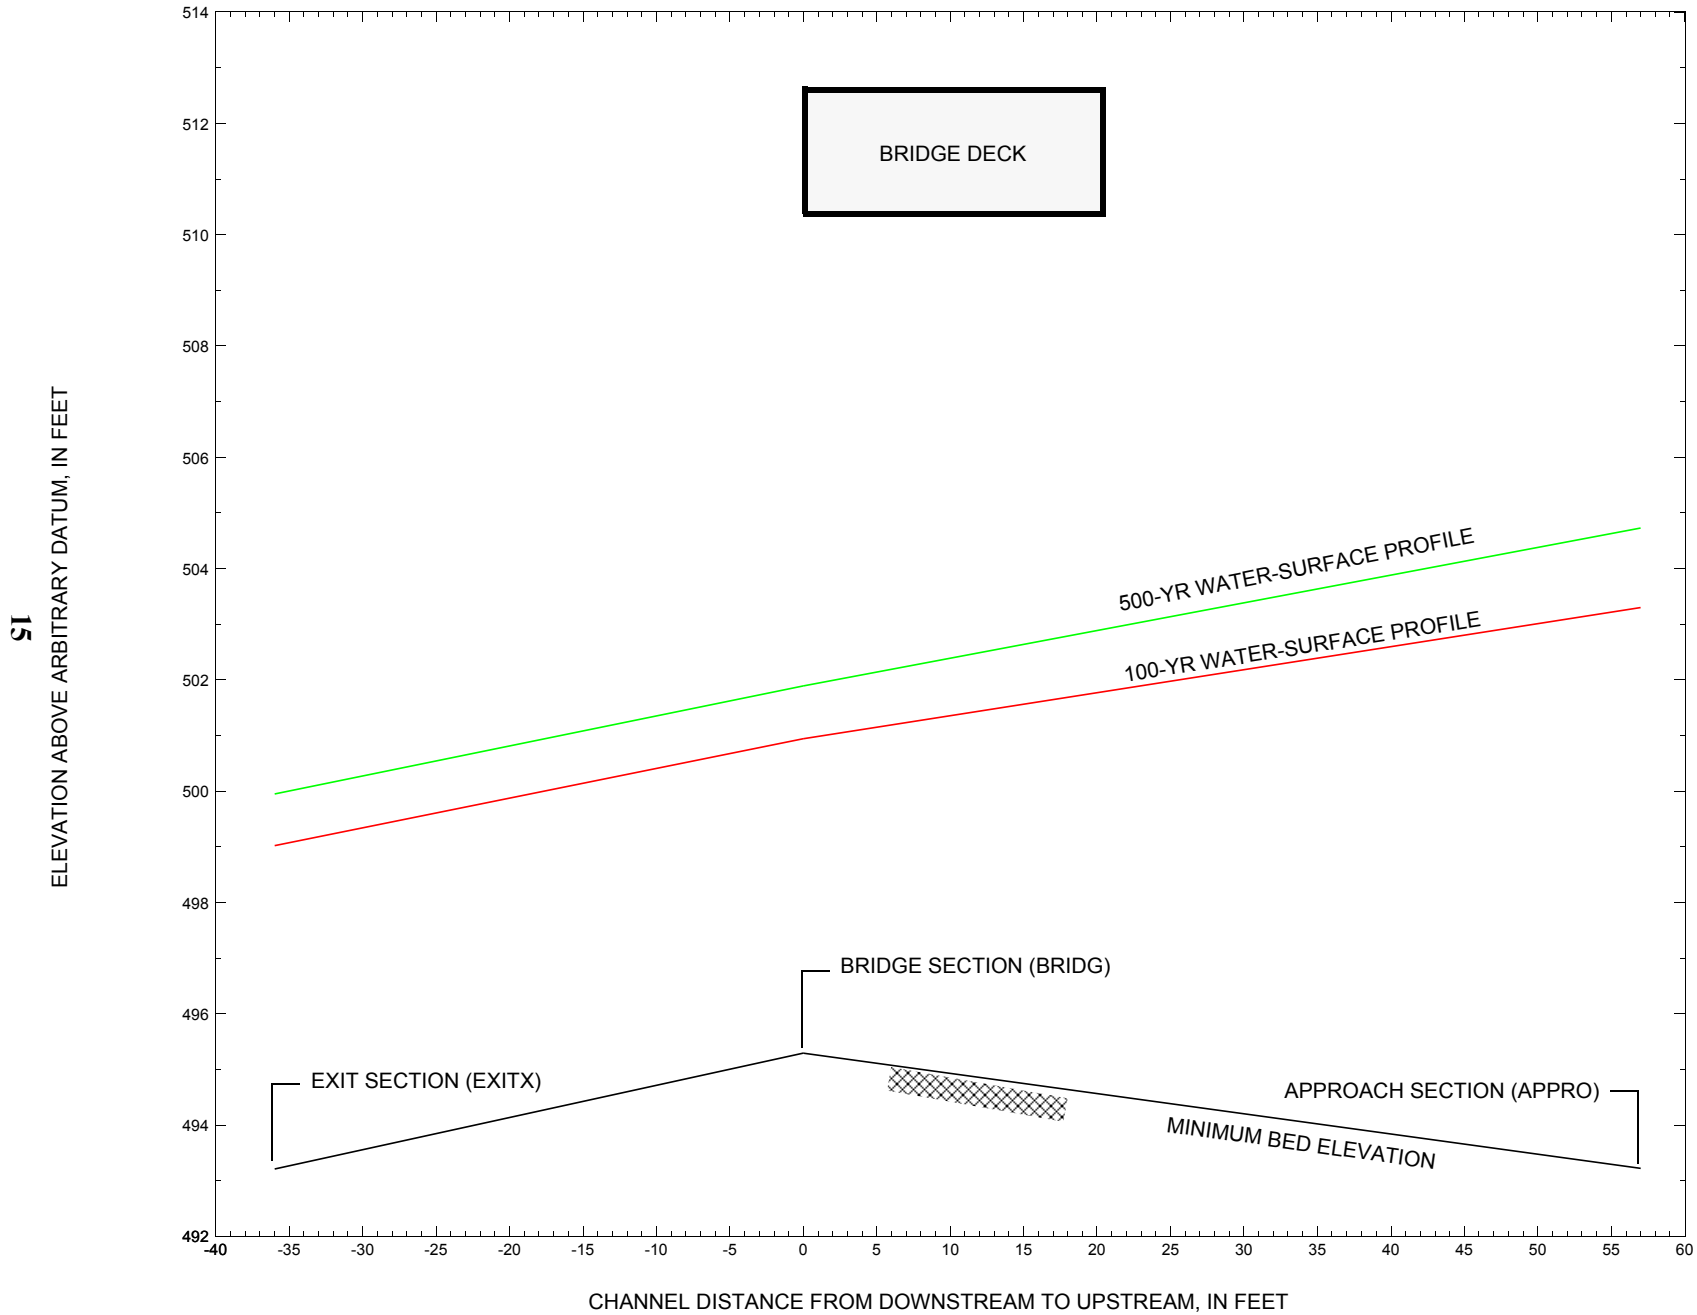
Figure 7. Water-surface profiles for the 100- and 500-year discharges at structure BURKTH00440032 on Town Highway 44, crossing Roundy Brook, Burke, Vermont.

Water-surface elevation at Approach section with bridge 503.3
Water-surface elevation at Approach section without bridge 501.7
Amount of backwater caused by bridge 1.6 *ft*

Water-surface elevation at Approach section with bridge 504.7
Water-surface elevation at Approach section without bridge 503.0
Amount of backwater caused by bridge 1.7 *ft*

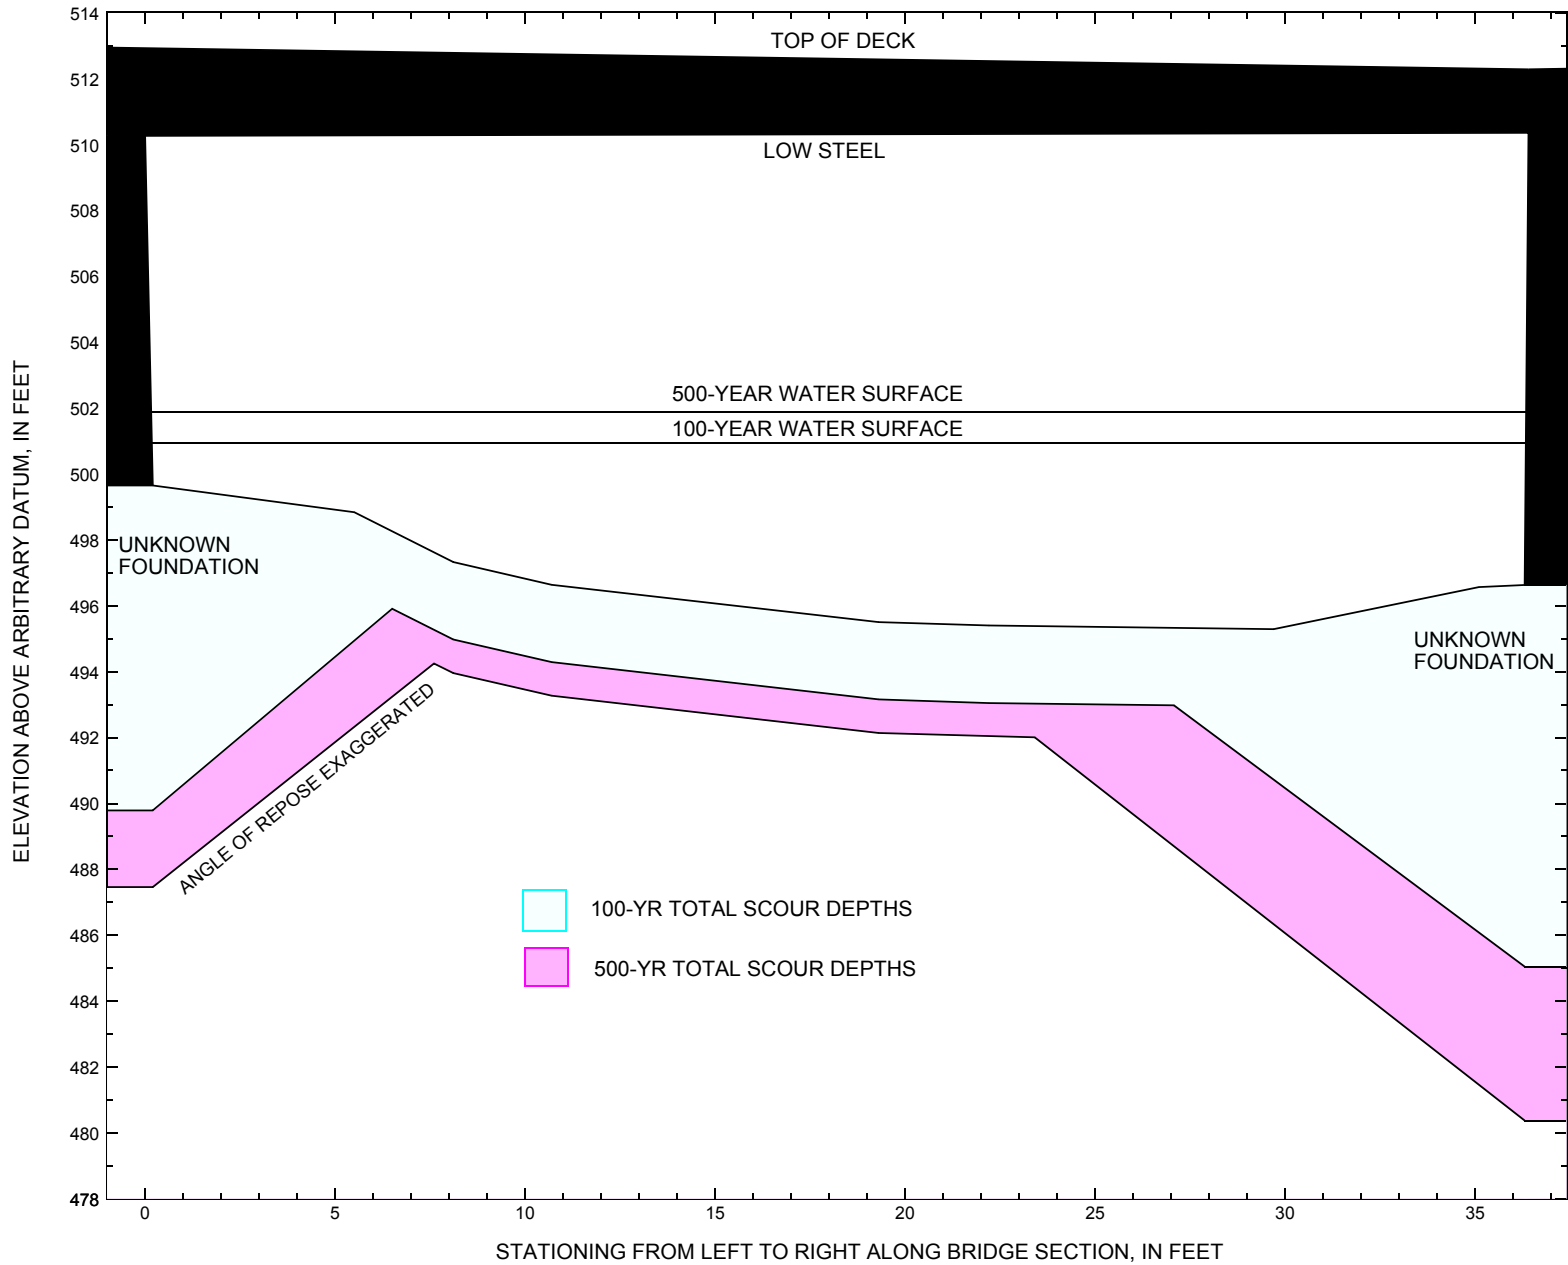
Figure 8. Scour elevations for the 100-year and 500-year discharges at structure BURKTH00440032 on Town Highway 44, crossing Roundy Brook, Burke, Vermont.

Contraction scour for all modelled flows ranged from 2.4 to 3.4 ft. The worst-case contraction scour occurred at the 500-year discharge. Abutment scour ranged from 7.5 to 12.9 ft. The worst-case abutment scour occurred at the 500-year discharge. Additional information on scour depths and depths to armoring are included in the section titled “Scour Results”. Scoured-streambed elevations, based on the calculated scour depths, are presented in tables 1 and 2. A cross-section of the scour computed at the bridge is presented in figure 8. Scour depths were calculated assuming an infinite depth of erosive material and a homogeneous particle-size distribution.

Scour depths were computed using the general guidelines described in Hydraulic Engineering Circular 18 (Richardson and Davis, 1995). Scour depths were calculated assuming an infinite depth of erosive material and a homogeneous particle-size distribution. The results of the scour analyses for the 100- and 500-year discharges are presented in tables 1 and 2 and the scour depths are shown graphically in figure 8.

<i>100-yr discharge</i>	<i>500-yr discharge</i>	<i>Incipient overtopping discharge</i>
	<i>(D₅₀ in feet)</i>		
<i>Abutments:</i>	--	1.8	2.2
<i>Left abutment</i>	-----	-----	-----
<i>Right abutment</i>	--	--	--
<i>Piers:</i>	--	--	--
<i>Pier 1</i>	-----	-----	-----
<i>Pier 2</i>	--	--	--
