Assessment of Landslide Hazards in Kaluanui and Maakua Gulches, Oahu, Hawaii, following the 9 May 1999 Sacred Falls Landslide

By Randall W. Jibson *and* Rex L. Baum

Open-File Report 99-364

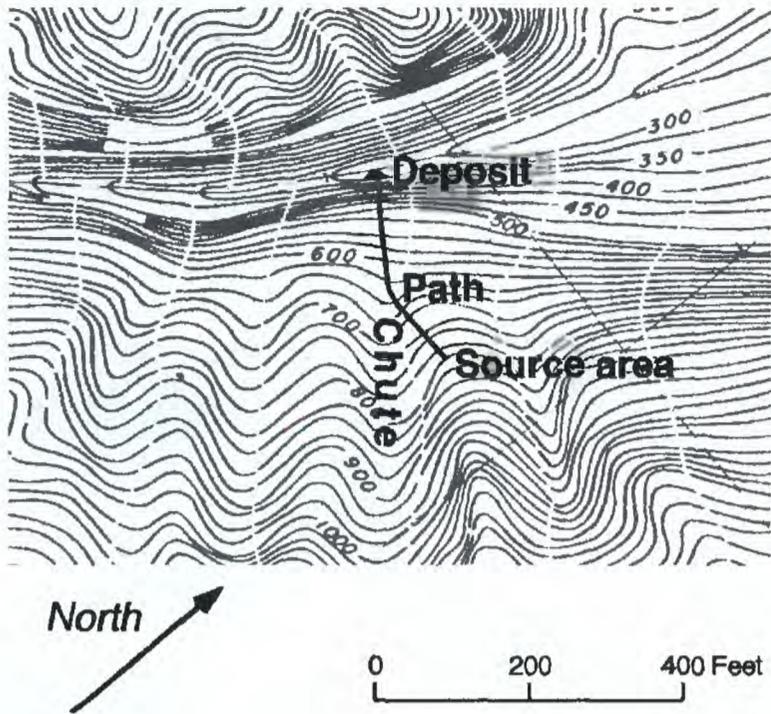
Figure 2. Topographic map showing approximate source area and path of 9 May rock fall (from Hawaii Department of Land and Natural Resources, contour interval 25 feet). Location shown in Figure 1.

The landslide material cascaded down a 70°-80° slope and entered a dry waterfall chute that points directly at the downstream end of the plunge pool at the base of Sacred Falls. The lip of this waterfall chute is at an elevation of about 470 feet; below this point the chute forms a slight overhang with its surface being 2°-4° out of vertical. Below the lip of the waterfall chute, the landslide debris would have lost contact with the ground surface and been in free fall over the last part of its descent to the impact area at the edge of the pool at the base of Sacred Falls, which lies at an elevation of about 320 feet. Thus, the landslide material fell a total of about 480 feet: the first 330 feet it cascaded down a precipitously steep waterfall chute, and the last 150 feet it was airborne and fell straight down to the impact zone. The landslide debris thus would have been traveling at a very high speed when it hit the impact area, probably 100-150 feet/second (about 70-100 miles/hour).

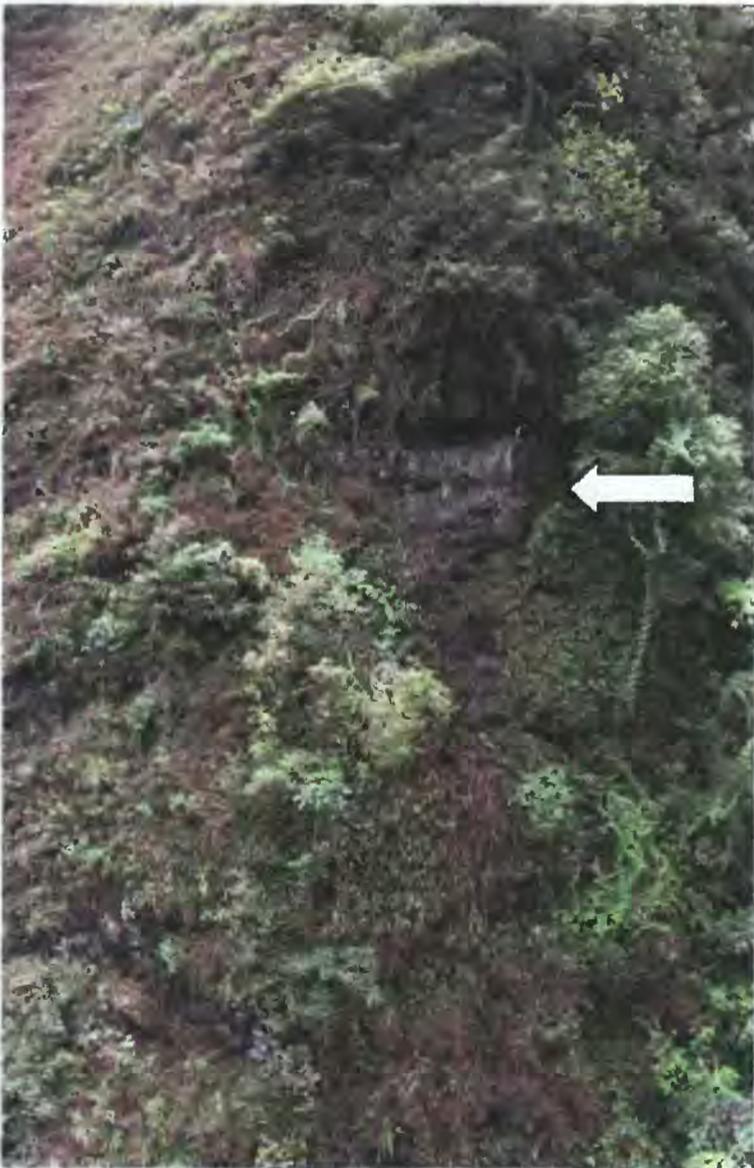
The Sacred Fall landslide is properly classified as a rock fall. The source of the Sacred Falls rock fall of 9 May 1999 is at an elevation of about 800 feet above sea level on the southeast canyon wall directly above the plunge pool of Sacred Falls (Figure 2). The source is easily visible because it is the only place on that part of the slope where there is no vegetation and fresh rock is exposed (Figure 3). The source area consists of a scar of freshly exposed rock about 15-20 feet wide by 10 feet high on a nearly vertical slope. The thickness of the slab of rock that failed appears to have been about 3-6 feet. The source is on a part of the valley wall that forms a promontory. Above the scar is a 3-foot overhang of intact rock that was created when the landslide material fell from beneath it. Below the scar is a track of uprooted or otherwise disturbed vegetation and impact marks left by the falling landslide material.

Figure 3. Source area (indicated by arrow) of Sacred Falls rock fall.

We saw no indication of additional potential landslide material near the source of the Sacred Falls landslide that appeared particularly likely to fall in the immediate future. The scar is relatively clean and free from loose debris that could come down in the aftermath of the main landslide. There may be additional rock fragments trapped in the vegetation along the landslide track that could come down during rainstorms, but such fragments, if they exist, are probably small and few in number. The overhang created by the landslide is certainly less stable than before the landslide, but it appears to be firmly anchored to the slope, and we saw no fractures or other indications of impending failure. However, this newly created overhang should be periodically inspected for fresh cracks or other indications of potential instability.

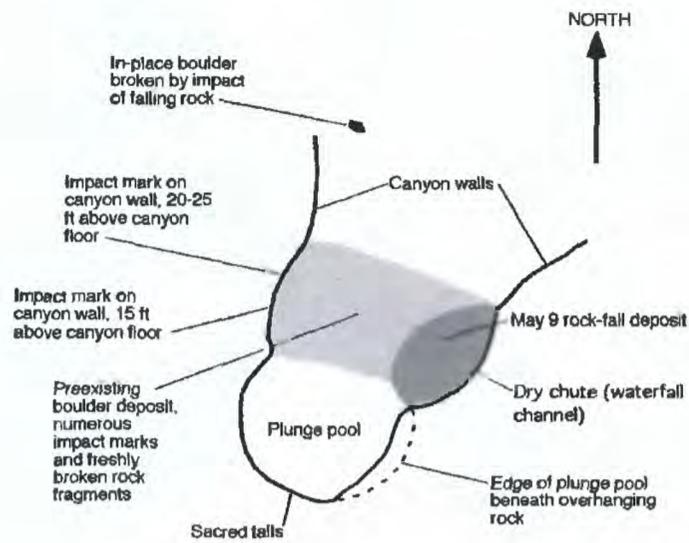
Accurately delineating the area of the deposit is somewhat difficult because of the large number of pre-existing boulders in the impact zone. The deposit from the 9 May rock fall filled a shallow channel that formerly drained the plunge pool and appears to extend 30-40 feet downstream from the northeast edge of the pool (Figure 4). The deposit has a maximum width of about 20 feet and averages 2-3 feet in thickness. Scattered freshly broken fragments of rock lay on the ground surrounding the deposit. The total volume of the 9 May deposit appears to have been less than 50 cubic yards. The deposit consisted mainly of rounded, weathered boulders of basalt (lava rock) and a few freshly broken boulder fragments (Figure 5). Soil partially covered some of the deposit and occupied space between the boulders. Pieces of shrubs and small trees that were growing in the source area and along the path of the rock fall made up the remainder of the deposit. The boulders had apparently weathered in place to a rounded shape high on

Figure 4. Sketch map (not to scale) showing location of 9 May rock-fall deposit in relation to Sacred Falls, plunge pool, and other features.

Several observations on the ground confirm that the landslide material was in free fall during the final part of its descent and that many rocks bounced on impact. We saw many impact marks and freshly broken rocks on the surface of the older boulder deposit and on the opposite (northwest) valley wall. We saw two impact marks on the northwest valley wall, which consisted of rounded, shallow depressions several inches in diameter exposing fresh rock. One of the marks was about 15 feet above the valley floor and the other was 20-25 feet above the valley floor. It is unlikely that any of the rocks bounced high enough to make these marks, rather they resulted from impact by airborne falling rocks. Numerous impact marks were on the valley floor; most consisted of small areas of crushed rock and small depressions on the faces of basalt boulders. The farthest impact point of a rock from 9 May is about 120 feet downstream from the impact zone (Figure 4).

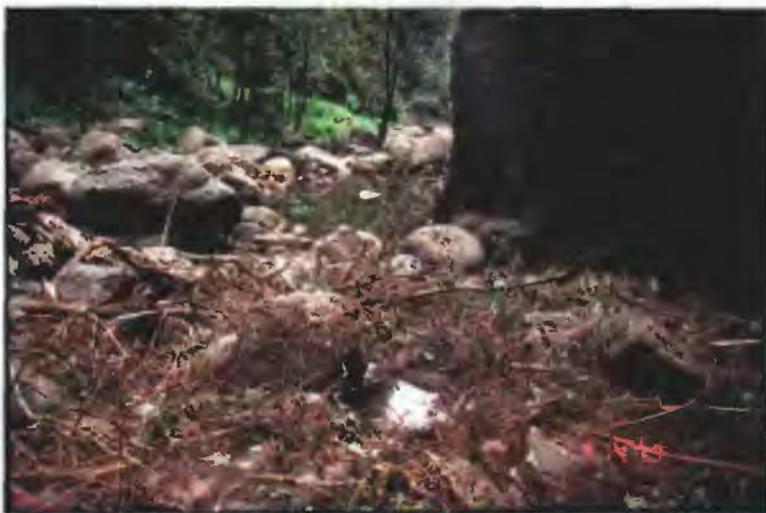
the valley wall prior to falling to the valley floor. Except for the size of the boulders and the covering of loose soil and brush on the deposit, the deposit of the 9 May rock fall looked remarkably similar to the older deposit of boulders at the downstream edge of the plunge pool. Most boulders in the 9 May deposit were smaller than 2 feet across. Many of the boulders in the older deposit were much larger, up to 3-5 feet across.

Figure 5. Sacred Falls rock-fall deposit.
