Rock falls from Glacier Point above Camp Curry, Yosemite National Park, California

by Gerald F. Wieczorek¹ and James B. Snyder²

U.S. Geological Survey Open-file Report 99-385

1999

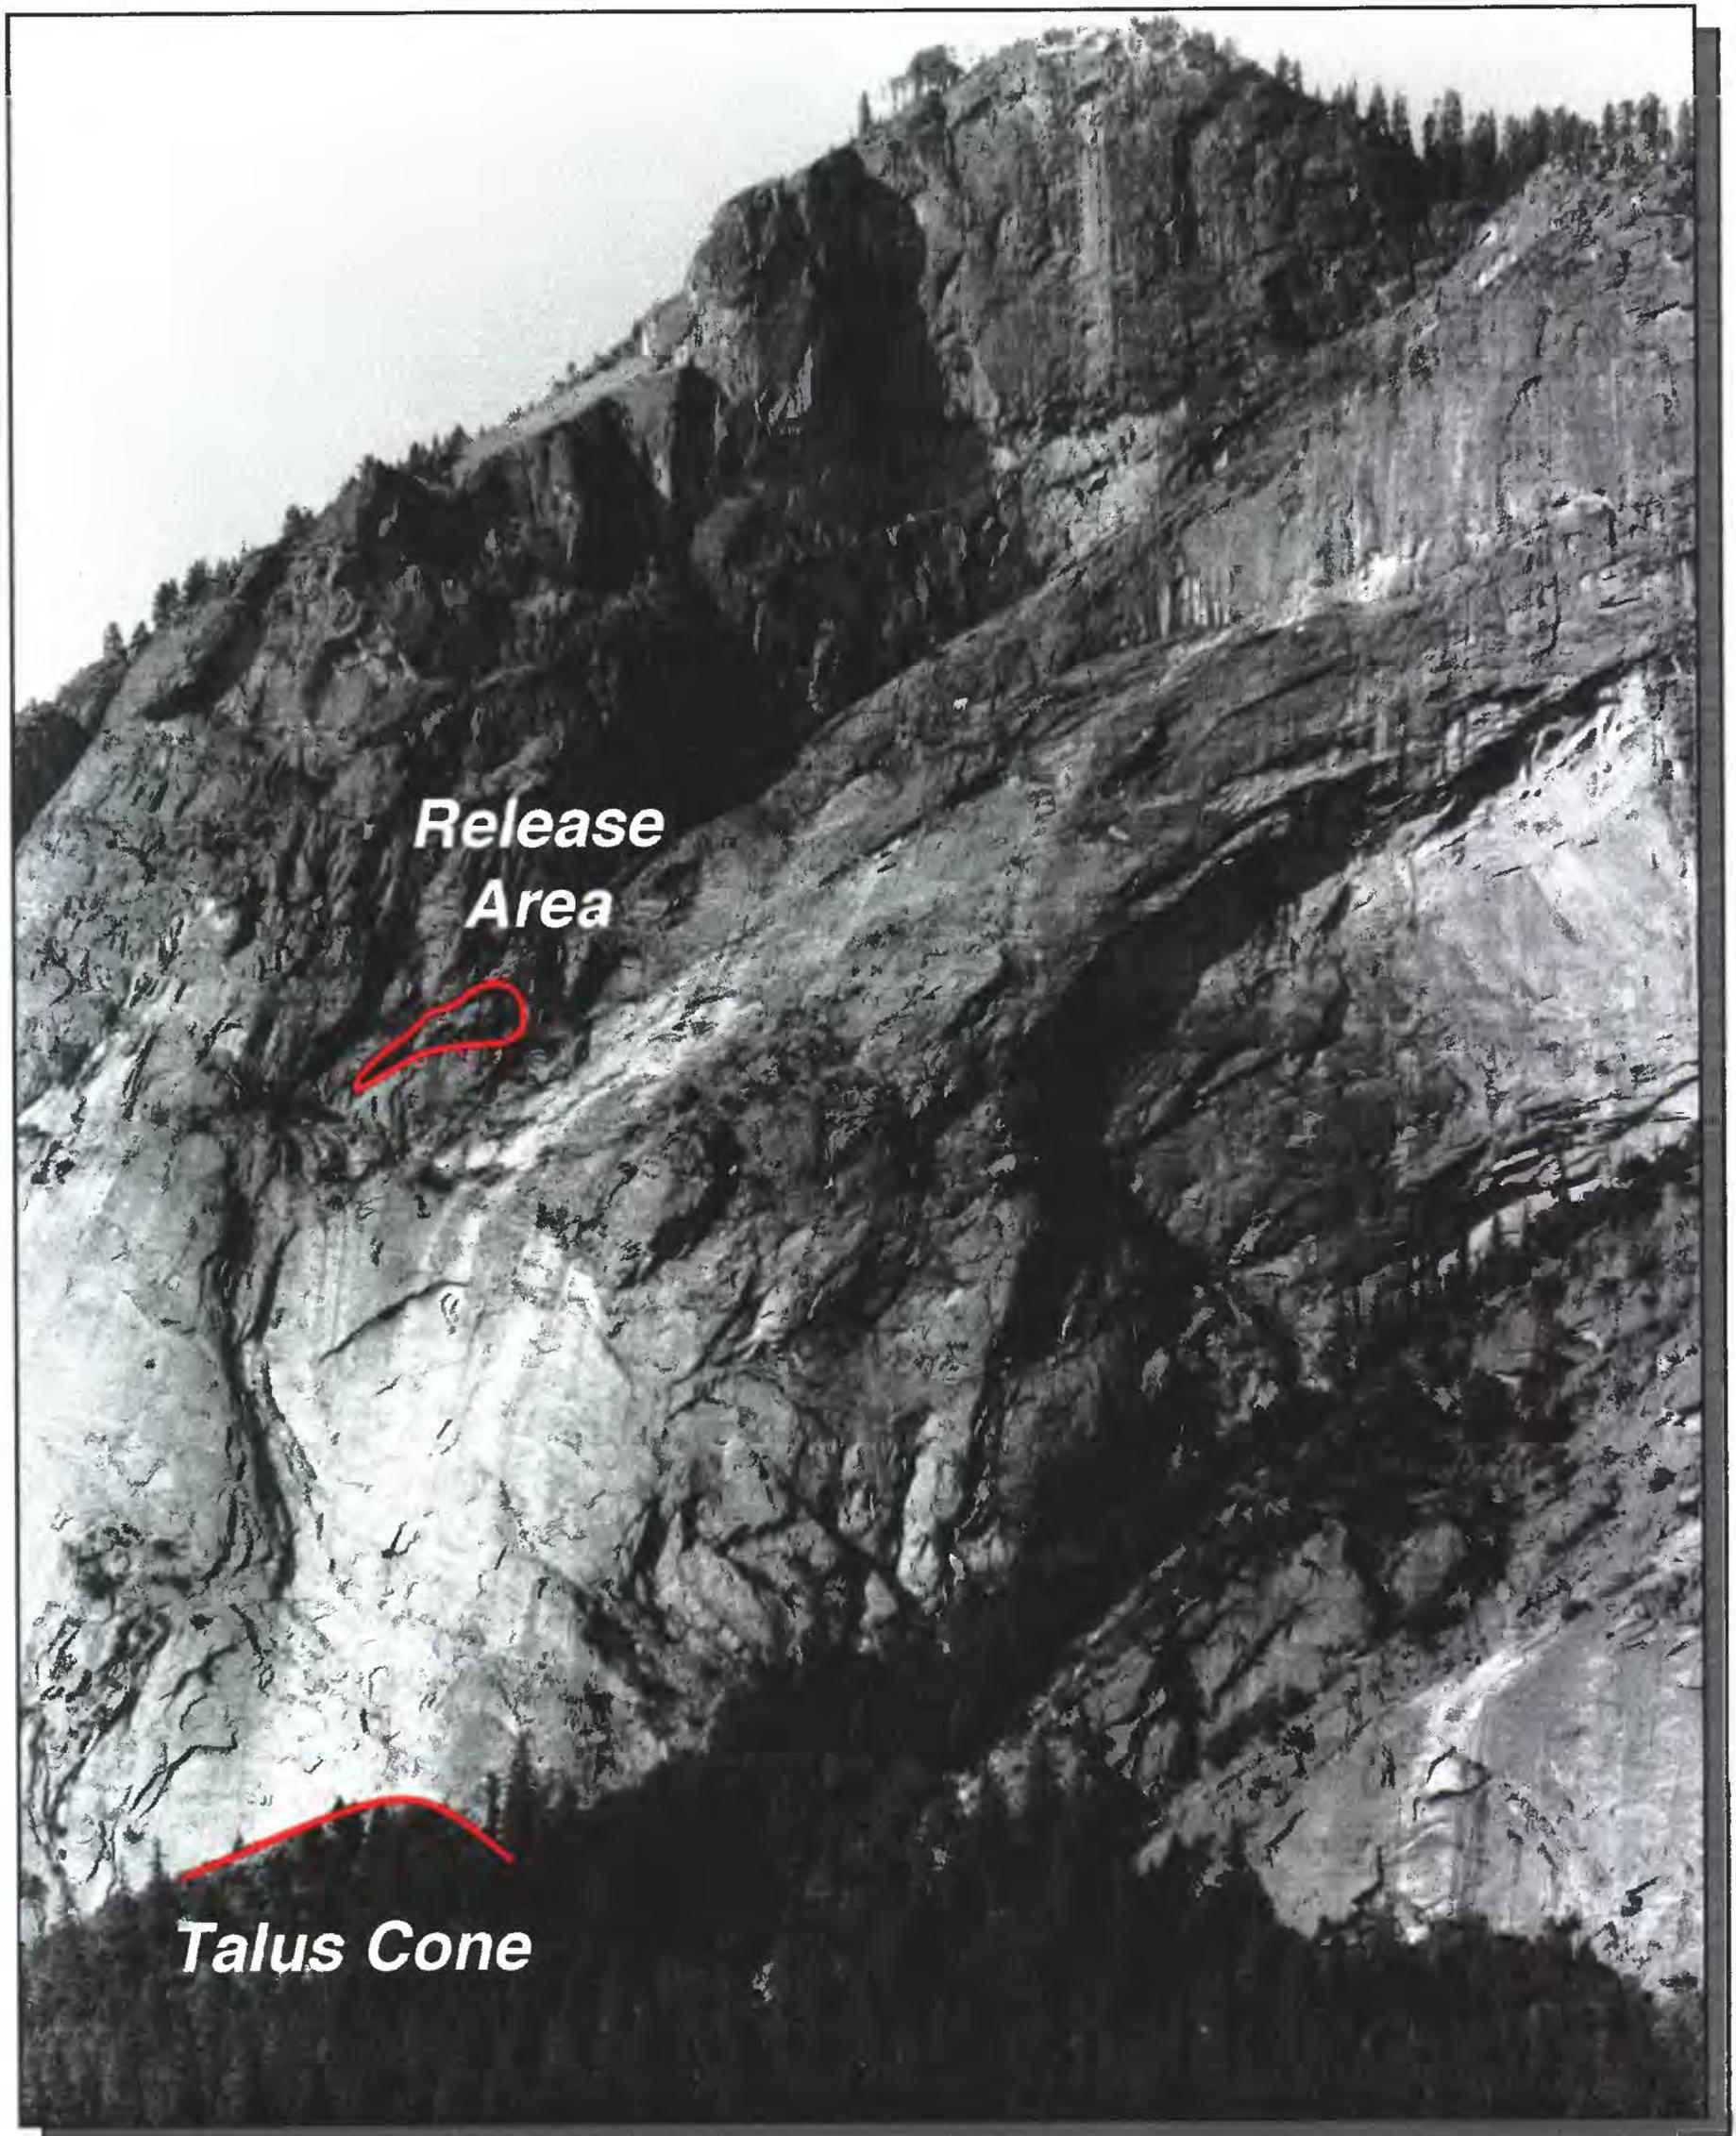
The block(s) fell 100-150 ft down the the steep (75°) cliff face to a ledge, breaking up against the cliff. From there the rock fell another 950 ft, breaking up more before hitting the top of the talus (fig. 1A). The size and velocity of the rocks were sufficient to knock over and clear many large trees from the upper part of the talus. The rocks continued to bounce, roll, and slide down the talus, their paths determined in part by the distribution of larger boulders from prehistoric rock falls and large trees which either stopped or directed their paths. The rocks that travelled furthest, about 1600 ft from the top of the talus, took a northeasterly direction (fig. 2A). Large rocks reached within about 75 ft of the closest tent cabin (Tent 29), highest on the talus. A profile of the talus is shown on figure 3 with selected locales, such as Tent 29, identified for reference to the rock-fall events.

Figure 1- Photographs of rock-fall release areas below Glacier Point (A) north face of Glacier Point (top), area of recent releases (center), and talus above Curry Village, photograph taken in 1984 (NPS, Yosemite National Park, Search and Rescue neg. # 5444). (B) Solid colored lines indicate individual release areas: blue-11/16/98, brown-5/25/99, red- 6/13/99 and yellow-6/15/99 taken from helicopter on June 16, 1999. Dark shaded areas indicate water seeps from joints and cracks. Photograph slightly oblique to rock face with approximate scale as indicated.

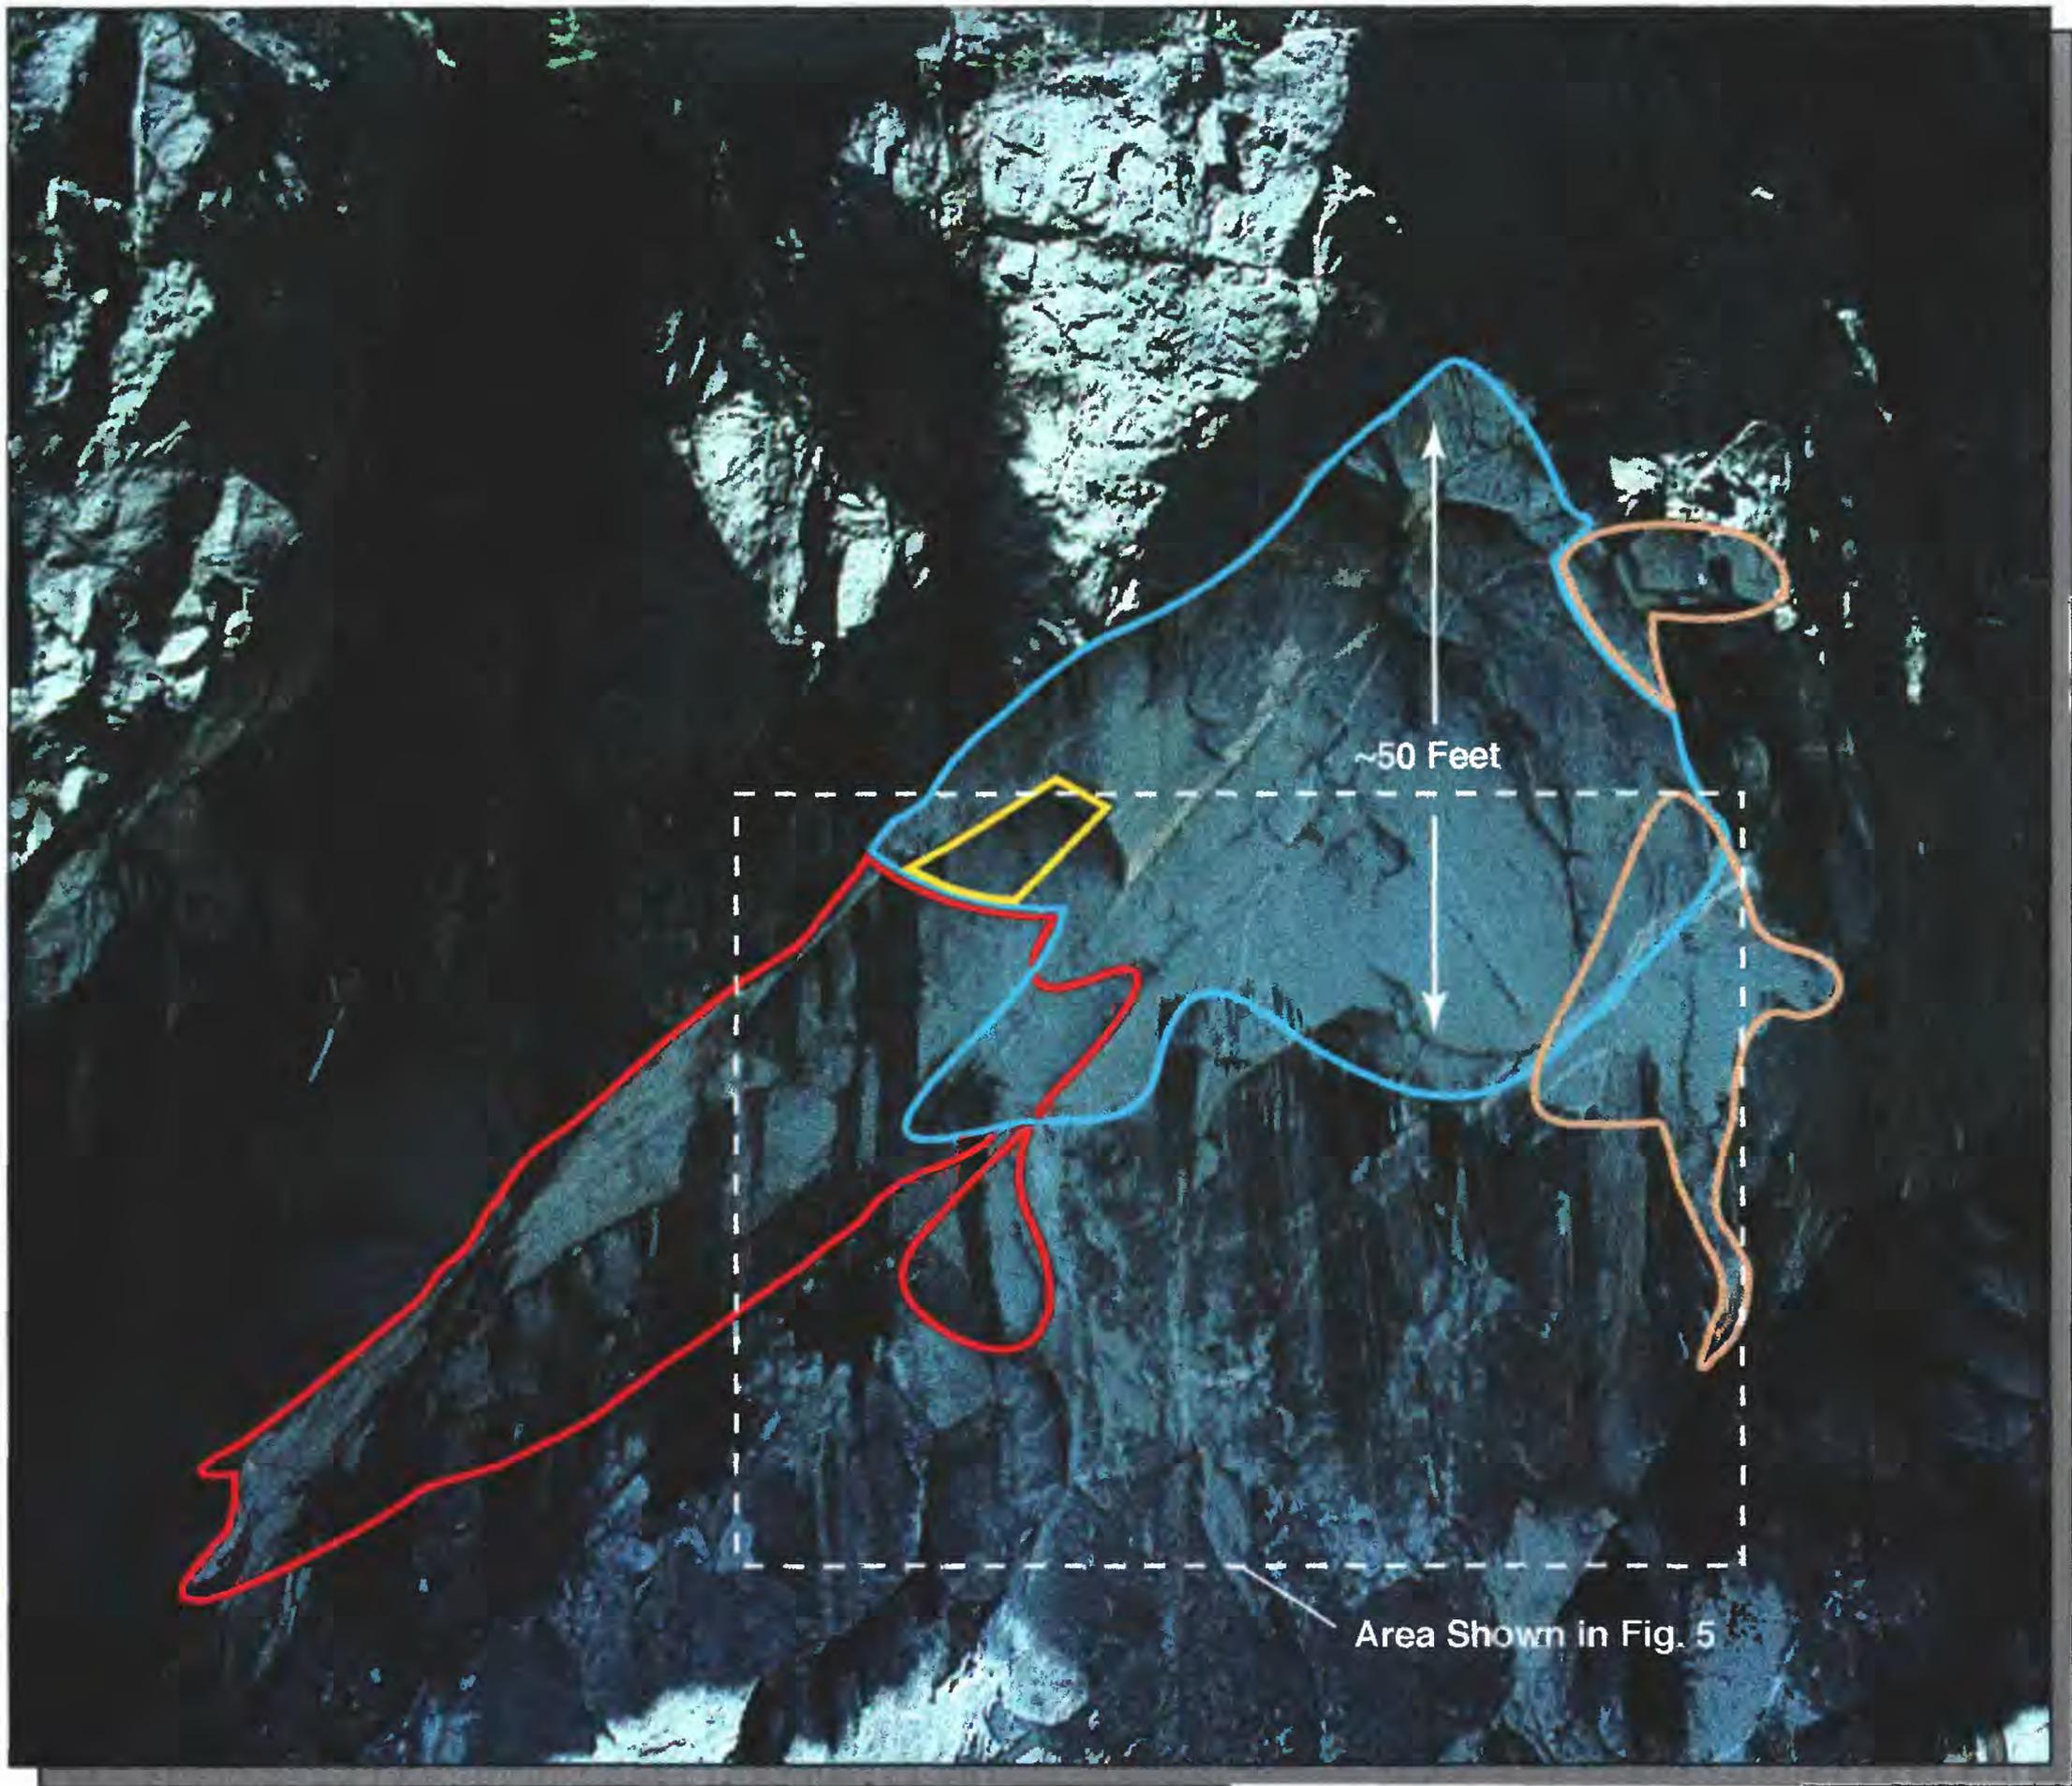
Fig. 1B

The first rock fall in a sequence (table 1) from the location above Curry Village occurred on November 16, 1998 and had a volume of about 736 yd³ (1738 tons). The location of some of the various releases from the cliff face are shown in figure 1B. Weights have been calculated using a density of 175 lbs/ft³. Volume calculations were revised from earlier initial estimates on the basis of subsequent more detailed mapping and scaling using pre-existing photographs, photographs taken subsequent to the rock fall from helicopter, and photos of the release area

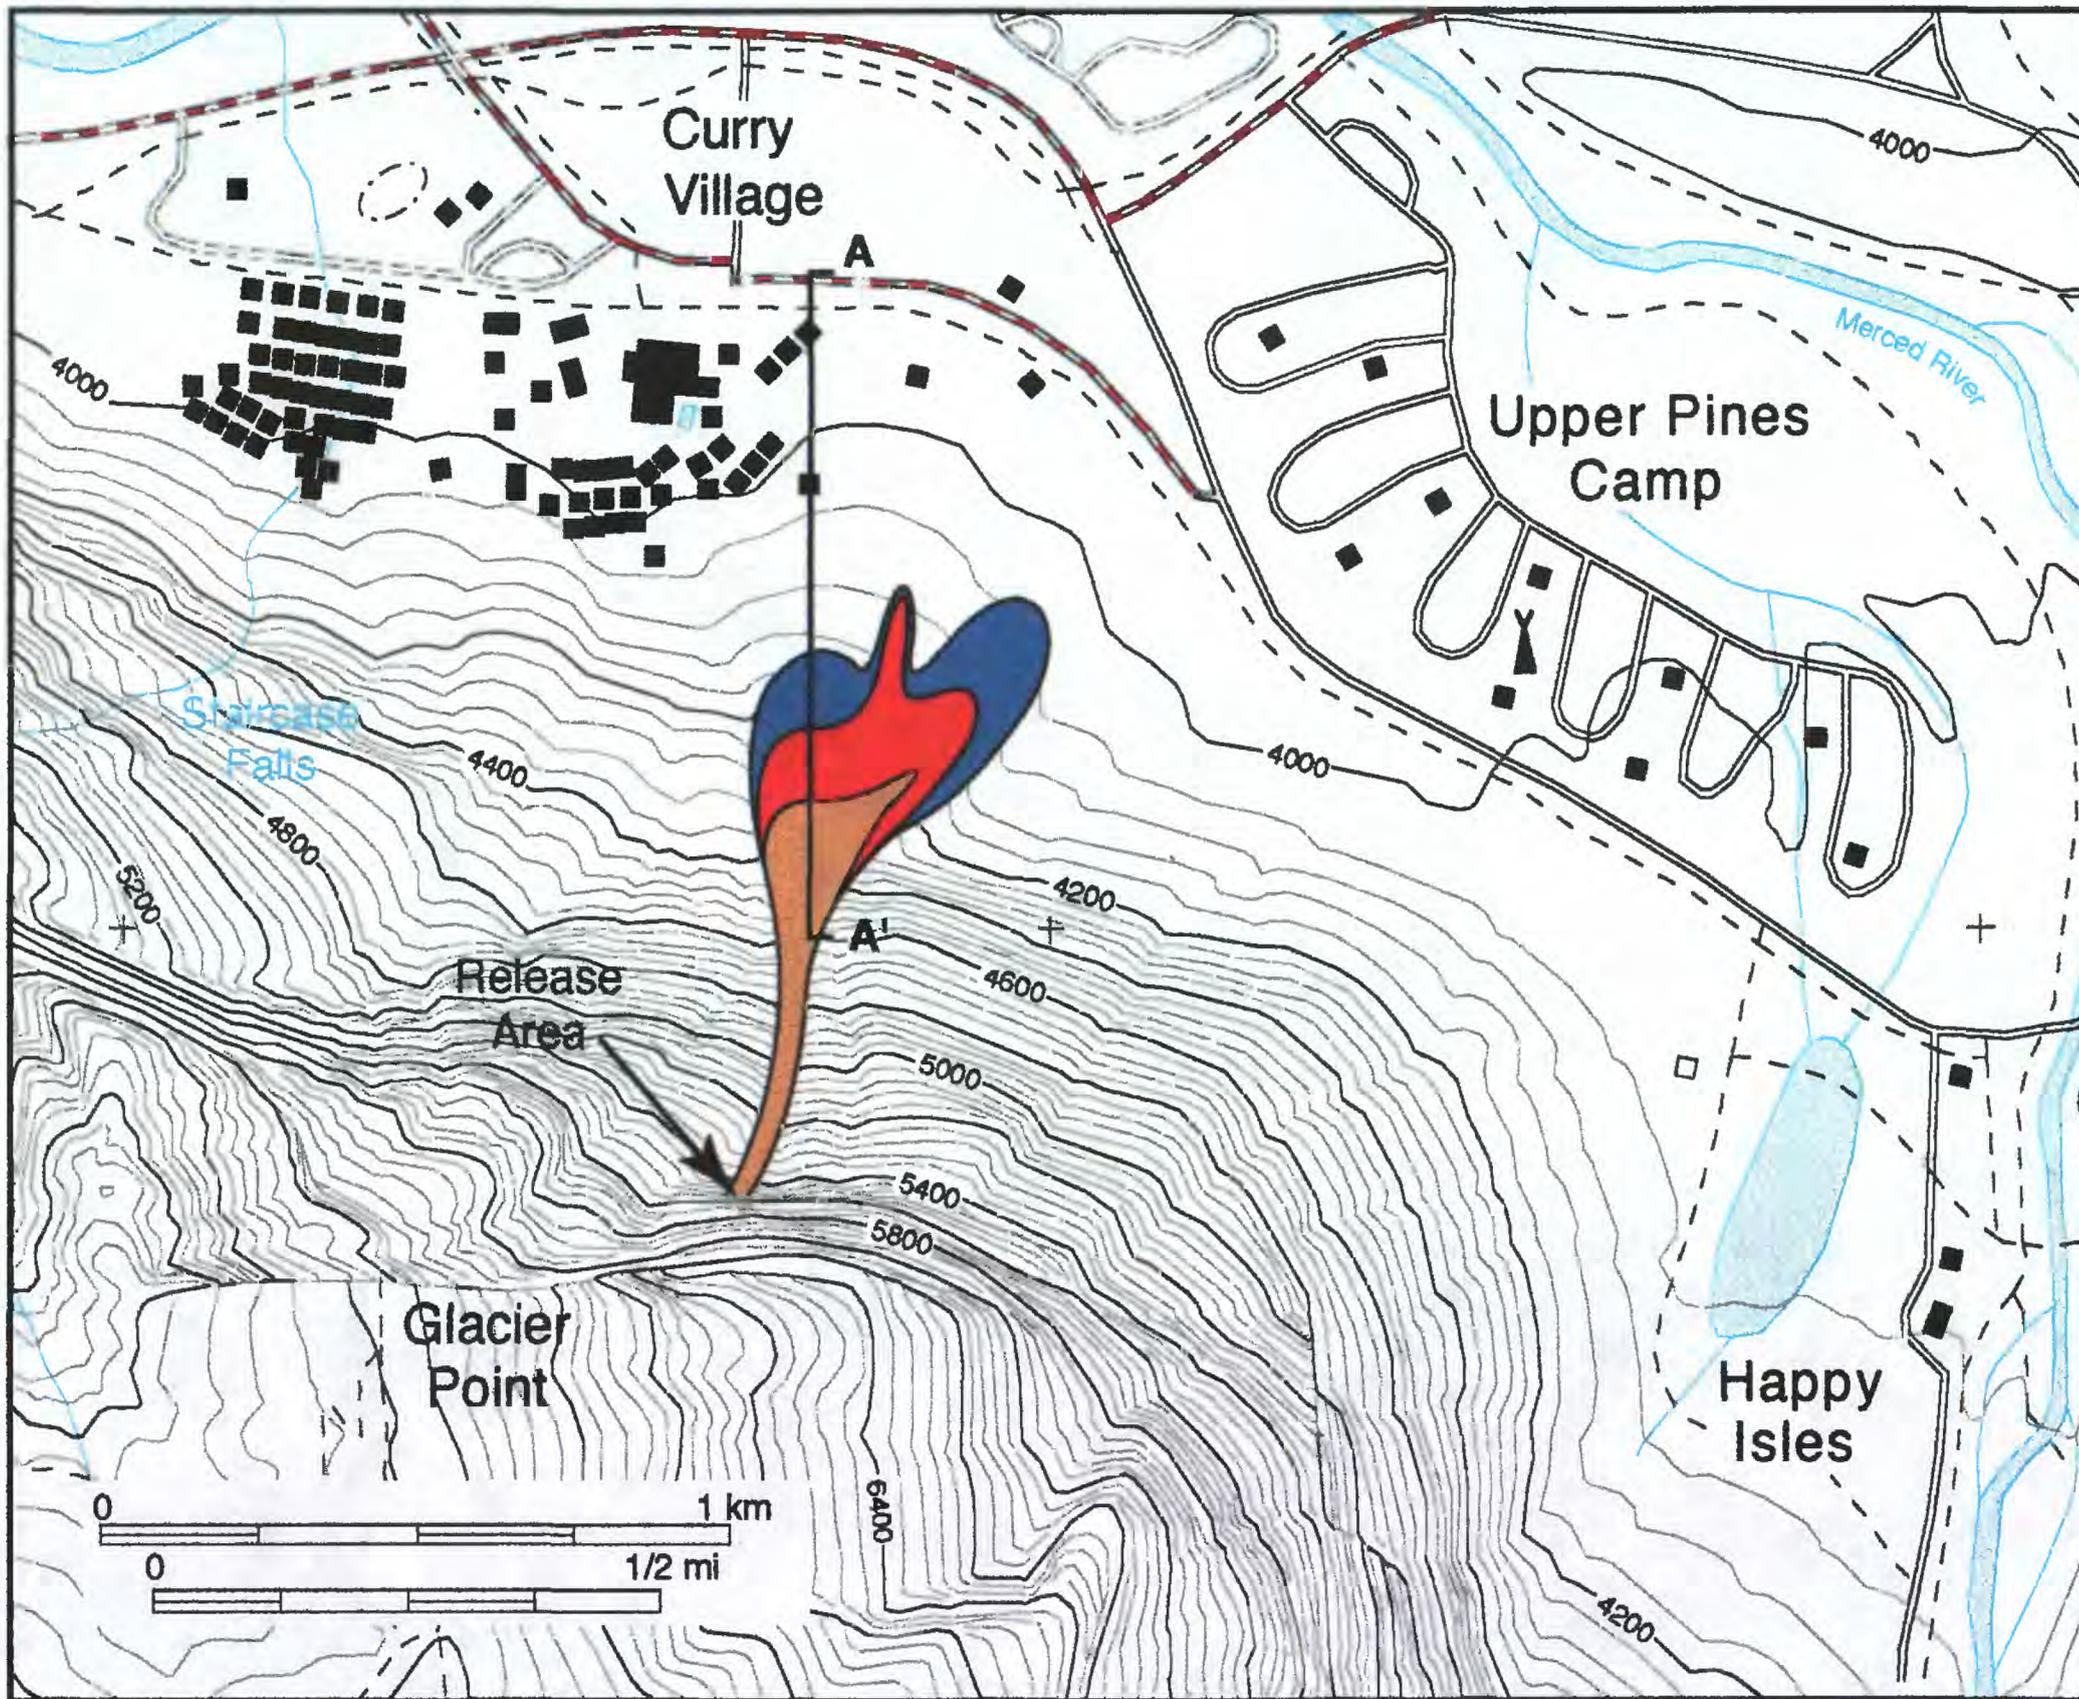
Fig. 2A

Fig. 2. Maps of rock-fall release area below Glacier Point and affected areas in Camp Curry, Yosemite National Park. Maps does not include locations of all structures within Curry Village. (A) Recent rock-fall impact zone near Camp Curry in the Yosemite Valley. Outlines of 11/16/98 (blue), 5/25/99 (brown), and 6/13/99 (red) rock-fall impact zones. Location of profile line A-A' along eastern talus cone shown in Fig. 3. (B) Recent rock-fall fly rock zone near Camp Curry. Outlines of 11/16/98 (blue), 5/25/99 (brown), and 6/13/99 (red) rock-fall flyrock zones.

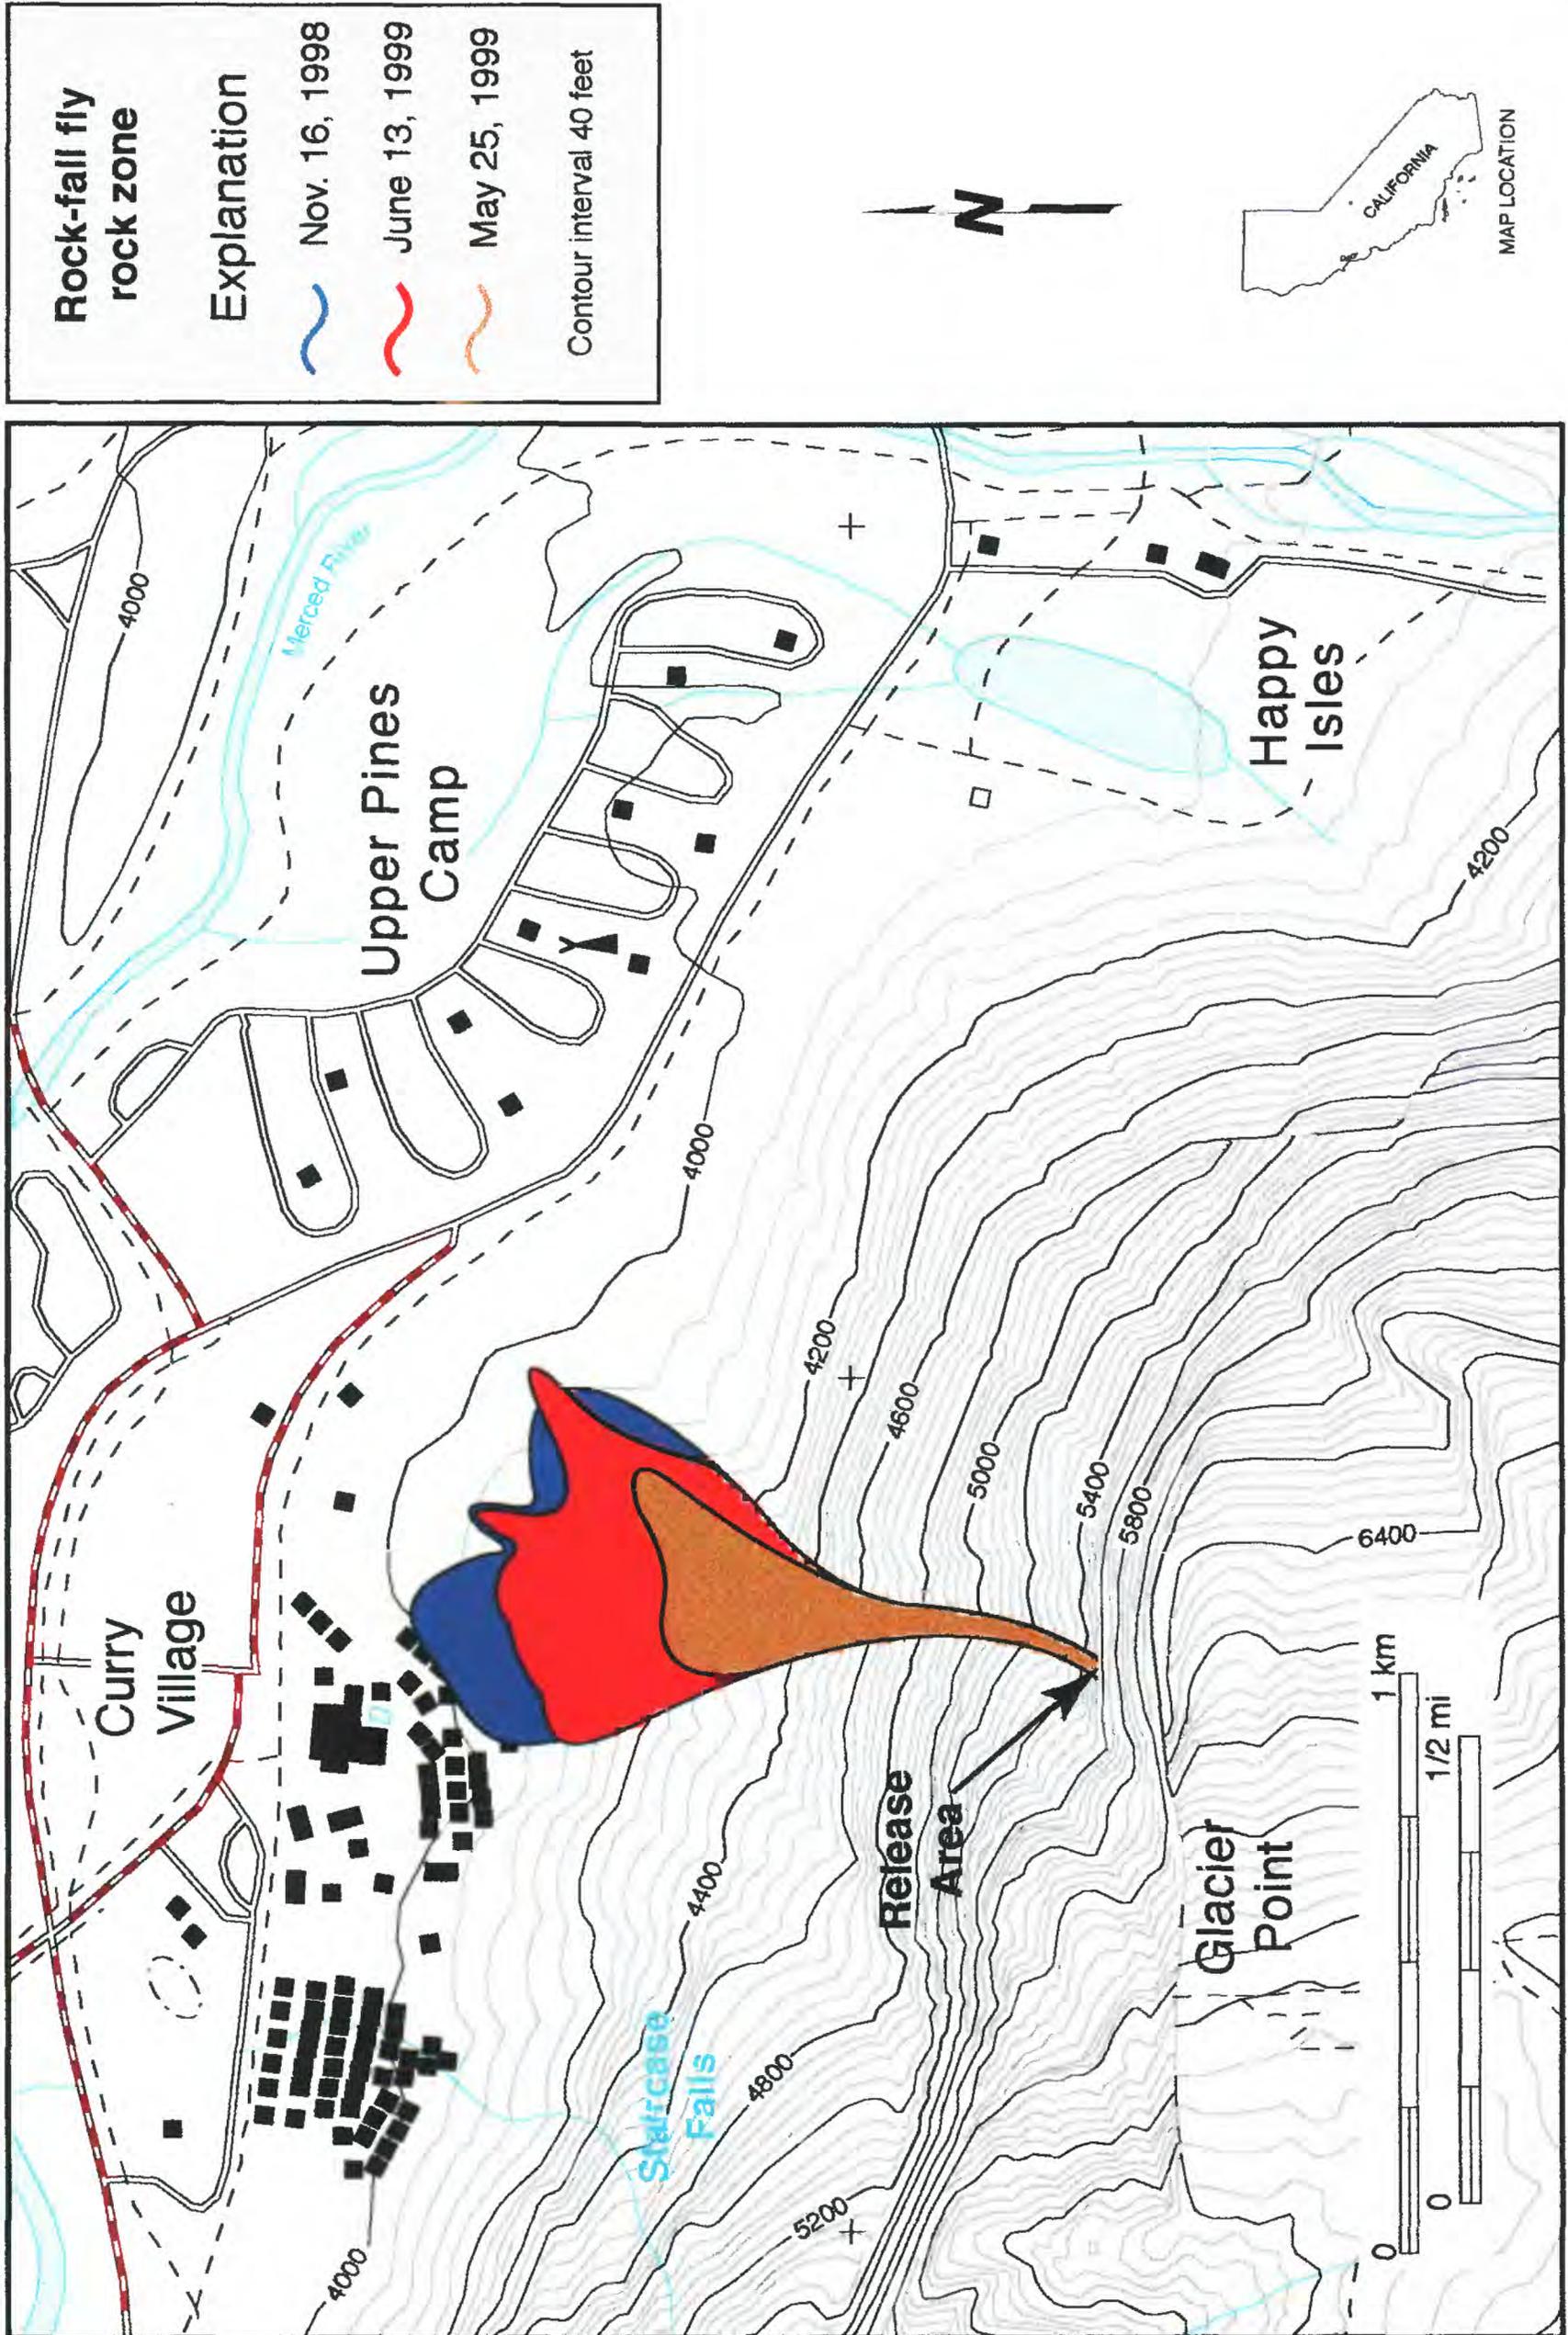
Fig. 3

On June 13, 1999, an intermediate-sized rock fall of about 279 yd³ (660 tons) occurred that killed one climber and injured two others who were climbing along a route beginning near the top of the eastern talus cone at Curry Village, immediately below the release area. The travel of rocks along the talus and airborne splatter of rock was again very similar to the previous observed distributions, extending to nearly the limits of the November 16, 1998 event (figs. 2A and B). Some of these airborne splatter pieces reached the tent cabins and, falling at steep angles, pierced the canvas tops, broke beams, and fell to the floor. Two of the larger projectiles, approximately the size of a football, pierced the canvas roofs of Tents 28 and 36.

Fig. 3. Profile (A-A') of eastern talus cone at Camp Curry showing location of selected features on and above the Terrace. Location and representation of trees and boulders is approximate. Location of profile is indicated in fig. 2A.

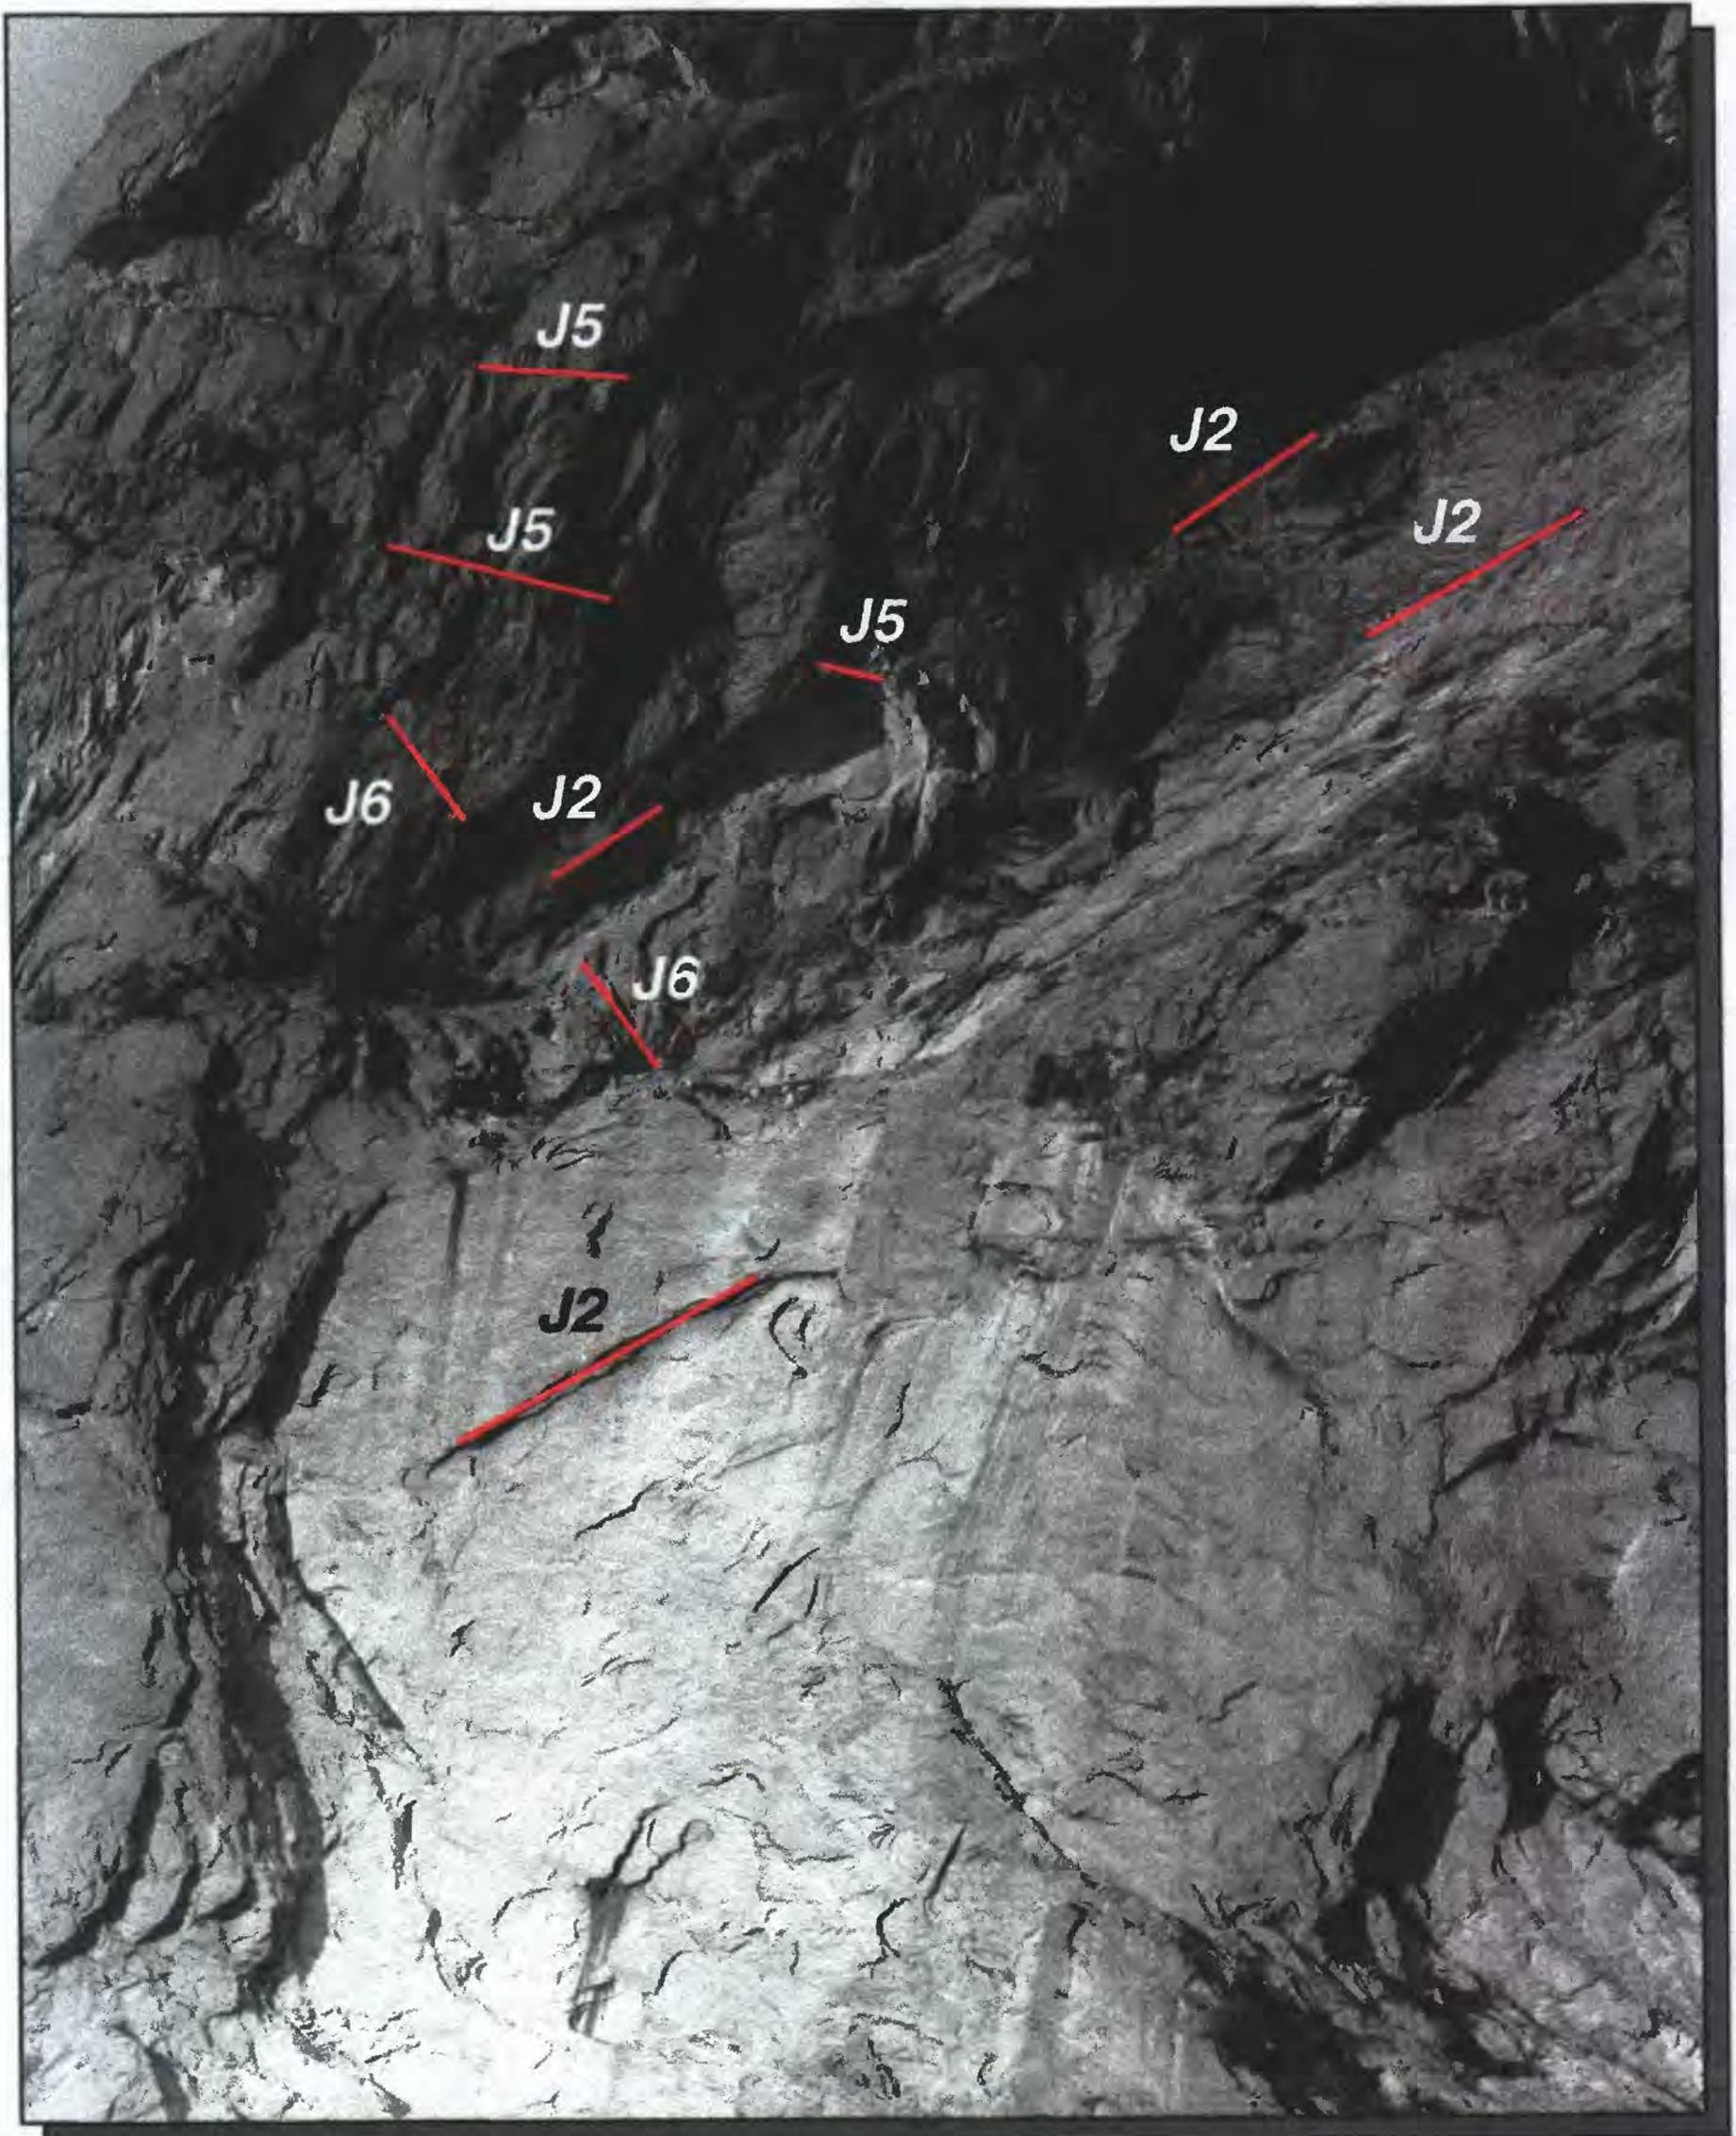
Fig. 4B

In addition to the plane of the steeply dipping exfoliation joints (J1) parallel to the cliff face, the site of the rock-fall releases and developing cracks is dissected by five other joint sets (J2-J6) shown in figures 4A, B. Characterization of the orientation of these joint sets (table 2) is approximate because of the inaccessibility of the site; estimates of the orientations of joint planes were made from stereo photographs made from helicopter, and from photographs taken from Stoneman Meadow with several cameras and telescopic lenses.
