Rock falls from Glacier Point above Camp Curry, Yosemite National Park, California

by Gerald F. Wieczorek¹ and James B. Snyder²

U.S. Geological Survey Open-file Report 99-385

1999

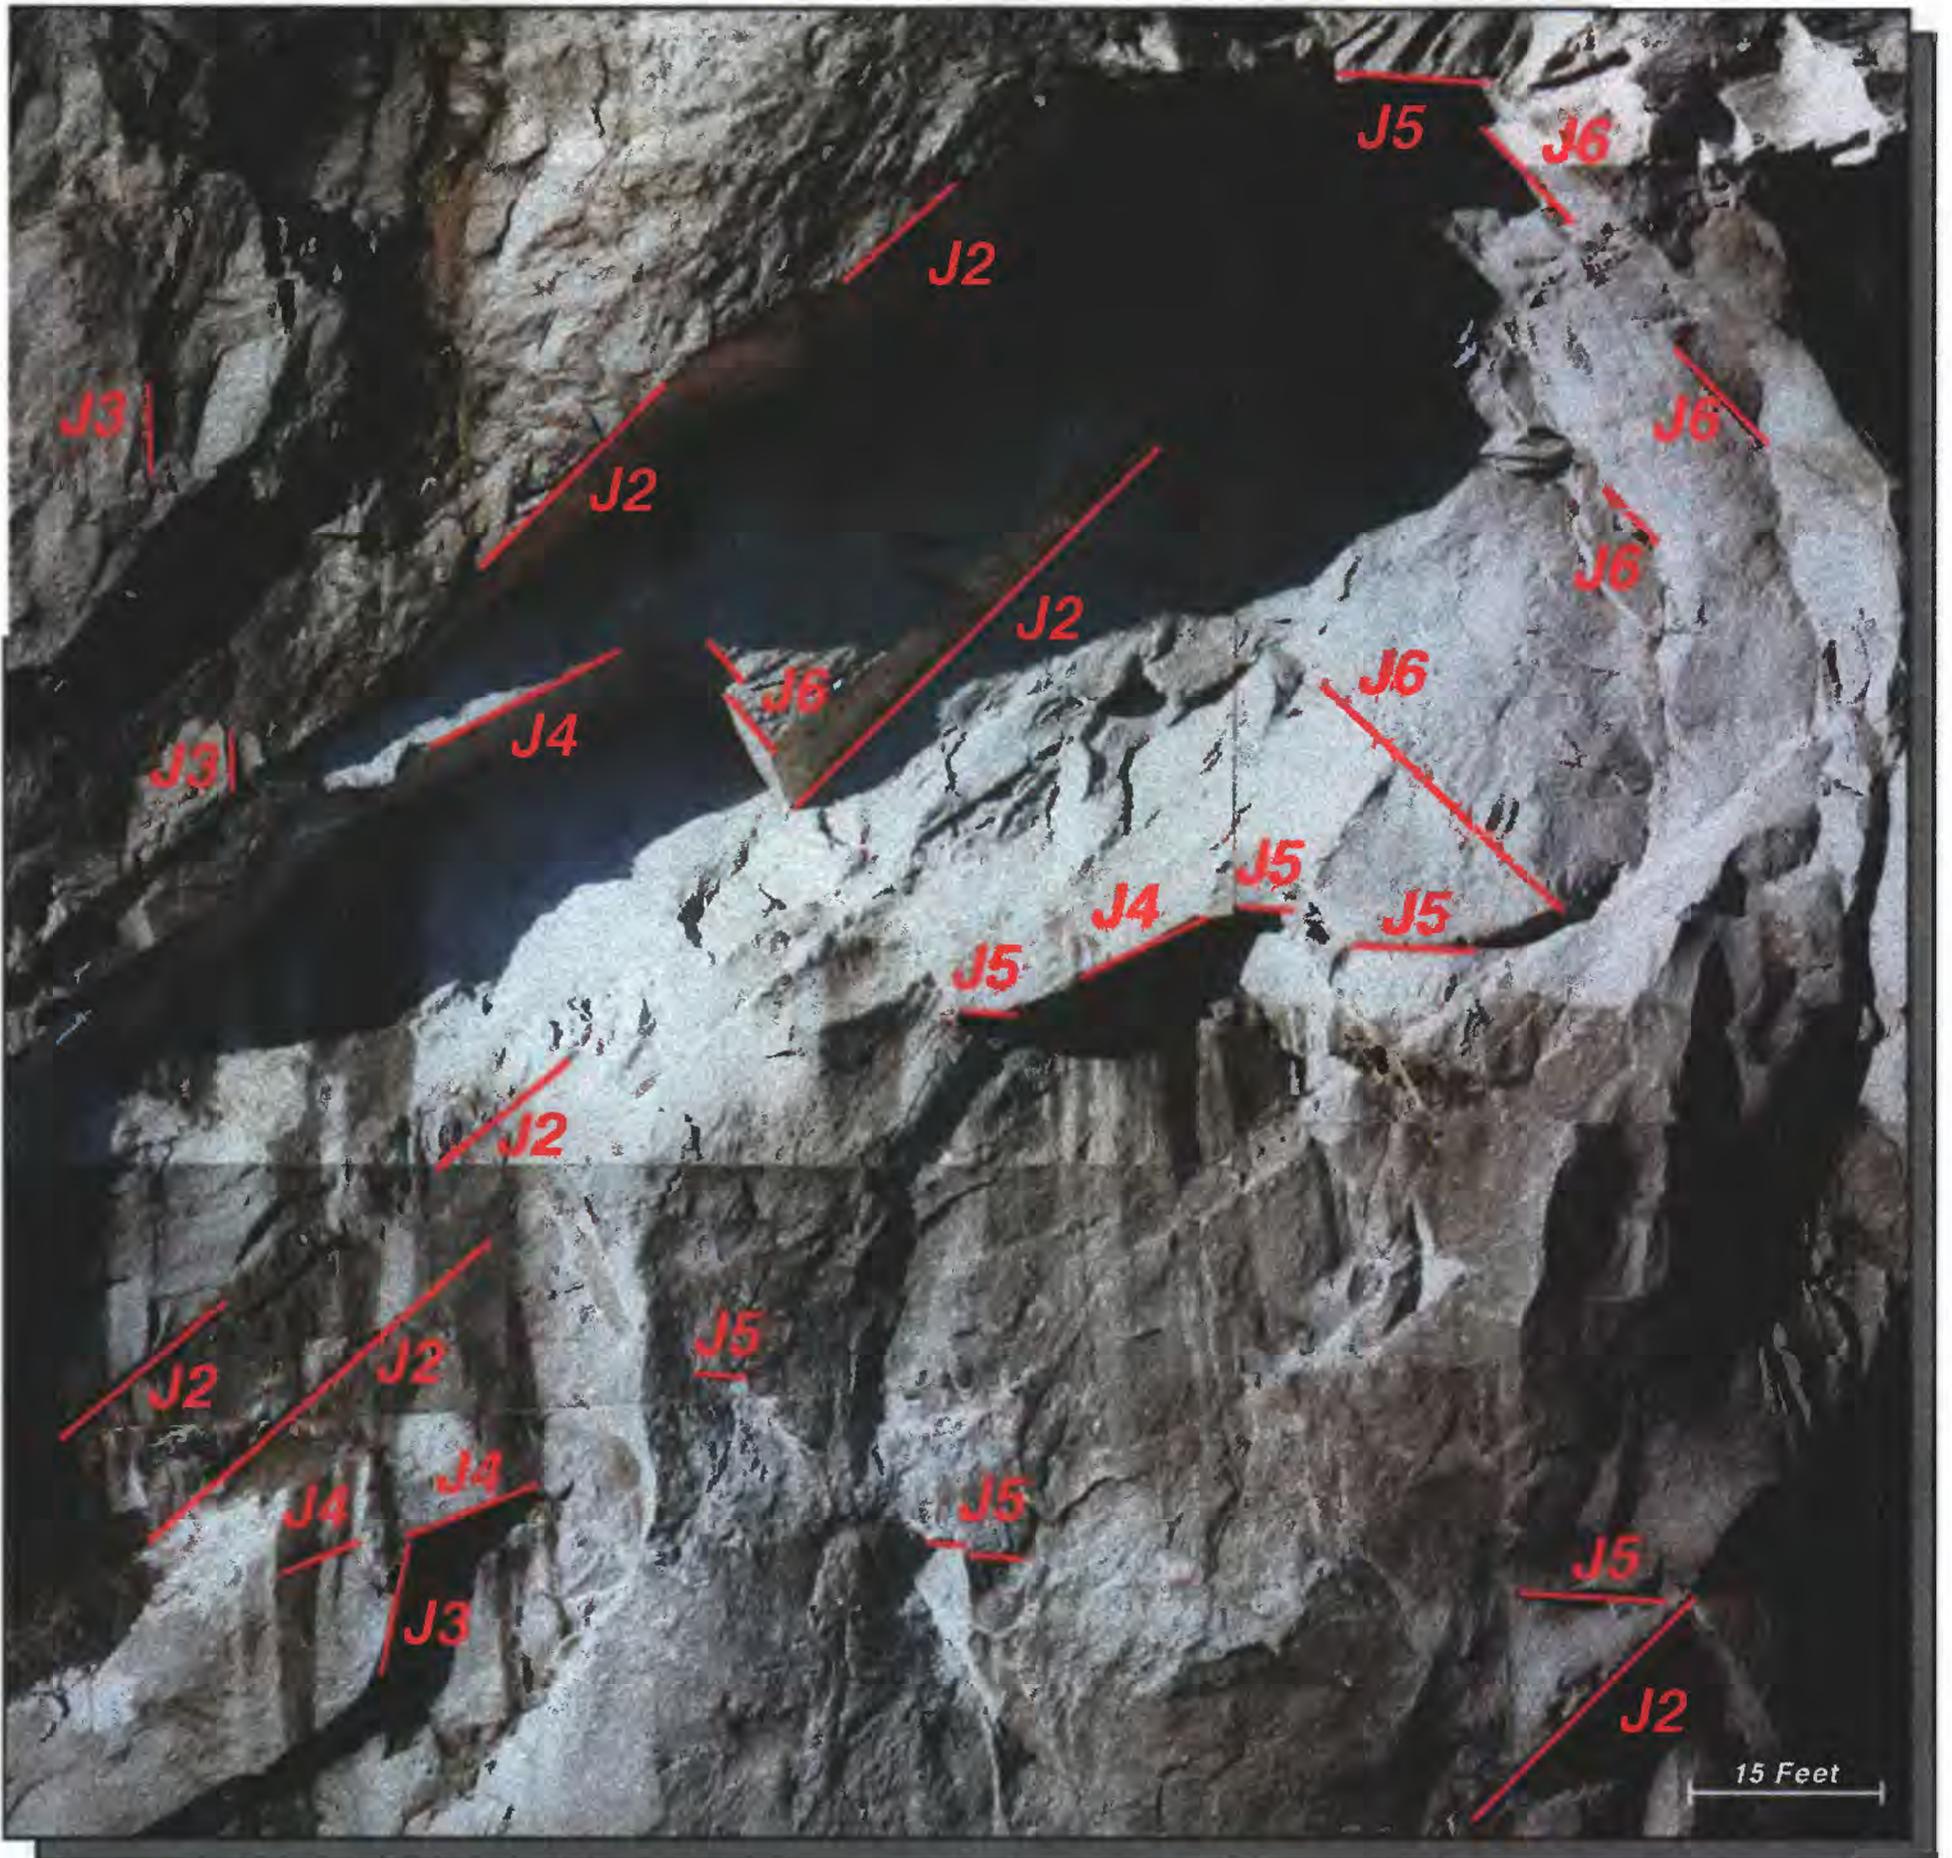
Fig. 5A

The pattern and timing of cracks that developed below the rock-fall releases may indicate something about the present stability of the mass, and the mechanism of how it will eventually fail. The cracks appear to be of three apparent types: 1) shear, and 2) tension cracks exposed in the plane of the exfoliation sheet that are in the process of splitting the top exfoliation sheet, and 3) parting or opening cracks that indicate separation between successive exfoliation sheets in the plane perpendicular to the slope face. These cracks are concentrated in a roughly rectangular area of about 60 by 75 ft with a center section devoid of cracks. This center section is an exposure of an exfoliation plate extending behind the two sections to the east and west as an apparent “window” into the deeper exfoliation sheet (fig. 5).

Fig. 5. Depiction of cracks and their propagation. (A) Photomosaic of releases and area of cracking below Glacier Point. Cracks are shown by red dashed lines. Some selected joints and other structural features are identified by solid red lines for reference. Window notation refers to area of inset exfoliation sheet. Note water seeps over surface of exfoliation sheet J1 issuing from joint set J2 (left). (B) Sketch showing progressive propagation of cracks with time in area below rock-fall releases.

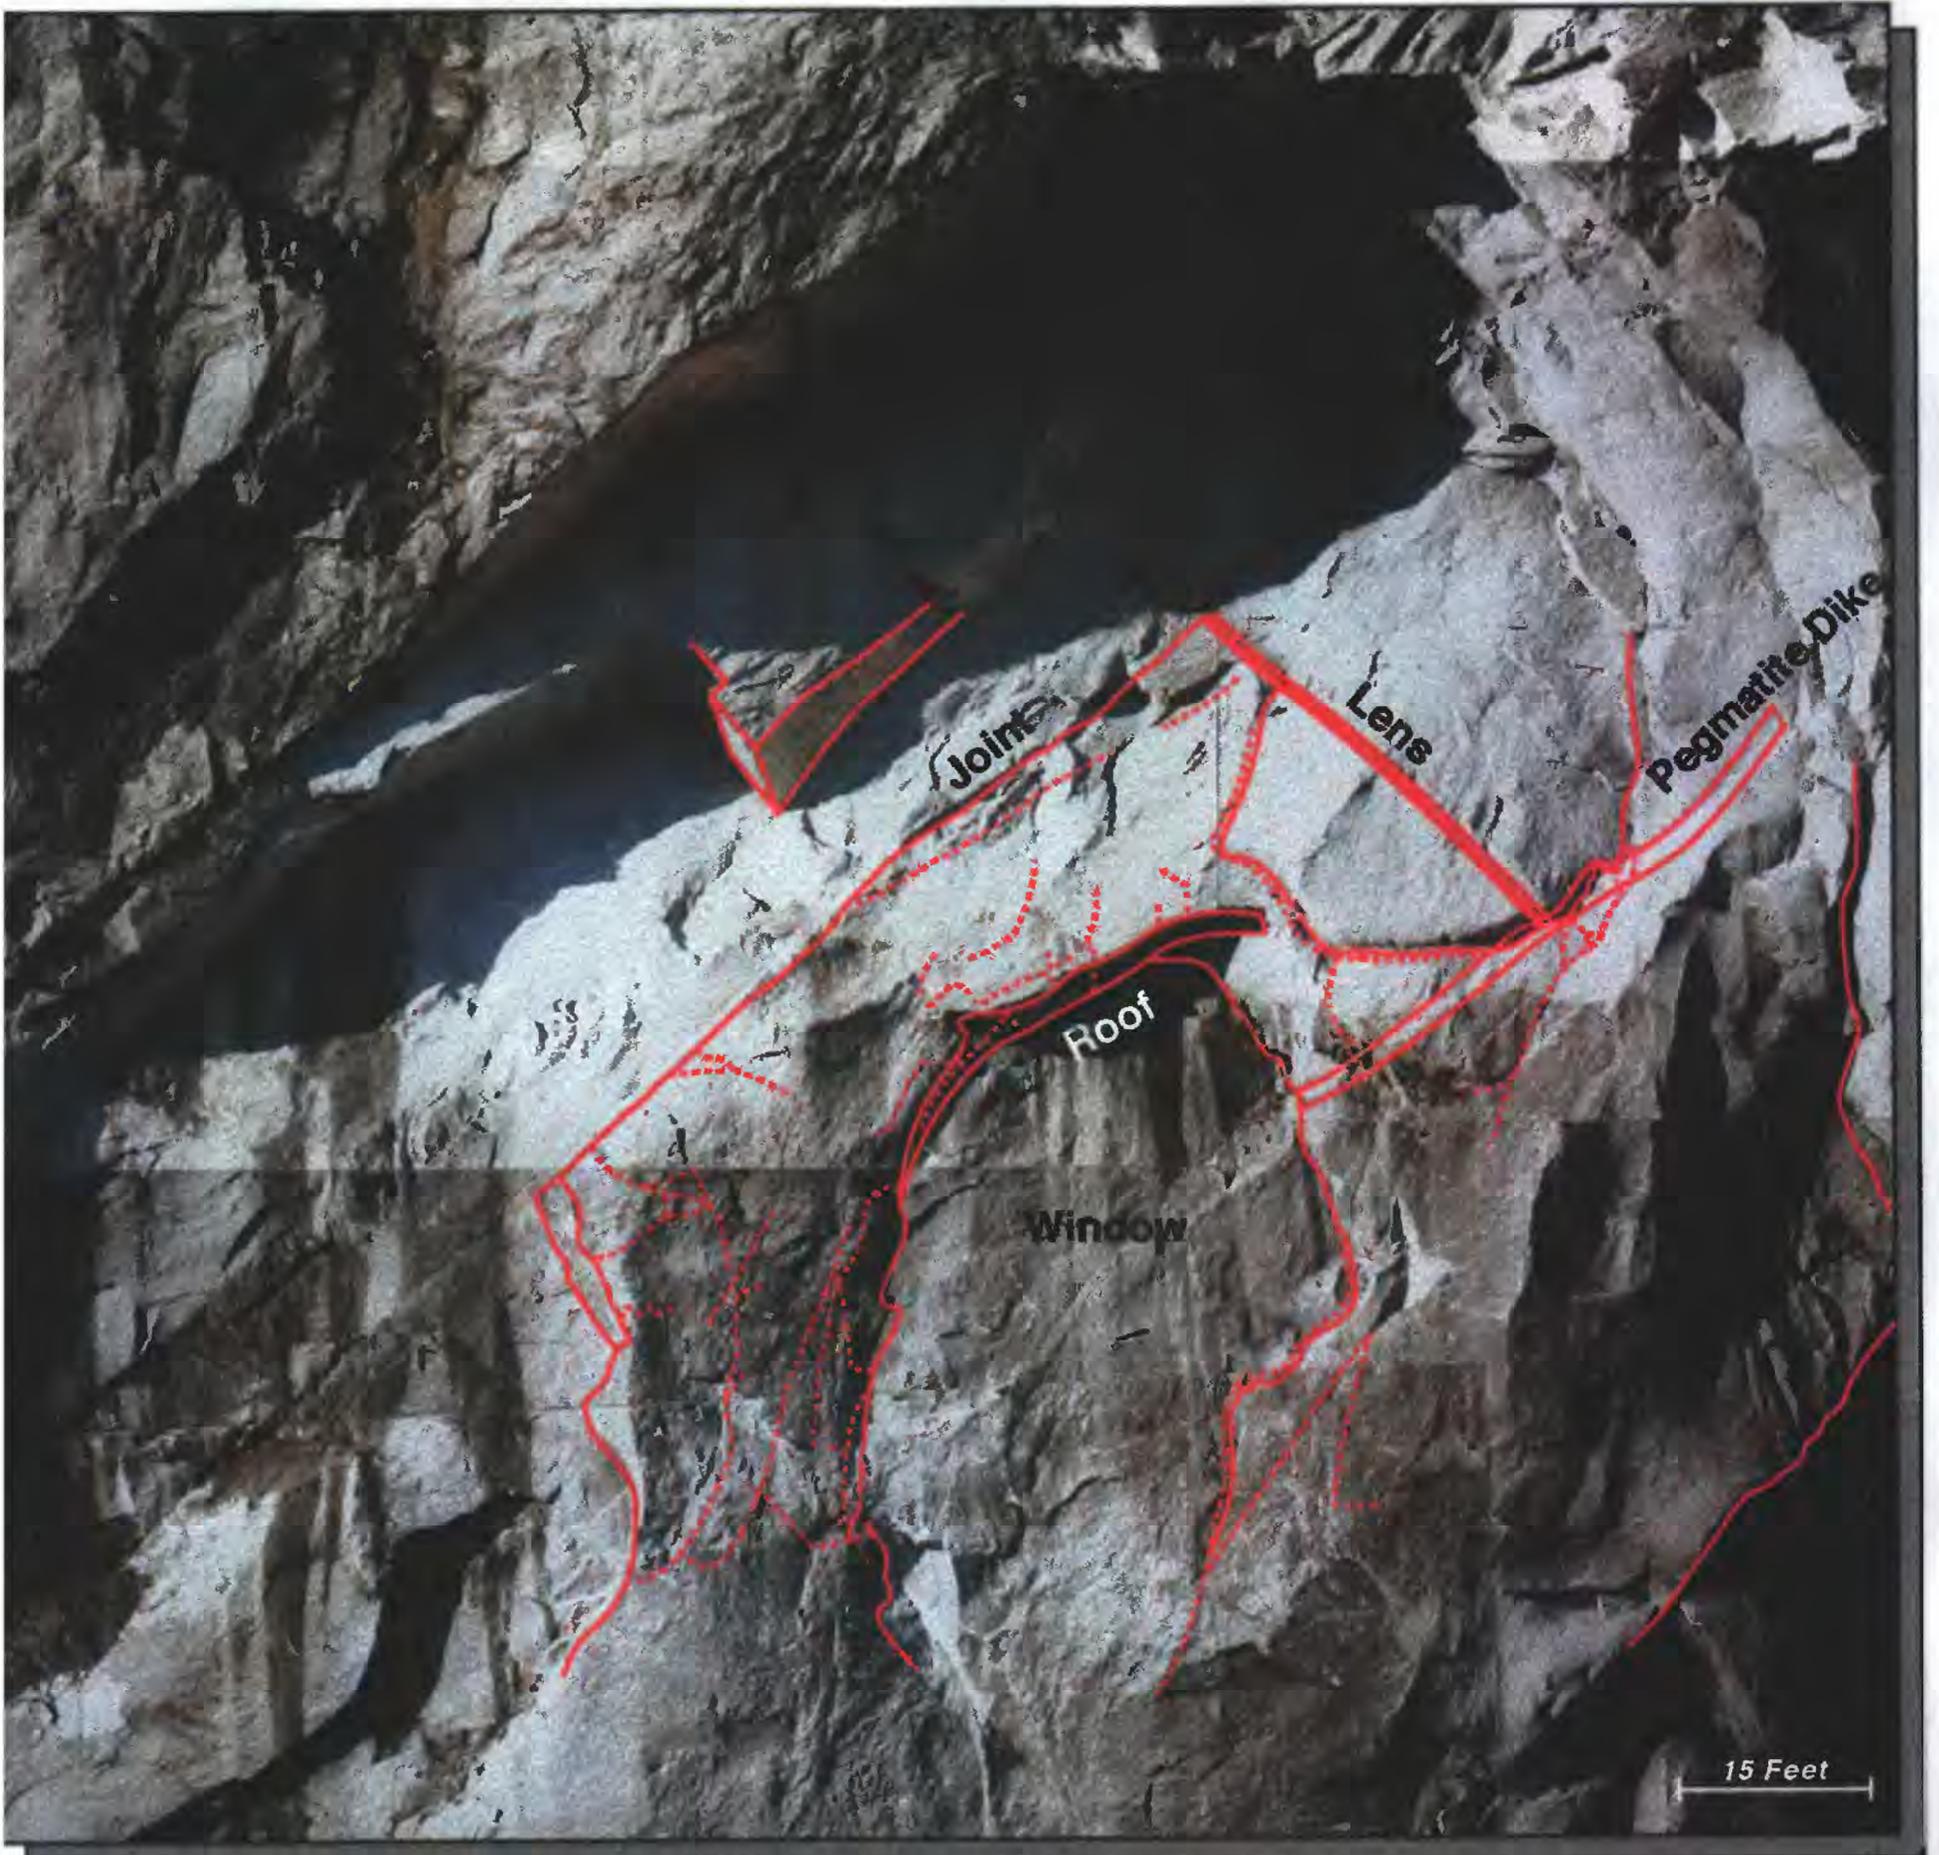
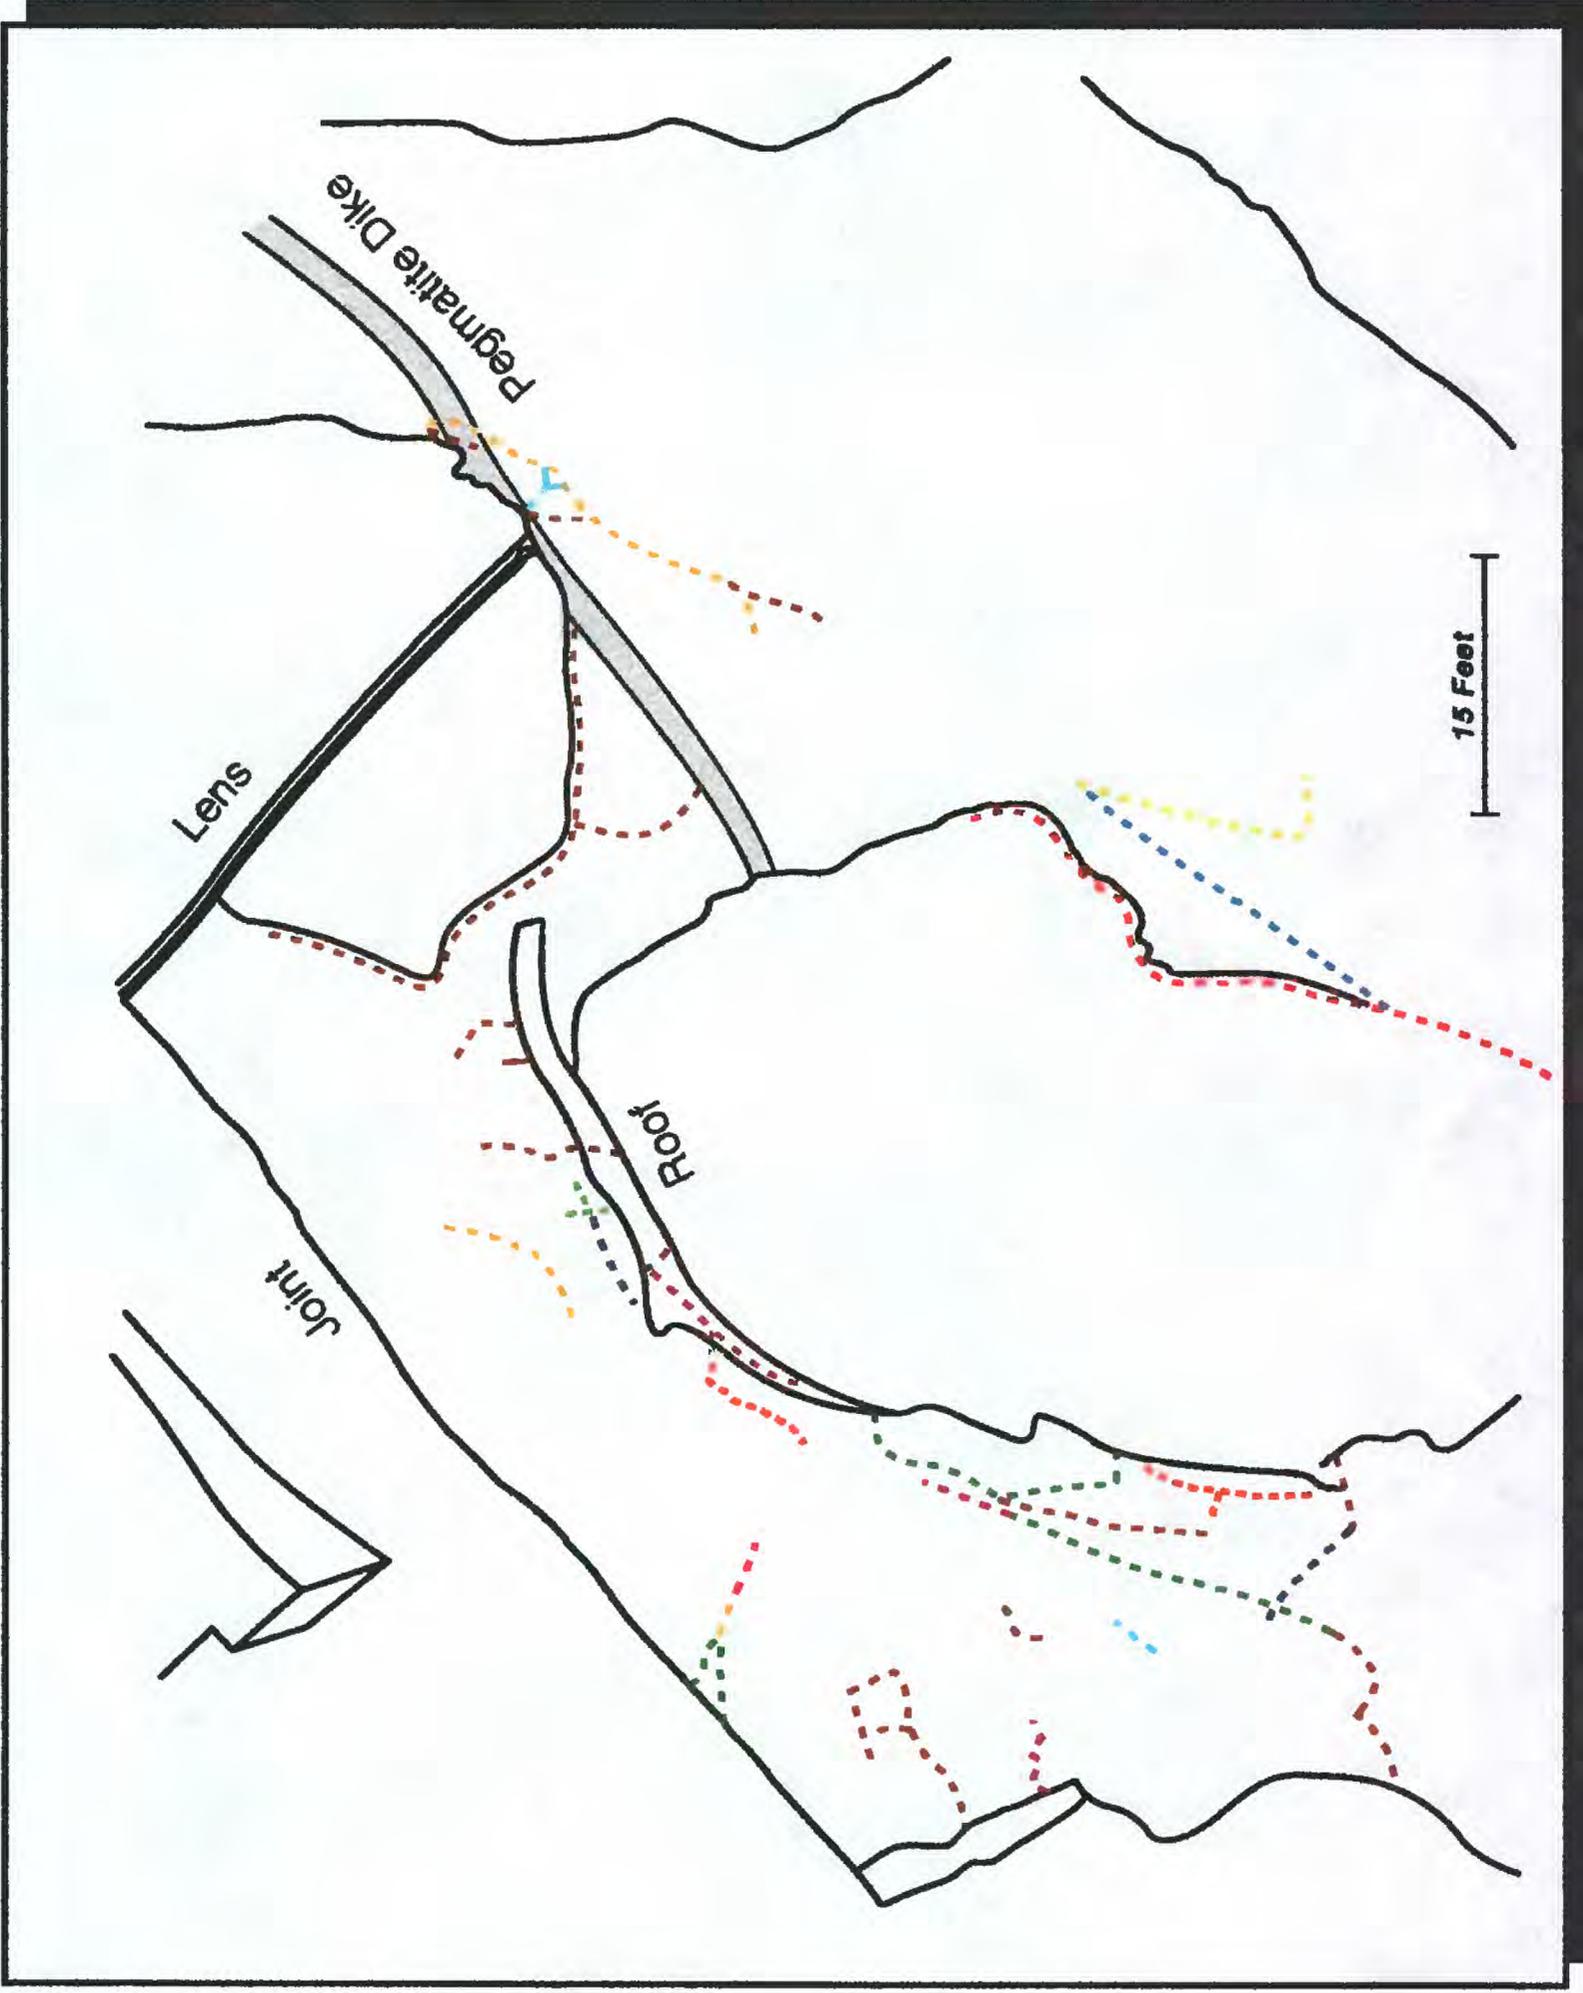
Using the length of new shear and tension cracks detected since June 14, we compared the percentage length of new cracks formed during each 48-hr period. This rate of crack propagation fluctuated widely although some of the variation could be attributed to the selected time intervals and to observational difficulties. Initially, the rate of crack propagation rate was high during the June 13-14 period, but gradually decreased during the following week. The rate again increased dramatically during the period of June 20-22. Between June 22 and 26 the rate of new crack formation notably decreased. Subsequently, only a few very short additional cracks have been detected, although a spike of small rock-fall activity and a few short cracks occurred between July 8 and 14. The pattern of the propagation of cracks with time is shown in fig. 5B.
