**ROCK-FALL HAZARD ASSESSMENT OF THE ASPEN FOREST
TRAIL, NAVAJO NATIONAL MONUMENT, ARIZONA**

**U. S. Geological Survey Open-file Report 00-305
2000**

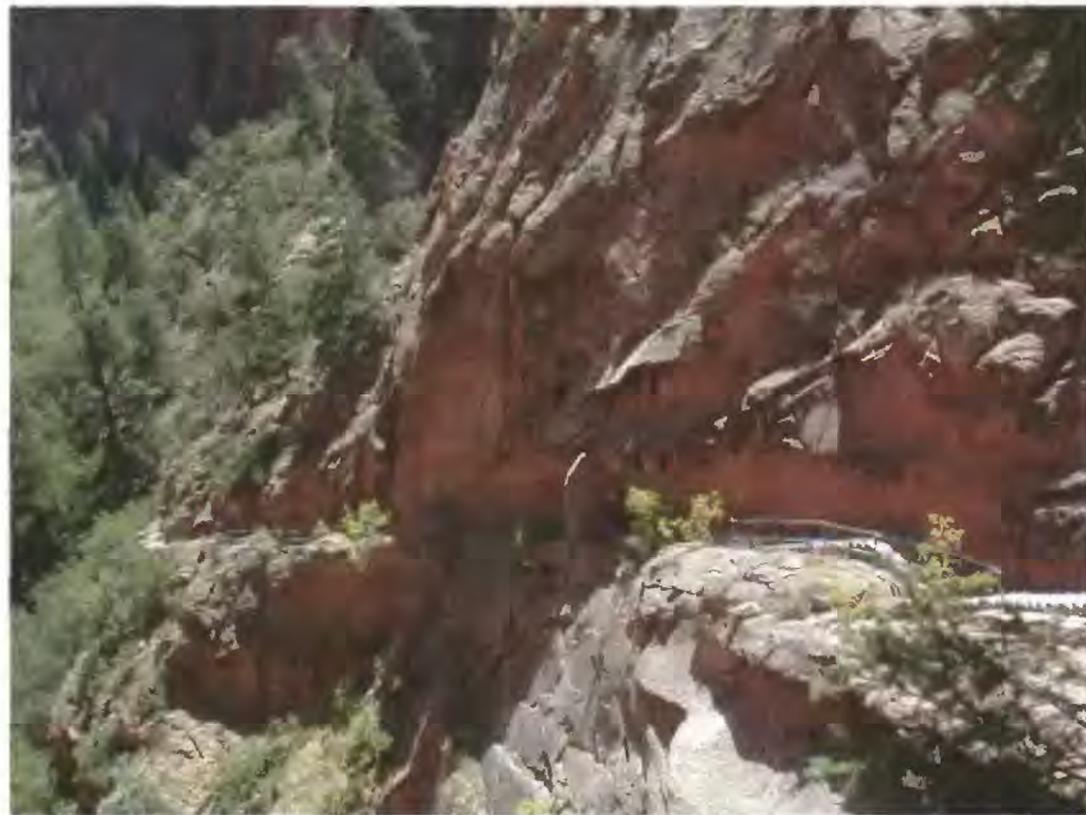
The trail, constructed in 1963, has many steep switchbacks at the head of Betatakin canyon and a short constructed overhung section along the southern side of the canyon (Fig. 1). The trail has experienced rock falls beginning after construction in 1963 (Frank Osterwald, written commun. 4/28/82), most seriously in 1982 after two rock falls (3/18-25/82; 12/8/82) blocked the trail in the steep overhung section just below the locked gate. The first rock fall exceeded some 9.5 tons and the second was estimated at 200-300 tons. Since April of 1982 the trail has remained closed to the public. In early 1983 (sometime during February to March) another large rock fall occurred slightly further down the trail that covered the trail and sent rocky debris to the valley floor near Saucer Cave (John Laughter, pers. commun, 6/22/00). The remains of this 1983 rock fall still cover about a 40-foot wide section of the trail.

Fig. 1- Steep, overhung section of Aspen Forest Trail to Betatakin ruins.

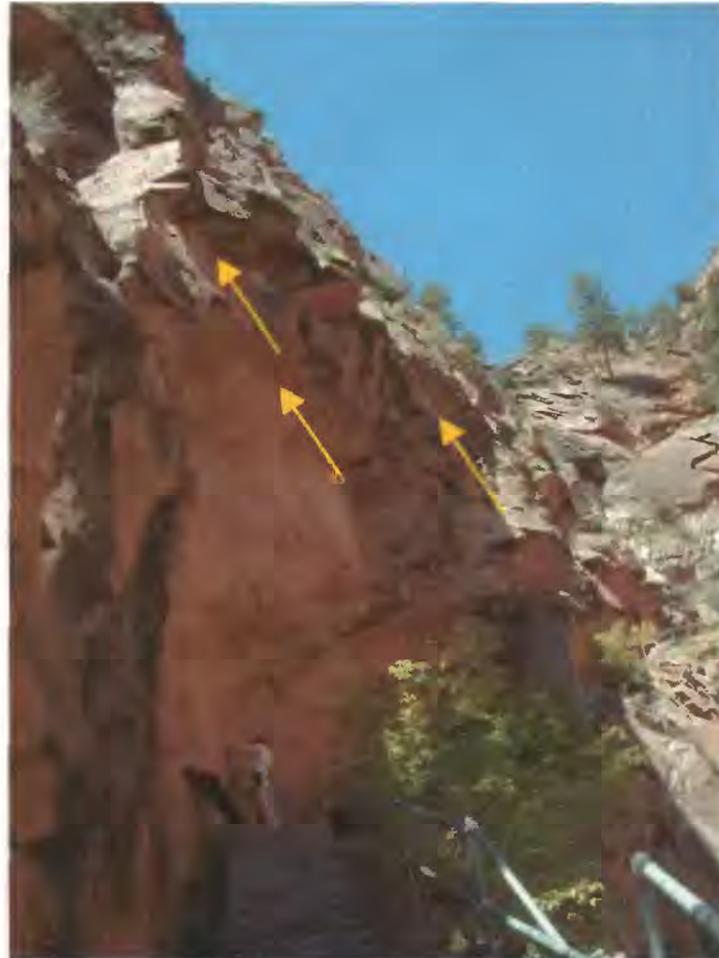
The stability of the Aspen Forest trail at the head of Betatakin Canyon is controlled by several geologic factors. The Navajo Sandstone bedrock, weakly cemented by calcite and iron, is strong enough in places on the Colorado Plateau to form steep-sided canyons. The head of Betatakin Canyon, through which the Aspen Forest Trail passes, is very steep and represents an actively eroding canyon that is slowly advancing westward. The density and orientation of joints, bedding planes, and other discontinuities as well as their properties affect the quality or strength of the rock mass, which influences the stability of the rock mass (Fig. 2). The occasional presence of water in discontinuities or infilling of weak materials in the discontinuities creates local zones of weakness. The timing of noted failures during the generally wet winter and spring periods strongly suggests that water infiltrating the joints plays some part in destabilizing the rock mass.

Fig. 2- Numerous joints near Sta. 38.5 and site of 1982 rock falls along overhung section of Aspen Forest Trail. Arrows denote joint surfaces (J_1 , see figure 3) that dip steeply out of the slope.

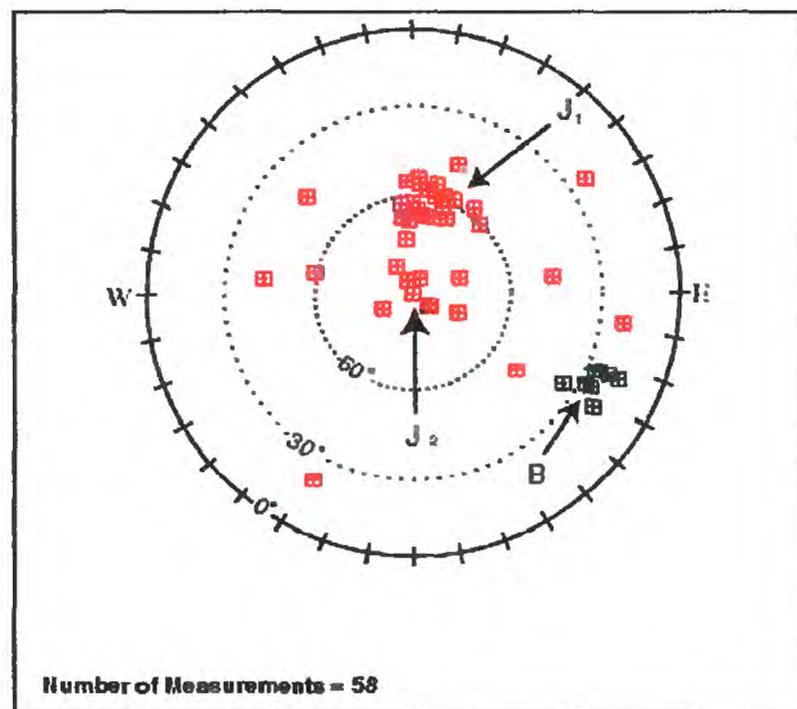
We measured the direction and amount of dip of 58 planar discontinuities along a steep section of about 800 feet of the Aspen Forest Trail (between Sta. 14 and Sta. 47; station locations are referenced to a survey by Lachel Hansen & Associates, 1985). Based on these measurements we distinguished bedding B and two major joint sets, J_1 and J_2 , as well as other isolated random discontinuities (fig. 3).

Fig. 3-Equal-area stereonet plot of dip vectors of discontinuities along Aspen Forest Trail between Sta. 14 and Sta. 47. Cluster of measurements in E-SE represent bedding (B) which generally dips about 26 degrees to E-SE. Two other major joint sets are evident, one of which dips about 60 degrees to N (J_1), and the other is near vertical (J_2). The few remaining measurements represent individual, more random joints.

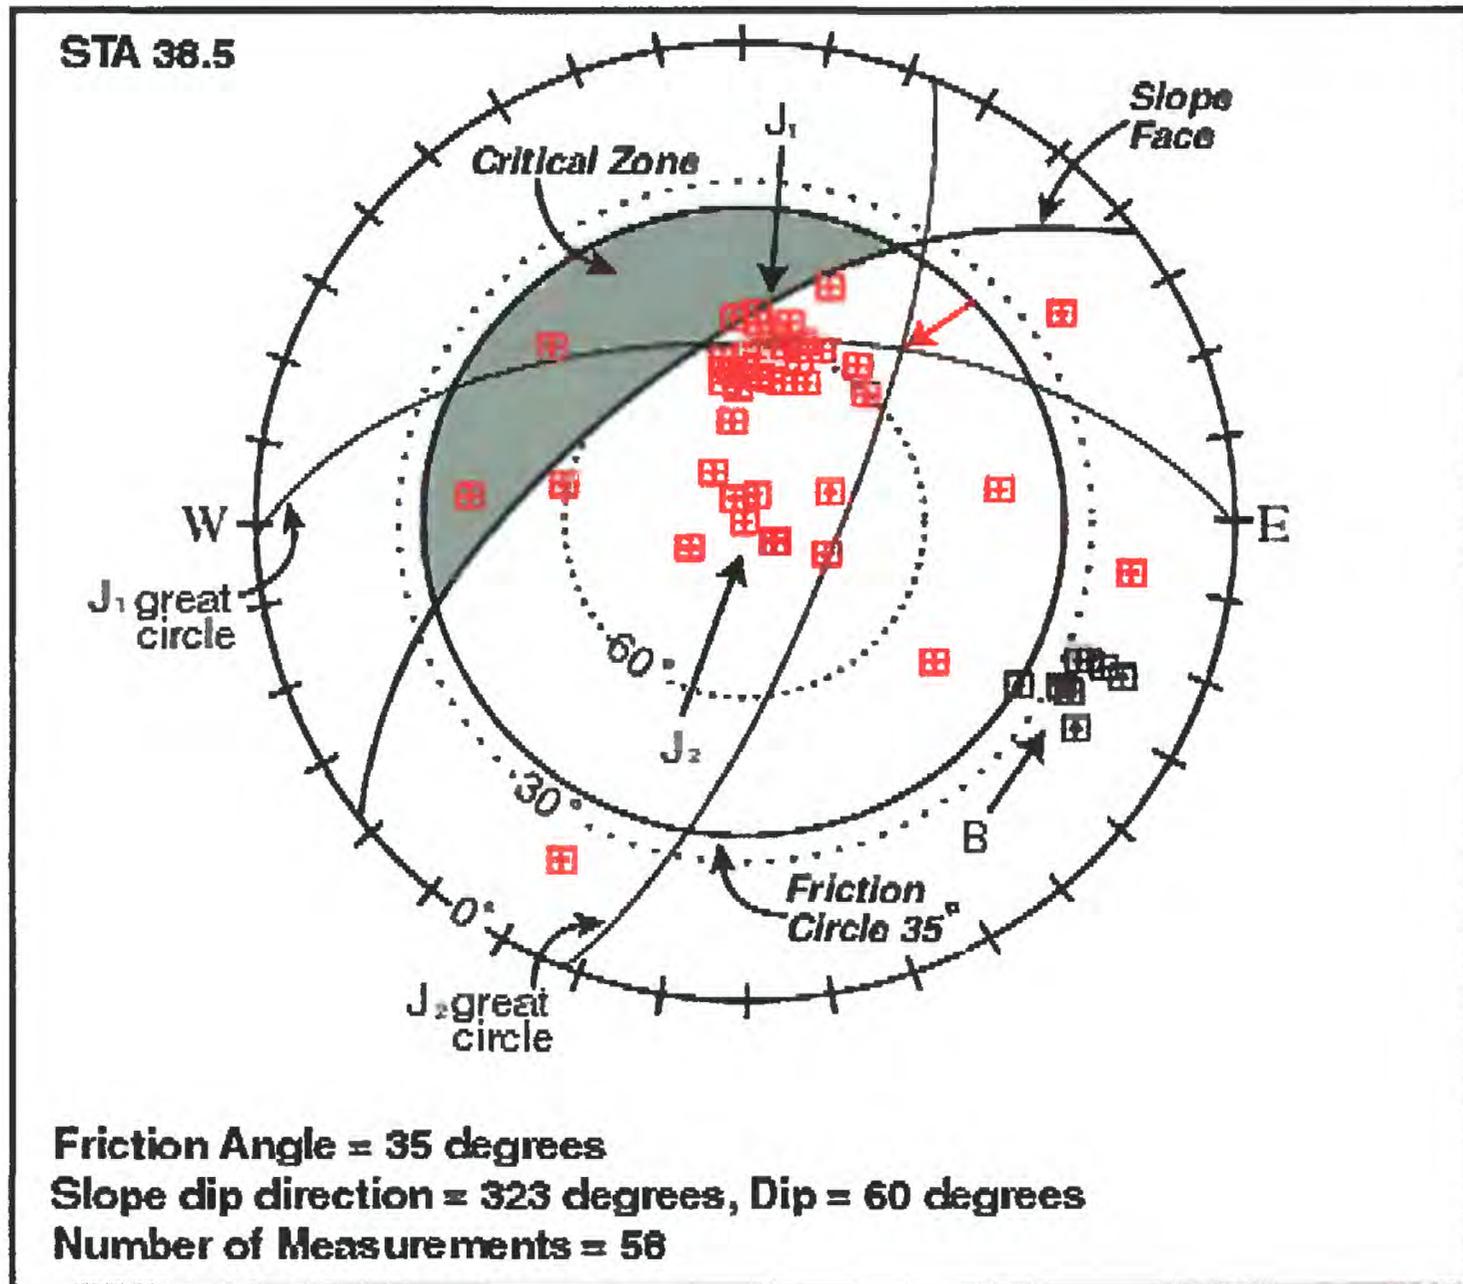
Near the location of the previously mentioned 1982 rock falls (Sta 38.5), a plot of the discontinuities (fig. 4) shows that the cluster of dip vectors of the major N-dipping joint set J_1 nearly enter the critical zone. The original slightly steeper slope (prior to the 1982 rock falls) could have posed a more critical condition for planar sliding than that at present.

Fig. 4-Markland test plots for planar and wedge failures. Slope face, friction circle, and critical zone for sliding failure are indicated. Red arrow indicating intersection of great circles for joint sets J_1 and J_2 outside of critical zone precludes wedge failure of these discontinuities.

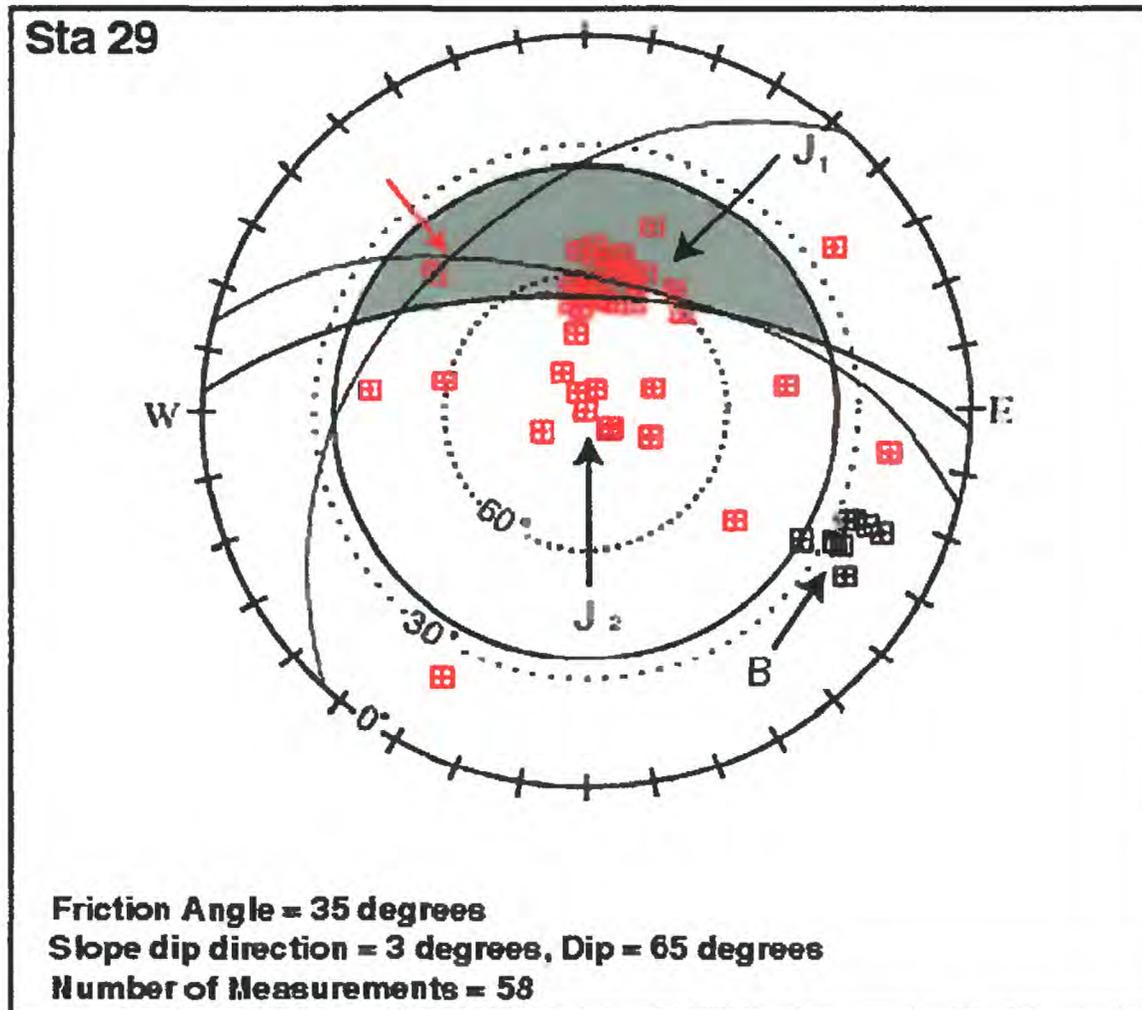
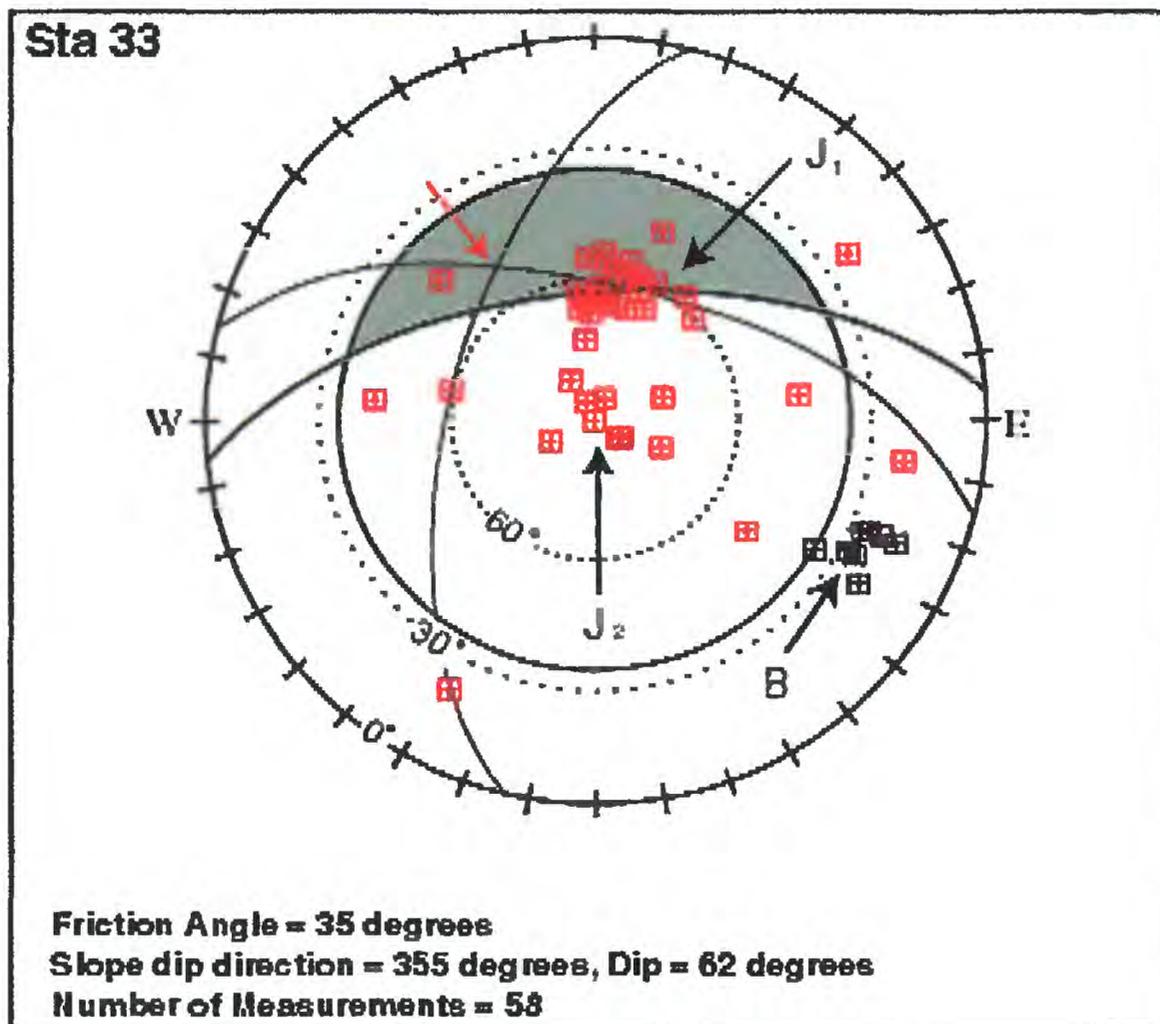
To illustrate the effect of a slight variation in the direction of the cut face on slope stability, we examined Markland test plots for Stations 29 and Sta. 33 shown in Fig. 5. In this section of the trail immediately upslope of the gate, the N-dipping joint set J_1 daylights in the slope face, shown as the cluster of points inside the critical zone, thus creating a potential for planar sliding. The intersection of great circles within the critical zone (red arrows in fig. 5) show that conditions are favorable for wedge failures formed by intersection of joint set J_1 and other isolated joints. The conditions are similarly favorable for planar sliding between Sta. 23 and 29.

Fig.5-Markland test plots for planar and wedge failures. Red arrows to intersections of great circles for discontinuity J_1 and isolated joints in critical zone indicate potential for wedge failures.

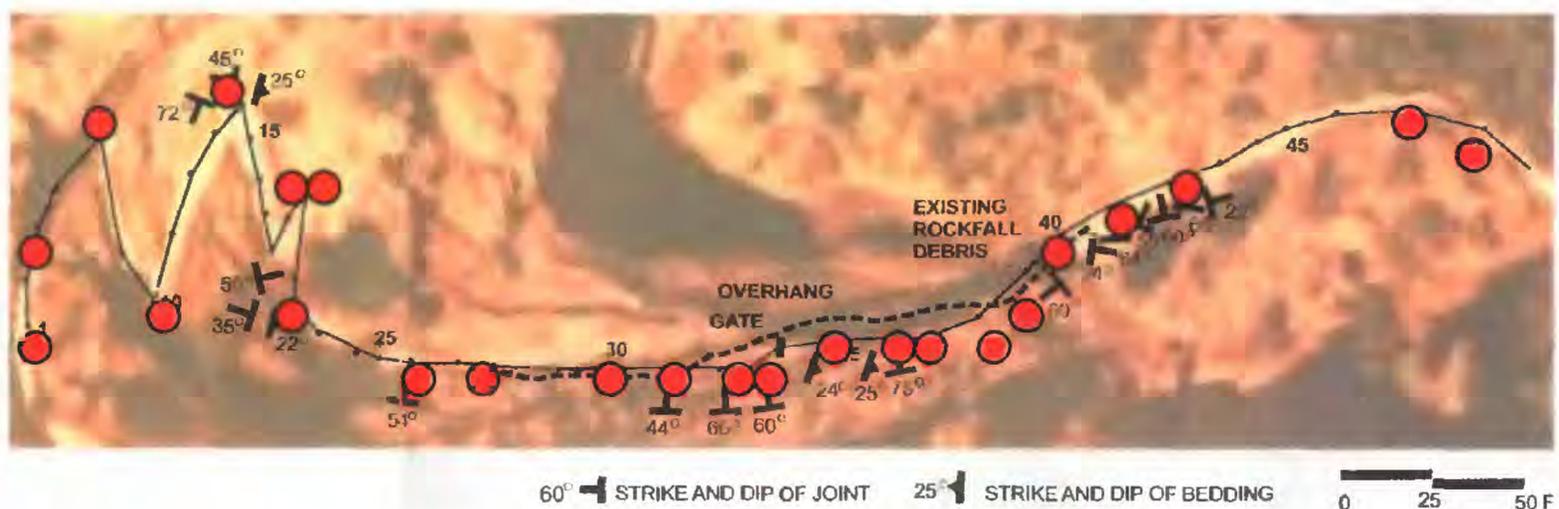
Figure 6. Plot of survey stations (shown as small black numbered dots along solid line) from west (Sta. 1 at left) to east (Sta. 48 at right) along Aspen Forest Trail by Lachel Hansen & Associates (1985). Larger red dots denote sites of measured Q-values. Dashed line indicates position of rock cliff above trail. Strike and dip measurements are from Lachel Hansen & Associates (1985).

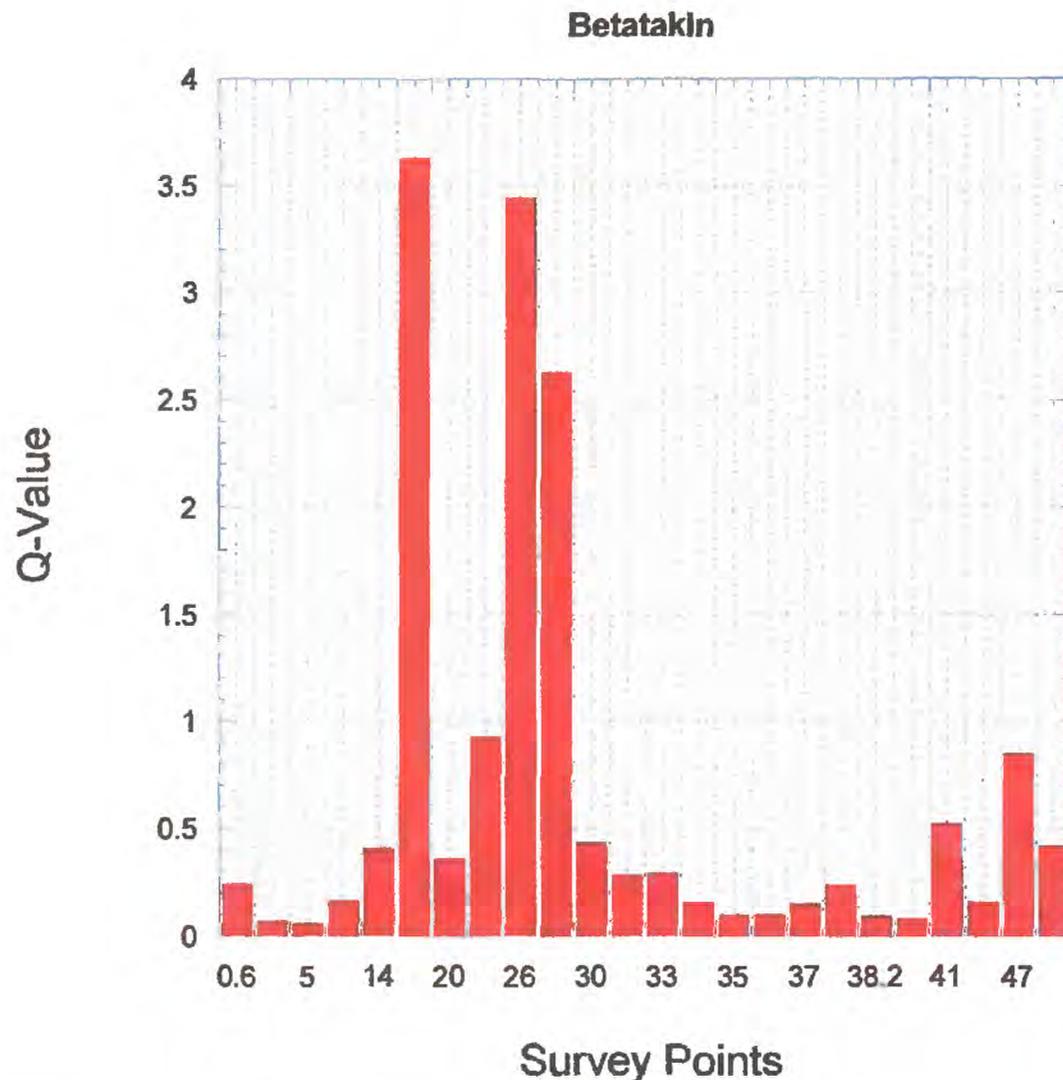
The bar graph in figure 7 shows the relative susceptibilities of the rock adjacent to the trail from survey points 1 to 48. As can be seen in the figure, the lowest values, and therefore the highest susceptibilities, are found adjacent to points 35 to 40 along the overhung section of the trail and adjacent to points 2.4 to 5 above this section. The rock along these two sections of trail would be rated as “high susceptibility” due to the fact that the numerical values are less than 0.1 for most of the points in these sections. The remainder of the sites qualify as “moderate susceptibility”. None of the rock where Q-values were calculated can be considered as “low susceptibility.” Compared to much of the Navajo Sandstone outcrops in this area, the Q-values along the measured section of trail are relatively low. Massive outcrops of Navajo Sandstone can have quite high Q-values that place it well within the “low susceptibility” range.

Figure 7. Numerical values of Rock Mass Quality with respect to survey points of Lachel Hansen & Associates (1985).
