A Debris Avalanche at Forest Falls, San Bernardino County, California, July 11, 1999

By Douglas M. Morton¹ and Rachel M. Hauser¹

Open-File Report 01-146

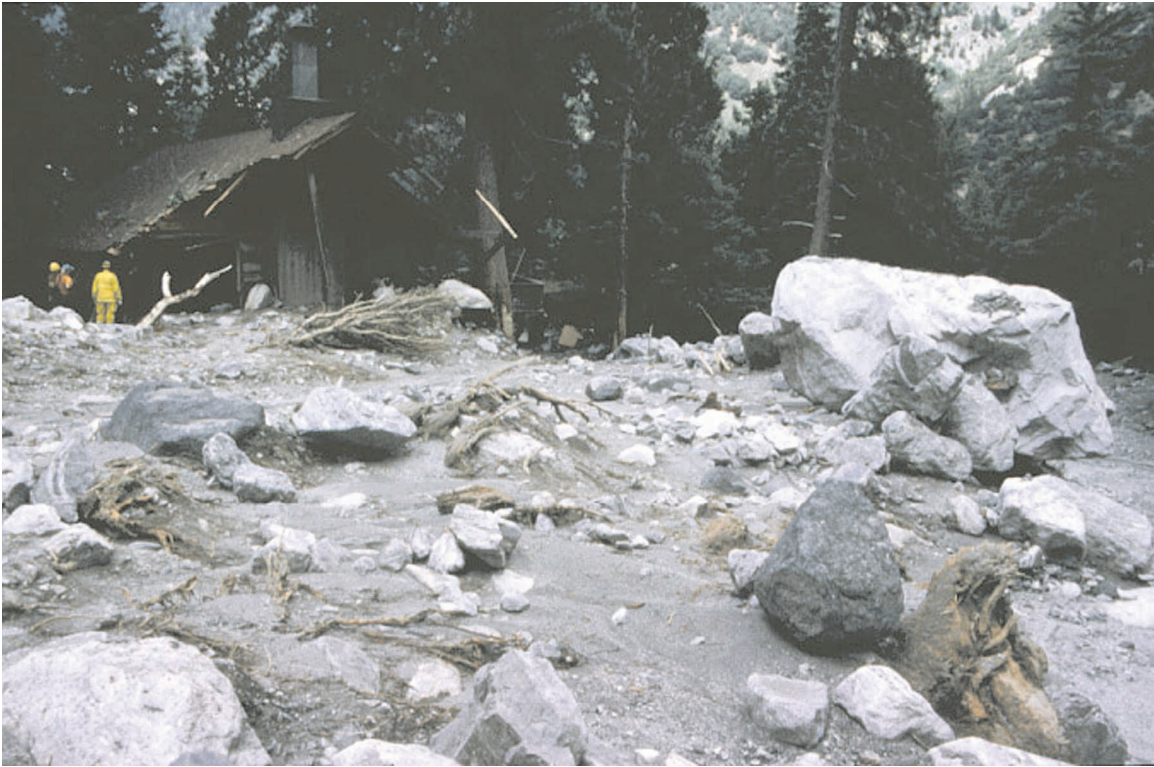
Witnesses described the debris avalanche as having three “waves” that topped the debris flow channel wall. The house where the fatality occurred was directly in the path of the first wave. One or both of the subsequent waves apparently exited the channel a short distance down channel from where the first wave exited. One house, adjacent to the channel, was struck on both sides by different waves (Figure 32).

Figure 32. Left side of house was removed by 1st and/or 2nd debris avalanche waves and the right side by the 2nd and/or 3rd avalanche waves, July 11, 1999. Note the 'swept' appearance in foreground produced by avalanche degradation where it removed both rocks and vegetation. Large boulder on right side of the photograph is shown in Figure 21. Photograph taken July 12, 1999.

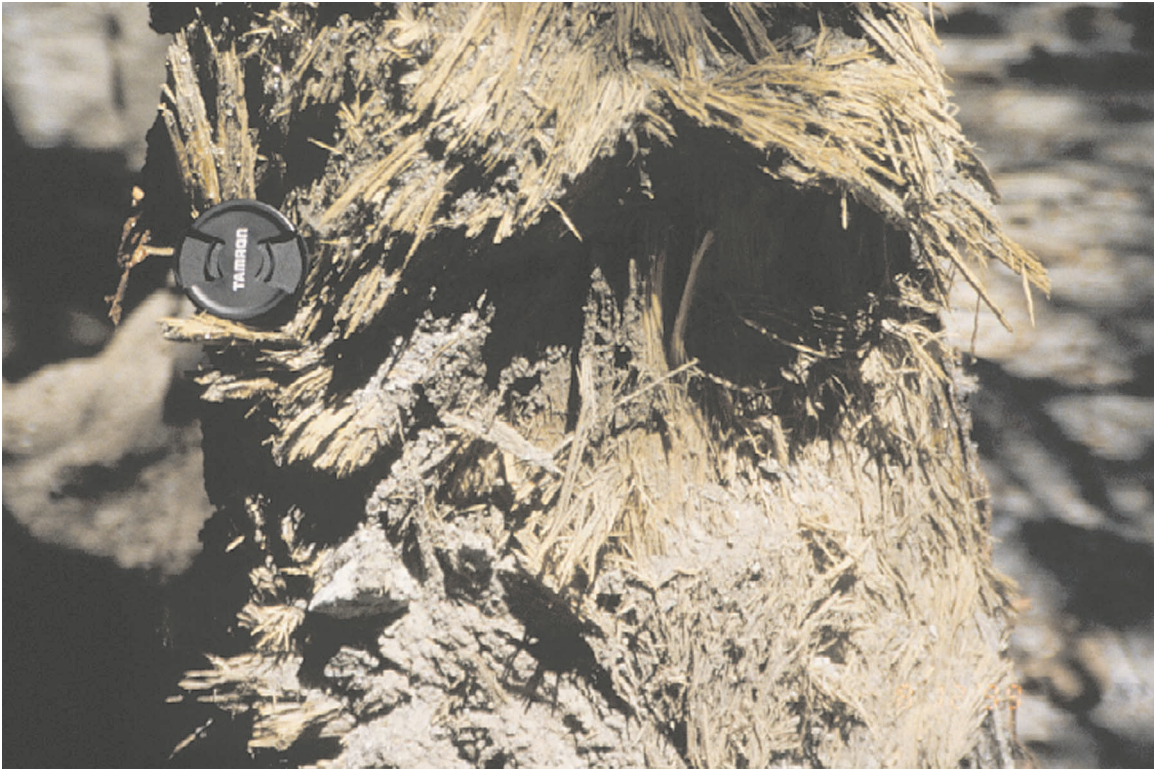
Figure 34. Upslope side of tree fragmented by the July 11, 1999, avalanche. Note the rock embedded in the fragmented wood below the lens cap.

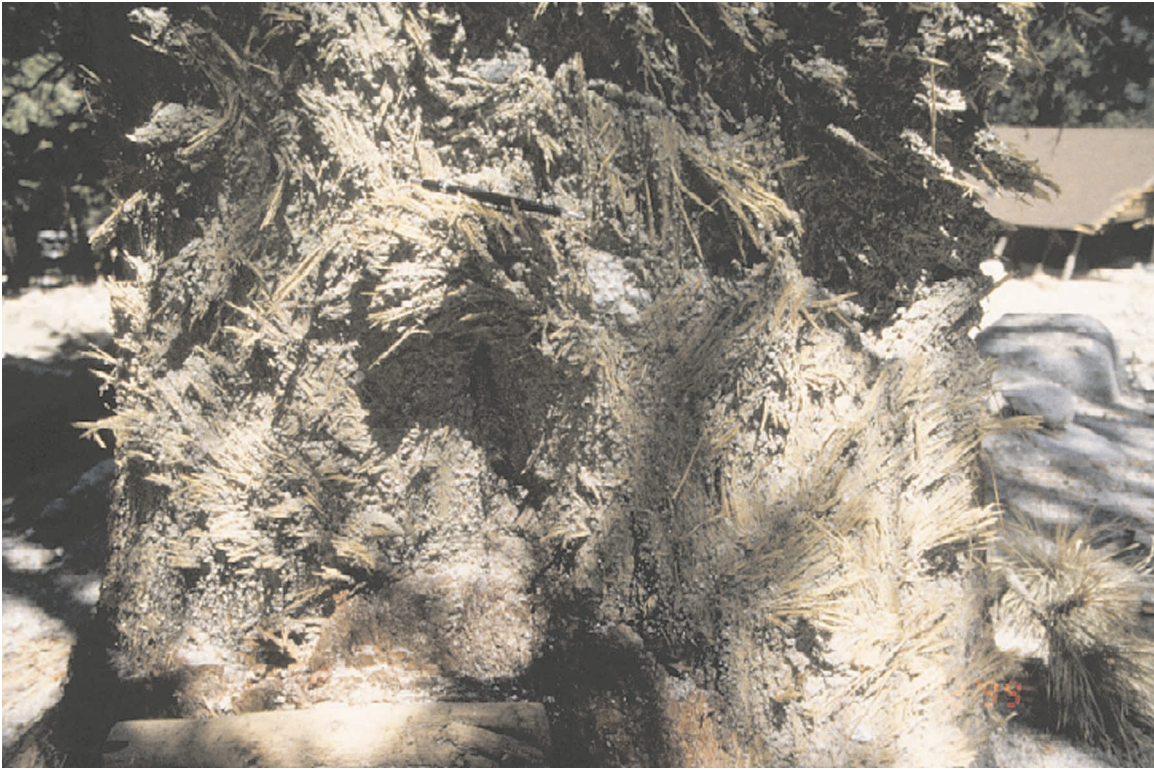
Figure 35. Upslope side of tree fragmented by the July 11, 1999, avalanche. Note the rock embedded in the fragmented wood below the right side of the pencil.

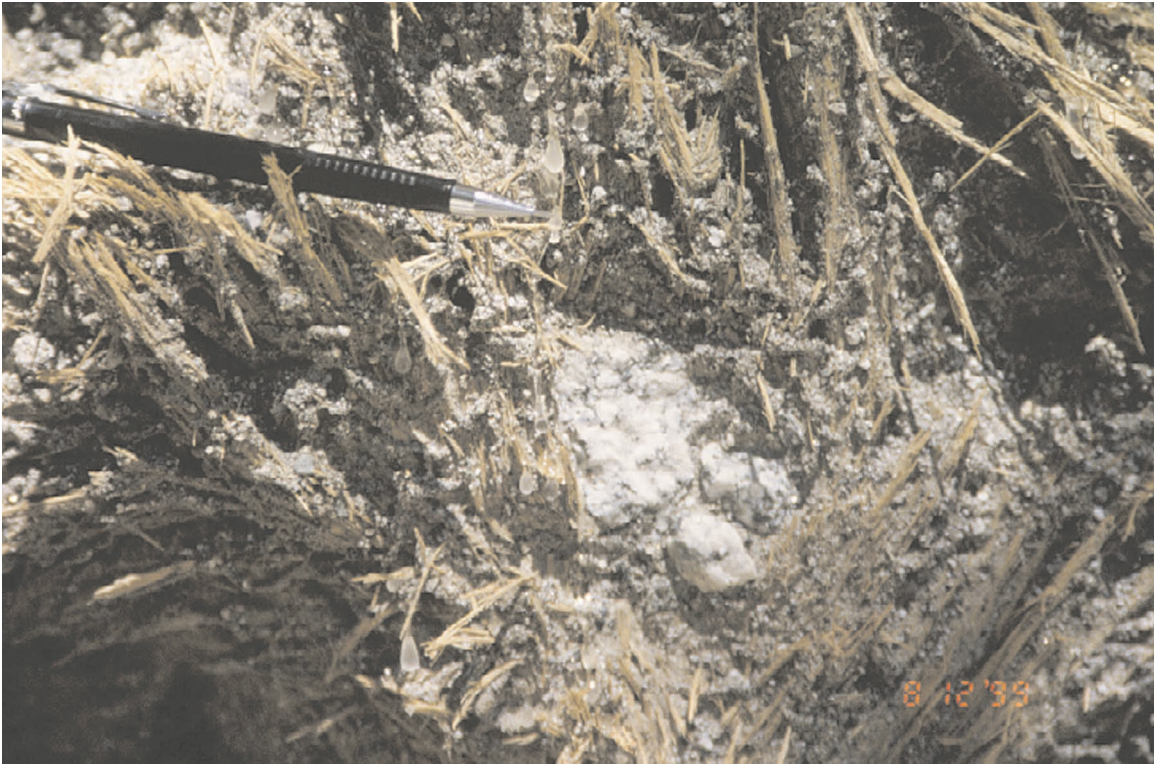
Figure 36. Rock embedded and fragmented by impact of the high velocity debris avalanche of July 11, 1999.

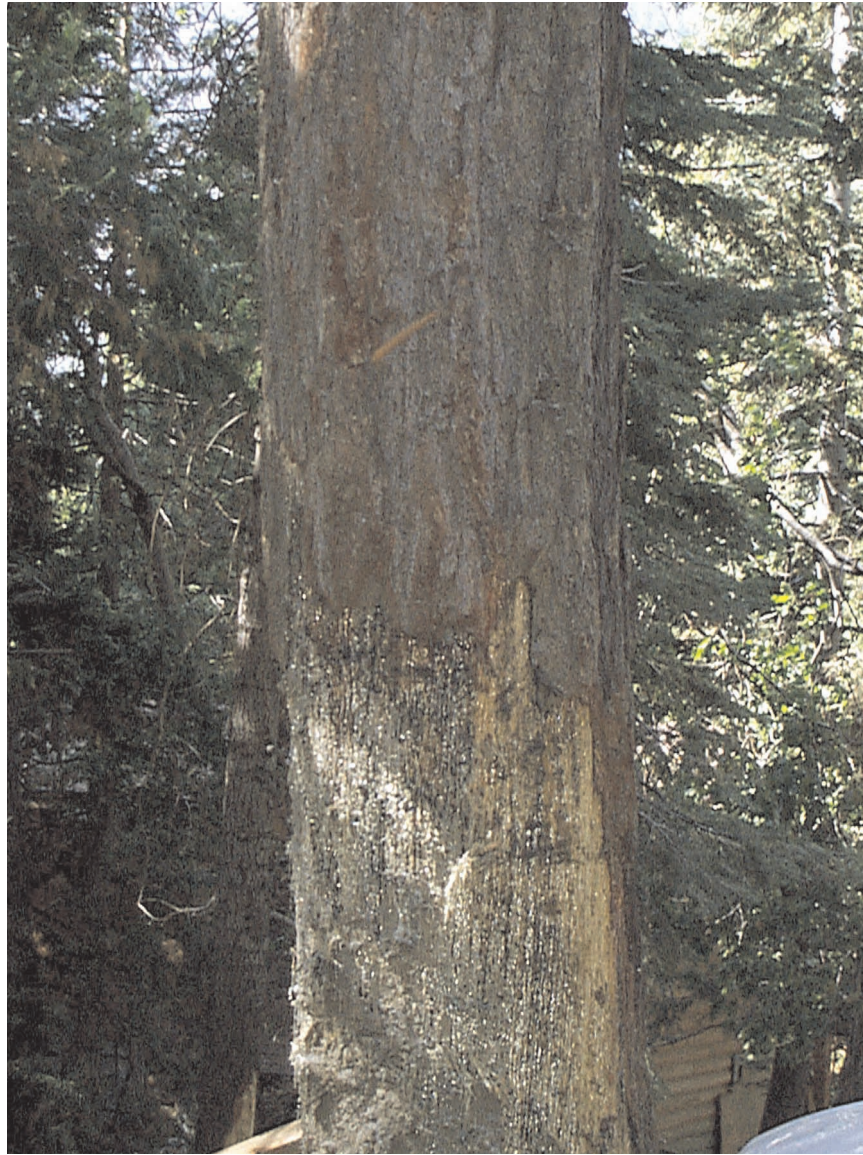
Figure 37. Wood splinter propelled by avalanche that was embedded in a tree about 300 feet below point where avalanche shot-over the channel. Height of the debris avalanche at this location, marked by the debarked side of the tree, was about 1.5 feet below the wood splinter.

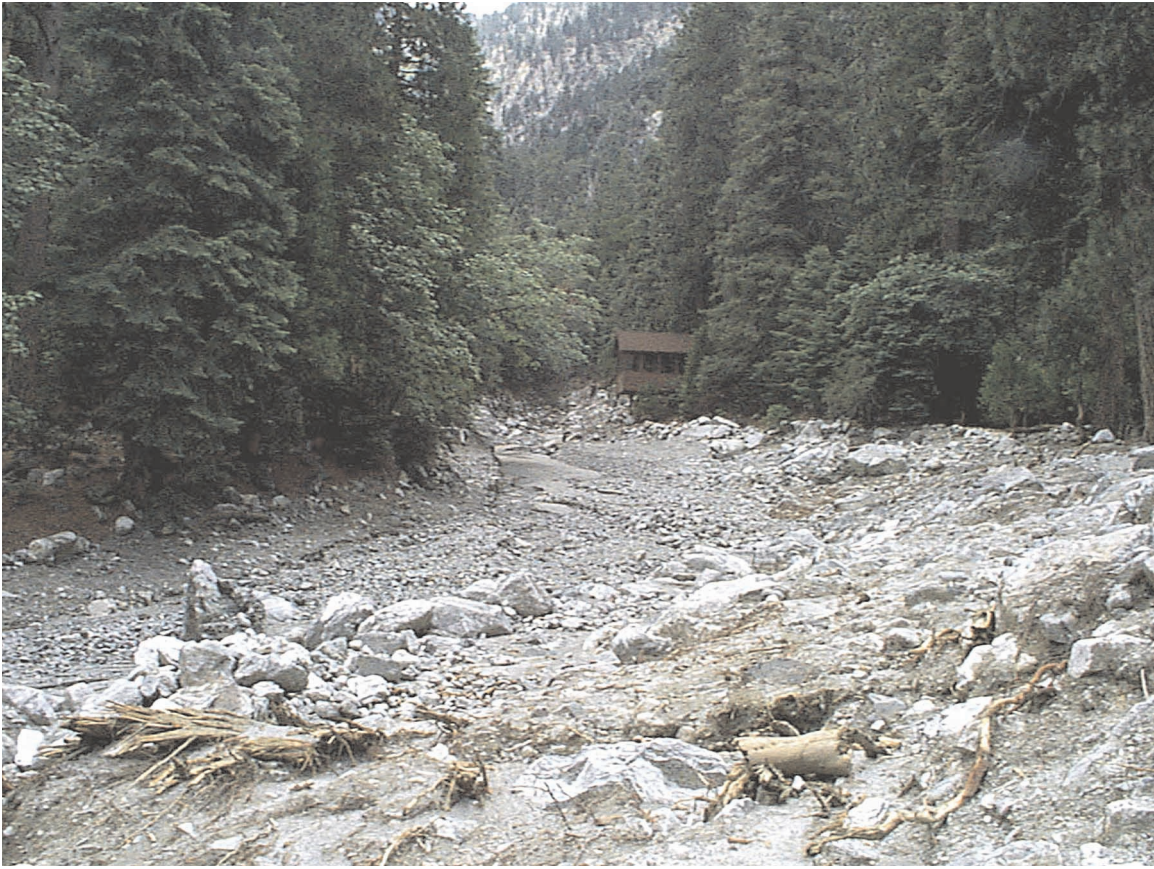
Figure 42. Curve in Snow Creek debris flow channel where avalanche shot over the channel wall. Note the 'swept' appearance of the degraded channel wall. Brown building in center of the photograph is that in the left side of Figure 41. Relative open curve in the channel to the left of the building is where the avalanche had a superelevation of a minimum of 11 feet. Photograph taken on July 12, 1999.

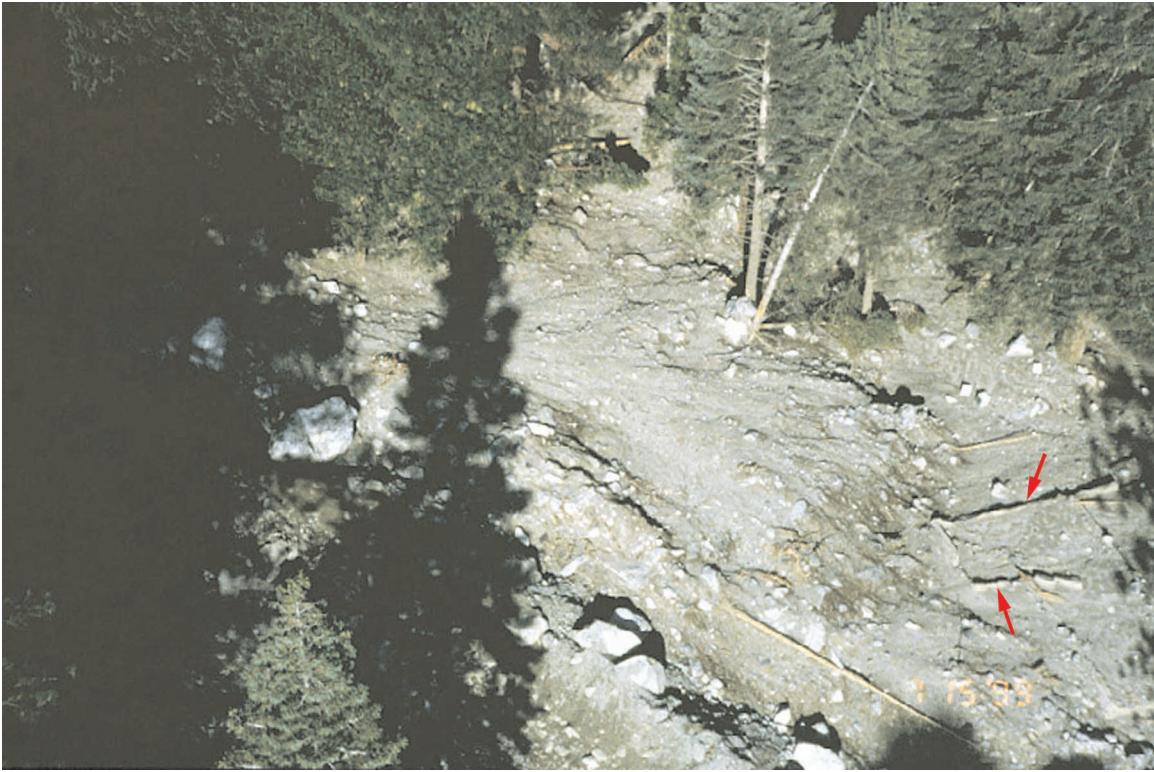
Figure 43. Surface of Snow Creek fan degraded by the debris avalanche where it shot over the channel wall. The rectangular area (arrows) is the foundation of the house completely destroyed and removed by the avalanche. The 1st avalanche wave struck the end of the house at 90 degrees. The direction of the 1st avalanche 'wave' is indicated by the flattened tree that is parallel to and just beyond the far side of the foundation. The fragments of the house are located to the right of the photograph parallel to the direction of length of the foundation and the flattened tree. The direction of the 2nd and/or 3rd avalanche 'waves' is indicated by the orientation of the flattened tree in the foreground. The new sharp-topped debris flow ridge was produced by 'overflow' from the debris flows of July 13 is seen in the center of the bottom of the photograph. Photograph taken on July 15, 1999.

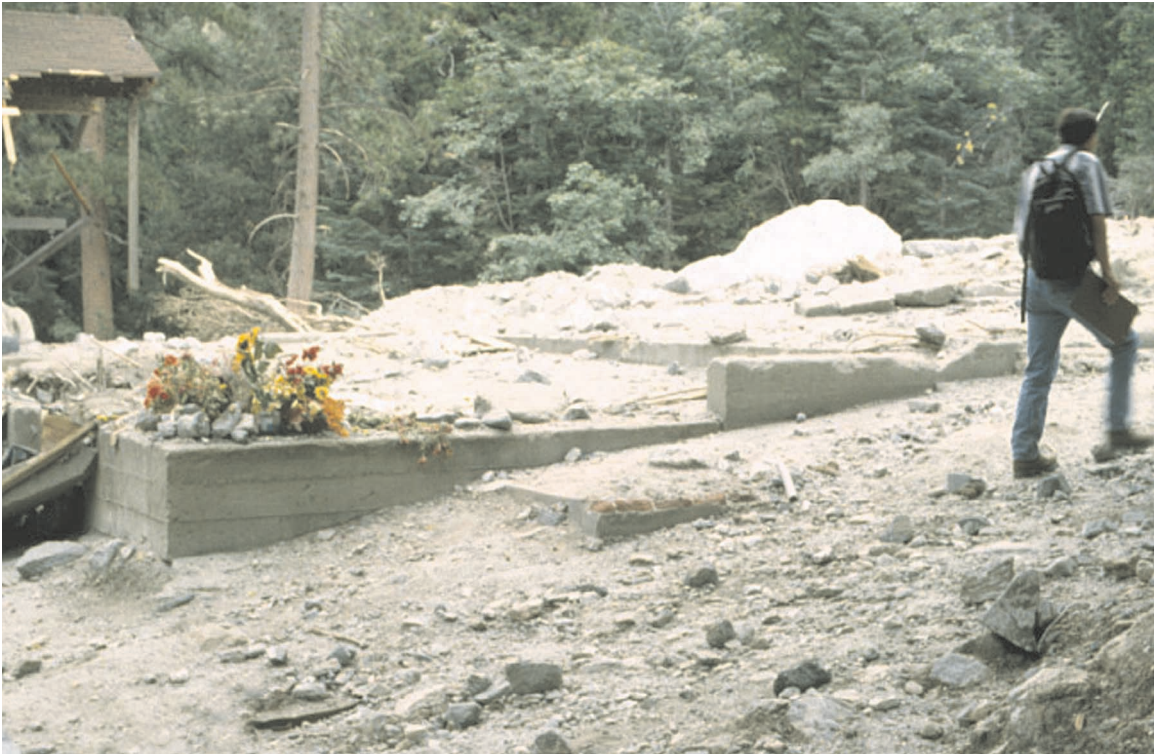
concrete foundation of the house remained (Figures 43, 44, and 45). The fragmented house was transported 450 feet down the fan; three of the occupants remained within the wreckage, the fourth was carried about 550 feet further down the fan. One of the occupants in the wreckage was killed, the others severely injured.

Figure 44. Battered foundation of the house that was destroyed and removed by the debris avalanche.

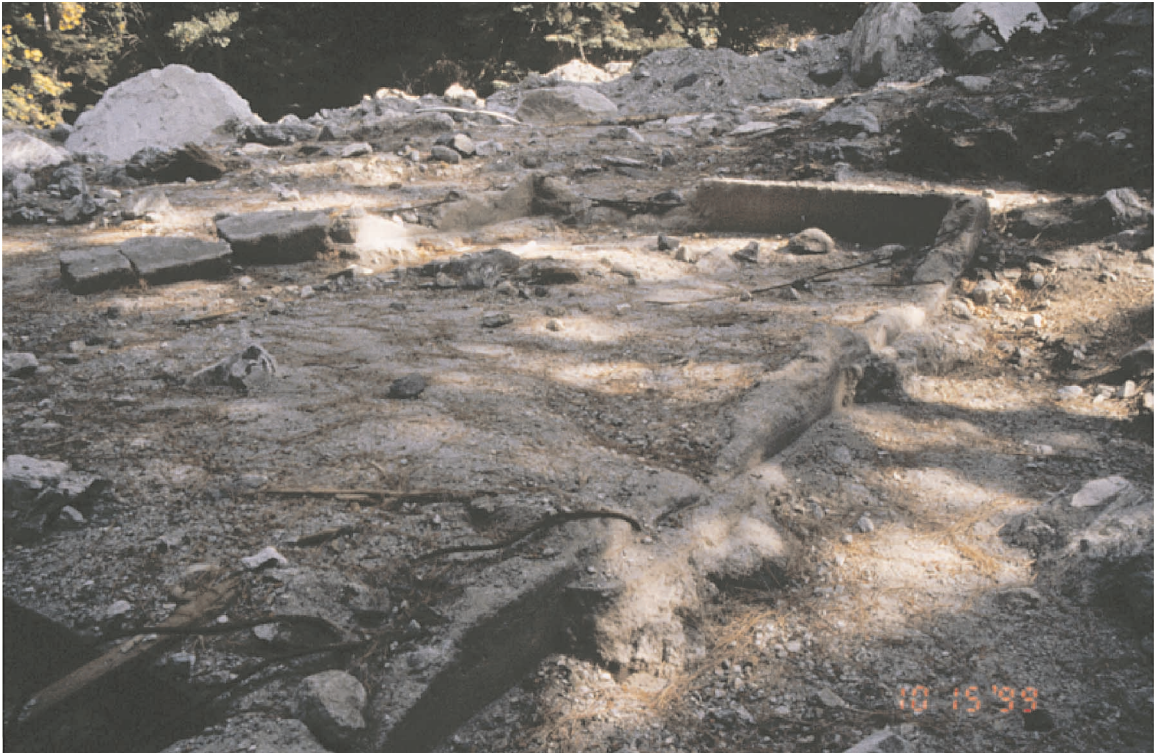
Figure 45. Close up of the foundation of the house. Note the fragmentation of the foundation and the reinforcing rods bent into the direction of flow of the debris avalanche.

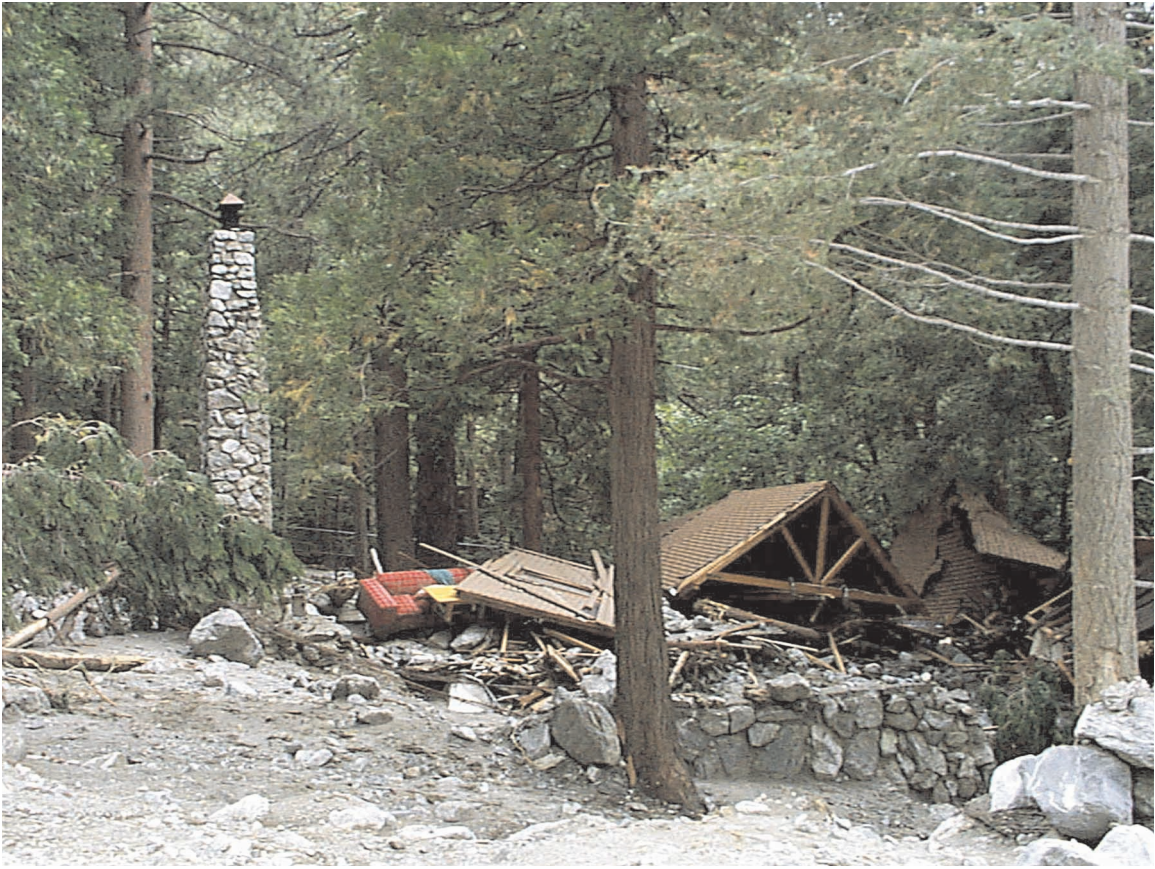
Figure 47. Houses destroyed by the first debris avalanche wave on the west side of the avalanche. Photograph taken July 12, 1999.

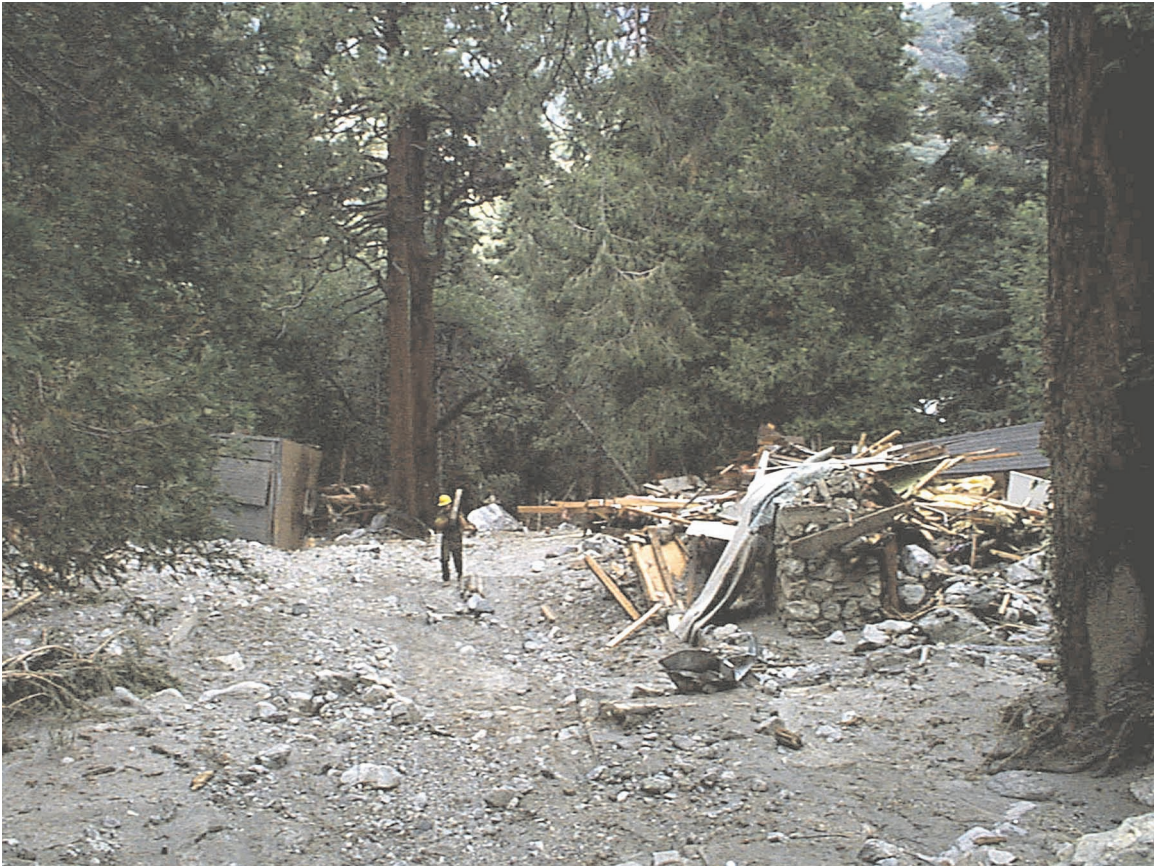
Figure 48. Destroyed houses down Snow Creek fan along the central path of the first debris avalanche wave. Here the debris avalanche, no longer confined by a channel had spread out over a width of more than 100 feet. Photograph taken July 12, 1999.

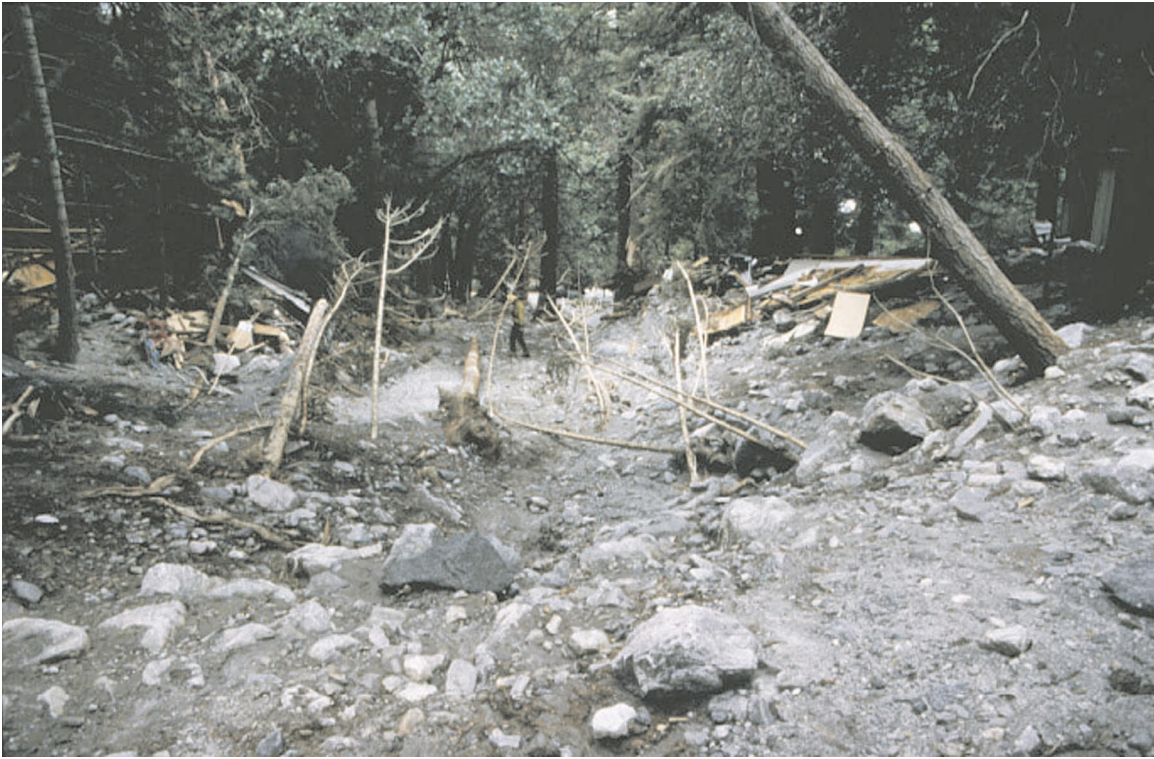
Figure 49. Destruction of structures in the path of the 1st and perhaps 2nd avalanche 'waves' as the debris descended down Snow Creek fan. This location down fan from the location of Figure 47. Note the bent and stripped small pine trees oriented parallel to the flow direction of the avalanche. Although the avalanche was slowing it still retained considerable energy. Photograph taken July 12, 1999.

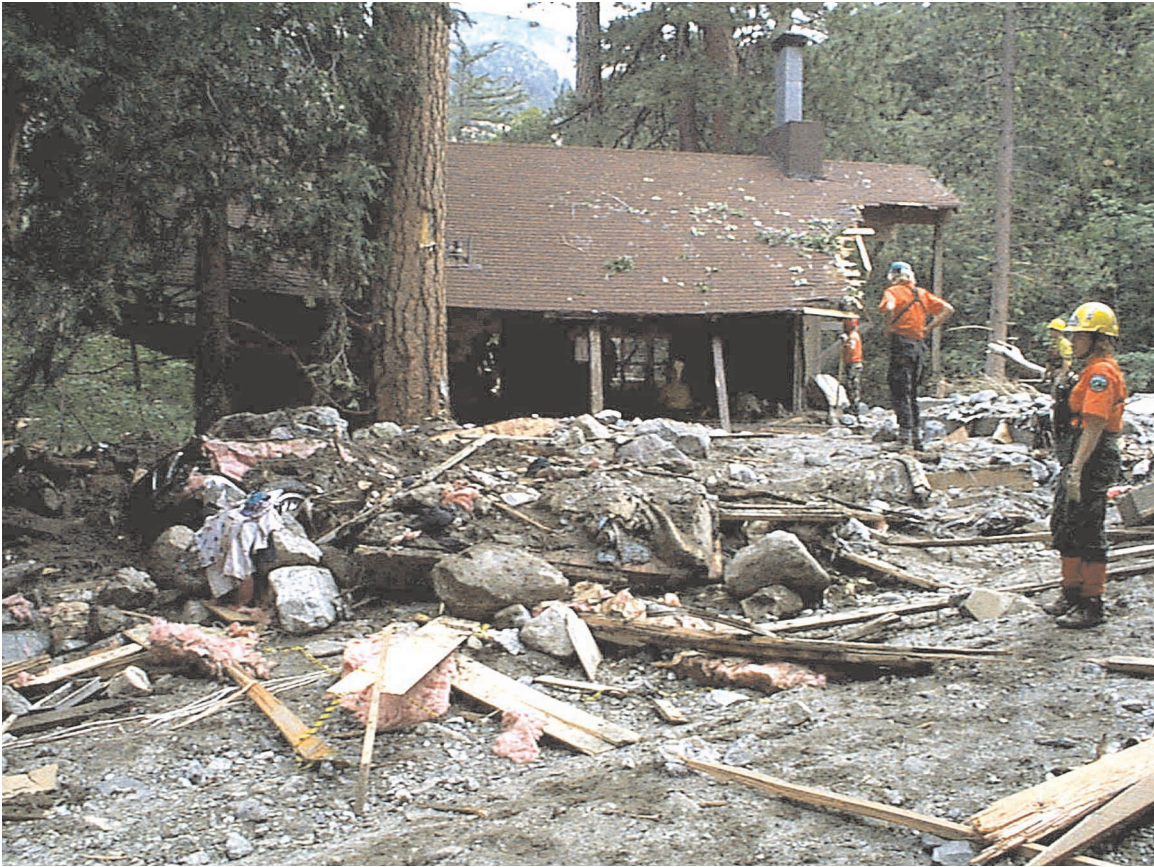
Figure 50. Two cars flattened by the debris avalanche are partly exposed in the mixture of rock and house debris. Note the scar on the large pine tree produced by debris ‘thrown’ by the debris avalanche (see Figure 55 for detailed photograph of the scar). Photograph taken July 12, 1999.

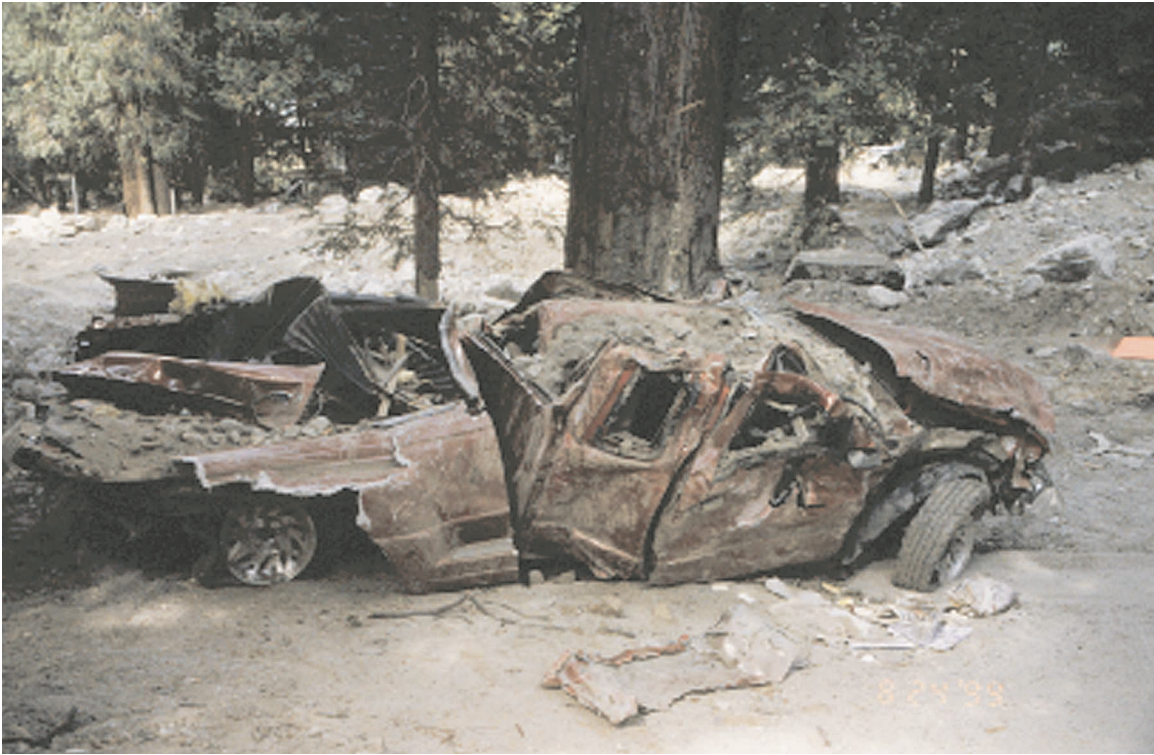
Figure 51. Car exhumed from the site of Figure 50.

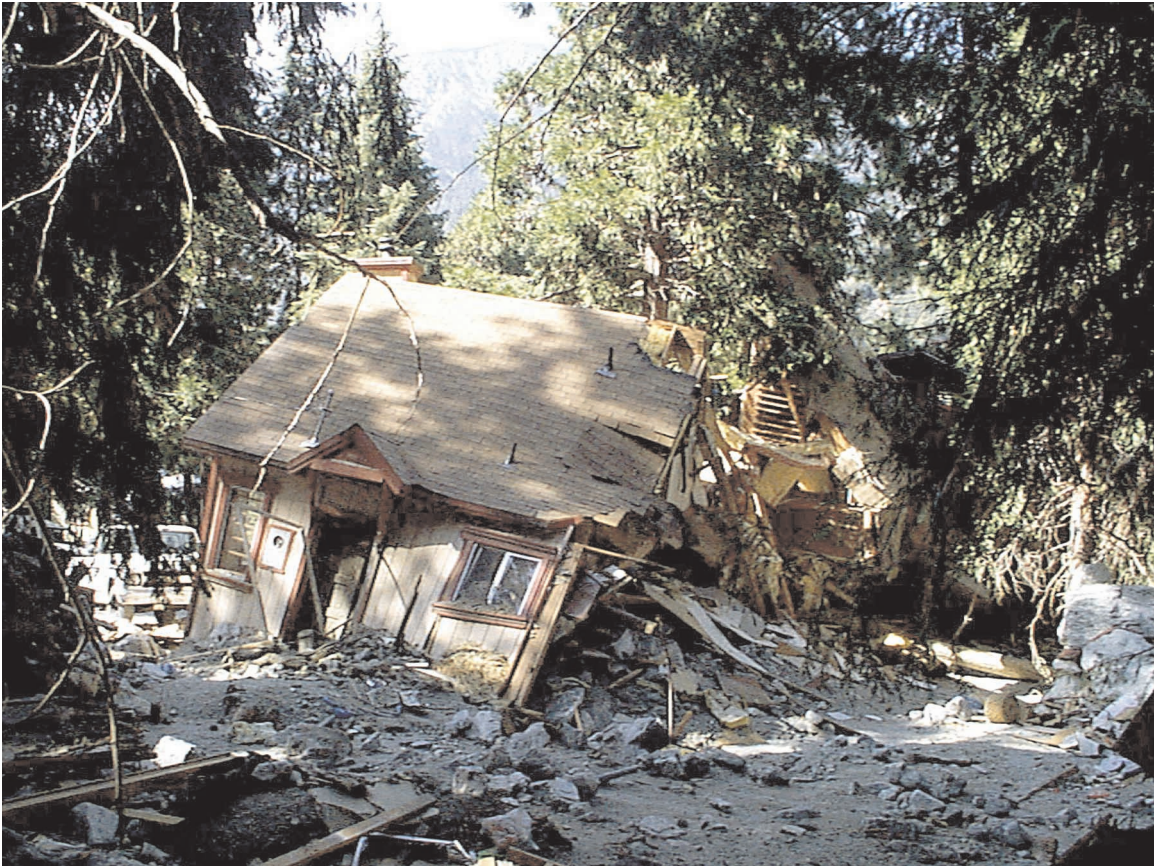
Figure 52. Damage to structures produced down fan on the east side of the 3rd(?) wave of the debris avalanche.

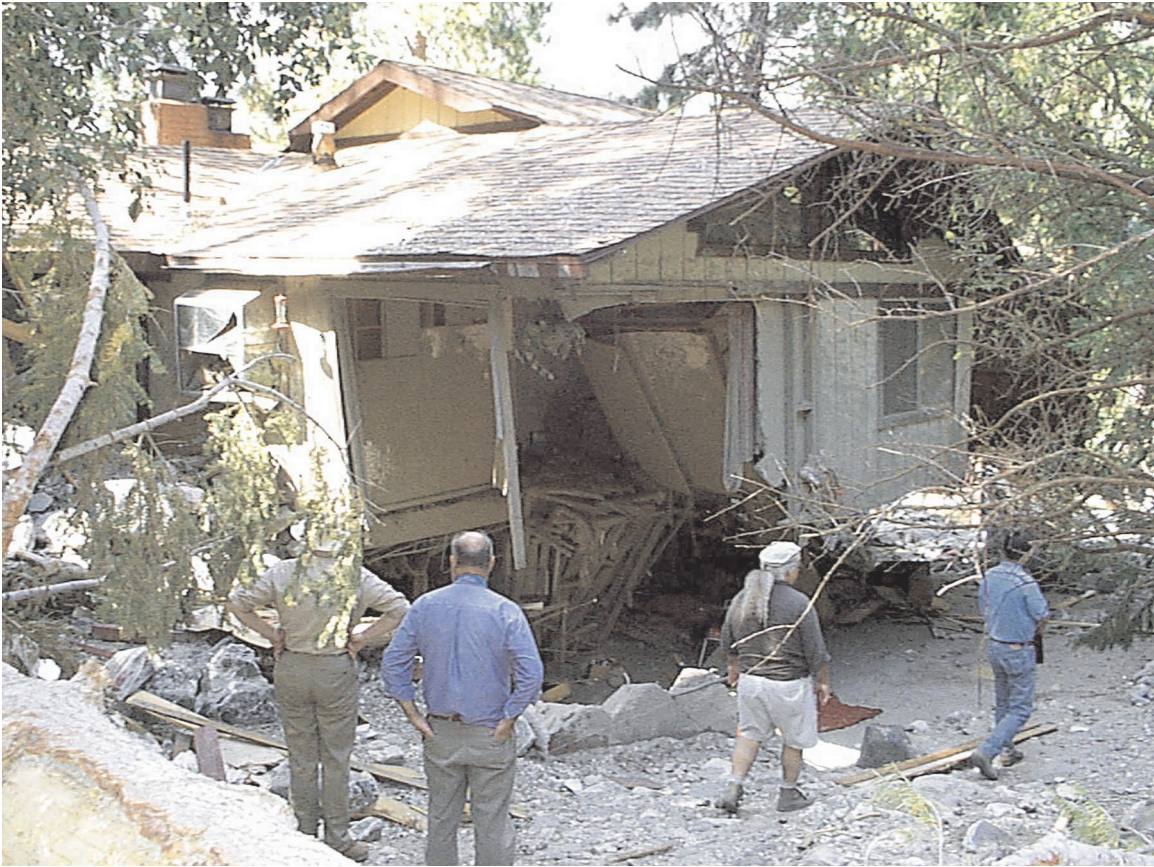
Figure 53. Damage to structures produced down fan on the east side of the 3rd(?) wave of the debris avalanche. Note the fragmented foundation in the foreground.

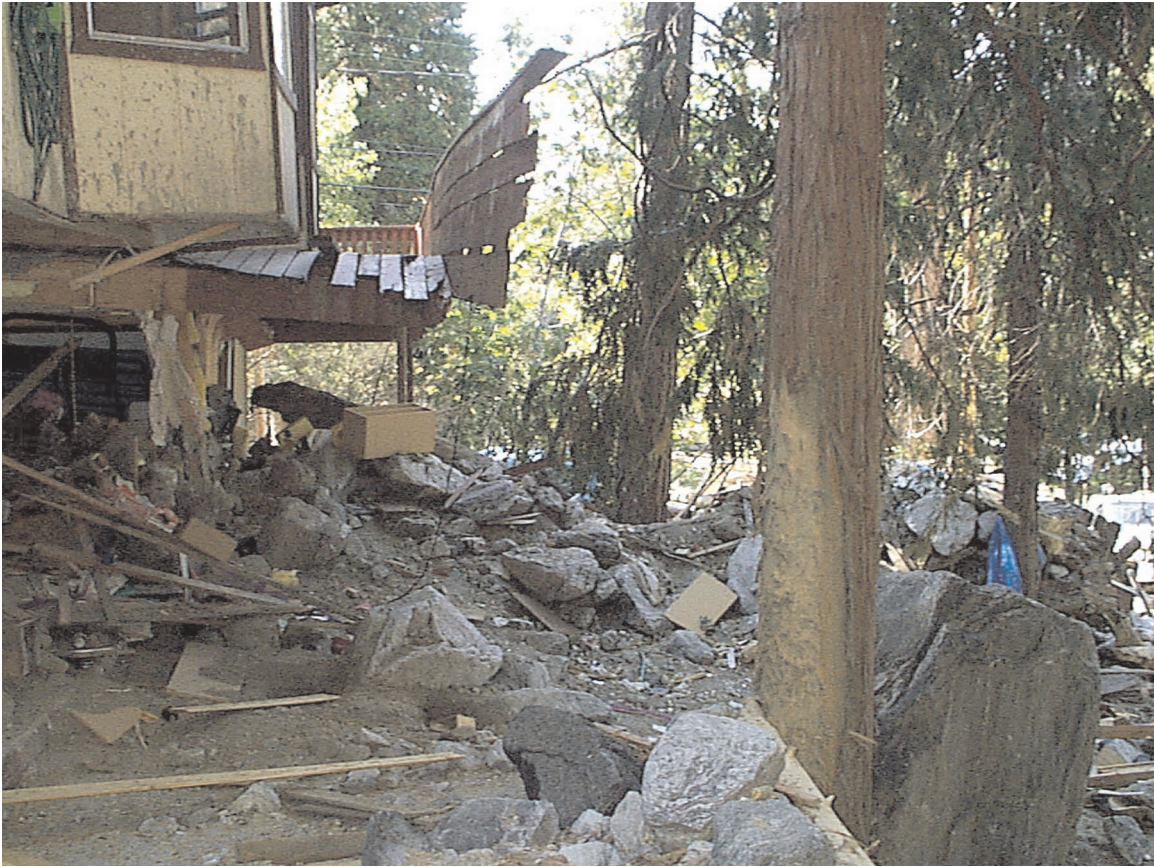
Figure 54. Damage to structures produced down fan at the east edge of the 3rd(?) wave of the debris avalanche. Note the scarring on the left side of tree in the foreground.

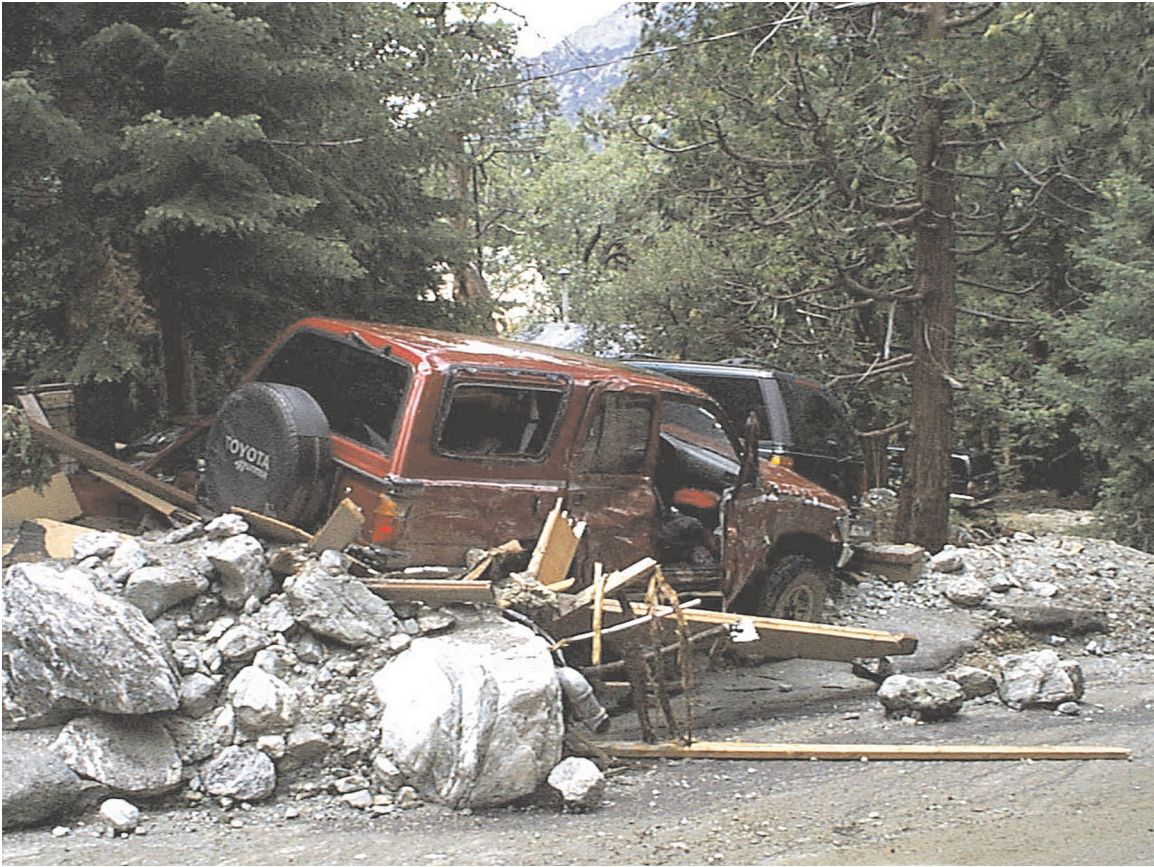
Figure 56. Damage where the 3rd(?) wave of the debris avalanche spread-out down fan and was losing velocity. Note the relatively clean nature of the deposit.
