Assessment of Landslide Hazards Resulting from the February 13, 2001, El Salvador Earthquake

A report to the Government of El Salvador and
the U.S. Agency for International Development

Open-File Report 01-119
On-line Edition

U.S. Department of the Interior
U.S. Geological Survey

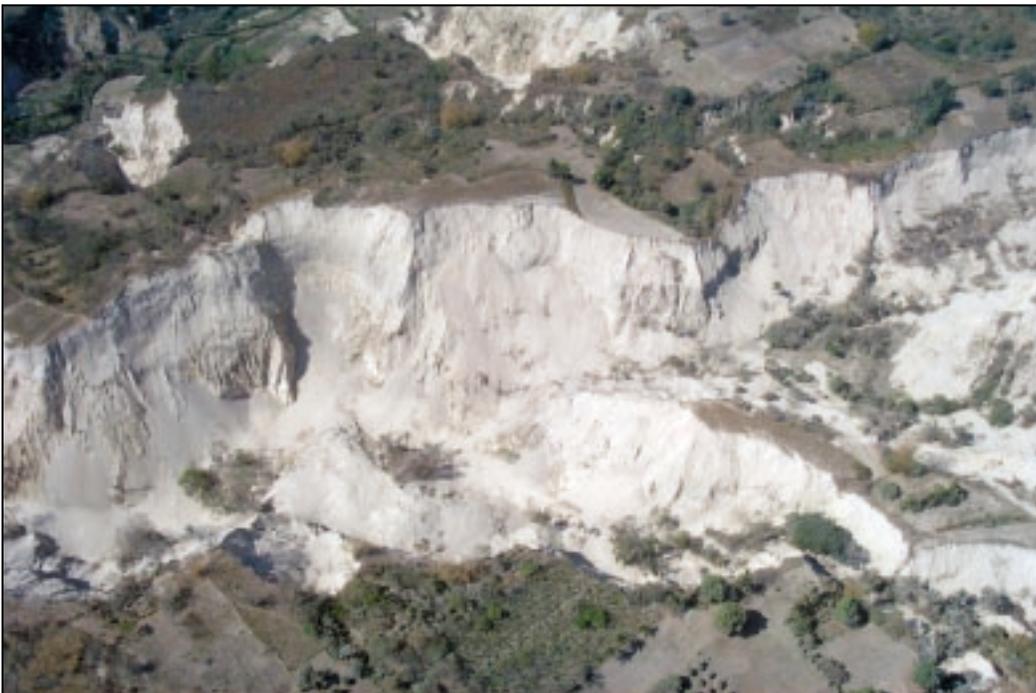
Figure 3. Aerial view of coalescing falls and slides in rhyolitic tephra east of Lago de Ilopango caused by the February 13 earthquake. The abundant fine-grained landslide debris in the valleys may be mobilized as debris flows during the upcoming rainy season.

Because the landslides are so locally abundant, many valleys of the small-order drainages are clogged with landslide debris that, in many places, has completely buried valley floors. During the upcoming

rainy season, this loose landslide debris will be reworked and possibly remobilizing as debris flows. Also landslide-dammed lakes could impound small lakes in the narrow valleys, and failure of these dams could generate moderate to small floods.

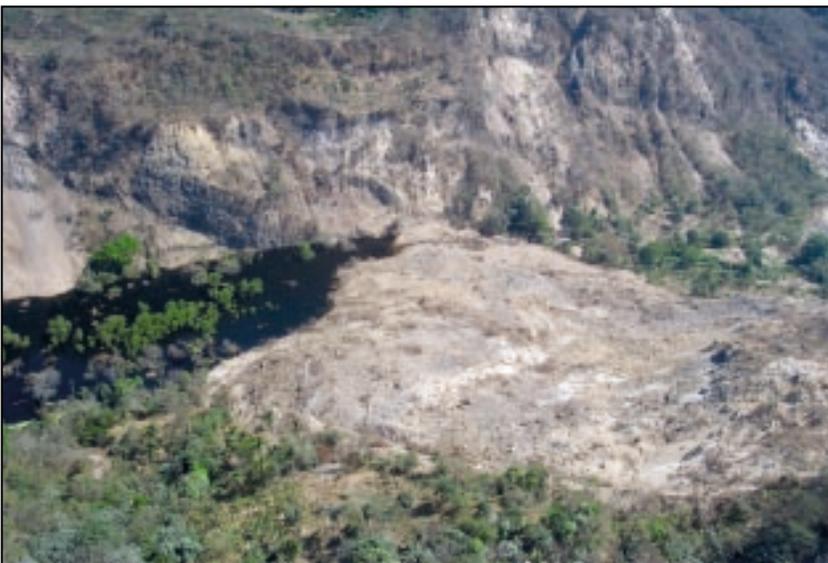
The Río El Desagüe lake is about 1.5 km long and contains an estimated 500,000 m³ of water. The lake's maximum depth is estimated to be about 5 m on the basis of exposed tree tops near the landslide dam (fig. 4). A hand-dug spillway channel has been excavated across the toe of the landslide to allow the lake to drain. The flow in this 3-m-wide, 2-m-deep channel was about 0.2 m³/sec in mid-March 2001 and was not eroding landslide debris in the spillway. Large, indurated clasts in the landslide debris have effectively armored the spillway and are preventing erosion of the dam under present low-flow conditions. Because the lake is actively draining across the spillway, its depth and volume will remain relatively constant. Even as flow in the Río El Desagüe increases during the rainy season, the large blocks of lithified rock will minimize erosion of the spillway, and will likely prevent a catastrophic failure of the landslide dam.

Figure 4. View to the north of the rotational slump/rock avalanche deposit that has dammed the Río El Desagüe near its confluence with the Río Jiboa. A shallow lake upstream from the landslide (left side of photograph) is draining through a man-made spillway that has been excavated across the toe of the landslide.

in the Río El Desagüe lake is very small compared to the volume of water that could potentially be released by a catastrophic failure of the Río Jiboa landslide dam. Water in the Río El Desagüe lake would make a negligible contribution to a Río Jiboa flood, therefore no further mitigation measures are needed for the Río El Desagüe landslide dam other than the current spillway.

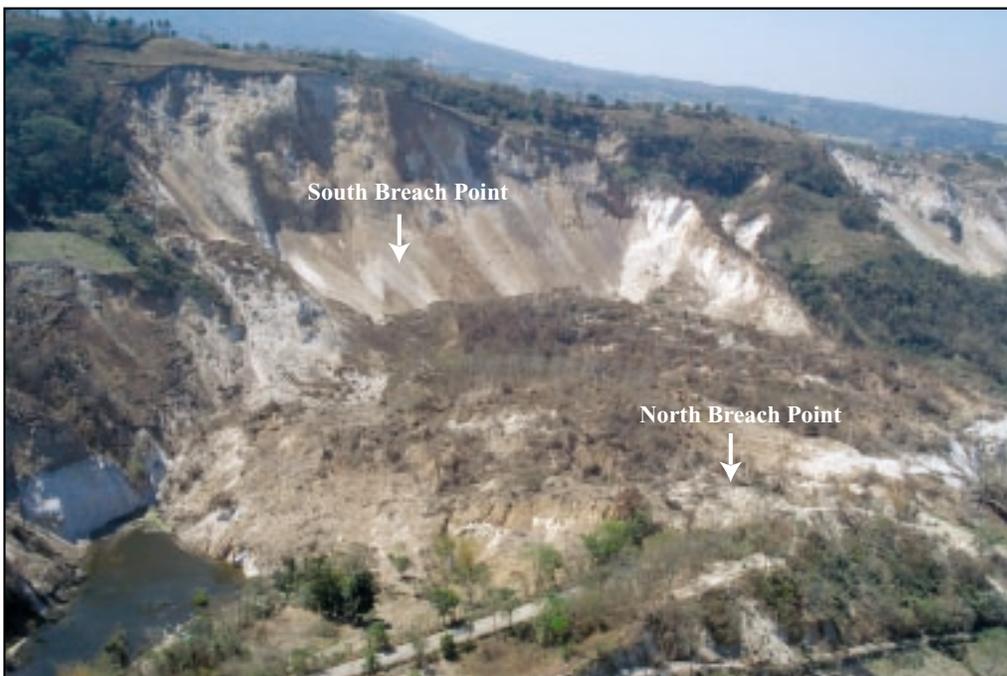
Approximately 2 km upstream from the confluence of the Río El Desagüe and Río Jiboa, a block slide containing about 12 million m³ of material completely blocks the Río Jiboa drainage (figs. 2 and 5). The Río Jiboa landslide dam consists primarily of rhyolitic tephra and pyroclastic debris of the Cuscatlán Formation, and most of the landslide material is poorly compacted and extremely porous. The landslide dam is about 700 m long (parallel to the river drainage) and about 250 m wide (across the val-

ley). A lake has formed on the upstream side of the dam; as of March 15, 2001, the lake was about 25 m deep, 400 m long, and was filling at a rate of less than 0.1 m³/sec (<8600 m³/day).

If allowed to fill completely, the lake will have an estimated maximum depth of 60 m, a length of about 2 km, and a volume of about 7 million m³. Two possible breach points exist on the landslide dam (fig. 5); the northern breach point has an estimated elevation of about

Figure 5. View to the southwest showing the landslide dam on the Río Jiboa. The impounded lake behind the landslide is visible on the lower left. Two possible points are labeled where the reservoir may overtop the landslide dam, if allowed to breach naturally.

510 m, and the southern breach point has an estimated elevation of 515 m. As of March 15, 2001, the lake-surface elevation was about 475 m. These elevations were estimated from field measurements made with barometric altimeters and hand-held GPS (global positioning satellite) receivers, which have considerable uncertainty. More accurate measurements of the breach-point elevations are needed to better quantify the volume of water that could be retained in the lake.

Catastrophic failure of the Río Jiboa dam would generate a potentially devastating flood. On the basis of the case study of a similar-size landslide dam composed of similar materials on the Río Pisque in Ecuador (Asanza and others, 1992), we speculate that the lake could drain in several hours once the dam has been overtopped. Upon failure, the flood could reach its peak discharge in a few hours, and the maximum discharge could range from 1,000 to 10,000 m³/sec, based on a numerical analysis of predicted peak discharges from dam failures (Walder and O'Connor, 1997). This estimated flood is 1.5 to 15 times the maximum discharge recorded on

If the lake breaches naturally, the landslide dam would erode rapidly because it is composed primarily of unconsolidated volcanic tephra. During the breach, the channel could incise at a rate of several meters to more than 10 m per hour. Such rapid erosion would release huge volumes of water from the lake and cause downstream flooding that could threaten people and property in the lower parts of the Río Jiboa valley.

As stated previously, a natural breach from the Río Jiboa landslide dam could quickly release nearly 7 million m³ of water. A flood generated by such a water release will flow violently through the narrow bedrock portions of the valley at high velocity, allowing little time to warn and evacuate downstream inhabitants. Downvalley in the broader floodplain, the effects of the flood are more difficult to estimate, but it will likely have detrimental effects. To minimize the impact of this flooding, a spillway could be excavated through the landslide debris that would reduce the volume in the impounded lake and reduce the size and effects of the potential flood. A spillway may also provide better control on the timing of the water release.

the steep (about 70°), 200-m-high headscarp of the landslide where rock falls are occurring continuously. Rockfall from this escarpment would be a constant hazard to workers. No such hazard exists at the northern margin.

The preceding discussion focuses on possible mitigation measures related to failure of the dam by overtopping. A more difficult problem is to determine the possibility of a dam failure induced by piping, in

which water from the lake percolates through the dam, causes caving and the formation of conduits in the dam through which the lake water can drain. As the depth of the reservoir increases, the potential for piping increases because the impounded water exerts increasing pressure on the dam. Thus as the reservoir fills, the dam should be checked regularly for evidence of significant seepage. If seepage develops, then it should be routinely monitored for changes in the rate of seeping water, which could be evidence of increasing piping and decreasing stability of the dam.

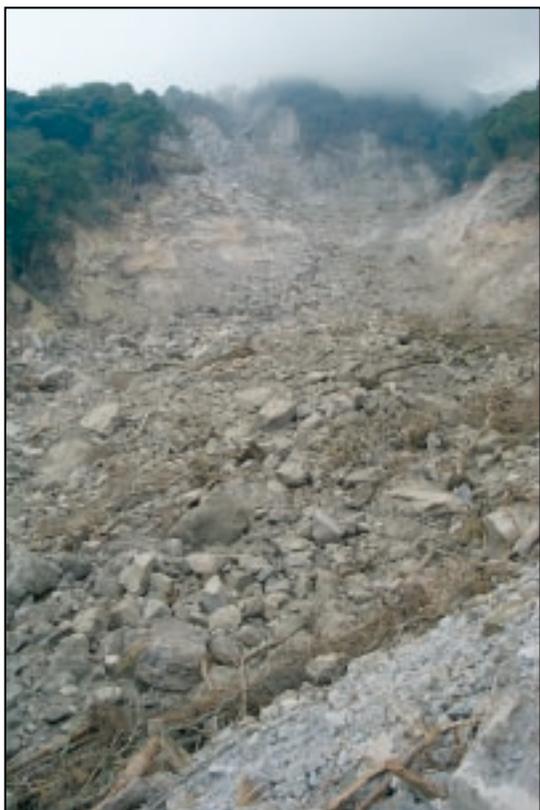
Debris within the rock slide ranges in size from sand to large boulders (fig. 6), but the landslide debris is dominantly large boulders, some as much as several meters in

diameter. Owing to the large size and indurated character of the rock fragments, it is unlikely that this landslide debris will be remobilized by rainfall into debris flows that will threaten downstream settlements or structures. Some of the finer-grained debris (sand and gravel fraction) could be transported downstream, but most of the rainfall and surface-water runoff will infiltrate the landslide debris and cut small runoff channels across the surface. Little of this coarse debris will be mobilized by flowing water. Therefore, it is unlikely that the town of Guadalupe will be seriously threatened by debris flows remobilized from this slide material unless a new large failure is triggered from the same source area by abnormally heavy rainfall.

Figure 6. View toward the source of the Quebrada Del Muerto rock slide on the northwest flank of Volcán San Vicente. The rockslide is composed mainly of well-indurated andesite, which has broken into boulder-sized debris. The composition and size of fragments in the landslide debris make it unlikely that the material will be remobilized as debris flows during the upcoming rainy season.

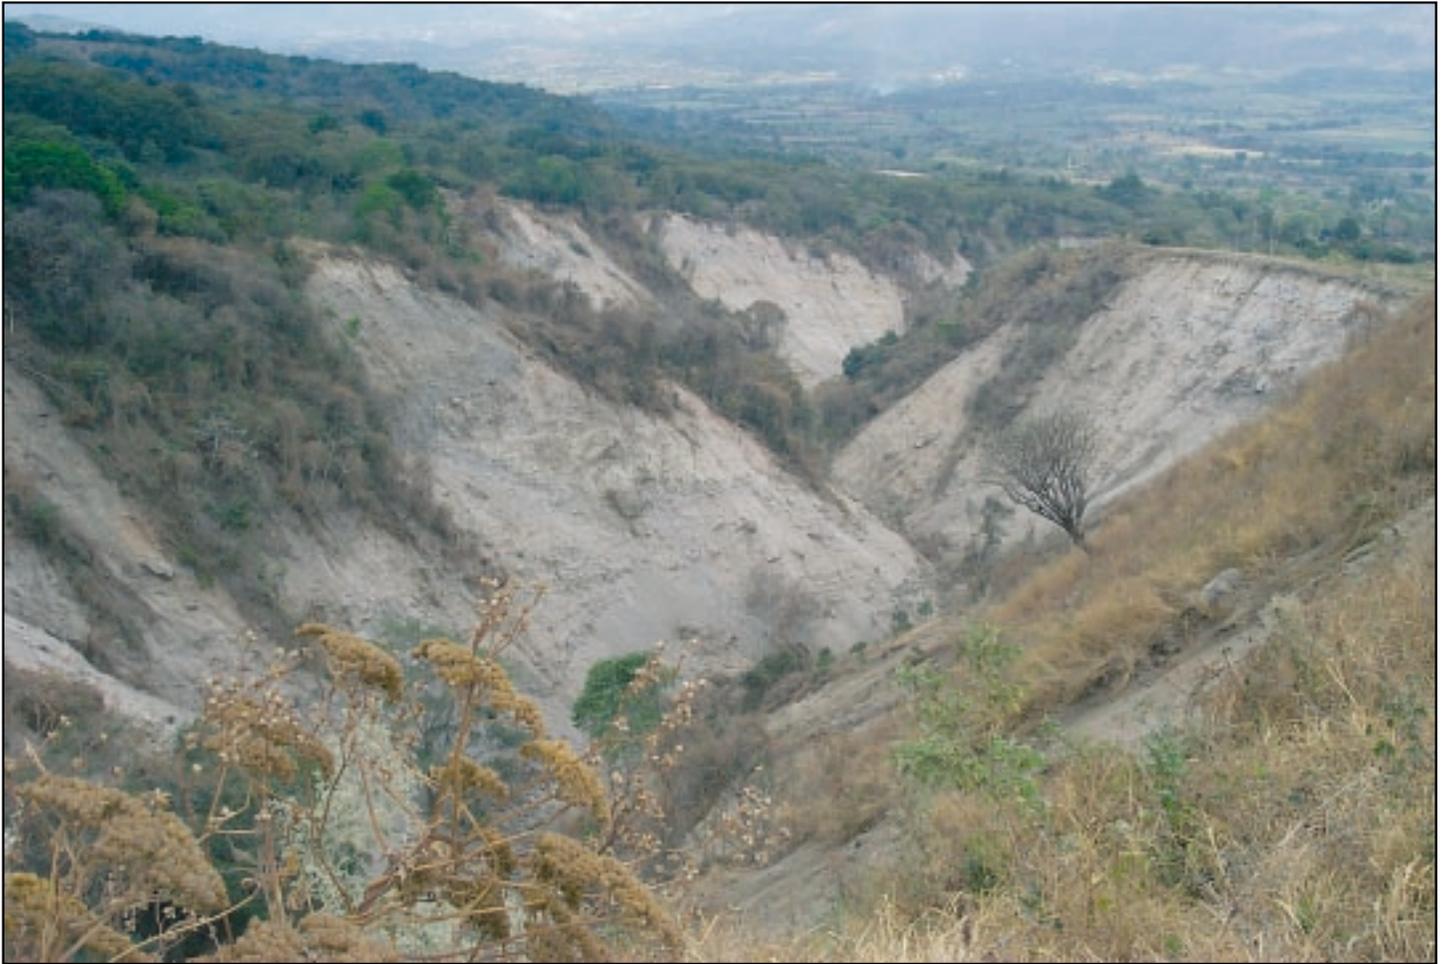
Lower, on the northern slope of Volcán San Vicente, numerous coalescing debris slides were triggered by the earthquake along the 40- to 50-m-deep incised gully of the Quebrada El Blanco. Unconsolidated pyroclastic and debris-flow deposits in the steep valley walls failed during the earthquake and produced numerous debris slides that are typically 1-3 m thick and have a cumulative volume of approximately 250,000 m³ (fig. 7).

Debris from these landslides has clogged the channel bottom with sandy and silty sediment that may remobilize as debris flows during the rainy season. Large flows triggered in Quebrada El Blanco may extend down to the broad, shallow slopes of the quebrada's alluvial fan. The

small town of Tepetitán is located on part of this alluvial fan. About 1 km upslope from Tepetitán, drainage in Quebrada El Blanco is confined to a channel that is incised several meters into older alluvial deposits. However, closer to the town, the drainage emerges onto a broad open slope that is cut by shallow channels less than 2 m deep. This broad open slope is the depositional surface of previous debris flows, and the active channels of the fan have routed flows near and toward Tepetitán in the recent past. The last debris flow that reached the town occurred in 1934, caused several fatalities, and buried parts of the old village in about 60 cm of sediment. After the 1934 event, most of the town was relocated to a higher, safer site, but

Figure 7. View to the northwest down the upper reaches of Quebrada El Blanco channel showing coalescing debris slides from the valley walls. The channel bottom is clogged with landslide debris, and rainfall runoff may trigger debris flows in these sandy, silty deposits.

The most effective mitigation measure for debris-flow hazards in the town of Tepetitán is to construct a sediment check dam or diversion levee(s), which will redirect small- to moderate-volume flows. Such structures are used successfully in debris-flow prone areas of the U.S., such as California, where the sediment basins are designed to collect the maximum volume of sediment expected from a specific drainage. As these basins are filled, the accumulated debris is removed to assure that the basin can retain future flows. Such basins must be designed to allow

Diversion levees are also effective devices to mitigate debris-flow hazards by diverting flows around and away from inhabited sites and man-made structures. Such levees are feasible where ample space is available to deposit the rerouted debris and where no people or property are at risk in the depositional areas. If either of the above mitigation options is considered, then hydraulic engineers should be engaged to design effective sediment catch basins or diversion levees.

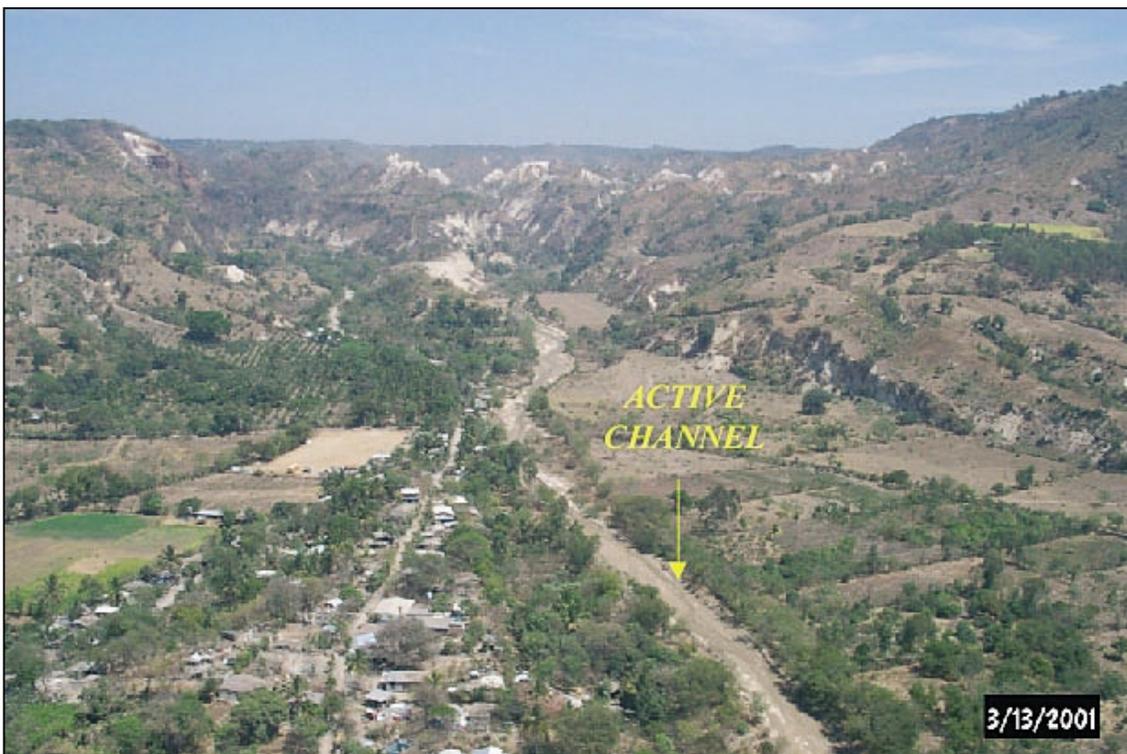
Two effects of the February 13 earthquake caused widespread damage in San Agustín: earthquake-induced strong shaking, and ground failures caused by liquefaction and lateral spreading. Damage from strong shaking had the greatest impact on poorly constructed buildings, particularly those built with adobe bricks. Liquefaction caused damage where the ground surface beneath buildings spread laterally.

Figure 8. View to the north of the Quebrada El Chaguite drainage basin and the village of San Agustín (in left foreground). The February 13 earthquake caused extensive damage in the village and widespread landslides throughout the drainage basin. The village of San Agustín is located adjacent to the active channel of the young alluvial fan of the quebrada.

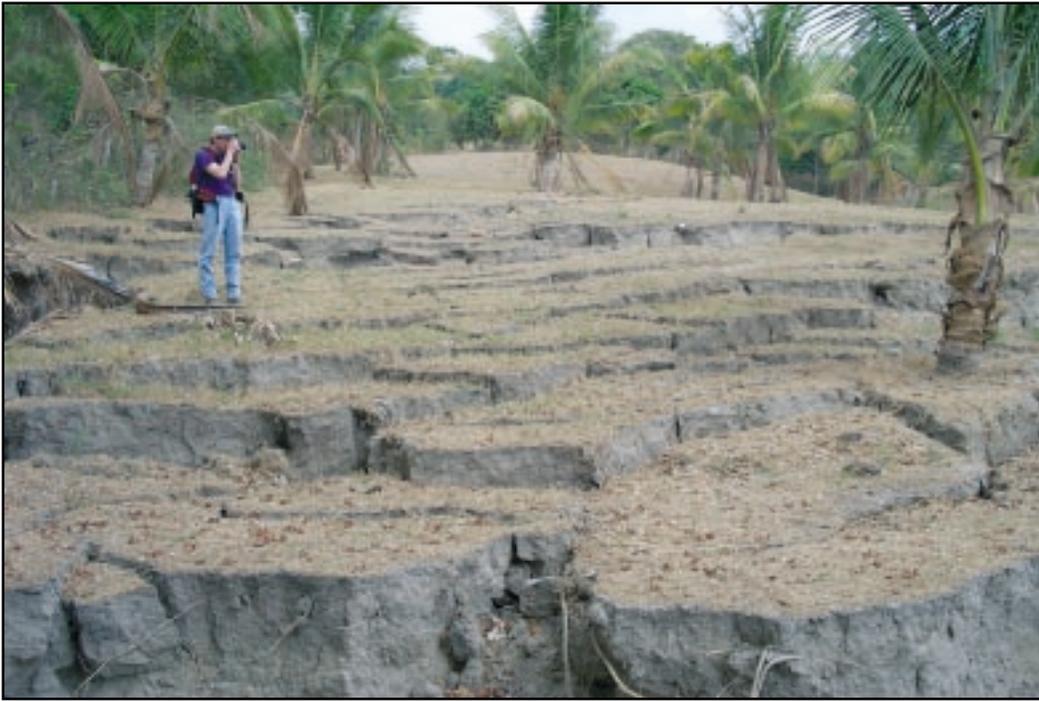
Figure 9. Ground deformation and scarps that formed at the head of a lateral-spreading landslide adjacent to the “Zona Experimental de Cultivo de Peces” on the eastern shore of Lago de Ilopango. Buildings that span scarps similar to these commonly suffer considerable damage.

can form (fig. 9), and structures that span these scarps are likely to be damaged. In addition, the pressurized water mixed with sand commonly erupts onto the ground surface along fissures and cracks and leaves distinctive deposits of sand called sand boils (fig. 10).

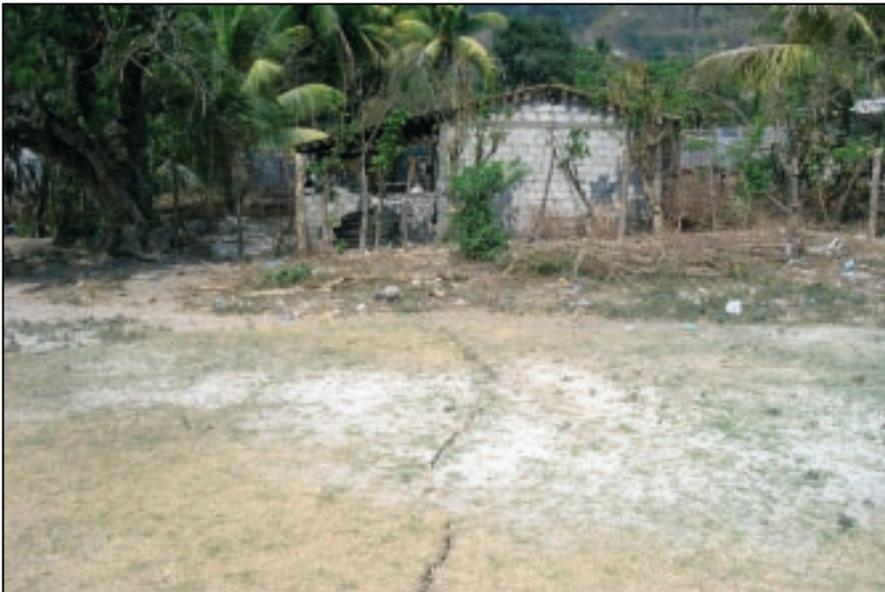
Figure 10. Liquefied sand that flowed to the surface through cracks and fissures during the February 13 earthquake in San Agustín. These sand boils formed on the village's soccer field.

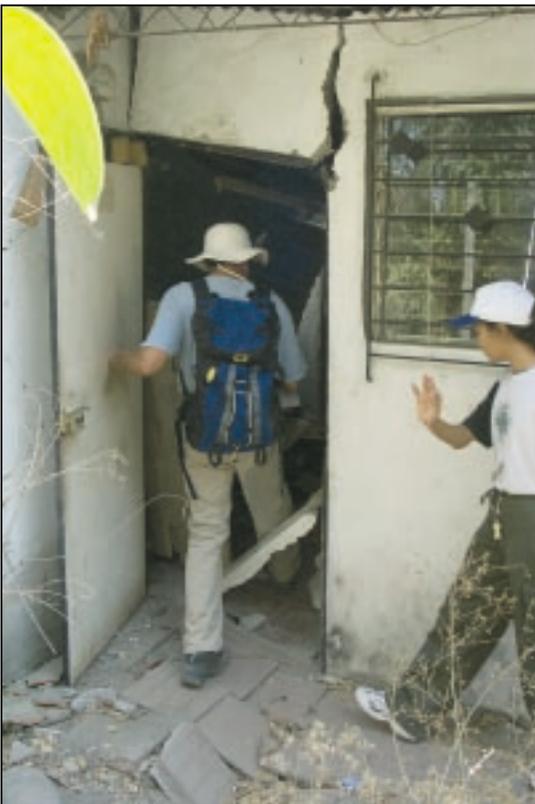
Generally, buildings constructed of adobe bricks suffered significant damage from the strong shaking, whereas buildings constructed of reinforced cinder blocks suffered limited damage. The adobe buildings had little or no internal reinforcement, and when the shaking dislodged a few bricks, entire walls became unstable and collapsed. In contrast, cinder-block buildings usually contained some reinforcement with steel rebar, and the more reinforcement a structure contained, the less damage it suffered. However, some cinder block buildings were damaged because they straddled scarps that formed as a result of lateral spreading (fig. 11).

In the absence of any future strong nearby earthquakes (approximately magnitude 5.5 or greater), it is unlikely that additional liquefaction will occur or that the lateral spreading will be reactivated. However, the San Agustín area is in a seismically active part of El Salvador, so it is possible that strong earthquakes could occur in the region, certainly on decade-long time scales. It is difficult to accurately determine exactly where lateral-spreading landslides may form during future earthquakes other than to note that they are more likely to occur where 1) the water table is close to the surface and 2) at sites where liquefaction has occurred in the past. Because the water level in Lago de Ilopango is a major control on the local depth of the water table, sites close to the shore line are more prone to liquefaction and lateral spreading than sites more distant from the lake or at higher elevations.

Figure 11. Damage to a home in San Agustín from lateral spreading beneath the structure. Further movement probably not occur again unless the sediment is severely shaken by another strong earthquake.

San Agustín is exposed to risk from several natural hazards. Liquefaction and lateral spreading caused damage during the February 13 earthquake, but these hazards will not cause further damage unless another strong earthquake occurs. To minimize the potential damage from future lateral spreading, one option is to relocate those homes damaged by lateral spreading to sites farther away from the lake shore or on higher ground, where the potential for lateral spreading is less. A possible relocation site is on the northwestern side of the village, in the area that is currently occupied by families living in emergency shelters. The vacated part of the village where lateral spreading occurred (and may occur in the future) could be used for recreational purposes such as soccer fields, where no structures would be located.

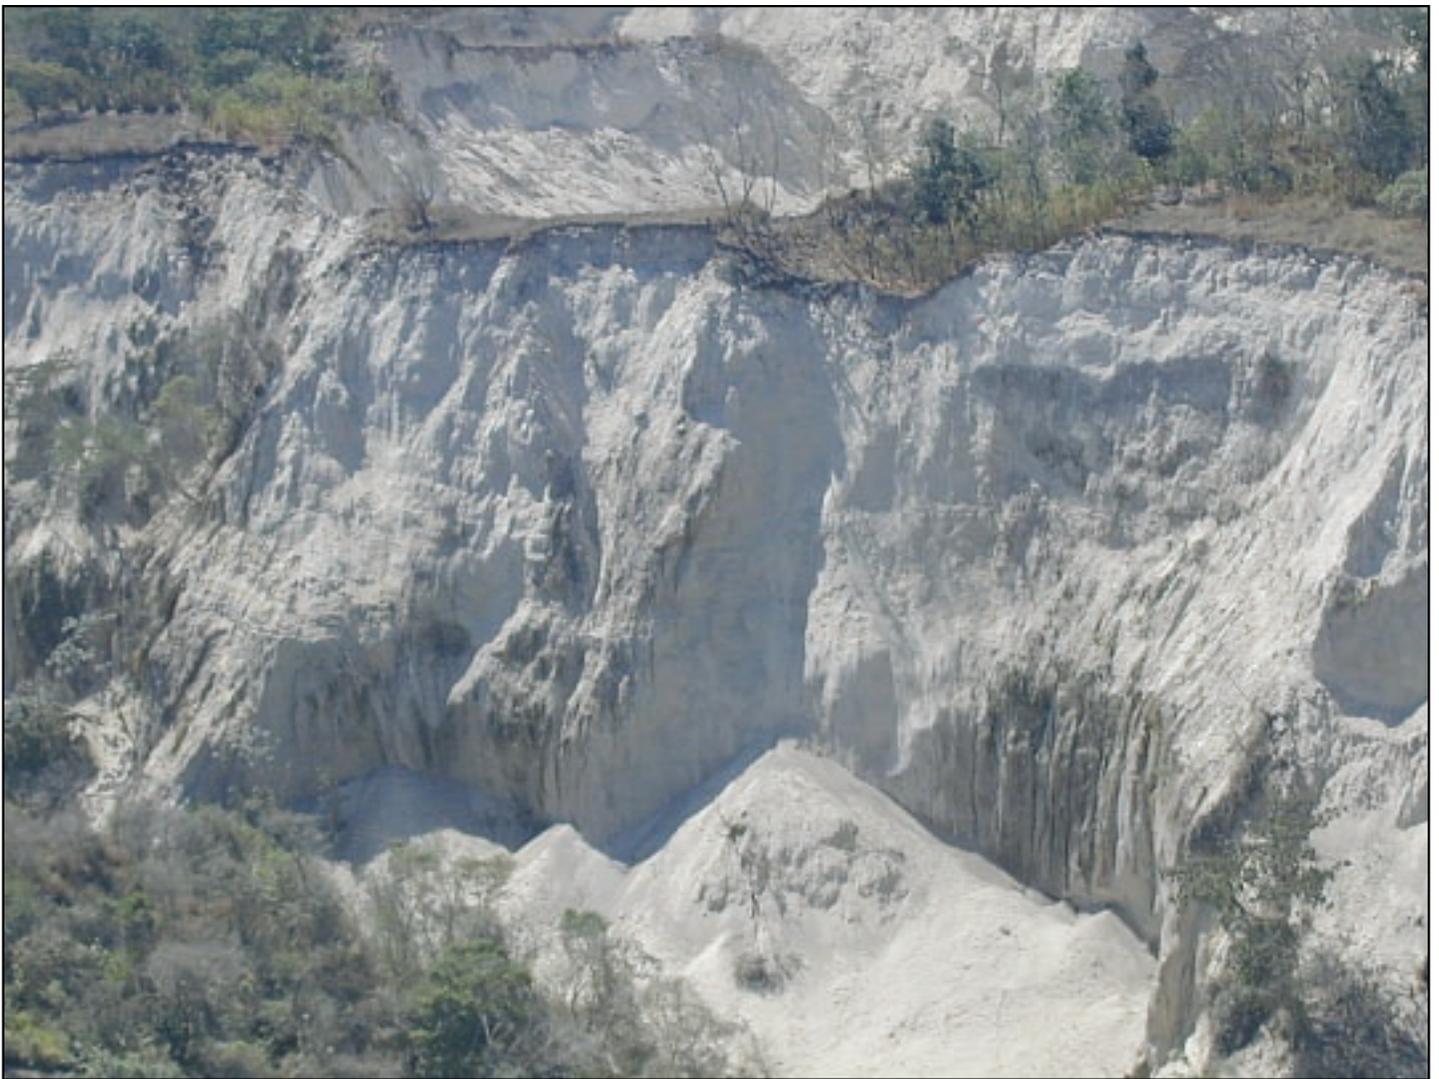
The Quebrada El Chaguite drainage basin, which includes the tributary drainages of the Quebrada El Camalote and the Quebrada Guluchapa, contains deposits of poorly consolidated Tierra Blanca tephra that are locally tens of meters thick (fig. 12). The February 13 earthquake caused hundreds of landslides in the drainage basin. Many steep canyon walls collapsed and filled the adjacent valleys with large amounts of loose, soft debris (fig. 12).

Figure 12. Widespread landslides in the Quebrada El Camalote, a tributary to the Quebrada El Chaguite drainage basin, exposed thick deposits of Tierra Blanca tephra. The loose tephra has now clogged the narrow valleys, and during the coming rainy season, much of the easily eroded tephra will be transported down the drainage system and into Lago de Ilopango.

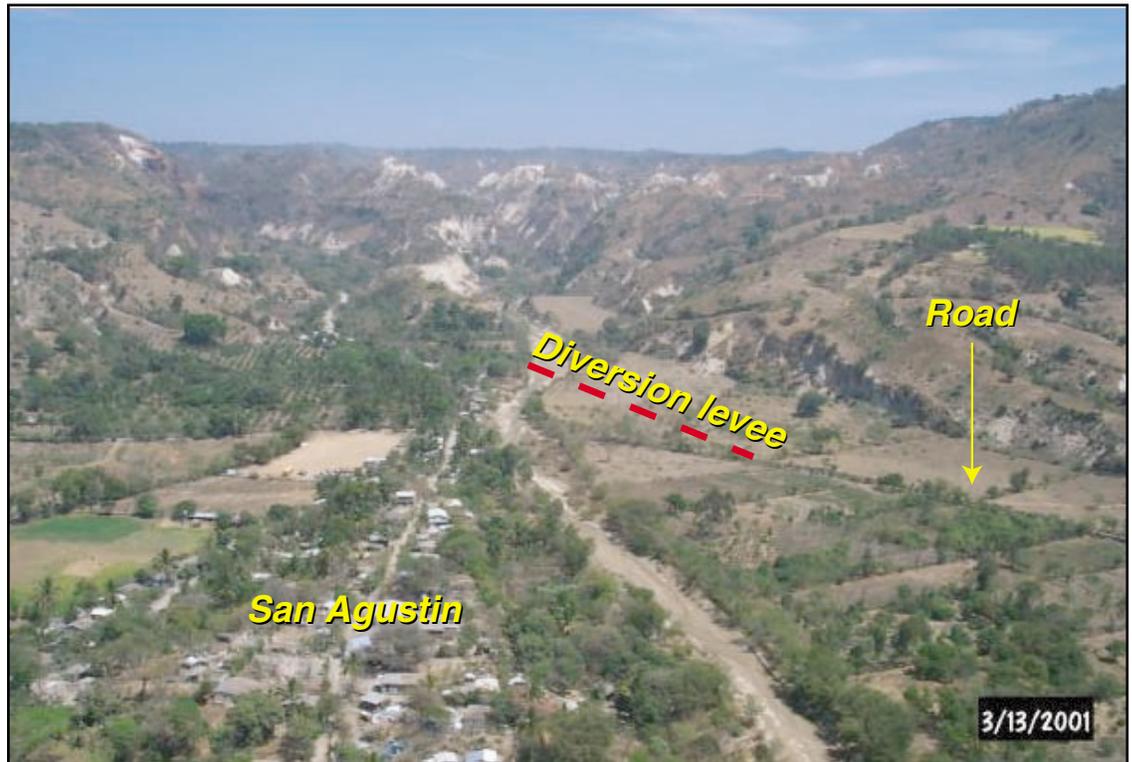
Figure 13. View toward the north of San Agustín and the adjacent stream course where large sediment influxes in the rainy season may cause the stream to change course and flow toward the village. A proposed diversion levee would direct the flow to the east into an ancient stream channel. This diversion would likely damage a road to a nearby finca (coffee plantation), but would reduce the potential of flooding in the village.

Flooding during the coming rainy season poses a more imminent threat to San Agustín and could originate in two ways. First, small lakes could form in the sediment-clogged valleys of the Quebrada El Chaguite and tributary drainage basins, and breaching of these lakes could send the impounded water rushing down the valley. Because the valleys in the upper reaches of the drainage basins are so narrow, the volume of water likely to be released in these breaching events would probably be relatively small and probably would not cause substantial flooding. The more significant flood hazard is associated with excessive sedimentation in the current stream channel and diversion of the stream flow into a new chan-

nel. If a new channel directed flow into the town, flood damage could be extensive. To prevent this possibility, we recommend that a diversion levee be constructed in the active channel immediately upvalley from San Agustín. This levee should be designed to redirect stream flow to the east, away from the village, and into an abandoned channel on the eastern side of the alluvial fan (fig. 13). The presence of a preexisting channel greatly simplifies the diversion process. Streamflow diverted into this abandoned channel will pass directly into Lago de Ilopango. Flow down this abandoned channel will damage a small road that leads to a nearby finca, but construction of a diversion levee will reduce the flood hazard in the village of San Agustín.
