Observations and Recommendations Regarding Landslide Hazards Related to the January 13, 2001 M-7.6 El Salvador Earthquake

By Randall W. Jibson and Anthony J. Crone

Open-File Report 01-141
On-line Edition

U.S. Department of the Interior
U.S. Geological Survey

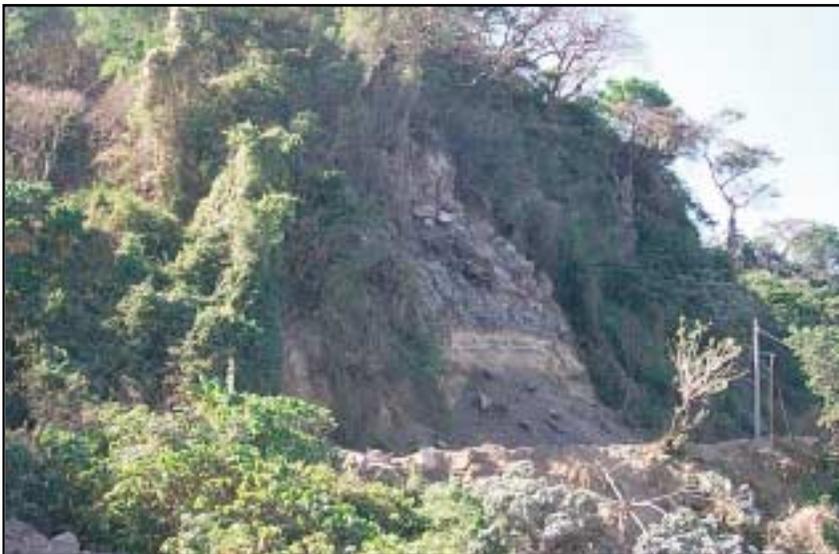
Figure 18. Rock fall on road from Alegria to Santiago de María.

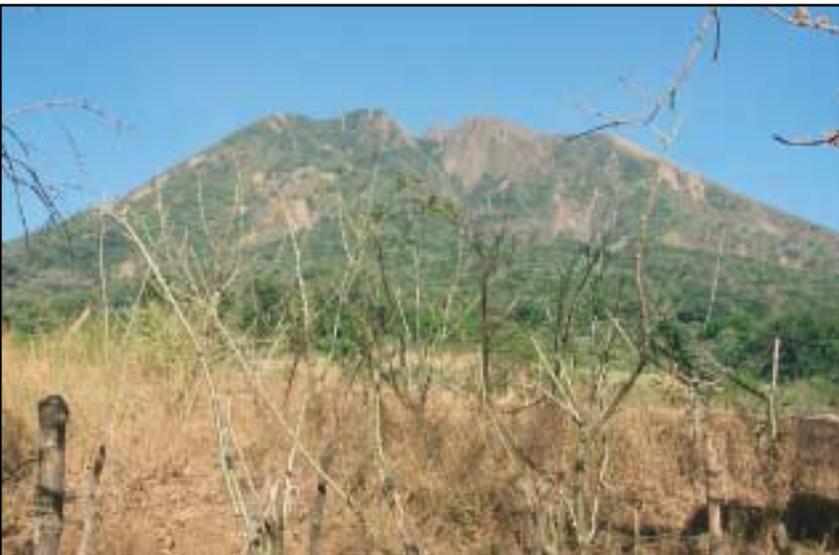
Situation: Many large landslides occurred on the flanks of Usulután Volcano (fig. 19). They probably affect only the coffee plantations on the slopes, but sediment from these land-

Figure 19. Landslides from the flanks of Usulután volcano.

slide deposits will wash into drainages over time and could cause sedimentation problems downstream.

Recommendations: Plantation owners should address landslide problems. Communities downstream from the flanks of the volcano should be warned of possible sedimentation issues in the future.
