# Intensity Distribution and Iseismal Maps for the Nisqually, Washington, Earthquake of 28 February 2001

Open-File Report 02-346

2002

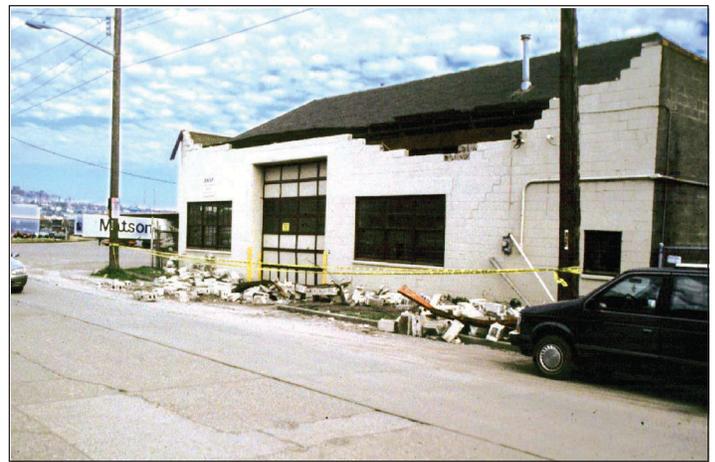
**Seattle (Sodo and Harbor Island) (RCII=7.6, MMI=8) (Zip Code 98134; 47.590N, 122.326W)**—Many buildings were damaged in Sodo along 1st Ave. South from South Jackson St. to South Hanford St. Along this stretch cracked or collapsed walls, fallen parapets and broken windows were common in old buildings (fig. 12; fig. 13). Notable damage included collapsed unreinforced masonry walls at the Seattle Chocolates building and at the Acme Tool and Specialty building and a collapsed front facade at the Starbucks Headquarters building.

*Figure 12. Partial collapse of URM building wall, Sodo neighborhood of Seattle.*

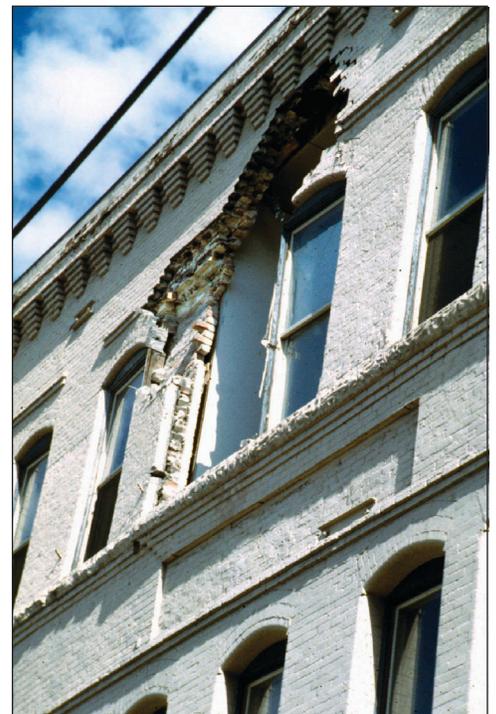
*Figure 13. Damage to upper wall of URM building, Sodo neighborhood of Seattle.*

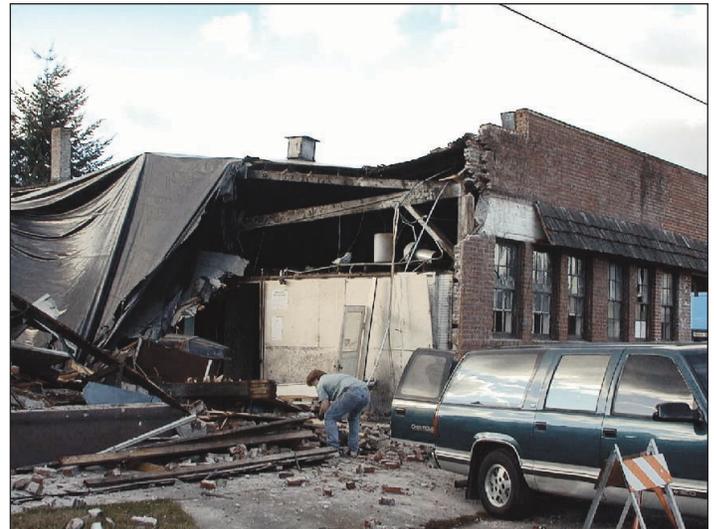
**Centralia (RCII=6.6, MMI=7)** (98531 46.725N, 122.967W)—A cornice was damaged on a downtown hardware store and bricks fell from the tops of several old unreinforced masonry buildings. An abandoned one-story unreinforced brick building that had once housed a garage and auto-glass shop was damaged by the earthquake and collapsed seven days after the earthquake (fig. 14). A large plate-glass window was broken in an automobile dealer-

**Figure 14. Unreinforced building in Centralia, damaged in the earthquake, and partially collapsed seven days after the earthquake.**

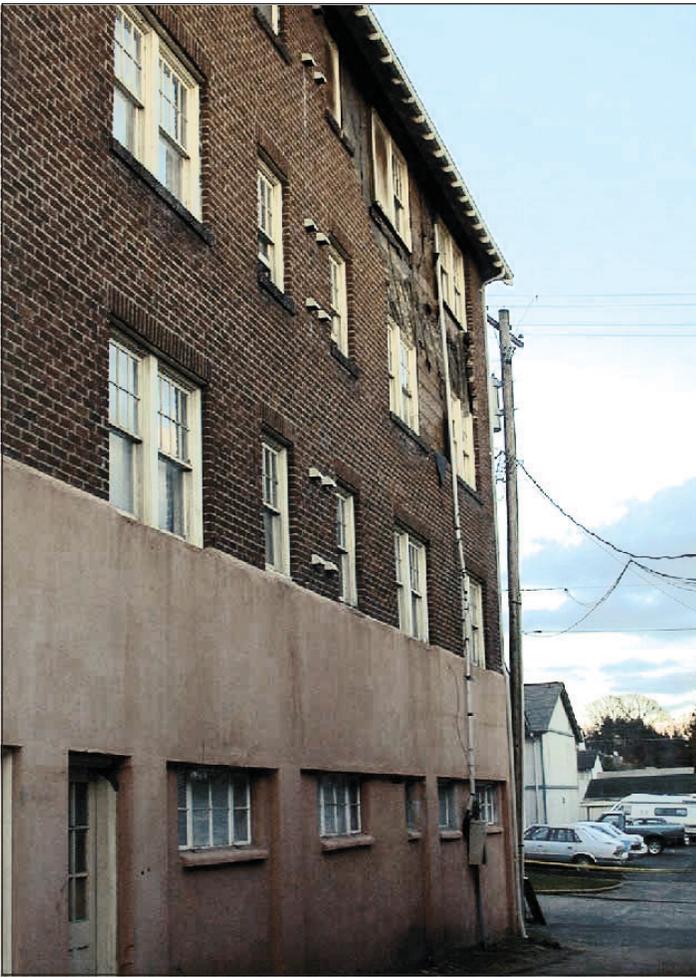
**Figure 15.** Brick veneer was peeled from the upper wall (near street) of this apartment building in Chehalis.

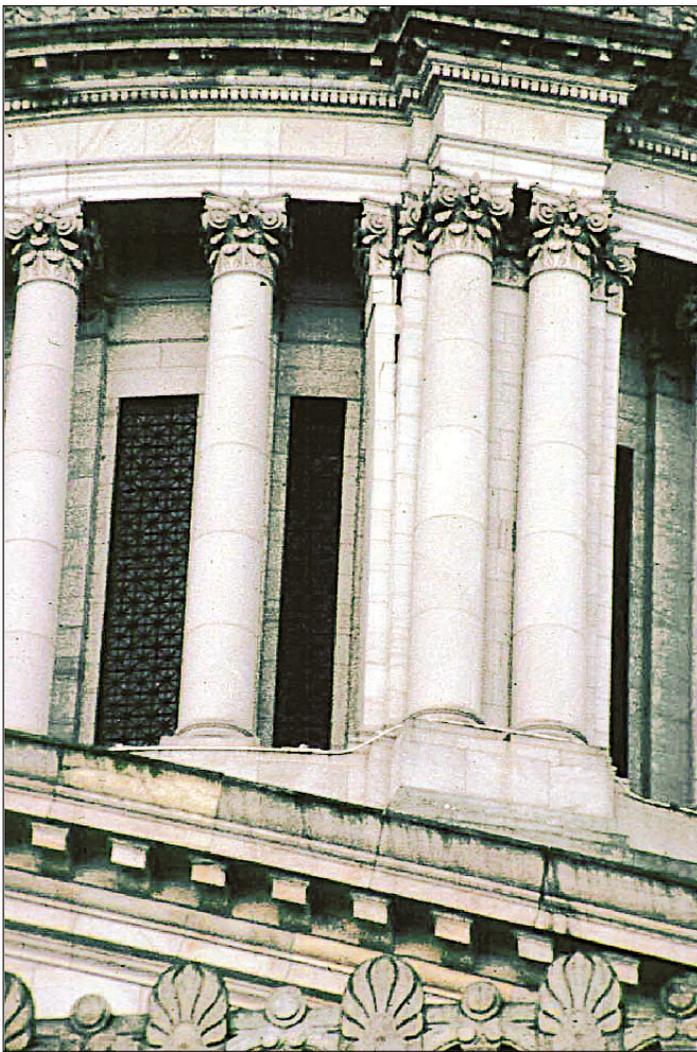
**Olympia (RCII=7.3, MMI=7, except MMI=8 in Capitol Hill) (98501; 47.003N, 122.878W)**—The Capitol Legislative Building was damaged and the legislators forced to move out. There was cracking in some of the ribs of the dome, and “severe cracking of the nonstructural sandstone pilaster from one of the exterior masonry buttresses supporting the dome... Significant differential movement occurred between the drum [cylindrical wall below the dome] and the lower masonry portion of the building... As a result of the movement of the drum and the dome, horizontal cracking of the architectural plaster occurred at the base of each [of the] interior masonry buttresses” (Pacific Earthquake Engineering Research Center

**Figure 16. Damaged pilaster on State Capitol building, Olympia.**

(PEER), p. 8-11; see our fig. 16). Inside the building one chandelier outside the Senate was found hanging from its safety chain and both House and Senate chambers were littered with plaster from the ceilings (Seattle Times (Web), March 5, 2001). A photograph shows a fourth-floor office knee-deep in folders and papers (Seattle Post-Intelligencer (Web), March 1, 2001).

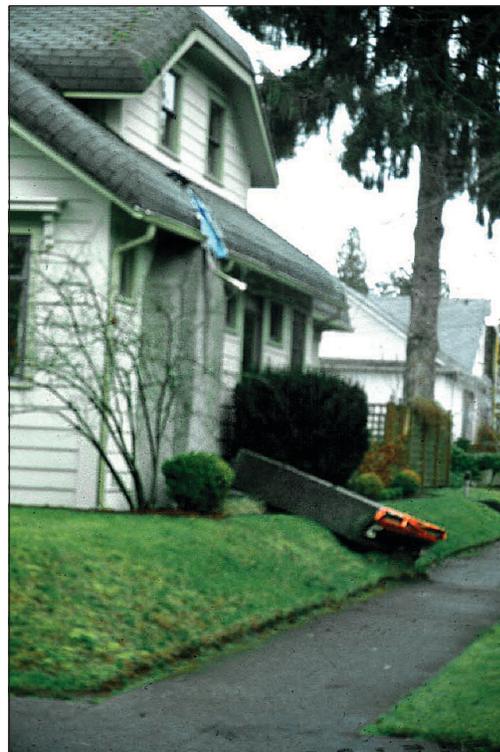
In the residential neighborhood adjacent to the Capitol, the USGS field team found many damaged chimneys and some that had fallen (fig. 17). In some blocks approximately 25% of houses experienced chimney damage. Lincoln Elementary School sustained in-plane cracking of masonry walls (PEER, p. 20-21); its damaged east facade caused the closure of the school for repairs; inside the

**Figure 17. Toppled chimney, Capitol Hill neighborhood of Olympia.**

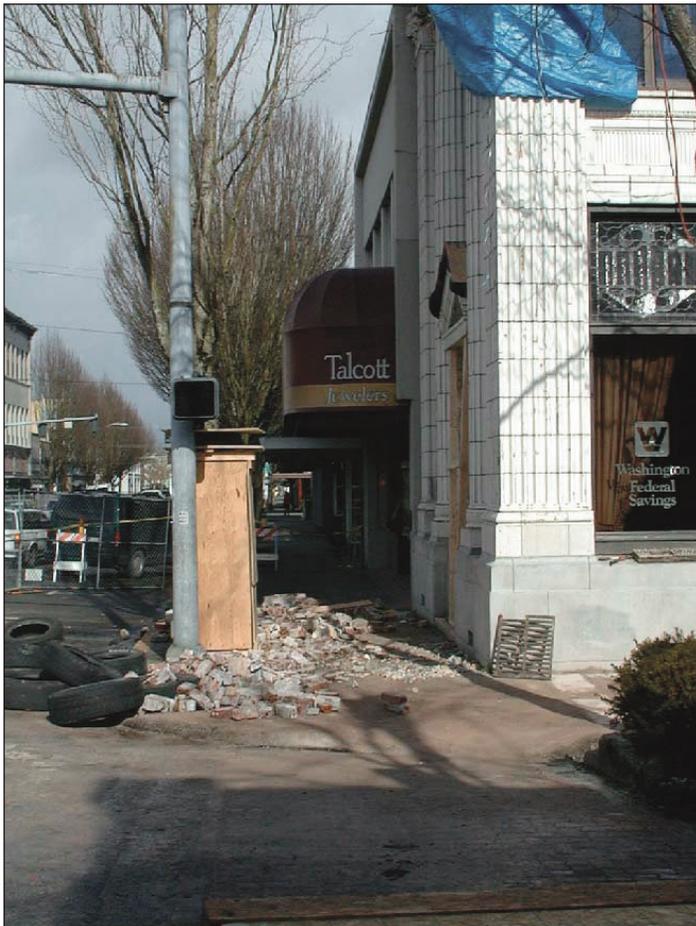
In downtown Olympia, an eight-story hotel on Capitol Way was damaged by differential settling of the west side of the building with respect to the east side; the structure also experienced minor spalling and cracking of reinforced concrete columns in the underlying parking structure, a broken water pipe on the roof that flooded several floors of the building and much overturned furniture in the upper three stories (PEER, p. 11-14, 59-60). In other downtown buildings masonry walls cracked or partially collapsed, plaster fell, lighting fixtures jarred loose and many books and other items fell from shelves (fig. 18).

**Figure 18.** Bricks fallen from an unreinforced masonry parapet litter a sidewalk in downtown Olympia. In the Puget Sound earthquakes of 1949 and 1965, debris falling from buildings killed people on sidewalks below. Fortunately, this did not happen with the Nisqually earthquake.
