Assessment of Hazards Associated with the Bluegill Landslide, South-Central Idaho

By William L. Ellis, Robert L. Schuster, and William H. Schulz

U.S. Geological Survey Open-File Report 2004-1054

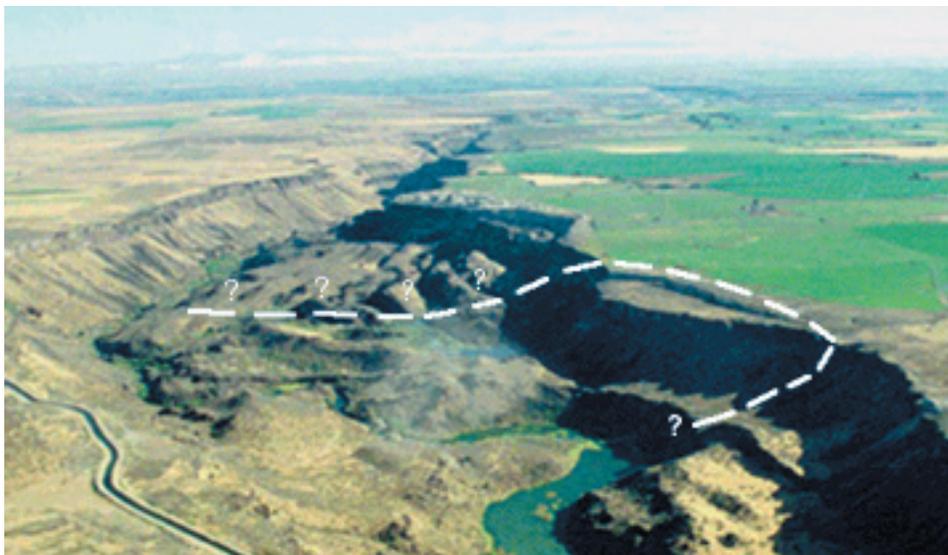
Figure 1. Oblique aerial photo of Sinking Canyon taken in March 2001, showing Sinking Canyon, Salmon Falls Creek, and Bluegill landslide. View is to the north. Approximate boundaries of the Bluegill landslide are shown by dashed line. Confluence of Salmon Falls Creek with the Snake River is approximately 10 km north of the landslide site. Photo courtesy of Karen Shilling, BLM.

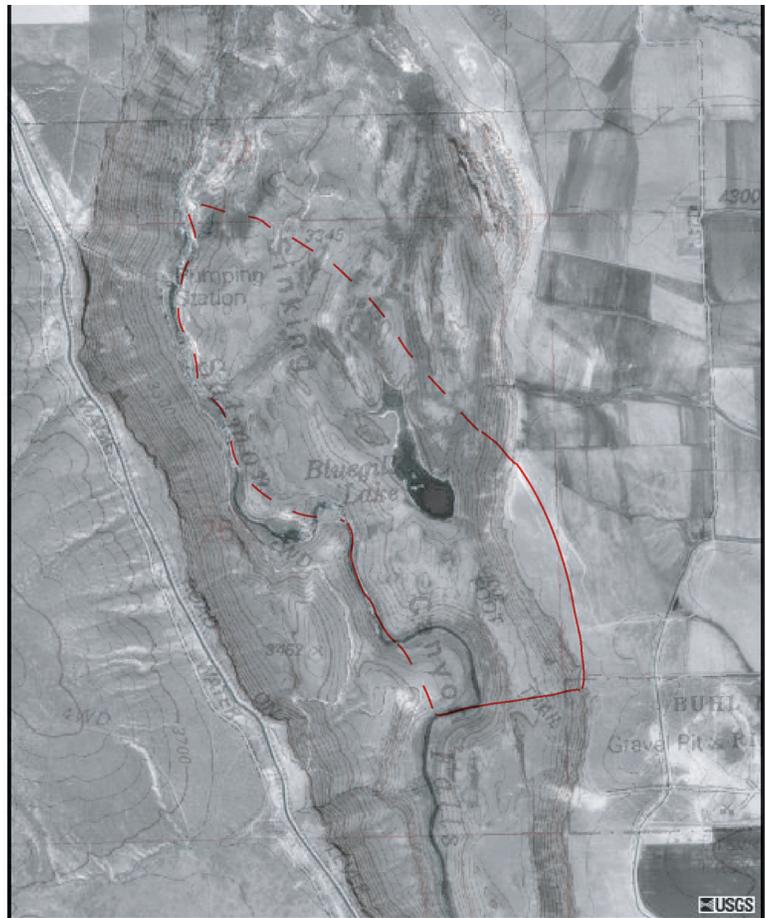
Figure 4. Map showing approximate boundaries of Bluegill landslide based on 24 September 2003 field reconnaissance and monitoring results. Base map consists of the USGS Balanced Rock topographic quadrangle dated 1 July 1987, superimposed on a vertical aerial photograph taken 16 May 1992. Note that Bluegill landslide dam and impounded lake were not present on date of the photograph.

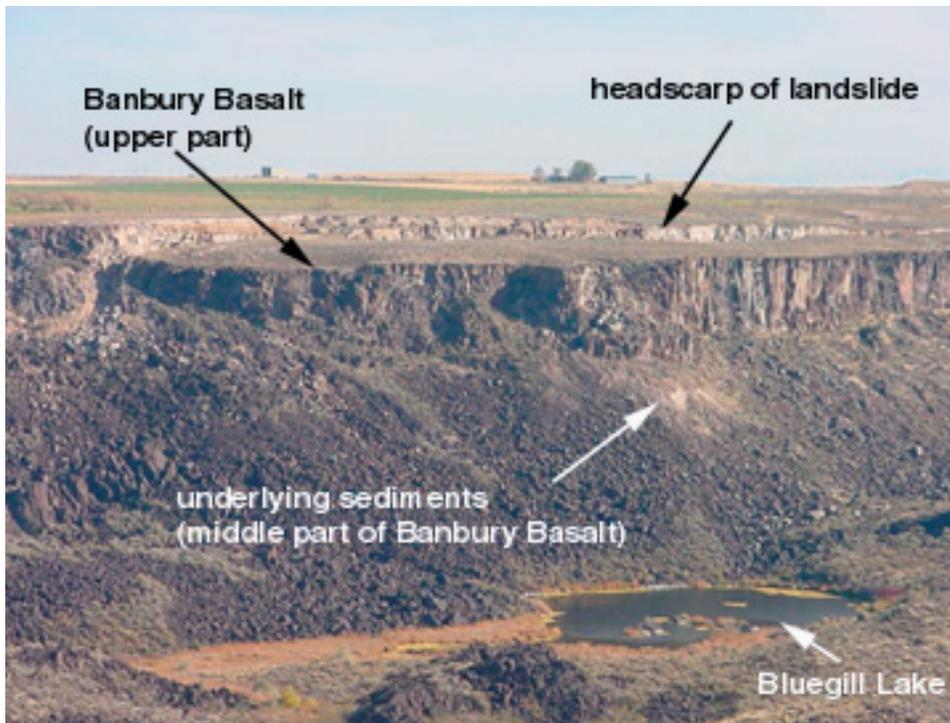
Figure 5. Photo of the upper portion of the Bluegill landslide taken from the west side of the canyon in November 2000. View is to the southeast. Length of the canyon rim that is visible in photo is about 600 m. The upper part of the Banbury Basalt that forms the canyon rim and an outcrop of the underlying sediments of the middle part of the Banbury Basalt are labeled. The headscarp of the landslide and Bluegill Lake are also identified. Photo courtesy of Karen Shilling, BLM.

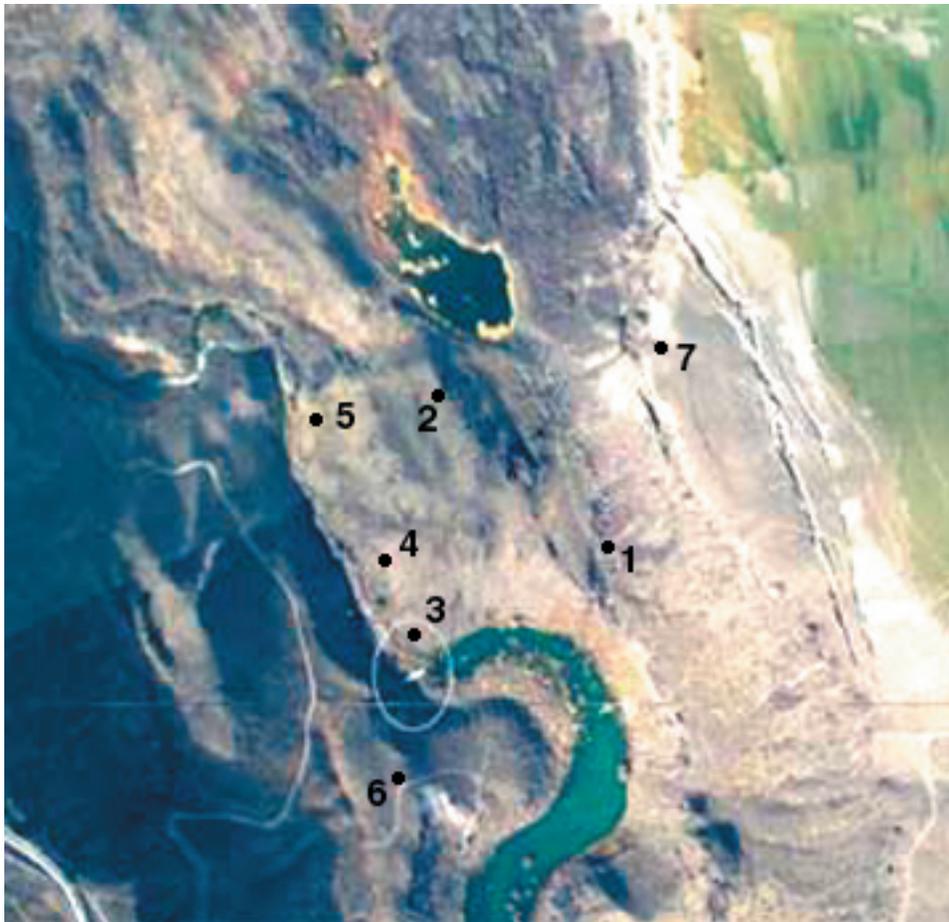
Figure 6. Aerial photo of Bluegill landslide showing locations of survey prism reflectors used in plots of landslide movement shown in figure 7. Area where uplift of toe of landslide has created landslide dam is circled. Photo courtesy of Karen Shilling, BLM.

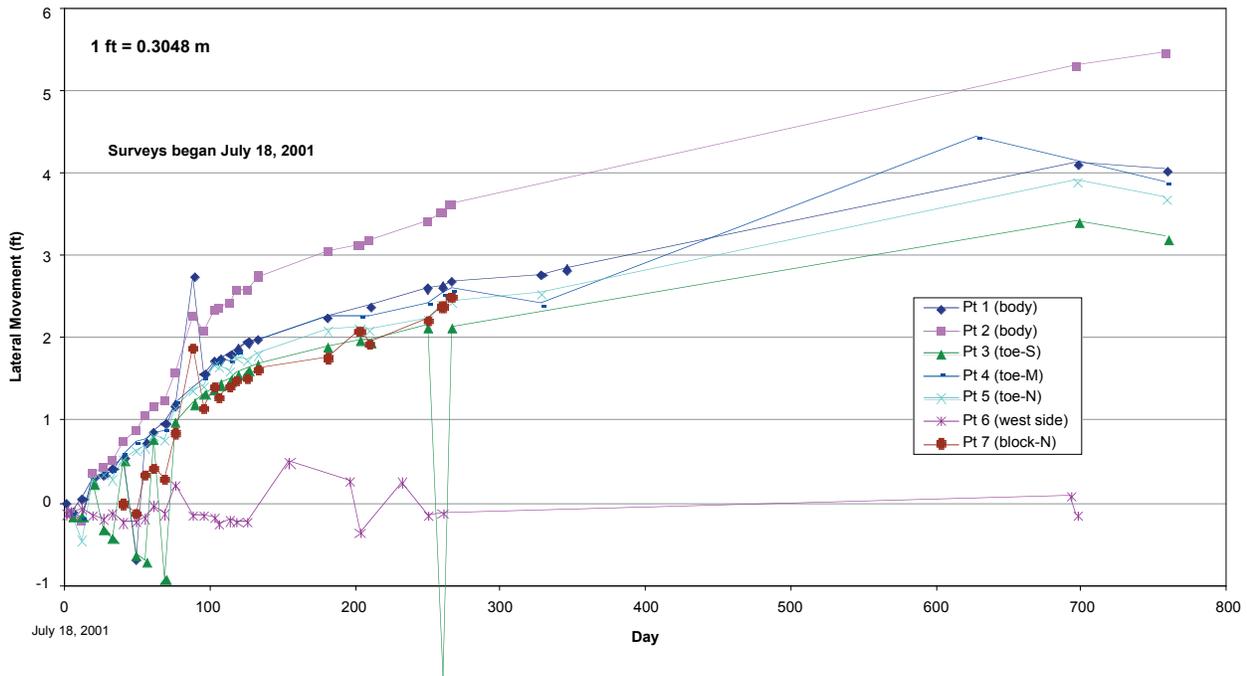
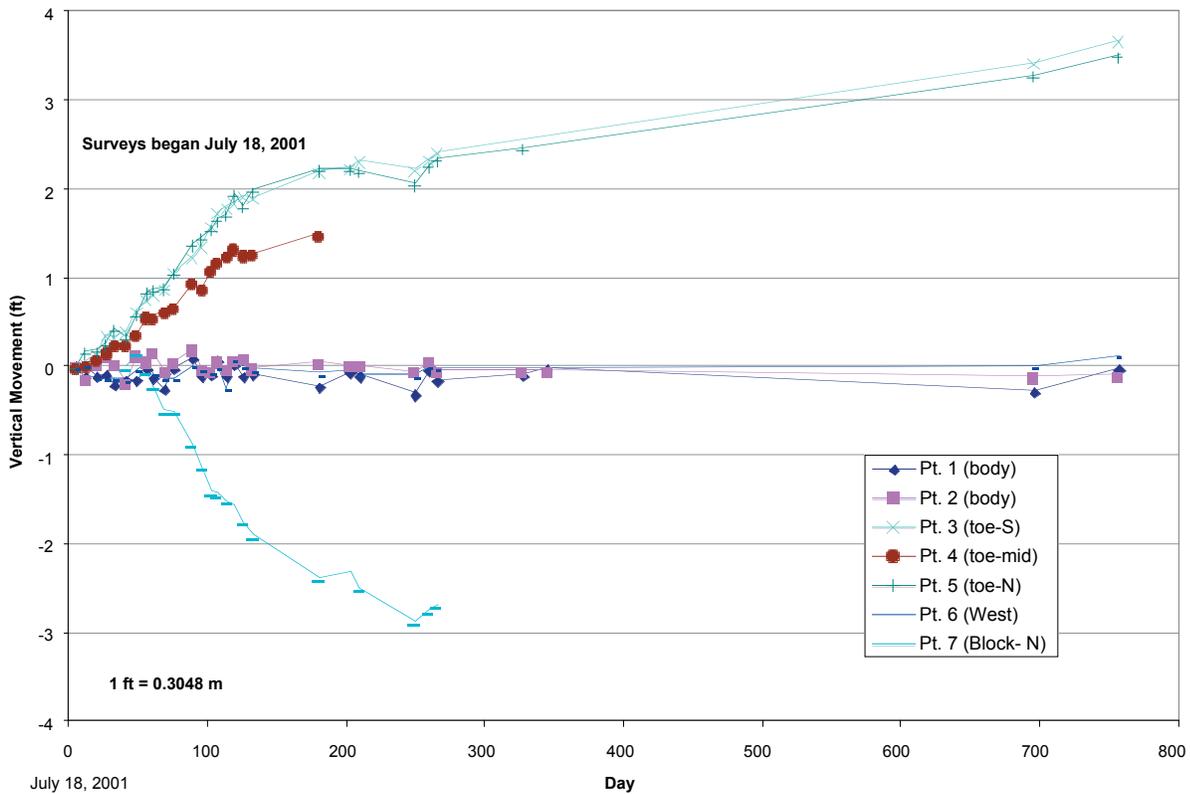
landslide movements of less than a centimeter per month (Chadwick and others, in press). Thus, the available data and observations indicate that the slide probably began moving in late 1998 or early 1999, moved relatively rapidly (several meters) over a period of about 1 year, began slowing in late 2001, and is now continuing to move at a rate of less than a centimeter per month.

Figure 7. Plot of A, horizontal movement; and B, vertical movement; as determined from repeat surveys of reflector prisms begun on July 18, 2001. Locations of survey points are shown in figure 6. Data plots courtesy of Karen Shilling (BLM) and Stephen Dorsch (Idaho State University).

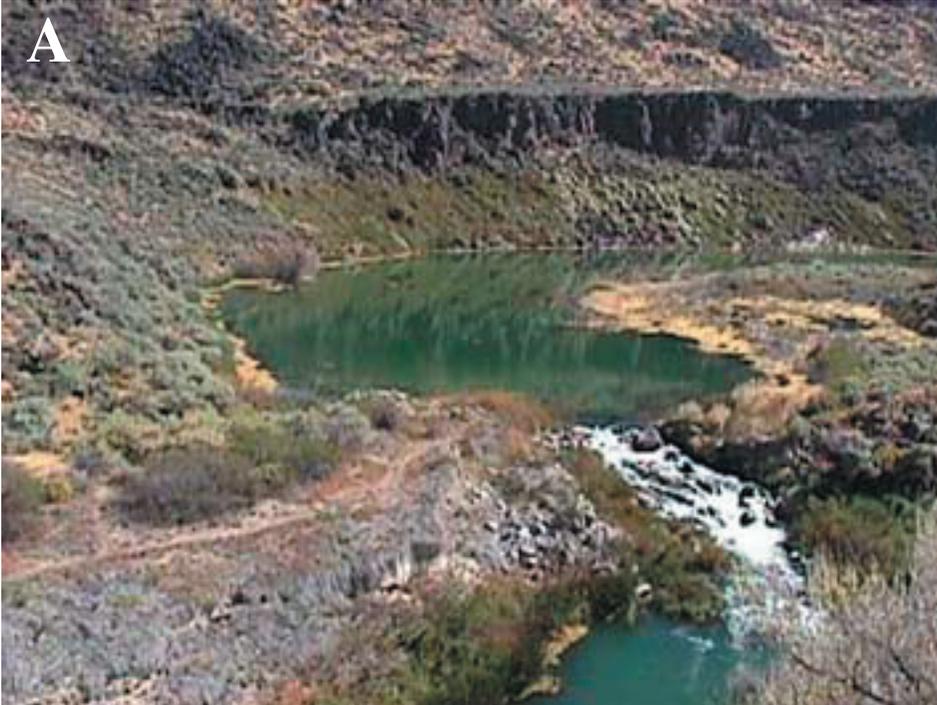
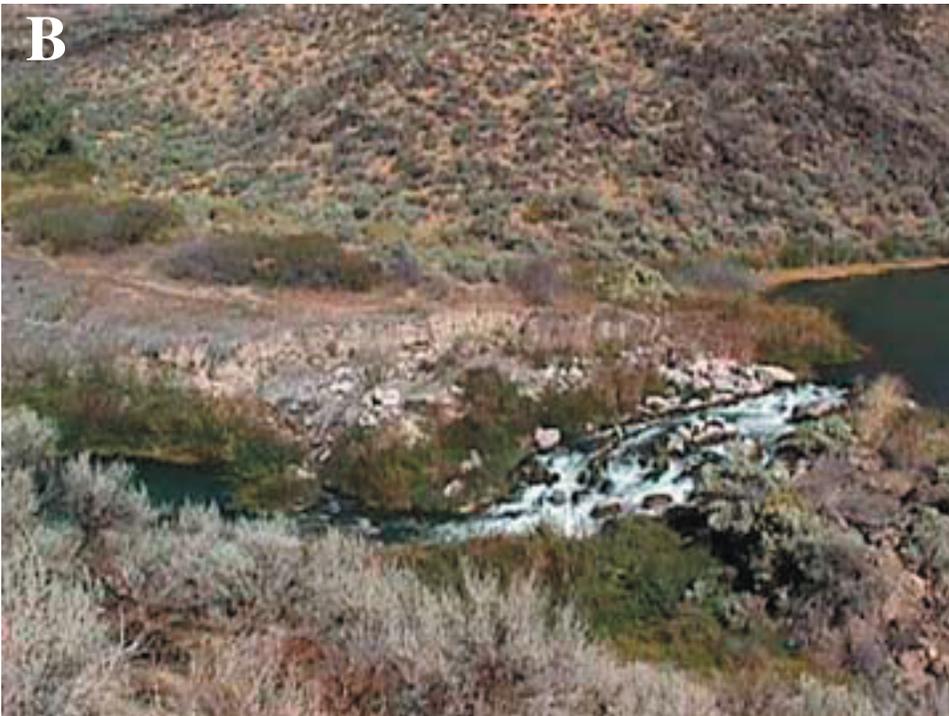
Recent movement of the Bluegill landslide has created a landslide dam that forms a lake that is approximately 2 km long and averages about 40 m wide (Chadwick and others, in press). The dam (fig. 9) has been formed primarily by uplift of the canyon floor at the southern boundary of the slide, rather than by closing of the stream channel due to horizontal movement of the landslide. To the north, and just downstream from the dam, horizontal and upward movement of the toe of the landslide have narrowed the stream channel, and in some places have caused realignment of the stream and created small impoundments of water (fig. 10). The primary hazard currently associated with the landslide is a possible breach of the landslide dam that could cause flooding and outburst debris flows downstream from the landslide.

Examination of the landslide dam indicates that it consists primarily of large boulders ranging in size from several centimeters to up to about a meter in diameter in a matrix of fine material (fig. 9). The fines are apparently derived from the sedimentary deposits underlying the upper basalt flow and are now intermixed with the basalt to form the bulk of the landslide deposit. Stream deposits in the canyon also contribute to the observed fines. Movement of the toe of the landslide has caused a portion of the old stream channel just below the dam to be uplifted several meters (fig. 9a). Uplift of the old streambed reveals fine-grained stream deposits about a meter thick on the east side of the current stream channel.

Where water from the impounded lake flows over the landslide dam, the streambed sediments and fine matrix material have been eroded away, leaving only the large boulders. As can be seen in figure 9, there has been some minor erosion of the dam, probably as a result of the removal of the fine matrix material by running water. The relatively small amount of downcutting into the dam indicates that boulders make up a sufficient volume of the dam for it to be “self armored” against erosion, and that sudden erosion and breaching of the dam is unlikely.

Figure 9. Photos of landslide dam formed by uplift of the toe of the Bluegill landslide. A. View to the southeast. Dam is on the south, or upstream side of the landslide and is approximately 3-4 m in height. Note the old stream channel to the left of the dam (northeast side of channel) that has been uplifted by the landslide. B. Close-up view of landslide dam looking toward the northeast. Dam is composed primarily of large boulders of basalt. Some erosion of the dam has occurred due to stream downcutting. Photo taken September 24, 2003.

Draining of the landslide-formed lake could be achieved relatively inexpensively by lowering the height of the landslide dam. Heavy equipment, such as a track-mounted excavator or bulldozer, could be used to gradually excavate the dam to a level near the original stream elevation. Dam material would need to be removed in small stages to prevent rapid flow and incision of the dam by the escaping water. Any significant future movement of the landslide would likely require additional excavation. An existing road from the west side of the canyon currently provides access into the canyon near the dam, and a short access road to the dam could easily be cut by bulldozer if necessary. Costs for conducting such an excavation of the dam would probably be less than \$10,000. The only other feasible option to drain the lake would be to construct a large-diameter siphon tube to carry water around the area of the canyon affected by the landslide. Such an action, however, would be extremely costly and would require that the tube pass along the west side of the canyon to avoid damage from future landslide movement. This option is considered impractical considering the high cost and the current low probability of rapid dam failure.

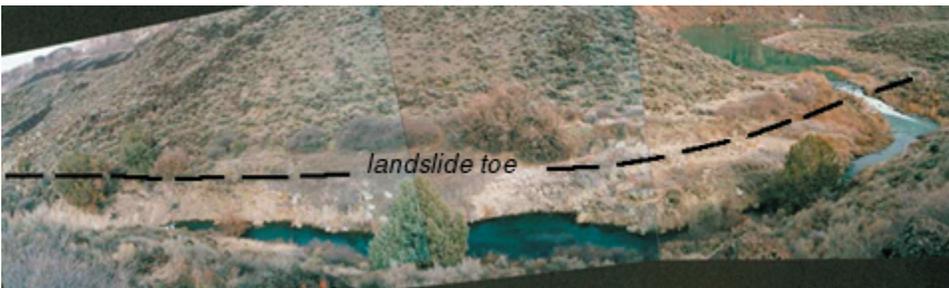
Another area of concern is that continued movement of the toe of the landslide downstream from the current dam, especially at rates like occurred early in the recent movement, could potentially dam the stream channel and create a larger and deeper lake than currently exists. However, because the toe of the active landslide is quite

Figure 10. Composite of photographs taken March 2001 showing toe of landslide encroaching into Salmon Falls Creek downstream of the landslide dam. View is from west to east. Photo composite courtesy of Karen Shilling, BLM.

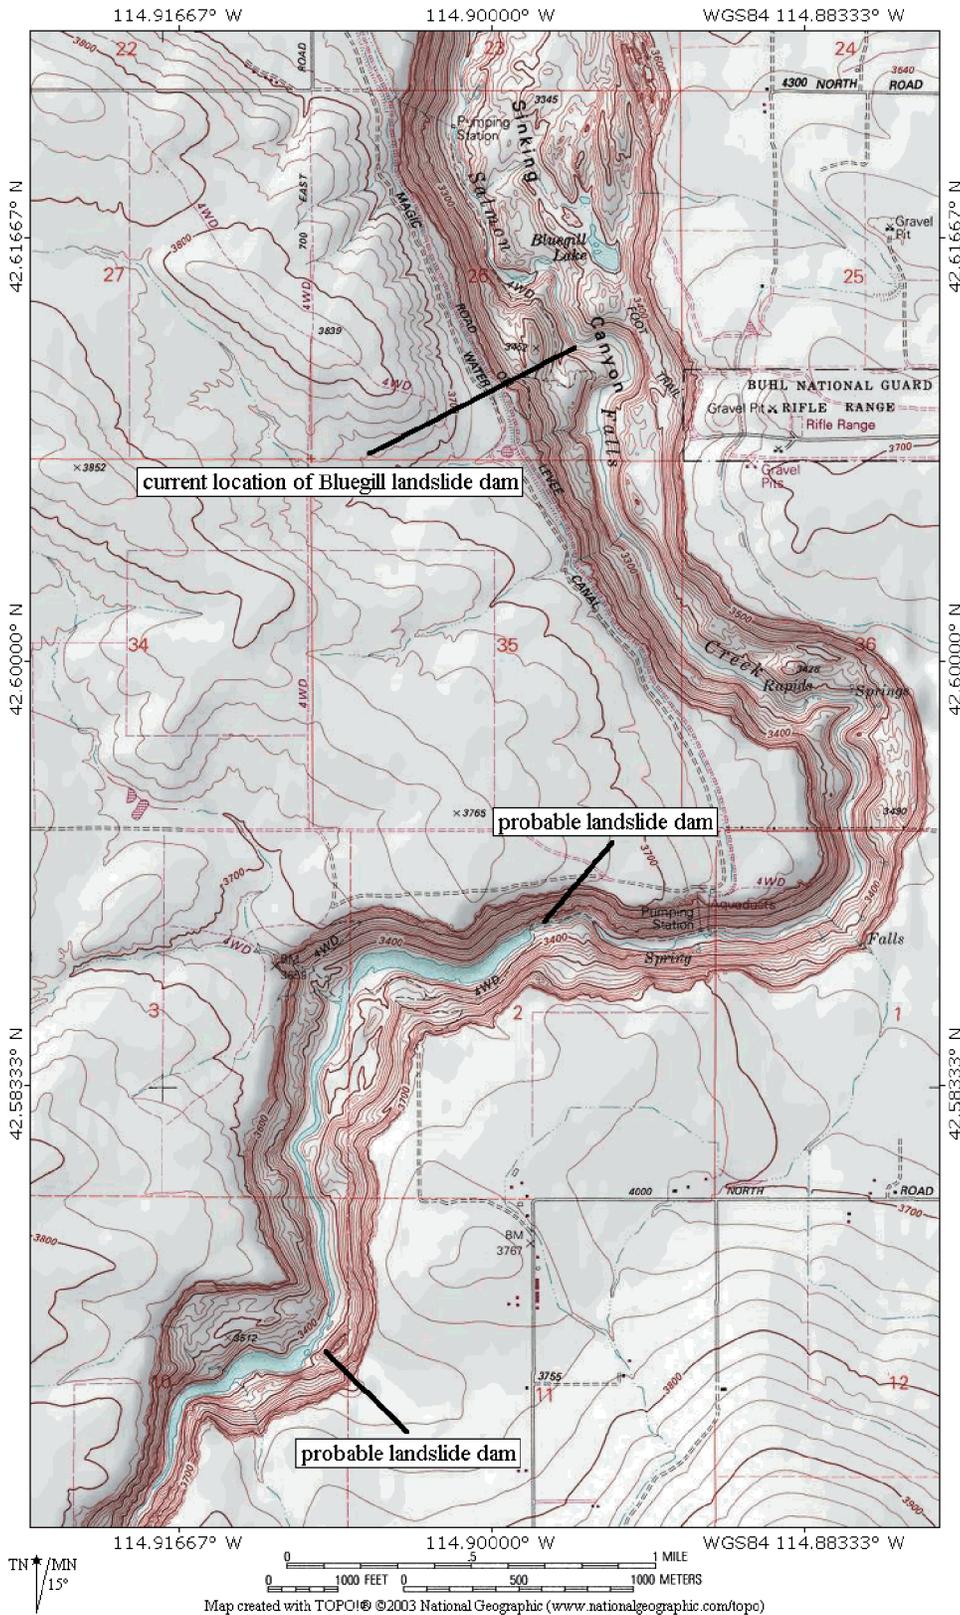
Figure 11. Topographic map of section of Salmon Falls Creek canyon showing old landslide dams approximately 4 km and 7 km upstream of Sinking Canyon and the Bluegill landslide. Ages of these older dams are uncertain. The topographic map (Balanced Rock 7.5-minute Quadrangle, USGS) was compiled in 1987. The sizes of the impounded lakes are similar to the size of the lake now formed behind the Bluegill landslide.

Some indication of the future stability of the Bluegill landslide dam can be inferred from other landslide dams in this area of the canyon. Examination of the USGS Balanced Rock quadrangle topographic map (dated July 1, 1987) indicates two apparent landslide dams within about 7 km upstream of the Bluegill landslide (fig. 11). These topographic landforms are typical of the landslide features in Sinking Canyon. While the ages of these landslide dams are not known, they at least occurred prior to July 1987, and are probably much older. The impoundments behind these older dams are similar in size to the Bluegill landslide impoundment, and their presence indicates that landslide dams formed in this geologic environment and topographic terrain may remain stable for many years. The ages of these older landslide dams could perhaps be better constrained by researching old maps and county records.
