# Stability of Leaning Column at Devils Tower National Monument, Wyoming

By Edwin L. Harp and Charles R. Lindsay

U.S. Geological Survey Open-File Report 2006–1130

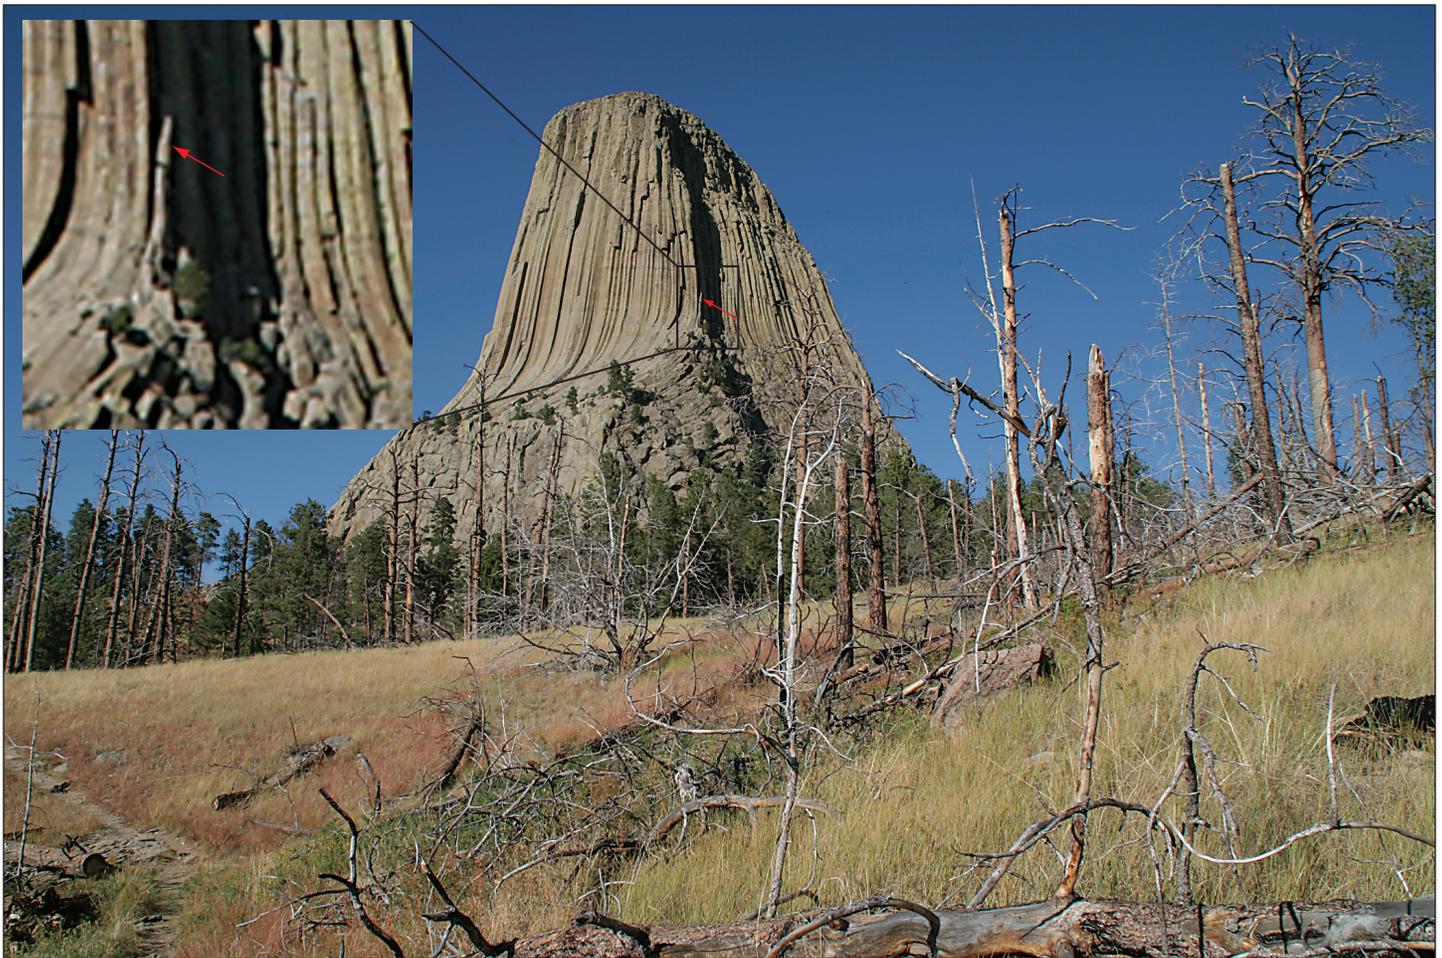
Cover photograph: Devils Tower with leaning column visible (red arrow) at lower left edge of vertical shadow on tower face.

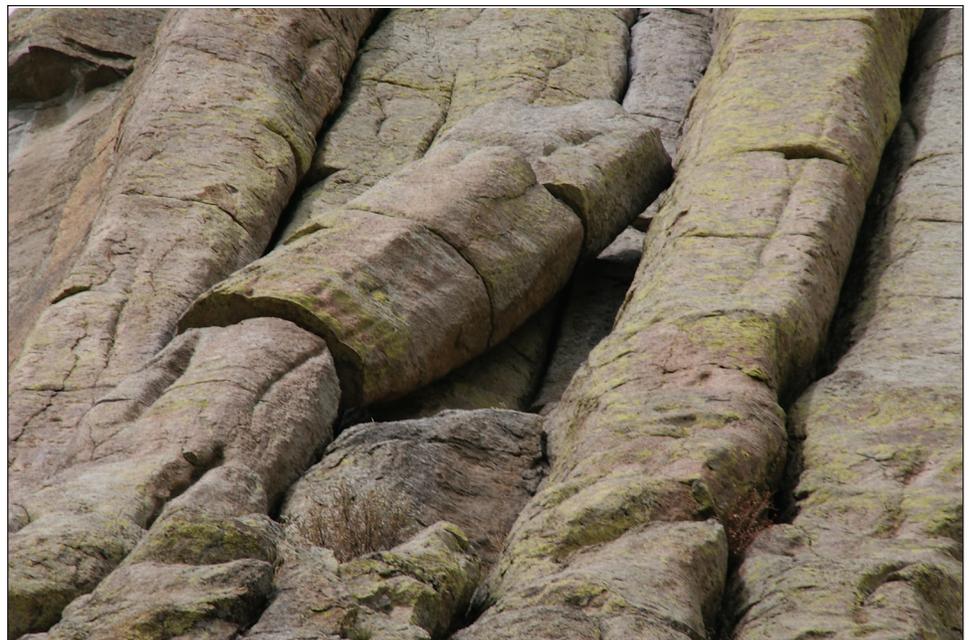
Figure 3. Telephoto of the leaning column showing the three segments, the underlying pedestal, and the upper point contact with an adjacent in-place column.

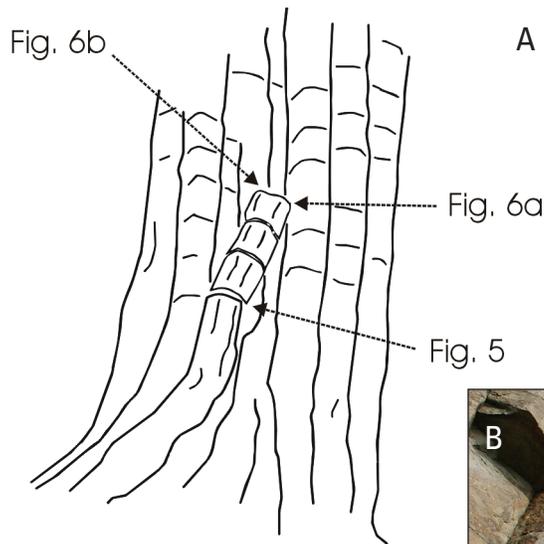
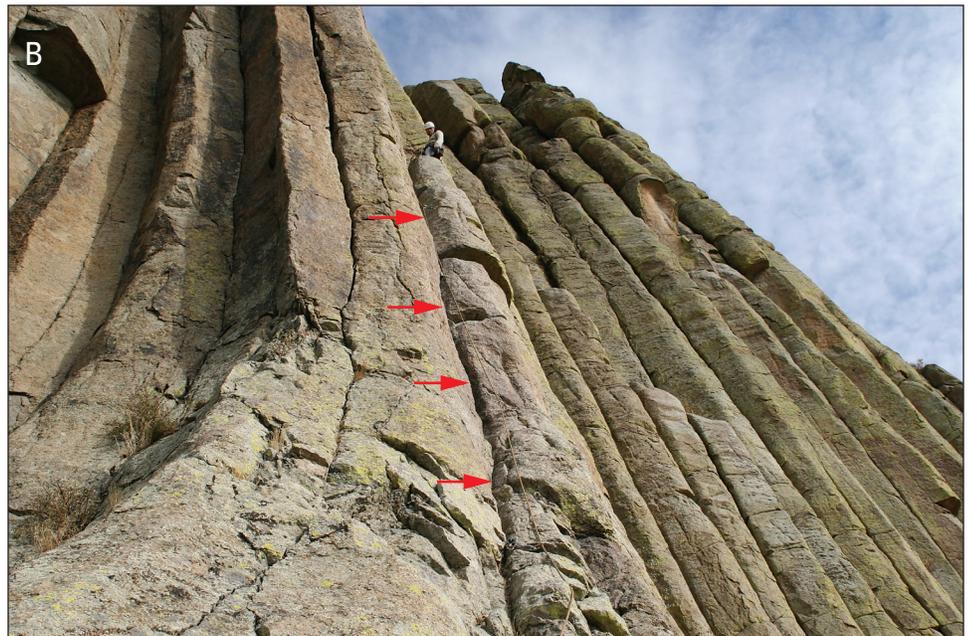
Figure 4. (A) Schematic drawing of leaning column indicating viewing orientations of figures 5, 6A, and 6B. (B) Leaning column from below with climber standing on top of the column. Line of arrows indicates lower part of Durrance route.

they climbed the column or stood on its top. According to NPS personnel and local climbers, the column has been in its present position during historical time and has given no indication of movement until the recent reports in June. In September 2005 two geologists from the U.S. Geological Survey, one a former climbing ranger at Devils Tower National Monument, scaled the column and inspected the column's movement and stability. The motion of the column in response to a person's shifting weight was observed both at its base and at its top. In both cases the motion was initiated by rapidly shifting weight at the top of the column. Once in motion, the column moved with an amplitude on the order of 5 mm with a frequency of about 2 Hz. The column, which is actually three segments vertically stacked (fig. 4A), moved as a unit.

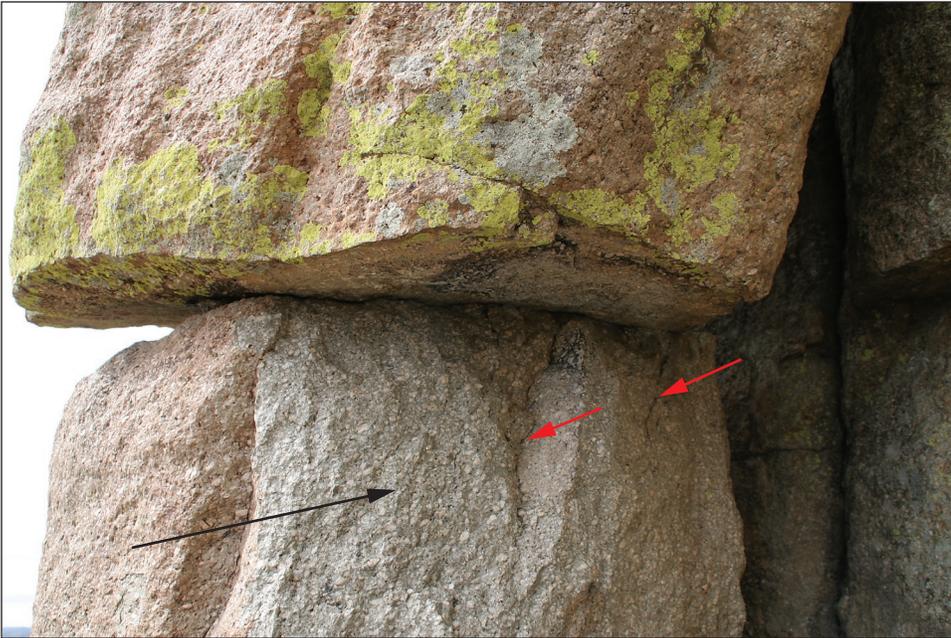
At its base, the leaning column is in contact with the underlying columnar pedestal along a linear contact (fig. 5). The leaning column is offset from the pedestal to the northeast by approximately 30 cm where its base rests on the edge of the underlying column, which serves as a fulcrum. The top edge of the leaning column is in point contact with an adjacent column of the tower (fig. 6A, B). Along the linear contact with the underlying pedestal are several hairline fractures extending from the contact downward approximately 10–20 cm (see fig. 5). Figure 5 shows a patch of relatively fresh phonolite just below the linear contact, suggesting that a flake-shaped piece of the pedestal has recently spalled from the underlying column, possibly in response to the stress concentration imposed by the overlying column along the linear contact.

Figure 5. Leaning column resting on underlying pedestal in line contact. Black arrow points to area of fresh phonolite where spalling failure has occurred. Also note hairline fractures (red arrows) extending down from line contact with overlying column.

At present, it would seem to require considerably more force than a climber could exert to actually push the leaning column away from the tower and topple it. However, the real concern is that the stress concentration at the linear contact between the leaning column and the pedestal may result in further spalling of the pedestal which could in turn accelerate further fracturing and spalling of the pedestal and lead to eventual collapse of the pedestal and toppling of the leaning column.

- The leaning column does move with the weight and movement of climbers with vibrations of about 5-mm amplitude at roughly a frequency of 2 Hz.
- The pedestal underlying the column has a relatively fresh surface of phonolite adjacent to the linear contact between the column and the pedestal that was probably created by spalling of a fragment of the pedestal due to the stress concentration imposed by the weight of the overlying column along the contact.
- Fractures present in the underlying pedestal near its contact with the leaning column seem to be recent and were probably created when a recent spalling failure occurred.

- The area around the contact between the column and pedestal should be spray-painted so that any new spalling failures can be detected and documented.
- Any new failures detected would indicate that the condition of the contact between the column and the pedestal is unstable and that closure of the route to climbers should be considered.
- New failures would also indicate that the area below the leaning column could be hazardous from a possible toppling failure of the column and subsequent rock fall.
- Determination of the area of possible rock-fall travel below the leaning column should be made by mapping the distribution of talus accumulation in that area of the monument.
- The area of talus accumulation below the leaning column would be hazardous in the event of column failure and should be considered for closure to the public.

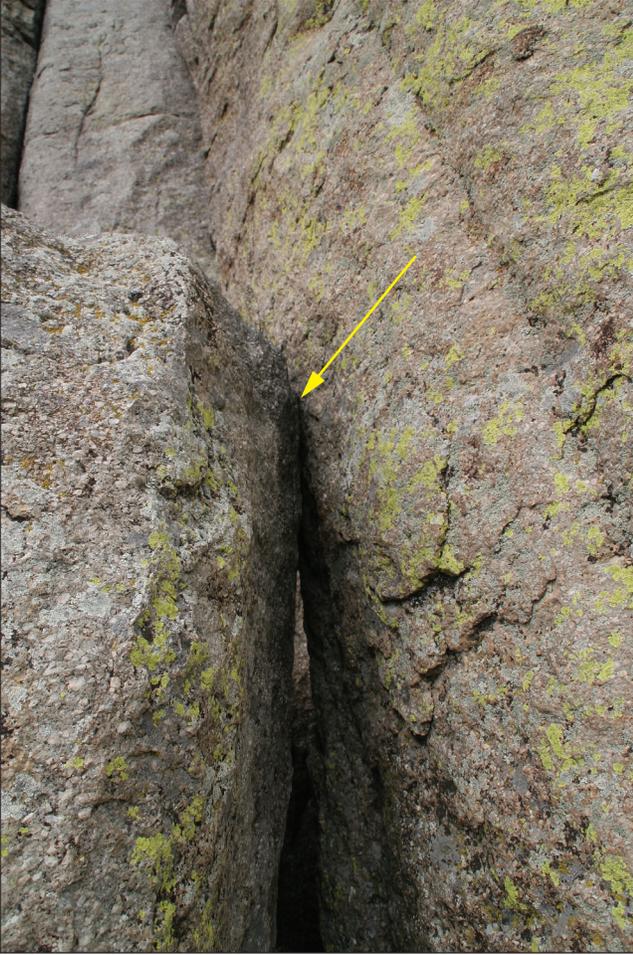
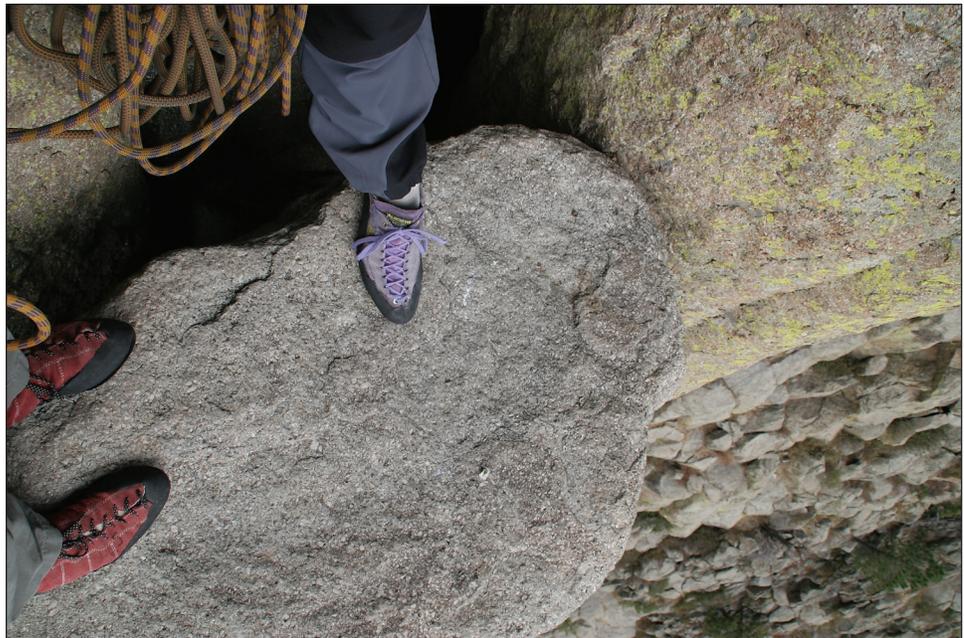
Figure 6. (A) Upper corner of leaning column showing point contact (arrow) with adjacent column, and (B) Point contact of leaning column with adjacent column from above.

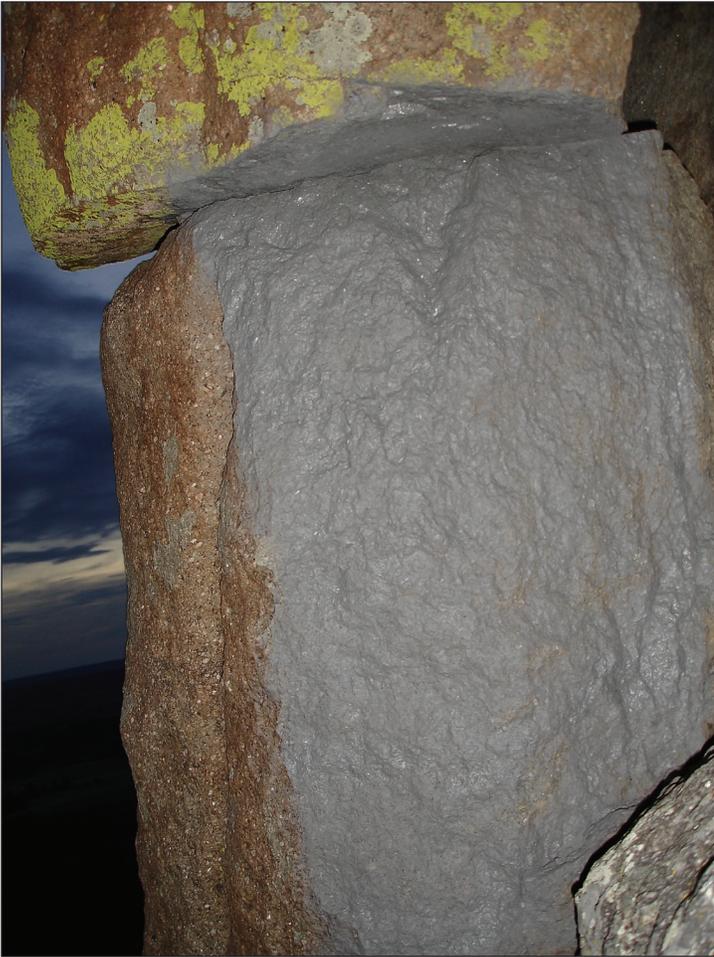
The integrity of the pedestal column and the present level of stress concentration placed on it by the overlying leaning column is of paramount importance to the stability of the leaning column. Observation of the pedestal revealed that it is not fractured except in the immediate vicinity of the linear contact with the overlying column (fig. 5). To answer the question of whether the weight of the overlying column may provide sufficient concentration of stress along the linear contact to further fracture the underlying pedestal, we recommended that the area of the pedestal adjacent to the contact be spray-painted (fig. 7) so that any further spalling of the pedestal could be easily detected by observing fresh surfaces upon subsequent inspection. Any

fresh surfaces produced from additional spalling would serve to indicate that the stress concentration is high enough to further fracture the pedestal and that this process might iteratively produce higher stress concentrations until collapse of the pedestal occurred. Additional spalling of the pedestal may also occur when the leaning column is moved by climbers.

Figure 7. View of line contact of leaning column with underlying pedestal showing freshly painted surface, which will allow any further spalling failures to be detected.
