Field Reconnaissance of Debris Flows Triggered by a July 21, 2007, Thunderstorm in Alpine, Colorado, and Vicinity

By Jeffrey A. Coe¹, Jonathan W. Godt¹, T.C. Wait², and Jason W. Kean¹

Open-File Report 2007-1237

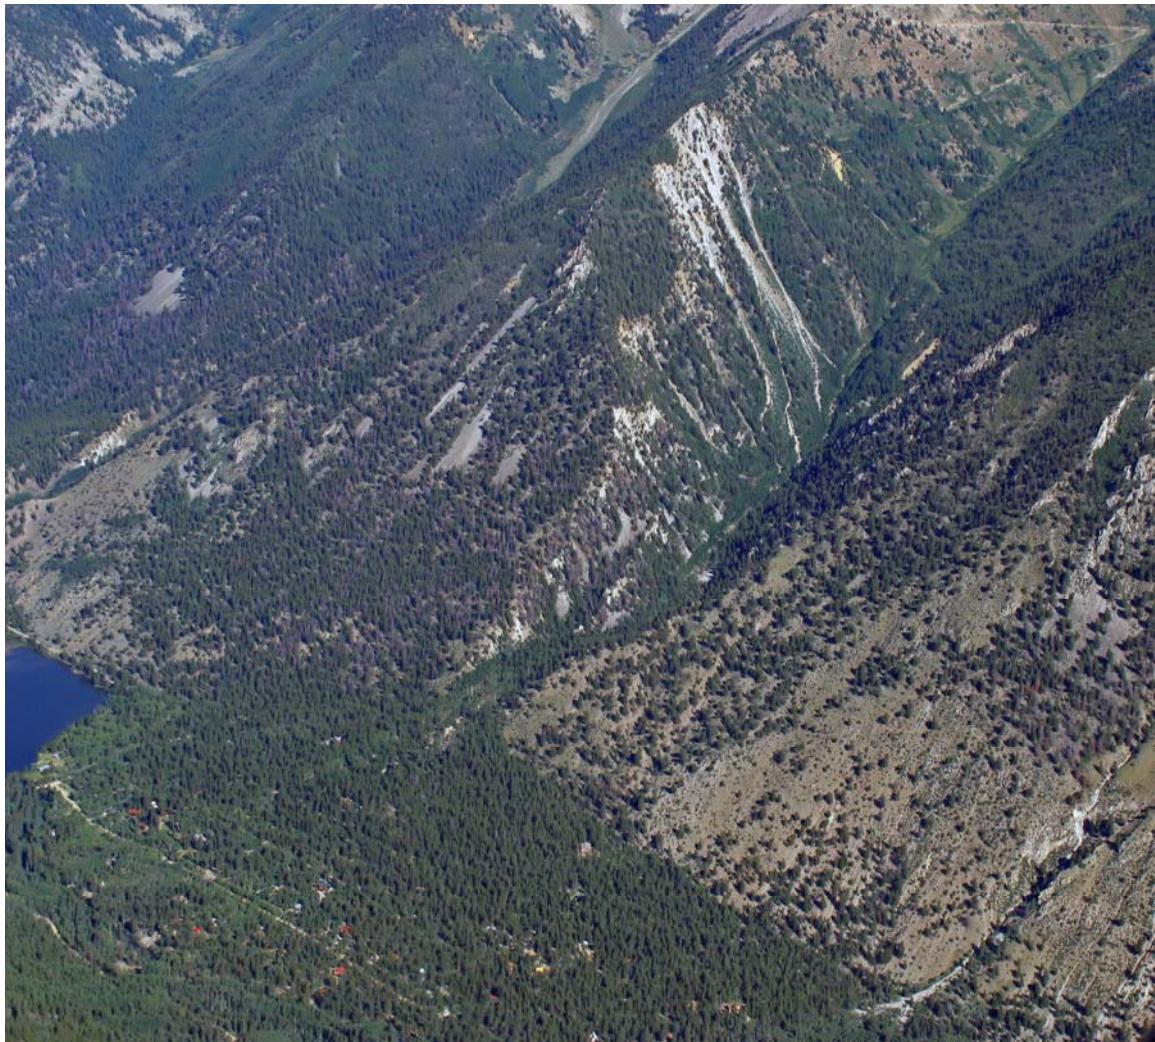
Frontispiece. Oblique aerial view of debris flows in Weldon Gulch upslope from the community of Alpine. View to the northwest. Photograph by J.W. Godt on July 25, 2007. Total relief visible in the photograph is about 730 m.

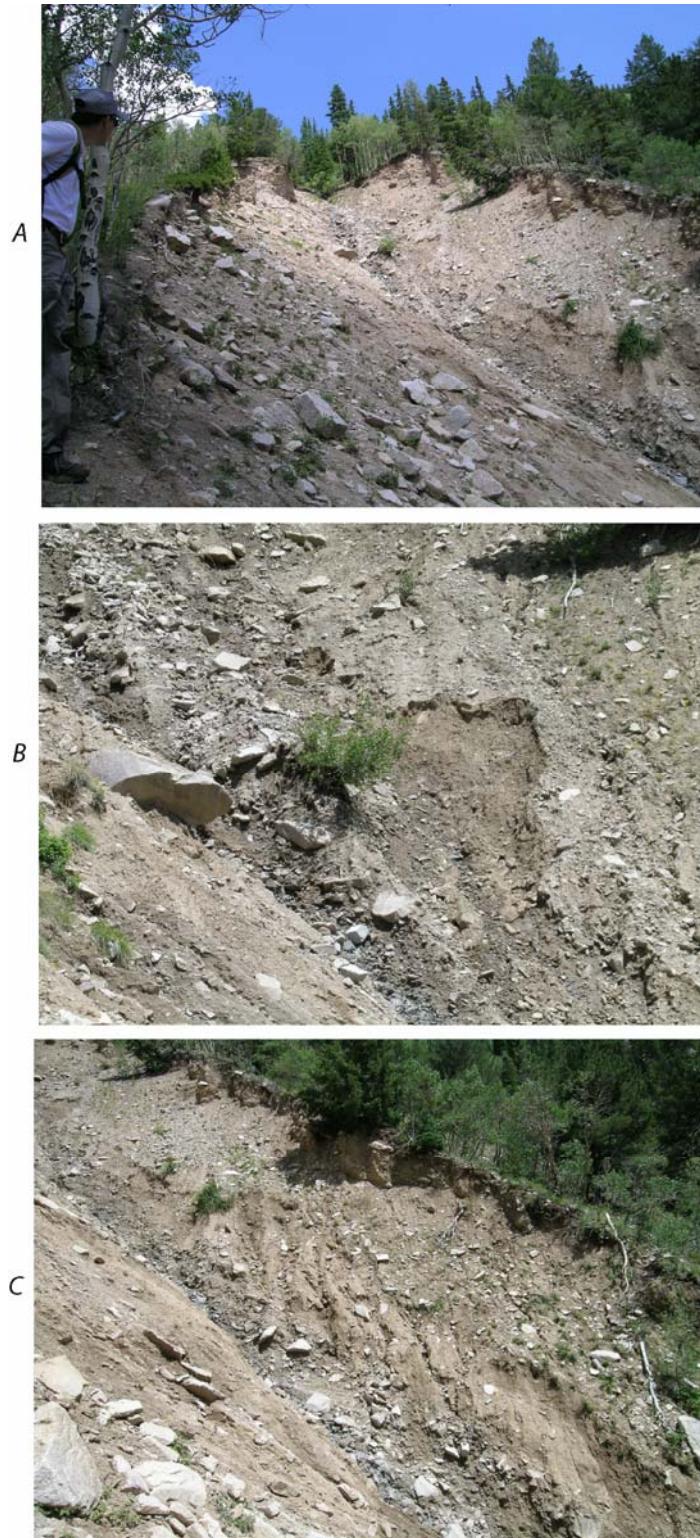
The debris flows in Weldon Gulch were investigated by entering the Gulch from both the ridgeline at the head of the Gulch and from the mouth of the Gulch at the fan. The upper one-half of the Gulch (the part above tree line) did not contain any debris flows (fig. 3). There were no scars on slopes at the head or flanks of the upper Gulch, and the channel coming from the upper half of the Gulch was not eroded and did not appear to have transported debris. All of the debris flows initiated from the east and west flanks of the lower one-half of Weldon Gulch. On the east flank, debris flows initiated from several small, shallow landslides (fig. 4), and from entrainment of sediment through rilling and channel erosion by the runoff of water (fig. 4), within a large, pre-existing landslide scar (fig. 4). The rills and shallow slides were easily visible because they contrasted with undisturbed parts of the scar, which had grass and bushes growing on the surface. There were no large, unstable blocks of old landslide material visible in the scar, but the flanks of the scar were steep and appeared to be gradually failing by raveling and periodic, small earth falls. The slope on the undisturbed northern edge of the old landslide scar was 33°. The channel downslope from the old landslide scar was eroded by water runoff and debris flows flowing from the scar. The channel split into two channels approximately 100 m downslope from the old scar (fig. 3). Both of these channels existed prior to July 21. On the basis of exposed roots and soil horizons, incision in these two channels ranged from about 0.5 to 2 m (fig. 5). In some locations, bedrock was exposed in the channel bottoms. The best estimate is that sediment eroded from these two channels on the east flank of Weldon Gulch contributed approximately 10 to 20 percent to the total amount of debris deposited on the debris fan.

Figure 4. Landslides and erosion on eastern flank of Weldon Gulch. *A*, Pre-existing landslide scar. *B*, 3-meter-wide shallow slide in pre-existing landslide scar. *C*, Rill erosion in pre-existing landslide scar. Rills are approximately 5 to 10 centimeters wide.

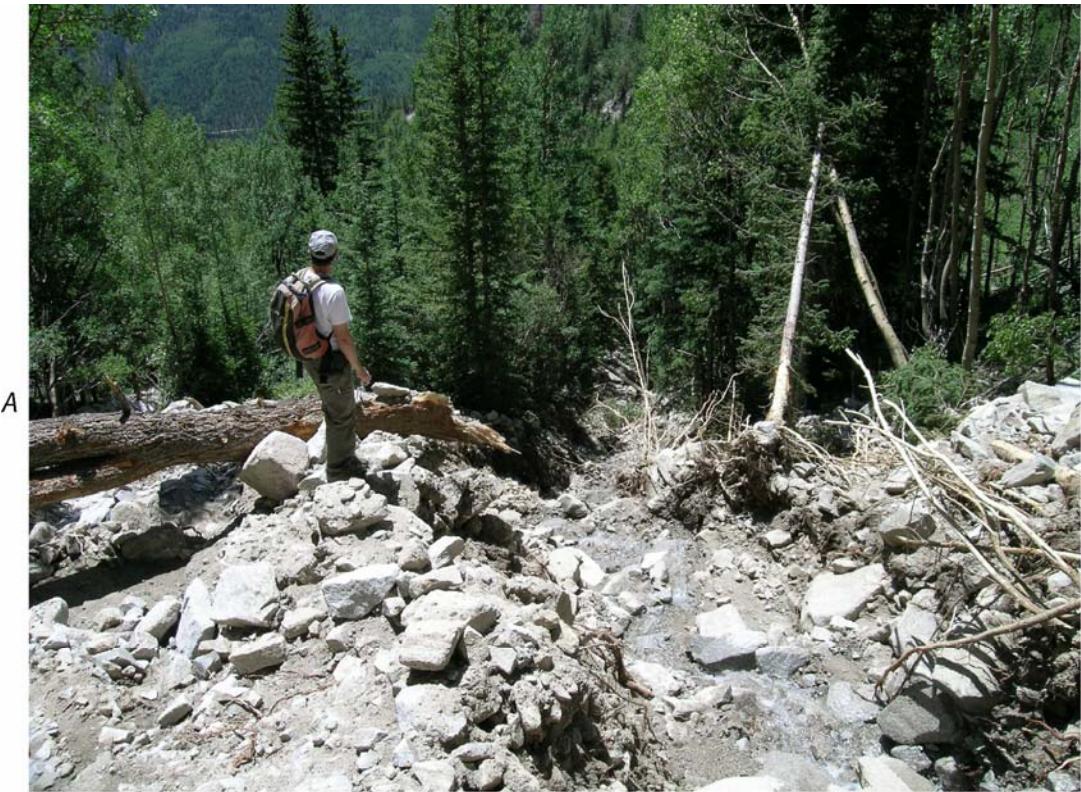
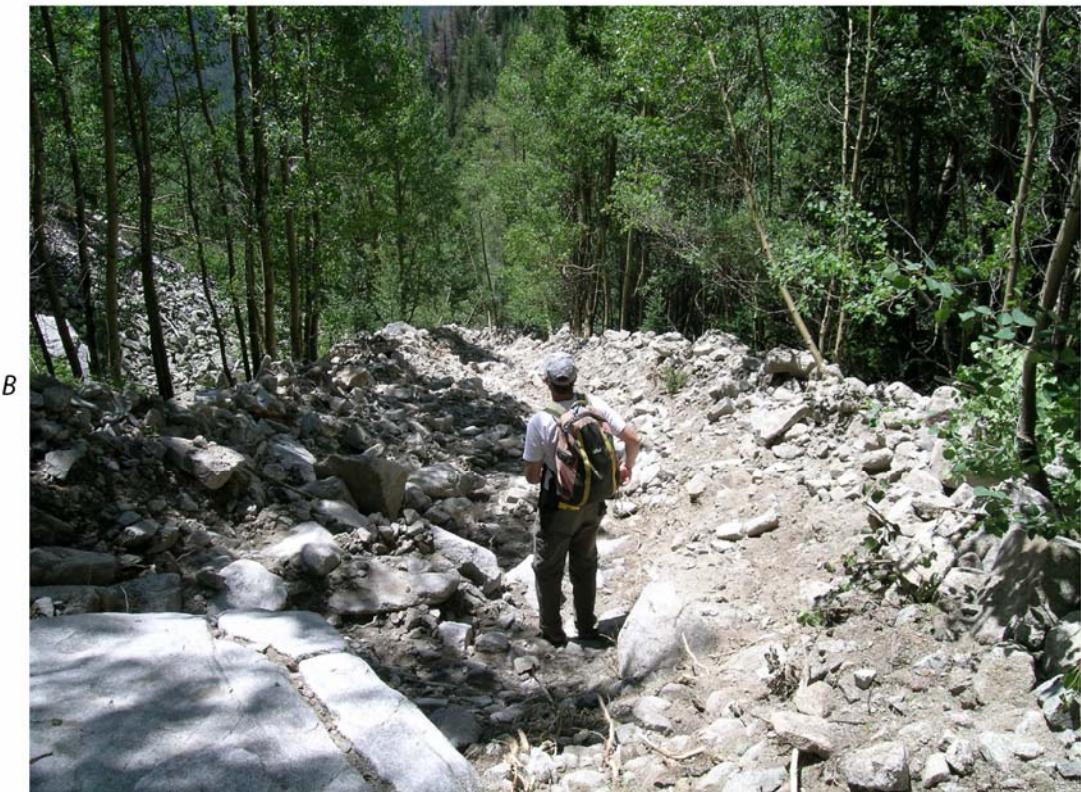
Figure 5. Channels downslope from old landslide scar on the eastern flank of Weldon Gulch (see fig. 3 for location). A, Eastern channel, and B, western channel.

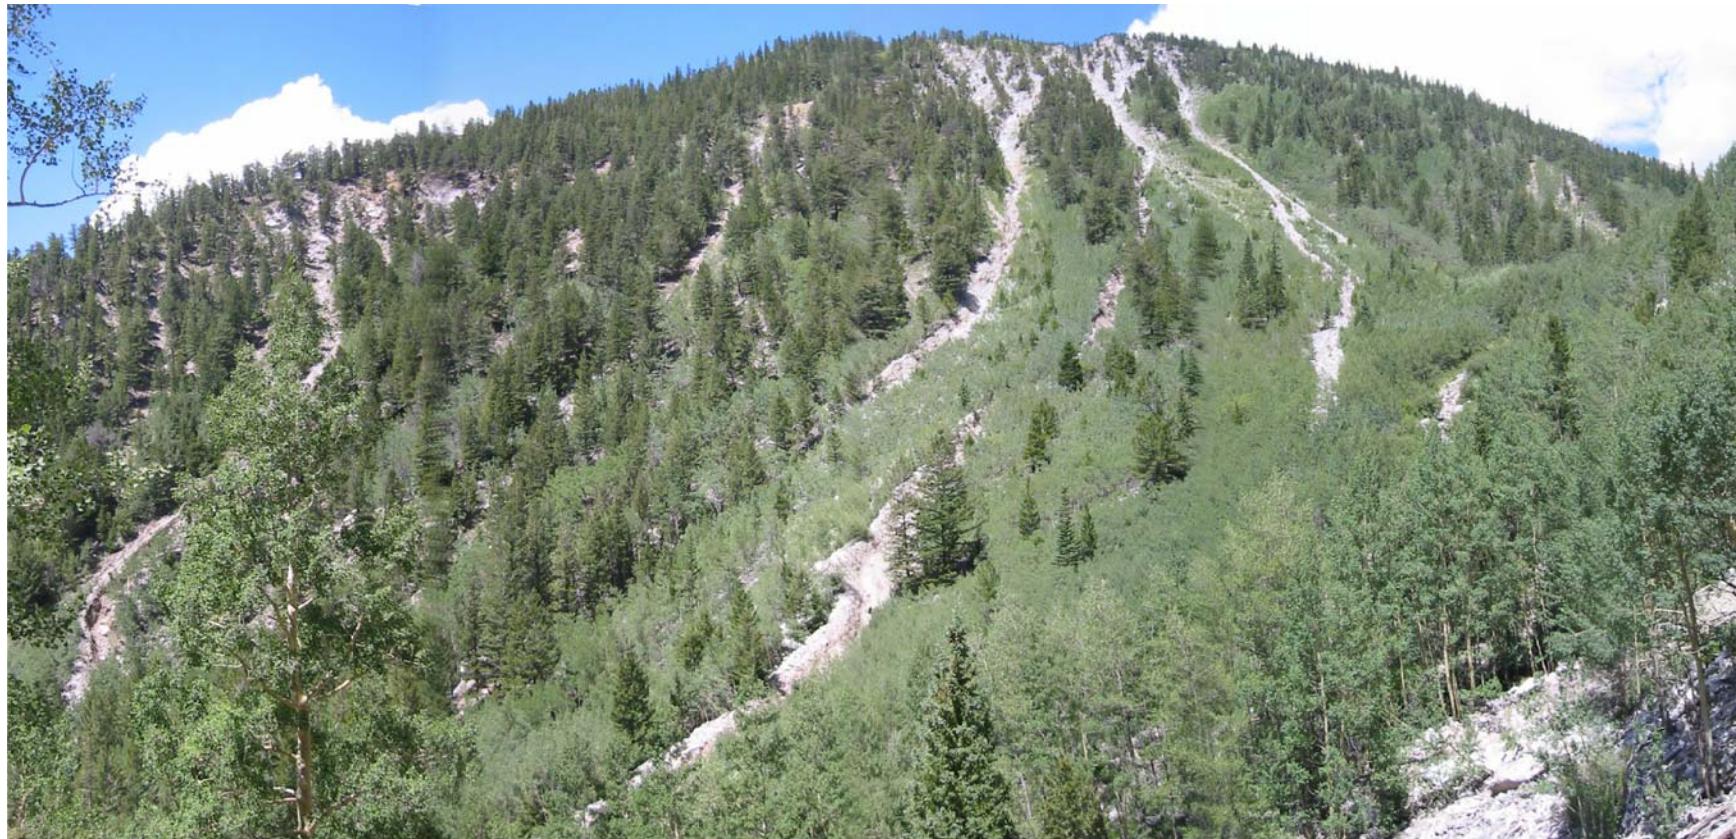
On the west flank of Weldon Gulch, debris flows initiated in about 10 previously existing channels (compare fig. 1B with the frontispiece and fig. 6), 9 of which were directly downslope from steep bedrock outcrops (fig. 7). One channel was downslope from a mine dump (the northern most channel on the west flank of Weldon Gulch, see frontispiece and figure 3). The debris in this channel had been eroded from the dump by rilling, but was deposited on the western flank of Weldon Gulch and, thus, did not contribute any debris to the fan at Alpine. Field observations indicate that no other prospect pits or mine dumps were related to debris flows. The position of the nine debris-flow channels with respect to the bedrock outcrops (figs. 6 and 7), as well as a lack of slides at the heads of the channels, indicates that the initiation mechanism for the debris flows was entrainment of channel material from water running off the bedrock, commonly known as “firehose” initiation (Johnson and Rodine, 1984). Firehose initiation is caused by the mobilization of material by a concentrated flow of water, just as if the material had been washed away by a firehose. Deepening and widening of the channels by erosion was extensive. Most of the newly expanded channels had widths of 2 to 4 m and depths of 1 to 3 m (fig. 8A, B), but maximum widths and depths were 9 and 4 m, respectively (fig. 8C). The slope of undisturbed ground adjacent to the channels ranged from 30° to 35°. On the basis of exposed roots and soil horizons, it is estimated that incision of the channels from the July 21 storm ranged from about 0.5 to 3 m. Channel banks were nearly vertical (fig. 9) and were actively failing and contributing sediment to the channel bottoms (fig. 9). Bedrock was exposed in channel bottoms at some locations, but, in general, colluvium was exposed

Figure 6. Composite of ground-based photographs showing debris-flow channels on the western flank of Weldon Gulch. Total relief visible is about 420 meters.

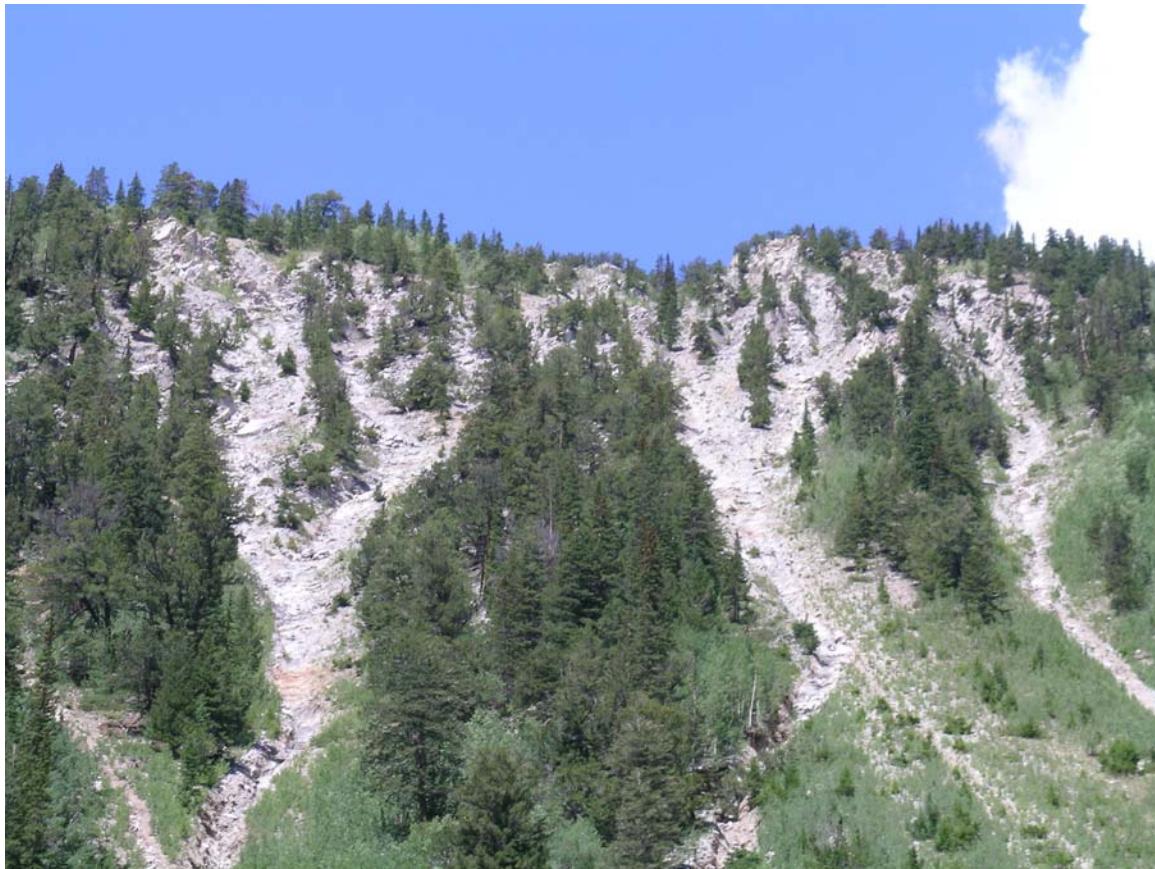
Figure 7. Bedrock at the head of debris-flow channels on the western flank of Weldon Gulch. Total relief visible is about 120 meters.

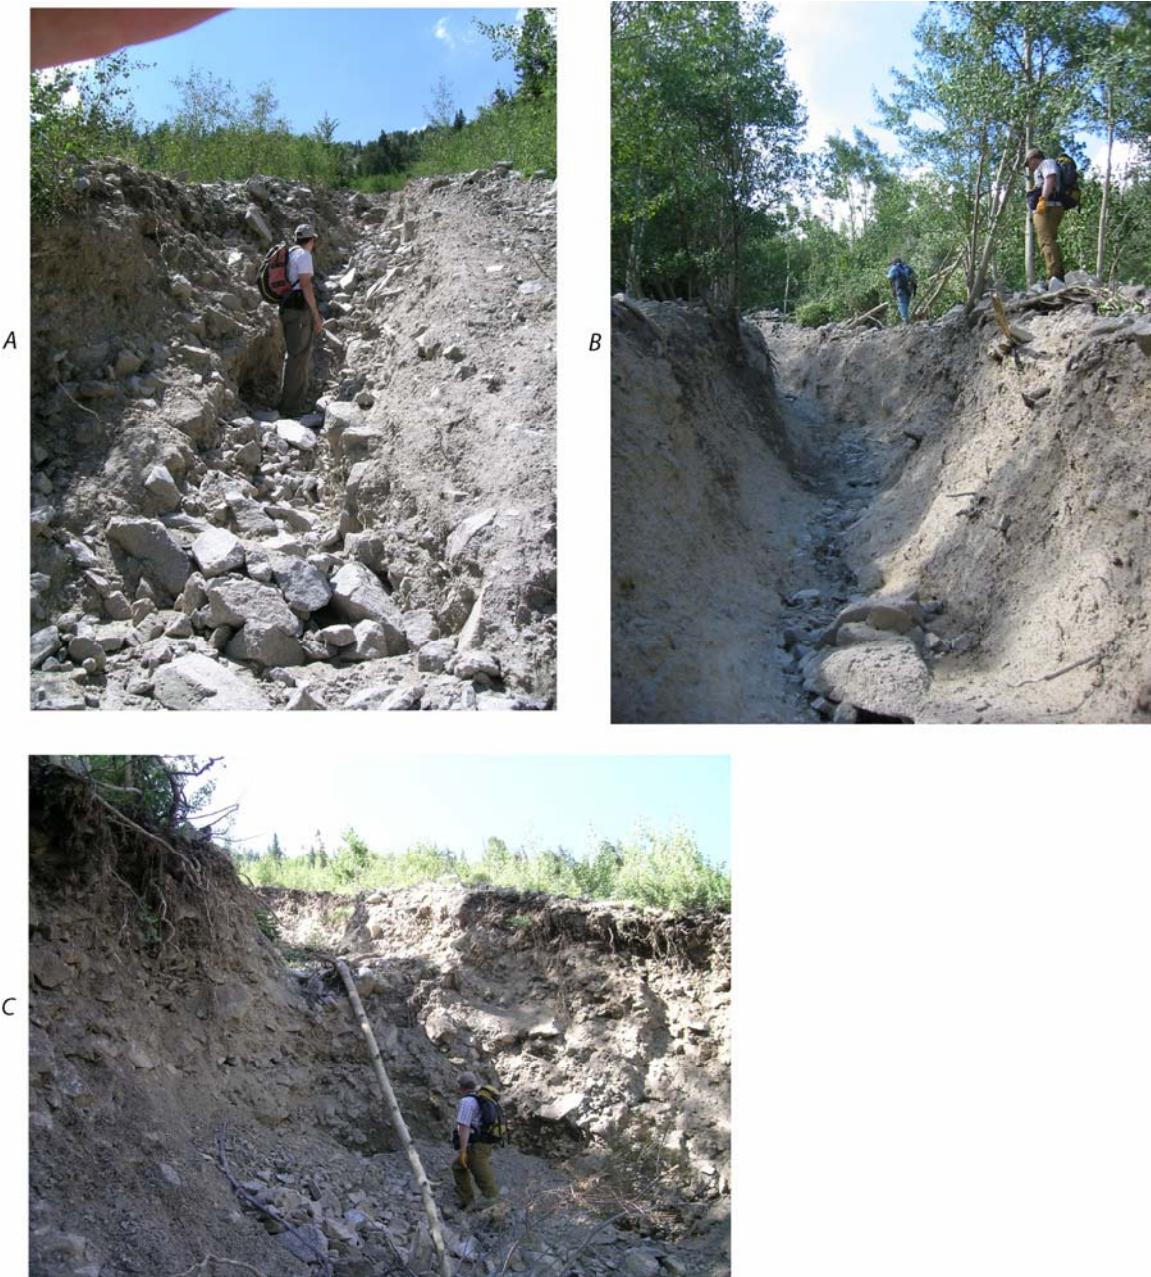
Figure 8. Debris-flow channels on the western flank of Weldon Gulch. A,B, Channels 2 to 4 meters wide and 1 to 3 meters deep. C, Channel with maximum observed width (9 meters) and depth (4 meters).

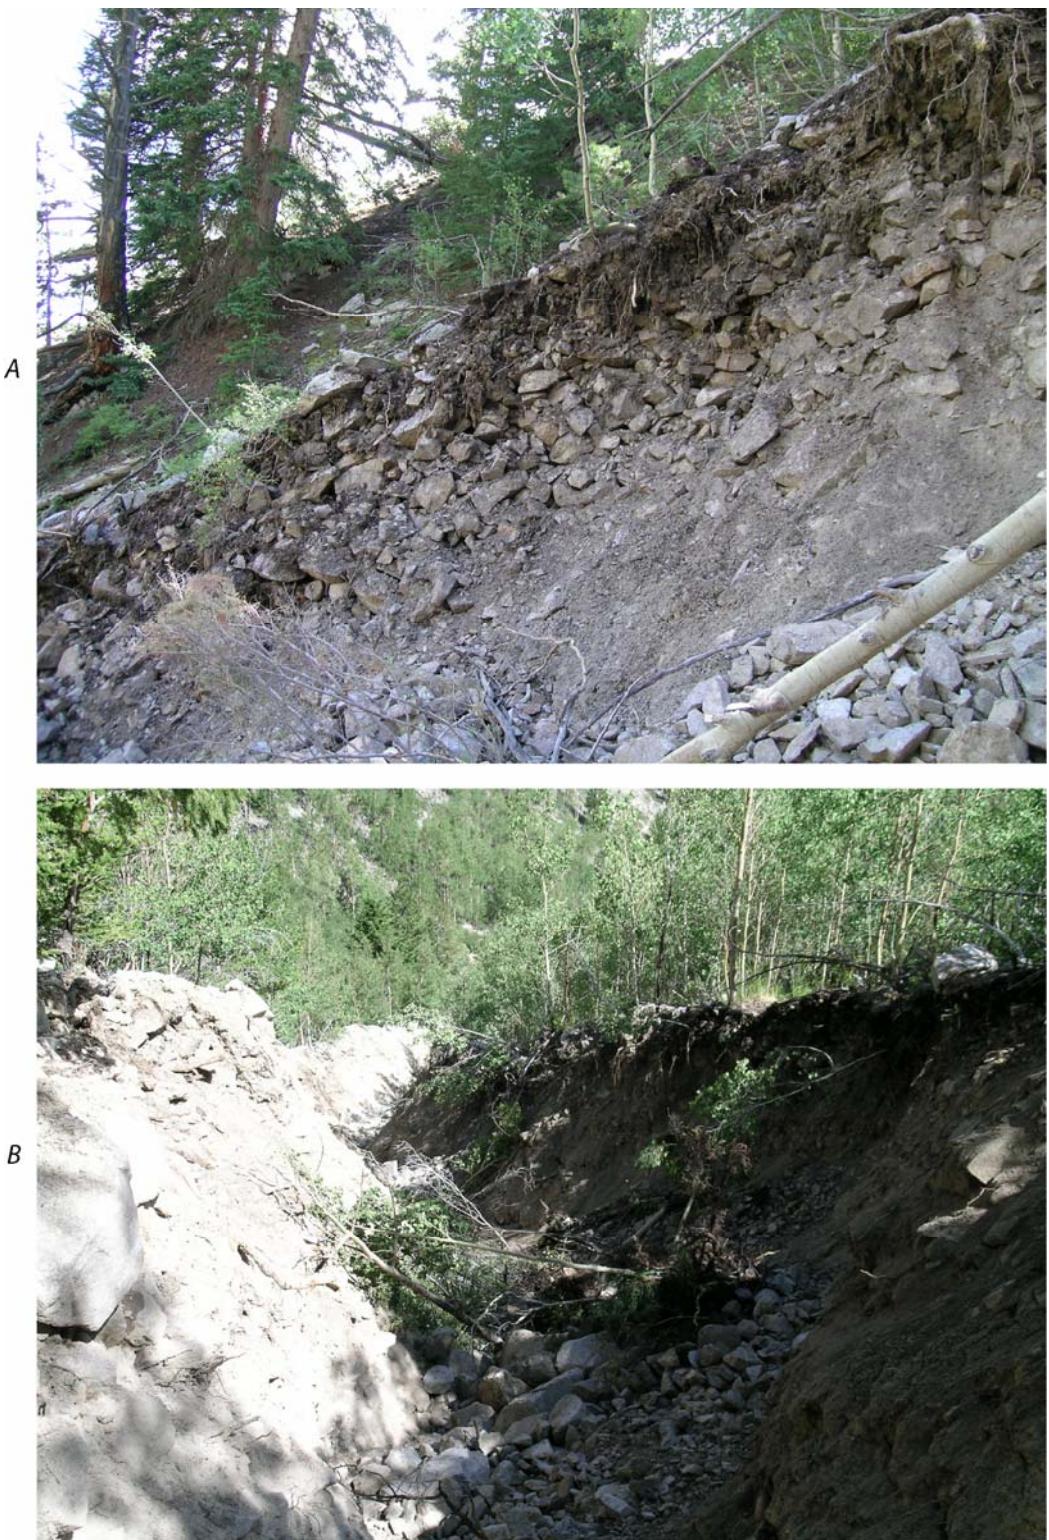
Figure 9. Channel banks on the western flank of Weldon Gulch. A, Nearly vertical, 3-meter bank of loose colluvium, and B, 3-meter bank that has failed into the channel.

Within Weldon Gulch, channels that contributed sediment on July 21 have been deeply scoured, removing much of the loose material available for incorporation into debris flows. However, the now oversteepened banks of these channels are actively failing and refilling the channels with loose debris. There is not a good estimate of the rate of channel filling, and so an accurate estimate of the amount of debris that will be available for incorporation into debris flows in the future cannot be made. Prevention or mitigation of the buildup of debris in the channels appears to be impractical because of their steep slopes and large sizes. Also, although the upper one-half of Weldon Gulch did not produce debris flows in the July 21 thunderstorm, a storm having a different extent and intensity could produce debris flows from the upper one-half of the basin that could travel to the fan. Given these constraints, the best estimate is that the debris-flow hazard on the fan is about the same as it was before the debris flows on July 21.

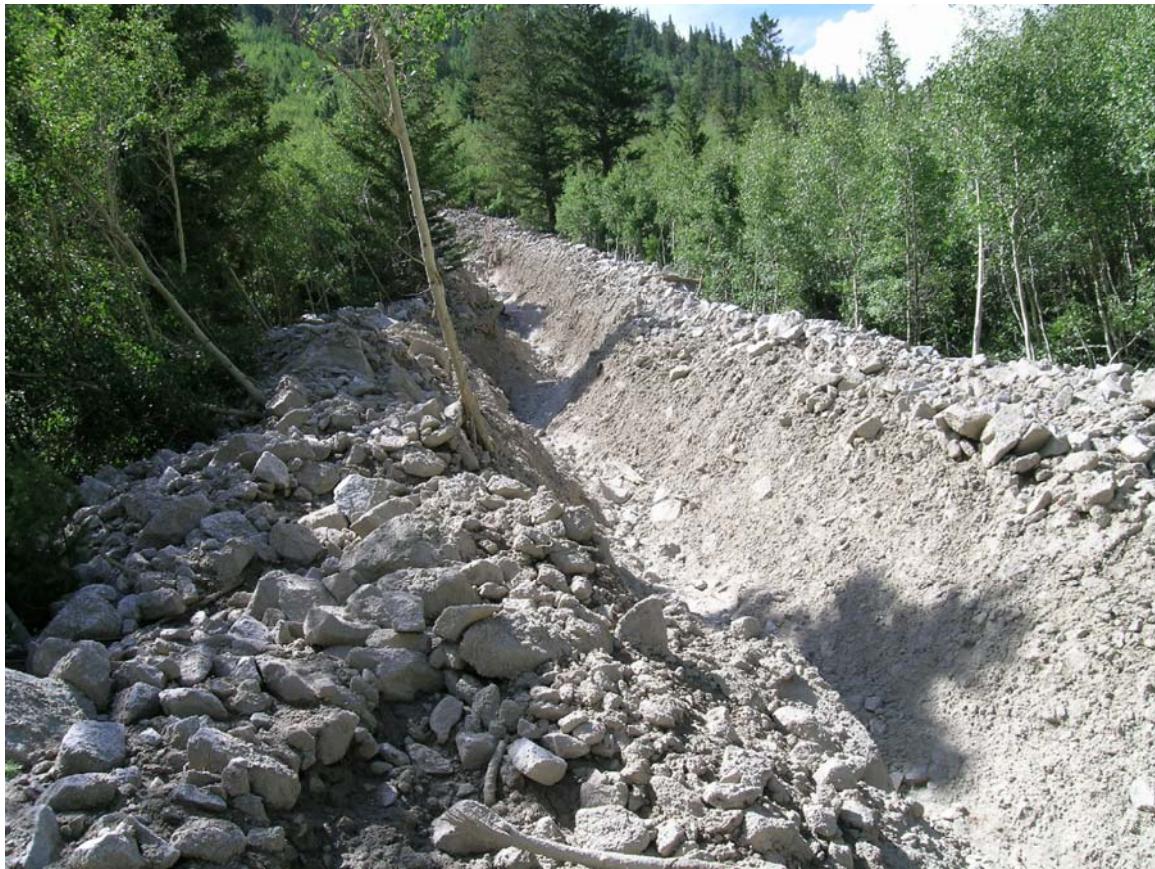
along the bottoms of most channels. Fresh debris-flow levees and lobes were common along the flanks of channels, particularly in the middle and lower parts of the slope (fig. 10). The best estimate is that sediment eroded from the channels on the western flank of the Gulch contributed 80 to 90 percent to the total sediment deposited on the debris fan.

Figure 10. Debris-flow deposits along the flank of a channel on the western flank of Weldon Gulch. Channel is about 4 meters wide.

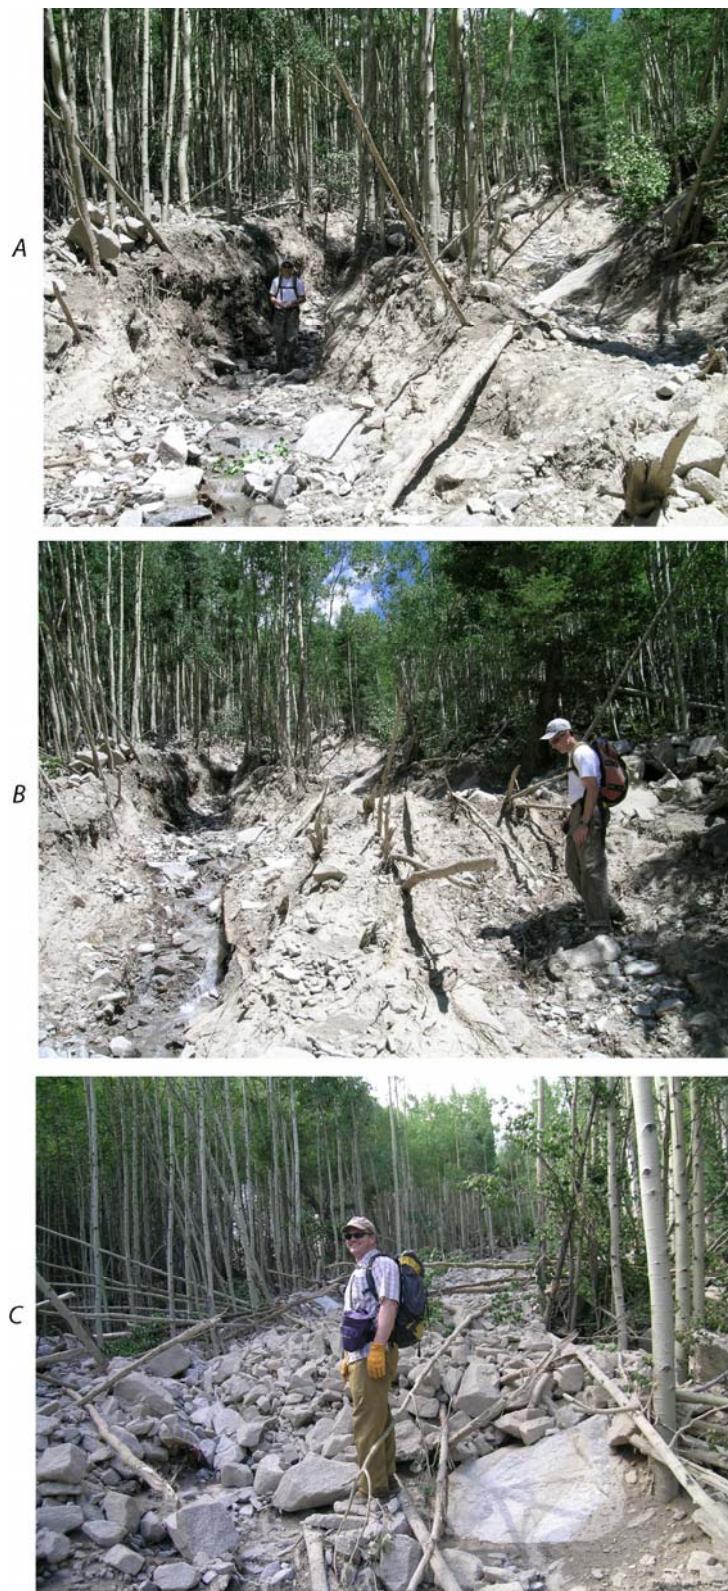
Erosion and deposition occurred in about equal proportions along multiple, anastomosing channels on the floor of Weldon Gulch (fig. 11). Maximum channel incision was 1 to 2 m, and maximum thickness of deposition appeared to be about 1 m. Incision was limited mostly to channels, whereas deposition occurred as levees along the flanks of channels, and in lobate deposits where debris flows left channels and flowed along the floor of the Gulch. Numerous trees (mostly aspen as much as 20 cm in diameter) were sheared off by, and incorporated into, the debris flows along the floor of the Gulch (fig. 11). The slope of the floor of the Gulch above the head of the fan ranged from about 14° to 17°.

Figure 11. Photographs from the floor of Weldon Gulch. *A*, Area of channel erosion, *B*, trees sheared off by debris flows, and *C*, steep, bouldery front of a debris-flow deposit.

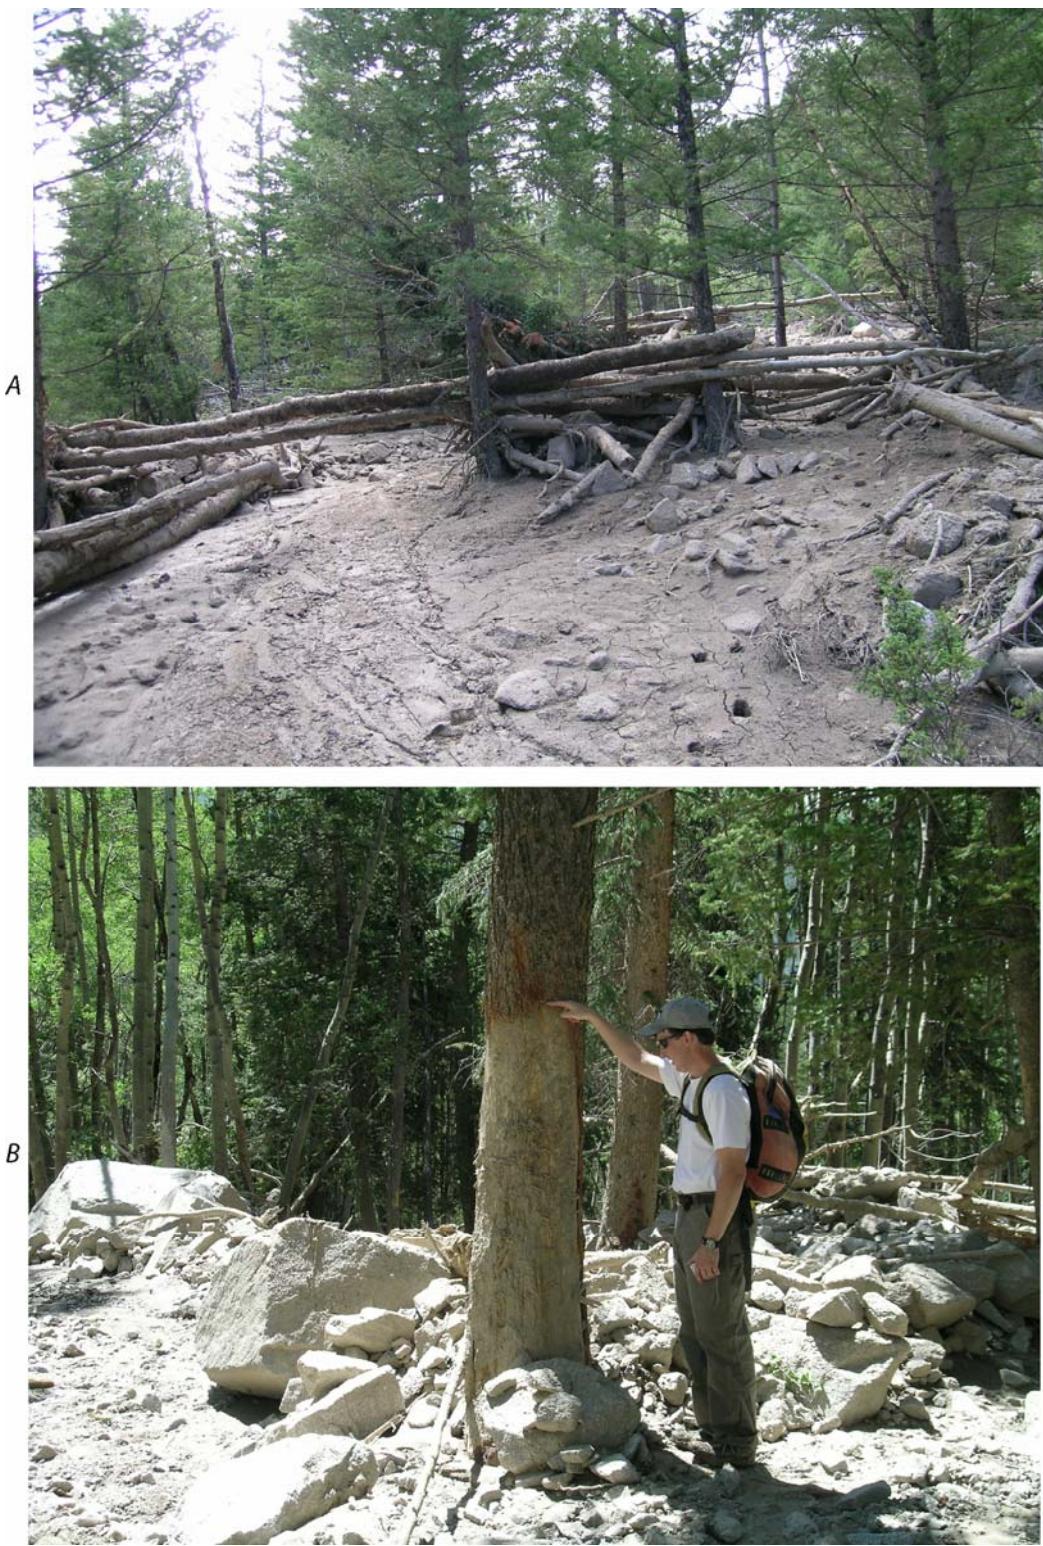
Most of the trees that had been sheared off in Weldon Gulch, as well as old dead trees that had been lying in or near previously existing channels in the Gulch, were deposited near the head of the fan (fig. 12). The trees typically were deposited when they became trapped against larger, intact trees. Many of these deposits of trees created natural dams that then trapped mud and rocks. Numerous scars from impacts by flowing debris were observed on trees. Some scars reached heights of about 2 m above the surface of fresh deposits (fig. 12).

Figure 12. Photographs of trees on the debris fan. *A*, Natural dam formed by trees, and *B*, scar on tree from passing of debris flow.

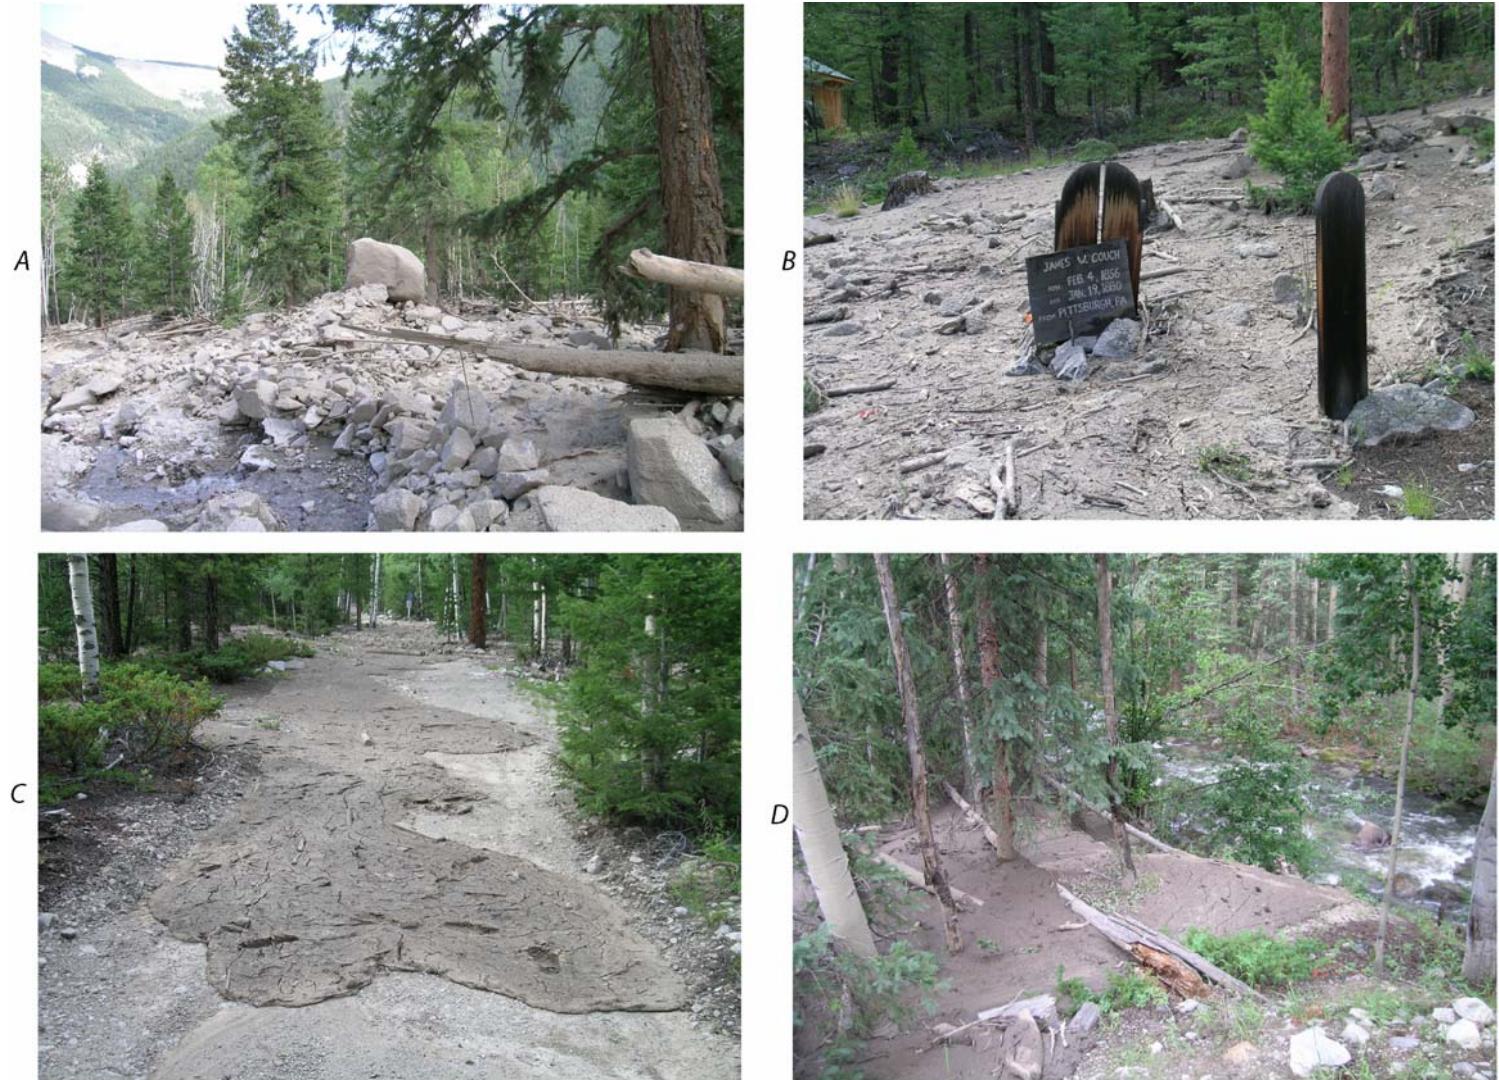
Fresh debris-flow deposits on the fan generally became finer grained and thinner with distance from the head of the fan (fig. 13). Deposits near the fan head had maximum thicknesses of about 1 m and contained boulders up to about 1 m in diameter. Larger boulders were observed in and near channels on the fan, but it was unclear how far these boulders had been transported by the debris flows (fig. 13A). The debris flows reached Chalk Creek in at least two locations. Deposits at these locations were thin (less than about 10 cm thick), fine grained, and did not dam the creek (fig. 13D).

Figure 13. Photographs showing progressive fining of debris-flow deposits from head to toe of the debris fan. *A*, Deposits near head of the fan. Large boulder is about 2 meters high. *B*, Deposits in the cemetery (see fig. 3 for location). *C*, Deposits just south of County Road 292, the main east/west trending road in Alpine. *D*, Deposits at Chalk Creek.

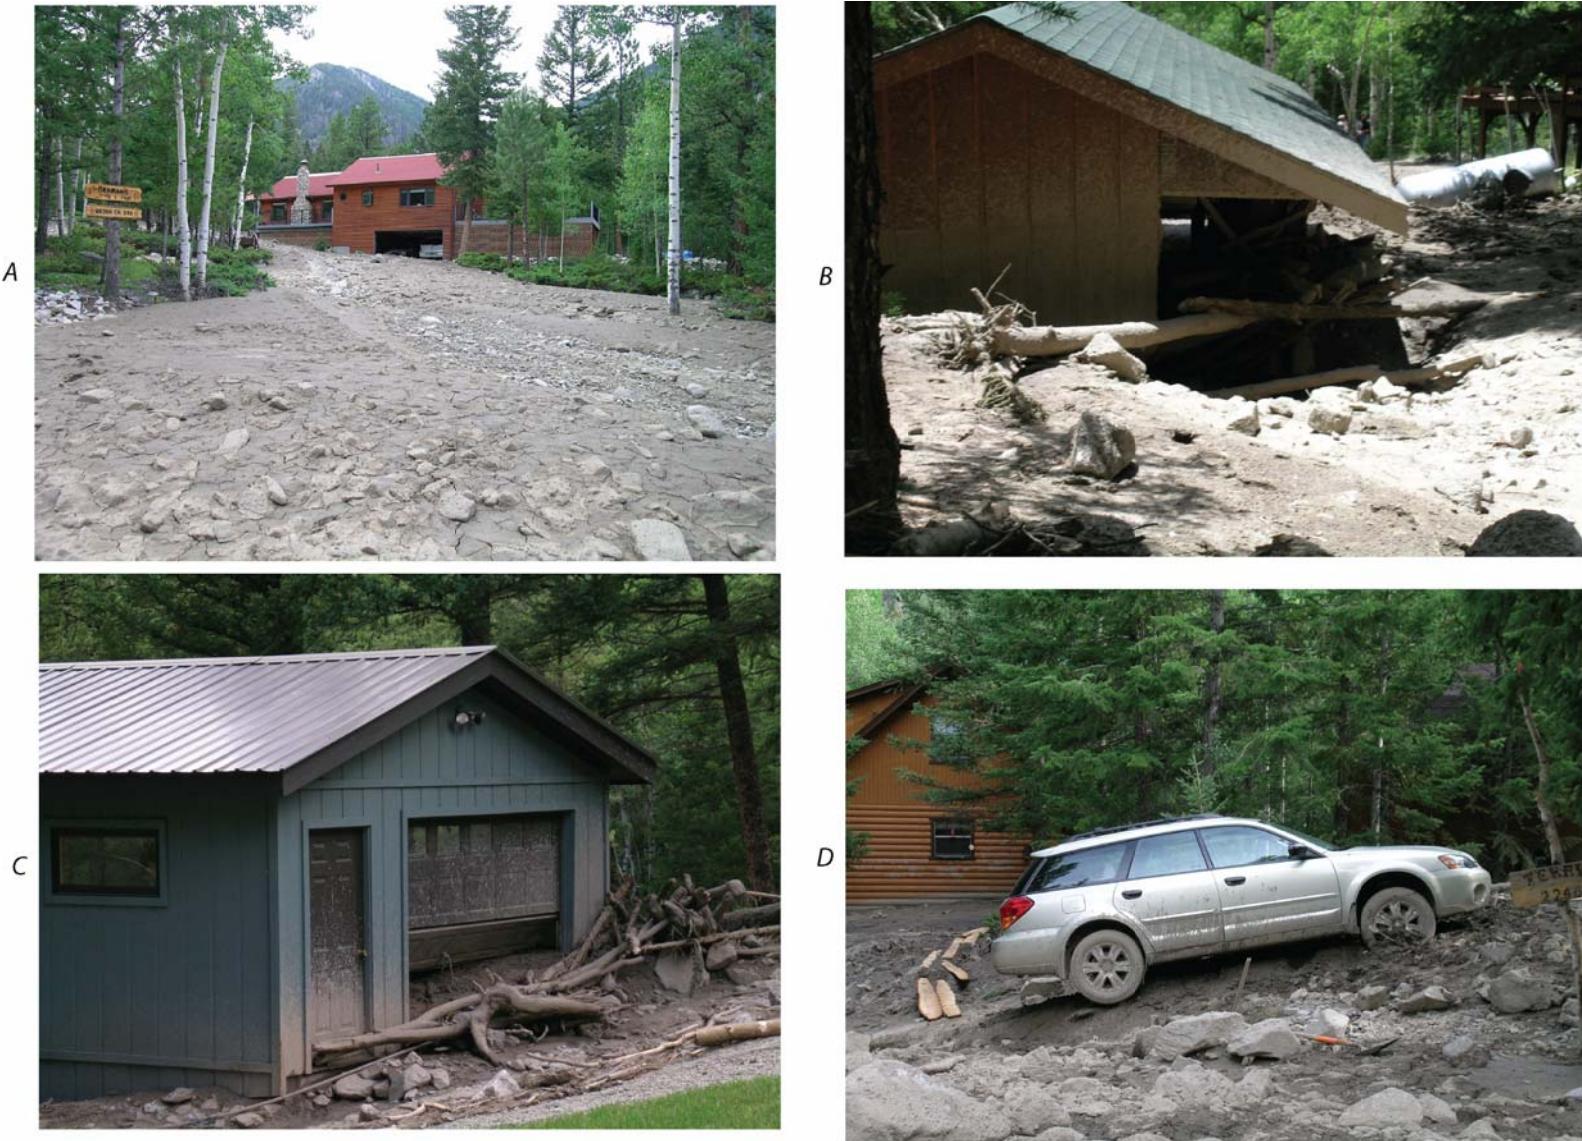
At several locations on the fan, debris flowed along roads and driveways (fig. 14) and impacted adjacent structures (houses, garages, and trailers), but no one was injured. A few vehicles were buried and(or) transported by the debris flows (fig. 14). Numerous structures had deposits around them (fig. 14), and some were damaged by the flows (fig. 14).

Figure 14. Photographs showing damage from debris flows in Alpine. *A*, Deposit in driveway of a residence. *B*, Damaged garage and propane tank. *C*, Damaged garage. *D*, Damaged car.

1. Mitigation techniques for the debris-flow hazard in Alpine could include establishing a channel on the fan that routes potential water and debris flows in a manner that protects existing roads and structures. The Colorado Geological Survey has made a similar suggestion to the Colorado Department of Emergency Management (Berry, 2007), and this technique is already being used near the Chalk Cliffs east of Alpine. Currently, there are multiple channels on the fan; some have been scoured (deepened), some have been filled, and some are carrying the current flow of water from Weldon Gulch to locations that could cause problems for existing roads and structures. The natural geomorphic processes on fans like the one in Alpine are that these channels migrate laterally through time, effectively distributing material across the fan surface. Establishing a channel, possibly in combination with a deflection wall(s), debris catchment basin(s), debris rack(s), or check dam(s) to catch or divert debris-flow material away from roads and structures and prevent the channel from becoming plugged could help reduce the impacts of some future debris-flow events.

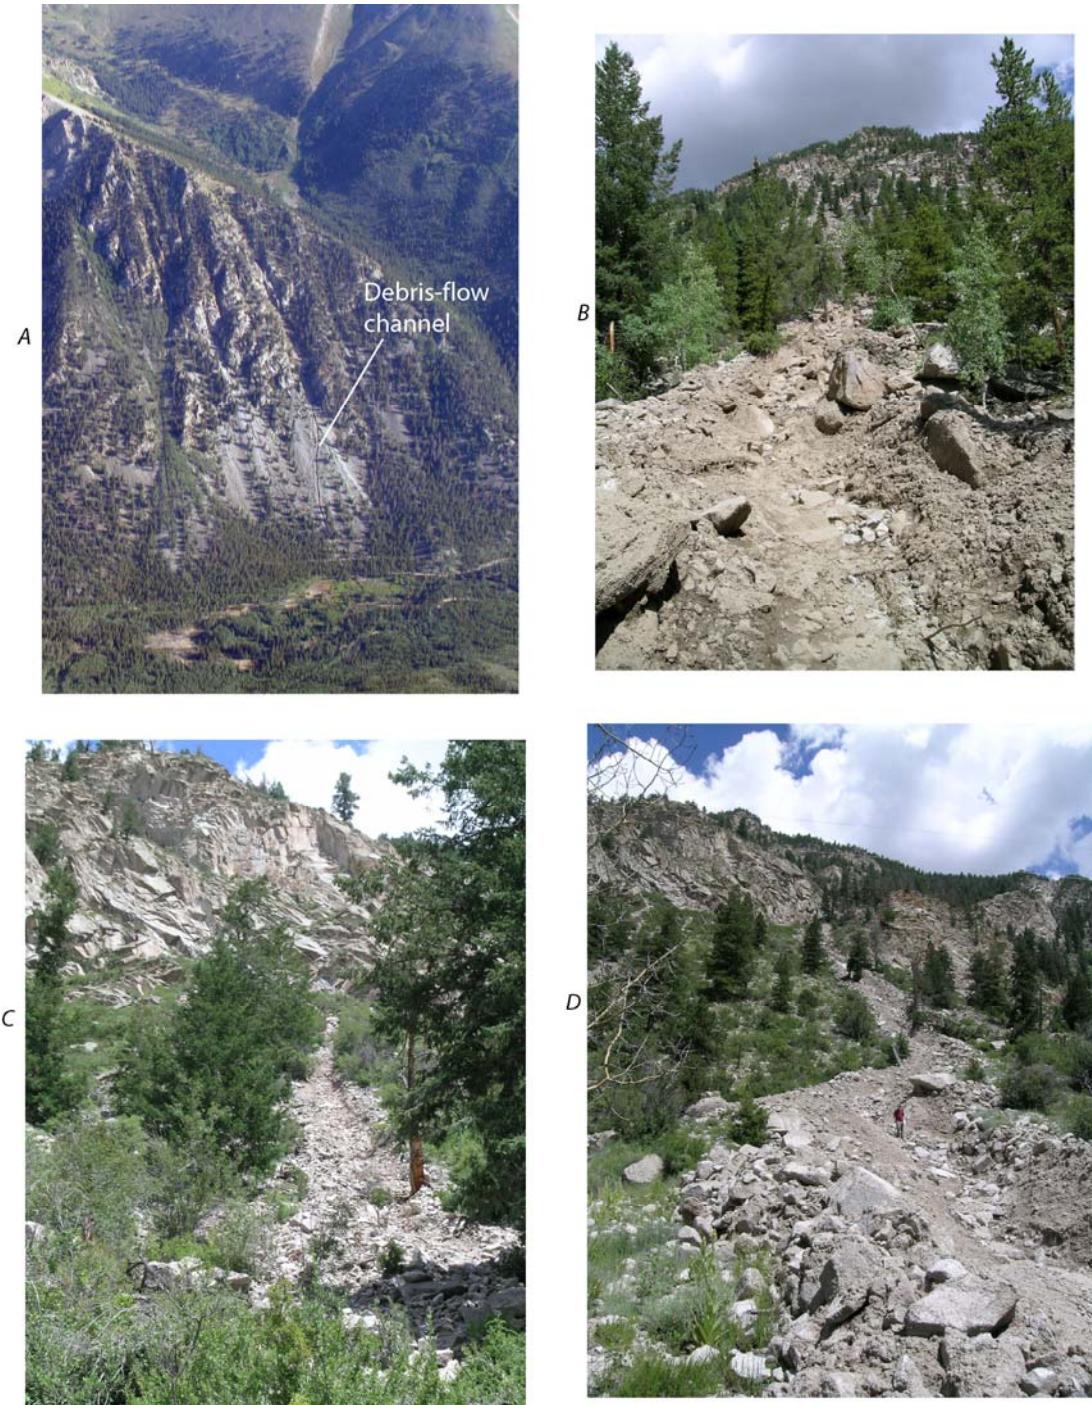
In addition to Weldon Gulch and the community of Alpine, debris flows also occurred in areas along the north flank of Chalk Creek east and west of Alpine (fig. 3). Based on viewings from the valley floor and the air (fig. 15), nearly all of the debris-flow channels began at steep bedrock outcrops and progressed downslope over an apron of colluvium before reaching the floor of the Chalk Creek Valley. All observations indicate that the debris flows were caused by streams of water flowing from bedrock that entrained material from the channel and the colluvial apron (a “firehose” initiation process, Johnson and Rodine, 1984). Some material from these debris flows was deposited adjacent to channels in the form of levees, but most made it to the valley floor where it was deposited at multiple locations on County Road 292 (CR 292) (fig. 16). The sedimentology of the deposits on CR 292 varied from boulder-rich (fig. 16A, B, D) to boulder-poor and mud-rich (fig. 16C).

Figure 15. Photographs of debris-flow channels and source areas along the north flank of the valley of Chalk Creek. *A*, Debris-flow track and source area just west of the mouth of Coal Camp Canyon (see fig. 3 for location). Relief visible on the mountain side where the track is located is about 700 meters. *B*, *C*, and *D*, Debris-flow tracks and source areas upslope from County Road 292, east of Alpine.
