Field Reconnaissance of Debris Flows Triggered by a July 21, 2007, Thunderstorm in Alpine, Colorado, and Vicinity

By Jeffrey A. Coe¹, Jonathan W. Godt¹, T.C. Wait², and Jason W. Kean¹

Open-File Report 2007-1237

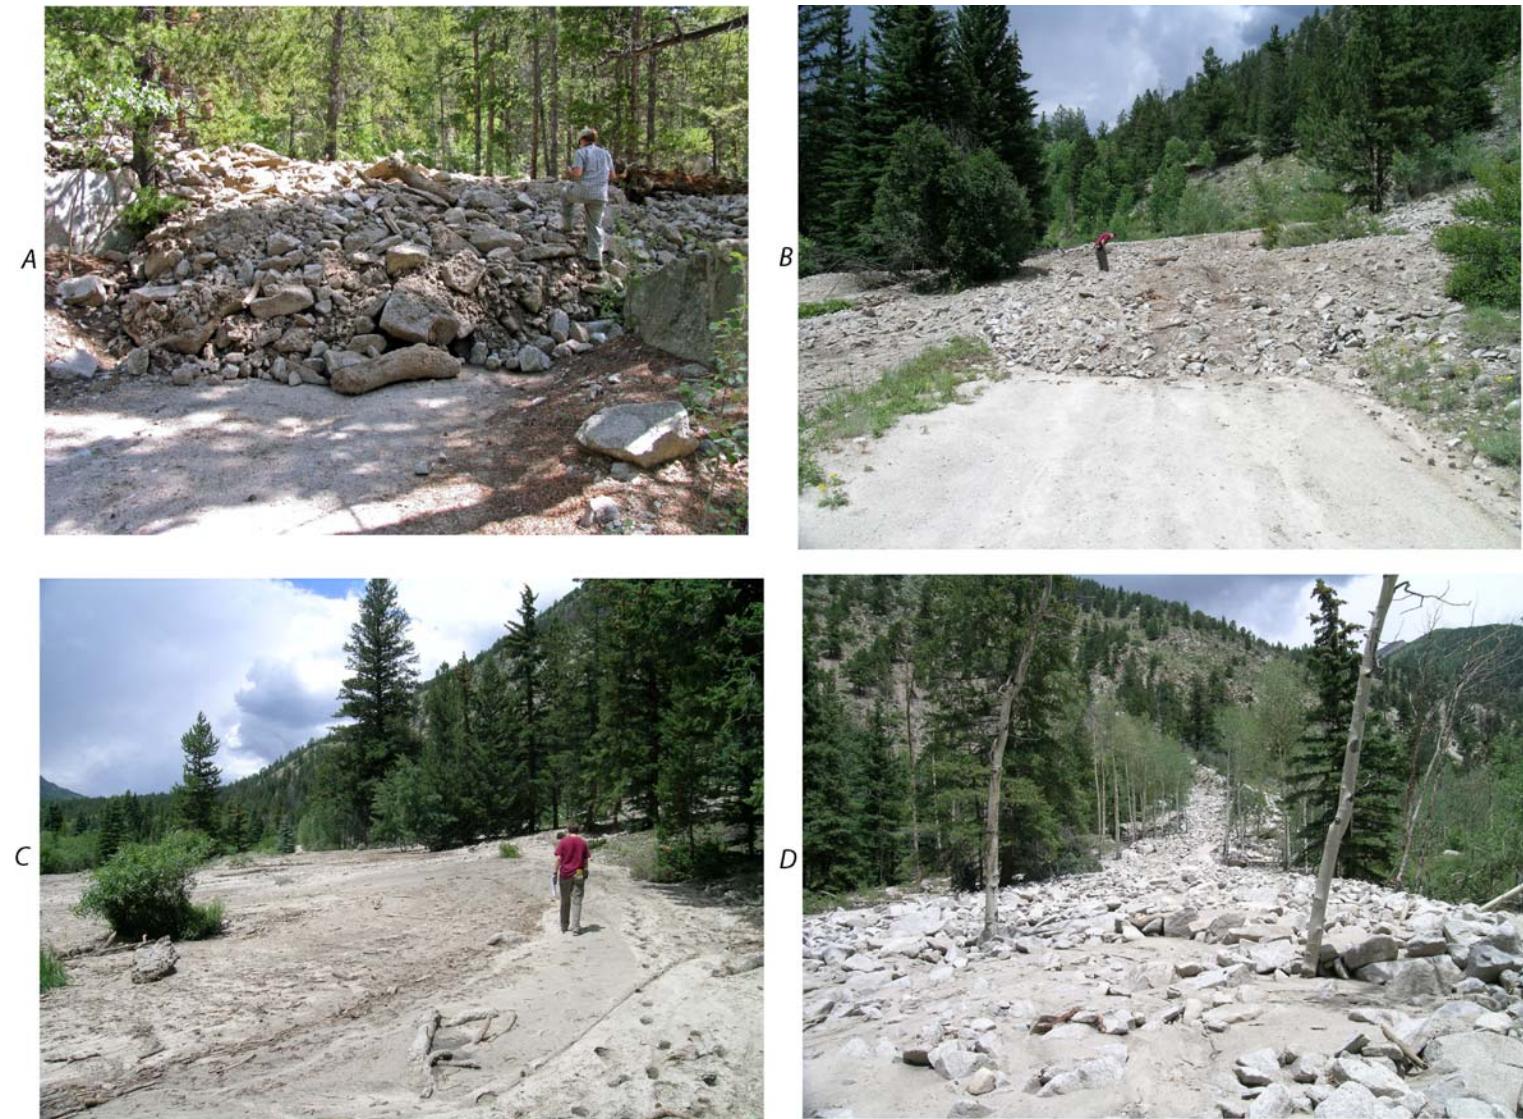
In addition to Weldon Gulch and the community of Alpine, debris flows also occurred in areas along the north flank of Chalk Creek east and west of Alpine (fig. 3). Based on viewings from the valley floor and the air (fig. 15), nearly all of the debris-flow channels began at steep bedrock outcrops and progressed downslope over an apron of colluvium before reaching the floor of the Chalk Creek Valley. All observations indicate that the debris flows were caused by streams of water flowing from bedrock that entrained material from the channel and the colluvial apron (a “firehose” initiation process, Johnson and Rodine, 1984). Some material from these debris flows was deposited adjacent to channels in the form of levees, but most made it to the valley floor where it was deposited at multiple locations on County Road 292 (CR 292) (fig. 16). The sedimentology of the deposits on CR 292 varied from boulder-rich (fig. 16A, B, D) to boulder-poor and mud-rich (fig. 16C).

Figure 16. Debris-flow deposits on and near County Road (CR) 292 to the west and east of Alpine. *A*, Deposit just to the west of the mouth of Coal Camp Canyon (see fig. 2 for location). *B* and *C*, Deposits on CR 292 to the east of Alpine. *D*, Deposits just upslope from CR 292 to the east of Alpine.
