# Investigation of the M6.6 Niigata-Chuetsu Oki, Japan, Earthquake of July 16, 2007

Open File Report 2007–1365

2007

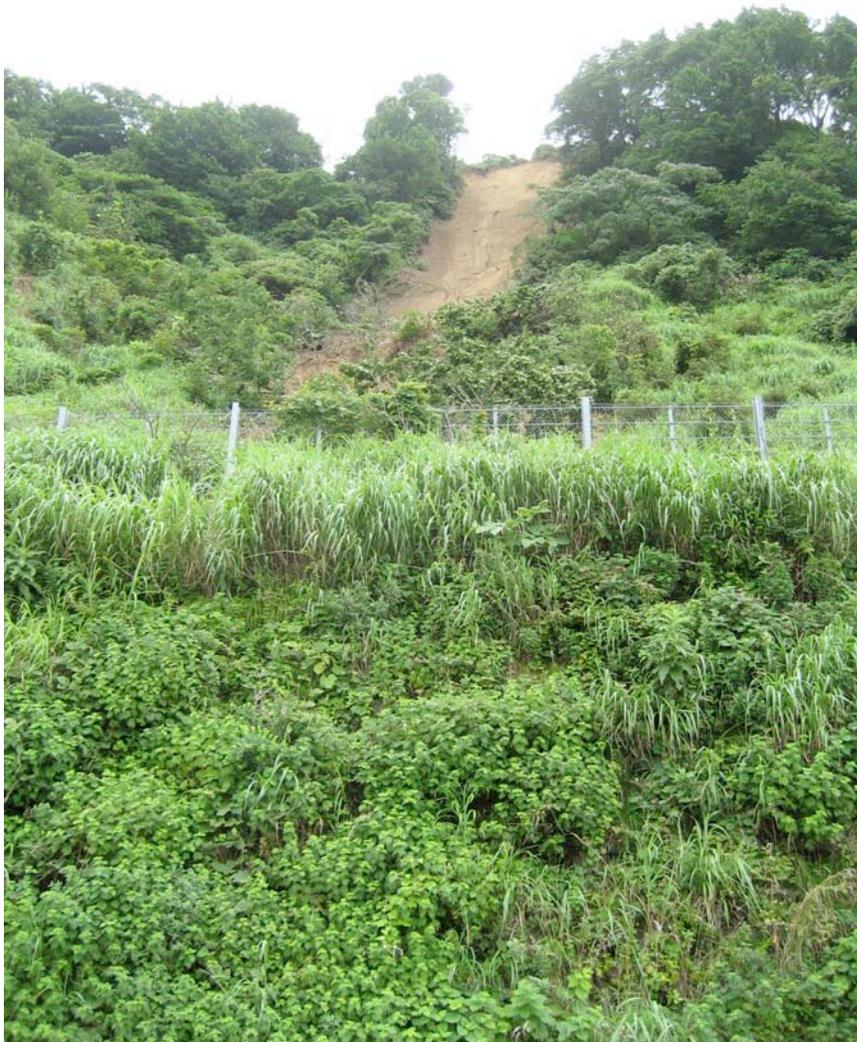
Figure 3.3: Coastal landslides on Highway 352 north of Kashiwazaki-Kariwa Nuclear Power Plant at road closure south of Route 373 (Site RK34-Slide 4; N37.48455° E138.62435°, photos taken 7/22/07 at approx. 10:45). This landslide is typical of many of those observed along the coast, and in this case did not damage transportation lines. Slide is approximately 10 m wide, 25 m long, and 0.5 m thick. Failure plane has approximate 50° inclination.

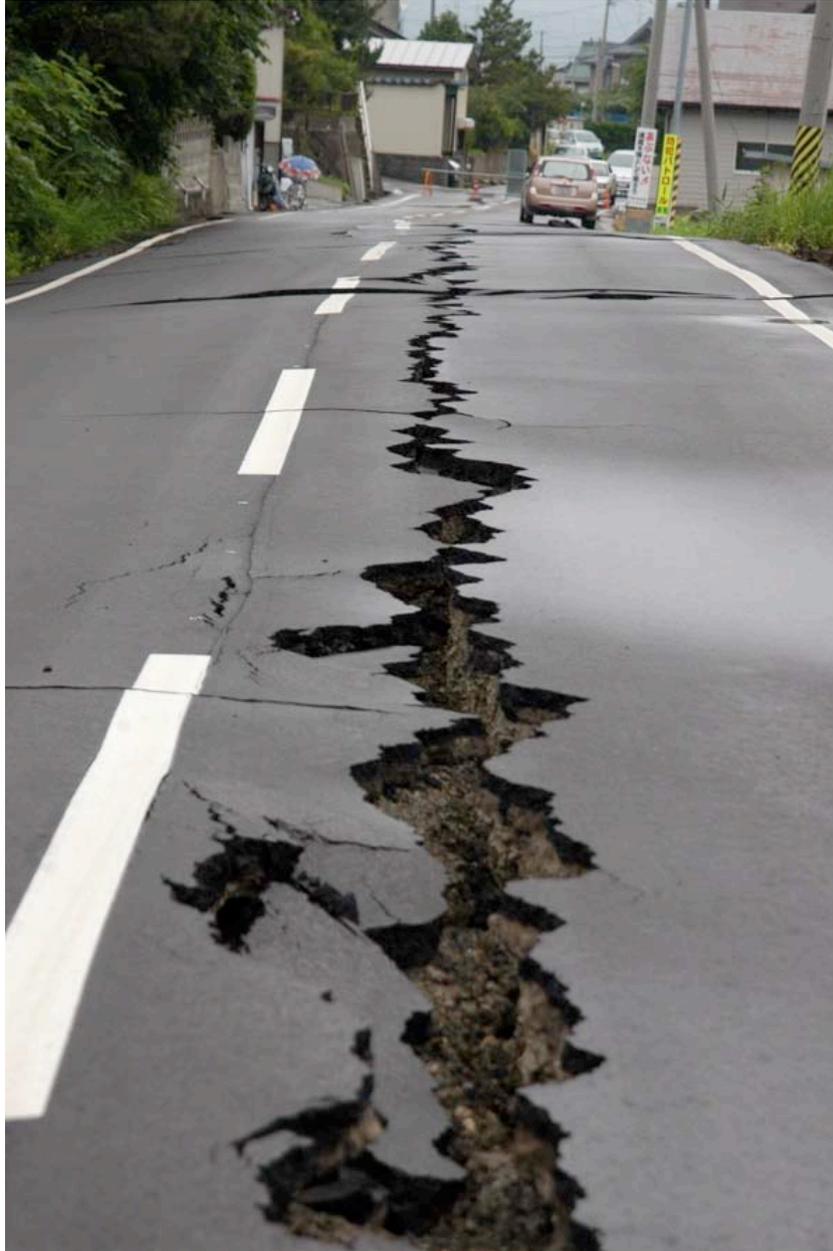
Figure 4.13: North side of Kai-Un Bridge area Sabaishi River - Lateral Spread on Road to Kashiwazaki Incinerator (Site RK6, N37.39343° E138.58555°, 7/19/2007). Lateral spreading on the north side of the river adjacent to the Kashiwazaki Municipal Incinerator damaged the access road of the facility.

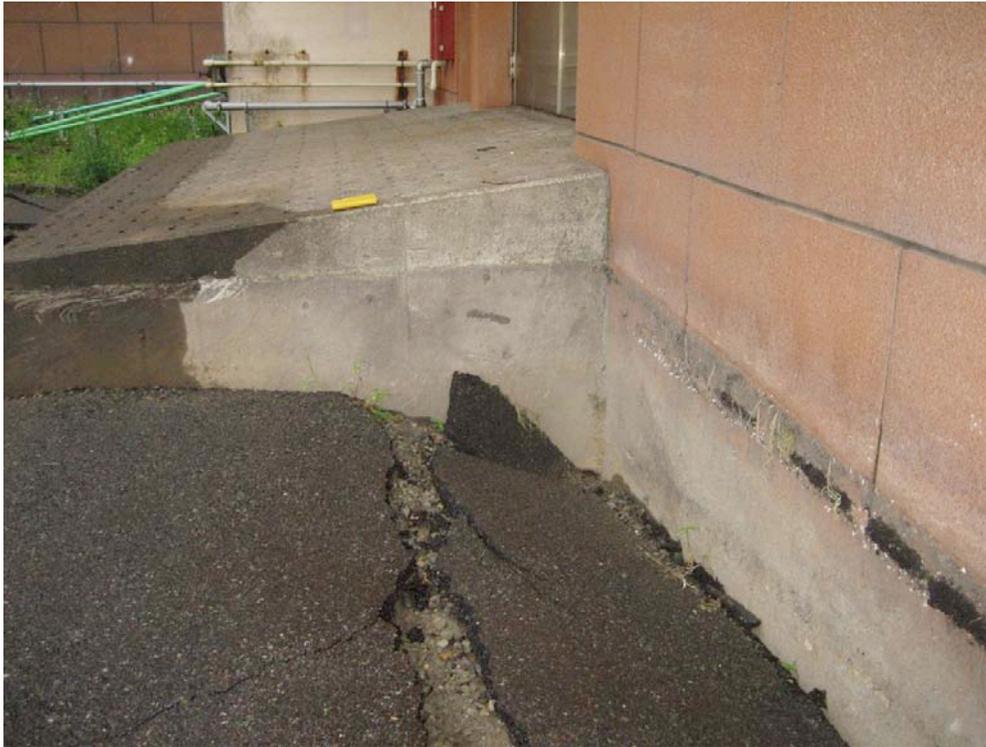
We observed structural failures to the main building, liquefaction of ground resulting in extensive road damage, and minor tank damage. The main feature at this site was the complete separation of two adjacent, yet integrated, three-story buildings with associated building and ground settlements, as well as pipe breaks between the two sections of the building. Severe road and pavement damage were also observed as a result of liquefaction - nearby areas of sand boils were noted.

Figure 4.15: Kashiwazaki Wastewater Treatment Plant on the south side of Sabaishi River near the Sea of Japan (Site RK9 N37.38748° E138.56587°, 7/19/2007). Damage to the main building from liquefaction of ground resulted in meter-scale ground settlements.

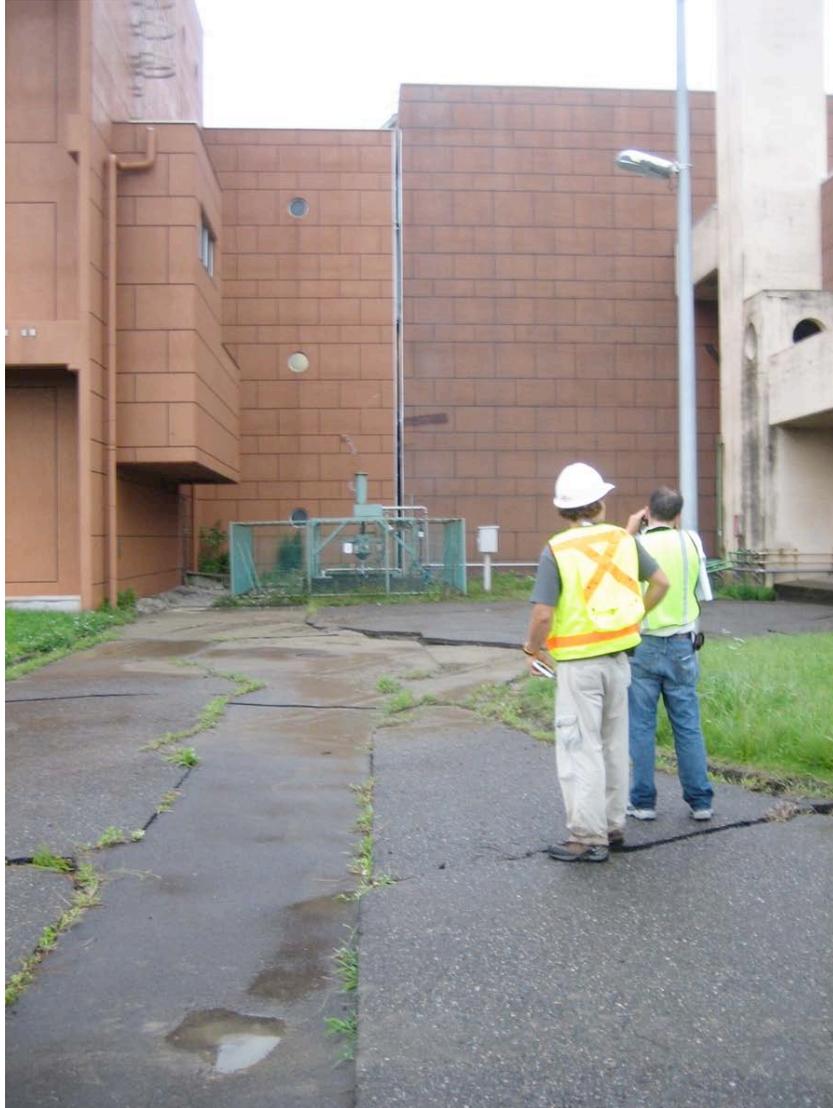
Figure 4.16a: Kashiwazaki Wastewater Treatment Plan on the south side of Sabaishi River near its outlet to the Sea of Japan (Site RK9 N37.38748° E138.56587°, 7/19/2007). Damage to the main building from liquefaction of ground resulted in the complete separation of two sections of the adjacent, yet integrated, three-story buildings with associated building and ground settlements.

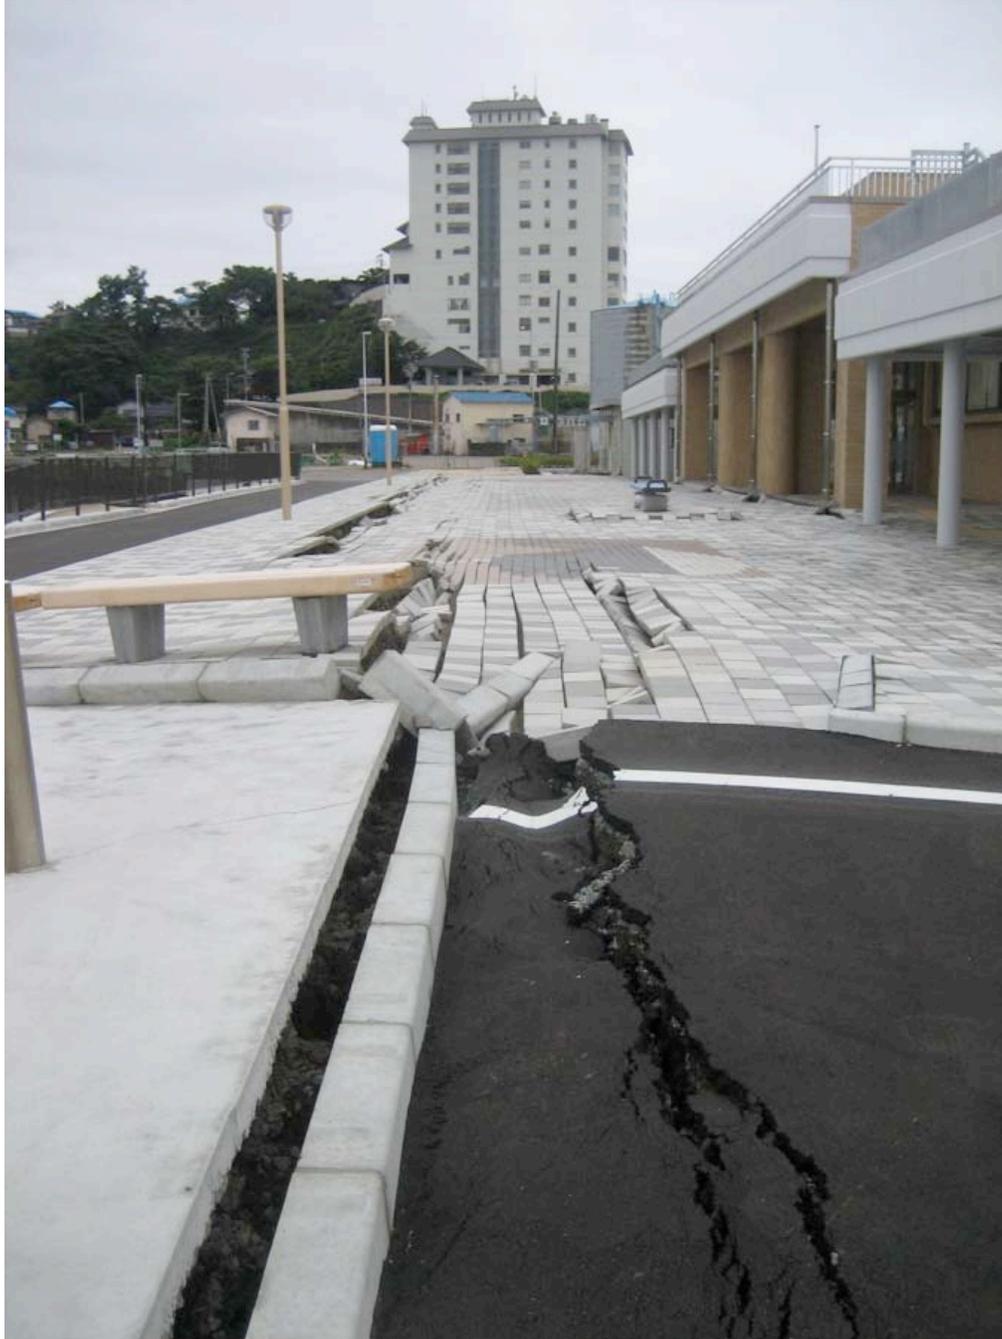
Figure 4.21: Kashiwazaki Harbor - The southern area experienced ground damage from liquefaction-induced lateral spreading and settlement. A harbor-front caisson rotated toward the harbor, to the left of the photo, initiating lateral displacement of the soil behind it, between the caisson and port building (Site RK25, N37.36713° E138.53210°, 7/20/2007).

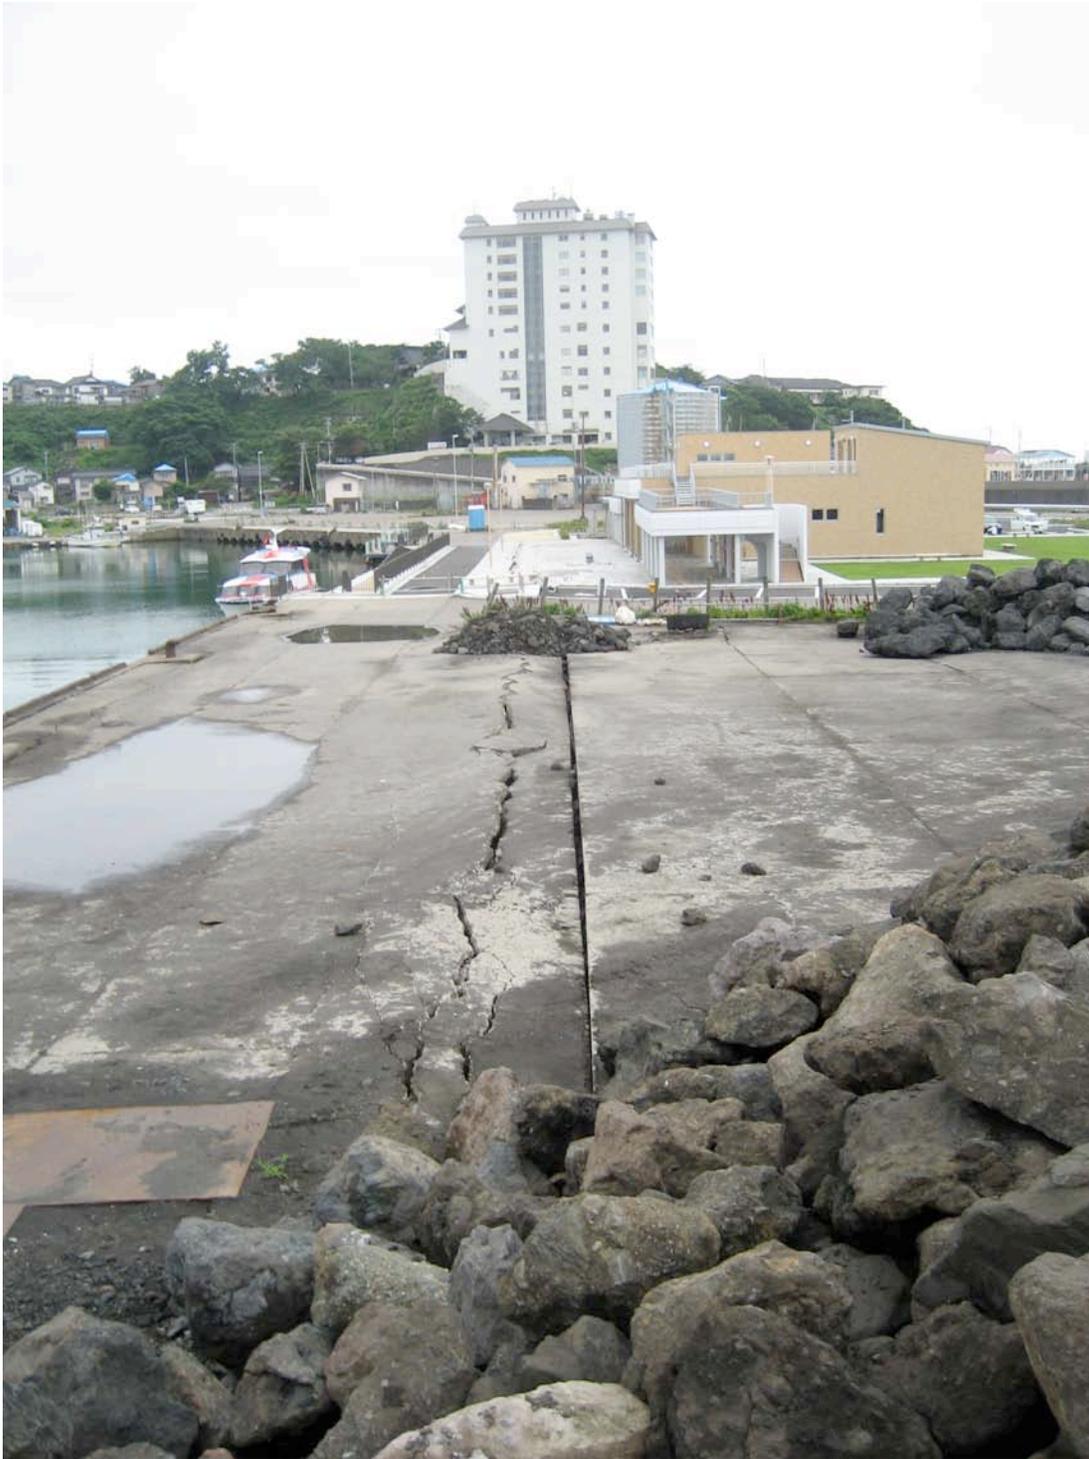
Figure 4.24: Kashiwazaki Harbor - South area experienced ground damage from liquefaction-induced lateral spreading and settlement, here seen from a mound of riprap (Site RK25, N37.36713° E138.53210°, 7/20/2007).

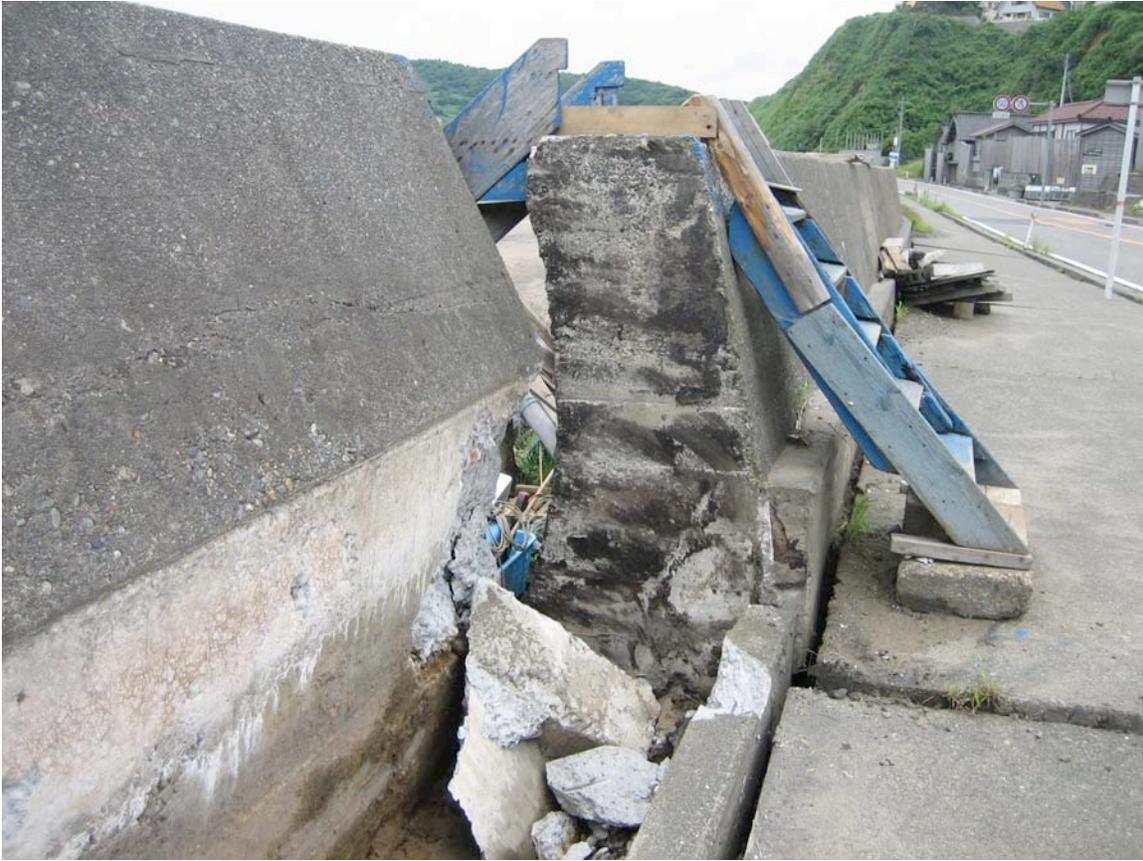
Figure 4.30: Concrete seawall deformations were on the order of 25 cm vertical (failed section up), and up to 64 cm horizontal, with a component of rotation as measured by 32 cm lateral deformation at the base of wall and 64 cm lateral deformation at 2 m height of wall. (Site RK35, N37.48497° E138.62645°, 7/22/2007).

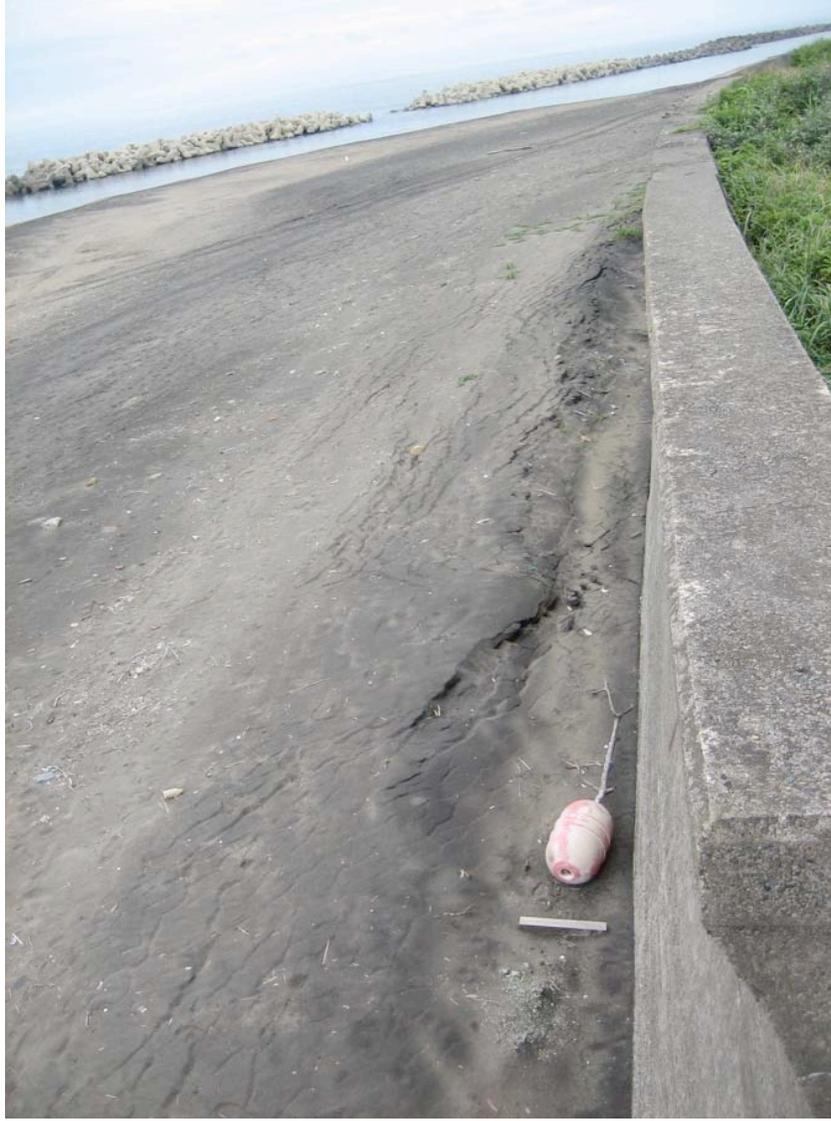
Figure 4.32: Lateral spreading related ground cracking in front of seawall. (Site RK37, N37.45478° E138.60927°, 7/22/2007).

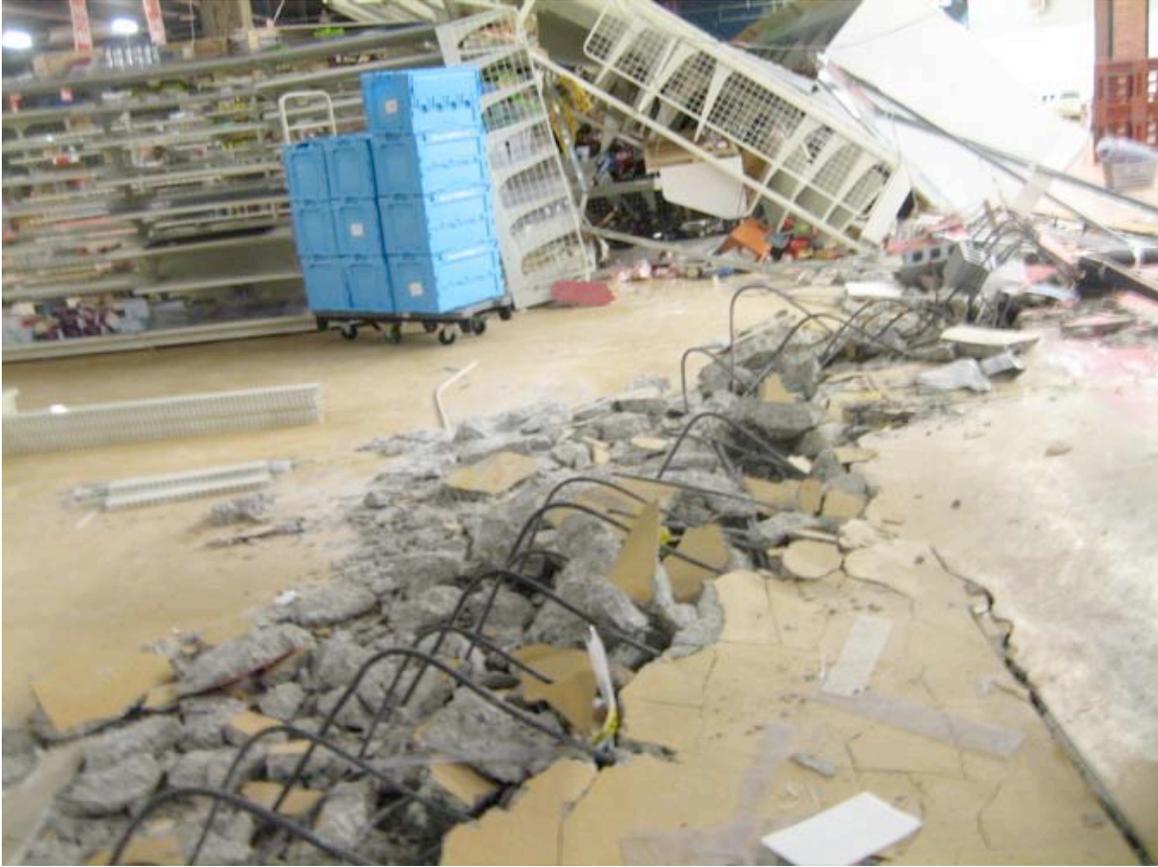
Figure 4.39: Plant 5 – Failure of slab on grade with buckled reinforcing bars. (Site RK41, N37.41468° E138.60840°, 7/22/2007).

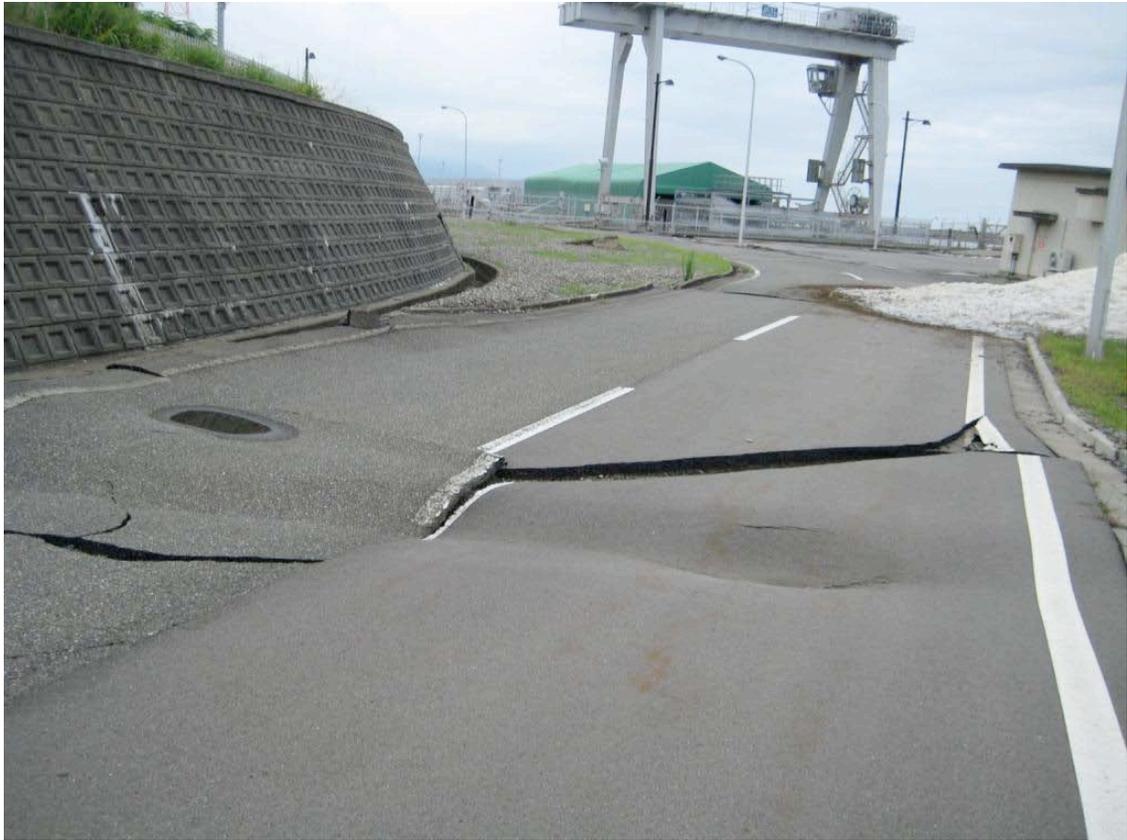
Figure 5.3: Damaged road at power plant.

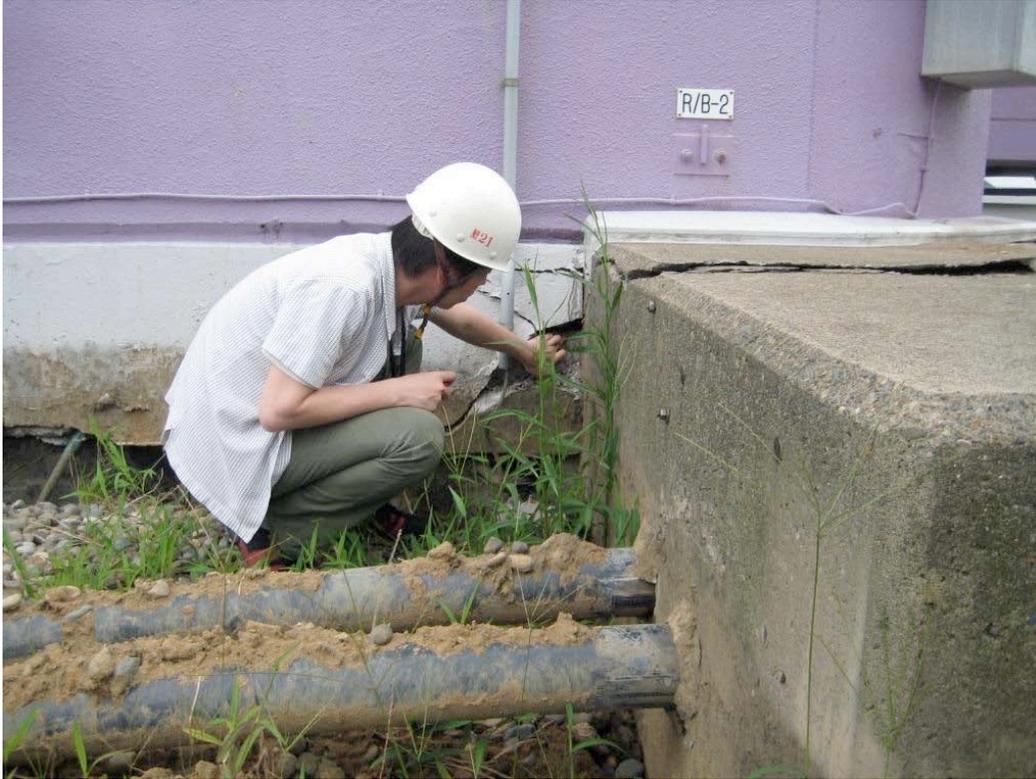
Figure 5.4: Cracks in reinforced concrete element at ground level.

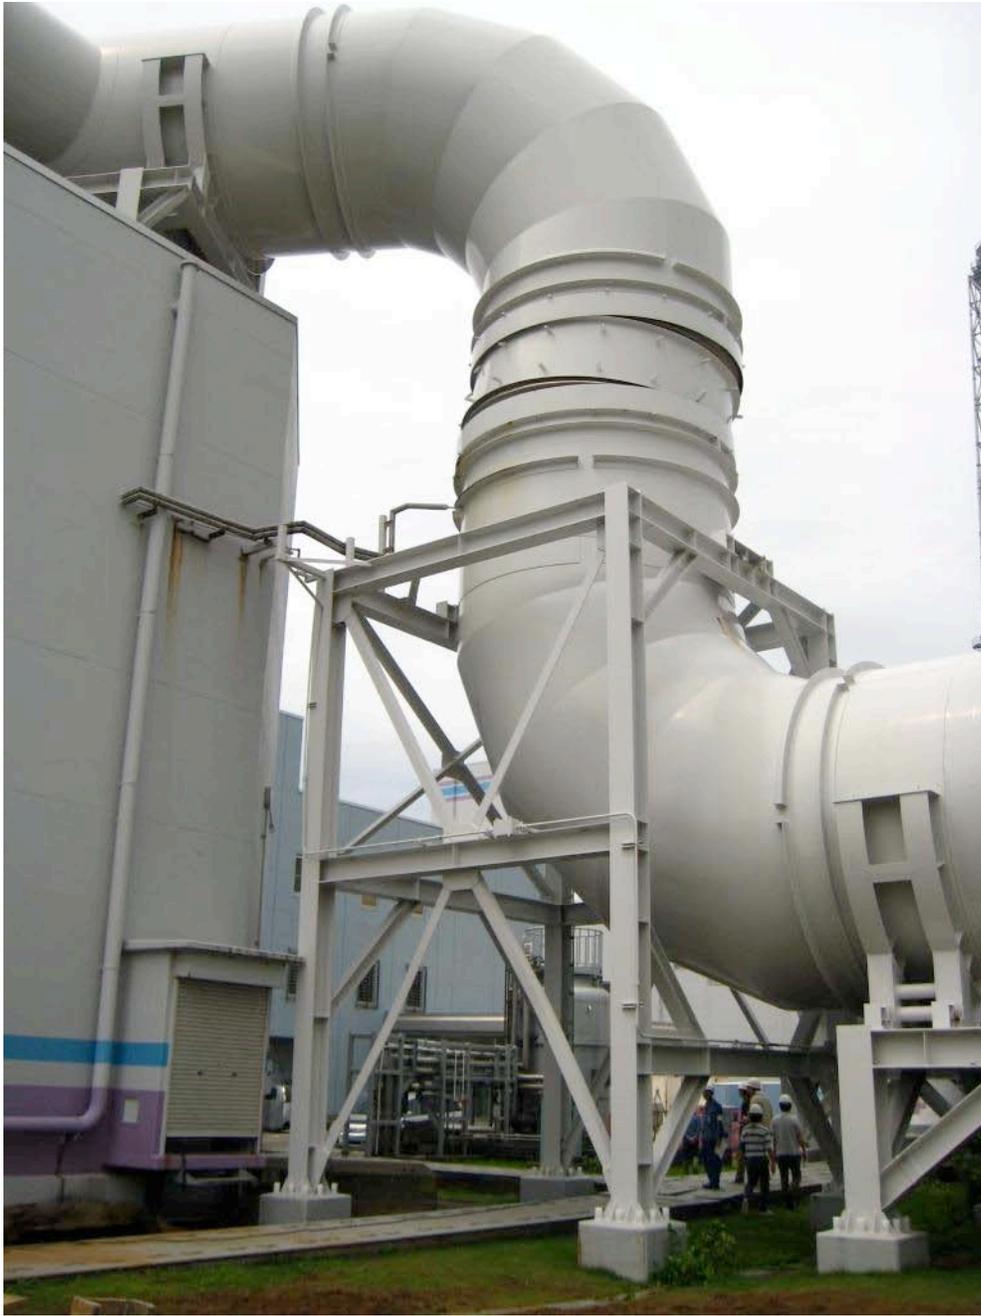
Figure 5.5: Failure of joint in exhaust pipe.

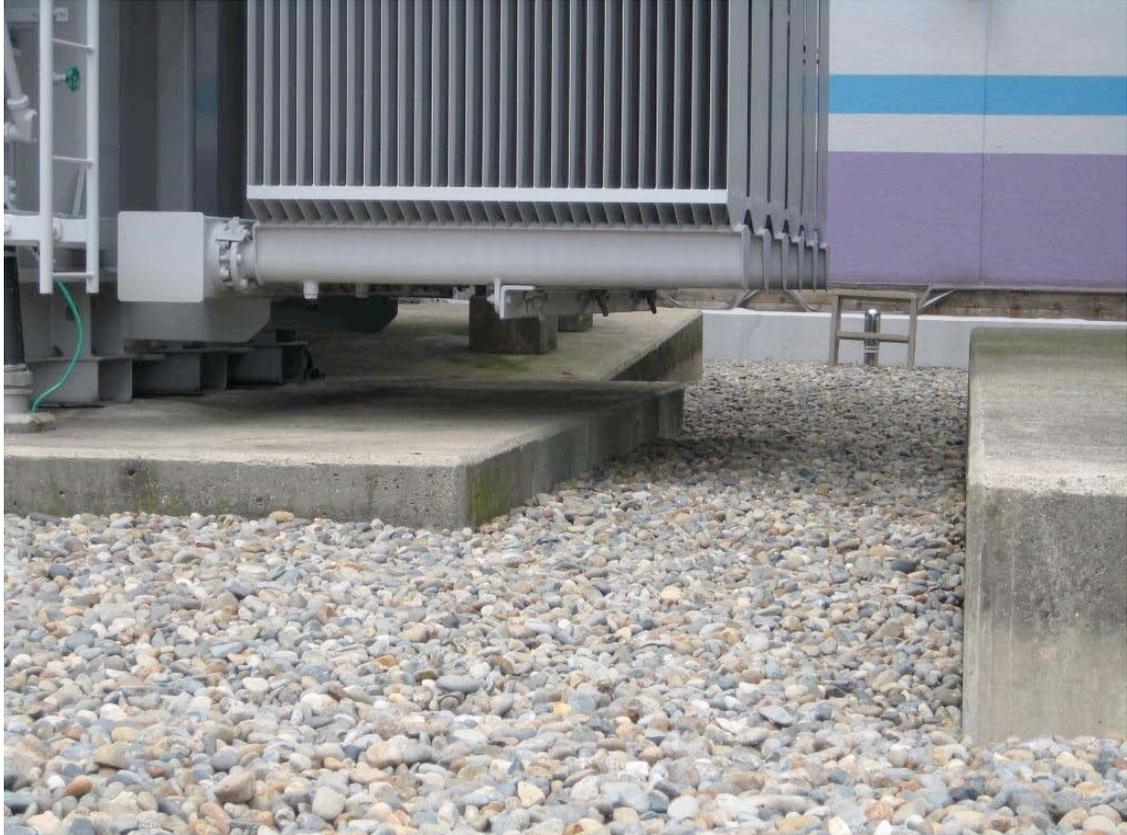
Figure 5.6: Rotation of isolated footings for equipment at nuclear power plant.

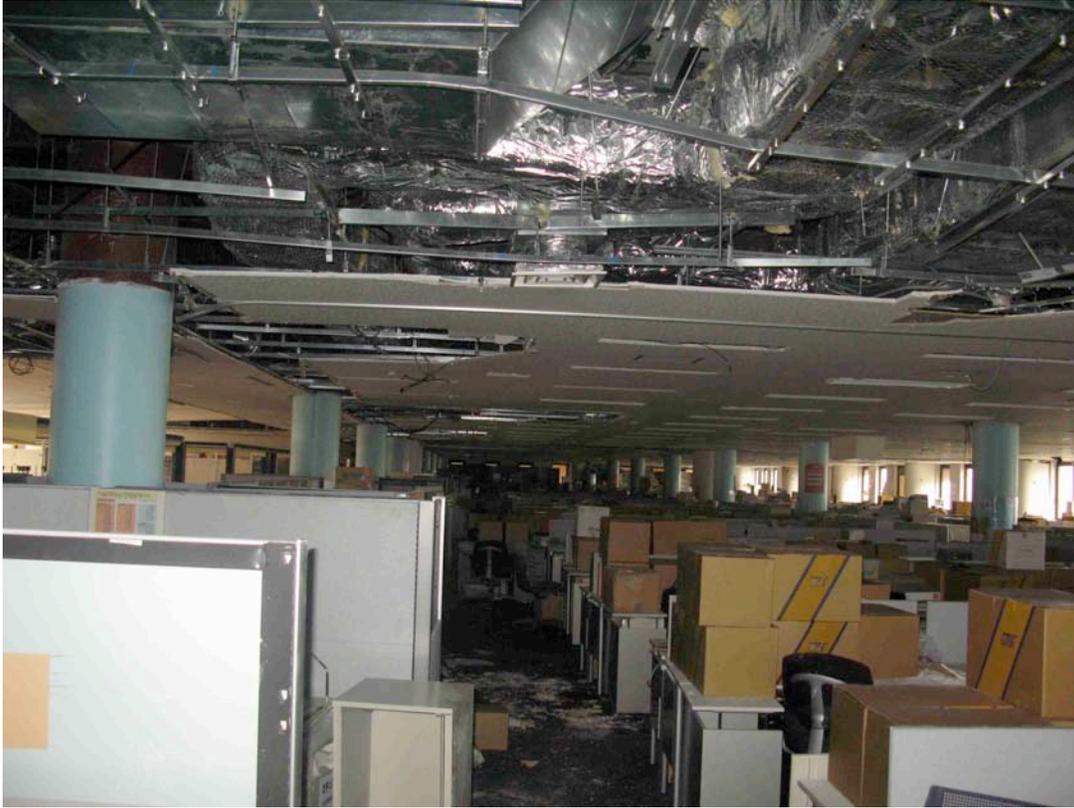
Figure 5.7: Ceiling damage in administration building of nuclear power plant.

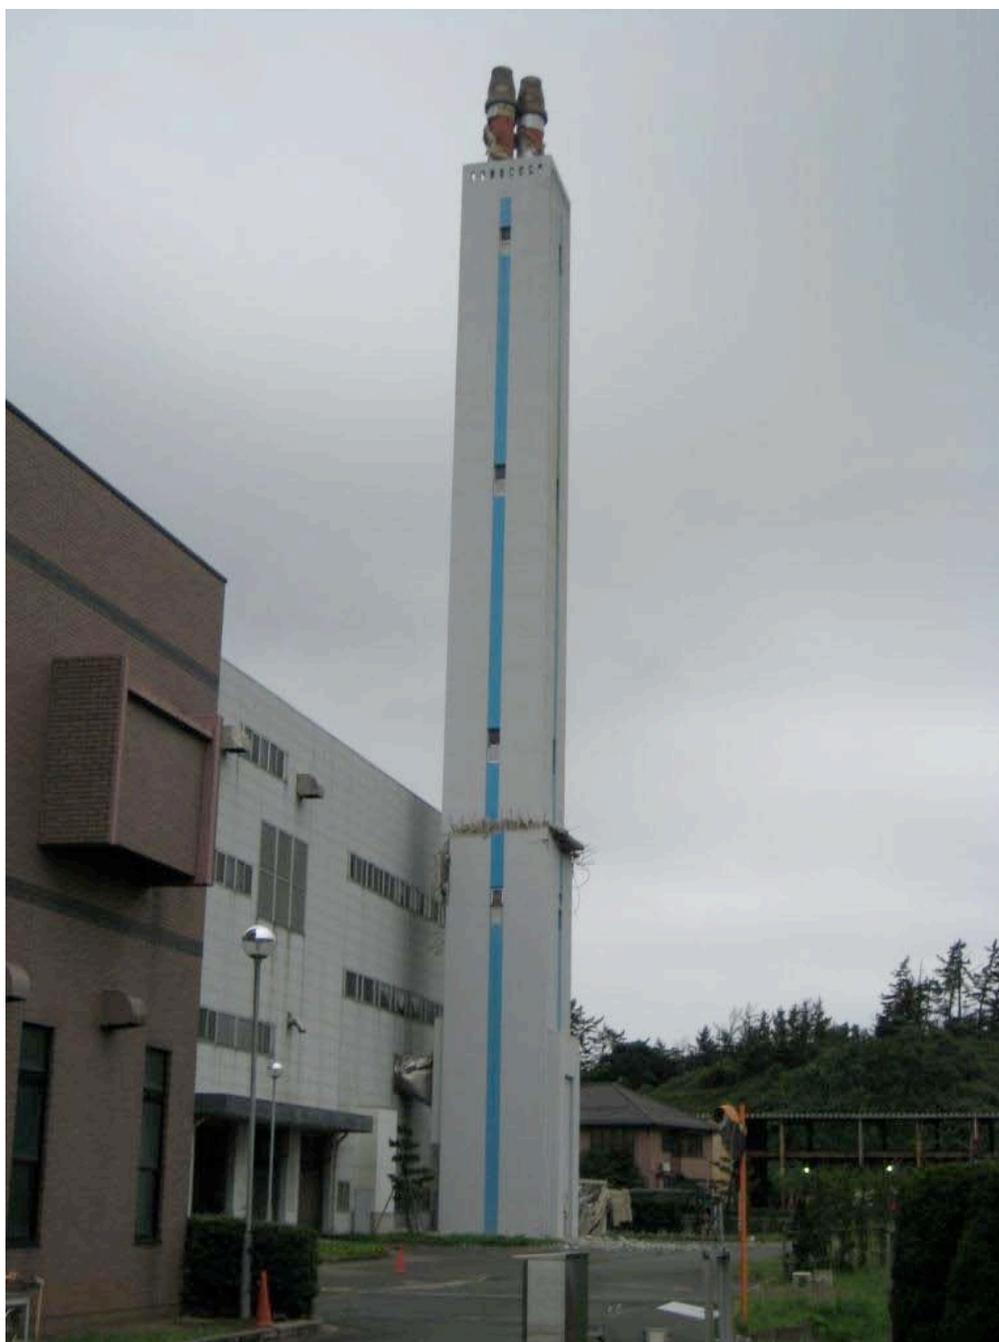
Figure 5.8: Failure of reinforced concrete stack (Site SP31, N37.3939° E138.5840°).

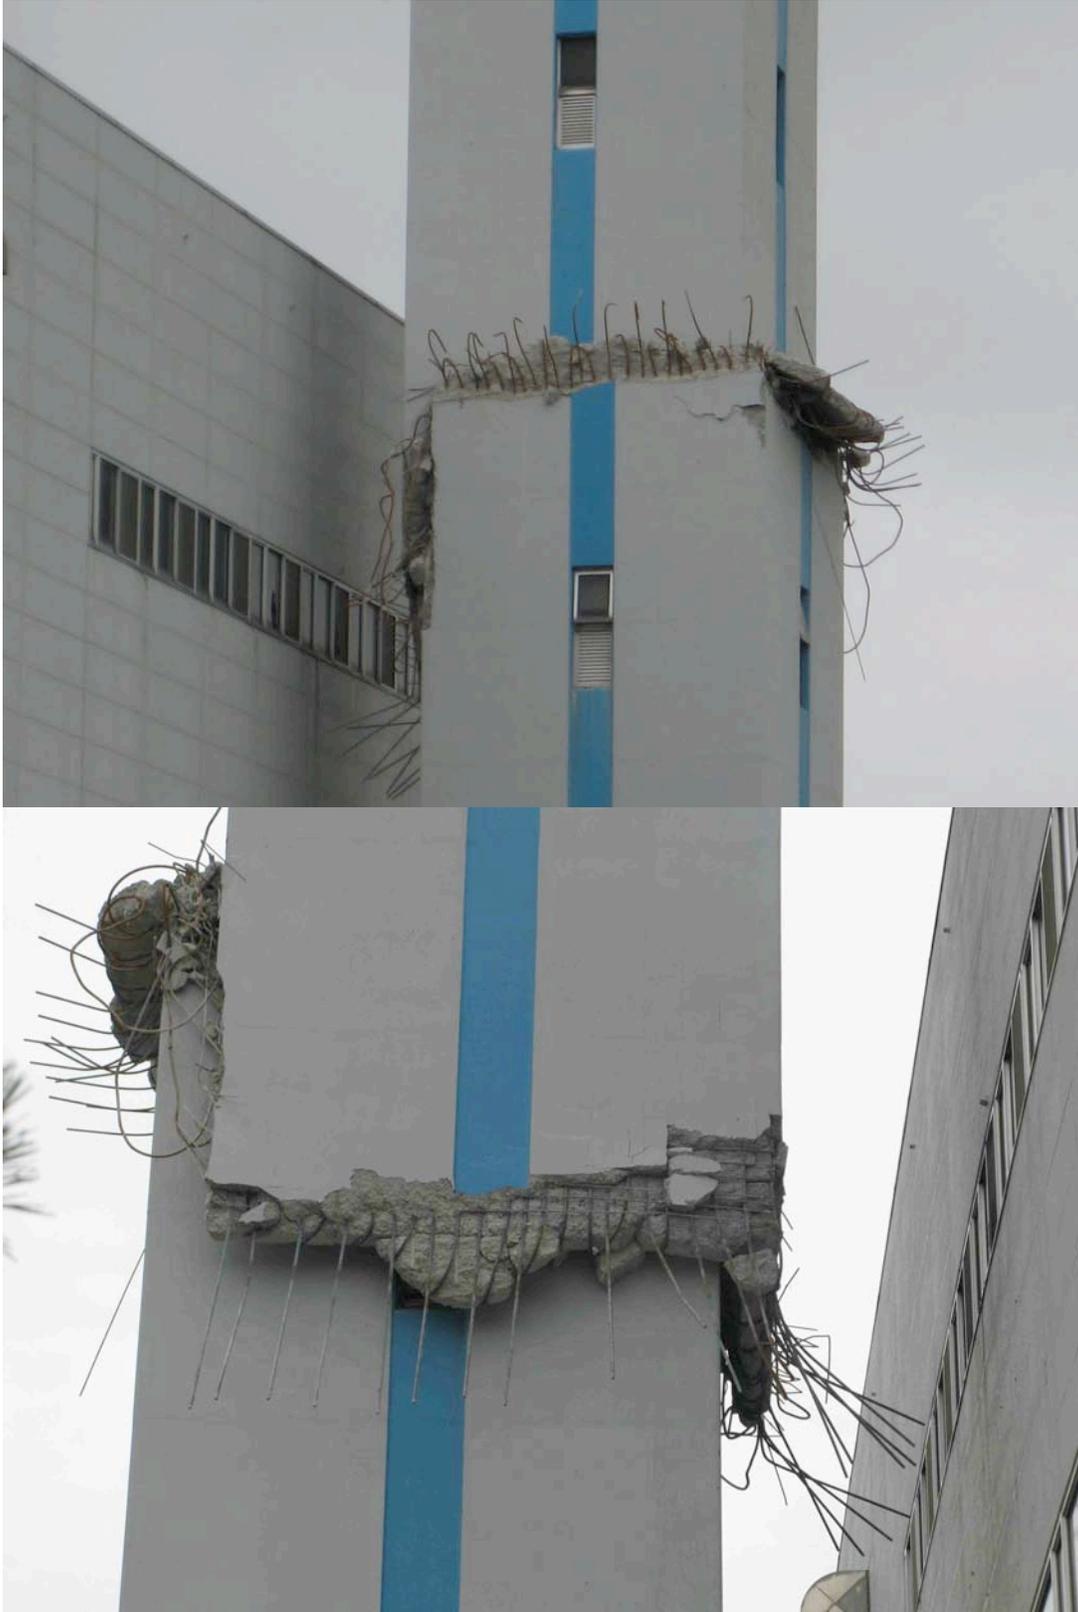
Figure 5.9: Details of failure of reinforced concrete stack (Site SP31, N37.3939° E138.5840°).

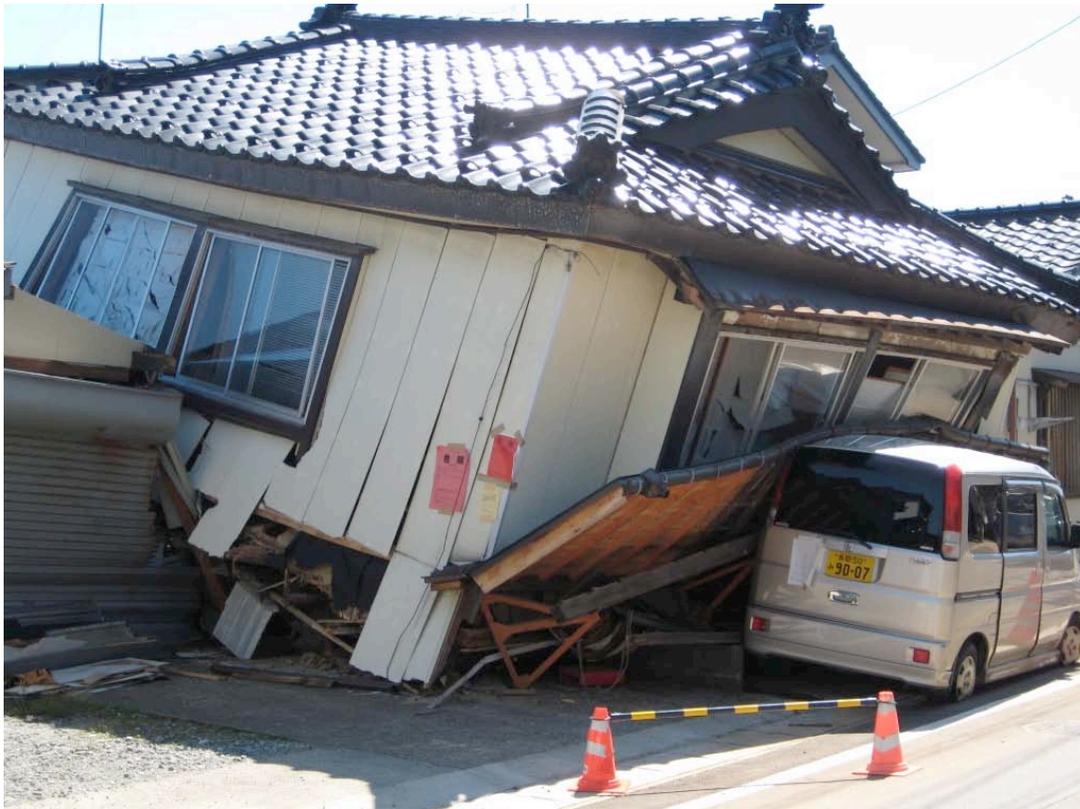
Figure 5.10: Collapse of house (N37.367°, E138.567°).

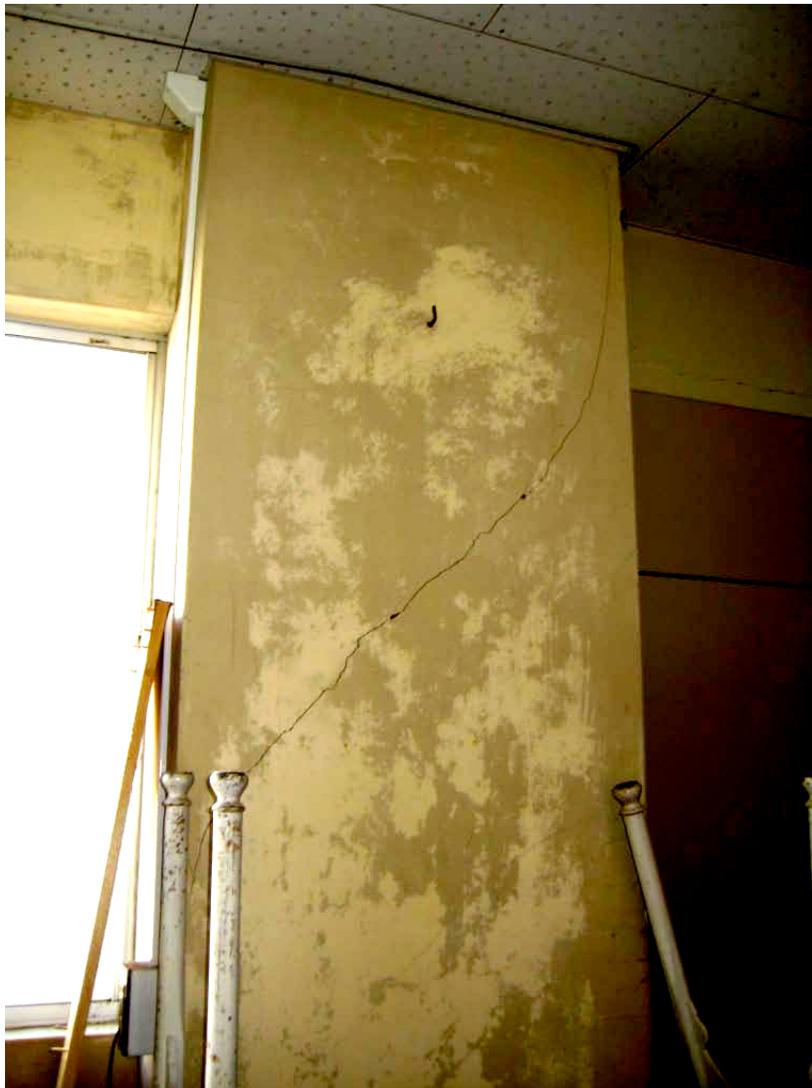
Figure 5.21: Column in first story of The Kashiwazaki High School, cross section and observed crack pattern (Site SP11, N37.3721°, E138.5569°).

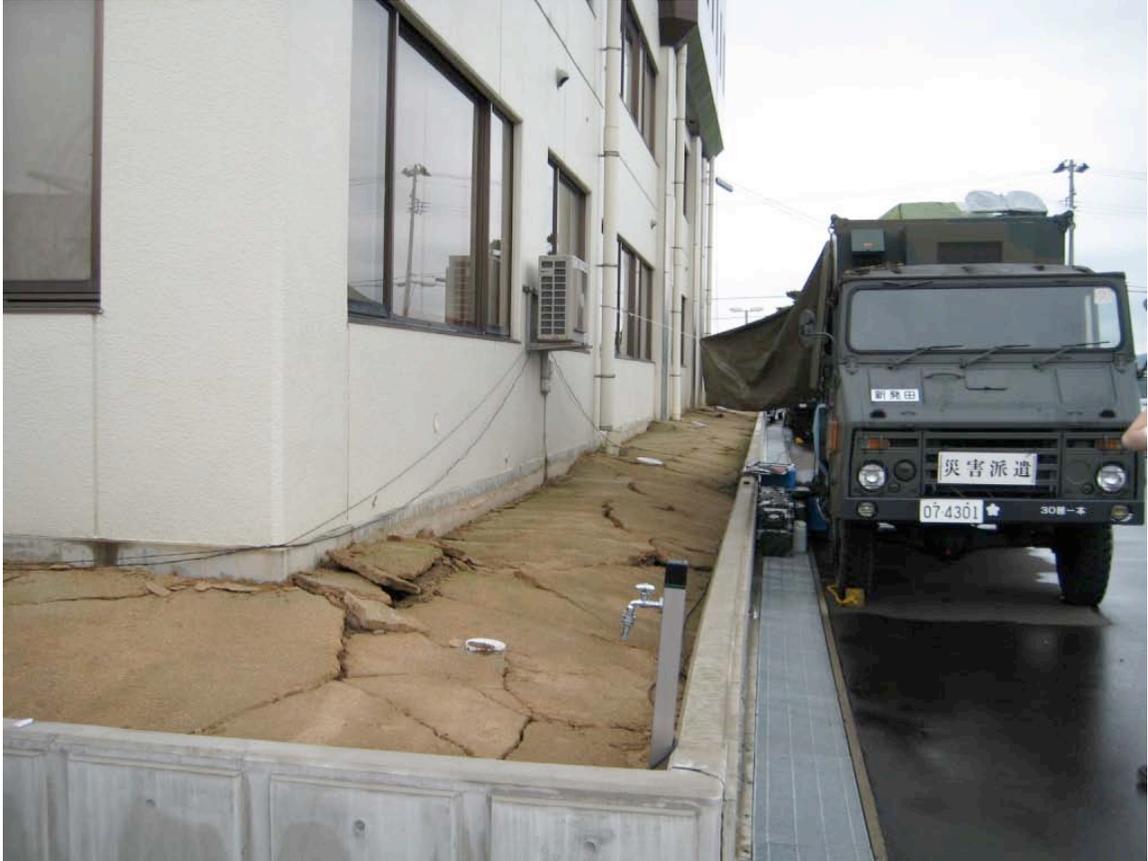
Figure 5.22: Disruption of soil surrounding a government building in Kariwa (Site SP33, N37.4223° E138.6222°).

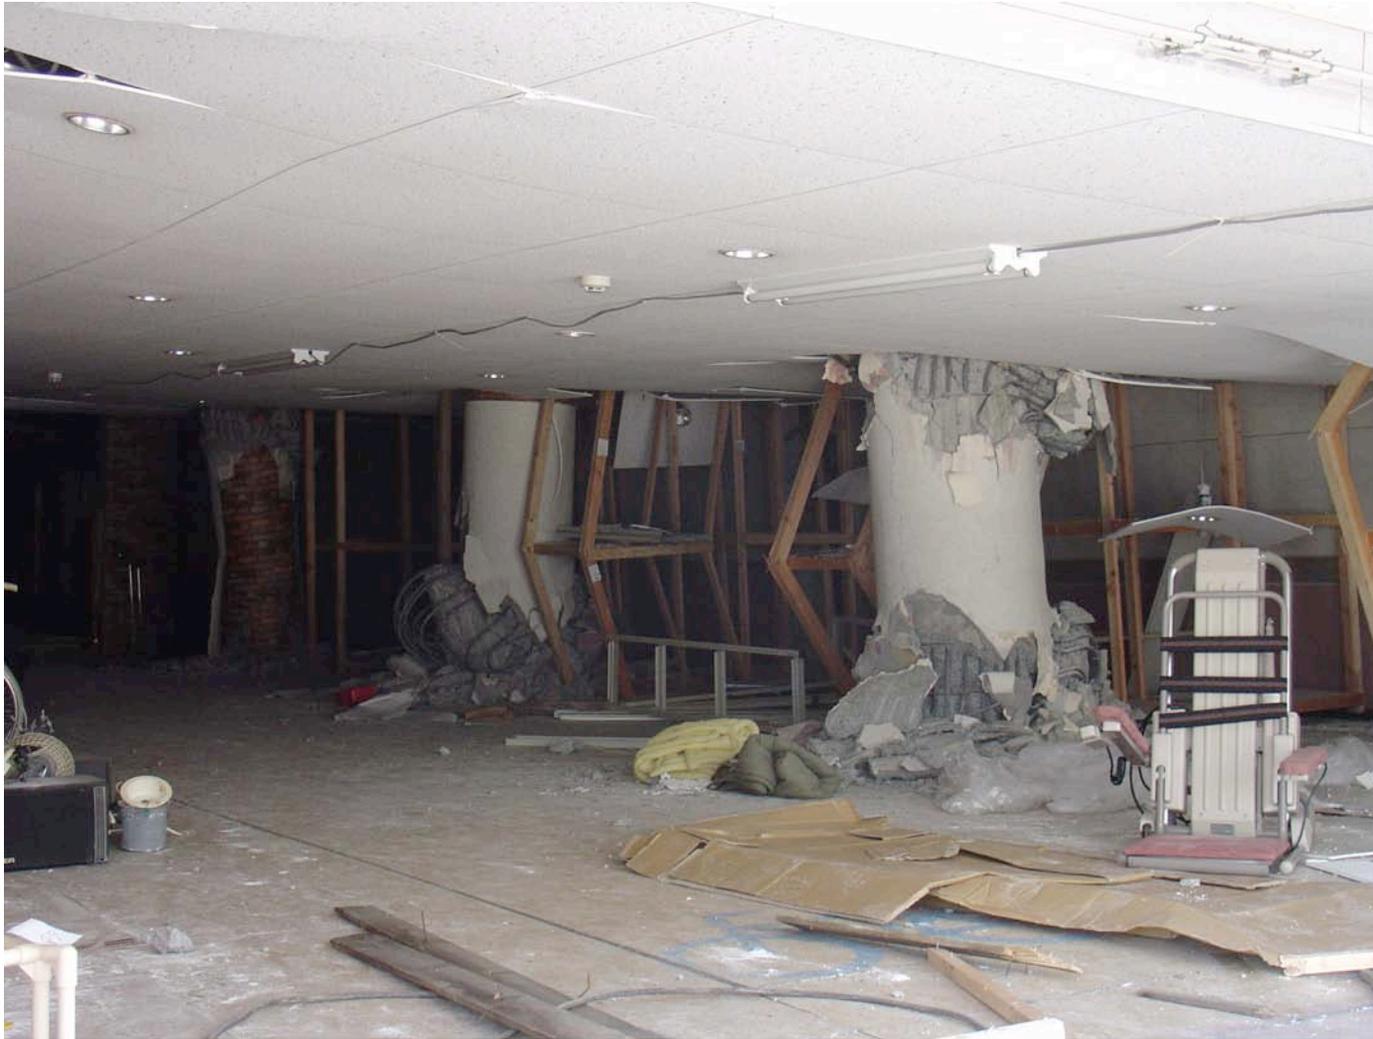
Figure 5.24: Shear failures of reinforced concrete columns (Site NIT-81, N37.37000° E13855825°, photo by Peter Yanev)
