# Investigation of the M6.6 Niigata-Chuetsu Oki, Japan, Earthquake of July 16, 2007

Open File Report 2007–1365

2007

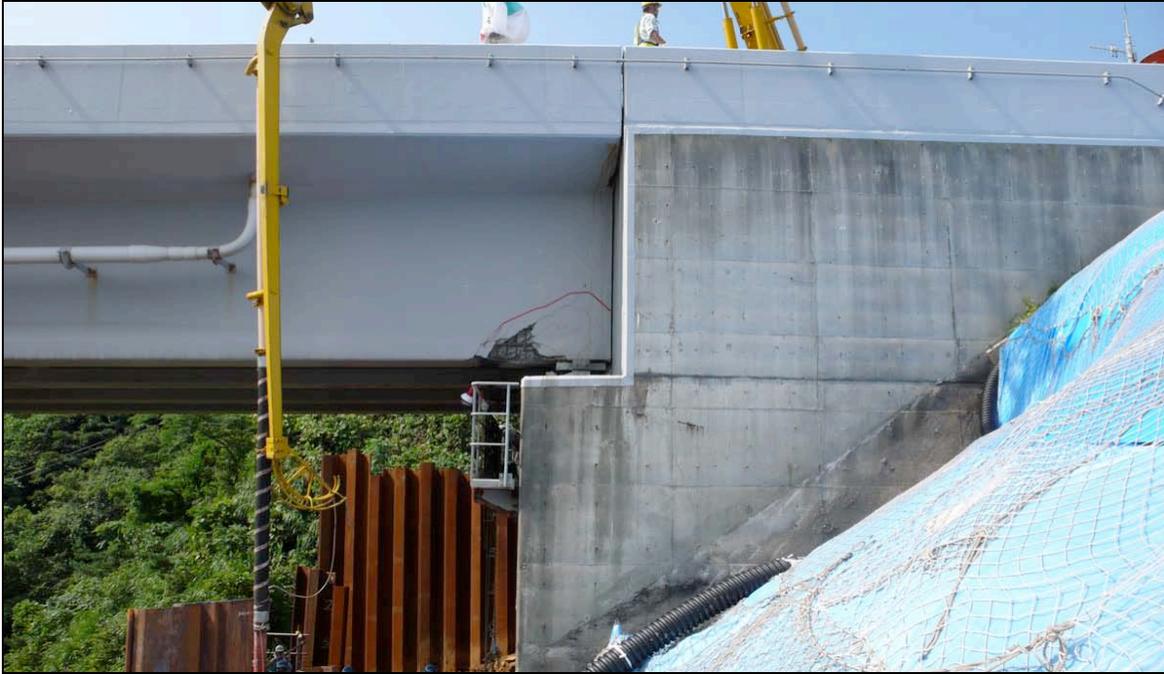
Fig. 6.3. Damage at north end of the west Hachisaki Bridge.

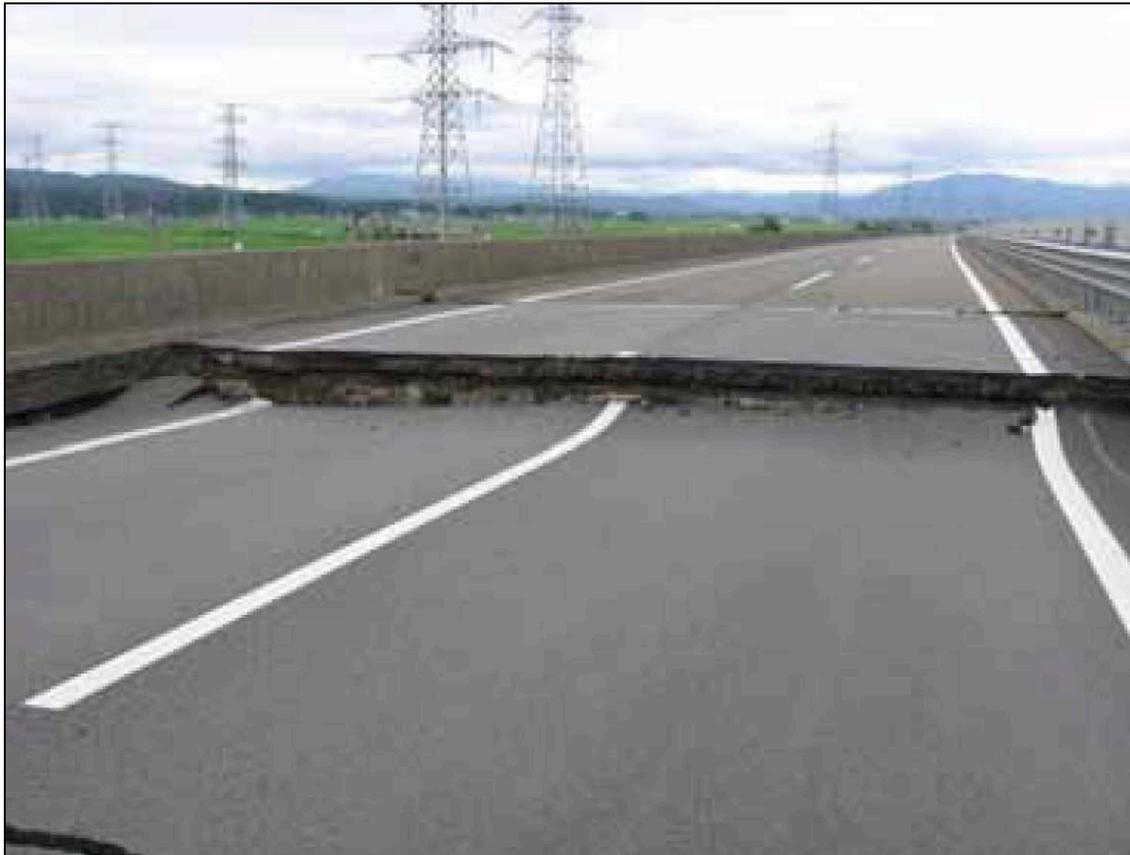
Fig. 6.8. Damage to approach slab and embankment at Yoshiigawa Bridges.

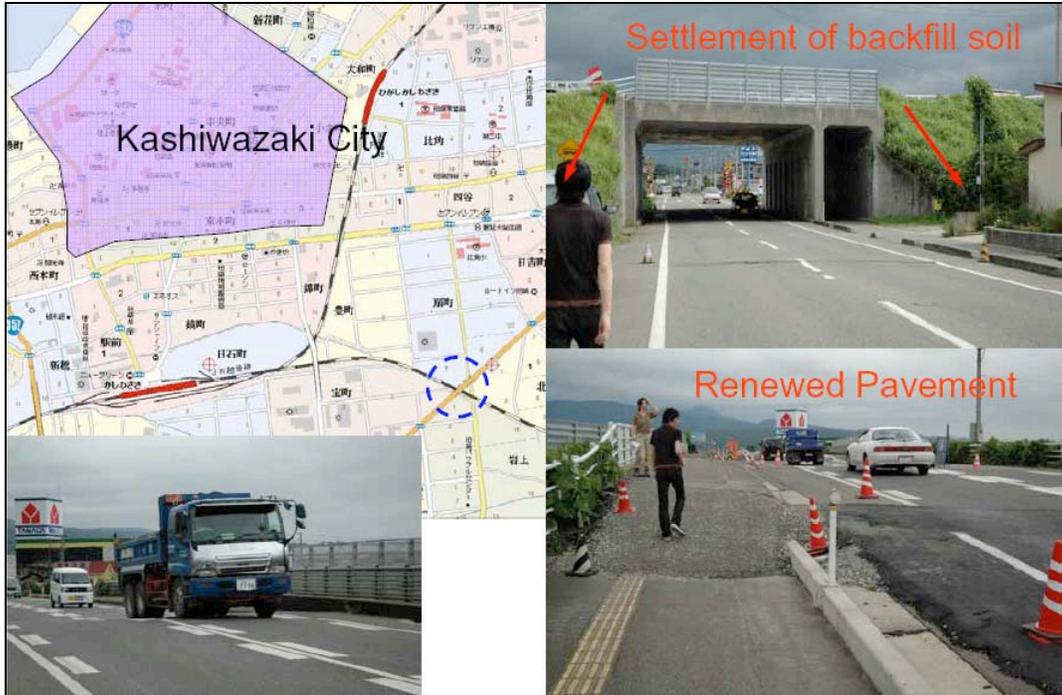
Fig. 6.16. Damage and repairs where Highway 8 crosses Route 522 Bridge (courtesy G. Watanabe, Tokyo Institute of Technology).

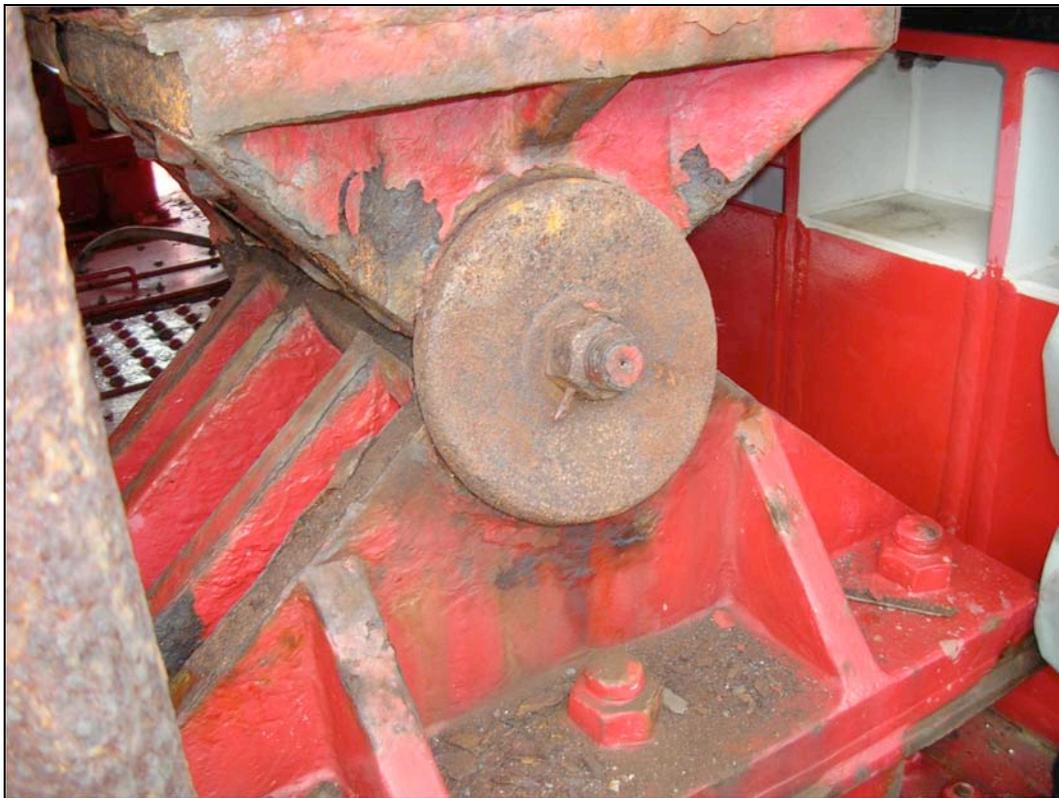
Fig. 6.23. Deformation of Bearing Pin-Cap caused by uplift force (courtesy of S. Unjoh, PWRI).

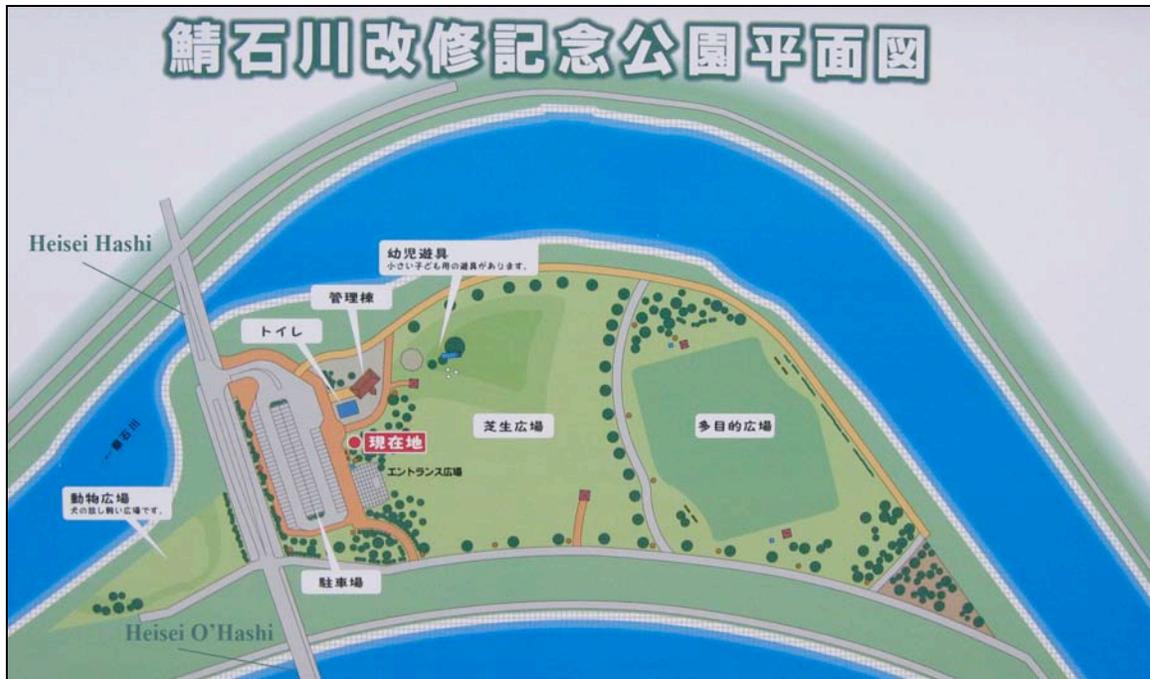
Fig. 6.30. An island in the meander of the Sabaishi River liquefied.

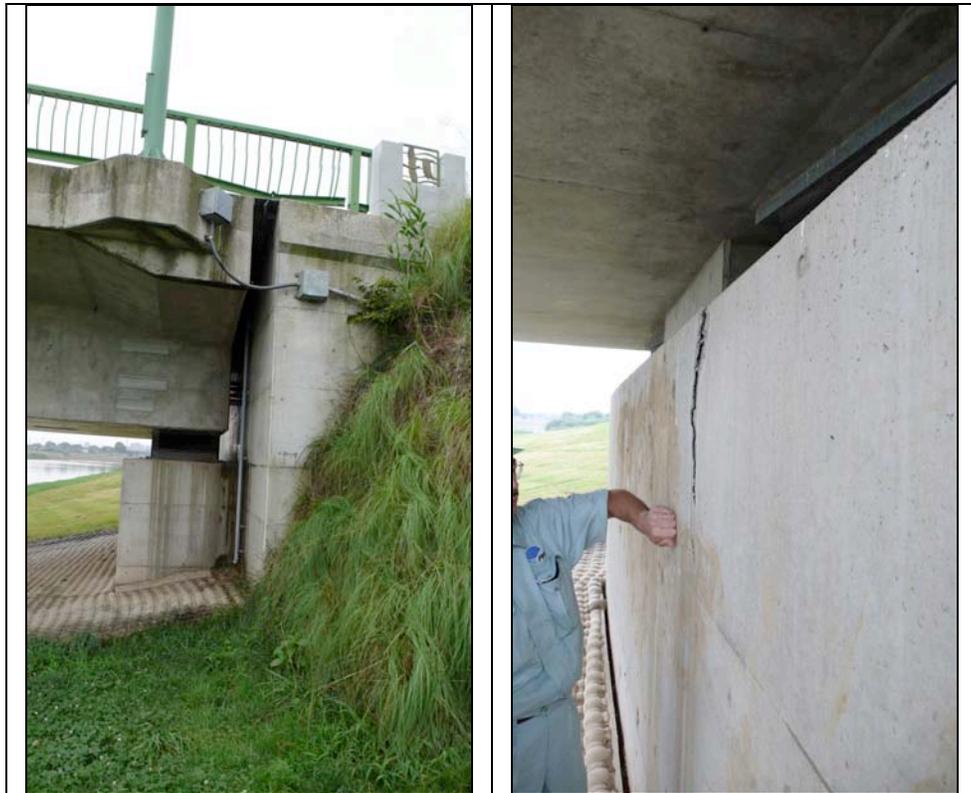
Fig. 6.36. The superstructure and bearings moved back and forth, cracking the abutment.

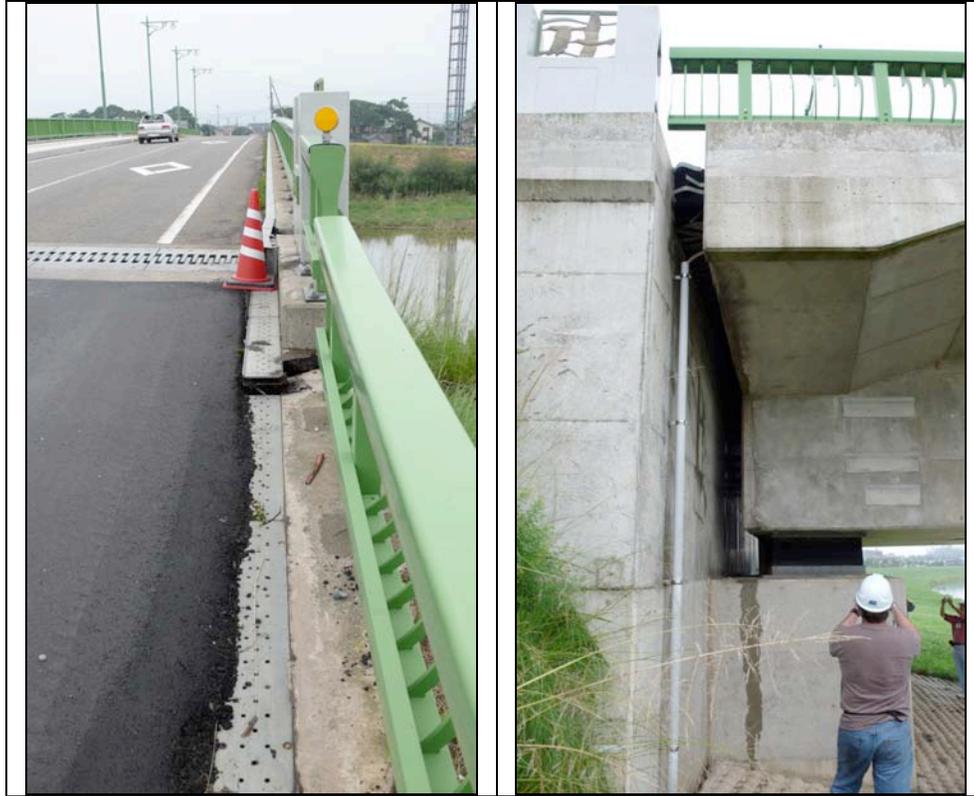
Fig. 6.37. Signs of movement of the abutments included distortion of bearings.

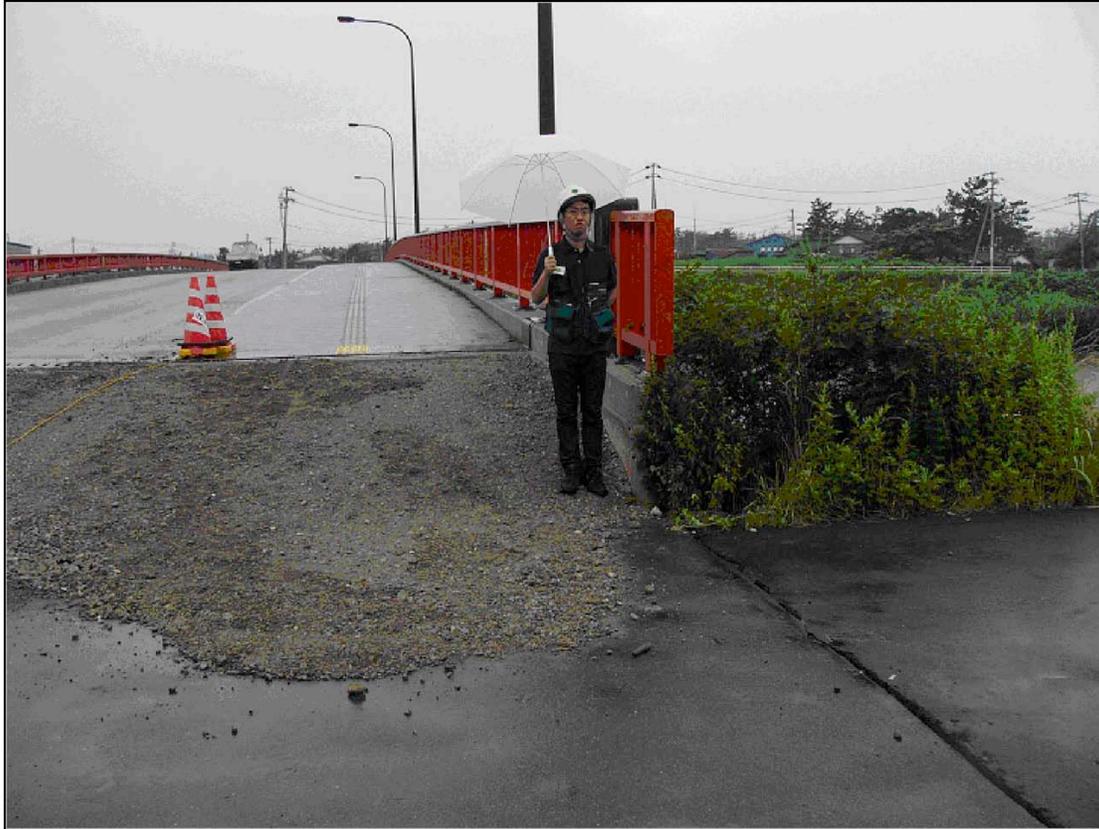
Fig. 6.41. About one meter settlement of south Kaiun bridge approach.

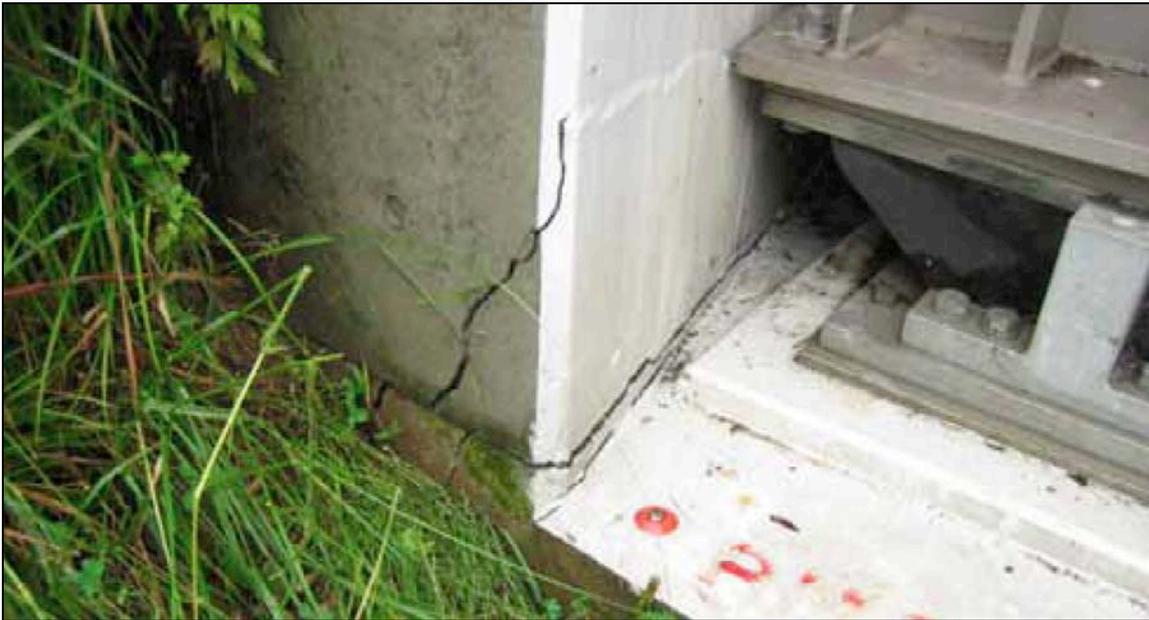
Fig. 6.46. Distorted bearing and cracked abutment backwall (photo courtesy of Scott Brandenburg).

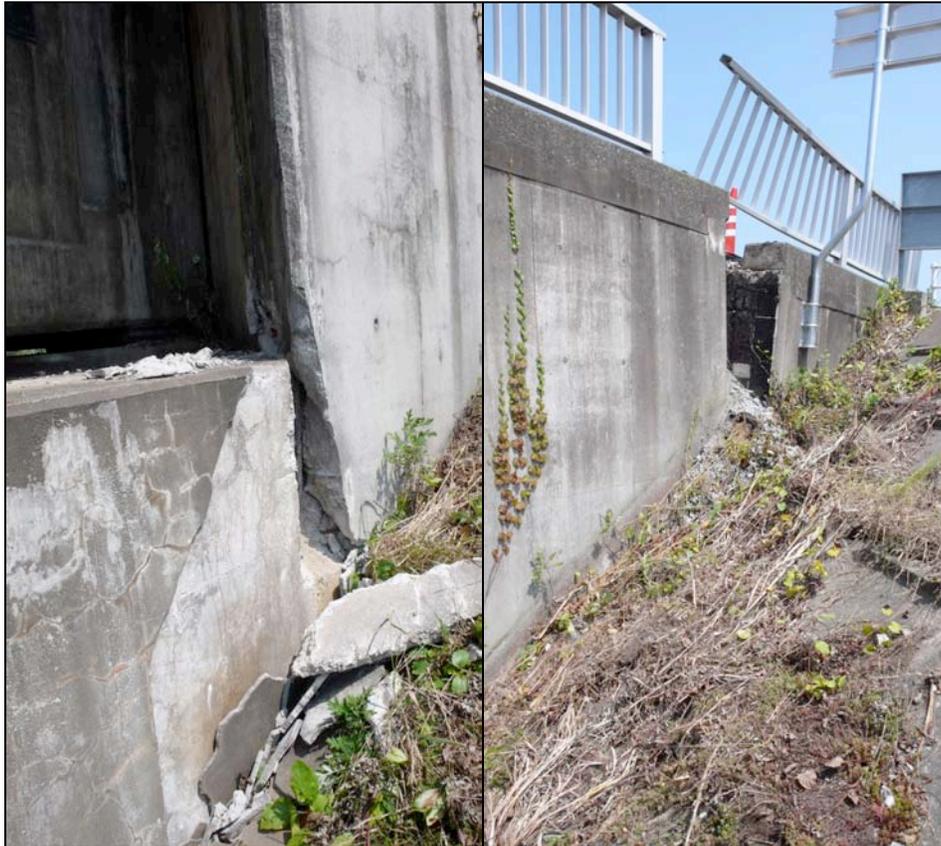
Fig. 6.51. Abutment and wingwall damage from the earthquake.

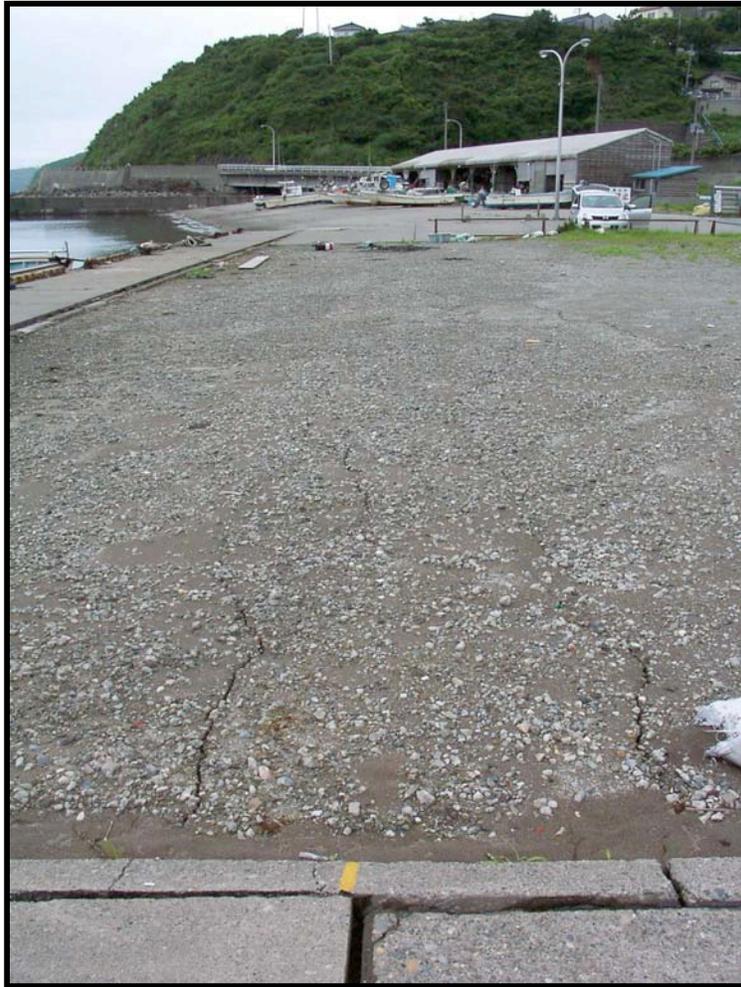
Figure 8.1: Minor ground failure along the waterfront at Kasashima (Site RK21, N37.33702° E138.46680°, photo taken 7/21/07 14:49). The limited extent of the ground cracking indicated incipient lateral movement.

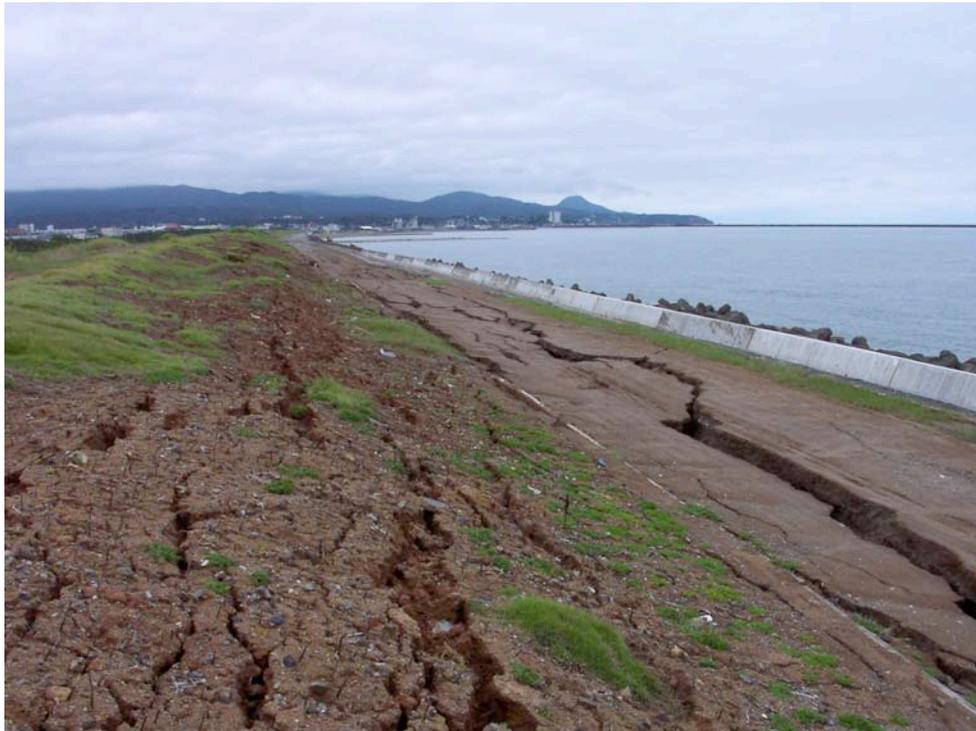
Figure 8.36: Representative cracking and lateral displacement of the clayey earth embankment adjacent to the seawall (Location is southwest of Site SD1, photo taken 7/22/07 11:35).

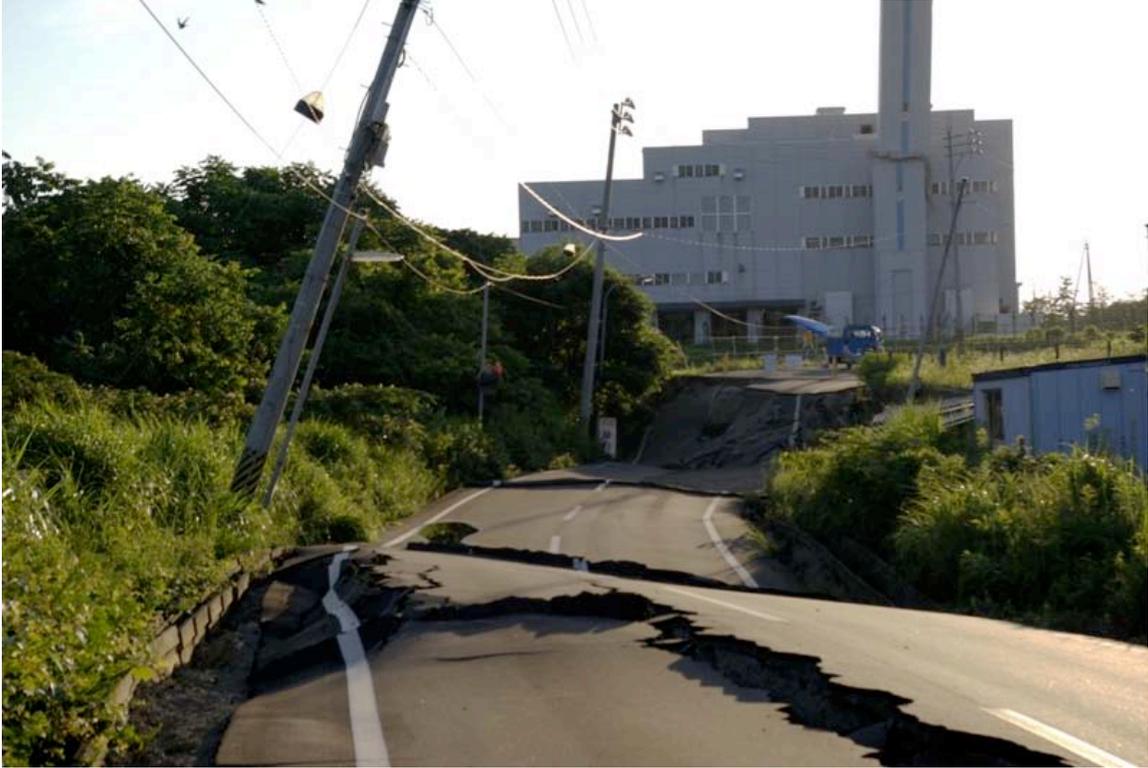
Figure 9.2: Road to Kashiwazaki municipal waste incinerator plant (Site RK6, N37.39343° E138.58555°, photo taken 7/24/07 18:06). Liquefaction-induced lateral spreading led caused the roadbed and associated slope to move southwards towards the Sabaishi River. Photos show formation of a 2.5 meter tall head scarp at the west end.

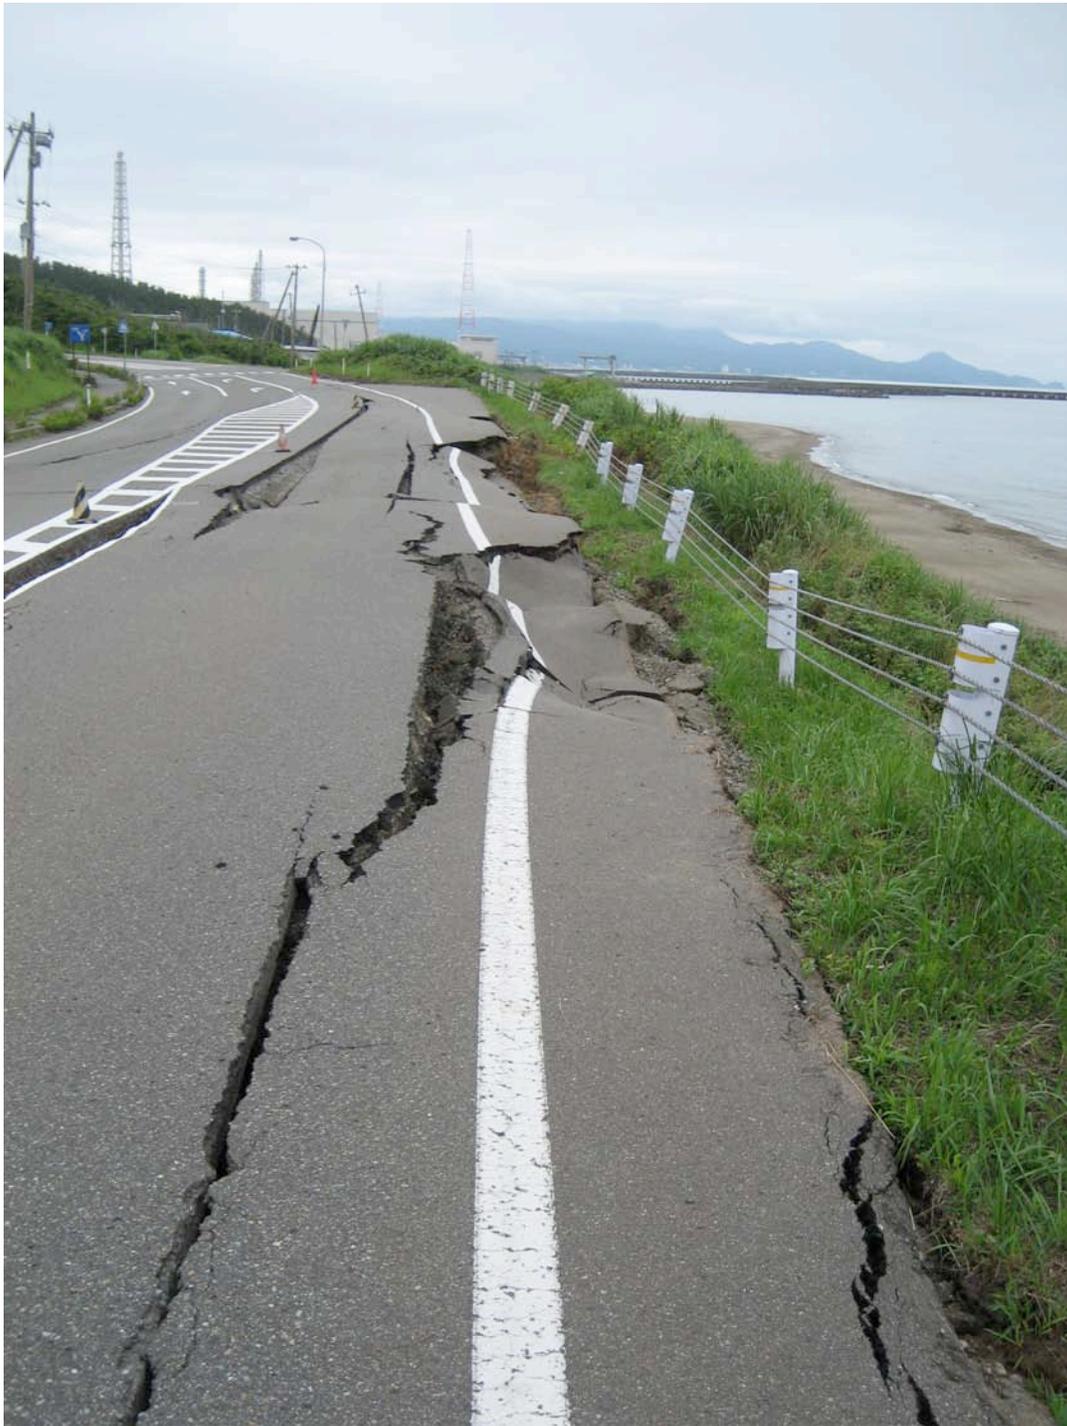
Figure 9.3: Road damage from fill embankment failure on coastal road north of Kashiwazaki Nuclear Power Station (Site RK38, N37.44927° E138.60572°, photo taken 7/22/07 13:04). Such damage tended to increase with distance toward the epicenter, often requiring traffic controls to guide cars across the one open lane.

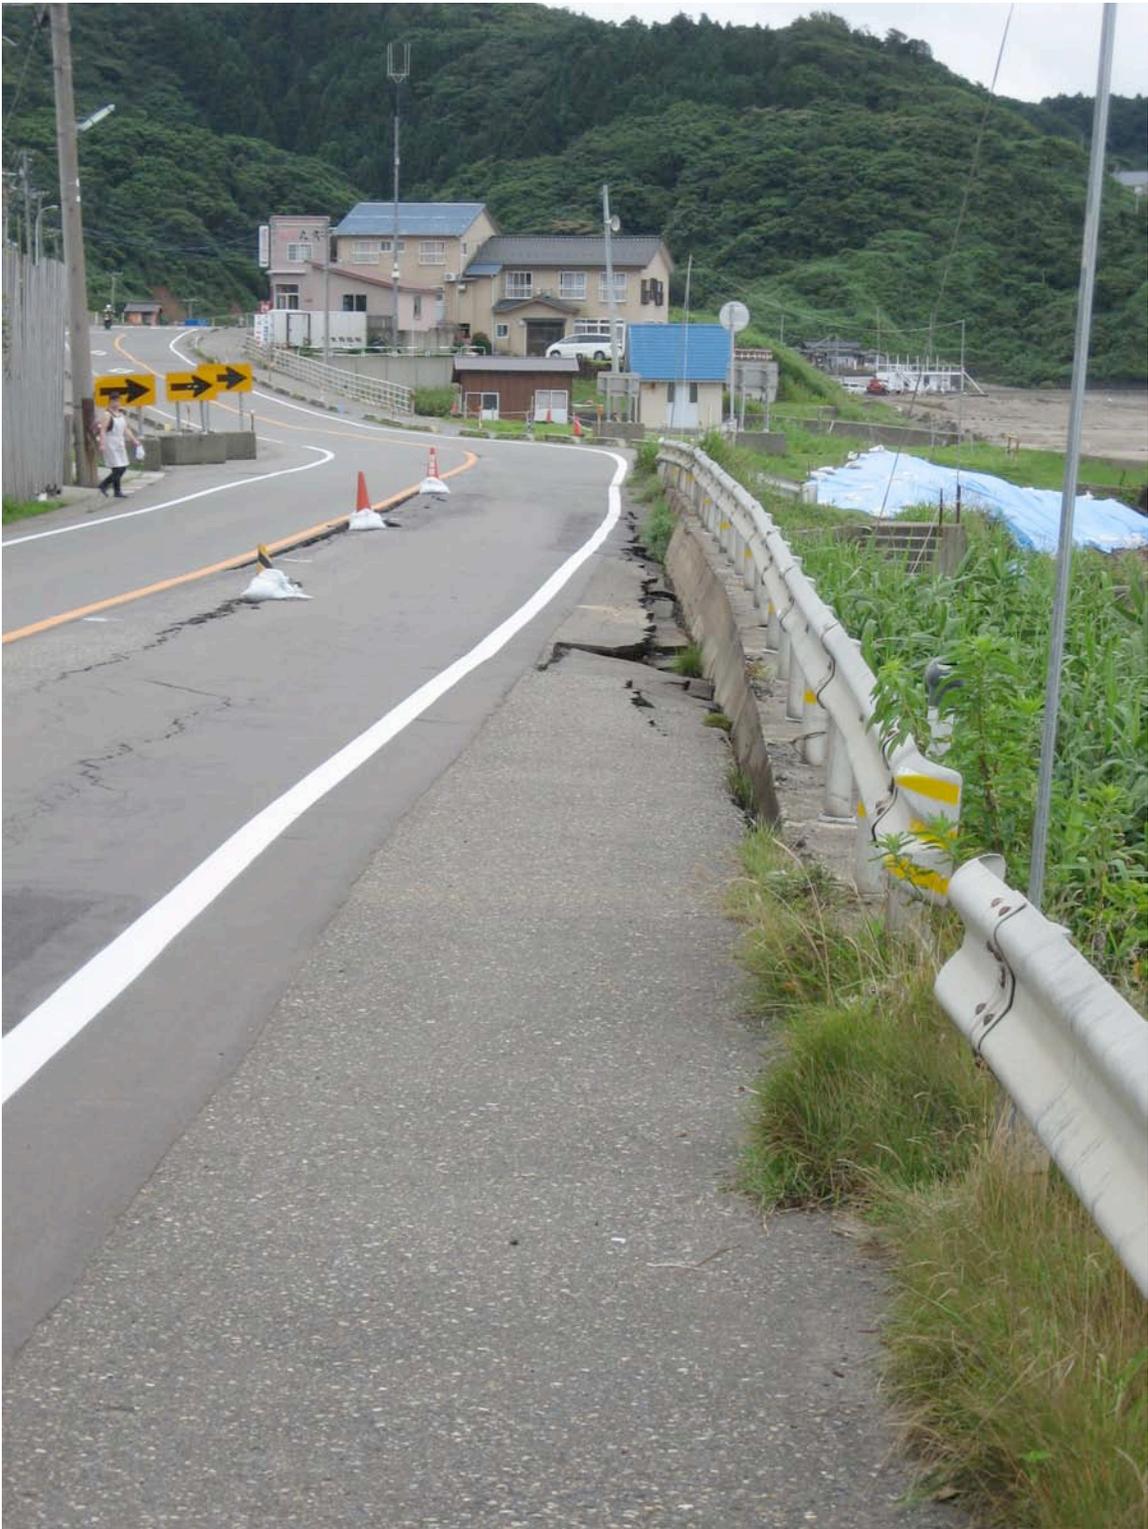
Figure 9.4: Site RK34 - Road damage from fill embankment failure on coastal road north of Kashiwazaki-Kariwa Nuclear Power Plant (Site RK34, N37.48455° E138.62435°, photo taken 7/22/07 09:56).

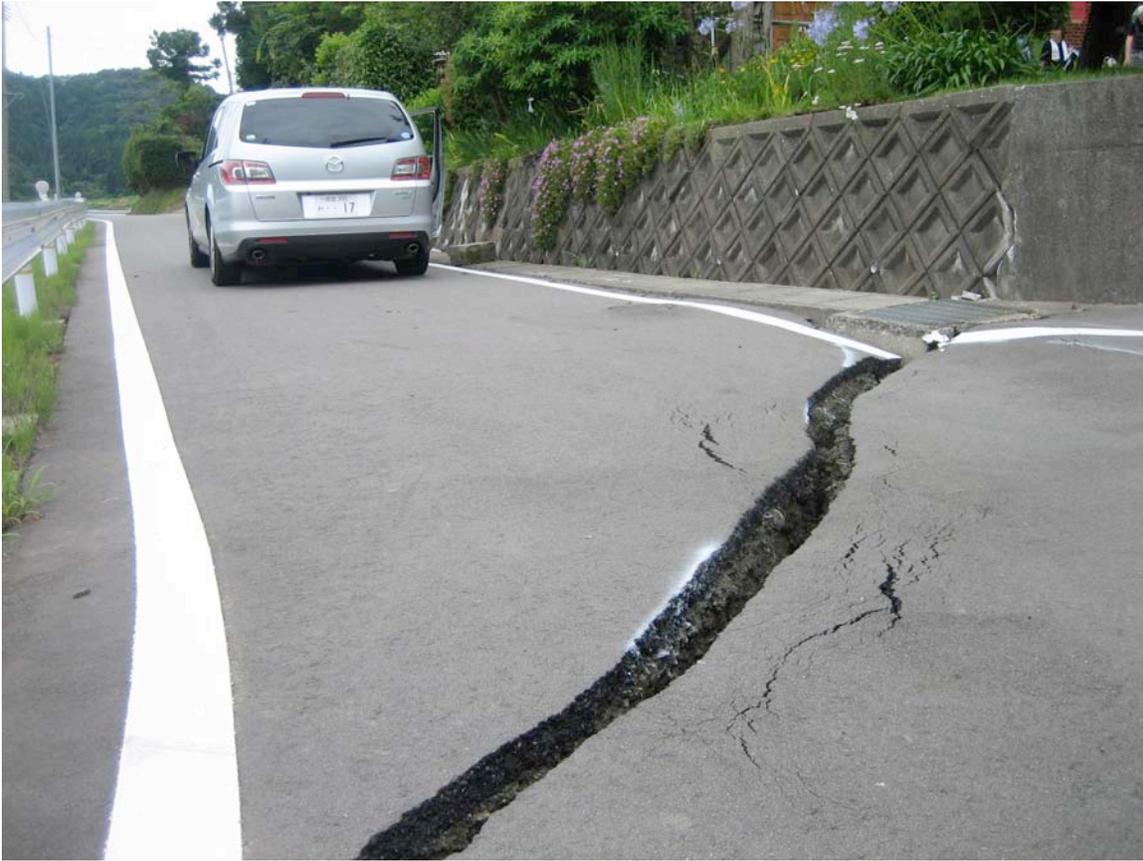
Figure 9.5: Typical road damage near epicentral region (Site RK30, N37.45727° E138.65328°, photo taken 7/22/07 09:46). Cracks of 5 to 10 cm were often quickly paved over in high-traffic areas, within one or two days of the earthquake. On local community roads with alternate traffic routes, this damage was not immediately repaired.

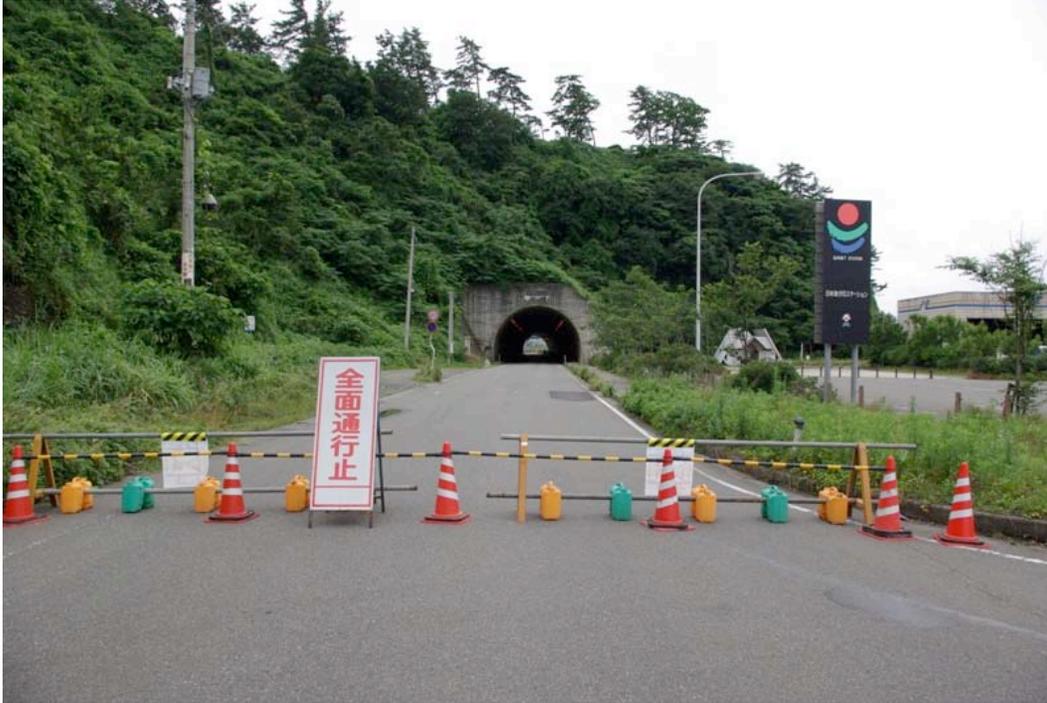
Figure 9.8: Tunnel was initially open to traffic following earthquake, but subsequently closed as of July 22<sup>nd</sup> (Site SD4, N37.38439° E138.60083°, photo taken 7/22/07 13:36). Damage to tunnel was not observed, but landsliding and toppled monuments on top of the tunnel was observed.

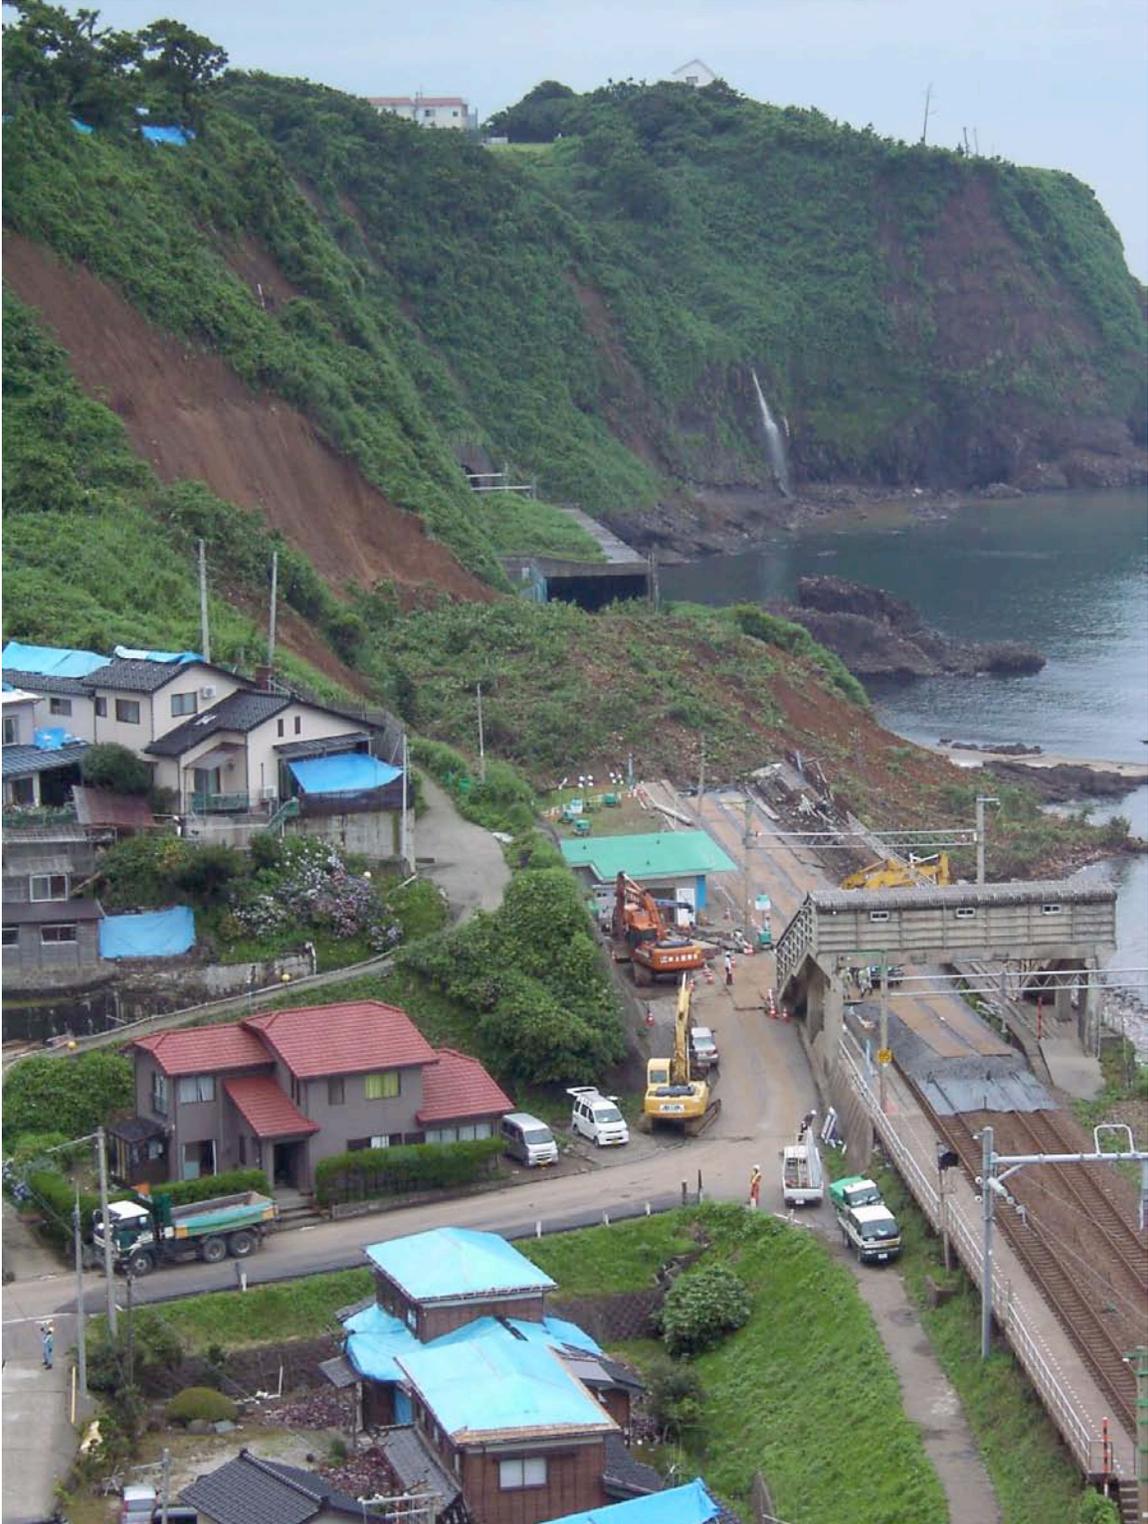
Figure 9.10: Landslide at Oumigawa Train Station impacted Shin-etsu line railway (Sites RK20/YT16/SA9, N37.34490° E138.48435°, 7/21/07 13:52).

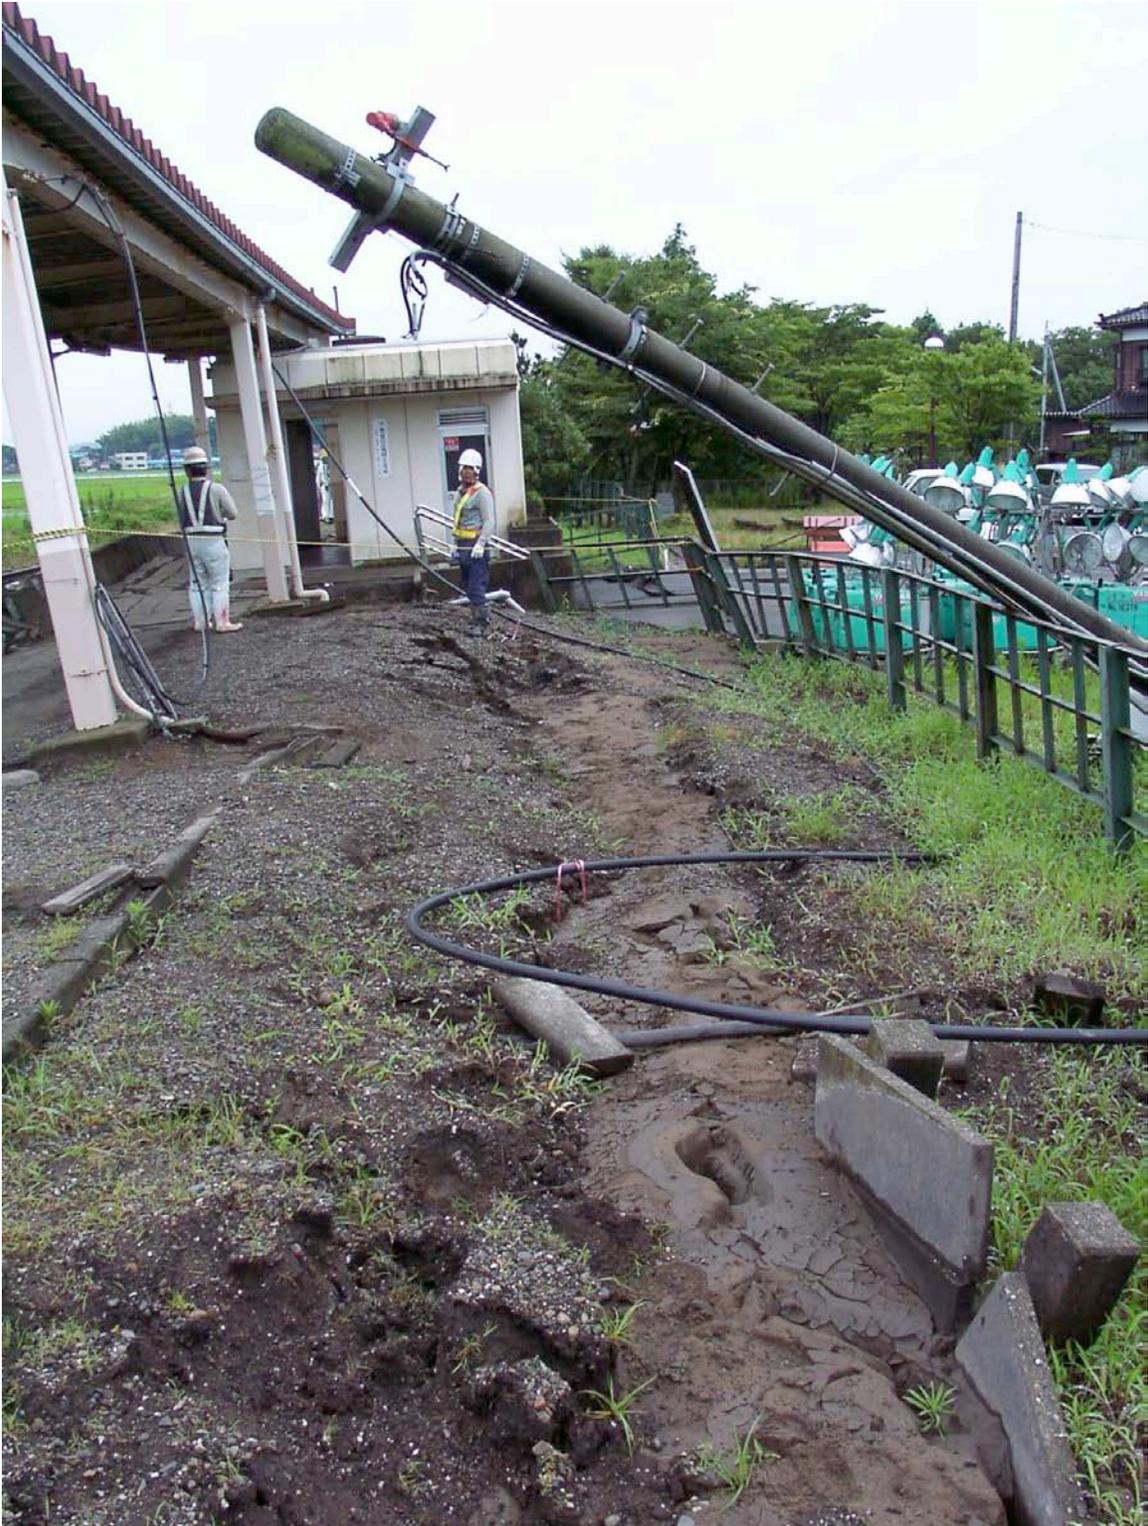
Figure 9.11: Liquefaction-induced damage at Arahama Station (Site RK13, N37.40555° E138.60197°, 7/21/07 09:42).

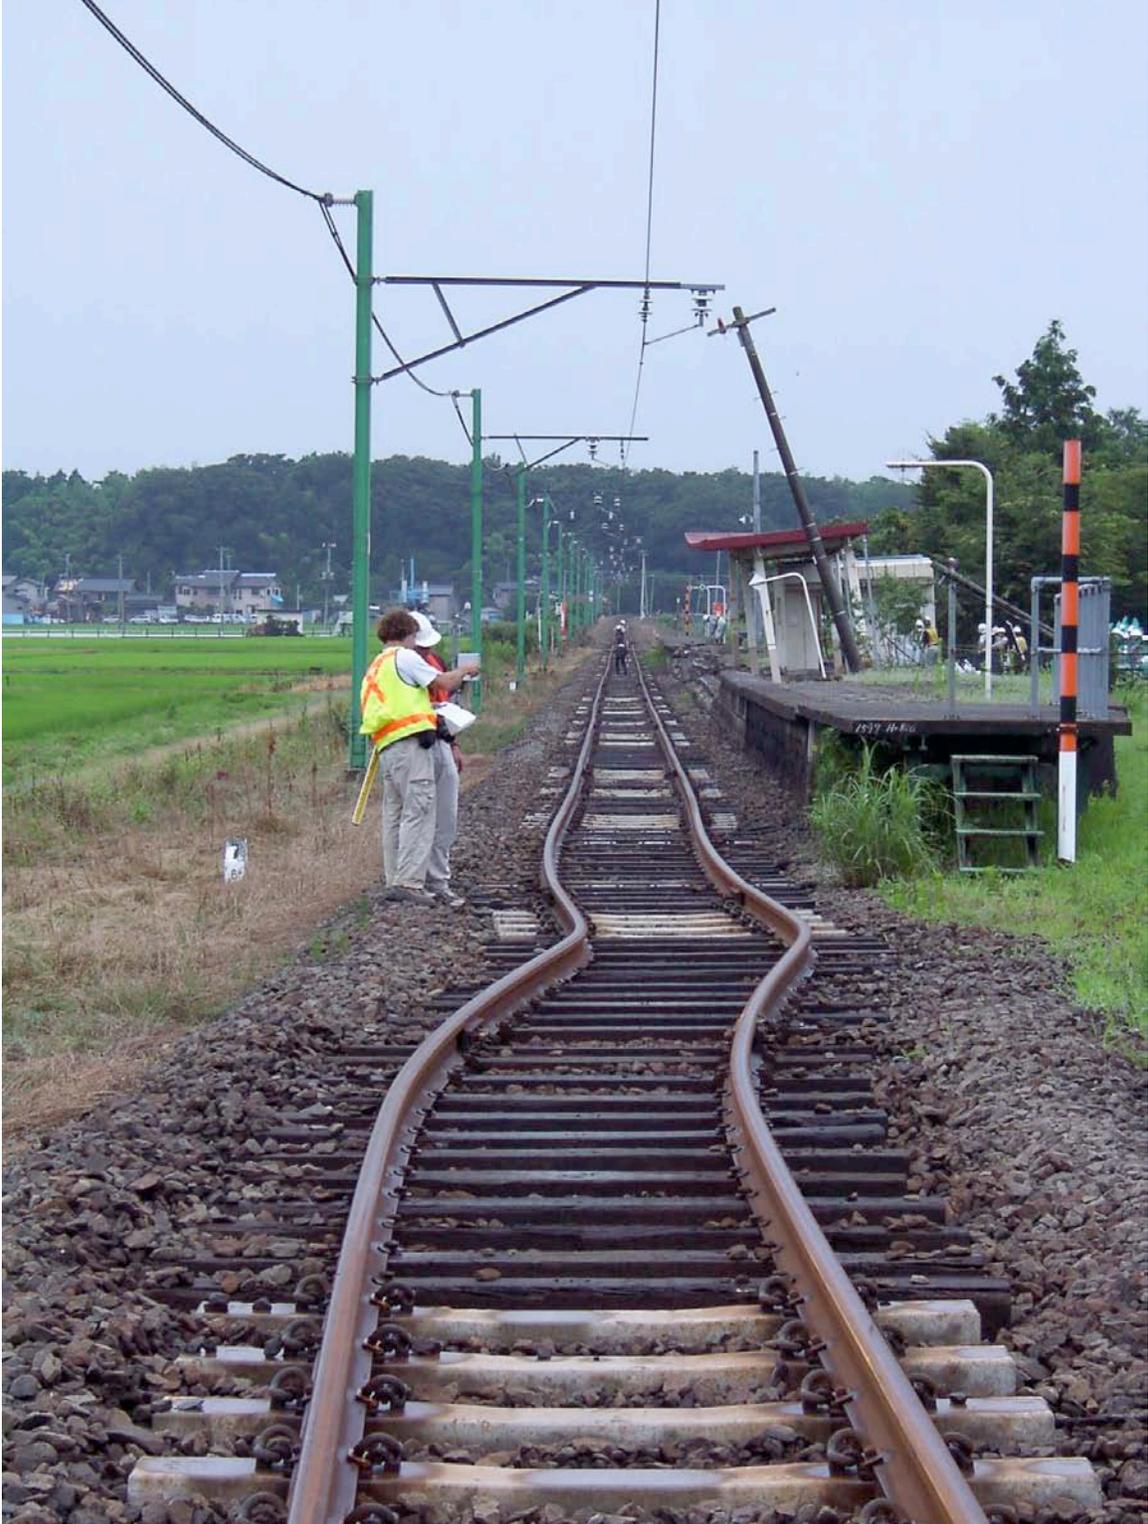
Figure 9.12: Lateral deformation of train tracks at Arahama Station (Site RK13, N37.40555° E138.60197°, 7/21/07 09:52).

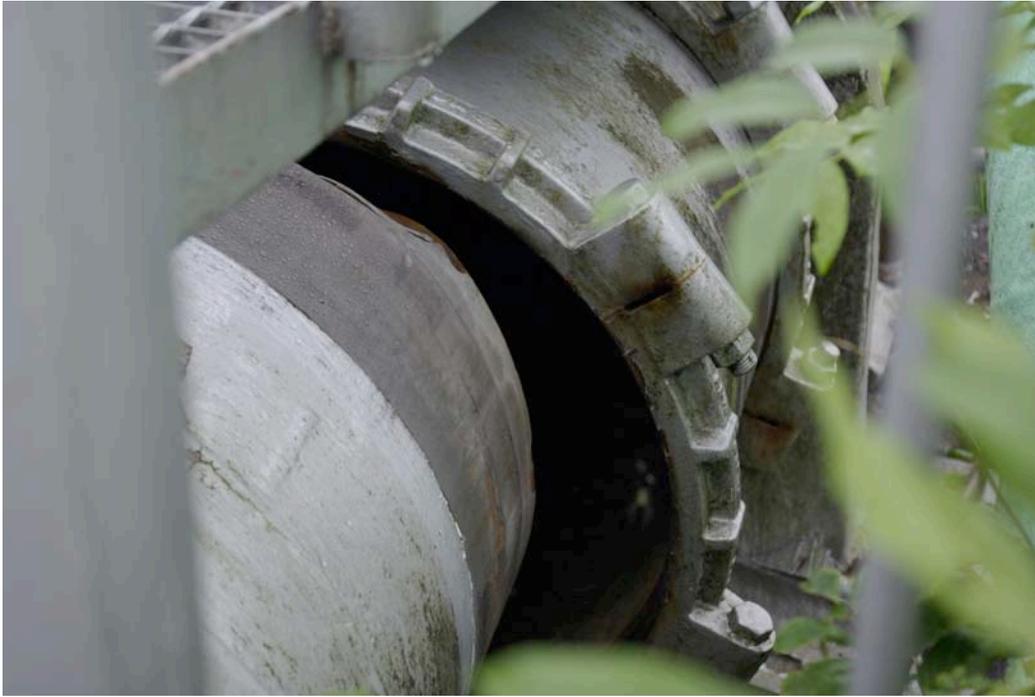
Figure 10.3: Damage to a water pipe at a stream crossing (Site RK4/YT3, N37.39233° E138.58063°, photo taken 7/20/07).

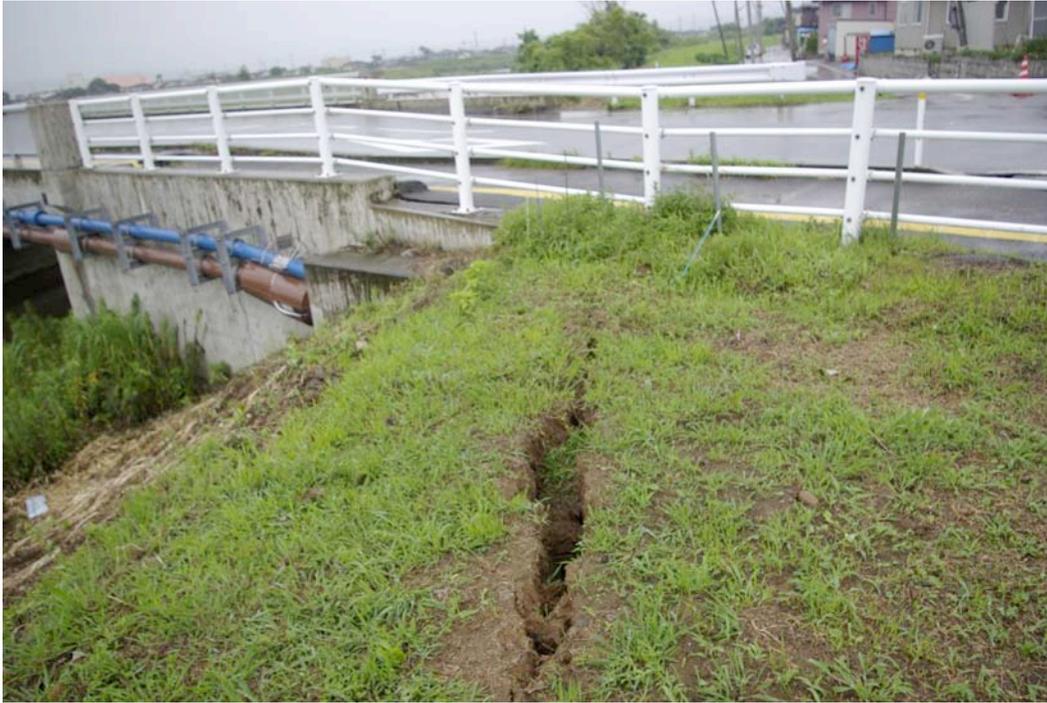
Figure 10.9: Evidence of moderate ground failure in an approach fill. Minor damage to the pipes was observed (Site RK7, N37.38940° E138.57393°, photo taken 7/21/07).
