Bathymetric and Hydraulic Survey of the Matanuska River near Circle View Estates, Alaska

Open-File Report 2008–1359

By Jeffrey S. Conaway

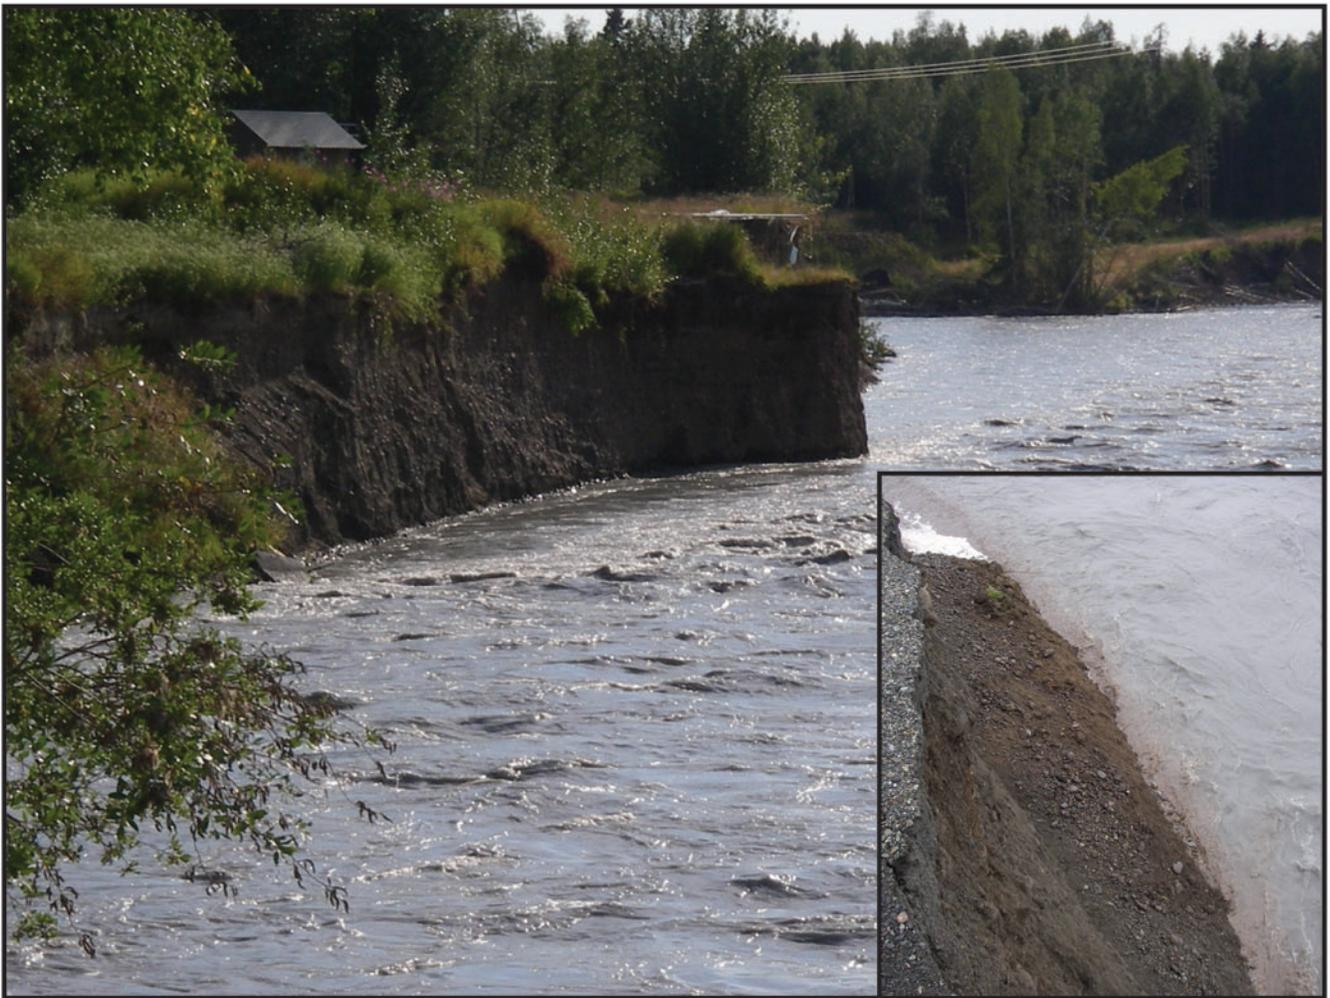
Figure 3. Views of bank section looking downstream and bank material at base of slope immediately after bank failure (inset photograph) on the Matanuska River near Circle View Estates, Alaska.

During data collection, the bank was eroding in a repeating process. The toe of the bank was eroded and transported away by the river until the bank reached a slope that ranged from near vertical to overhanging. The bank would then fail in sections that extended several feet back from the edge and were about 1 to 20 ft in length. This material would then temporarily protect the bank and direct flow towards the center of the channel until the material was eroded from the base of the slope and another failure would occur at periods ranging from 5 to 30 minutes (fig. 3).

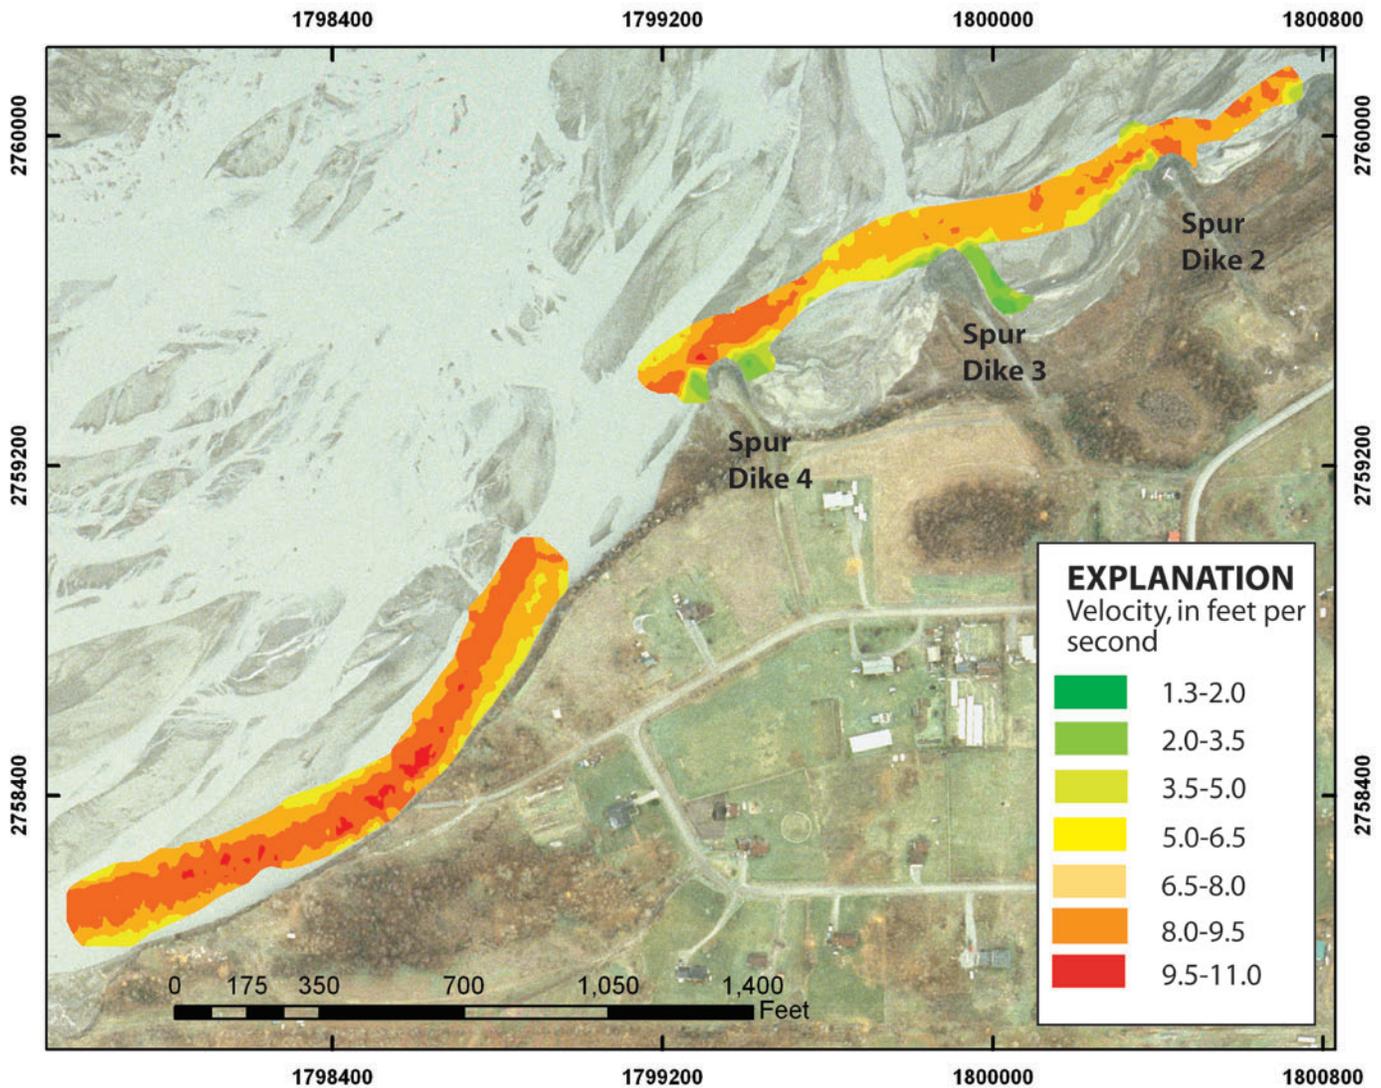
Channel bathymetry and streamflow velocity were measured in the channel that passed in front of the four spur dikes (appendix A). The highest flow velocities and depths were measured at the nose of the spur dikes although the lowest measured velocities were towards the streambank just upstream and downstream of each dike. The maximum measured velocity was 13.3 ft/s and the area with the overall highest velocities was at the nose of spur dike 4 (fig. 6). The maximum measured depths also were at the nose of the spur

Figure 6. Interpolated depth-averaged velocities along dikes and downstream bank section of the Matanuska River near Circle View Estates, Alaska. Flow direction is from right to left.

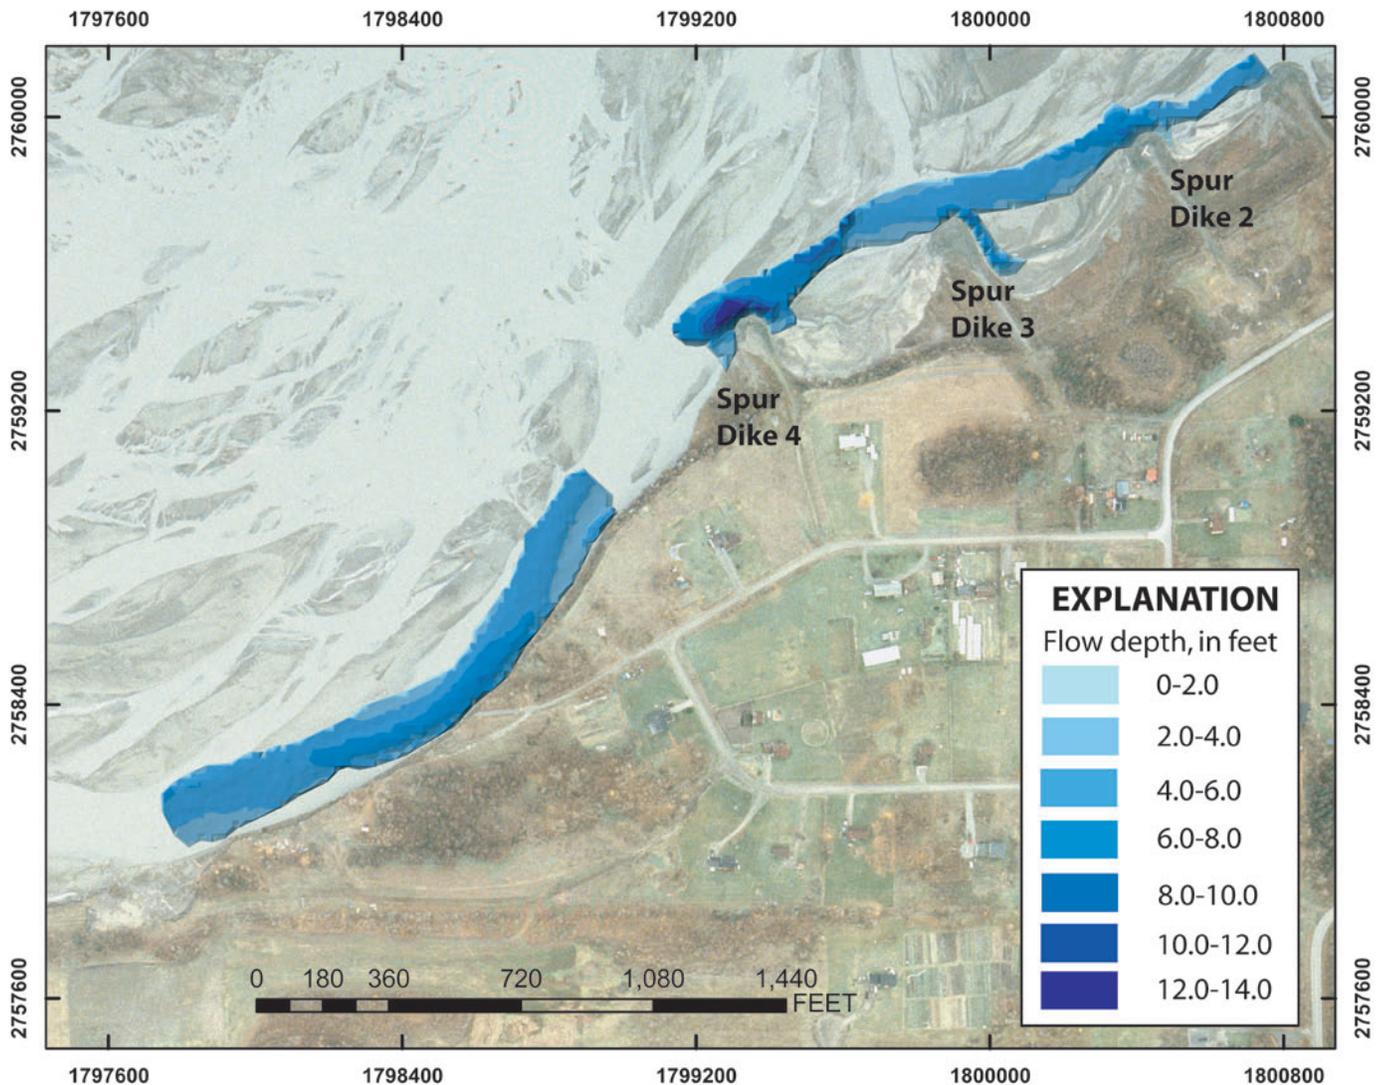
dikes and correspond to the areas with the highest velocities. As expected, the maximum measured depth was at the nose of spur dike 4 (fig. 7) and measured 12.0 ft.

Figure 7. Interpolated bathymetric dataset for dikes and bank section of the Matanuska River near Circle View Estates, Alaska. Flow direction is from right to left.

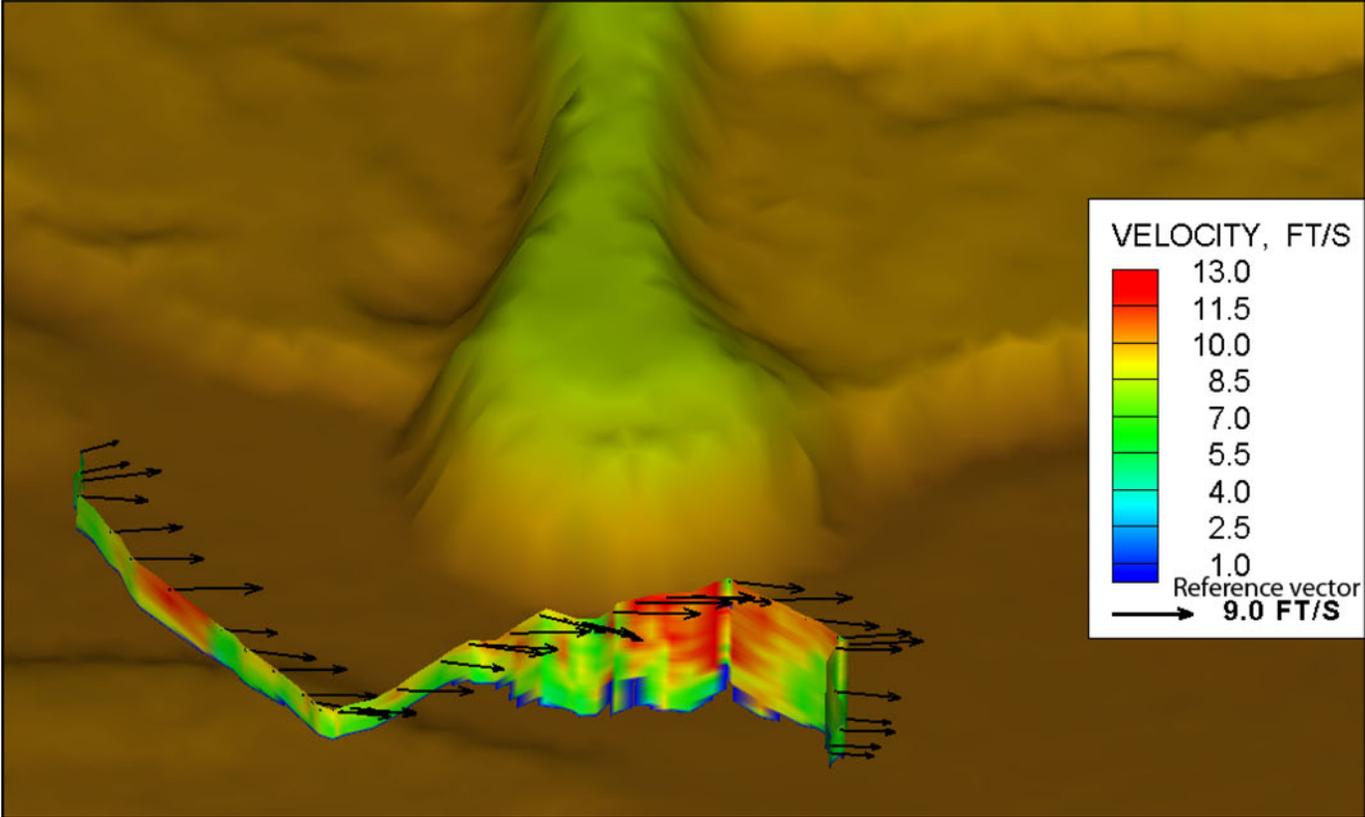
ADCP data collected at spur dike 4 were plotted with the LIDAR data to visualize the velocity distribution in front of the dike (fig. 9). At the nose of the spur dike, a zone of high velocity extended through most of the water column with measured velocities greater than 10 ft/s persisting to a depth of 10 ft (fig. 10). The total depth at this location was 13.7 ft. The

Figure 9. Three-dimensional view of measured flow velocities and depth-averaged velocity vectors at dike 4 on the Matanuska River near Circle View Estates, Alaska. Base digital elevation model created from LIDAR data that were collected on October 12, 2006.

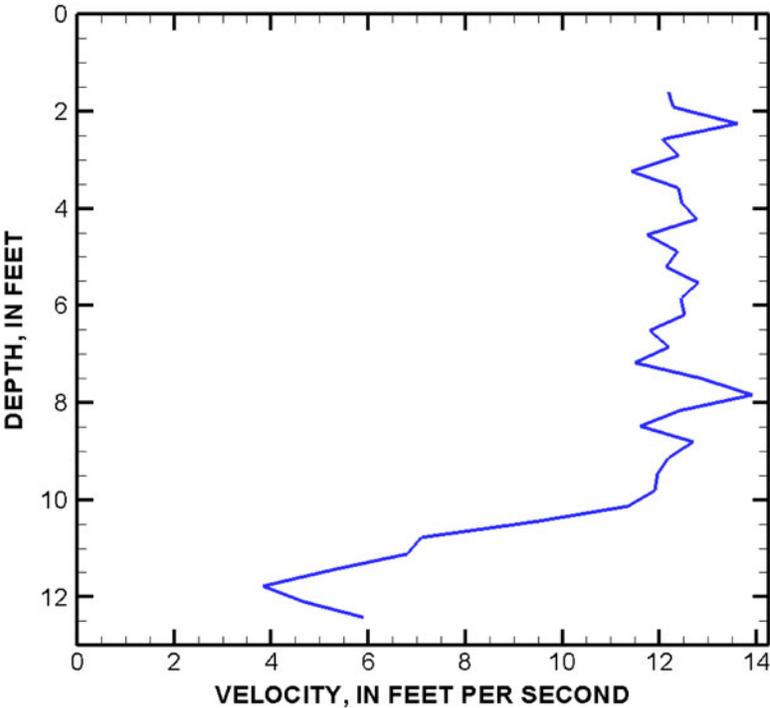
ADCP was able to measure down to a depth of 12.1 ft where the velocity was 4.7 ft/s. The depth-averaged flow vectors at the dike indicate water approaching the dike directly before being redirected towards the center of the channel. The largest velocity vectors were those that were redirected into the channel at the nose of the dike.

Figure 10. Velocity profile collected at the nose of dike 4 on the Matanuska River near Circle View Estates, Alaska.

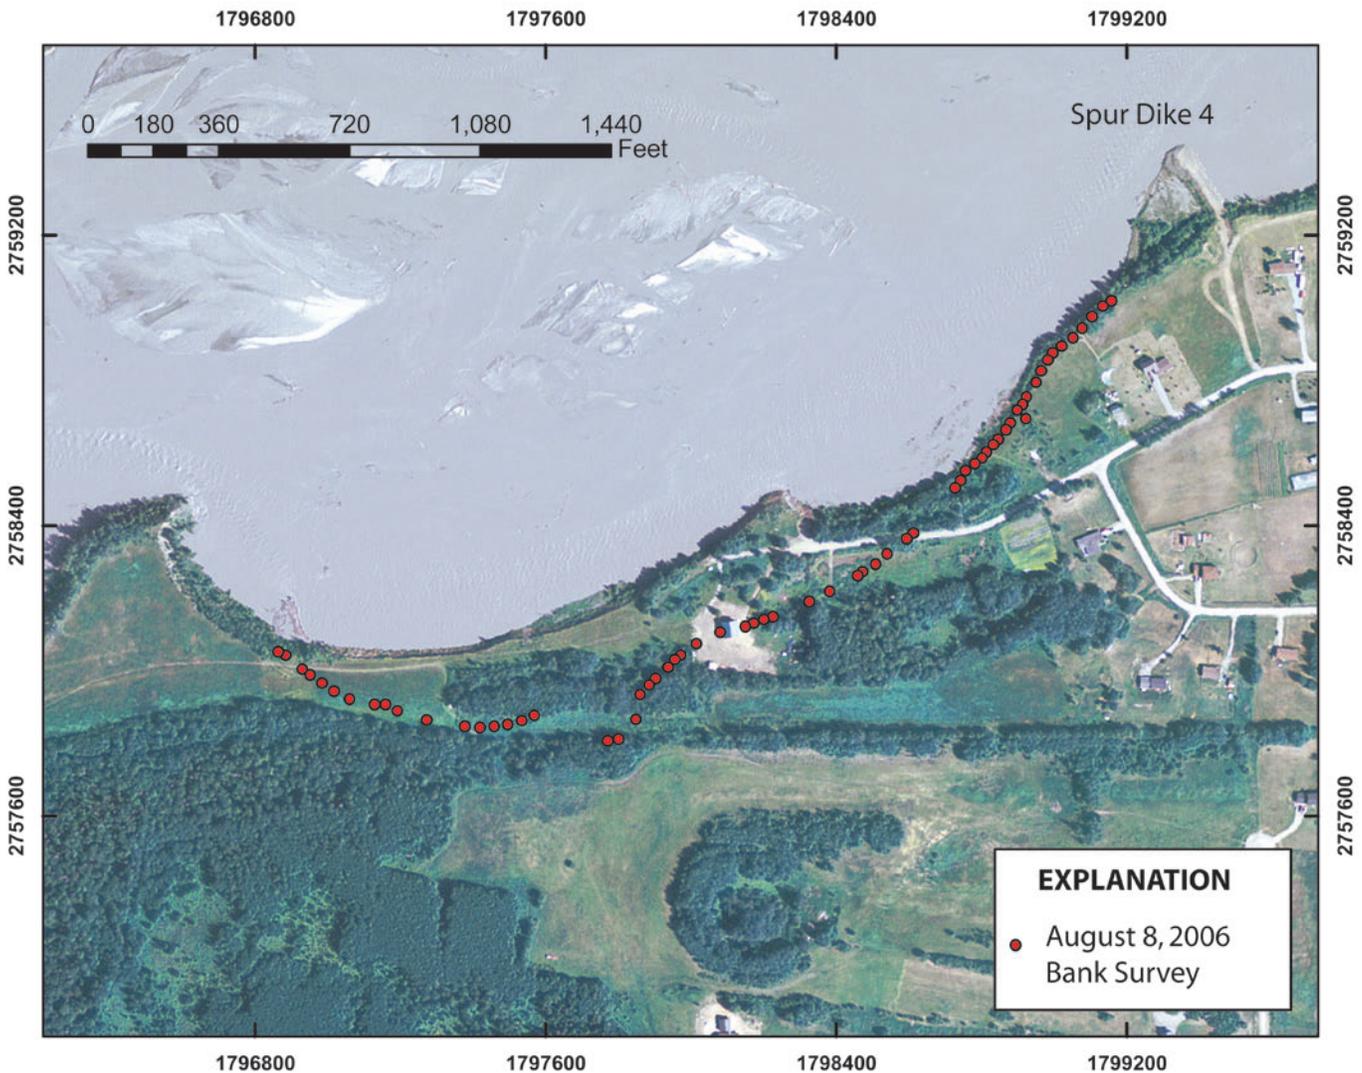
The top of the bank was surveyed on August 8, 2006, to document the position and elevation of the bank during the survey. A maximum of 400 ft of lateral channel migration was measured from the bank position in the 2004 aerial photograph

Figure 11. Surveyed bank locations for the Matanuska River near Circle View Estates, Alaska, August 8, 2006. Flow direction is from right to left.

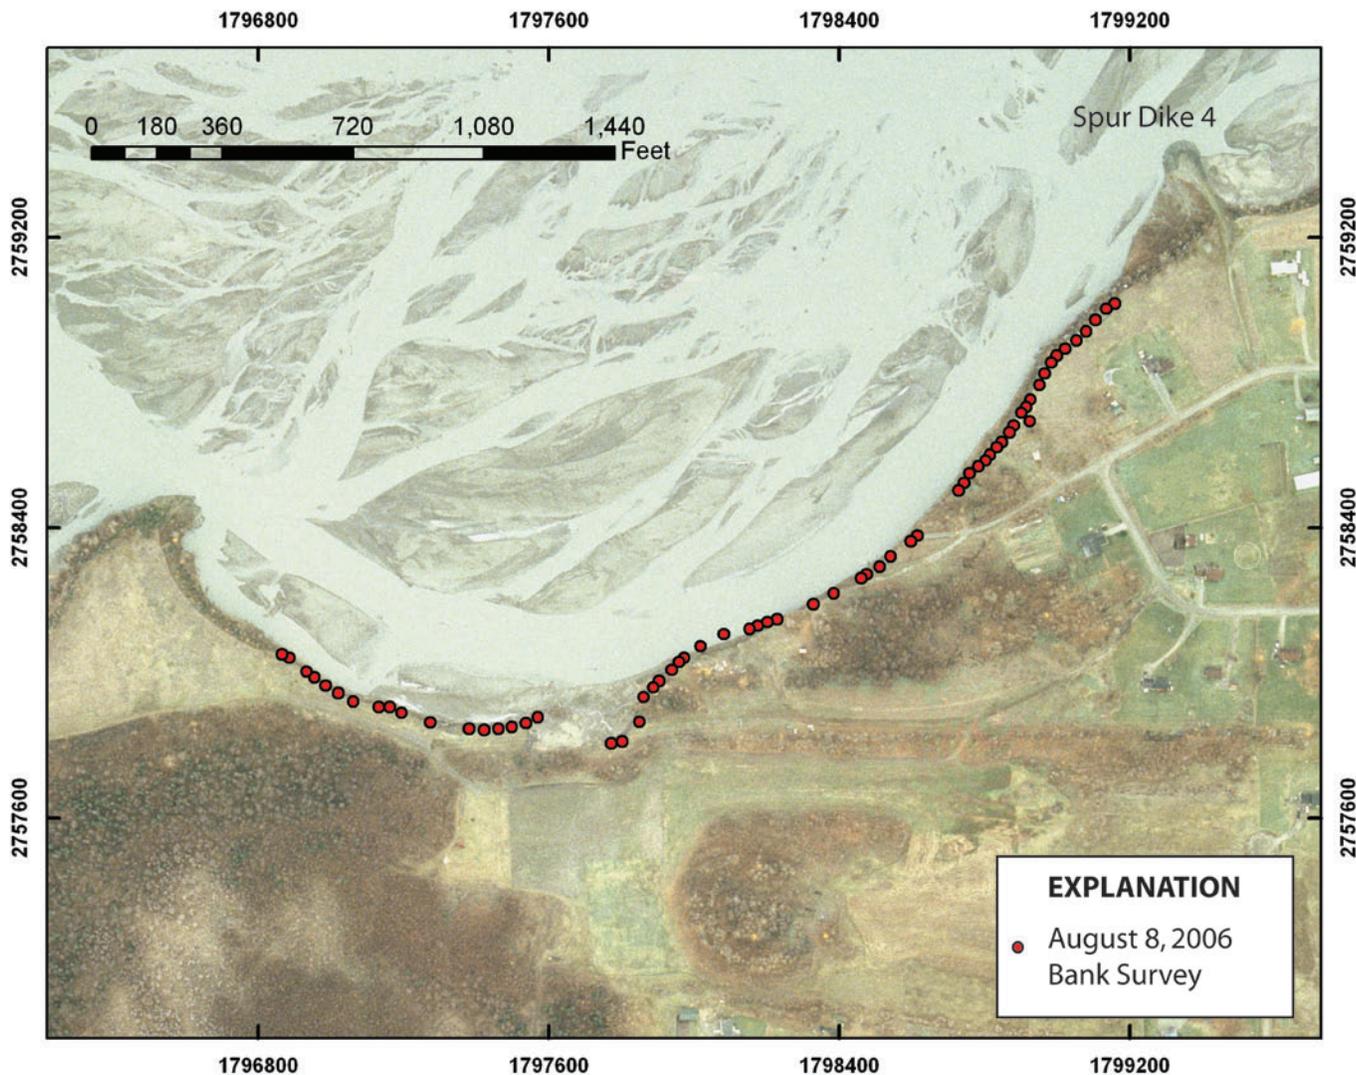
to the surveyed bank position (figs. 11 and 12). Approximately 25 ft of bank erosion was measured over a 24-hour period from August 18–19, 2006, at a discharge of 27,900 ft³/s. The recurrence interval of this discharge was estimated between 2 and 5 years using procedures outlined by Curran and others (2003).

Figure 12. Surveyed bank locations for the Matanuska River near Circle View Estates, Alaska, August 8, 2006. Flow direction is from right to left.

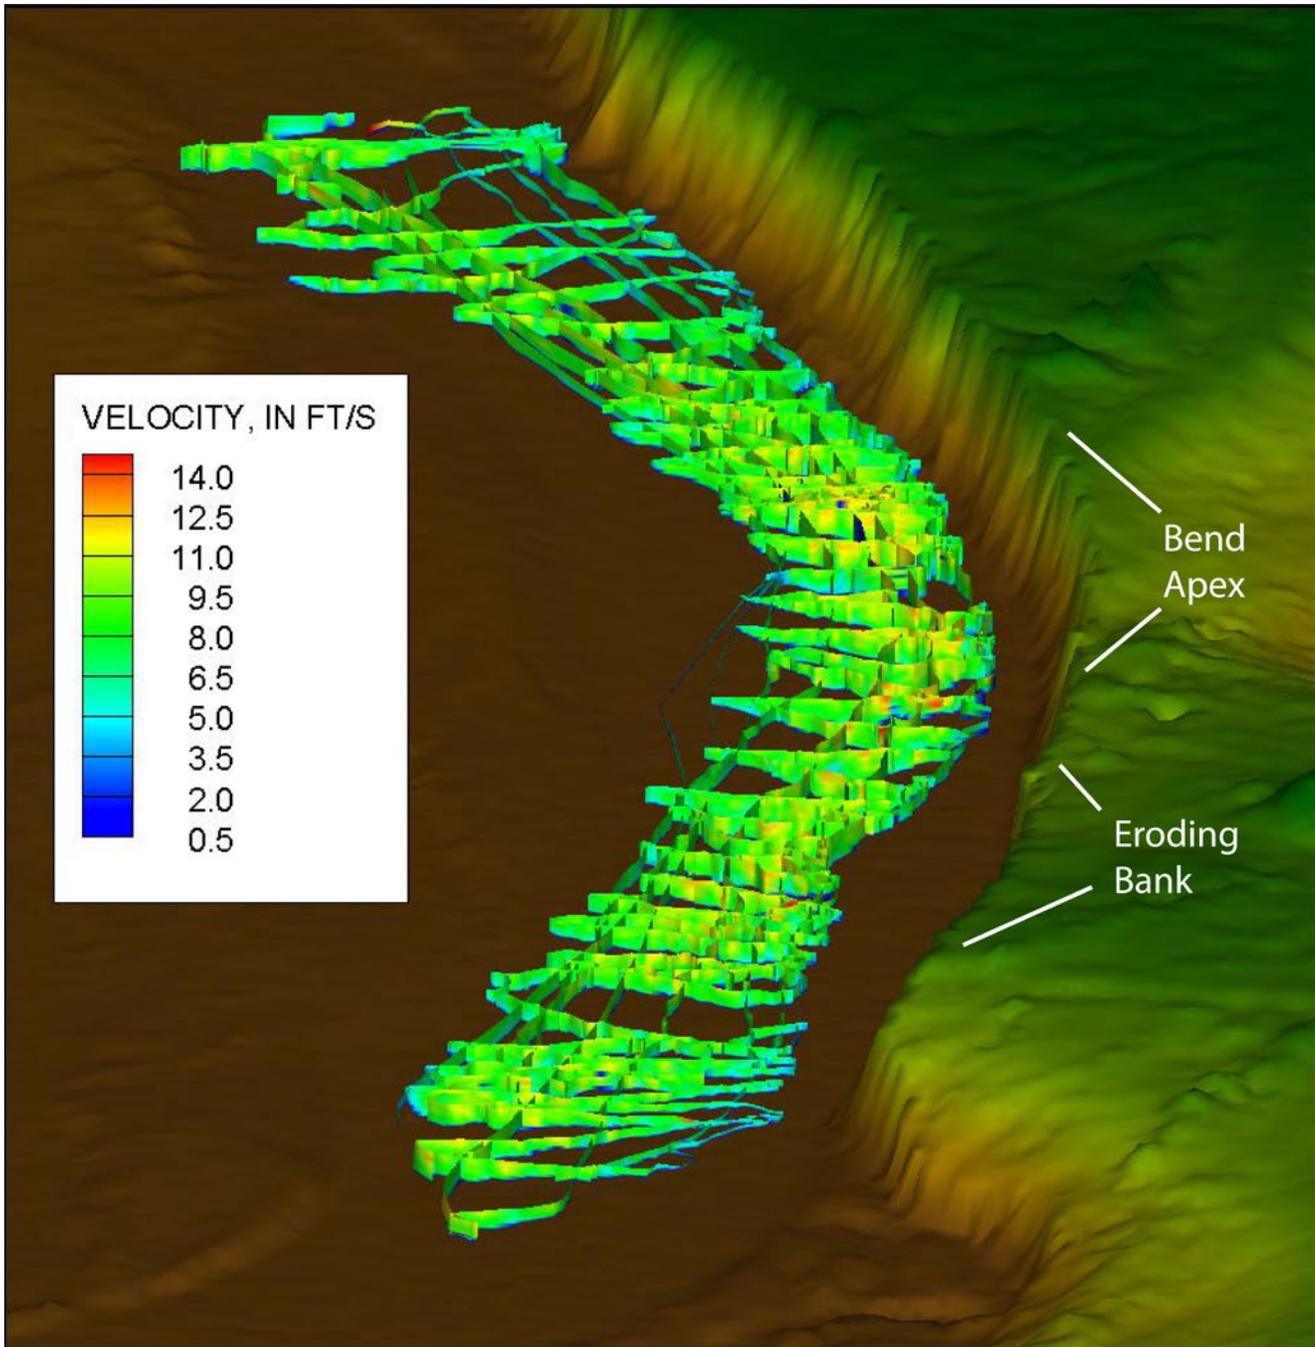
Flow depths and velocities were greatest at the apex of the river bend (fig. 13). Here, the maximum measured depth was 10.2 ft (fig. 7), the maximum measured velocity was 15.0 ft/s, and the maximum depth-averaged velocity was greater than 11.0 ft/s (fig. 6). During the survey, the streambank at the apex of the bend was stable and bank failure

Figure 13. Measured flow velocities collected along the bank section of the Matanuska River near Circle View Estates, Alaska. Base digital elevation model created from LIDAR data that were collected on October 12, 2006. Flow direction is from top to bottom.

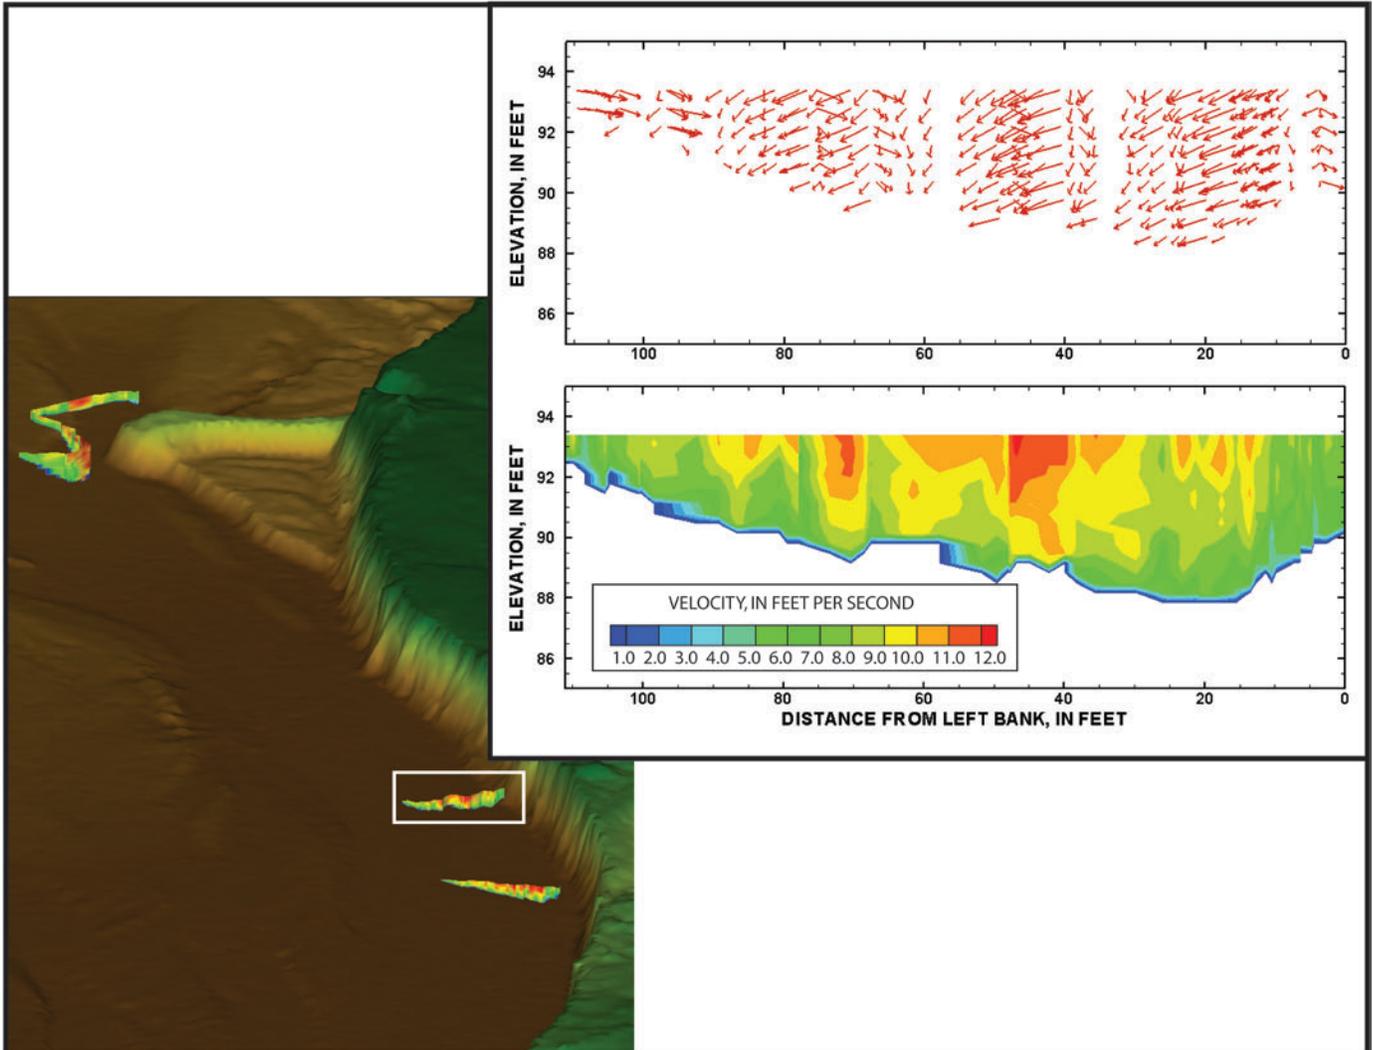
Figure 15. Vertical profiles of measured downstream velocity upstream of the apex of a bend of the Matanuska River near Circle View Estates, Alaska. Cross section location is indicated by the white box in the three-dimensional view of the cross sections and LIDAR data.

Two cross sections were selected to display the measured velocities at the apex of the bend. The first cross section measured at the upstream end of the bend indicates the highest measured velocities were in the center of the channel (fig. 15). The water velocity vectors were not uniform in direction and were not pointed into the bank at the left edge of the section. In contrast, water velocities at the second cross section at the

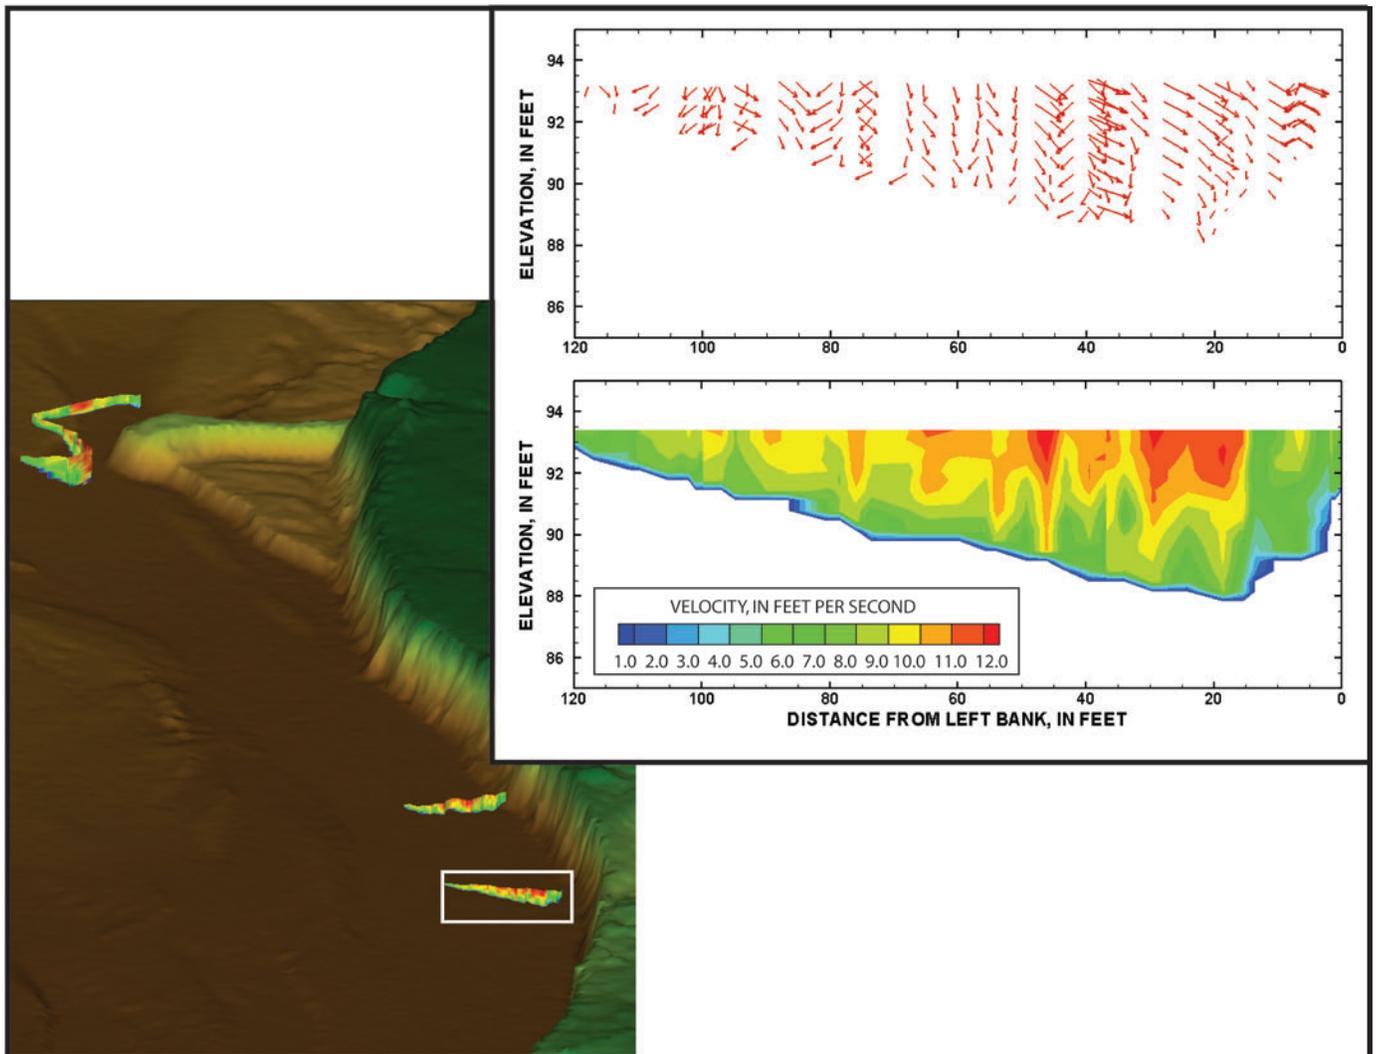
apex of the bend were highest near the left bank (fig. 16). Flow direction here generally was directed towards the outside of the bend. In all cross sections surveyed, the areas of highest velocity did not occur just along the bank (fig. 12). The slower velocities along the bank are likely the product of channel roughness along the bank and turbulence along the edge of flow.

Figure 16. Vertical profiles of measured downstream velocity at the apex of a bend of the Matanuska River near Circle View Estates, Alaska. Cross section location is indicated by the white box in the three-dimensional view of the cross sections and LIDAR data.
