Application of the Multi-Dimensional Surface Water Modeling System at Bridge 339, Copper River Highway, Alaska

Open-File Report 2009–1237

By Timothy P. Brabets and Jeffrey S. Conaway

Prepared in cooperation with the
Alaska Department of Transportation and Public Facilities

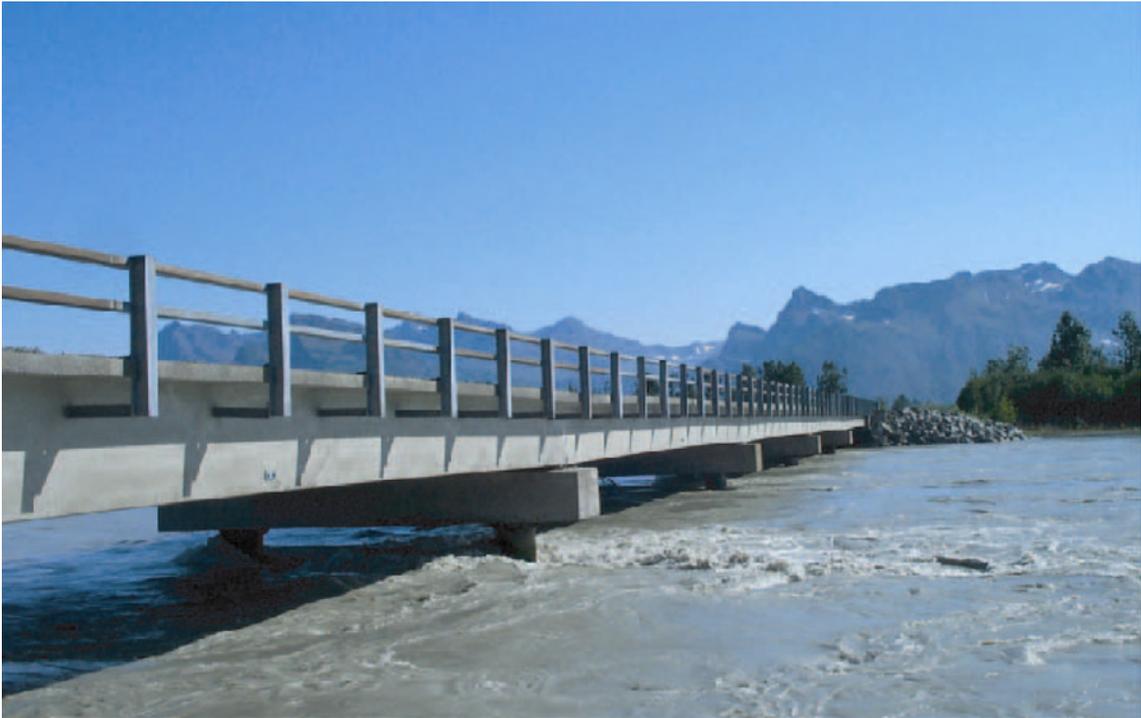
The bridges from Flag Point to the Million Dollar Bridge were damaged in the 1964 earthquake. Beginning in 1970, as part of a major reconstruction effort, all the bridges were rebuilt. Bridge 339 was designed for a flow of 17,500 ft³/s and rebuilt during 1976–78. When completed, the bridge was 400 ft long and supported by four sets of concrete-filled steel piers spaced 80 ft apart (fig. 4).

Figure 4. Bridge 339, Copper River Highway, August 6, 2004. (Discharge is 27,200 ft³/s.)

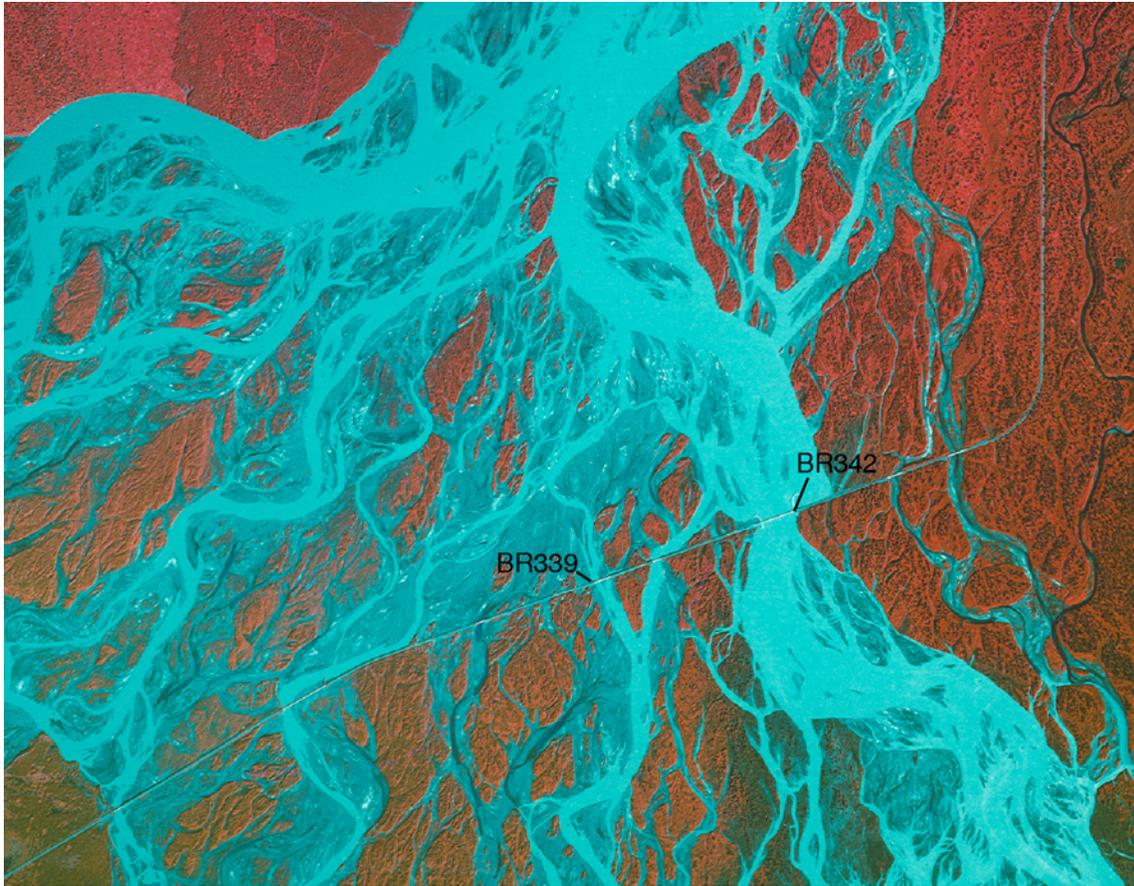
The flow conditions at Bridge 339 documented by the USGS remained the same until 2001, based on aerial photography taken in 1996 and records of the Alaska Department of Transportation and Public Facilities (AKDOT&PF) Cordova maintenance office. In 2001, most likely due either to high flow in the Copper River or to the effects of ice jams, a major channel change occurred at the bridge. A comparison of aerial photography flown in 2002 with aerial photography flown in 1996 clearly showed the channel change (figs. 5–6). A fairly large sinusoidal (S-shape) channel formed towards Bridge 339.

Figure 5. Aerial photography of the lower Copper River near Bridge 339 taken in July 1996.

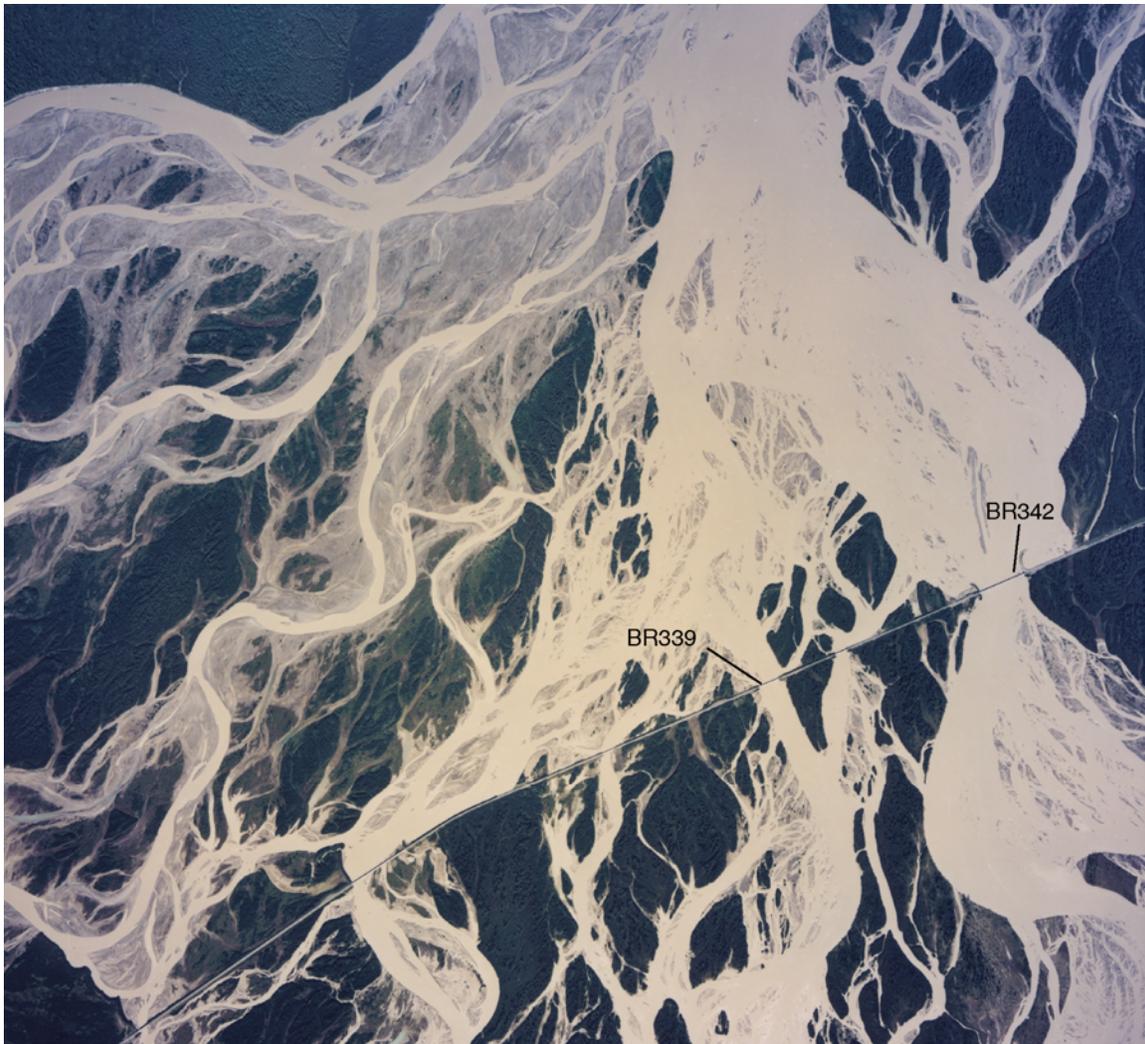
Figure 6. Aerial photography of the lower Copper River near Bridge 339 taken in August 2002.

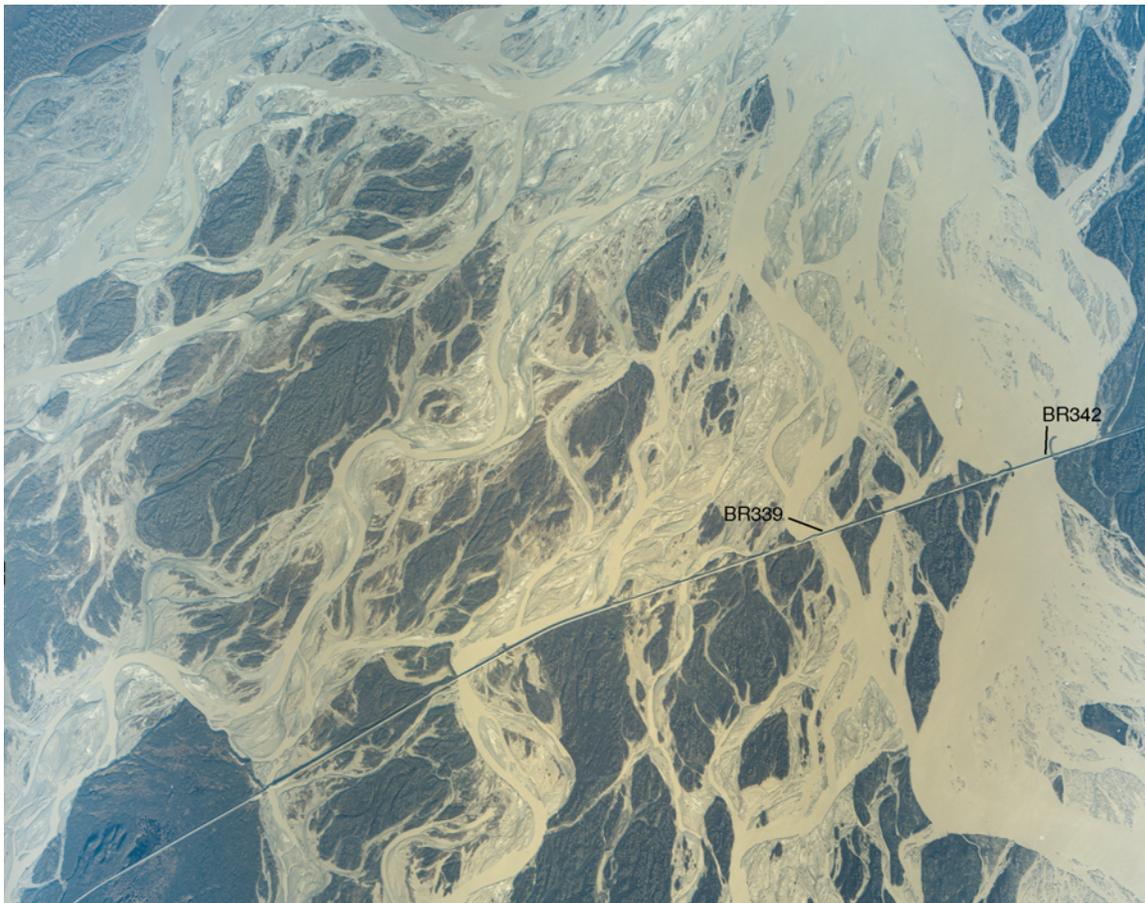
From 2002 to 2009, the main channel to Bridge 339 has been constantly changing. LIDAR (Light Detection and Ranging) imagery obtained in 2005 and aerial photography flown in 2006 and 2007 (figs. 7–8) show the channel migrating toward the west and impacting the approach to the bridge. The channel then reverses direction and then heads eastward, parallel to the approach, and then flows under the bridge. Because of the changing direction of the channel, the angle of attack, and the foundation material beneath the approach to Bridge 339 (fig. 9), large quantities of riprap have been needed to stabilize the approach; in most instances, this provided only temporary bank stabilization during the summer runoff months. Since 2004, approximately 10,000 yd³ of large riprap have been placed along the approach by AKDOT&PF personnel.

Figure 7. Aerial photography of the lower Copper River near Bridge 339 taken in October 2006.

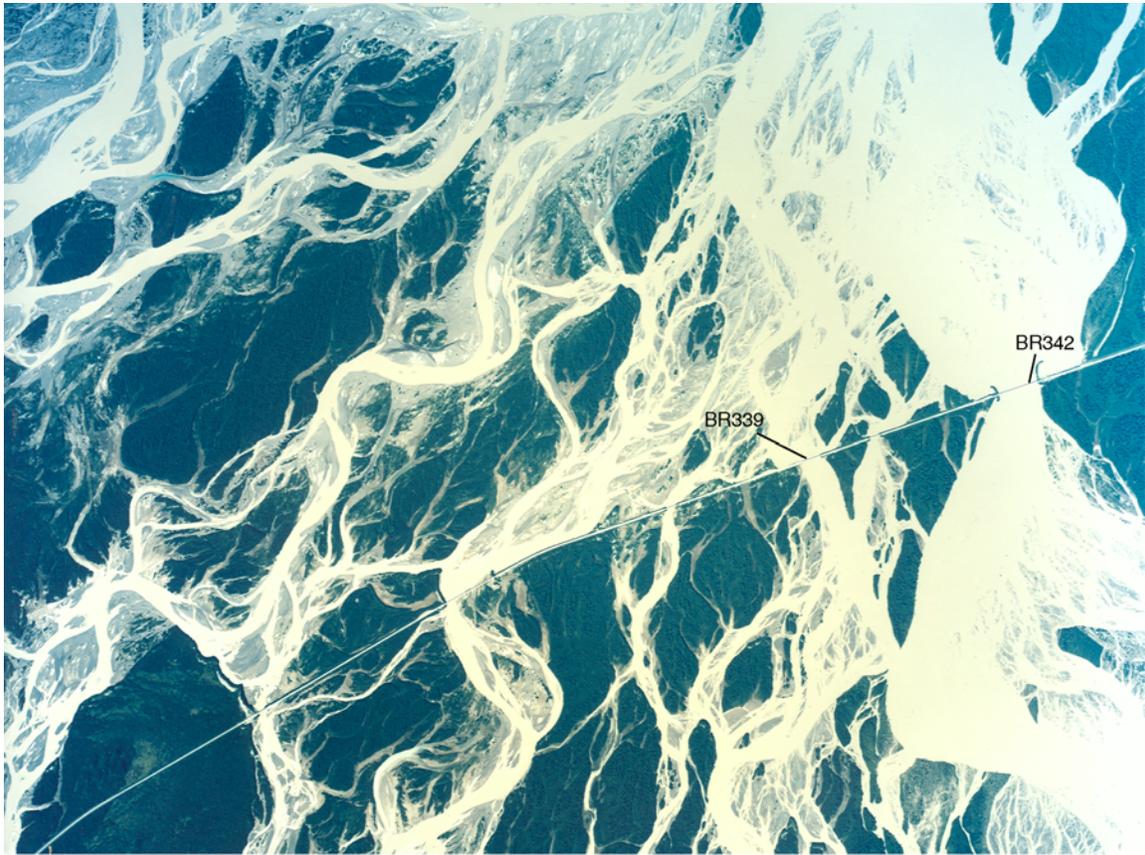
Figure 8. Aerial photography of the lower Copper River near Bridge 339 taken in August 2007.

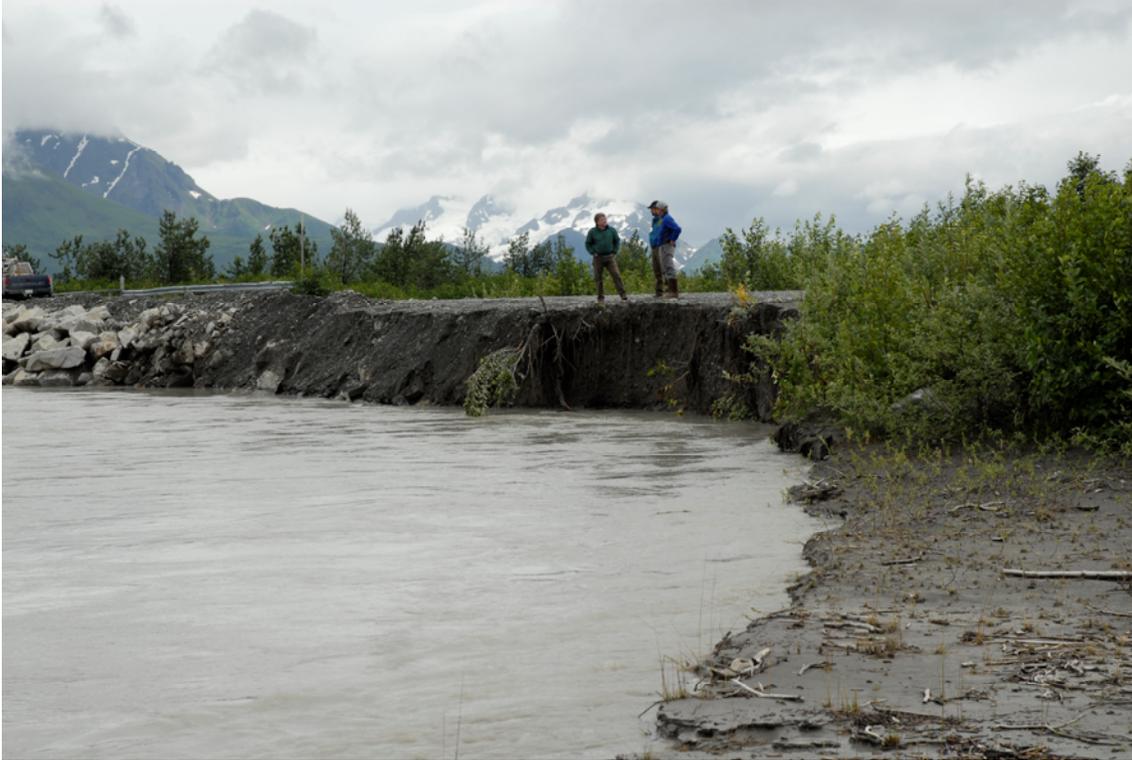
Figure 9. Photograph of the approach section to Bridge 339 showing the material that comprises the approach and the large riprap placed to protect the bank.

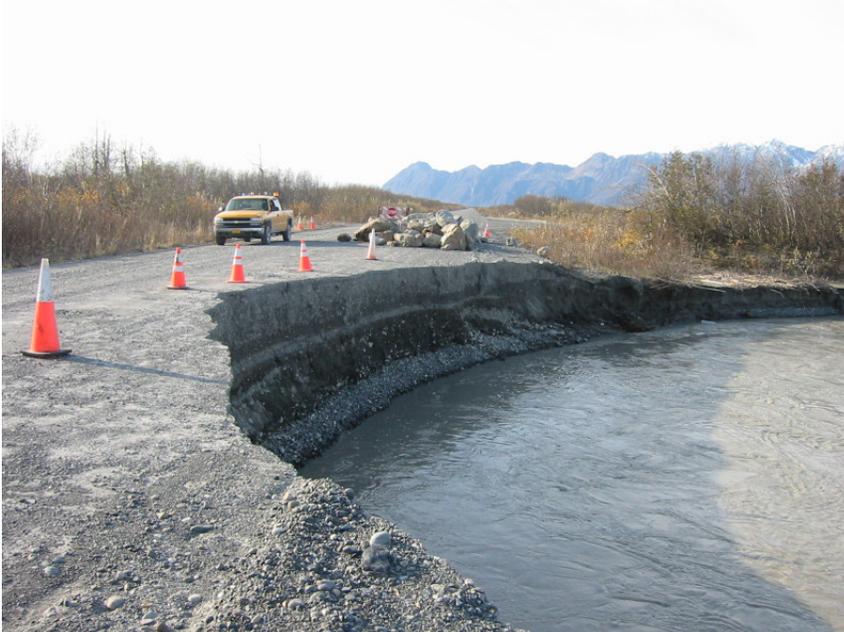
In October 2006, the Copper River Basin experienced flooding as a result of a ‘pineapple express,’ a low-pressure system that moved inward from the Gulf of Alaska. The resulting flood peak of 437,000 ft³/s at the Million Dollar Bridge was estimated to have only a 1 to 1.5 percent chance of occurrence. The peak stage at Bridge 339 was 53.47 ft, and the estimated peak discharge was 55,000 ft³/s. Although there was no structural damage to Bridge 339, the flood damaged the western approach to the bridge, almost breaching the roadway, and the heavy riprap that had been placed along the approach was washed away (fig.10). Based on the inspection of the aerial photography and discharge measurements taken after the October 2006 flood, it does not appear that any long-lasting channel changes resulted from the flood.

Figure 10. Photograph of west approach section to Bridge 339, showing damage from the October 2006 flood.

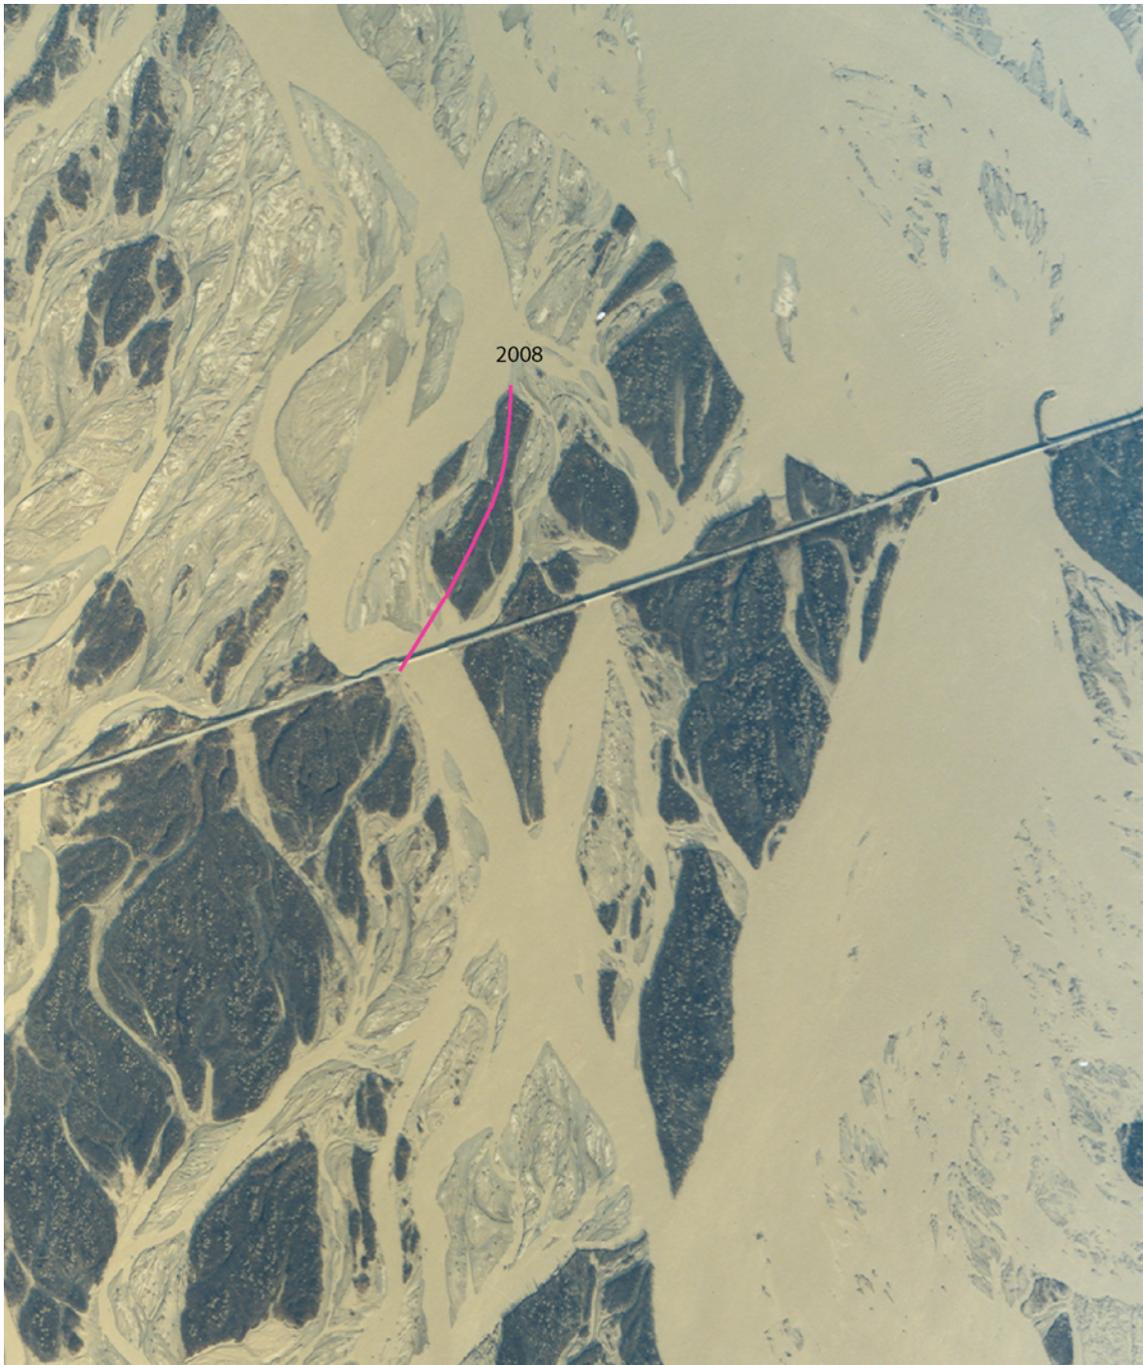
The migration of the approach channel to Bridge 339 during August – September 2008 (figs. 11–12) also is of concern to AKDOT&PF. The main channel now directly impacts the right downstream abutment, requiring placement of additional heavy riprap to reinforce the west abutment. If movement of the channel continues, flow will be directed towards the east approach (left bank) to the bridge, most likely creating the same conditions that occurred on the west approach.

Figure 11. Aerial photography of the Bridge 339 area taken in October 2006. Red line indicates the position of the left bank in August–September 2008.

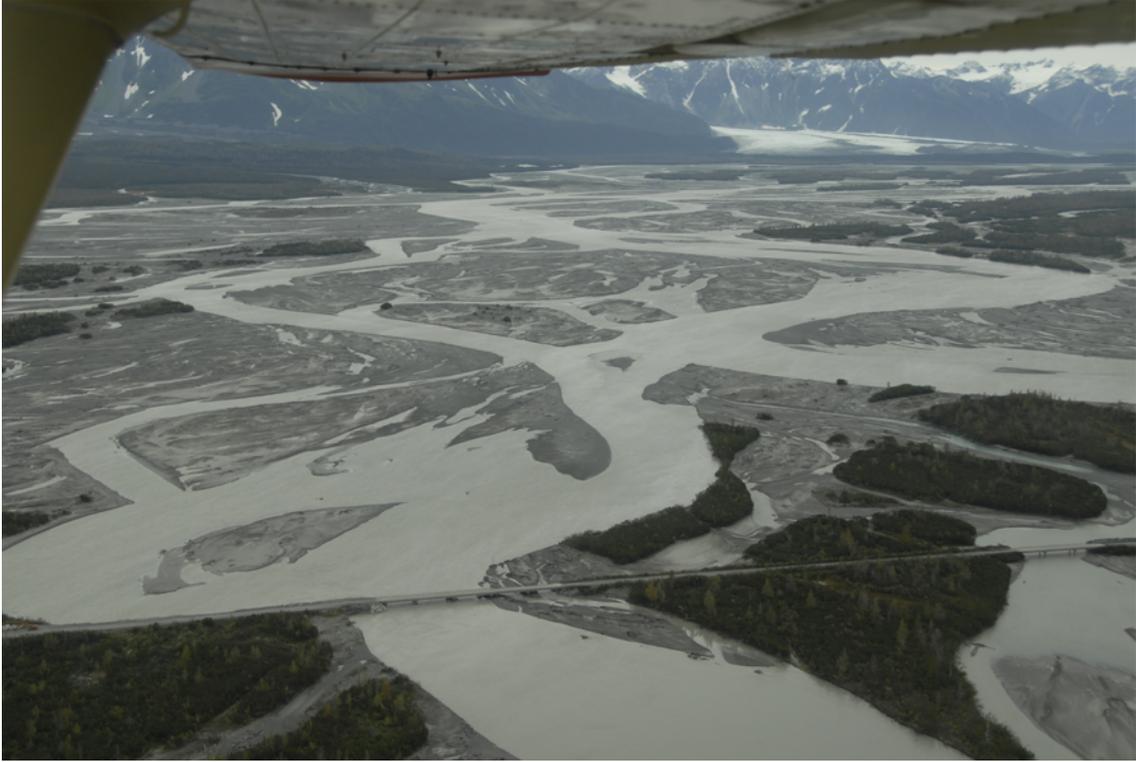
Figure 12. Photograph of Bridge 339 taken on September 29, 2008, looking upstream. The left upstream bank has eroded considerably and the main channel heads directly towards the right downstream abutment.

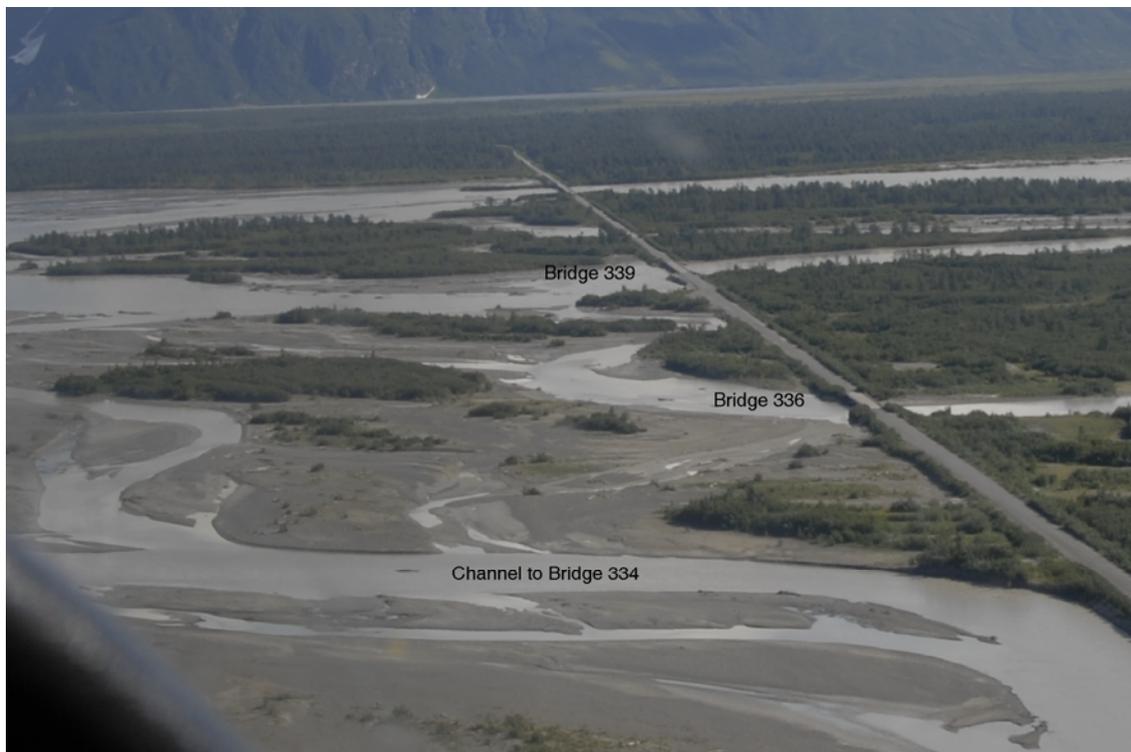
The migrating approach channel and river discharges well in excess of the design discharge at Bridge 339 have and will continue to require maintenance by AKDOT&PF at the west approach to the bridge. Additionally, the piers at Bridge 339 are subject to excessive scour and the structure itself could be at risk. The channel will continue to undercut the west approach, which consists of fine-grained material (figs. 9-10), and as a result of the undercutting, riprap will continue to be washed away and will need to be replaced. As the channel erodes in the vicinity of Bridge 339, there will be a tendency to flow into another channel towards Bridge 336 (fig. 13). Increased discharge in this channel would impact the highway in several points that have no riprap protection before passing through Bridge 336, which has a design discharge of only 8,500 ft³/s. The material of the roadbed between bridges 339 and 336 is easily erodible, and the road grade is lower than at Bridge 339. Thus, in addition to continued problems at Bridge 339, problems could also arise at Bridge 336 or along the highway between the two bridges if the approach channel to bridge 339 migrates to the west.

Figure 13. Photograph of the Copper River Highway taken in August 2007, looking east towards Bridge 336 and Bridge 339. Flow at Bridge 334 is 4,800 ft³/s, at Bridge 336 is 2,040 ft³/s, and at Bridge 339 is 24,800 ft³/s.

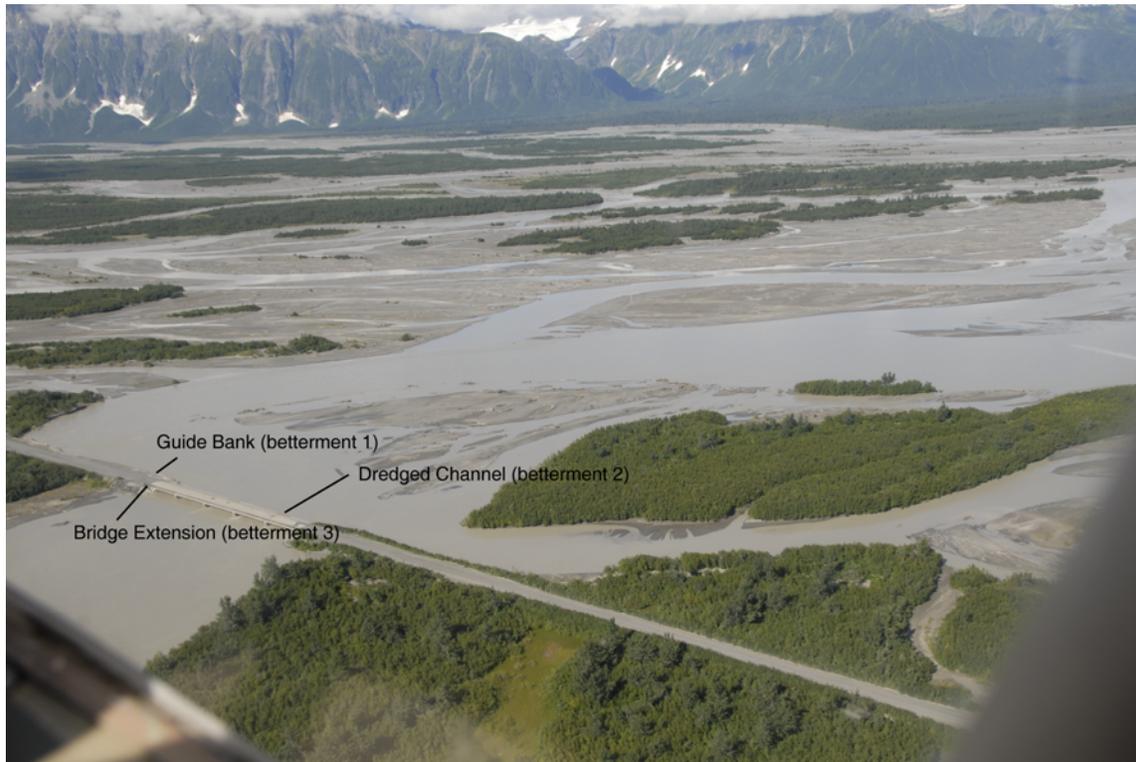
Figure 14. Photograph of Bridge 339 taken in August 2007, looking upstream.

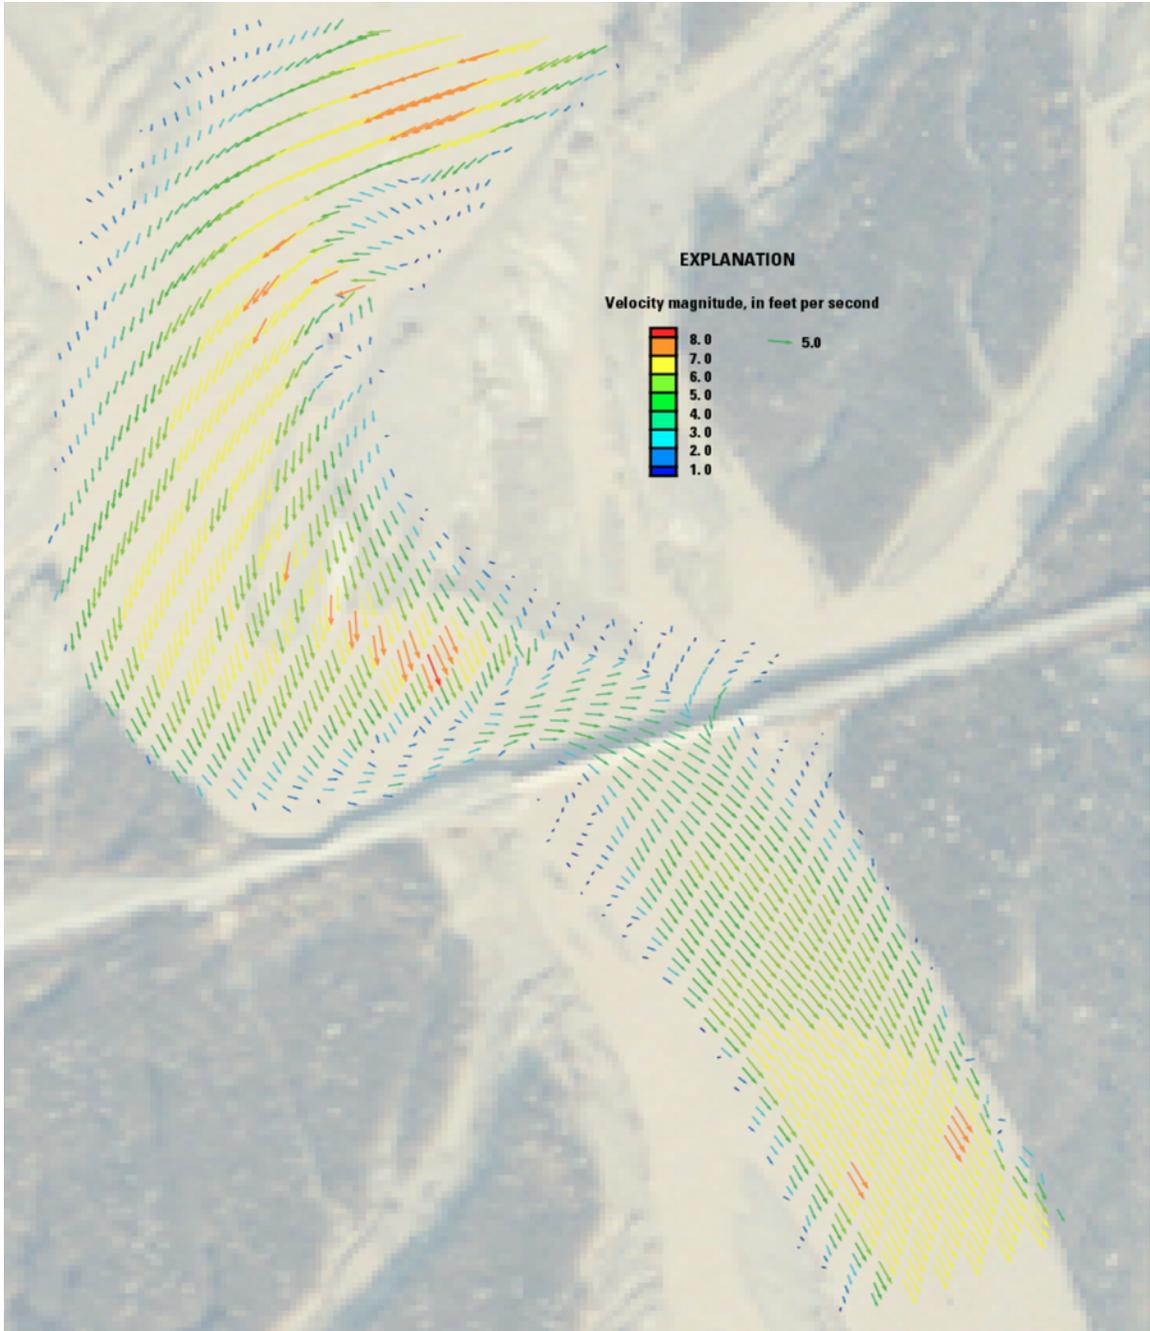
Input conditions for the simulated calibration discharge are presented in table 1 and appendix A. The output from MD_SWMS indicated an averaged predicted water-surface elevation of 51.94 ft versus the observed water surface of 51.08 ft at the bridge. Predicted velocities ranged from 3.4 to 8.6 ft/s along the right bank and the approach to Bridge 339 (fig. 15). Average velocities measured downstream for the calibration discharge ranged from 6.4 to 6.8 ft/s. Modeled shear stress values ranged from 0.21 to 1.04 lb/ft² (fig. 16). On the basis of previous work by Julien (1998), the critical shear stress for mobility of bed material with a diameter of 0.31 in. would be 0.12 lb/ft². Thus, the modeled reach would be considered a mobile bed. Based on field observations, the channel is constantly changing, thus verifying to a certain extent, the output from MD_SWMS. Although the channel is changing, it was felt the model could be used to simulate the various betterments for non-design purposes.

Figure 15. Output from MD_SWMS showing velocity vectors at the Bridge 339 reach based on a flow of 32,500 ft³/s. Aerial photograph taken October 15, 2006, when flow at Bridge 339 was approximately 25,000 ft³/s.

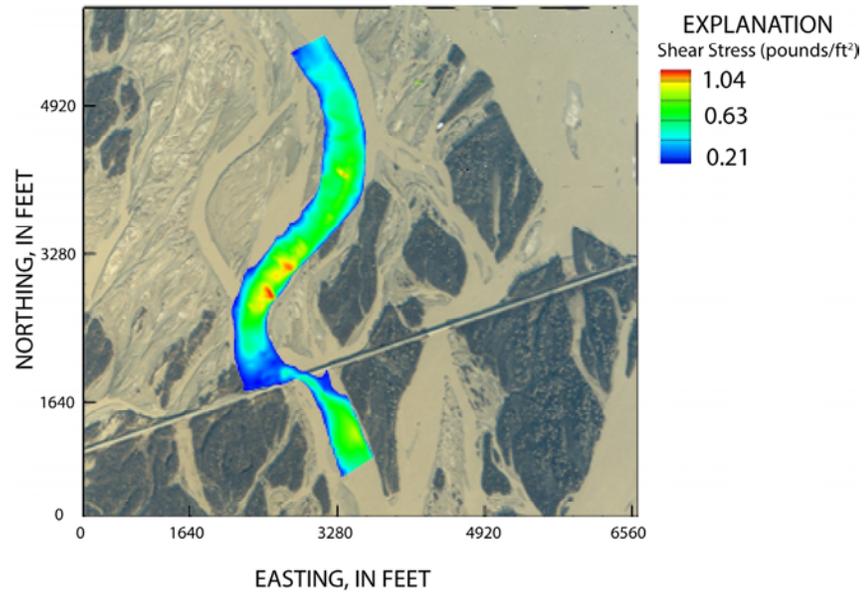
Figure 16. Output from MD_SWMS showing shear stress at the Bridge 339 reach based on a flow of 32,500 ft³/s.

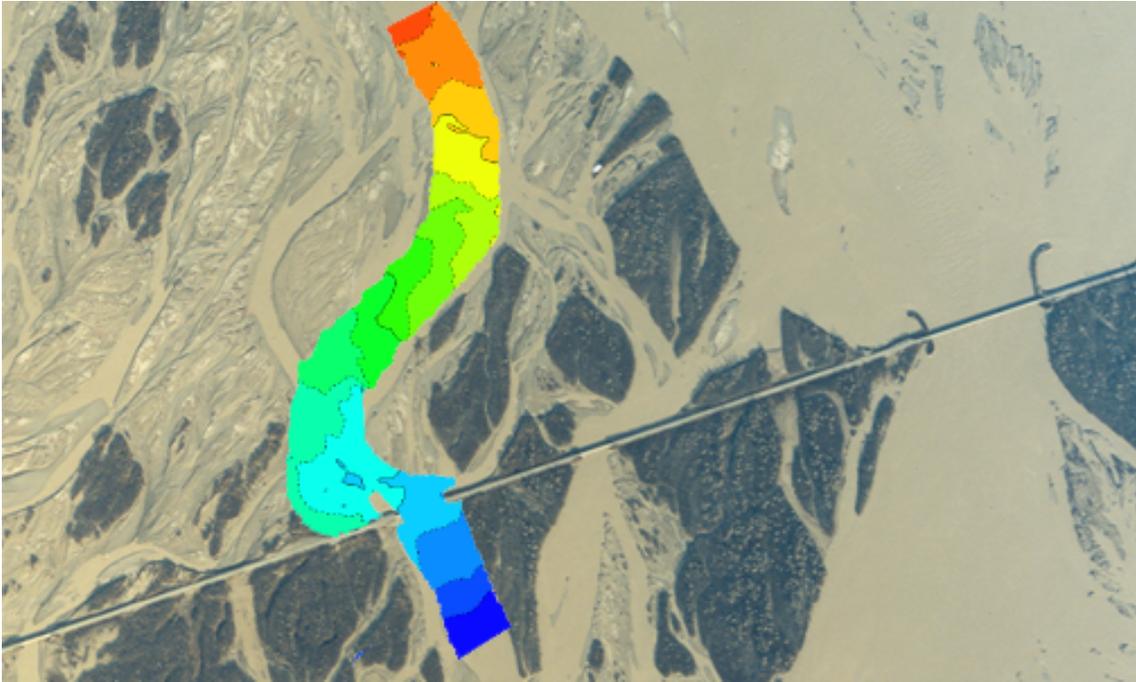
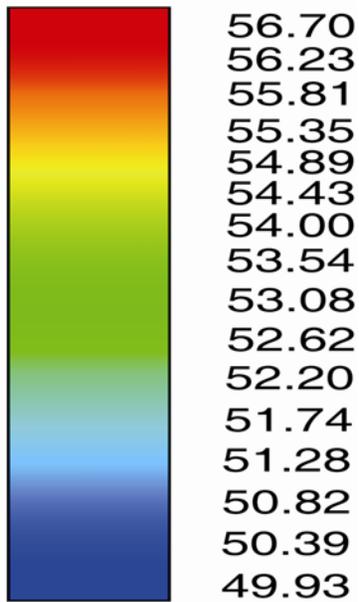
As proposed, the guide bank would be 250 ft long and constructed on the west end of the bridge. The guide bank would be perpendicular to the roadway and then angle slightly to the west. The desired effect of the guide bank would be to align the direction of flow perpendicular to Bridge 339. However, the output from MD_SWMS did not indicate this change in flow direction would take place. Velocities, velocity vectors, and bed shear stresses were nearly identical to current conditions, which would indicate that most of the flow still would be directed towards the approach and not towards the bridge (fig. 15). The simulation results indicated that the proposed guide bank would not be long enough to keep the approach channel from impacting the right bank bridge approach. A possible negative impact of the guide bank, based on the output from MD_SWMS, would be to increase the water-surface elevation along the right bank (fig. 17). Such an increase in water-surface elevation could possibly increase flow towards Bridge 336. However, no attempt was made to determine the amount of flow towards this bridge. A guide bank greater than 250 ft would limit flow towards Bridge 336.

Figure 17.—Output from MD_SWMS showing water-surface elevations at Bridge 339 based on a discharge of 32,500 ft³/s and construction of a 250 ft guide bank.

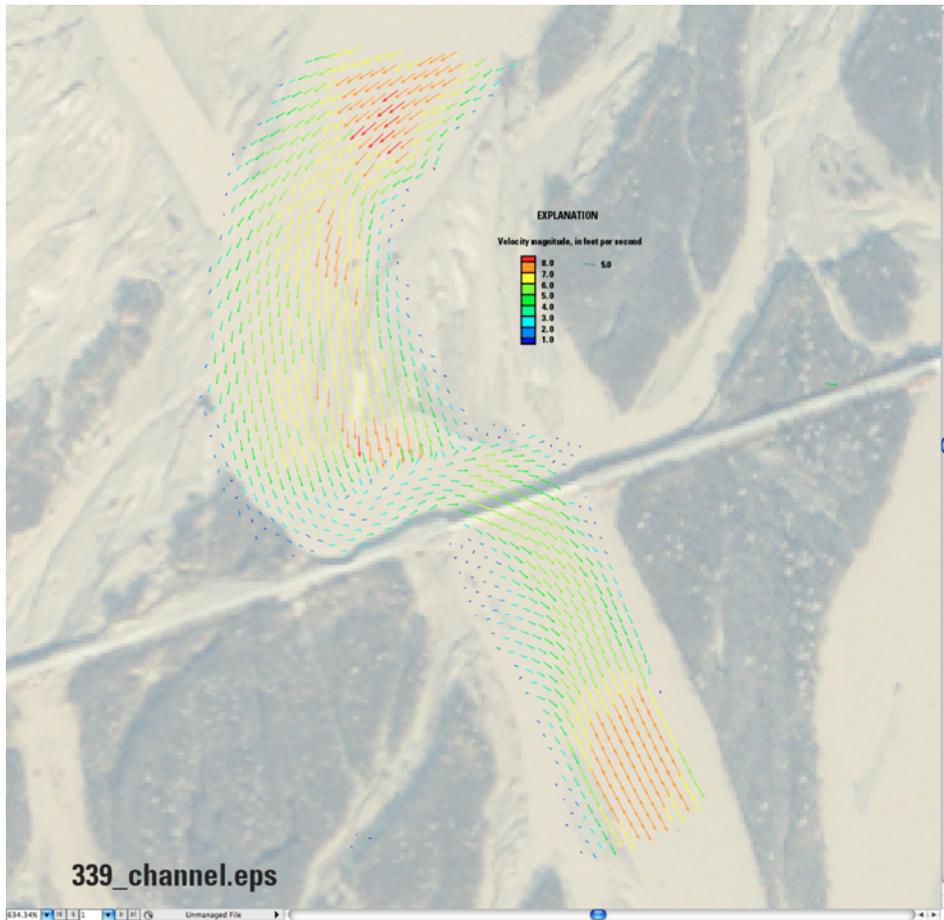
This simulation showed the highest velocities through the dredged channel, indicating that most of the flow was through this channel and perpendicular to the bridge (fig. 18). It is important to note, however, that on the basis of calculated shear stresses, the entire bed is mobile. Thus, the dredged channel could fill in when the bed is mobilized during high flow and the original channel would be re-occupied.

Figure 18. Output from MD_SWMS showing velocity vectors at Bridge 339 based on a flow of 32,500 ft³/s and re-channelization upstream from bridge.

Another proposed mitigation approach is re-channelization or dredging upstream of the bridge. The proposed dredging would begin at or near the upstream center of Bridge 339, would be 1,000 ft length, 150 ft wide, and 5 to 8 ft below the 2006 upstream bed elevation of 36 ft, and would be aligned perpendicular to the bridge opening. The desired effect of this option is to encourage the approach channel to align itself with the bridge opening. Using these geometric parameters, the channel bathymetry was modified and input to MD_SWMS.

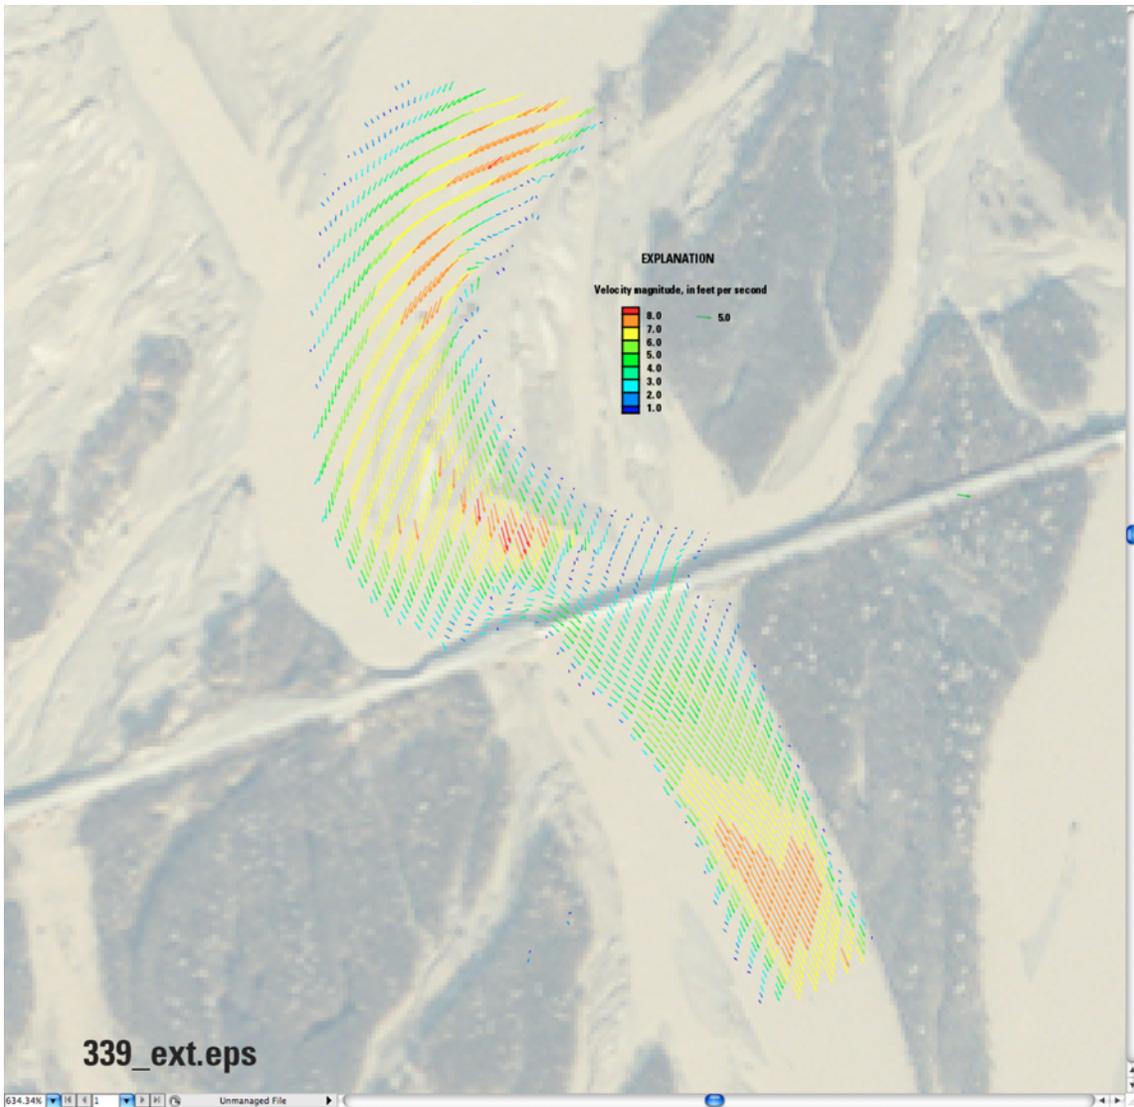
If Bridge 339 were extended 240 ft to the west, simulation results showed that water velocity and the corresponding velocity vectors were lower than the calibration conditions and were more uniform across the channel (fig. 19). Thus, flow would be more nearly centered through the bridge. On the basis of calculated shear-stress values, the channel would still be mobile, but the potential for scour would be reduced due to the lower shear-stress values. Based upon surveyed cross sections from 2005 to 2008, the flow tends to occupy discrete portions of the channel rather than its entire width. If this trend continues, an increase in the bridge opening would do little to mitigate scour.

Figure 19. Output from MD_SWMS showing velocity vectors at Bridge 339 based on a flow of 32,500 ft³/s and extending the bridge 240 ft to the west.

The third betterment analyzed was an extension of Bridge 339. Currently, it would appear that any extension of Bridge 339 should be to the west, but a thorough analysis of channel migration should be done before a final decision is made. Because the main channel is currently on the right bank and a bridge extension would consist of 80-ft sections, for this scenario, a 240 ft extension of Bridge 339 to the west was used for modeling purposes.
