## Triggered Surface Slips in Southern California Associated with the 2010 El Mayor-Cucapah, Baja California, Mexico, Earthquake

**Open-File Report 2010-1333**

**Jointly published as California Geological Survey Special Report 221**

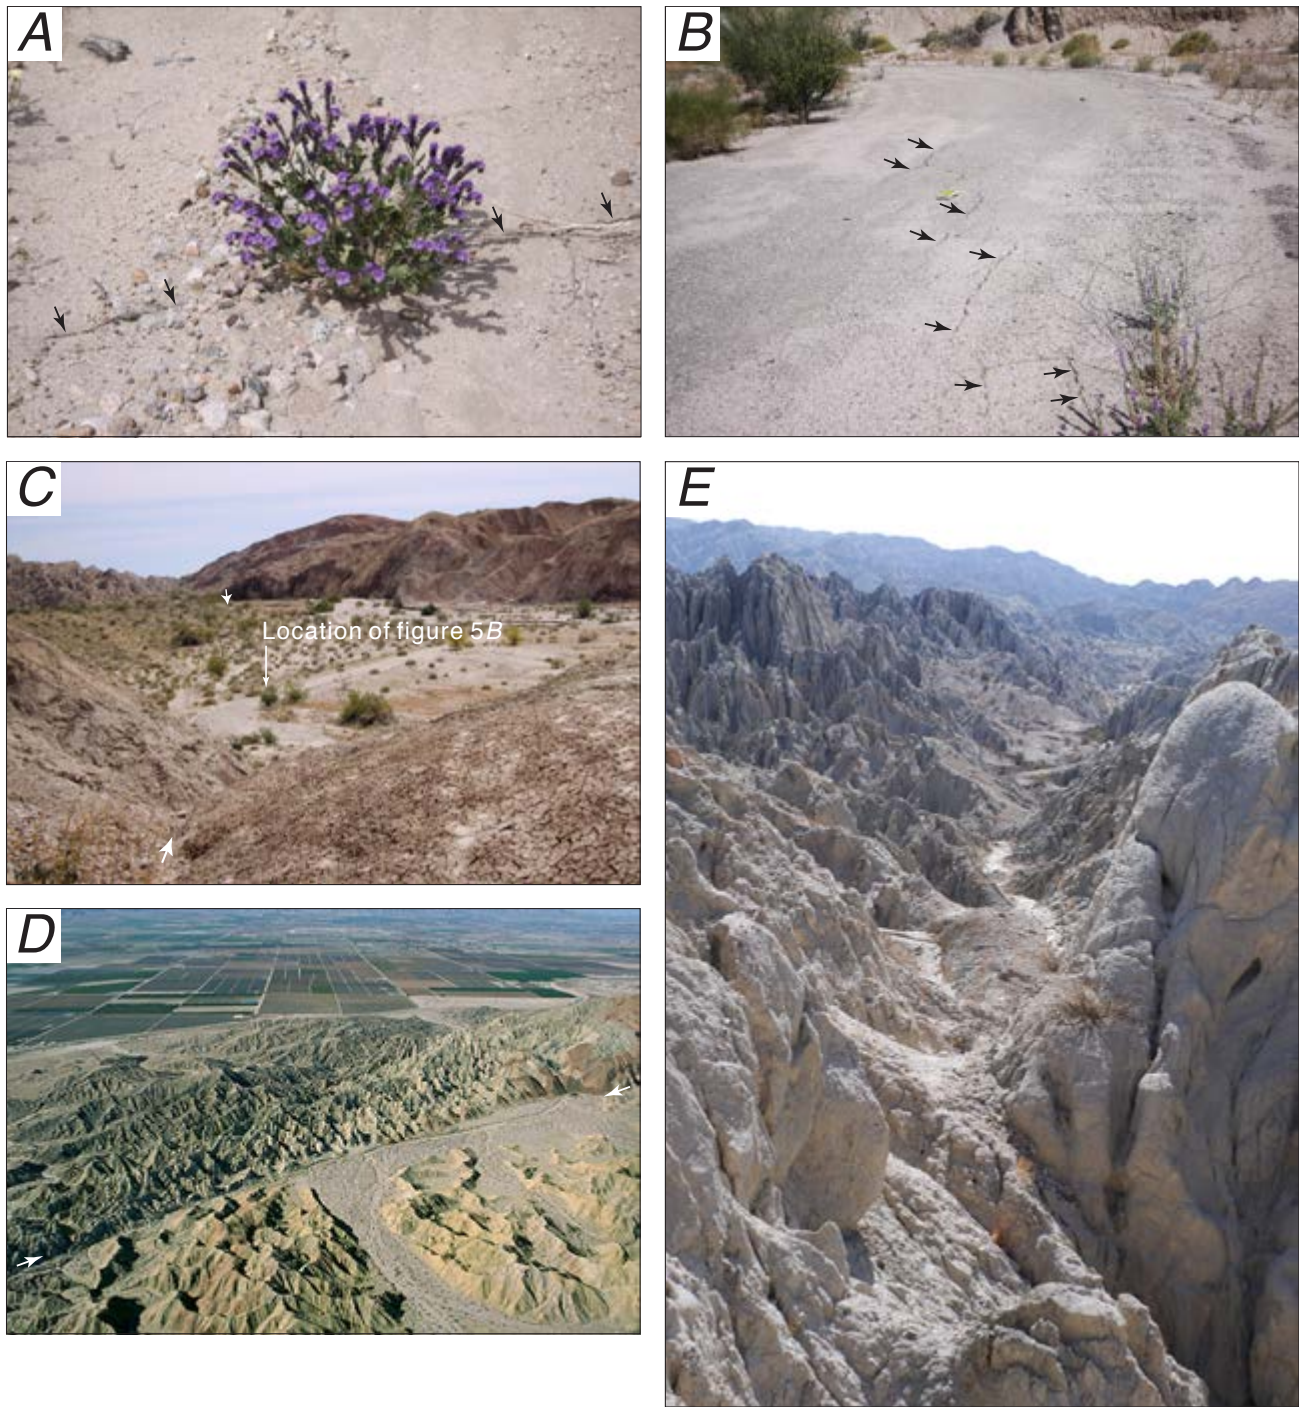
**Figure 5.** Photographs of fractures formed in response to the El Mayor-Cucapah earthquake and views of the San Andreas Fault in southeastern Coachella Valley. *A*, Fractures (black arrows) along San Andreas Fault in active wash between Thermal Canyon and Quarry Canyon; view to the northeast (see fig. 4, panel A–B for location). Photograph taken April 20, 2010, by K.J. Kendrick. *B*, Left-stepping fractures (black arrows) along San Andreas Fault in gravel road in Quarry Canyon. Photograph taken April 20, 2010, by K.J. Kendrick; view to the northwest. Green notebook in center of view for scale. *C*, View along San Andreas Fault (between white arrows) in Quarry Canyon; view to the southeast. Photograph taken April 20, 2010, by K.J. Kendrick. *D*, Oblique aerial view of San Andreas Fault (between white arrows) near Red Canyon; view to the west. Location of image shown in figure 4, panel B–C. Dark reddish-brown deposit beyond right white arrow is a sandy mudstone that was tectonically emplaced along this section of the San Andreas Fault. *E*, View along San Andreas Fault between Red Canyon and Painted Canyon; view to the southeast.

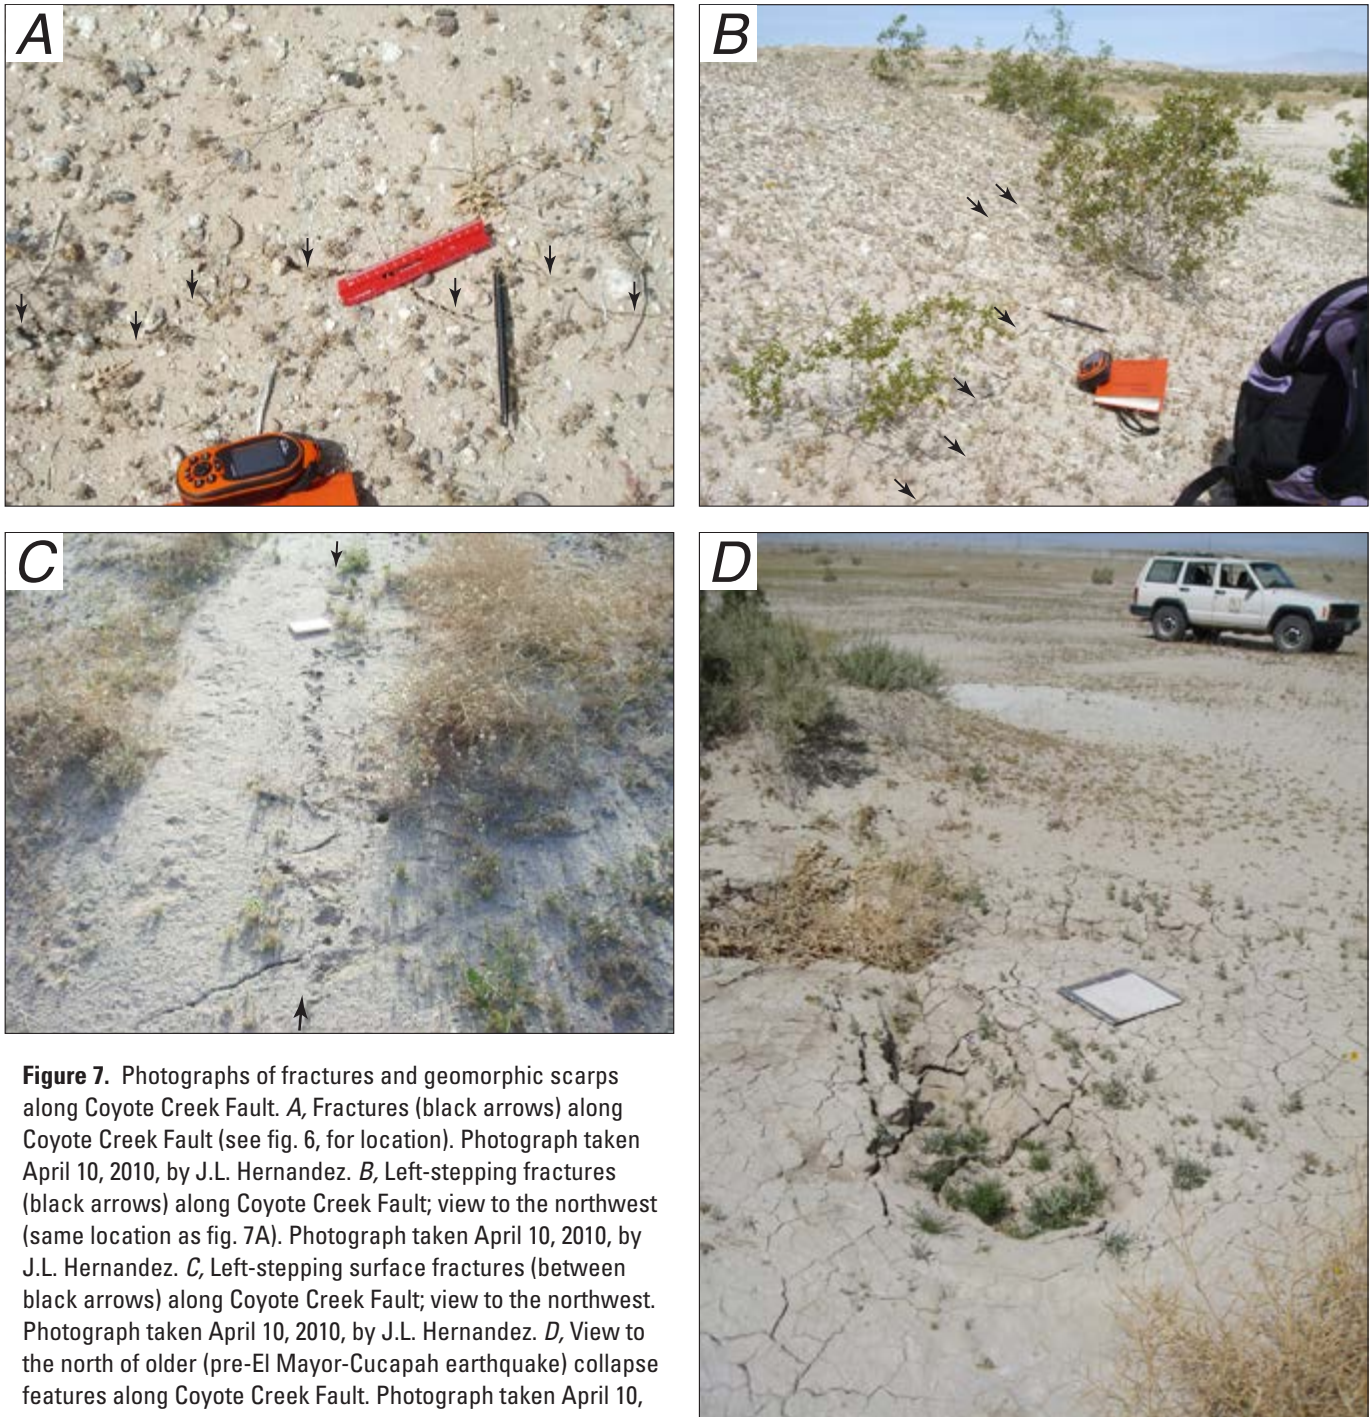
1987; the first of these was primary (coseismic) tectonic slip (Clark, 1972) and the second was slip triggered by the 1987 Superstition Hills earthquake (Hudnut and Clark, 1989). In 2010, discontinuous surface breaks formed along the Coyote Creek Fault over a distance of about 5 km (figs. 1, 6; table 1), at distances of 119–122 km from the El Mayor-Cucapah epicenter (table 1). The distribution and amounts of triggered slip were remarkably similar to those observed by Hudnut and Clark (1989) for the 1987 event. Breaks developed primarily in one broad area, immediately southeast of the Ocotillo Badlands (figs. 6, 7A–C) and in two, short isolated patches to the southeast (fig. 6). Displacements were small. Maximum measured dextral slip was only 16 mm. A feature of interest

**Figure 7.** Photographs of fractures and geomorphic scarps along Coyote Creek Fault. *A*, Fractures (black arrows) along Coyote Creek Fault (see fig. 6, for location). Photograph taken April 10, 2010, by J.L. Hernandez. *B*, Left-stepping fractures (black arrows) along Coyote Creek Fault; view to the northwest (same location as fig. 7A). Photograph taken April 10, 2010, by J.L. Hernandez. *C*, Left-stepping surface fractures (between black arrows) along Coyote Creek Fault; view to the northwest. Photograph taken April 10, 2010, by J.L. Hernandez. *D*, View to the north of older (pre-El Mayor-Cucapah earthquake) collapse features along Coyote Creek Fault. Photograph taken April 10, 2010, by J.A. Treiman.

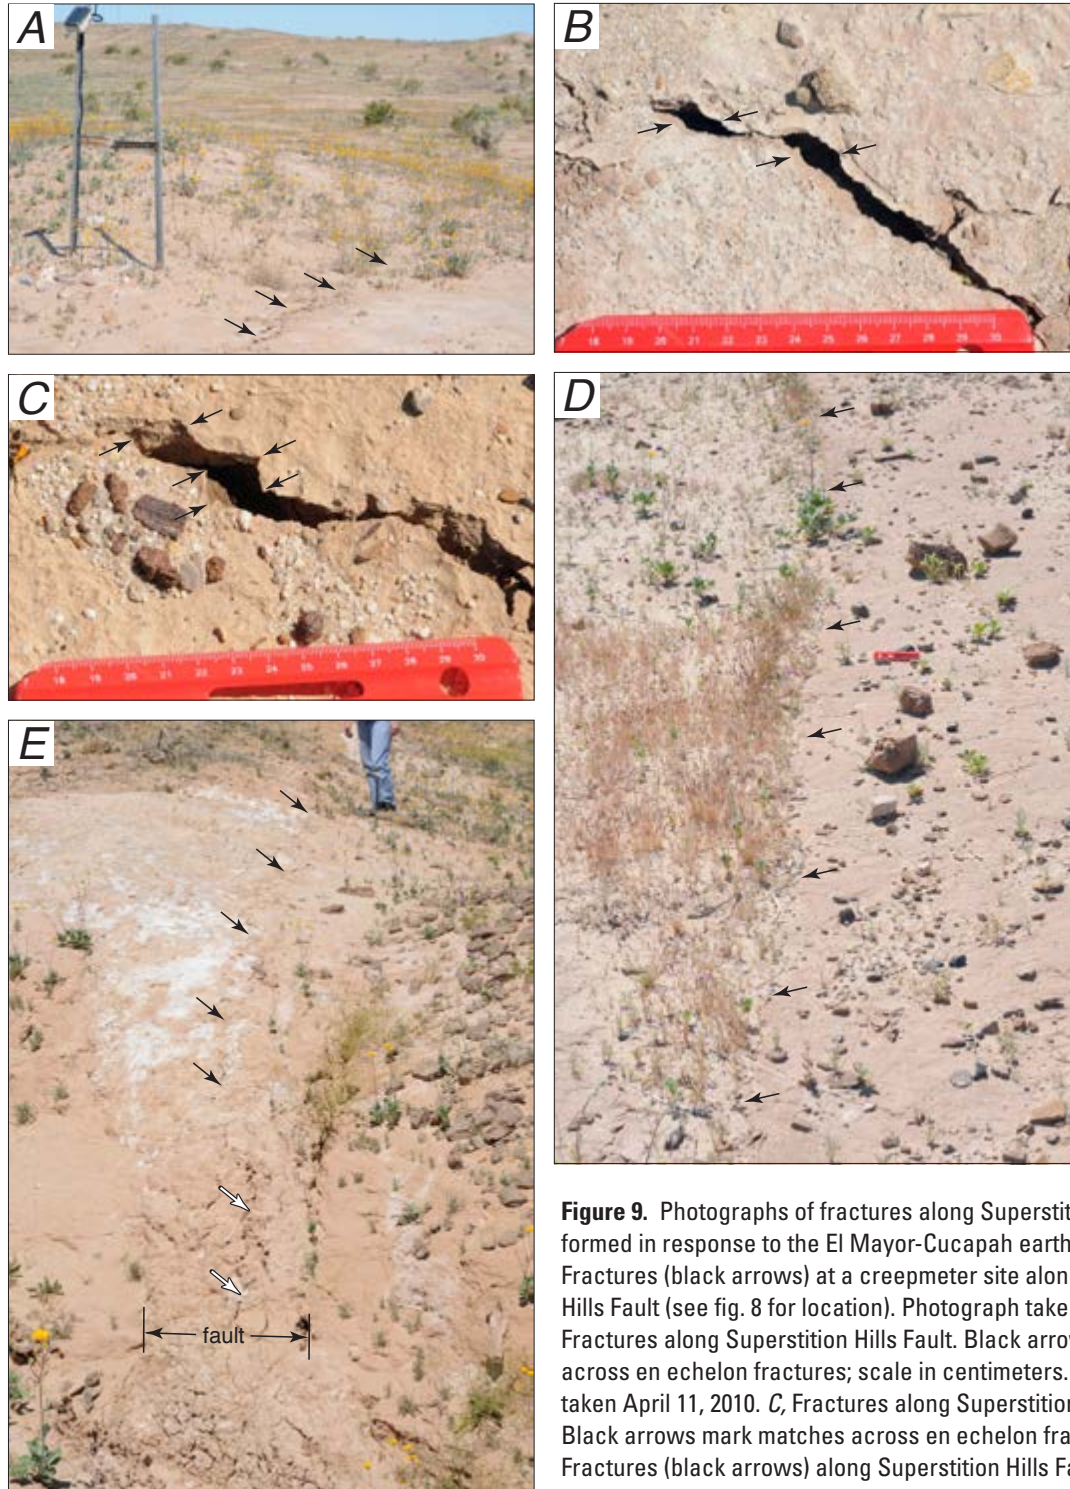
Observed offset was small, less than 16 mm (figs. 8, 9A–C). The amount of dextral slip was largest near the southeastern end of the central or Imler strand (fig. 8). Locally, a small vertical component of slip was measured; nowhere did

One of the most remarkable similarities between prior triggered slip events and the 2010 event is in the reoccupation of surface breakage localities. In each event, surface deformation occurred within a few centimeters of previous locations. Nail arrays and wooden-peg arrays placed across the Superstition Hills Fault following the 1987 primary surface faulting were offset by the El Mayor-Cucapah earthquake in exactly the same place as in 1987 and in intervening afterslip and triggered slip events. Figure 9D shows a site where slip was observed in 2010 and previous triggered slip events, all of which are superimposed on a preexisting fault scarp. At this location, the Superstition Hills Fault has juxtaposed different lithologies (siltstone against sandstone) that produce a pronounced vegetation lineament. Local, deep stream-cut exposures that cross the Superstition Hills Fault document the persistence of surface slip locations (fig. 9E).

**Figure 9.** Photographs of fractures along Superstition Hills Fault formed in response to the El Mayor-Cucapah earthquake. *A*, Fractures (black arrows) at a creepmeter site along Superstition Hills Fault (see fig. 8 for location). Photograph taken April 8, 2010. *B*, Fractures along Superstition Hills Fault. Black arrows mark matches across en echelon fractures; scale in centimeters. Photograph taken April 11, 2010. *C*, Fractures along Superstition Hills Fault. Black arrows mark matches across en echelon fractures. *D*, Fractures (black arrows) along Superstition Hills Fault; view to the southeast. The fault has juxtaposed relatively clay-rich and sand-rich strata from the same mid-Pleistocene sedimentary sequence, the transition expressed as a vegetation lineament. Photograph taken April 8, 2010. *E*, Fractures (black arrows) along Superstition Hills Fault where ground surface is cut by a gulley. Fractures (white arrows) continue into near-vertical gulley exposure, where Quaternary fault (see label) is visible; view to the northwest. Photograph taken April 8, 2010.

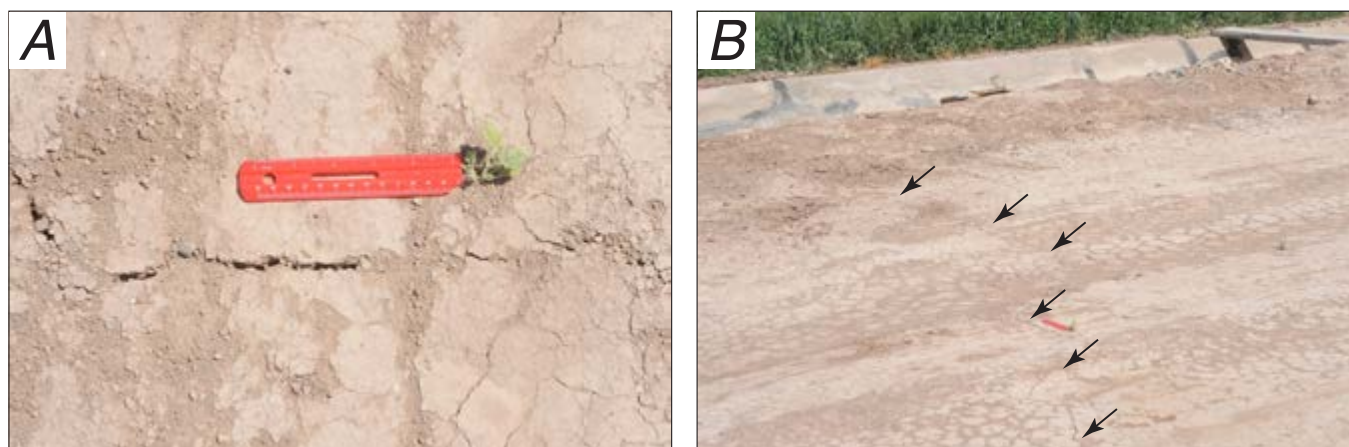
where the fault had broken the surface during a swarm of microearthquakes in 2005 (Lohman and McGuire, 2007; Rymer, Hudnut, and Kendrick, unpublished work). The 2005 slip event resulted in a series of fault breaks about 170 m long that vertically offset a concrete-lined canal. Slip on the Kalin Fault manifests as nearly pure vertical slip. In 2005 the ground surface was freshly warped, if not also faulted, for a distance extending north-northeastward from the offset canal liner at least 800 m into an adjacent field of dense crops (figs. 11, 12*B*).

**Figure 12.** Photographs of Kalin Fault and surface fractures formed in response to the 2010 El Mayor-Cucapah earthquake. *A*, Vertical view of fractures with 14-cm-long scale. *B*, View of fractures across dirt roadway. Concrete canal liner (at top of photo) was not broken by new fractures. Photographs taken April 10, 2010.

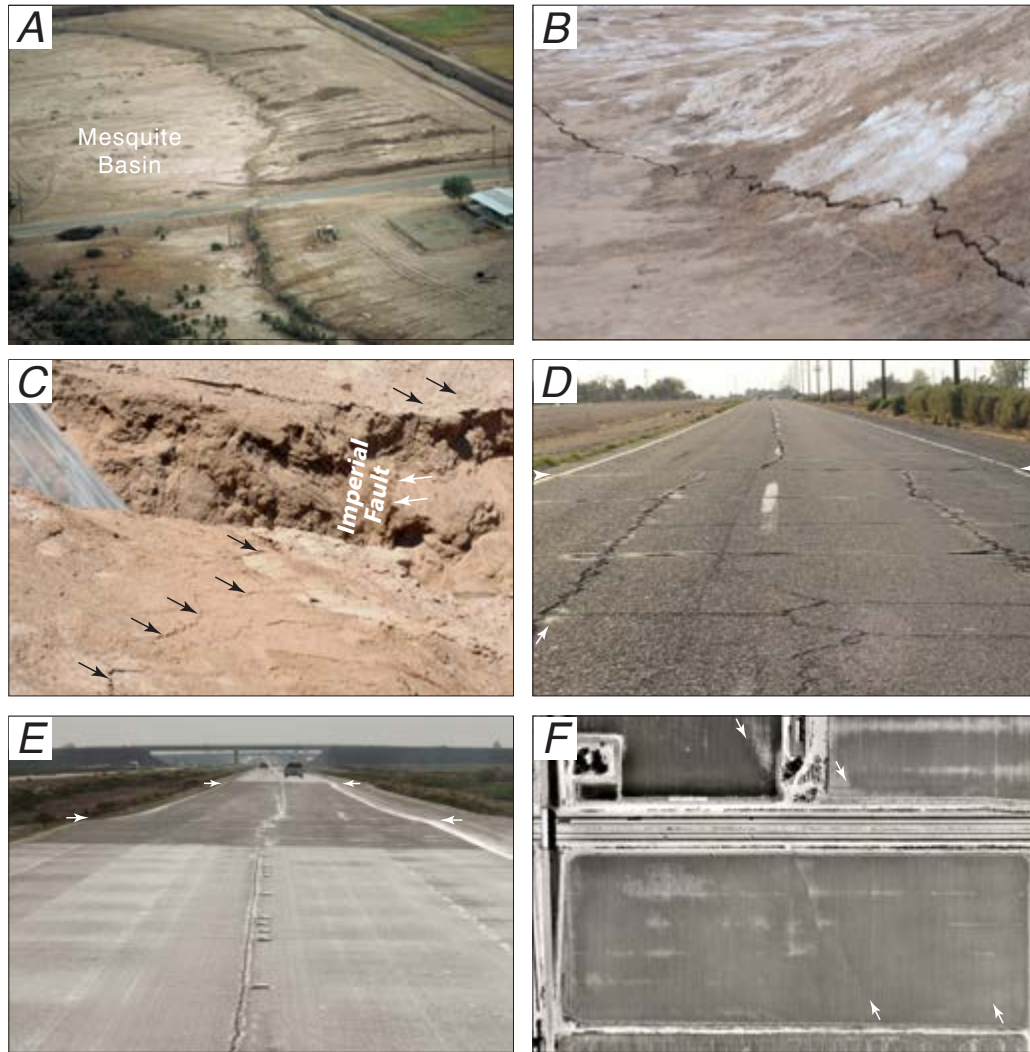
As with the San Andreas and Superstition Hills Faults, the location of surface breakage in 2010 along individual traces of the Imperial Fault closely matches the location of earlier triggered slip and primary surface rupture. Fresh surface breaks, where they occurred, formed in exactly the same place as previous slip features. In fact, both right-oblique slip and pure dextral slip recur in previously documented locations. Figure 14 shows a variety of locations with evidence of repeated slip, both in historical and geologic time. Figure 14A shows evidence of recurrent movement along the Imperial Fault near the base of a prominent scarp at Harris Road and along the southwest margin of Mesquite Basin (see fig. 1). Although surface rupture shown in figure 14A occurred in 1979, subsequent triggered slip events occurred in 1981, 1987, and 1999 at exactly the same location. In fact, figure 14B shows surface fractures that occurred in association with the 2010 El Mayor-Cucapah earthquake along the same persistent fault scarp.

Other examples of the recurrent movement of the fault and persistence in location of rupture or fracturing are shown in figures 14C–F. Fresh fractures across the ground surface and within an open paleoseismic trench exposure (of R. Tsang,

A. Meltzner, and T. Rockwell) align with the fault plane in the near surface at this location along the Imperial Fault (fig. 14C). Figure 14D shows surface expression and evidence of tectonic offset from the 1940 and 1979 earthquakes and their respective afterslips. This 2009 view to the west along Evan Hewes Highway shows the cumulative slip where the fault crosses the pavement. Unfortunately for geologic investigations, this roadway was repaved in the months before the 2010 El Mayor-Cucapah earthquake. The photograph was taken in March 2009, and a subsequent visit to the site revealed the same scene in June 2009. Movement on the Imperial Fault (identified by white arrows on the sides of the photo) has offset the center paving joint (center of road on distant side of fault and white arrow in bottom-left of image). We did not observe fresh surface fractures at this location following the El Mayor-Cucapah earthquake. This is consistent with other, nearby observations of no new slip. However, Interstate 8 was offset in 2010 (fig. 14E, F). We measured surface fractures on the northern frontage road of I-8 (to the left in fig. 14E; fig. 13, panel Y–Z). Figure 14F shows approximately the same area as figure 14E but is a vertical aerial view taken immediately after the 1979 Imperial Valley

**Figure 14.** Photographs of surface fractures and long-term offset of features along the Imperial Fault. *A*, Aerial photograph of the Imperial Fault at Harris Road. Photograph taken October 1979, shortly after the 1979 Imperial Valley earthquake. View to the southwest. *B*, Locally continuous, right-oblique surface fractures along Imperial Fault; view to the southwest. Photograph taken about 70 m south of Harris Road; photograph shows about 4 meters of surface fractures. Photograph taken April 5, 2010. *C*, Right-lateral surface fractures along Imperial Fault across and through a paleoseismic trench exposure. Photograph shows surface fractures (black arrows) and fresh fractures in a vertical exposure in the trench wall (white arrows), along edge of long-term Imperial Fault; view to the south. Photograph taken April 11, 2010. *D*, Right-lateral fault offset at Evan Hewes Highway due to recurrent movement on the Imperial Fault. View to the west. Photograph taken March 12, 2009; roadway was resurfaced some time between June 2009 and April 2010. *E*, Right-lateral fault offset at I-8 due to recurrent movement on the Imperial Fault; view to the east. Photograph taken April 11, 2010. *F*, Vertical aerial photograph of the Imperial Fault and I-8, showing two fault traces (between white arrows) in a structural stepover (compare with fault map in fig. 13). North is at top in this view. Photograph taken October 16, 1979.

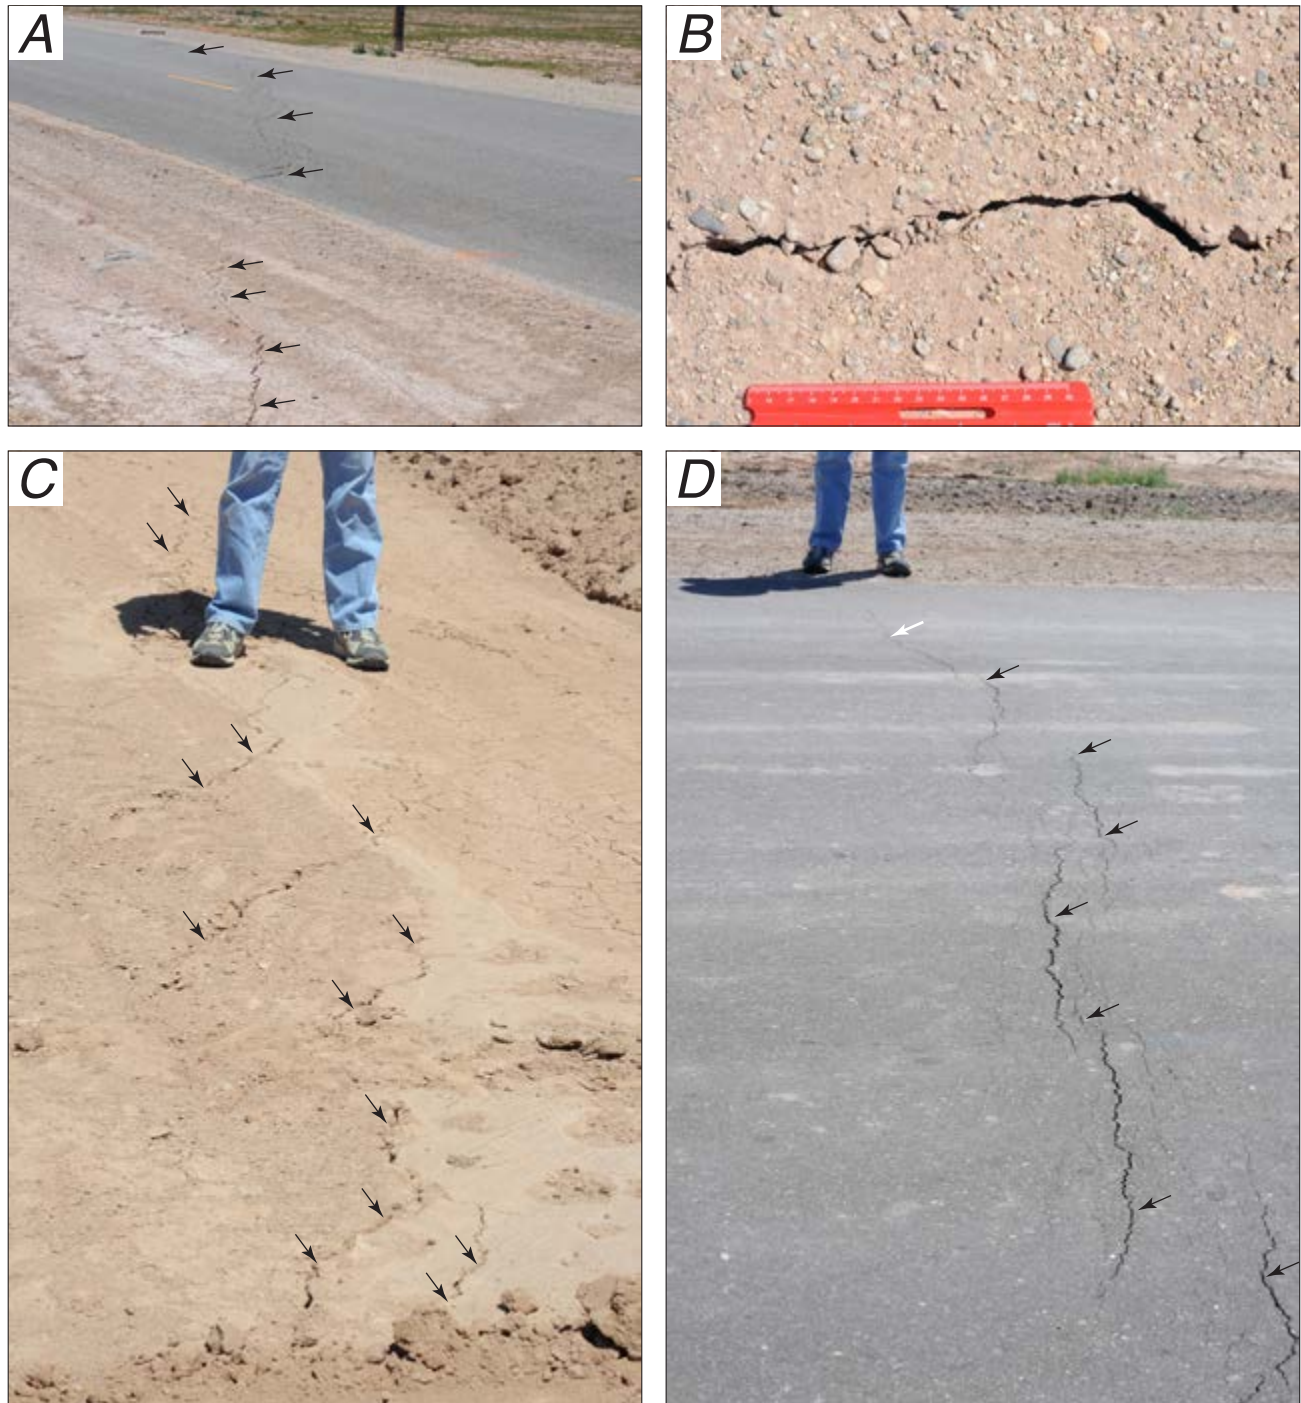
**Figure 16.** Photographs of surface fractures along Brawley Fault Zone in response to the 2010 El Mayor-Cucapah earthquake. *A*, Surface fractures (black arrows) along Brawley Fault Zone and across McConnell Road; view to the southwest. Photograph taken April 9, 2010. *B*, Close-up view of fresh surface fractures along Brawley Fault Zone in shoulder of Harris Road; scale in centimeters. Photograph taken April 9, 2010. *C*, Left-stepping, fractures (black arrows) along Brawley Fault Zone and across shoulder of Harris Road; view to the north. Photograph taken April 9, 2010. *D*, Fresh surface fractures (black arrows) along Brawley Fault Zone and across Ralph Road; view to the north. Slight vertical component of slip (2 mm, up on east [right] side) more noticeable at white arrow. Photograph taken April 9, 2010.

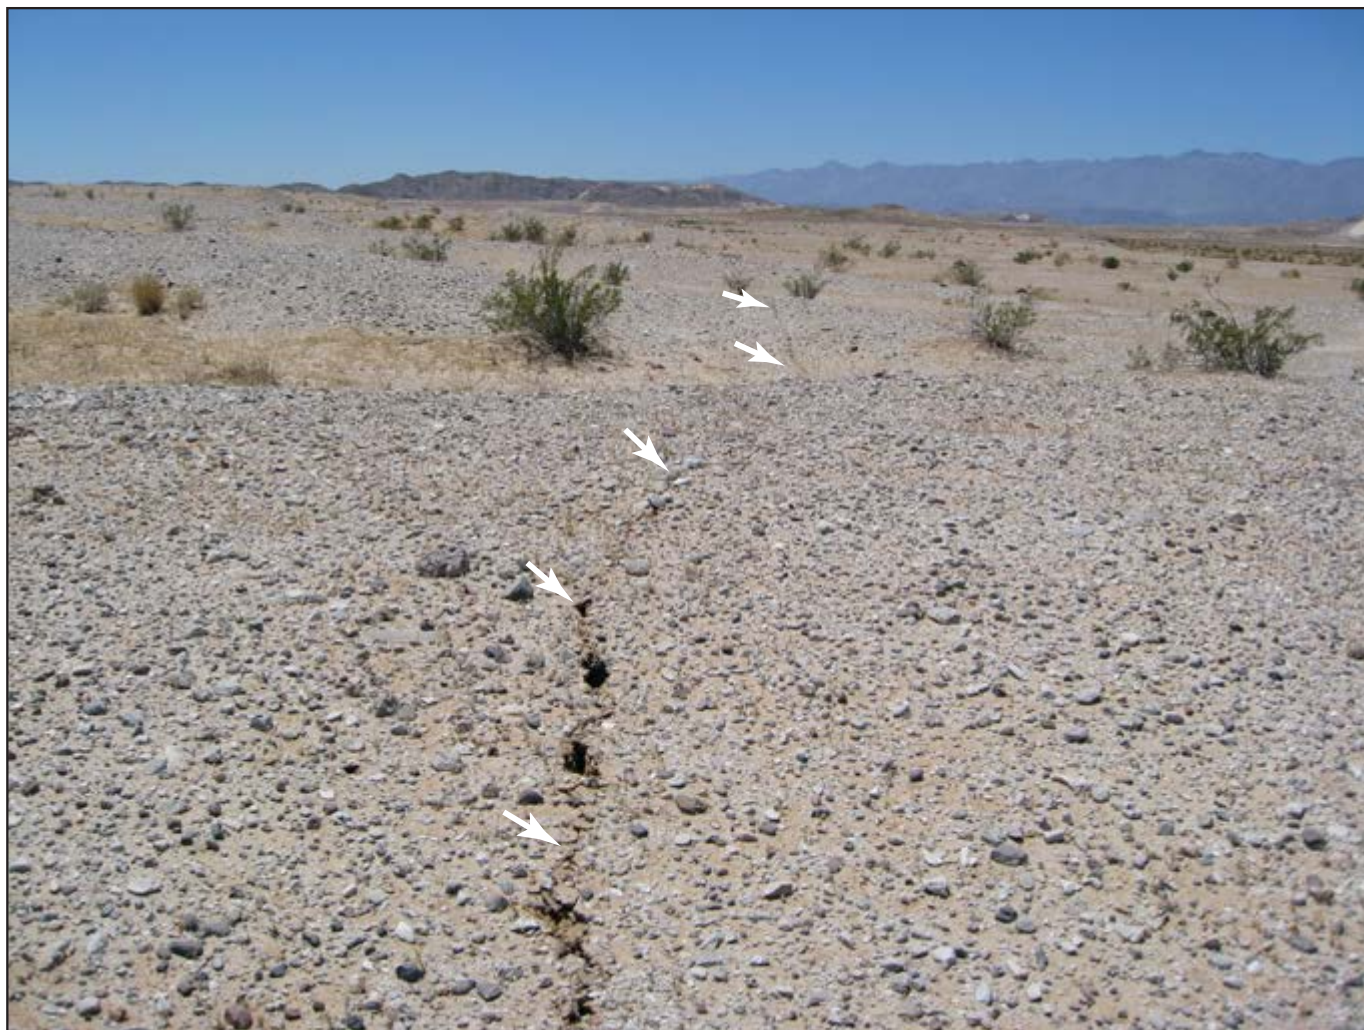
**Figure 20.** Photograph of surface fractures along fault south of Pinto Wash; view to the northeast. See figure 19 for location. Photograph taken June 18, 2010, by J.A. Treiman.

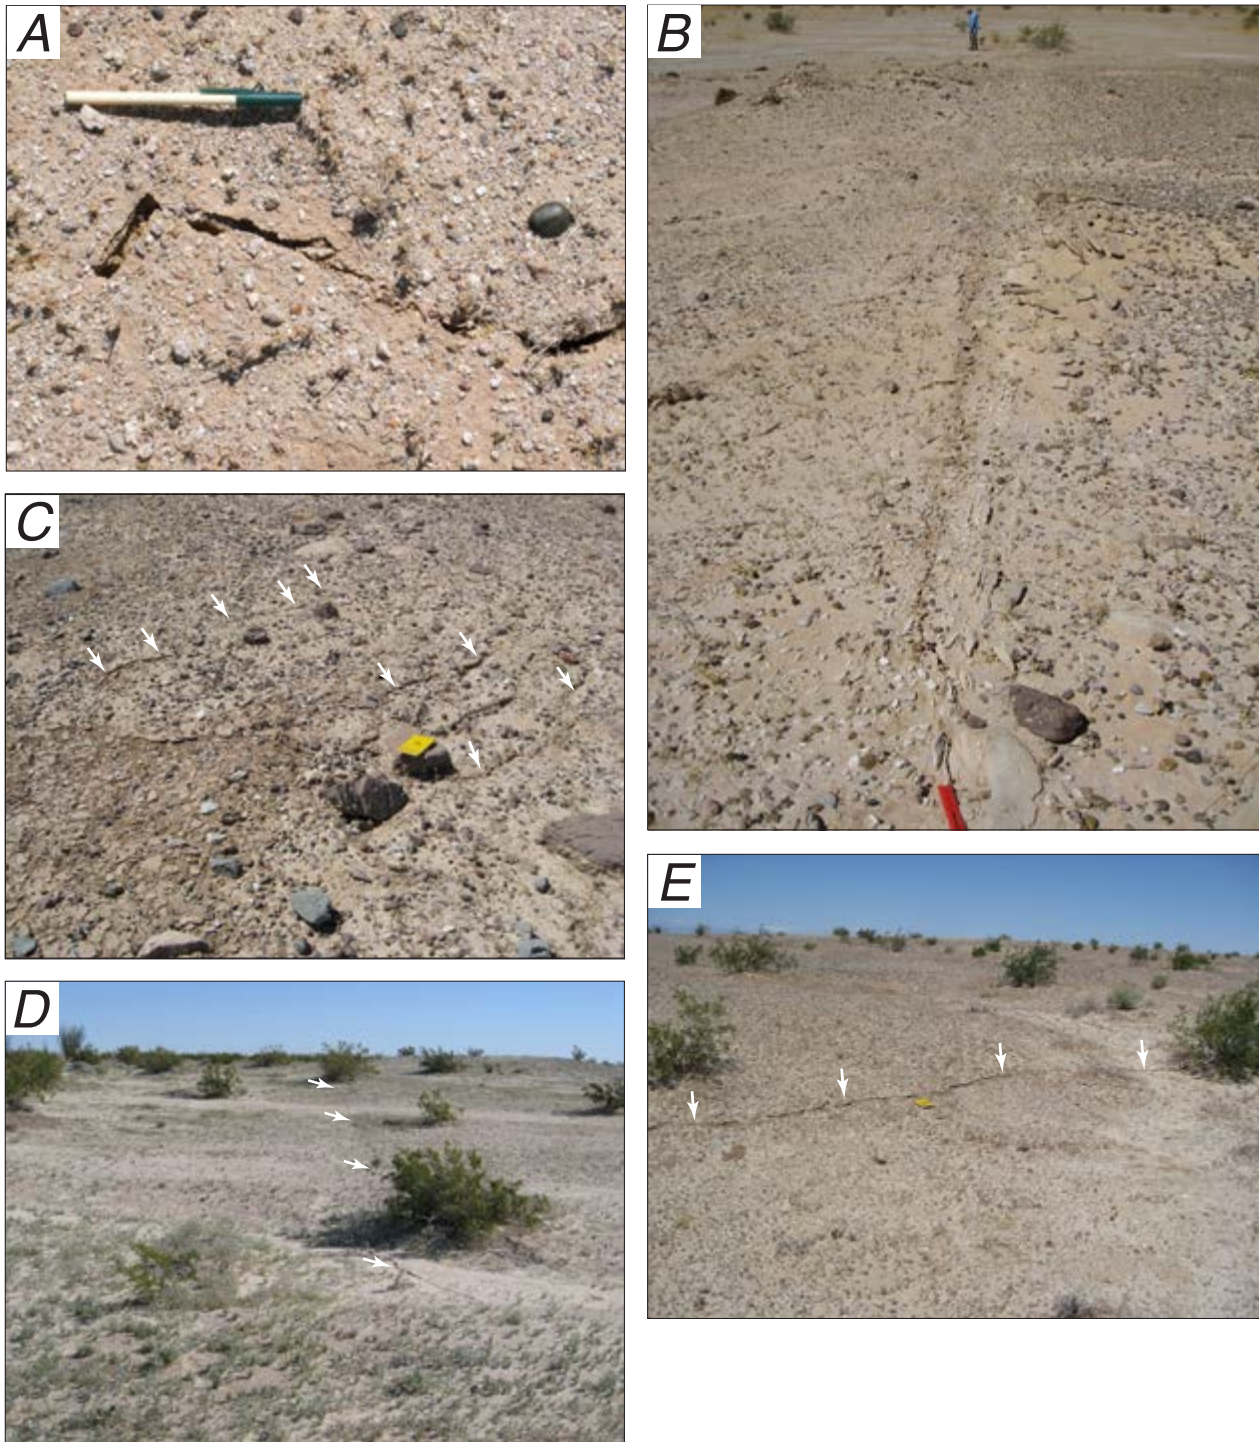
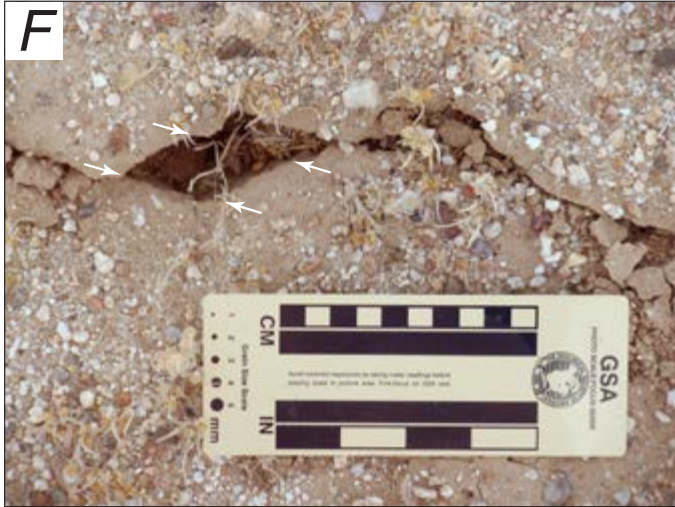
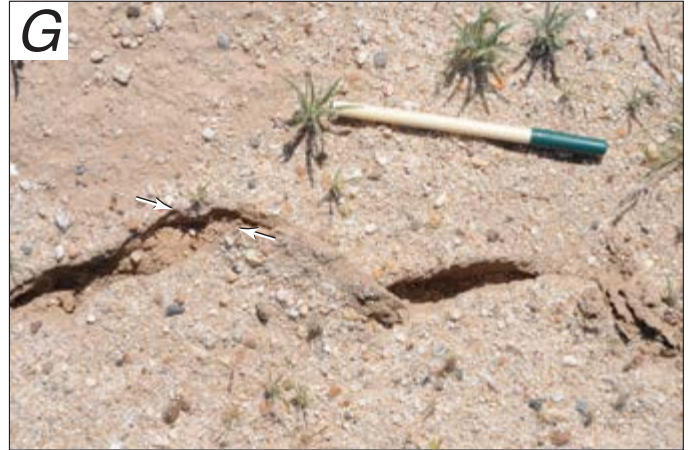
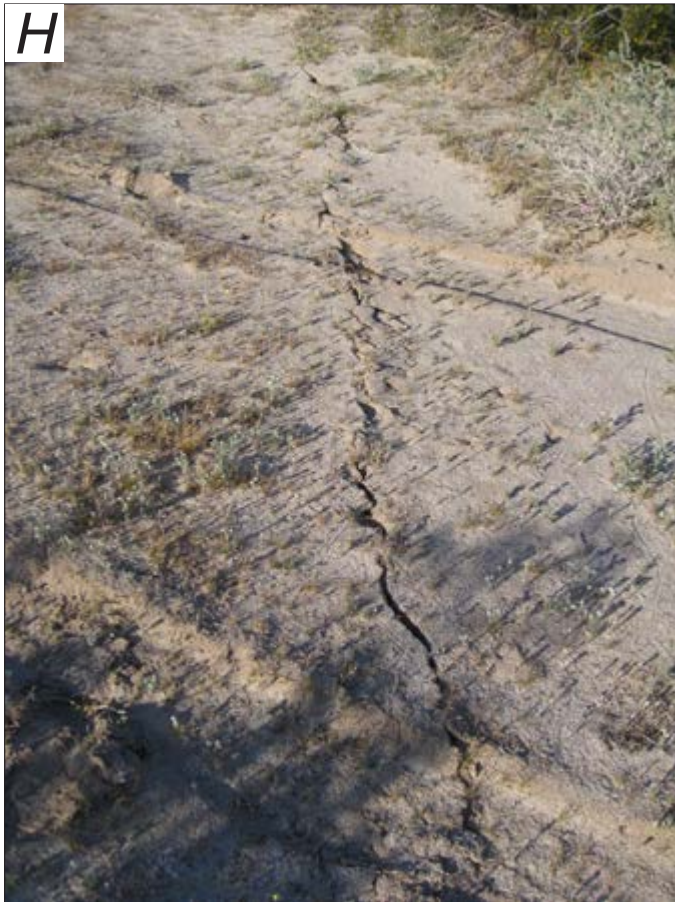
**Figure 22.** Photographs of fractures and Quaternary fault scarps along faults shown in figure 21. *A*, Left-lateral fractures along unnamed fault south of Pinto Wash, pen for scale. Photograph taken June 18, 2010. *B*, Continuous left-lateral fractures along unnamed fault south of Pinto Wash (surface slip extends between red scale in foreground and geologist in distance); view to the southwest. This section of fault consists of a cemented shear zone. Photograph taken June 18, 2010, by J.A. Treiman. *C*, Shattered and overturned surface crust. Shattered ground may be partly a topographic effect, given that the site is on a low ridge adjacent to a fault (as indicated by UAVSAR interferogram), which had no new surface fault breakage. There may also be some lateral spread of the ridge toward a wash

immediately to the southeast (note fractures marked with white arrows). Photograph taken June 19, 2010, by J.A. Treiman. *D*, Fault scarp (at change in slope) with fractures (white arrows) along Yuha Fault; view to the northeast. Photograph taken April 7, 2010, by J.A. Treiman. *E*, Fault scarp (above change in slope) with fractures (white arrows) along Yuha Fault; view to the northwest. Yellow notebook (in center) for scale. Photograph taken May 11, 2010, by J.A. Treiman. *F*, Left-lateral fractures along Yuha Fault. White arrows mark matches across en echelon fractures. Photograph taken May 27, 2010. *G*, Left-lateral fractures along Yuha Fault. White arrows mark matching features across en echelon fracture; pen (15 cm long) for scale. Photograph taken April 7, 2010. *H*, Continuous left-lateral surface fractures along Yuha Fault, immediately south of State Highway 98; view to the northeast. Photograph taken April 6, 2010, by J.A. Treiman.

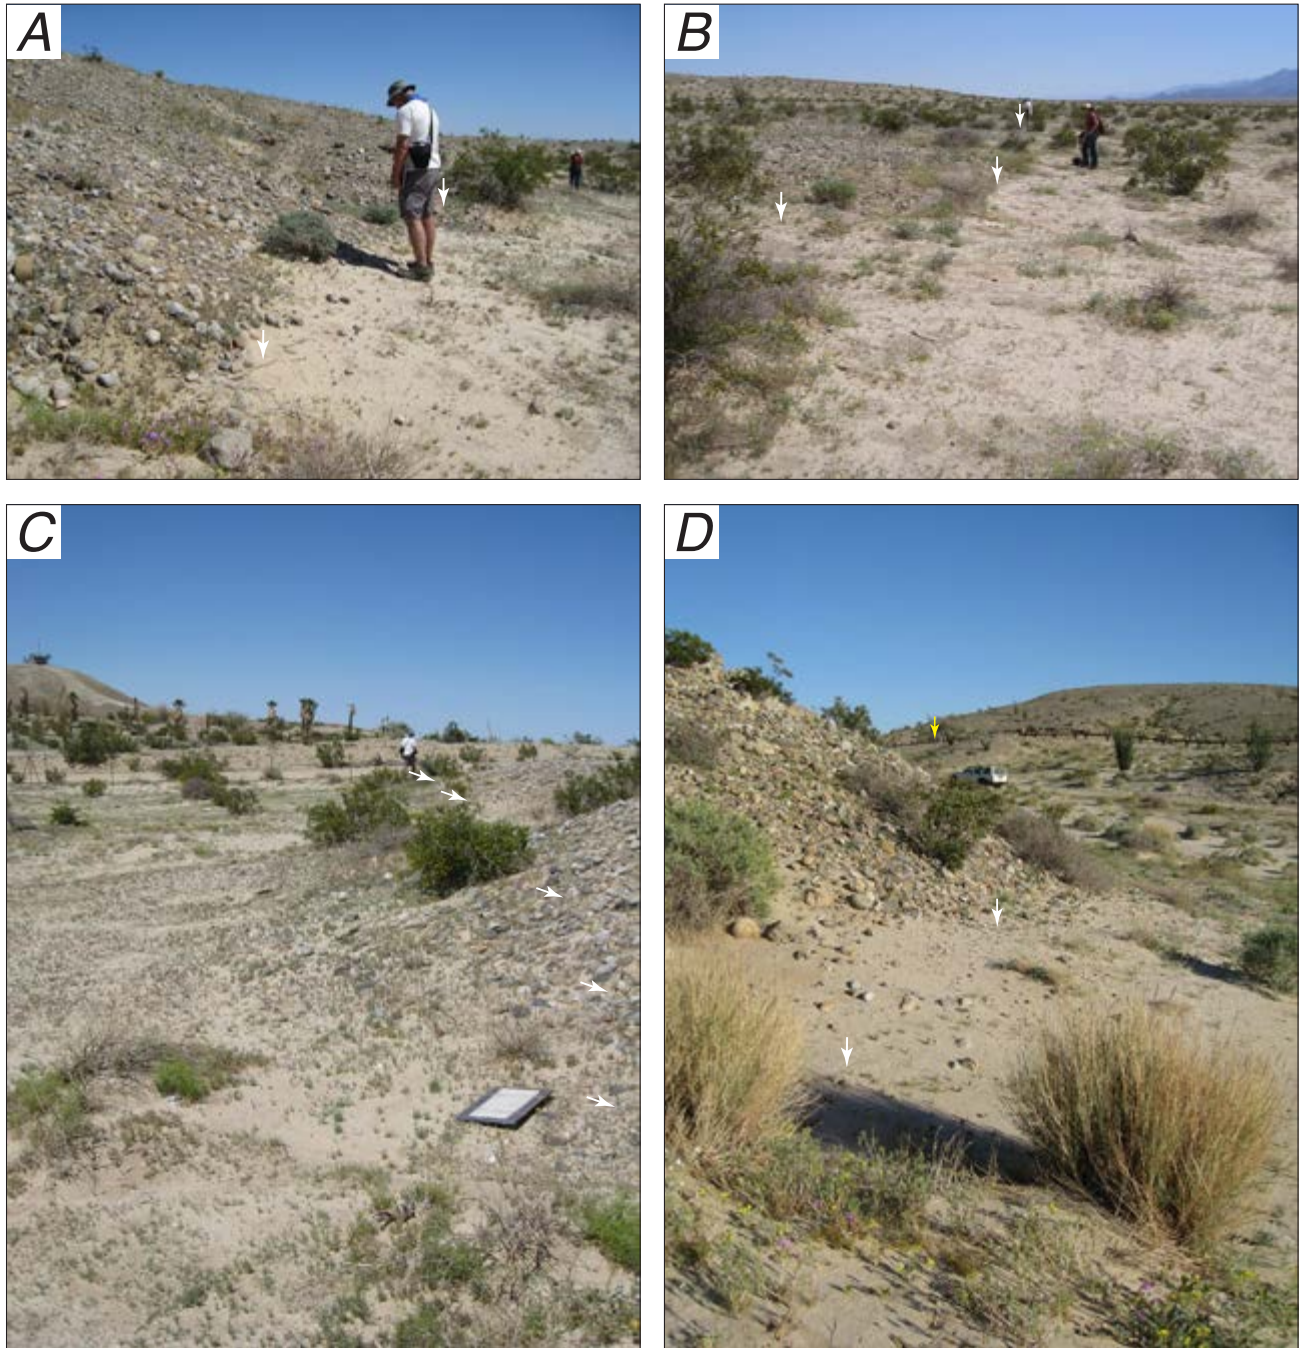
**Figure 24.** Photographs of fractures and fault scarps along faults shown in figure 23. *A*, Fault scarp (at change in slope) with fractures (white arrows) along the east branch of the Laguna Salada Fault; view to the south. Photograph taken April 6, 2010, by J.A. Treiman. *B*, Fault scarp (at change in slope) with fractures (white arrows) along east branch of the Laguna Salada Fault; view to the south. Photograph taken April 6, 2010, by J. A. Treiman. *C*, Fault scarp (at change in slope) with fractures (white arrows) along east branch of the Laguna Salada Fault; view to the north. Photograph taken April 6, 2010, by J.A. Treiman. *D*, Fault scarp (at change in slope) with fractures (white arrows) along east branch of the Laguna Salada Fault; view to the south. Location of U.S.-Mexico border fence marked with yellow arrow. Photograph taken April 8, 2010, by J.A. Treiman.

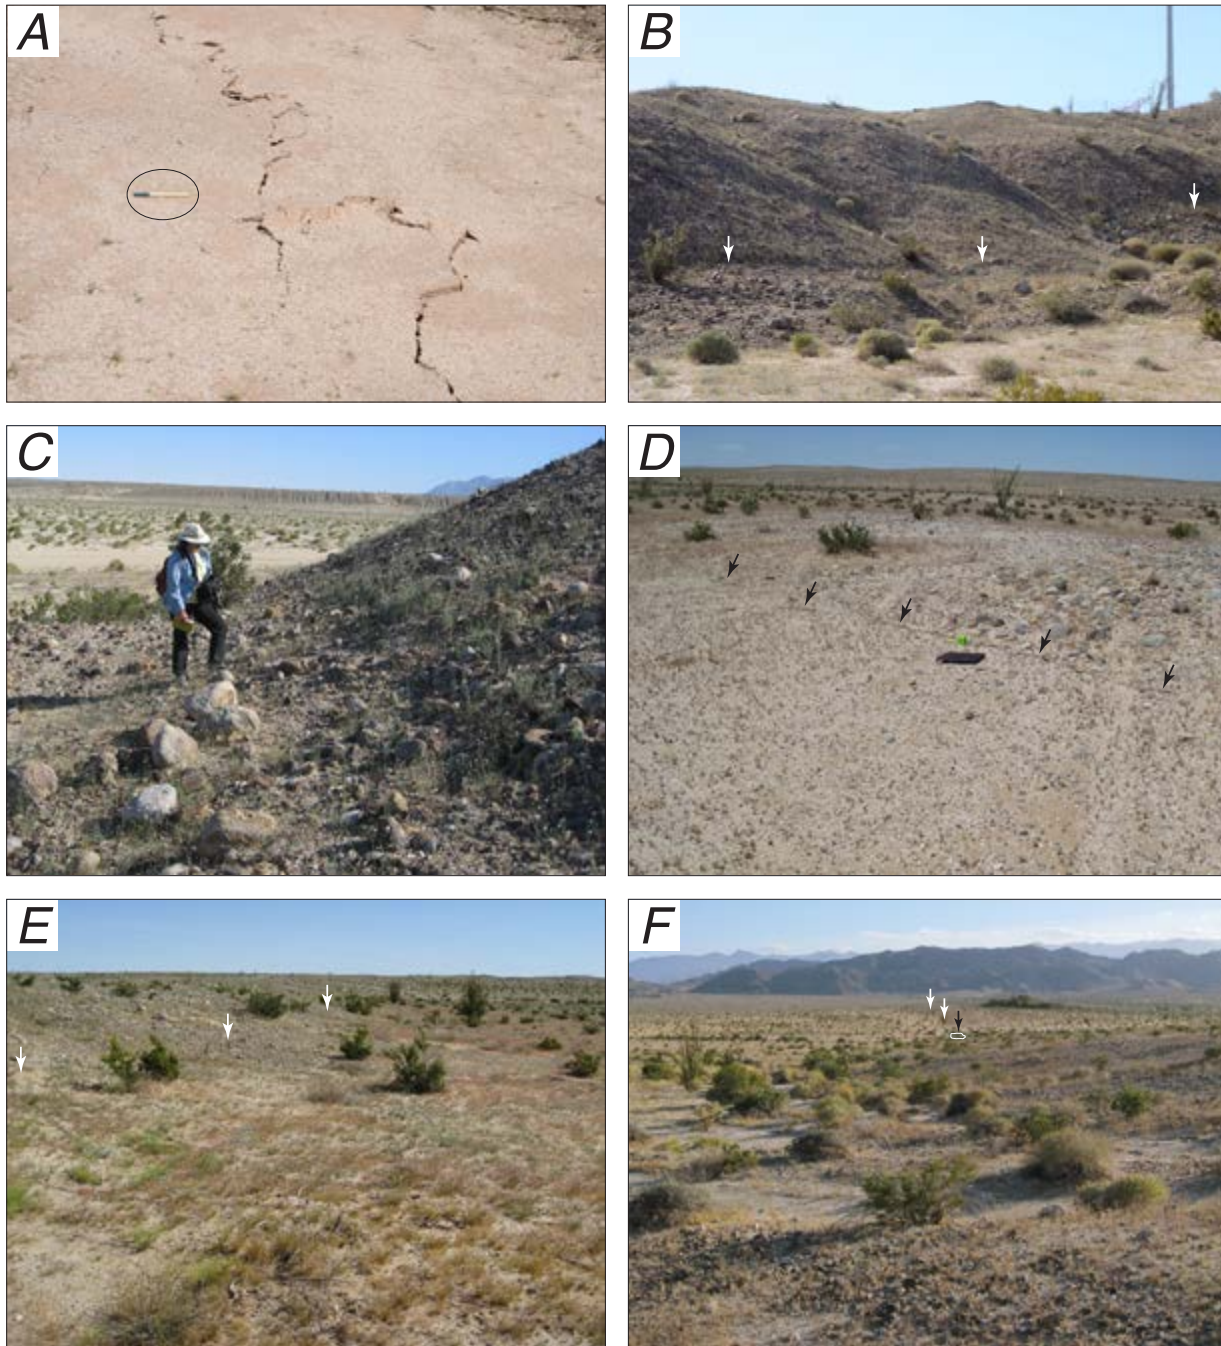
**Figure 26.** Photographs of fractures and fault scarps along faults shown in figure 25. *A*, Left-stepping, semicontinuous fractures with right-lateral offset and local “tent” structures along the Laguna Salada Fault, west branch; view to the northwest. Pen (circled) for scale. Photograph taken April 6, 2010. *B*, Fault scarp (white arrows) along Laguna Salada Fault, west branch. View to the west. Photo C is at leftmost arrow. Photograph taken April 7, 2010, by J.A. Treiman. *C*, Fault scarp (at change in slope, about 1 m in front of person) along Laguna Salada Fault, west branch; view to the south. Photograph taken April 7, 2010, by J.A. Treiman. *D*, Fault scarp (at change in slope) with fractures (black arrows) along one of several normal faults within an extensional zone near the juncture between the Laguna Salada Fault Zone and the Yuha Well Fault Zone; view to the north. Photograph taken May 12, 2010, by J.A. Treiman. *E*, Fault scarp (white arrows) along a northeast-trending fault within the Yuha Well Fault Zone; view to the northeast. Photograph taken April 6, 2010, by J.A. Treiman. *F*, Fault scarp (white arrows) along a fault within the Yuha Well Fault Zone; view to the southwest. Black arrow (and white outline), vehicle for scale. Photograph taken May 11, 2010, by J.A. Treiman.

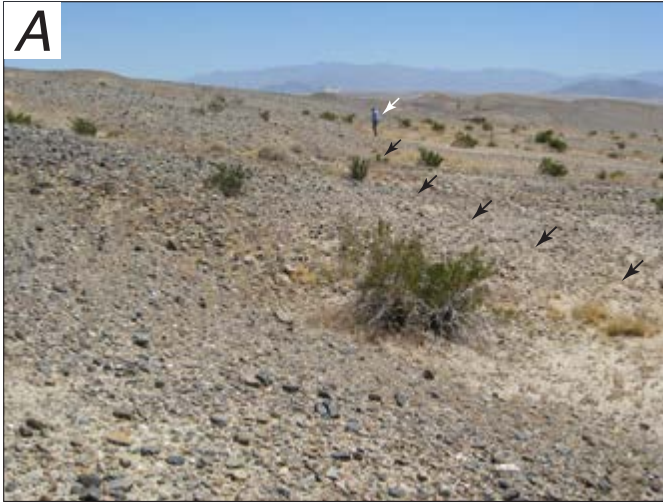
**Figure 28.** Faulting and nonfaulting fractures along the Yuha Well Fault. *A*, Discontinuous fractures (black arrows) along a dissected scarp in the northeastern section of the Yuha Well Fault; view to the southwest. Person for scale (white arrow). Photo taken June 18, 2010, by J.A. Treiman. *B*, Pole aerial photograph of fractures unrelated to surface faulting; view to the southeast. This is an example of nonfaulting, earthquake-related features; here fracturing in concentric rings (white arrows) centered in recent alluvial fill. Youngest material at site appears to have been “tossed” by recent earthquake activity, possibly by the June 14, 2010,  $M_w$  5.7 aftershock (see text). Location of site shown in figure 27. Photo taken June 18, 2010.

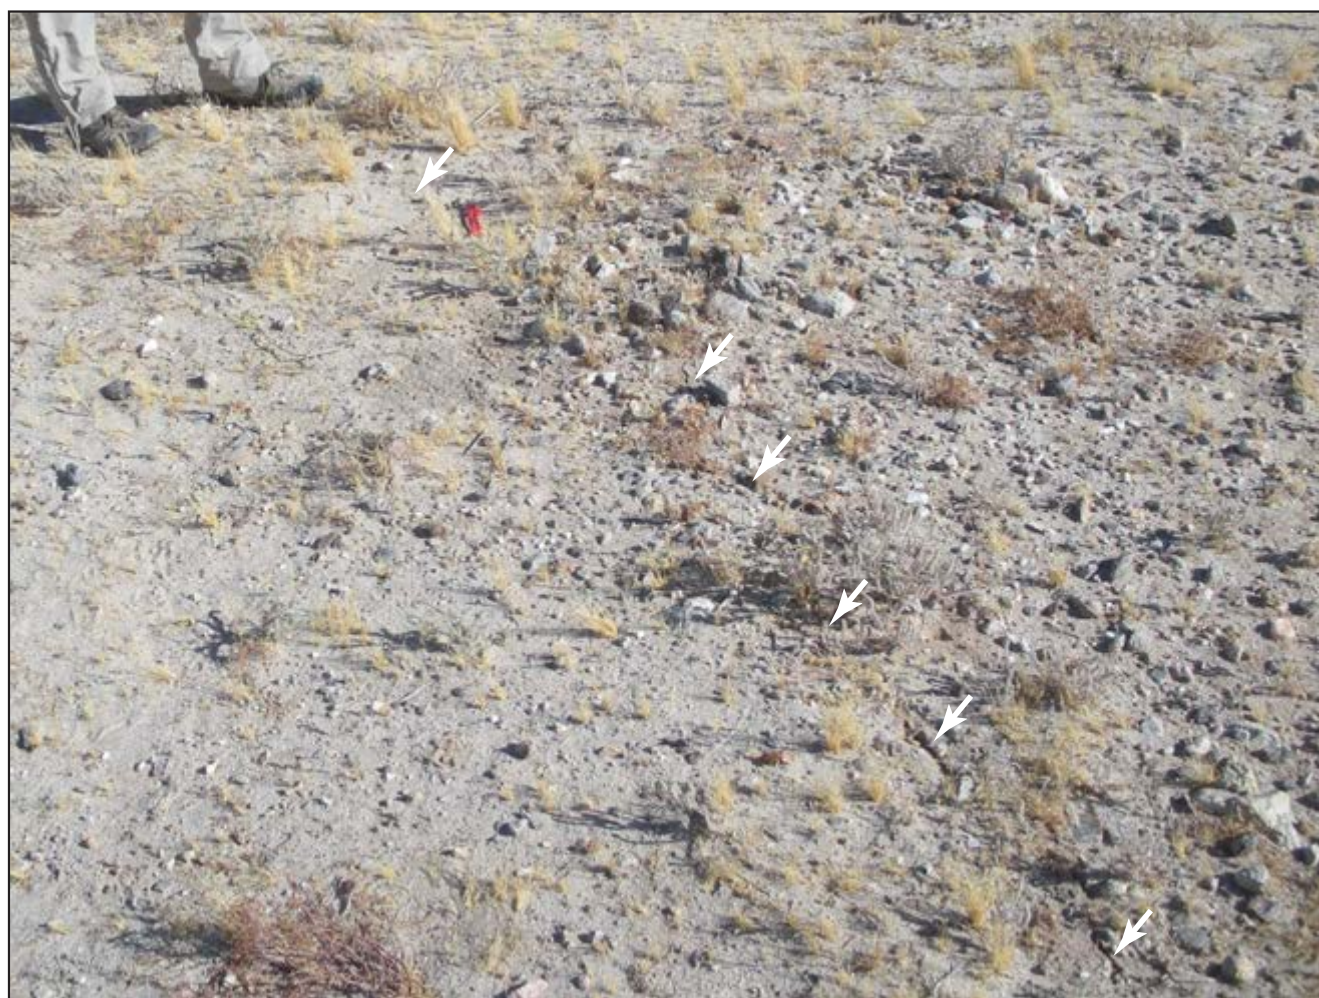
**Figure 32.** Photograph of fractures along an unnamed fault shown in figure 31. This isolated zone of minor fractures lies 2 kilometers southwest of the Laguna Salada Fault.
