## Triggered Surface Slips in Southern California Associated with the 2010 El Mayor-Cucapah, Baja California, Mexico, Earthquake

**Open-File Report 2010-1333**

**Jointly published as California Geological Survey Special Report 221**

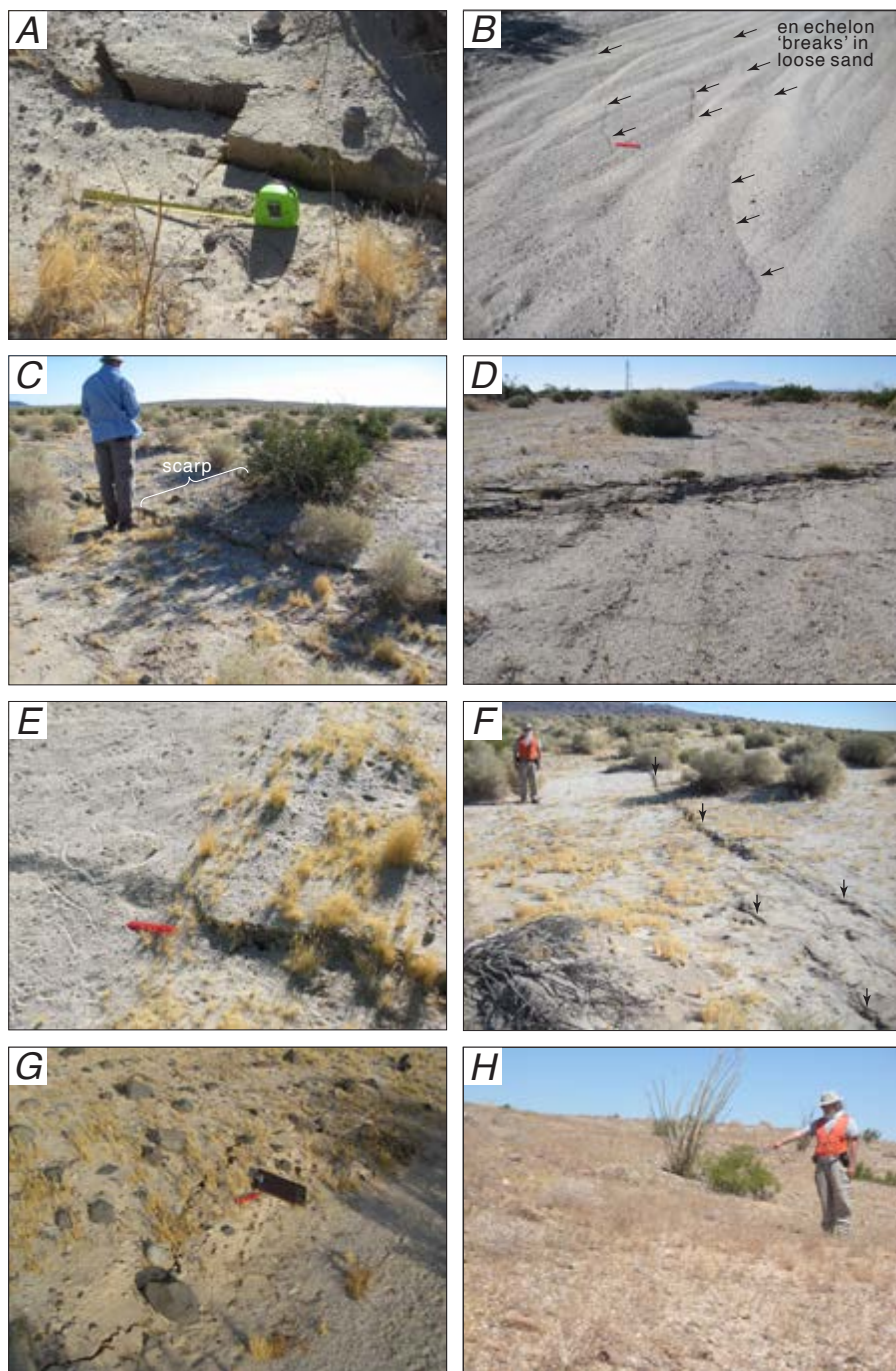
**Figure 34.** Photographs of fractures and fault scarps along faults shown in figure 33. *A*, Vertical surface fractures along Ocotillo Fault. Faulting here is associated with the nearby  $M_w$  5.7 aftershock of June 14, 2010. Photograph taken June 16, 2010. *B*, Left-stepping, right-oblique surface fractures along Ocotillo Fault in loose sand. Photograph shows en echelon 'breaks' (black arrows) in loose sand, suggestive of slight right-lateral component of slip; red ruler for scale. Photograph taken June 16, 2010. *C*, Fractures along Ocotillo Fault at base of preexisting west-facing scarp. View to northeast. Photograph taken June 16, 2010, by J.A. Treiman. *D*, Fractures along Ocotillo Fault in recent wash deposits; view to the southeast. Photograph taken June 16, 2010, by J.A. Treiman. *E*, Right-oblique fractures along Ocotillo Fault. Photograph includes brittle fault movement (on right) and diffuse fault slip in loose sand (on left). Loose sand section in this view includes fresh track from a sidewinder rattlesnake (to the left of red scale). Photograph taken June 16, 2010. *F*, Fractures with vertical slip along Ocotillo Fault in sandy soil; view to the north. Subtle fault scarp on east (right) side of fault. Photograph shows local structural complexity in rupture (in foreground). Photograph taken June 16, 2010. *G*, Right-lateral fractures along unnamed fault south of I-8. Black notebook and red ruler for scale. Photograph taken August 2, 2010, by J.A. Treiman. *H*, Photograph of scarp, about 1.5–2 m high, without fresh surface fractures; view to the northwest. Photograph taken June 16, 2010.

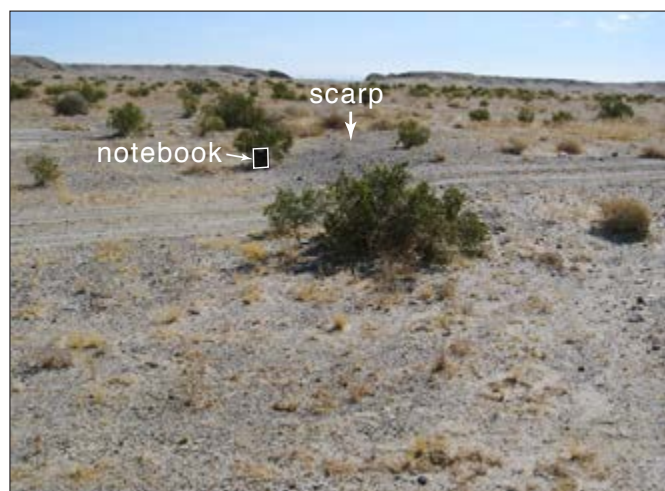
**Figure 36.** Photograph of fault scarp along fault farther northeast of surface slip in 2010 (see fig. 35 for location). Small white arrow points to black notebook (with white outline) for scale. Photograph taken August 3, 2010, by J.A. Treiman.
