# Liquefaction and Other Ground Failures in Imperial County, California, from the April 4, 2010, El Mayor–Cucapah Earthquake

By Timothy P. McCrink, Cynthia L. Pridmore, John C. Tinsley, Robert R. Sickler, Scott J. Brandenburg, and Jonathan P. Stewart

U.S. Geological Survey Open-File Report 2011–1071

California Geological Survey Special Report 220

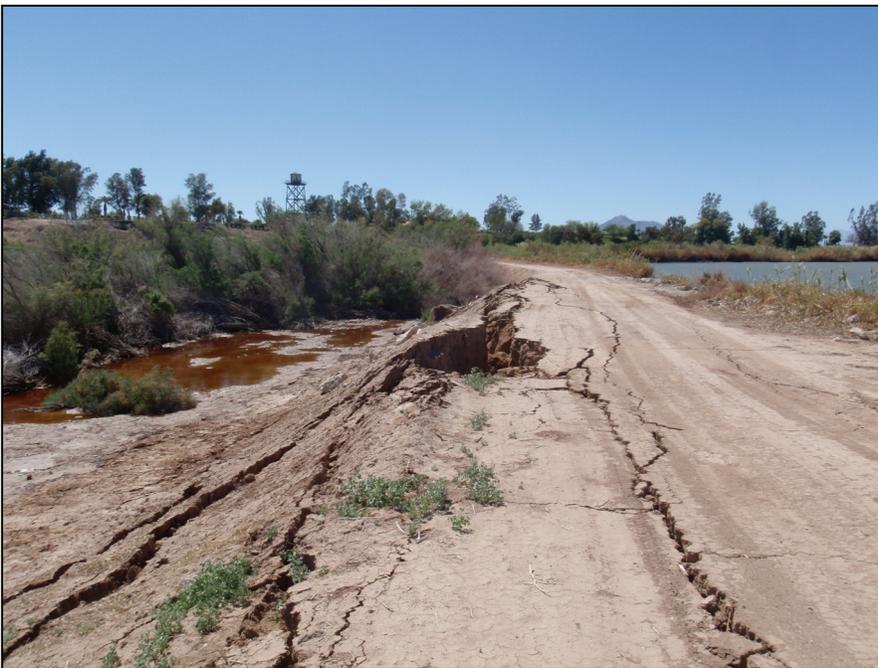
Liquefaction-triggered ground failure in Fig Lagoon levee. Scarps indicate probable differential subsidence into a liquefied substrate. Photograph by John Tinsley.

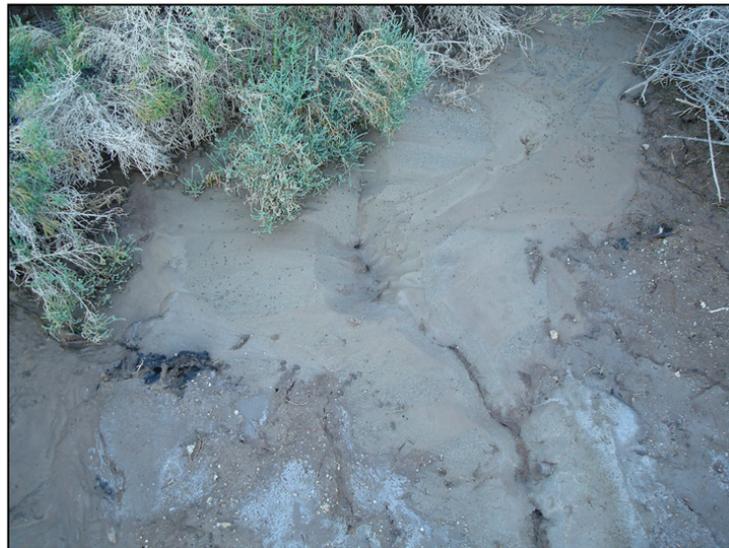
**Figure 13.** Vented sand in the marshy area east of the north approach fill to the Drew Road Bridge (R07). Lateral spreading damage to the road occurred immediately west. Photo by T. McCrink, 4/8/10.

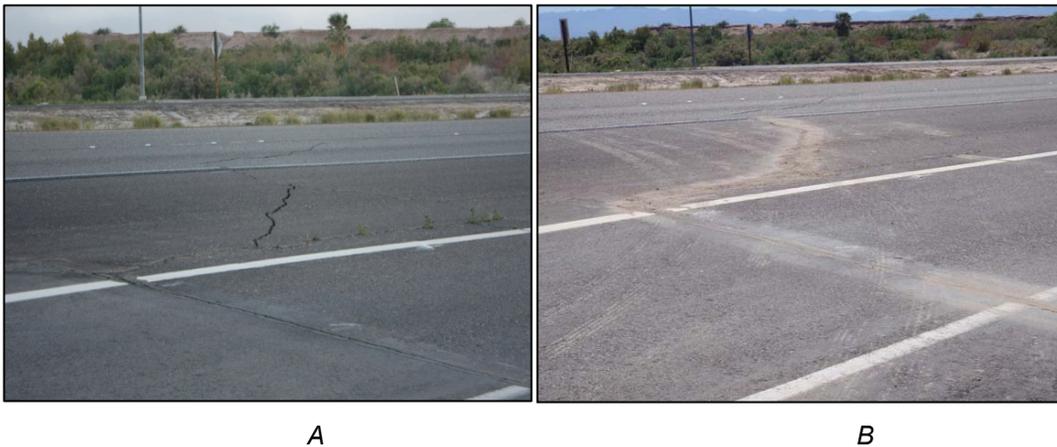
**Figure 17.** Extensional fractures across the westbound lanes of Interstate 8 and the Drew Road onramp (R08). *A*, Fractures as they appeared on 4/5/10. Photo by D. Y. Kwak. *B*, Fractures after being patched and sanded on 4/7/10. Photo by J. Tinsley.

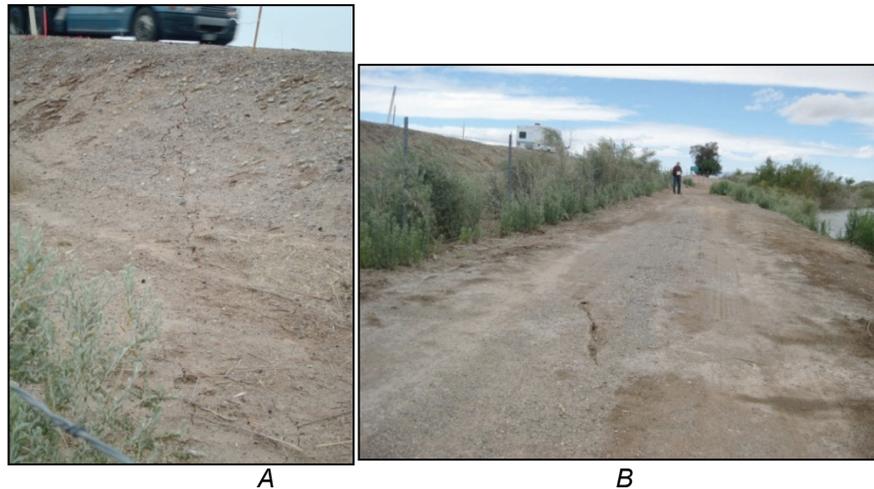
**Figure 20.** Minor cracks in fill at Interstate Highway 8 at the southern end of Sunbeam Lake (R10). *A*, Southeast-trending crack running obliquely through the Interstate Highway embankment. Photo by T. McCrink, 4/12/10. *B*, View to the west of a southwest-trending crack in access road fill. Person in the background is at the matching southeast-trending crack that forms the V-shaped pattern of cracks that open toward the lake on right. Photo by C. Pridmore, 4/12/10.

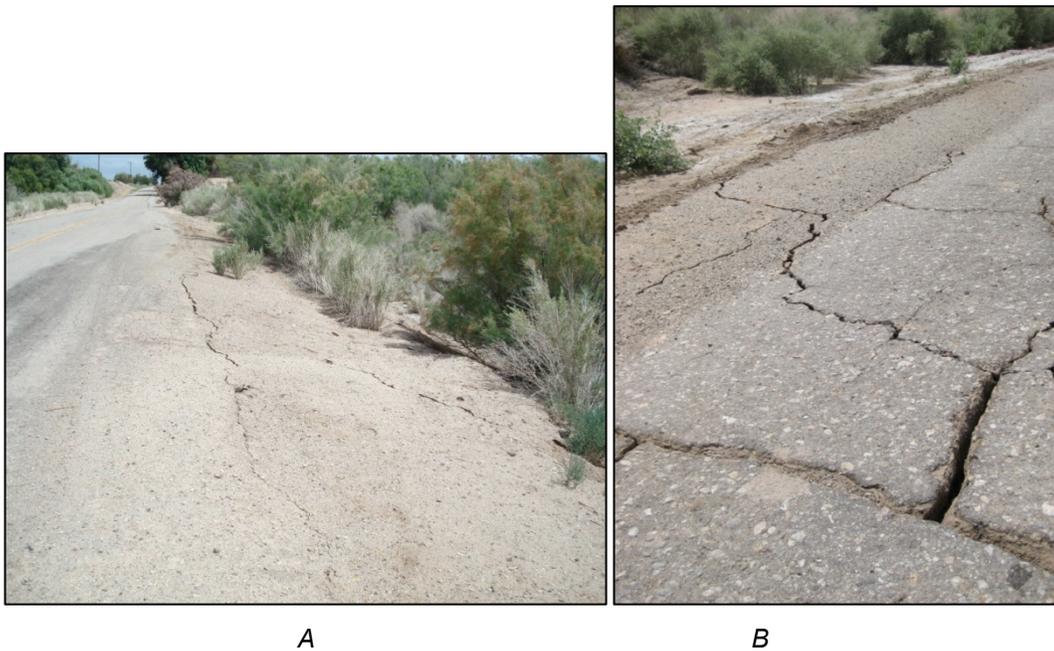
**Figure 21.** Typical shaking effects at Hetzel Road Bridge over Salt Creek Drain (R16). *A*, Incipient lateral spread cracks in the north side of the approach fill west of the drain (Photo by T. McCrink, 4/12/10). *B*, Pre-existing pavement cracks enlarged by shaking, and new cracks that continue into approach fill (Photo by C. Pridmore, 4/12/10).

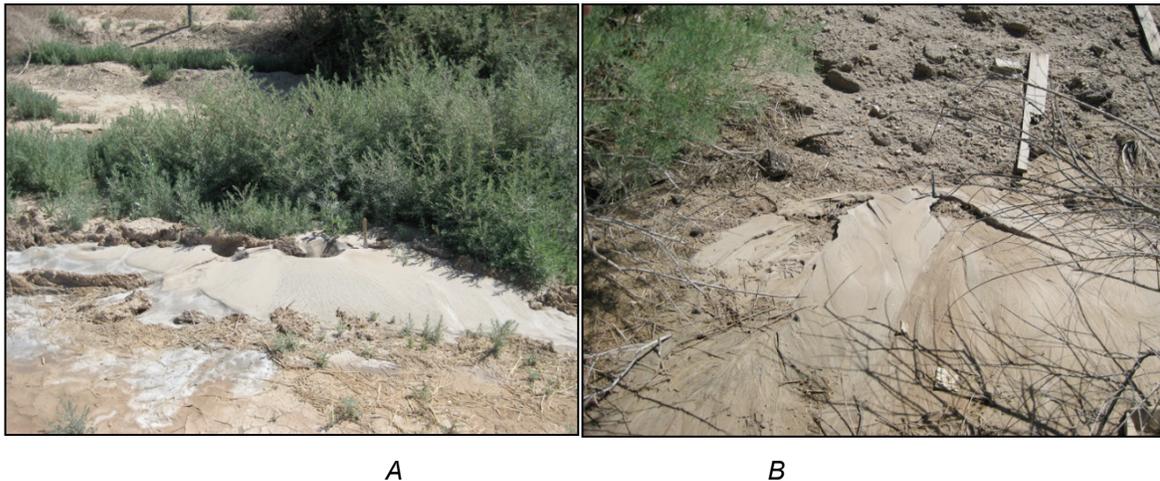
**Figure 22.** Sand vented on approach fill on the east side of the Worthington Road Bridge over the New River (R18). *A*, Light gray sand vented on the south side of the east approach fill indicates river sediments beneath the approach fill liquefied, whereas *B*, brown sand vented at the base of the fill on the north side indicates that fill materials liquefied also. Photos by C. Pridmore, 4/8/10.

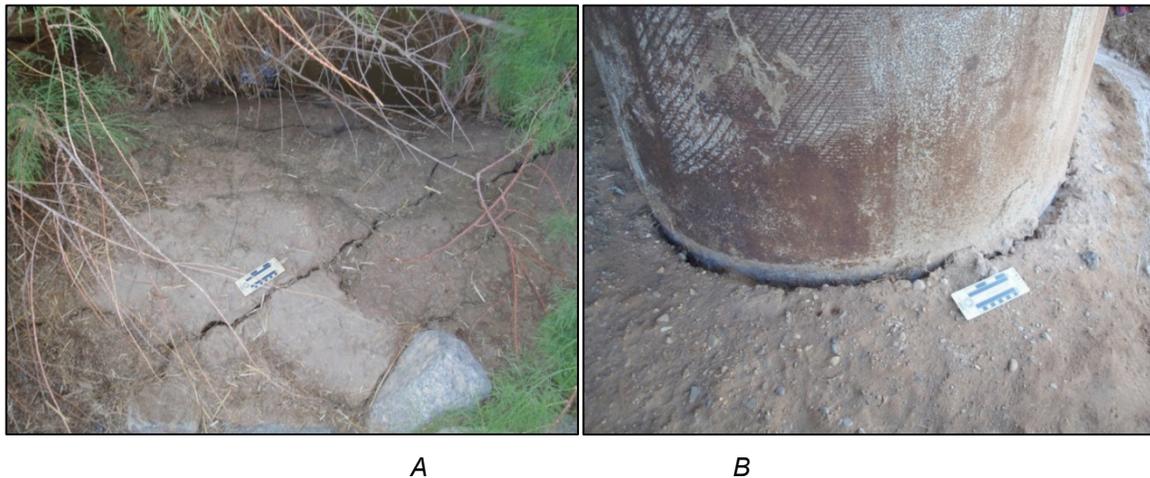
**Figure 28.** Indications of earthquake shaking at the State Highway 86 Bridge over the New River (R36). *A*, Minor soil cracks on the west bank of the New River beneath the bridge. Photo by J. Tinsley, 4/8/10. *B*, Soil apparently pushed 1 to 2 cm away from bridge pier on the west bank. Photo by T. McCrink, 4/8/10.

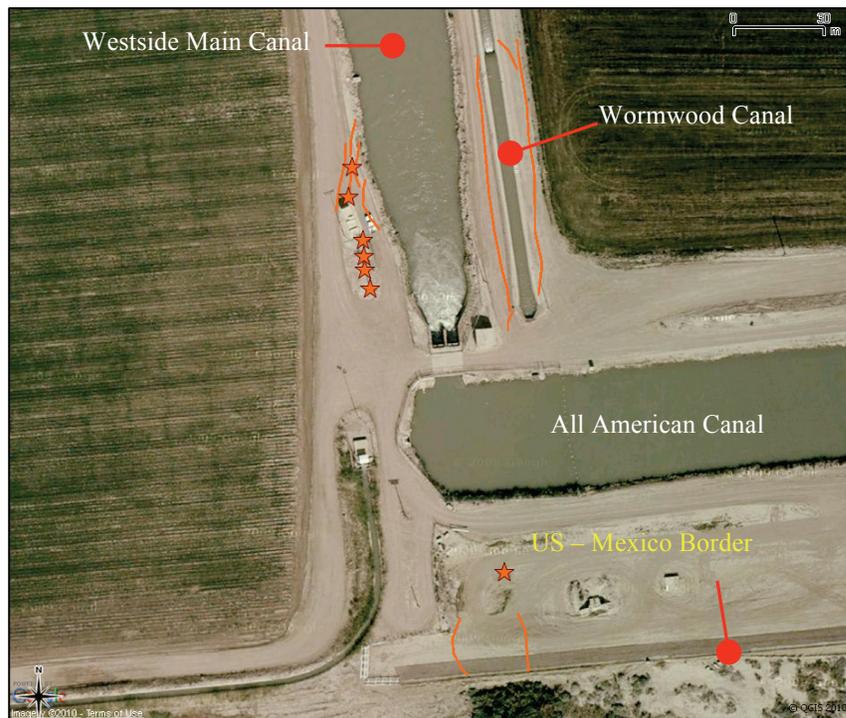
**Figure 30.** Diagrammatic view of the locations of vented sand (red stars) and related cracks and fissures (red lines) for the western end of the All American Canal and the southern end (start) of the Westside Main Canal (C01). Cracks south of the All American Canal coincide with the old alignment of the Westside Main Canal, and settlement of fill in this old canal appears to have displaced the International Border fence. Base Image is from Google Maps.

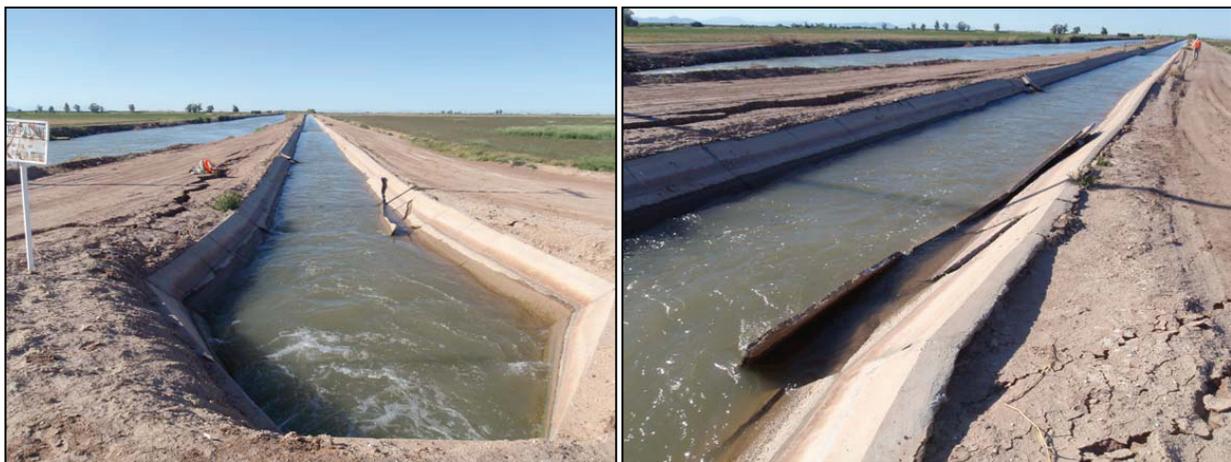
**Figure 31.** Images of Wormwood Canal flowing north from diversion from the All American Canal adjacent to Westside Main Canal (C01). The Westside Main Canal is visible to the west of Wormwood Canal. Lateral spreads on both sides of Wormwood Canal locally deformed the concrete liner, although the canal continued to function. Scarp height indicates about 14 cm of differential settlement. Photos by J. Tinsley, 4/6/10.

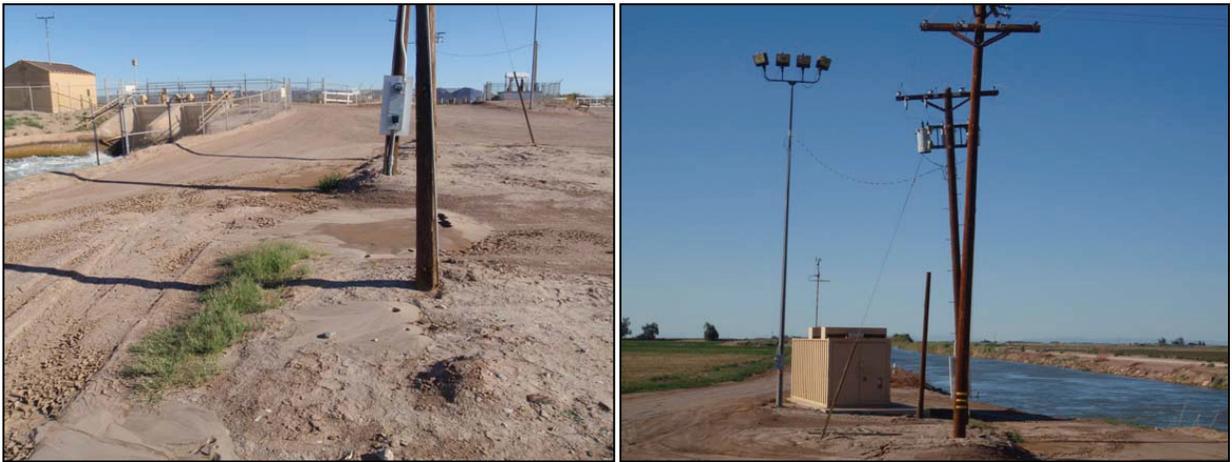
**Figure 32.** View north along west bank of Westside Main Canal, showing utility poles tilted from plumb due to lateral spreading ground failure (C01). Area around base of poles shows light-toned vented sand. Venting of sand in proximity to the poles probably reflects soil-structure interaction that enhanced liquefaction. Photos by J. Tinsley, 4/6/10.

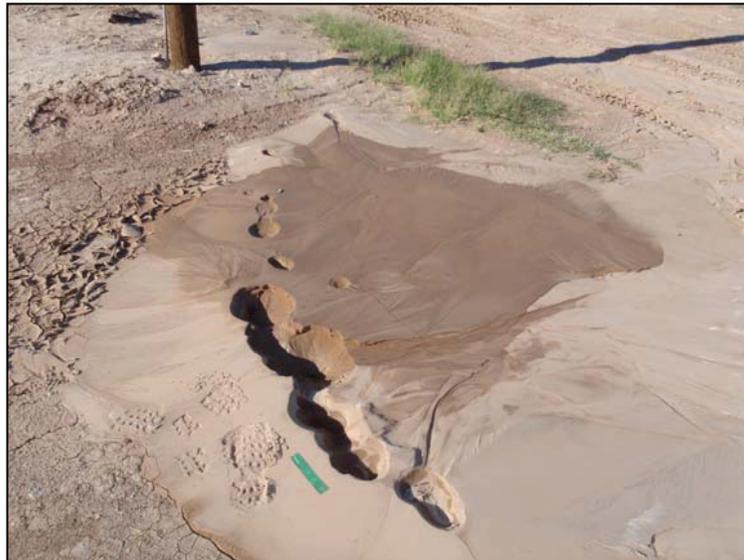
**Figure 33.** Principal fracture linking two tilted utility poles, showing vented sand with some water still seeping from pressurized strata in subsurface three days after the earthquake (C01). The role of large aftershocks in maintaining elevated pore-fluid pressures is suspected but uncertain. Green plastic scale is 15 cm long. Photo by J. Tinsley, 4/6/10.

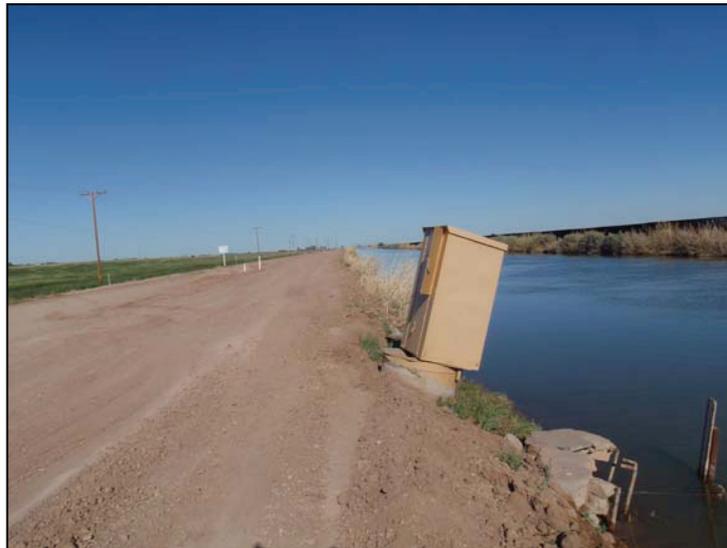
**Figure 34.** Former stage gauge stilling tower tilted from vertical at the Westside Main Canal; associated structures visible to the right of the tower were also tilted from plumb and damaged (C01). No vented materials visible locally. Photo by J. Tinsley, 4/6/10.

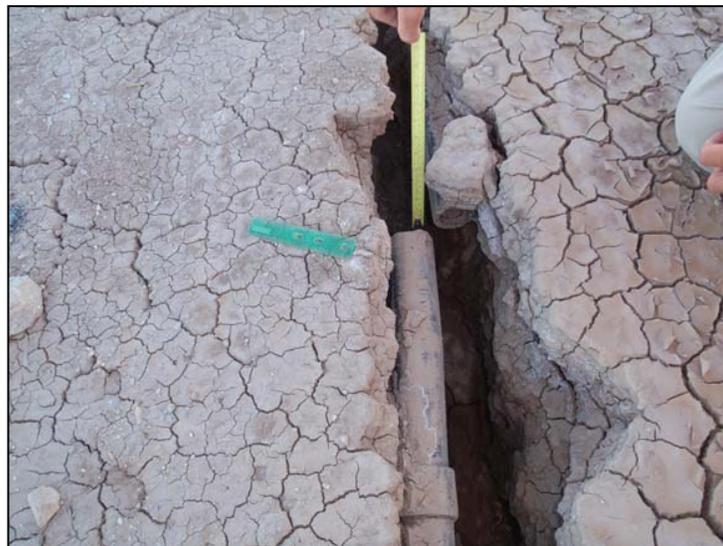
**Figure 35.** Liquefaction-induced extensional fracture near the junction of the Westside Main and All American canals (C01). Exposed pipe or conduit offset 70 mm. Vented sand partly fills fracture underneath the offset pipe. Spreading vector was towards the Westside Main Canal. Photo by J. Tinsley, 4/6/10.

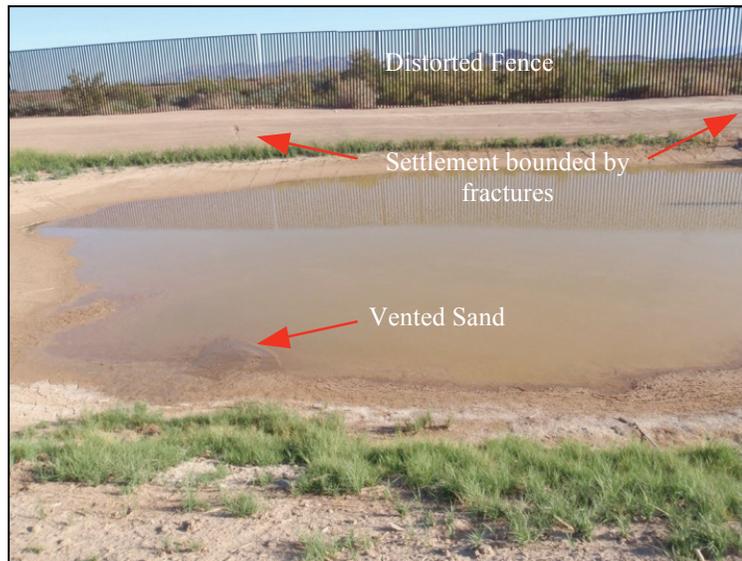
**Figure 36.** View to south, showing small subaqueous deposit of vented sediment in a puddle of water and, in background, fracture in border fence service road where ground deformation caused a distortion in the border fence (C01). Zone of settlement, as well as the depression forming the puddle, matches the old route of the Westside Main Canal from Mexico. Photo by J. Tinsley, 4/6/10.

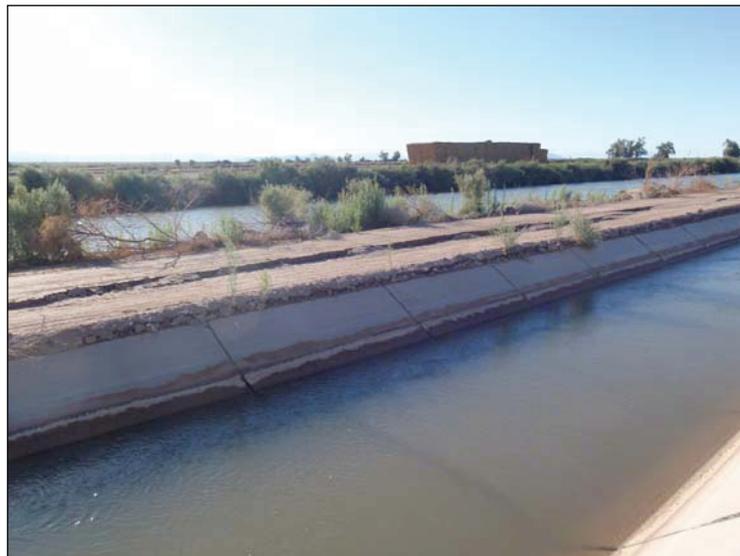
**Figure 37.** Lateral spread ground failure in a strip of fill separating the Westside Main Canal (background) from Wormwood Lateral (foreground) (C03). Photo by J. Tinsley, 4/7/10.

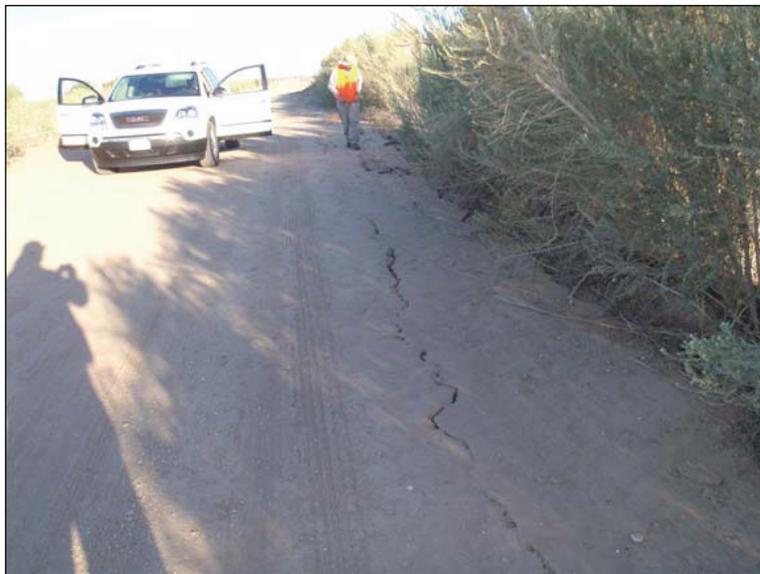
**Figure 40.** Minor extensional fractures parallel to the channel of the Westside Main Canal (C07). No vented materials were observed in association with this ground failure; the failure is likely a result of strong shaking and not liquefaction. Photo by J. Tinsley, 4/7/10.

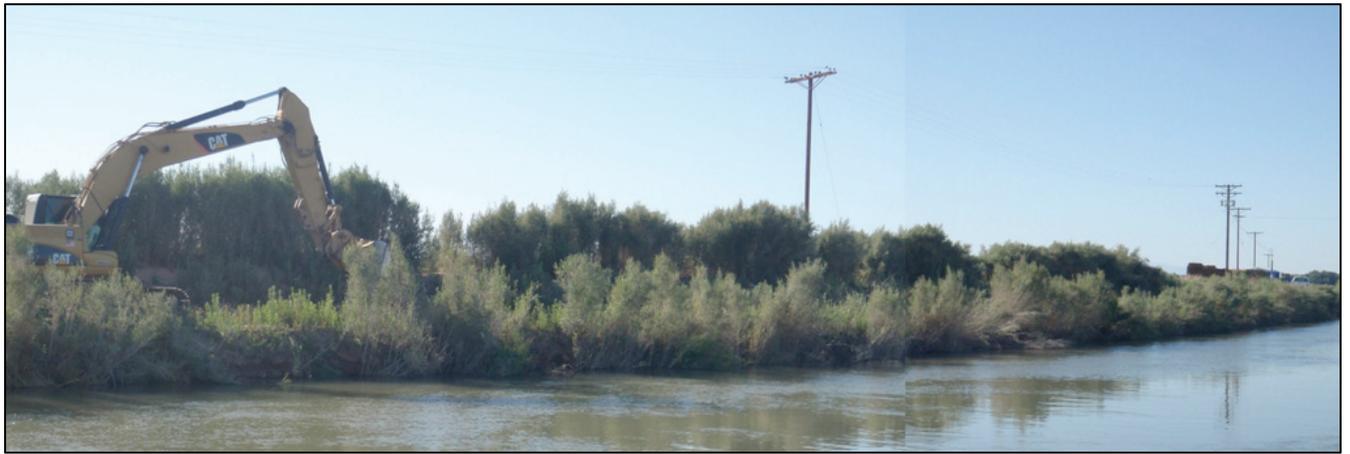
**Figure 43.** Ongoing repairs to the west bank of the Westside Main Canal on 4/7/10 (C15). Tilted and submerged vegetation indicate marked displacement of the levee bank. Photos by J. Tinsley, 4/7/10.

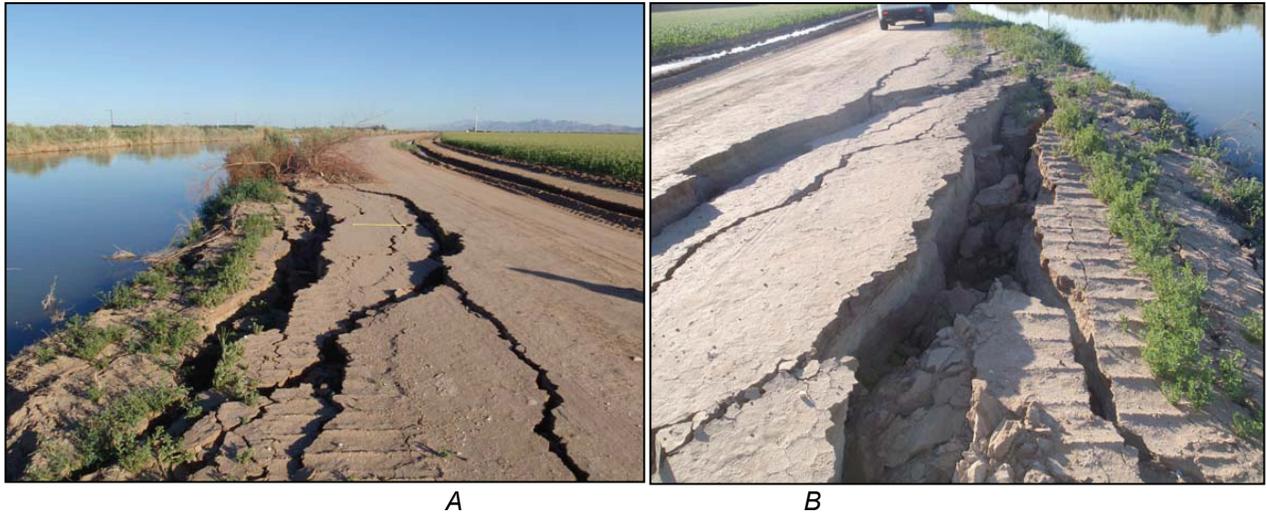
**Figure 44.** Arcuate lateral spread of levee fill on the west bank of the Westside Main Canal (C24). *A*, View to the south showing a portion of the liquefaction ground failure. Tape measure in center of photo is 1 m long. *B*, View north showing graben developed along system of extensional fractures in liquefaction-induced lateral spread ground failure. Photos by J. Tinsley, 4/7/10.

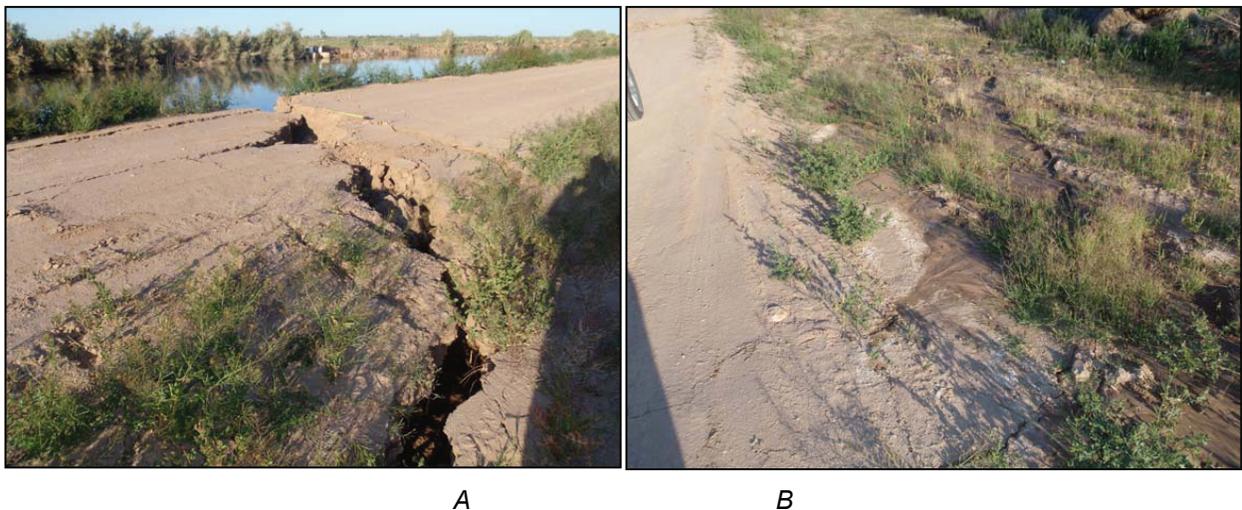
**Figure 46.** Liquefaction lateral spread and settlement of the southwest bank of the Westside Main Canal (C29). *A*, View to northeast along the western levee of the Westside Main Canal showing the large ground failure that spanned the entire width of the levee. *B*, View to the southeast of fractures and vented sand on the outside of the west levee. Photo by J. Tinsley, on 4/7/10.

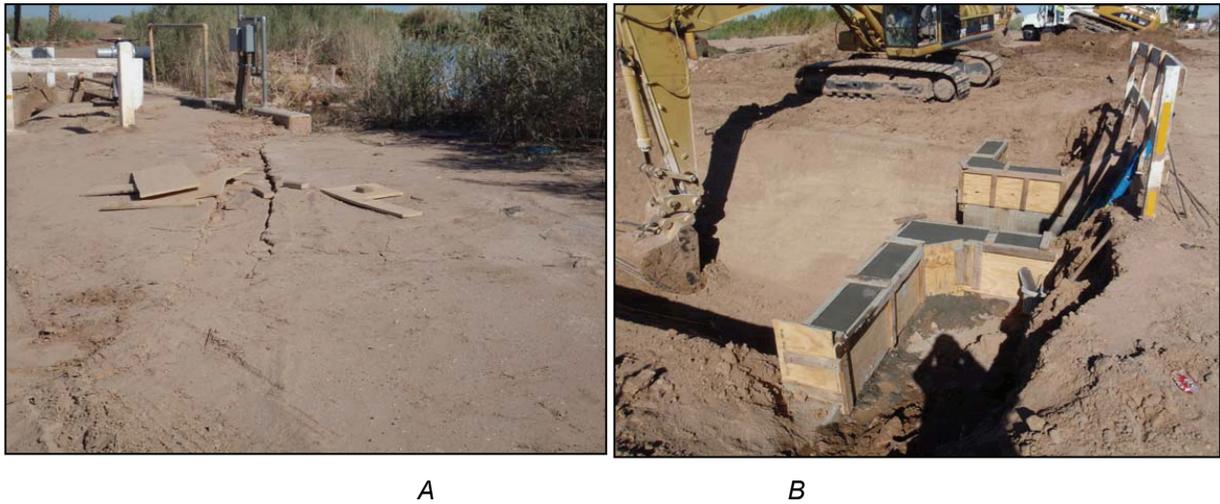
**Figure 47.** Lateral spreading fractures on the east levee of Westside Main Canal (C29). *A*, Diversion structure for the Fern Canal was damaged when ground was displaced eastward, away from Westside Main Canal. *B*, Newly poured foundation and wing wall for the Fern Canal outlet from Westside Main Canal. Photos by J. Tinsley, 4/7/10.

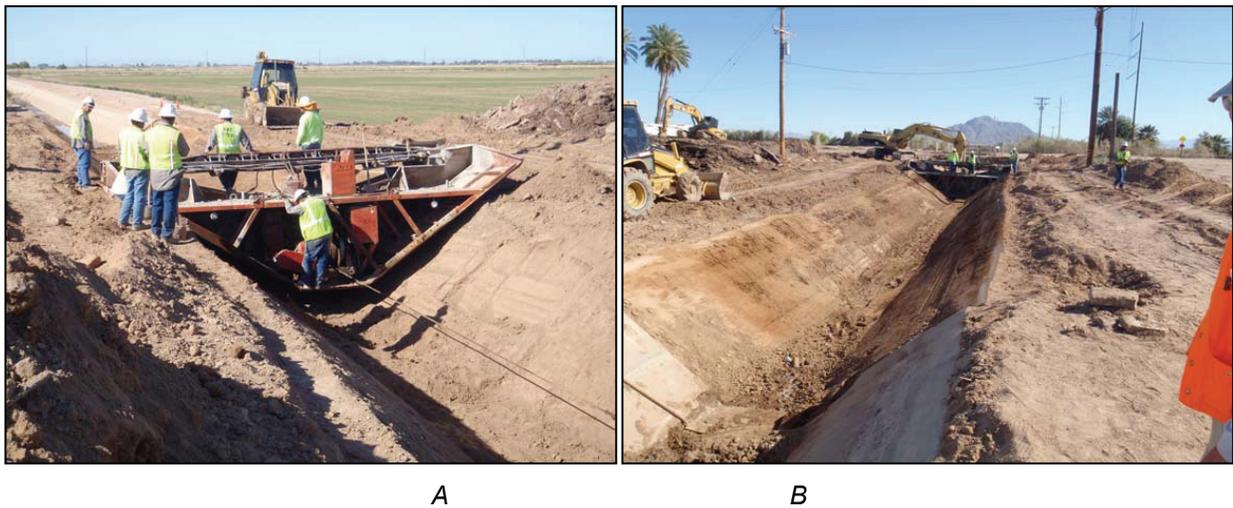
**Figure 48.** Repairs to the liquefaction-damaged Fern Canal (C29). *A*, Repair crew adjusts grading equipment to shape walls of the Fern Canal to repair the effects of lateral spread ground failure. *B*, View to the south with Mount Signal (El Centinela) in the distance, showing reshaped canal prior to pouring new concrete walls and bottom. Photos by J. Tinsley, 4/7/10.

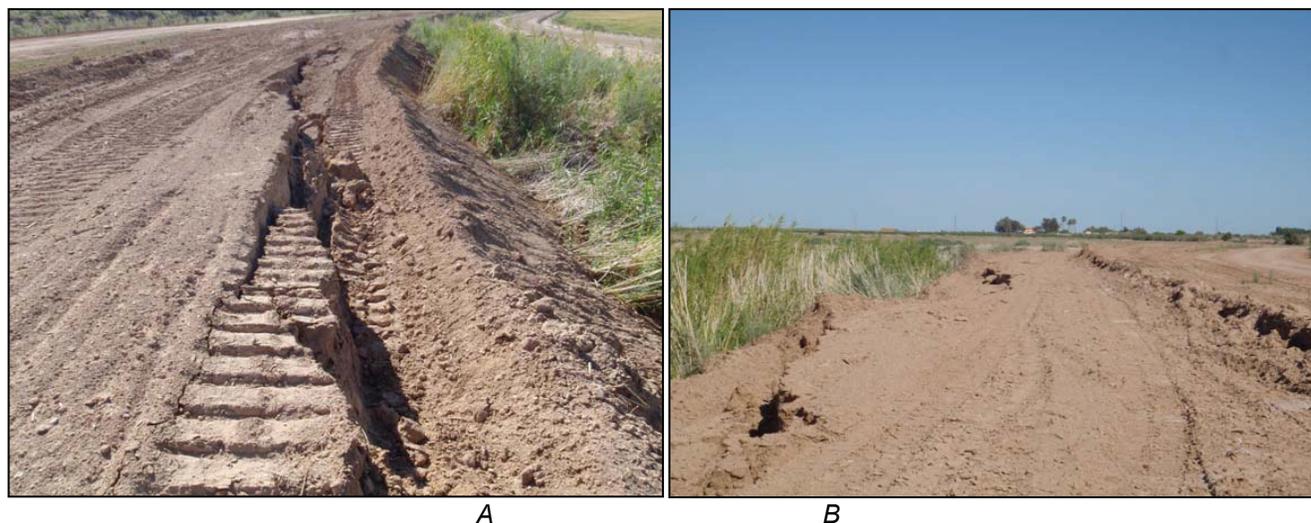
**Figure 49.** Views to the northwest (A, and southeast (B) of a lateral spread ground failure that developed on the east side of the east levee of the Westside Main Canal (D06). Lateral spread fractures extended for about 200 m. The spreading vector was towards the Dixie Drain No. 3B. Grading equipment has made at least one pass prior to these photos, dumping new material into the zone of extensional cracking and lateral spreading, but the major elements of the lateral spread are still visible. Photo by J. Tinsley, 4/7/10.

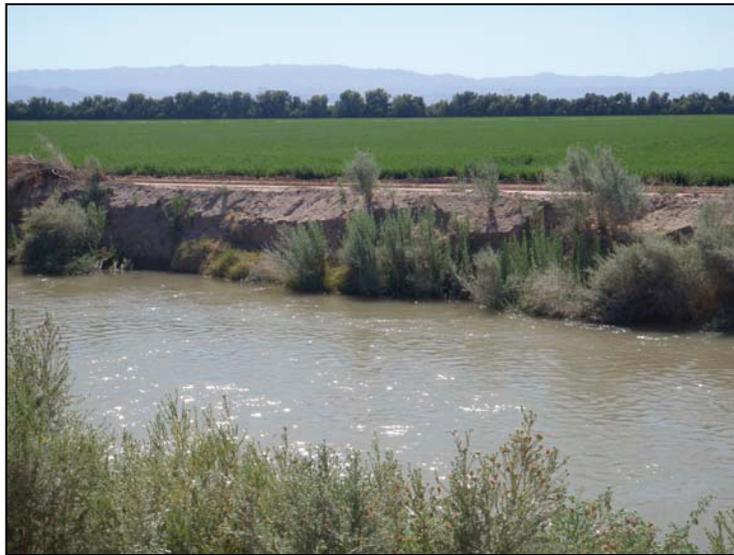
**Figure 51.** View of the west side of Westside Main Canal, showing recent bank failure and slumping of vegetation-bearing soil into the canal (C34). These shallow bank failures were extremely common on both sides of the Westside Main Canal throughout the examined reaches. Photo by J. Tinsley, 4/7/10.

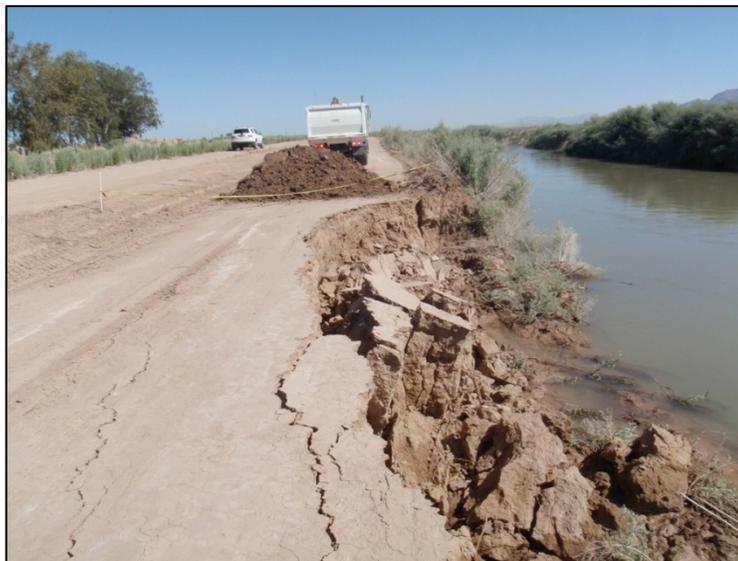
**Figure 52.** Probable liquefaction-related lateral spread slump into the Westside Main Canal (C35). Soil was being imported on 4/7/10 prior to repairs. Photo by J. Tinsley, 4/7/10.

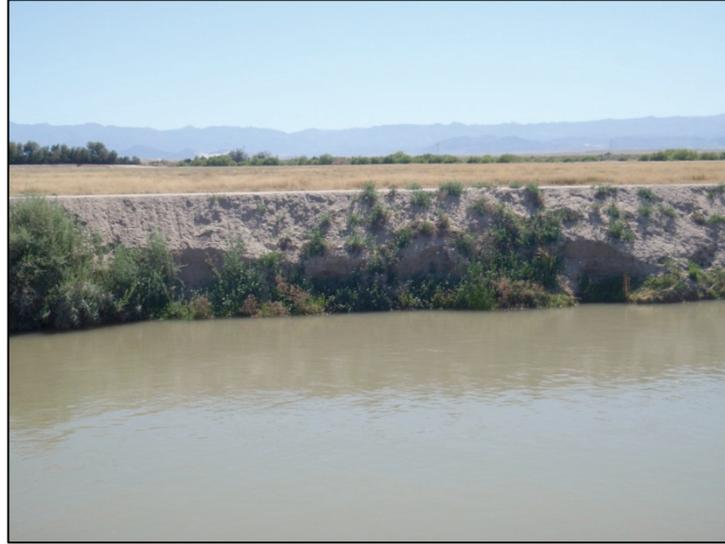
**Figure 53.** View to the west showing shallow slumping of the Westside Main Canal wall that dropped vegetation into the canal and oversteepened the canal-side face of the levee (C36). This stretch of slumping extended for 100 m. Photo by J. Tinsley, 4/7/10.

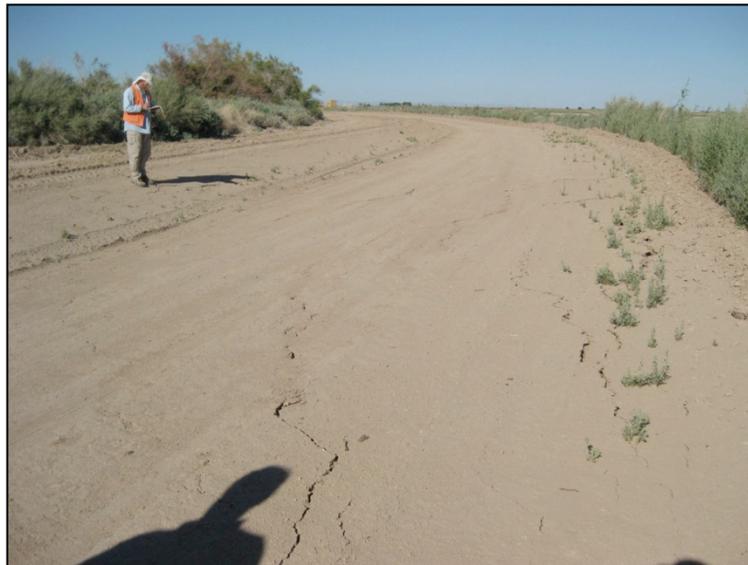
**Figure 54.** Set of three arcuate fractures across the full width of the levee on the west side of the Westside Main Canal (C44). Displacements amounted to a few millimeters, and the fracture set extended about 28 m along the Westside Main Canal. The last set of fractures is at the toes of the geologist on the left. Although no vented materials were observed, the morphology of the failure is consistent with the type of deformation produced by liquefaction. Photo by C. Pridmore, 4/8/10.

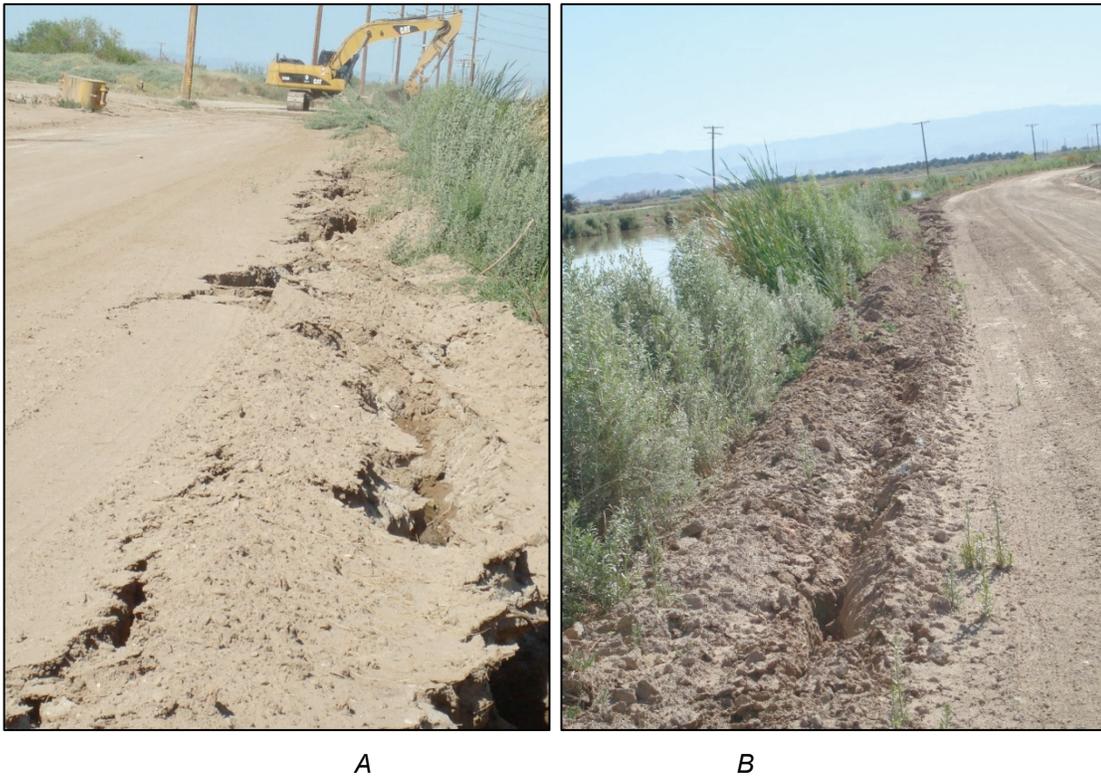
**Figure 55.** Failure of the Westside Main Canal west bank south of the Fillaree diversion structure (C51). *A*, View to northeast; excavator in the background is making repairs. *B*, View to the southwest of the same bank failure. Fractures end where the levee road turns to the right. Vegetation along the canal bank is tilted towards the channel and displaced tens of centimeters. Photos by T. McCrink, 4/8/2010.

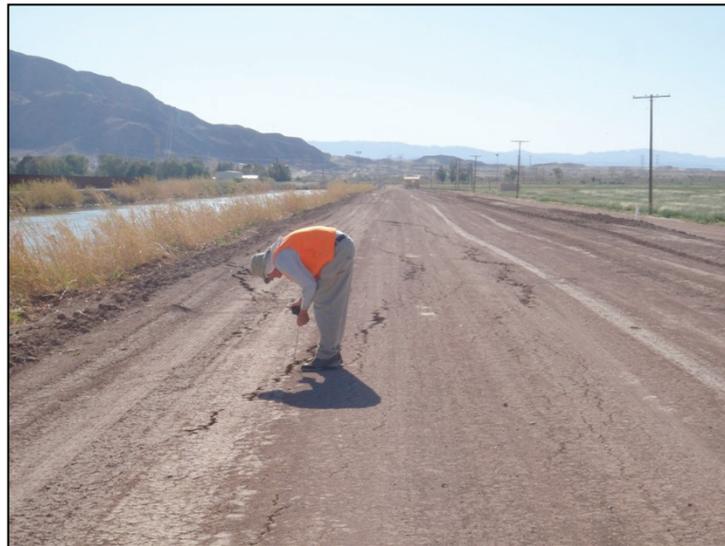
**Figure 57.** View looking west across the westernmost set of arcuate extensional fractures that deformed the north bank of All American Canal near Pullman Road (C02). This failure is 58 m long and open fractures were plumbed to depths of about 135 cm. Differential settlement is about 85 mm and total extension across apparent lateral spread is greater than 12 cm. No vented materials noted. Building in the distance marks the end of the All American Canal and the beginning of the Westside Main Canal. Photo by J. Tinsley, 4/6/10.

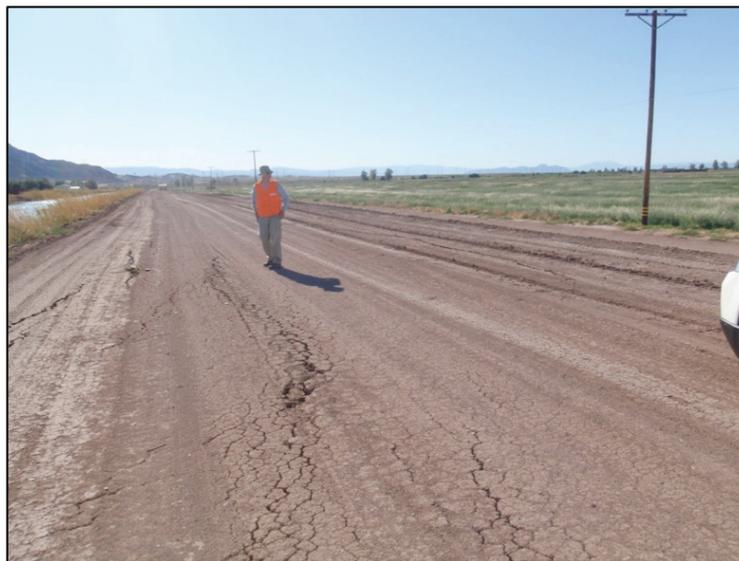
**Figure 58.** Wide-angle perspective image showing an incipient extensional failure that extends nearly across the entire width of the north embankment of the All American Canal near Pullman Road (C02). Total length of southward-extensional deformation exceeds 30 m. Liquefaction unconfirmed as no liquefied materials were vented. In-facing scarps indicate differential settlement involving the highest parts of the earthen levee. This pattern of deformation is consistent with liquefaction. Photo by J. Tinsley, 4/6/10.

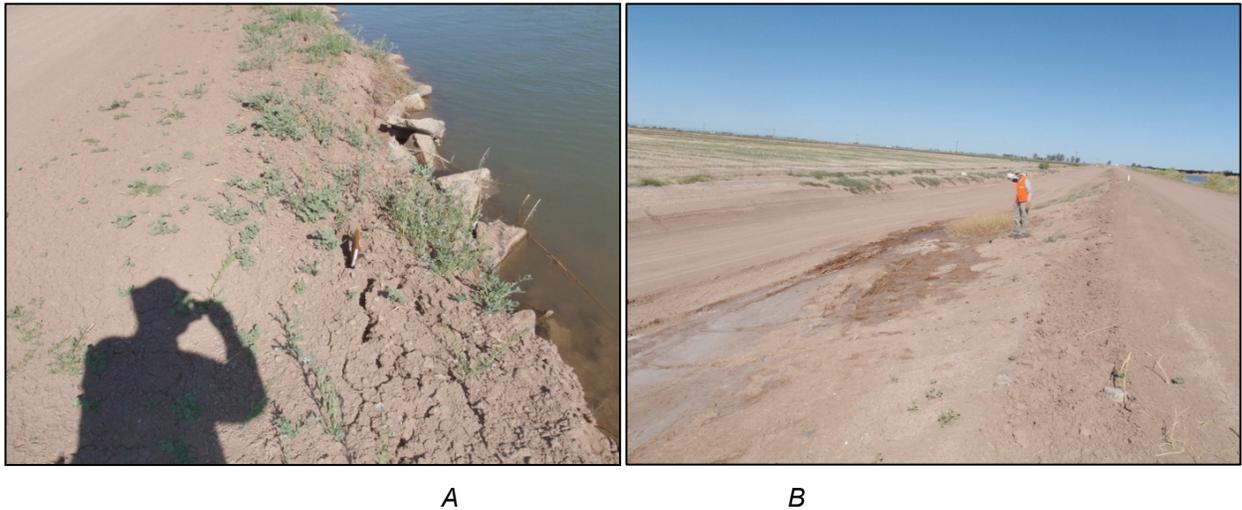
**Figure 59.** A, Extensional cracking and incipient slumping of the north bank of the All American Canal (C09). Slump is 23 m long with 8 to 15 cm extension. B, Active seep on north side of the north embankment, opposite the seemingly minor slump shown in A,. Photos by J. Tinsley, 4/6/10.

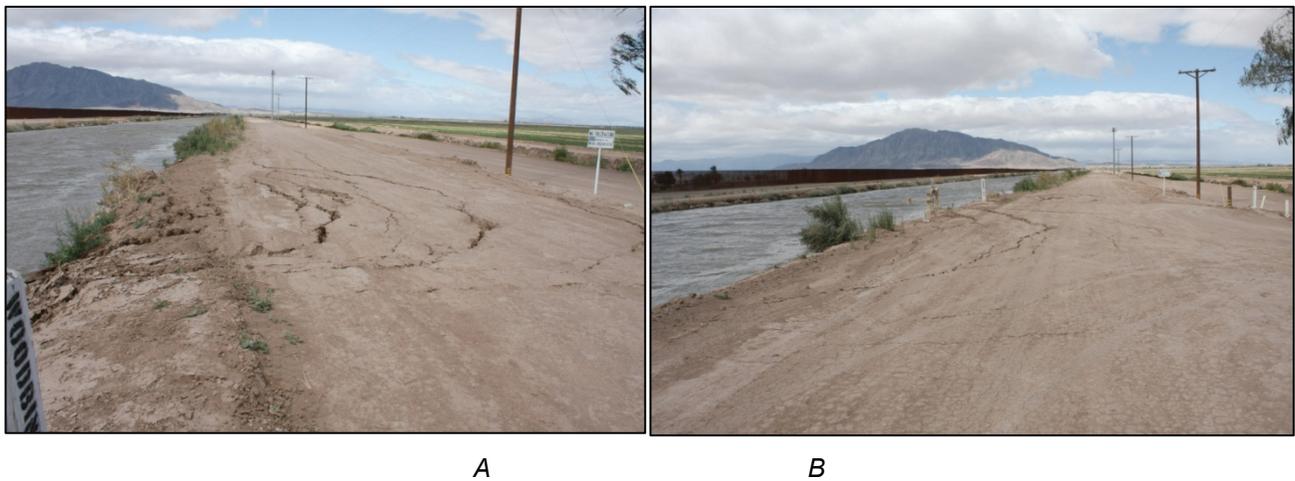
**Figure 60.** View to the west along the All American Canal showing arcuate fractures and incipient slumping on both sides of the Woodbine Lateral 2 diversion structure (C18). A, On the west side, concentric fractures extend through the full width of the levee road. B, Fractures on the east side extend right to the outlet structure and also form a concentric pattern deep into the levee. Photos by D.Y. Kwak, 4/5/10.

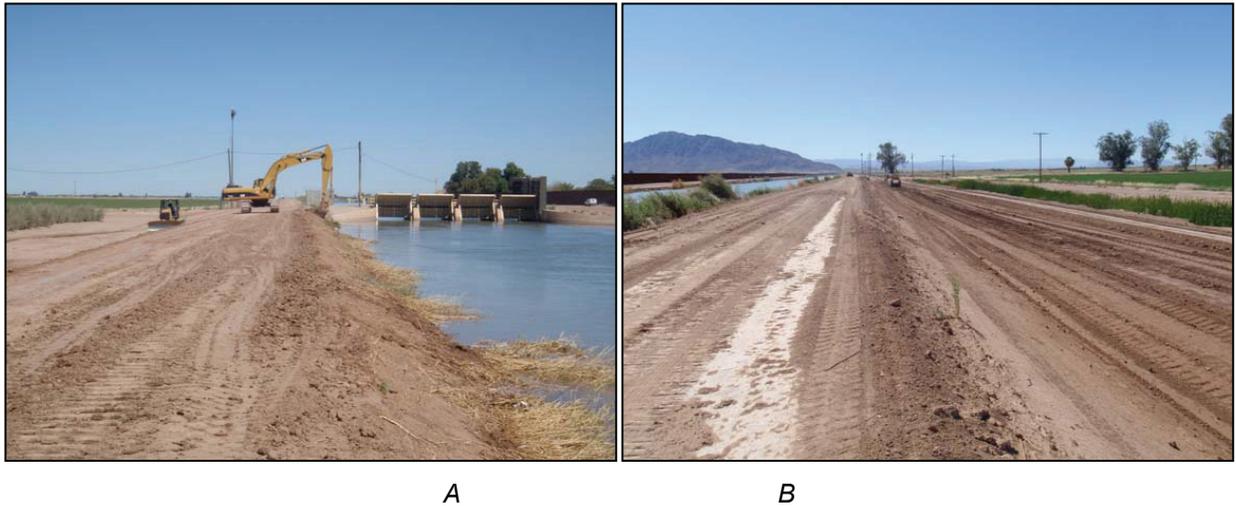
**Figure 61.** All American Canal repairs east of the Woodbine Lateral 2 (C18). *A*, View to the east along the All American Canal; excavator repairing bank slump in north levee. *B*, View to the west showing recent repairs to levee and access road along the All American Canal. The tree in the upper center of the photo marks the location of the slumps shown in fig. 60. Photos by J. Tinsley, 4/6/10.

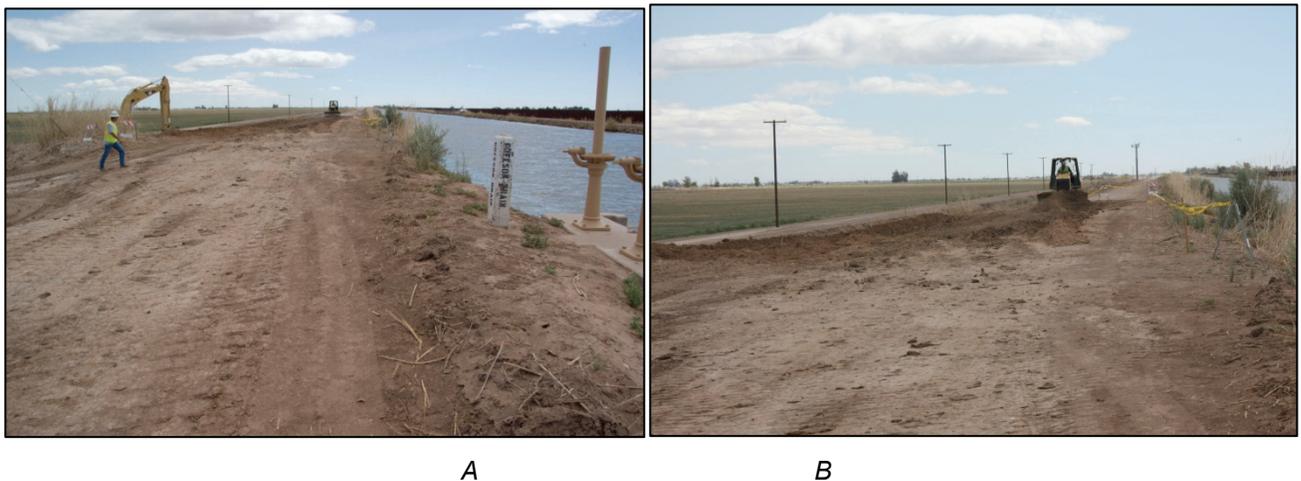
**Figure 62.** Levee repairs on the All American Canal east of the Greeson Drain outlet structure (C26). *A*, Track-hoe repairing the outer edge of the north levee. Photo by S. Brandenburg, 4/5/10. *B*, Bulldozer releveling the top of the levee. Photo by D.Y. Kwak, 4/5/10.

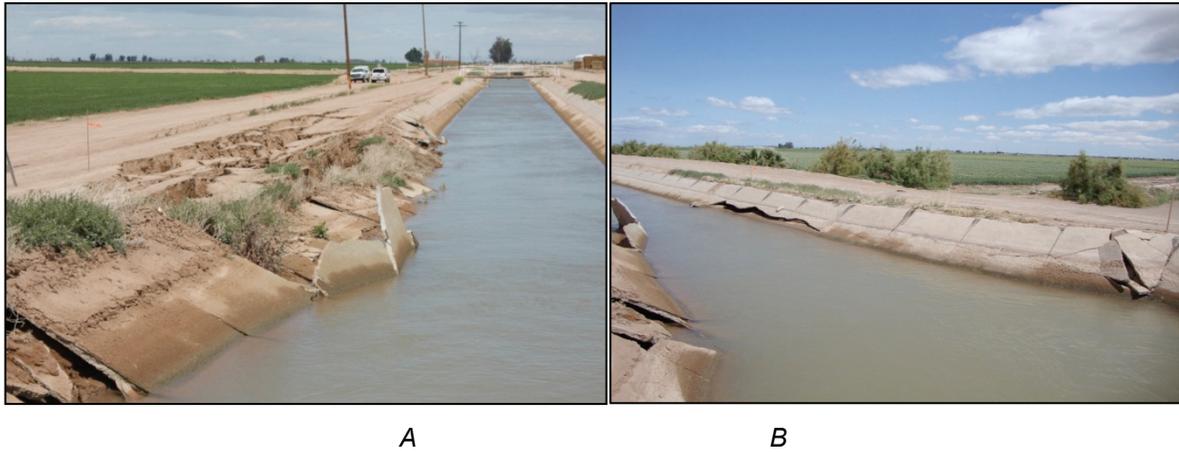
**Figure 63.** Lateral spread of the west bank of the Wistaria Canal near its origin at the All American Canal (C37). A, Lateral spread damage to the west bank. Photo by D.Y. Kwak, 4/5/10. B, Damage to the east bank liner. Photo by W. Lopez, 4/5/10.

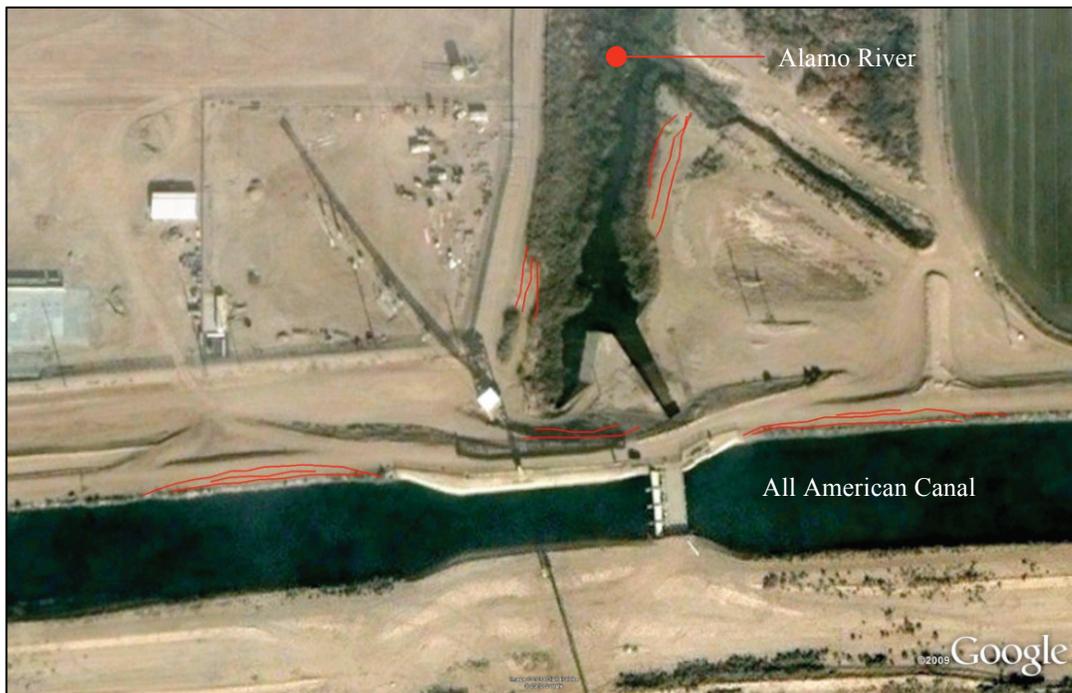
**Figure 64.** Diagrammatic sketch of cracks and fissures observed on the north side of the All American Canal where it crosses the Alamo River (C55). The Alamo River flows to the north beneath the canal. Base Image is from Google Maps.

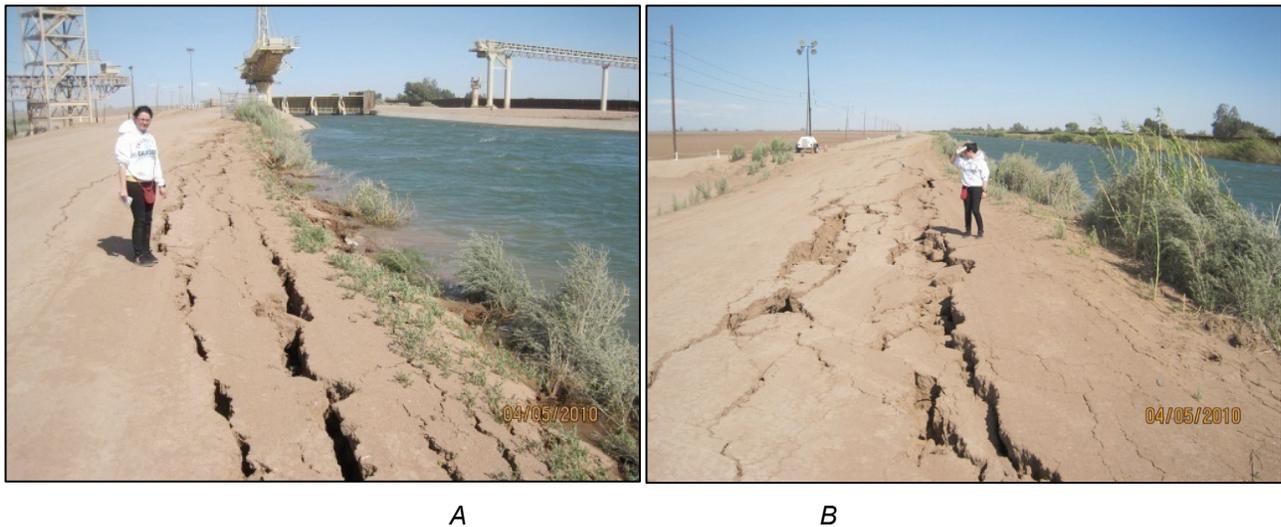
**Figure 65.** Lateral spread cracks on the north side of the All American Canal at the Alamo River crossing (C55). *A*, View to the east of cracks west of the canal crossing; rotating conveyor bridge and flood gates are visible in the background. *B*, Cracks on the east side of the Alamo River; view to the east. Photos by E. Seyhan, 4/5/10.
