# Liquefaction and Other Ground Failures in Imperial County, California, from the April 4, 2010, El Mayor–Cucapah Earthquake

By Timothy P. McCrink, Cynthia L. Pridmore, John C. Tinsley, Robert R. Sickler, Scott J. Brandenburg, and Jonathan P. Stewart

U.S. Geological Survey Open-File Report 2011–1071

California Geological Survey Special Report 220

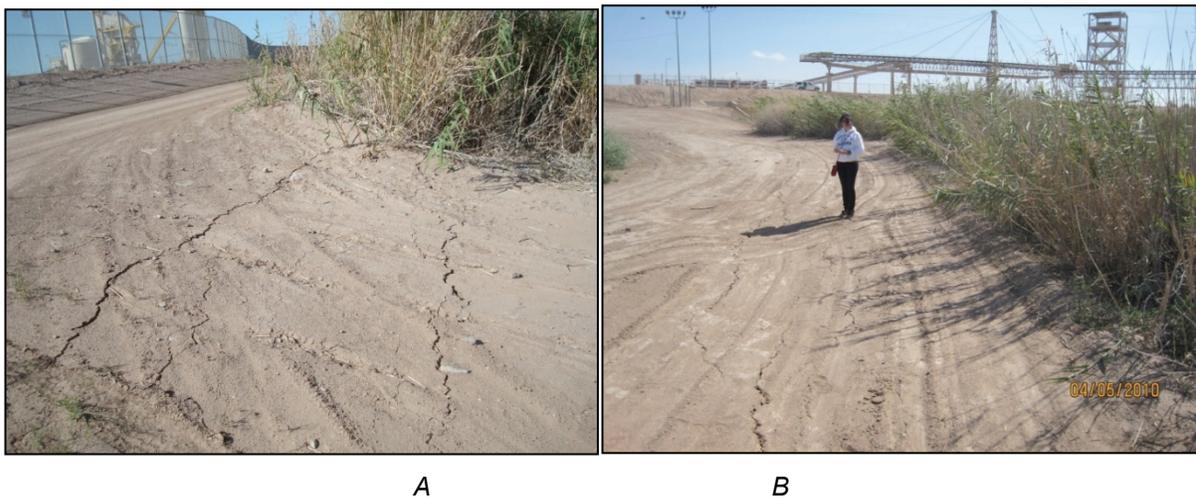
**Figure 66.** Small displacement extensional cracks on the *A*, west side and *B*, east side of the Alamo River immediately north of the All American Canal (D14). Photos by: *A*, T. McCrink, 4/9/10; *B*, E. Seyhan, 4/5/10.

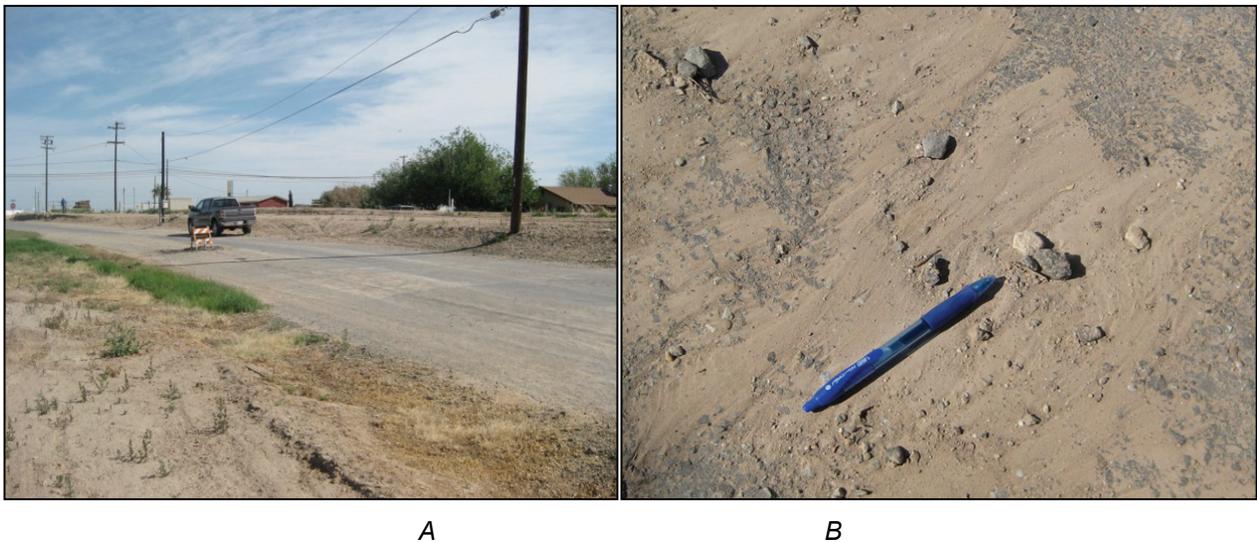
**Figure 68.** Area of seiching from the Eucalyptus Canal along Nichols Road south of Evan Hewes Highway (C48). *A*, View to the north of the Eucalyptus Canal and Nichols Road. Water flowed over the canal levee and across Nichols Road resulting in the temporary closure of the road. *B*, Pen is aligned parallel to water flow direction across Nichols Road pavement. Photos by C. Pridmore, 4/11/10.

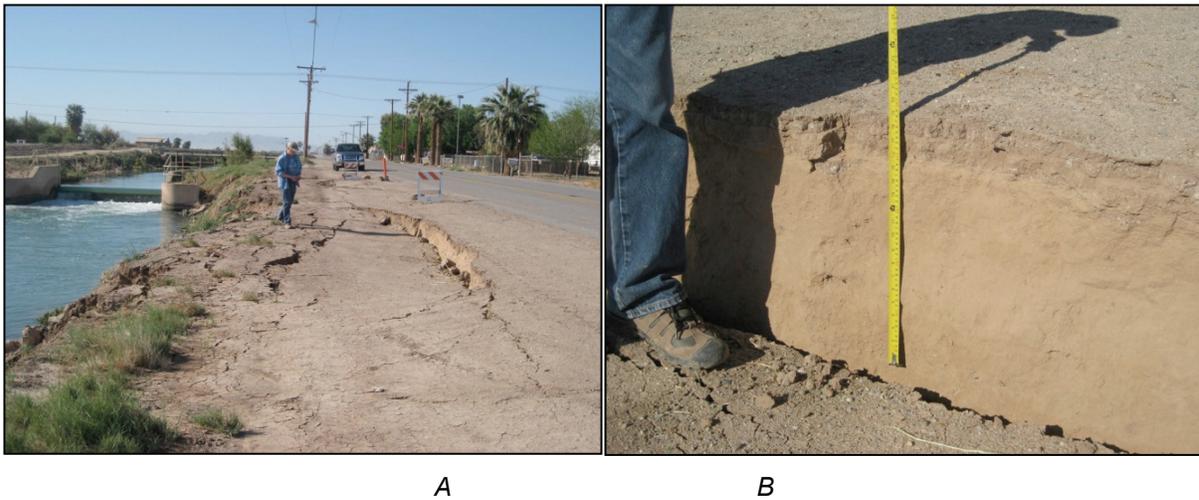
**Figure 69.** Slumping on east side of Austin Road just north of McCabe Road, near McCabe School. *A*, Large crack on shoulder of road that was part of fractured area more than 40 m wide (C42) and extended approximately 15 m back from canal. *B*, The slump had a maximum measured vertical displacement of 75 cm. No surface liquefaction features such as vented sand were observed. Photos by C. Pridmore, 4/11/10.

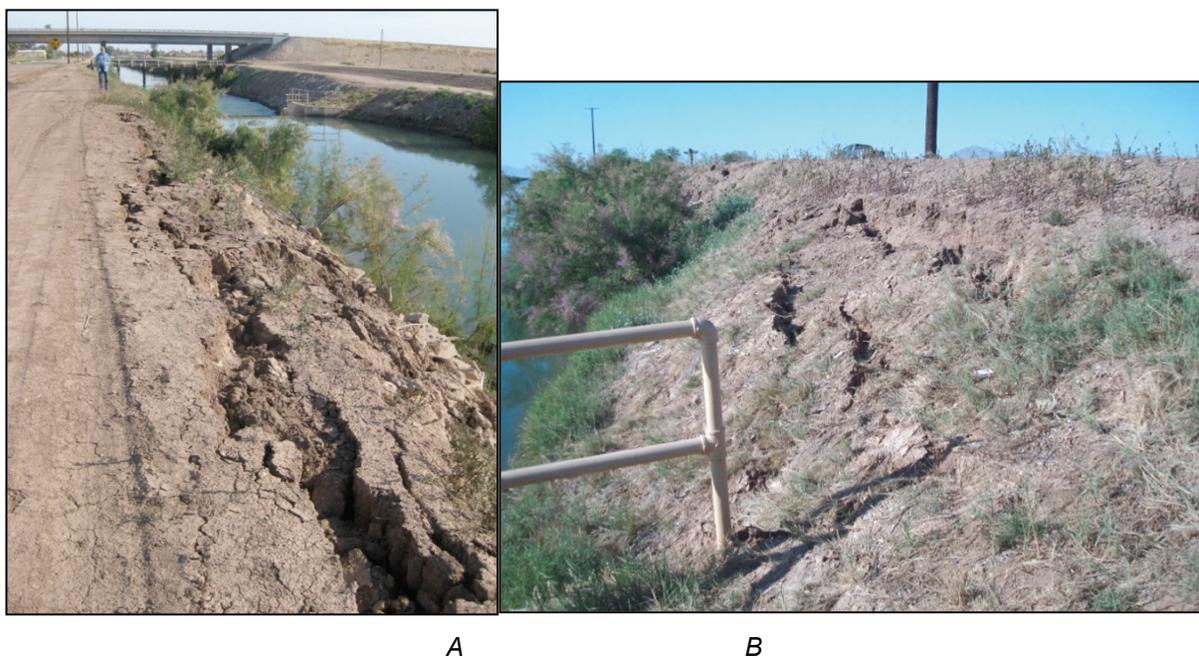
**Figure 70.** Shallow slumping along Austin Road adjacent to the Central Main Canal, just south of Interstate Highway 8 (C46). *A*, View to the north toward the weir and Interstate Highway 8 showing slumping of the outer 2 m of the canal bank. *B*, View to the south at a slump just upstream of the weir showing 30 to 40 cm of vertical displacement. Photos by: *A*, C. Pridmore, 4/11/10; *B*, T. McCrink, 4/11/10.

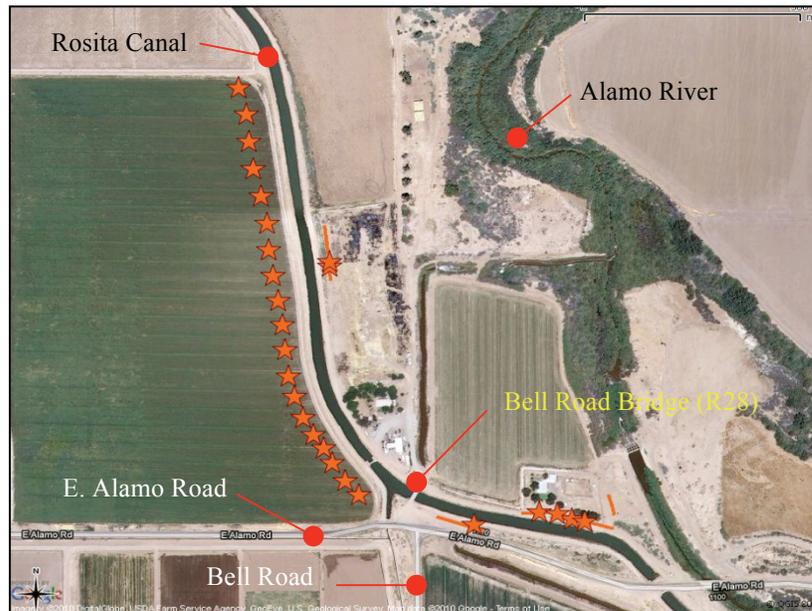
**Figure 71.** Diagrammatic sketch showing liquefaction features along the Rosita Canal west of Holtville. Lines represent approximate locations of cracks and fissures, and star symbols represent approximate sand boil locations (C56, R28). Base image is from Google maps.

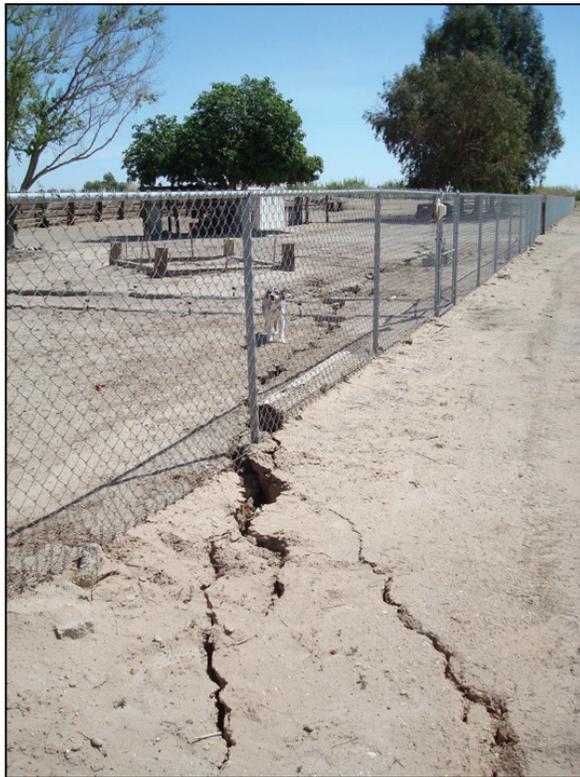
**Figure 72.** An arcuate lateral spreading crack running through a fenced yard on the north side of the Rosita Canal, northeast of the intersection of East Alamo and Bell roads (C56). Vented sand was found in several areas on both sides and filled some parts of the crack. The levee road, just to the right of the picture, had recently been graded, obliterating any liquefaction features that may have existed. View to the east. Photo by T. McCrink, 4/11/10.

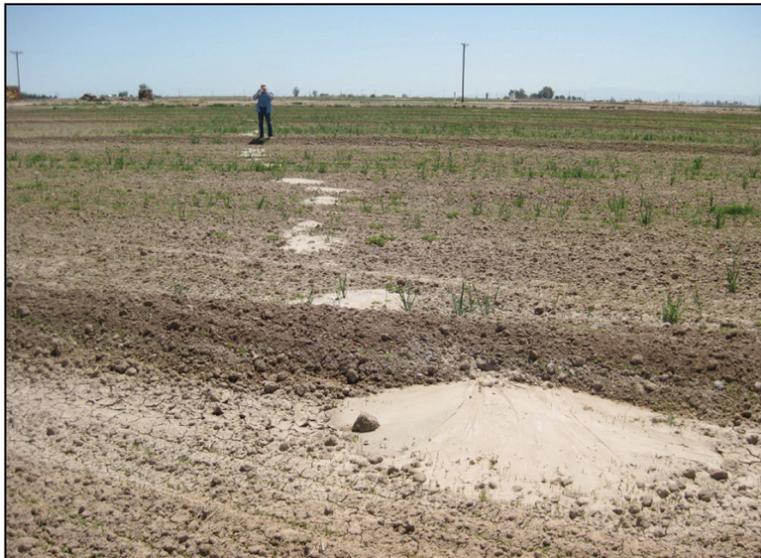
**Figure 73.** Continuous string of sand boils in an agricultural field west of the Rosita Canal (C56). View to the southeast. Photo by C. Pridmore, 4/11/10.

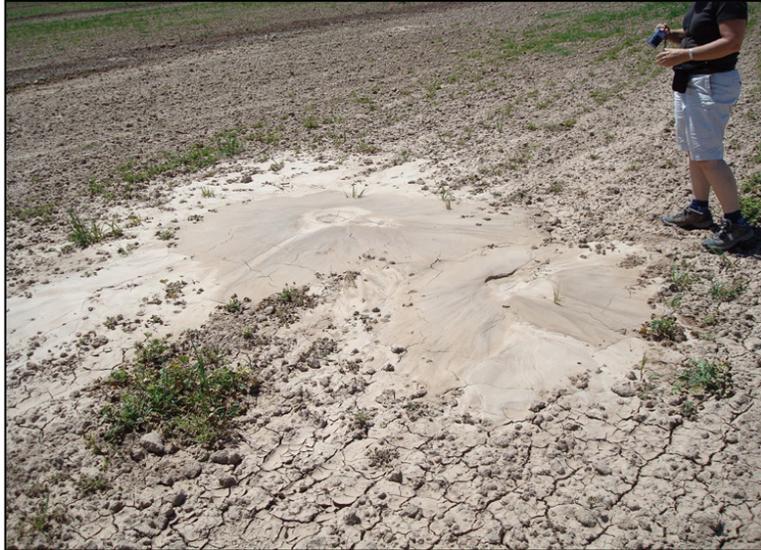
**Figure 74.** A pair of sand boils on the west side of the Rosita Canal that were wet 7 days after the earthquake, suggesting reactivation by aftershocks or subsurface conditions enabling prolonged seepage (C56). Photo by T. McCrink, 4/11/10.

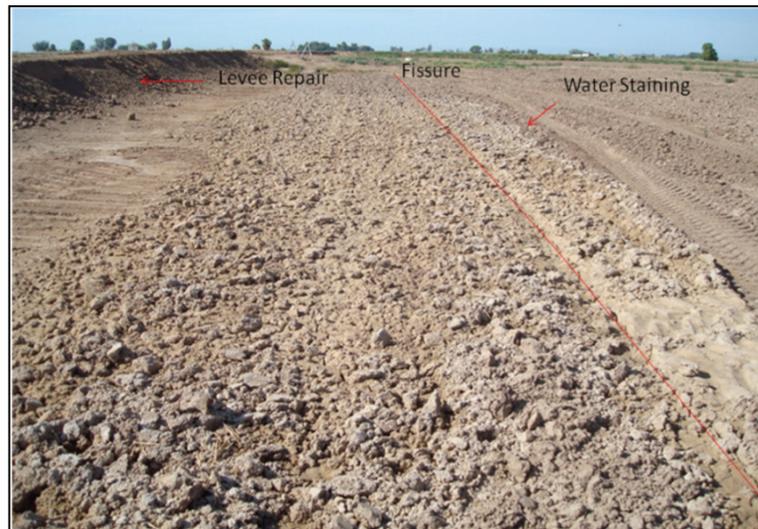
**Figure 76.** Evidence of excessive seepage from the east side of the Rosita Canal (C56). The fissure shown is slightly closer to the levee than the fissure related to the sand boils shown in figure 75. View to the north. Photo by T. McCrink, 4/11/10.
