Comments on the Yule Marble Haines Block—Potential Replacement, Tomb of the Unknown Soldier, Arlington National Cemetery

Open-File Report 2013-1182

Comments on the Yule Marble Haines Block— Potential Replacement, Tomb of the Unknown Soldier, Arlington National Cemetery

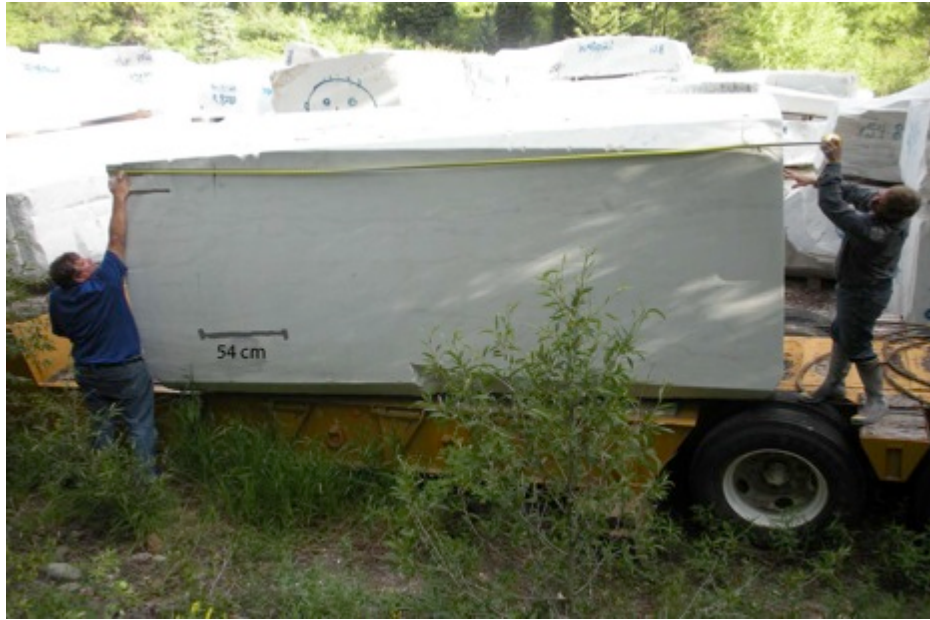
On the basis of the observable attributes of the Haines block, the cosmetic quality of the block is of the highest quality, and the block appears to be free of structural defects. Although it may be possible to cut other blocks of similar quality, few would exceed the apparent quality of the Haines block. The Haines block is an outstanding piece of Yule Marble; if it were needed, it would be an acceptable replacement to the existing die.

Figure 1. Photograph of the Haines block at its present location near the Yule Marble Quarry.

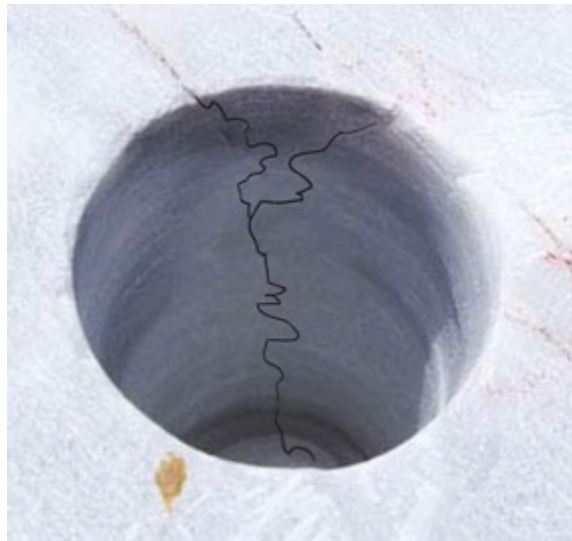
trains apparent in the Haines block, were identified as mica or feldspar (McGee, 1999). Perhaps the most troublesome observation was the discovery of a set of small set of hairline cracks on the top of the Haines block. In an attempt to discover how deep the specific hairline cracks run from the top of the Haines block into the stone, three 4-cm diameter cores were taken from the top of the block with each drill hole centered on a crack; the holes were drilled to a depth of about 4.5 cm (figure 4). Close inspection of the inner walls and bottom of the bore holes revealed that the small cracks penetrated the Haines block at least to the full depth of the holes. Because the hairline cracks extended beyond the depth of the drill holes, it was not possible to determine the full trajectory of the fractures by coring the surface.

Figure 4. Photograph of core hole ~3.5 cm diameter and ~4.5 cm deep, centered on hairline crack (graphically outlined for visibility) on the top of the Haines block; observed microcracks penetrated the Haines block at least to the full depth of the hole.

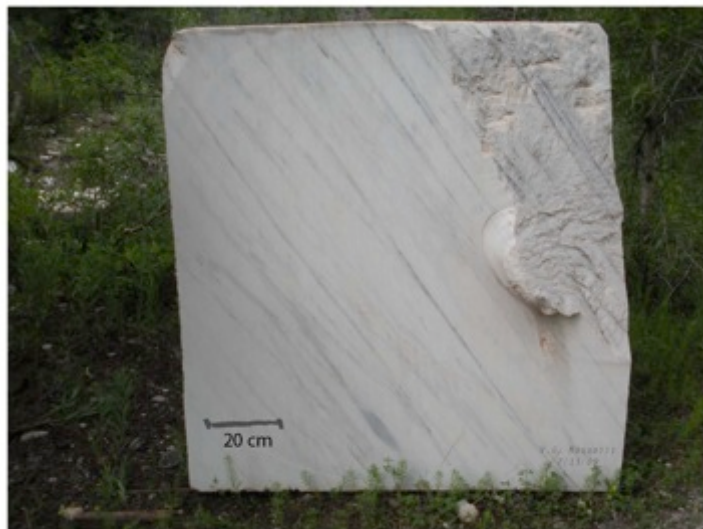
Figure 5 is a photograph of the back side of a block of stone that was first cut by wire saw and subsequently broken from the quarry wall; the final circular track of the wire saw is apparent at the separation of the smoothly cut surface from the rough broken surface. On the sawed faces, the natural internal texture of the block is shaved off and otherwise obscured by the action of the saw, whereas the broken corner shows internal texture of the block to the depth of the breakage. Although the wire saw freed most of the block from the rock formation, the entire corner of the block was sacrificed by the hydraulic technique that broke the remaining corner attachment wall, resulting in some mechanical shock to the block. At the scale of observation in figure 5, there appears to be no directional correlation of the inclusion trains with structural features associated with the host rock. Figure 6, a blow-up of the visible inclusion trains in figure 5, shows that inclusions penetrate the stone below the cut surface and that the growth history for the trains probably involved fluid flow along original bedding planes.

Figure 5. Photograph of the back side (last face attached to quarry wall) of a block first cut by wire saw and subsequently broken away from wall at the Yule Marble Quarry. The circular track of the wire saw is apparent at the boundary of the smoothly cut surface and the rough fractured surface.

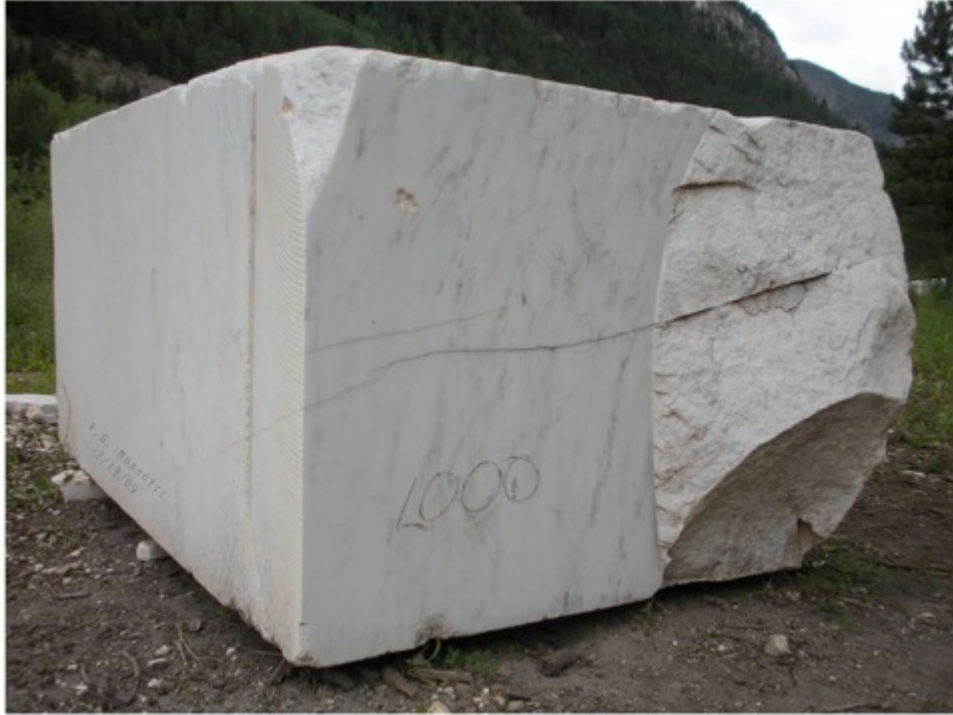
The photograph in figure 7 also shows the backside of a block that was cut by the wire saw and broken from the quarry wall. In this case, the violent release of the block from the wall may have initiated or extended an existing horizontal fracture that has propagated from the broken surface across the block and around the corner of the block. The width of the mildly curved fracture appears to decrease with distance from the point of shock. The fracture trajectory

seems to be associated with cracks initiated by mechanical shock to the stone. In this case, the crack runs almost perpendicular to the direction of the inclusion trains in the block, indicating the crack trajectory was not guided by the original bedding layers in the marble protolith.

Figure 7. Photograph of the back side of a block, about 1.7 m across, cut by wire saw, and broken from the Yule Quarry wall.

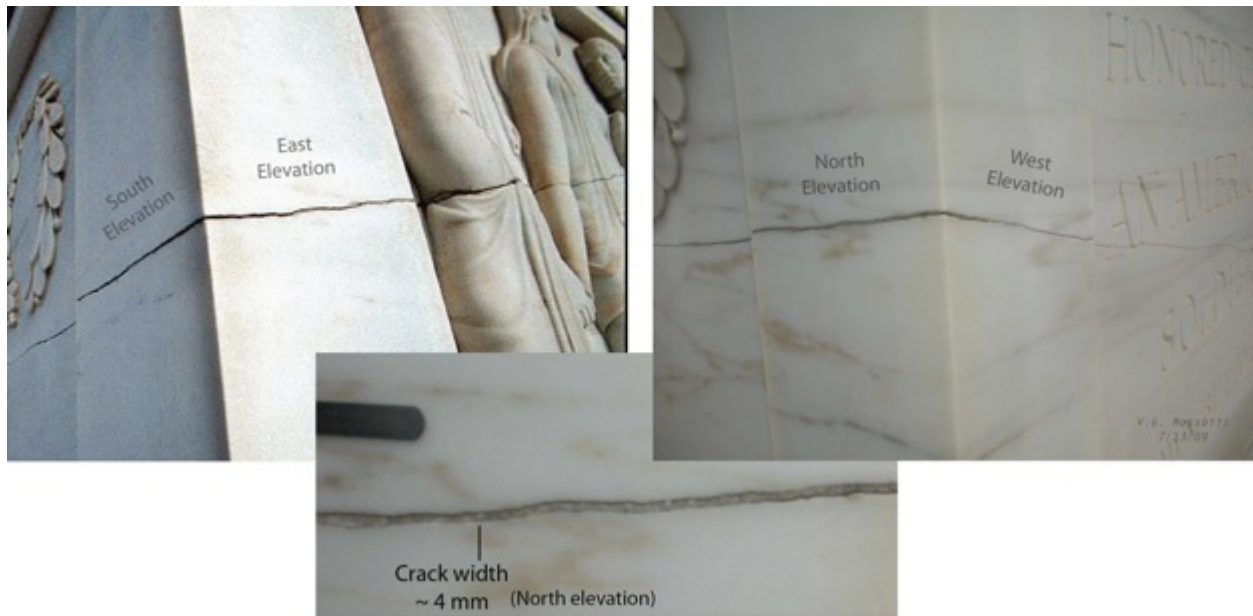
Figures 10–15 show close-up photographs of two relatively large cracks that define nearly parallel fracture planes that dip between 11° and 13° from the northwest to the southeast corners of the die. The maximal widths of the cracks at the northwest to the southeast corners are approximately 4 mm. The crack on the northwest corner, perhaps the better documented of two horizontal cracks on the die, has been referred to as the primary crack. The lower crack cutting the southeast corner is referred here as the secondary crack.

Figure 10 shows close-up photographs of relatively large cracks on the southeast and northwest corners of the tomb die where the maximal widths of the fractures are approximately 4 mm.

The geometry of the twin fractures on the die, as evident in figures 10–14, suggests an interpretation of compression along the central vertical axis of the die with possible down-drop tensional stress focused on the northwest and southeast corners of the die. Such a stress field could be the consequence of an upward warp of the 16-ton base supporting the die, resulting in a northeast-to-southwest trending ridge under the die. Such bowing could have been introduced in the original production of the base element, or it may have evolved with the natural anisotropic release of internal stress in the base element (Siegesmund and others, 2008).

Figure 10. Photographs showing cracks on the southeast and northwest corners of the tomb die; maximal widths of the fractures are approximately 4 mm. (Ruler width, 11 mm).

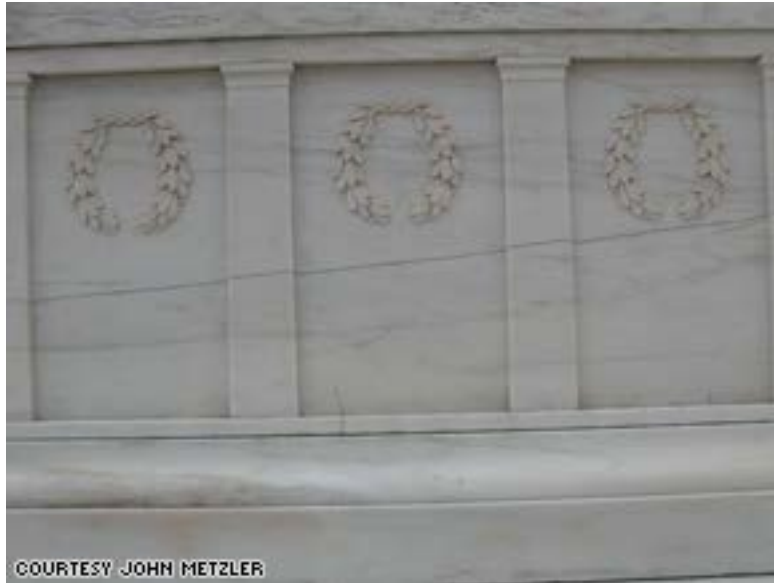
Similar to the fracture on the block shown in figure 7, the width of the primary crack on the north elevation (figure 11) decreases with distance from north to east, terminating on the east elevation the around the northeast corner. Note also that the primary crack traverses the west elevation starting from the northwest corner, wraps around the southwest corner (figure 12), traverses the south elevation (figure 13), and terminates at a point about two-thirds the distance across the east elevation (figure 14).

Figure 11. Crack across the north elevation of the die at the Tomb of the Unknown Soldier, Arlington National Cemetery.

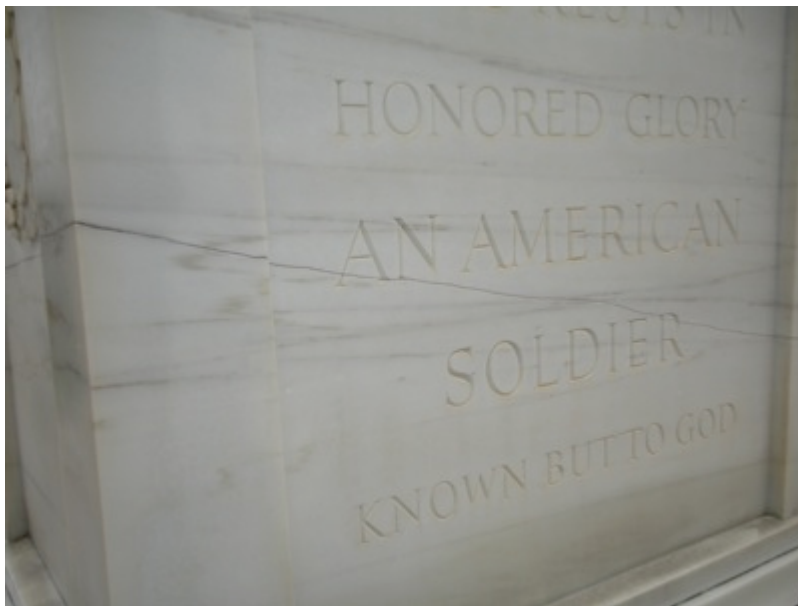
Note that cracks on the west and east elevations run nearly parallel, dipping between 11° and 13° (figures 12 and 14), respectively, while cracks on the north and south elevations run

Figure 12. Crack across west elevation of the die at the Tomb of the Unknown Soldier, Arlington National Cemetery.

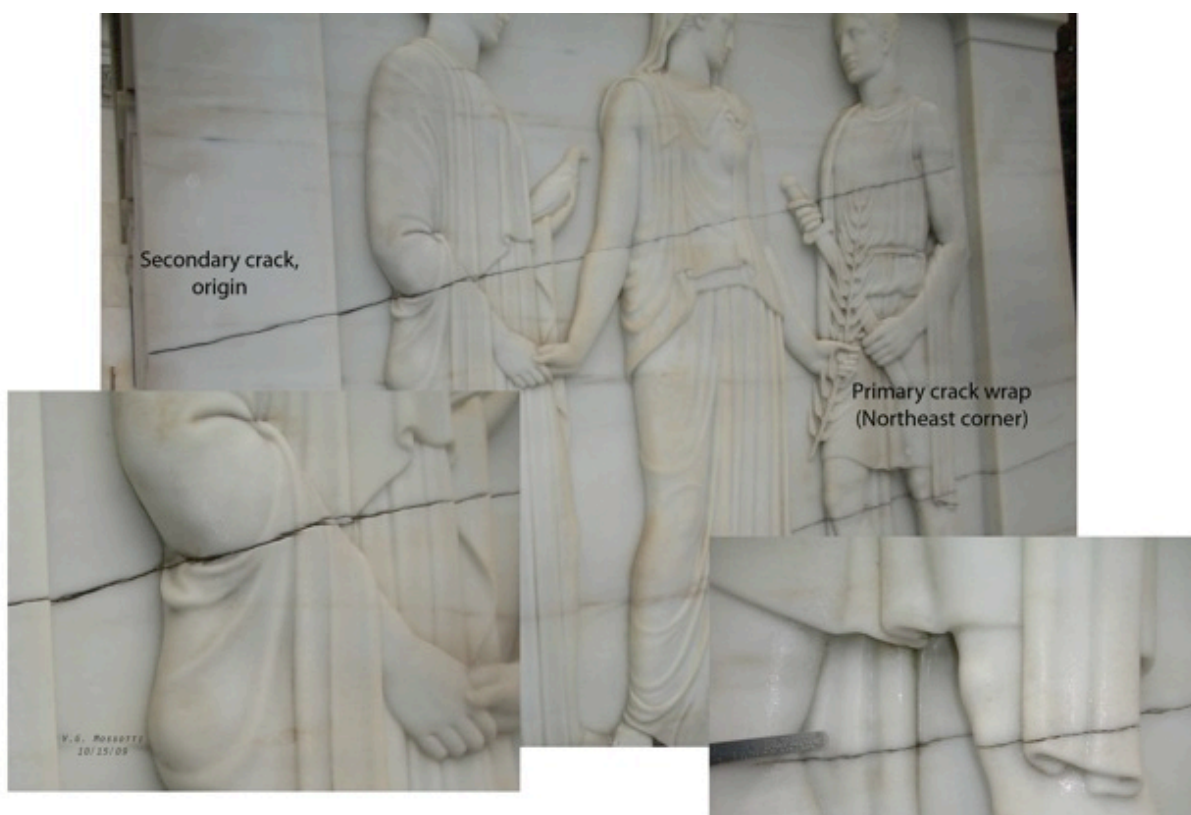
parallel in the horizontal direction. On the east elevation, it is clear that the fractures cut across the direction of the various inclusion trains, invalidating any notion that the cracks follow the original bedding planes in the Yule Marble protolith. Close inspection of the photos in figures 10, 13, and 14 shows no discernible lateral displacement of the fractured sections of the die, indicating that the fractures do not penetrate all the way through the block. Thus, the geometry of the fractures shown in figures 10–14, and the parallel projected fracture planes on the ANC die (about 12°), suggests a strong relation between the primary and secondary fractures on the die as depicted in figure 16. On the basis of these observations, the separation between the projected fracture planes is about 30 cm. Given the apparent vulnerability of Yule Marble to shear stress as illustrated in figures 5 and 7, the disquieting prospect exists—probably with a low probability—that at a particular shear stress threshold, the upper part of the block may radically break from the lower section without having been fractured on either the primary or secondary fracture planes through the center of the block.

Figure 14. Cracks on the east elevation of the die at the Tomb of the Unknown Soldier, Arlington National Cemetery. Close-up insert: Crack on the right arm on the left figure above the insert near the origin of the secondary crack.

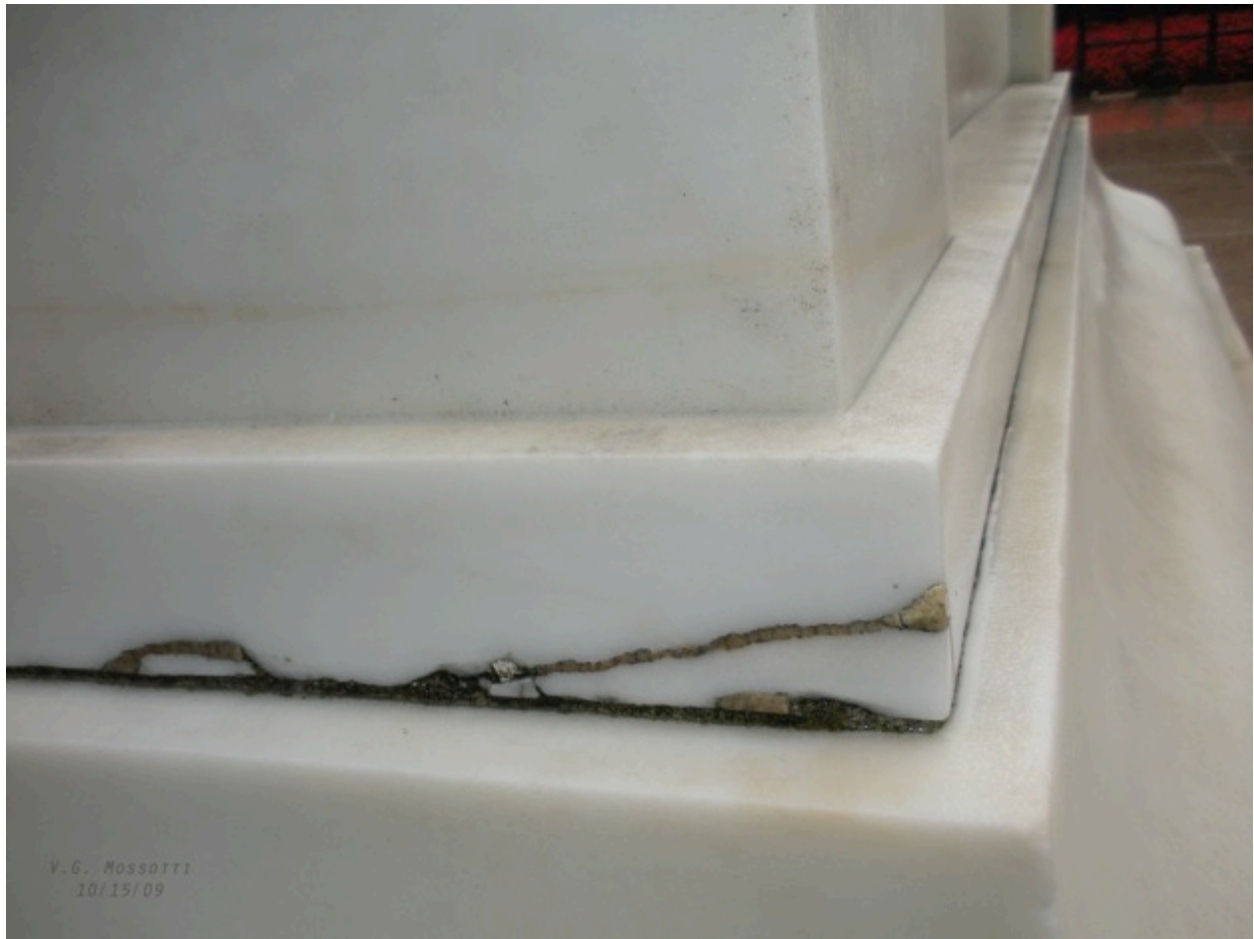
Alternatively, the damage could have been caused by mechanical shock, possibly when the die was originally put in place. The fractures on the bottom of the northwest corner of the die (north elevation view) as seen in figure 15 are evidence in favor of such an alternative hypotheses. The widths of the primary and secondary cracks on the die diminish as they propagate in opposite directions from the northwest corner and the southeast corners, respectively. This indicates that the primary crack originally opened at the northwest corner of the die and the secondary crack at the southeast corner (Mossotti, 2009). The quantitative similarity of the widths of the primary and secondary fractures at their origin indicates that the twin fractures were initiated around the same time.

Figure 15. Fractures on the bottom of the northwest corner of the die at the Tomb of the Unknown Soldier, Arlington National Cemetery (north elevation view).

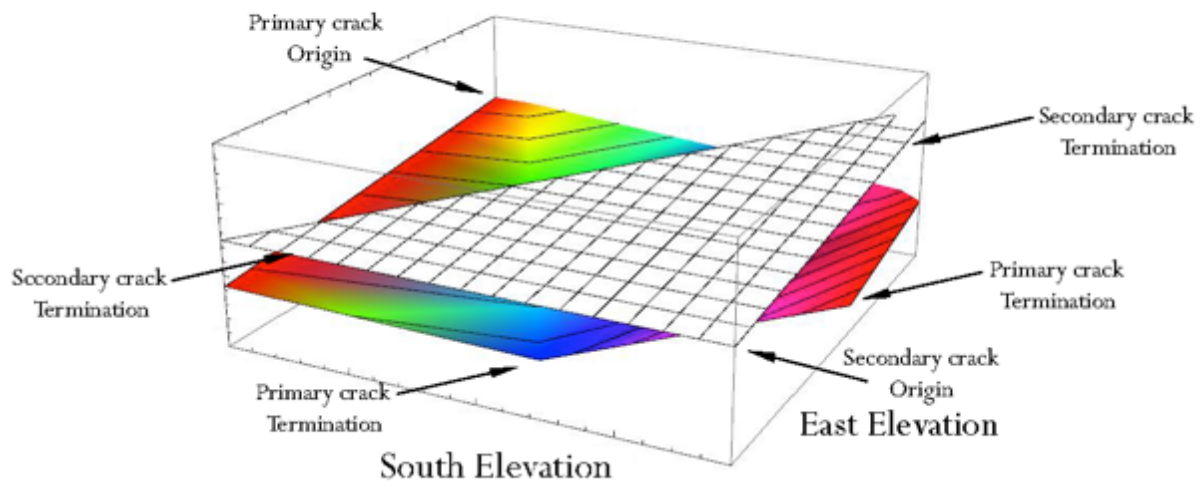
Figure 16. Schematic projection of fracture planes in the die at the Tomb of the Unknown Soldier, Arlington National Cemetery (South elevation perspective, not to scale).
