# Faulting, Damage, and Intensity in the Canyon Dam Earthquake of May 23, 2013

By K. Chapman, M.B. Gold, John Boatwright, J. Sipe, V. Quitoriano, D. Dreger, and Jeanne Hardebeck

Open-File Report 2016-1145

U.S. Department of the Interior  
U.S. Geological Survey

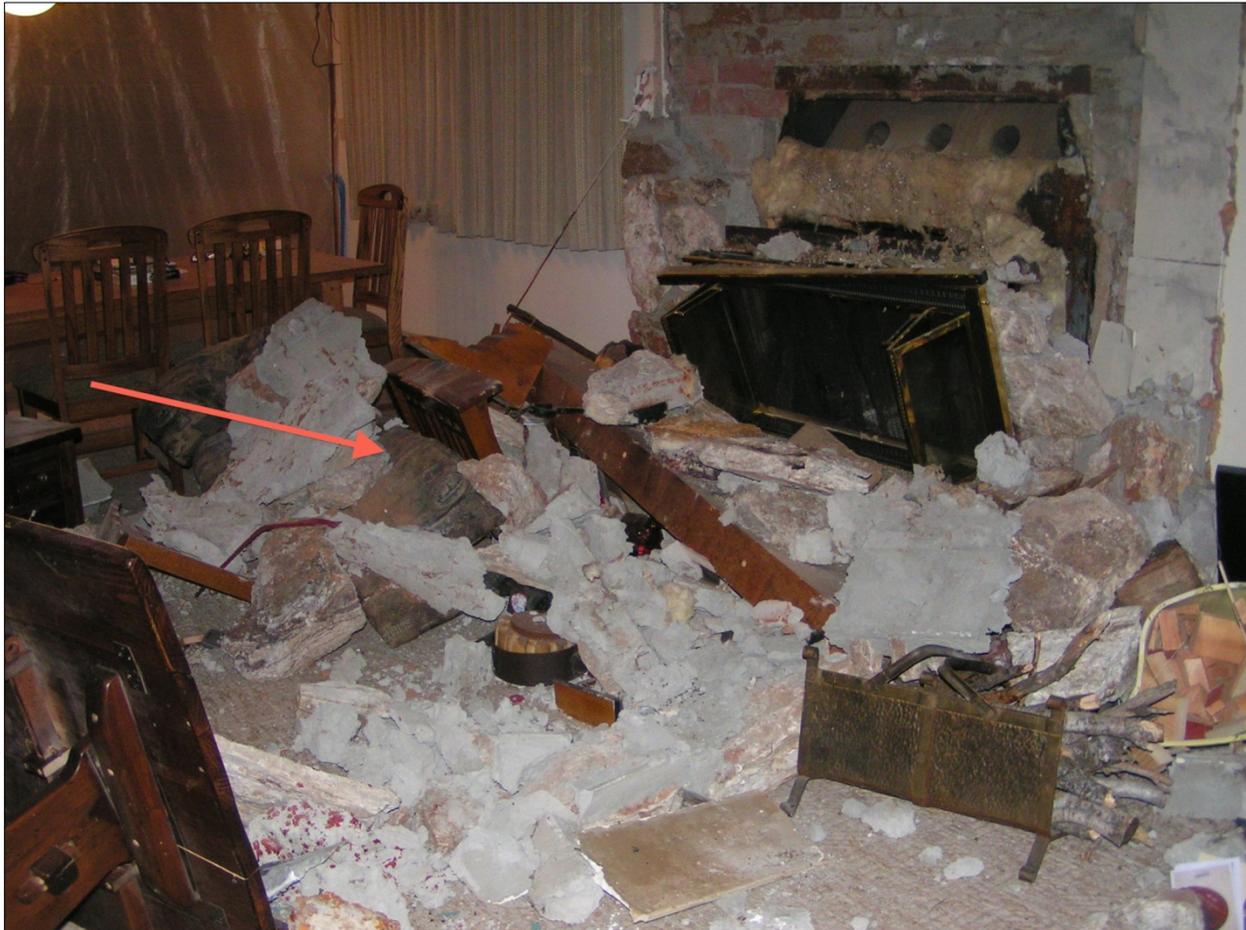
South of the golf course, many houses had tarps covering damaged or collapsed chimneys. In one house on Peninsula Drive, which runs along the eastern shore of the peninsula, the fireplace collapsed inside the house, breaking the homeowner's leg and damaging furniture. The chimney collapsed above the roofline, and bricks in the remaining chimney had separated (table 1–1, item 5). The porch had separated a few inches from the house. This injury was the only reported injury caused by the earthquake. Photographs of the damage to this house are shown in figures 2–1 to 2–3.

**Figure 2-1.** Internal damage at site 1.1.5, a house on Peninsula Drive in LACC. Brick fireplace and mantle collapsed into the home, damaging furniture and injuring one resident. Photo courtesy of homeowner.

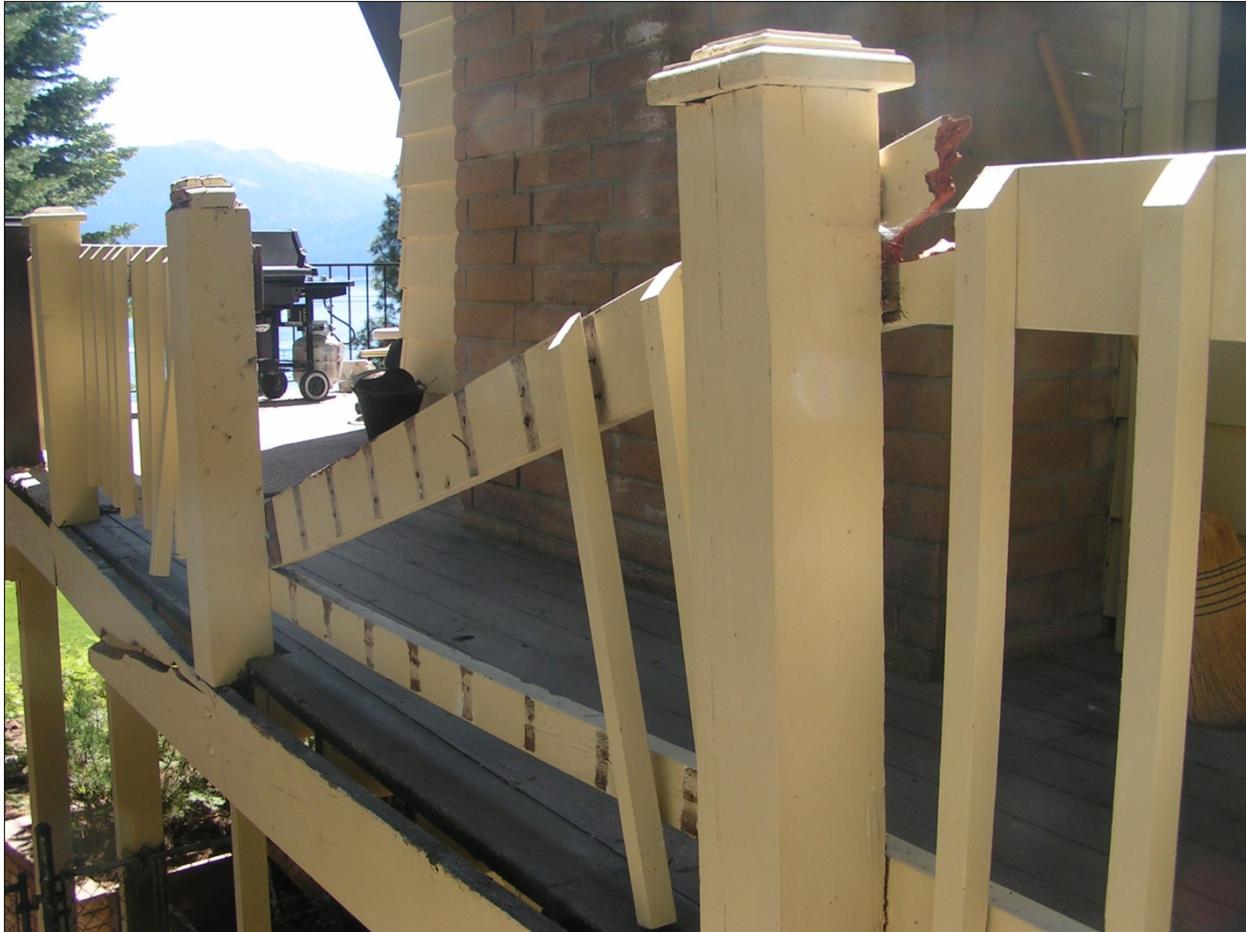
**Figure 2-2.** Porch railing damage to site 1.1.5 in LACC. Chimney collapsed above the roofline (in right background of photo) and damaged the porch railing as it fell. Porch became separated from the house by several inches. Photo courtesy of homeowner.

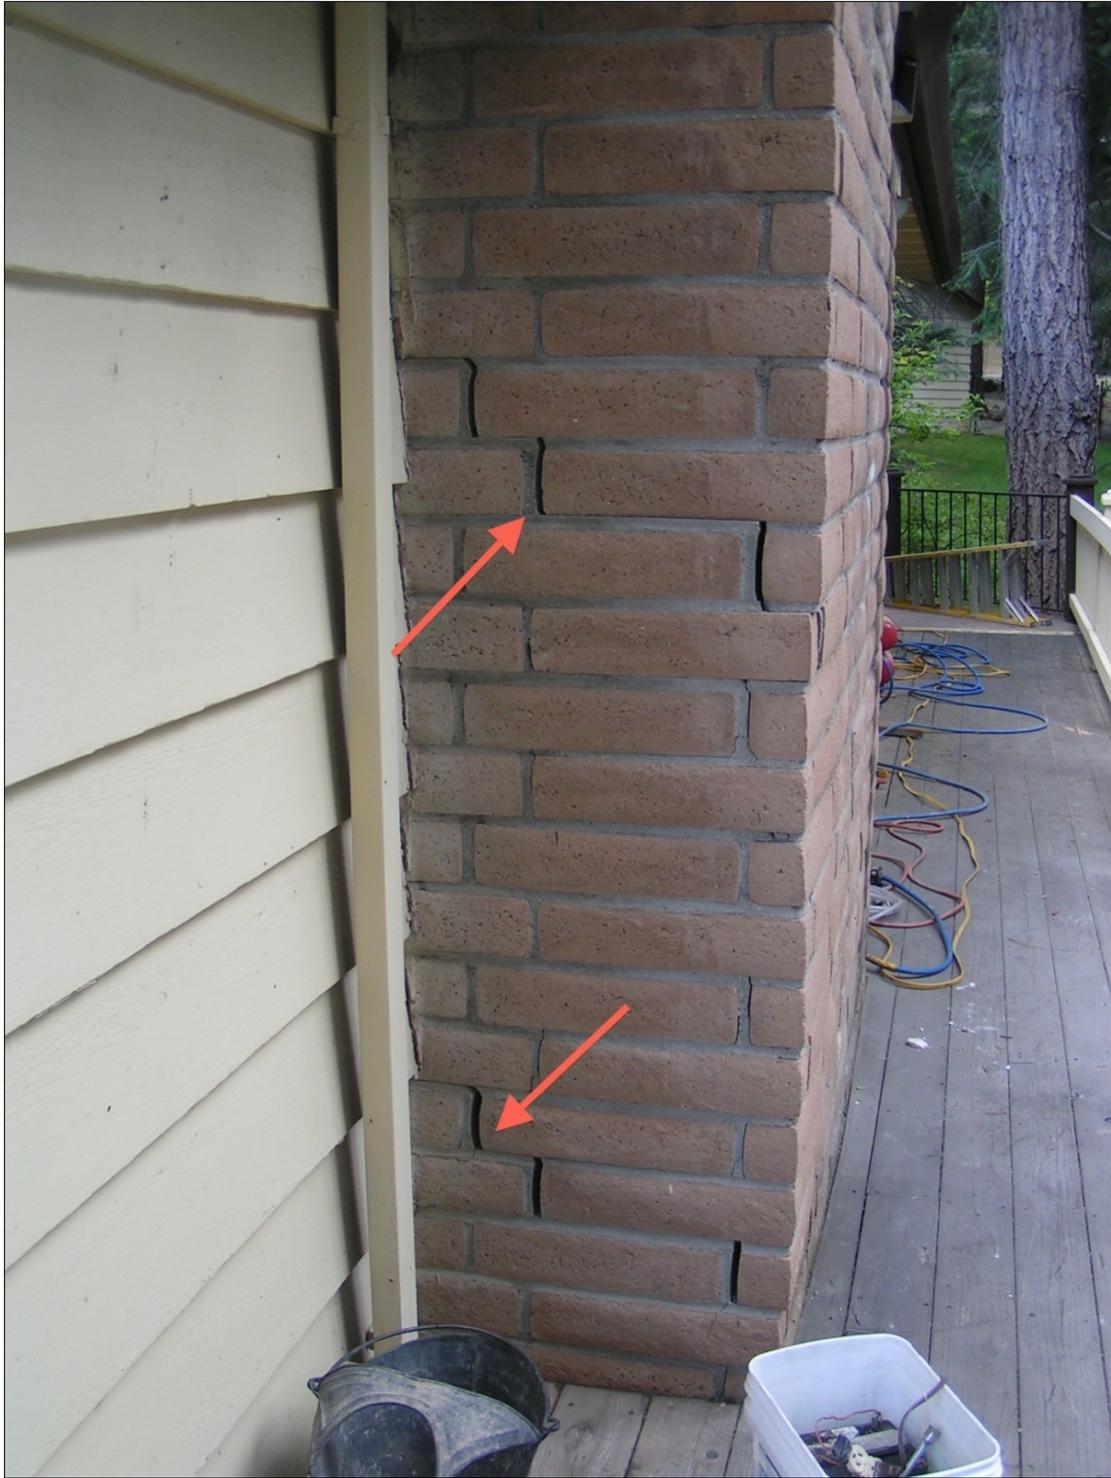
**Figure 2-3.** Chimney separation at site 1.1.5 in LACC. Separation of bricks in remaining chimney that collapsed above the roofline.

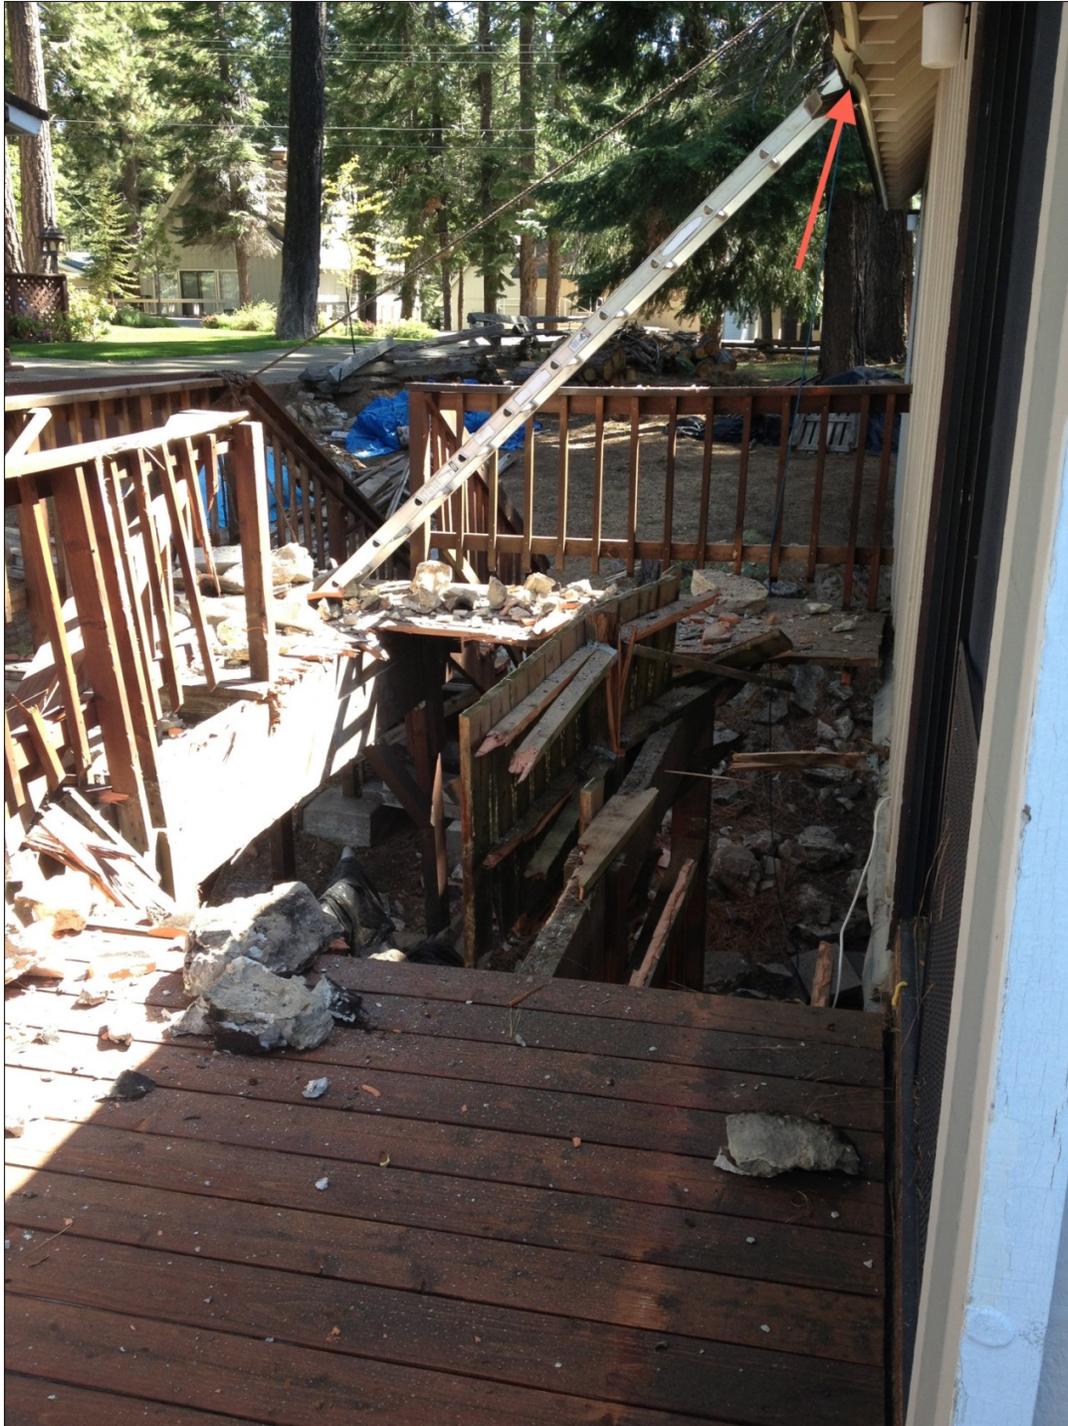
The greatest concentration of damaged or collapsed chimneys was on Lassen View Drive, which runs along the western shore of the peninsula. In one house, the chimney fell through the porch, leaving a hole and causing some roof damage (table 1–1, item 22; figs. 2–4 to 2–6). The cinder block foundation was cracked in several places (figs. 2–7 and 2–8), and there were many bent doorframes. Several other residents reported shifted or bent doorframes, owing to settling. There was one report of a broken gasline on this street, which was repaired the next day. There was also a report of a fissure that opened

**Figure 2-4.** Deck damage at site 1.1.22, on Lassen View Drive in LACC. Chimney collapsed (arrow indicates approximate location) and significantly damaged porch when it fell. Photo courtesy of homeowner.

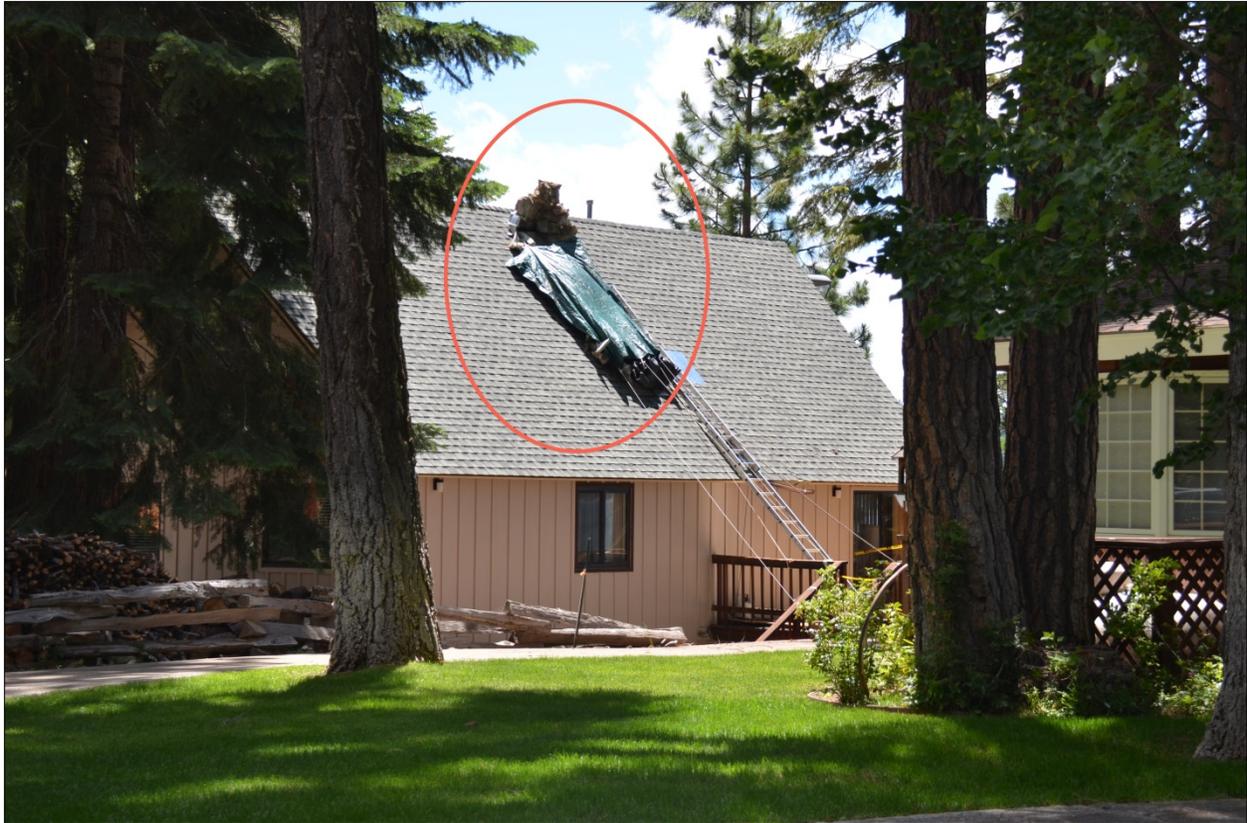
**Figure 2-5.** Chimney damage to site 1.1.22 in LACC.

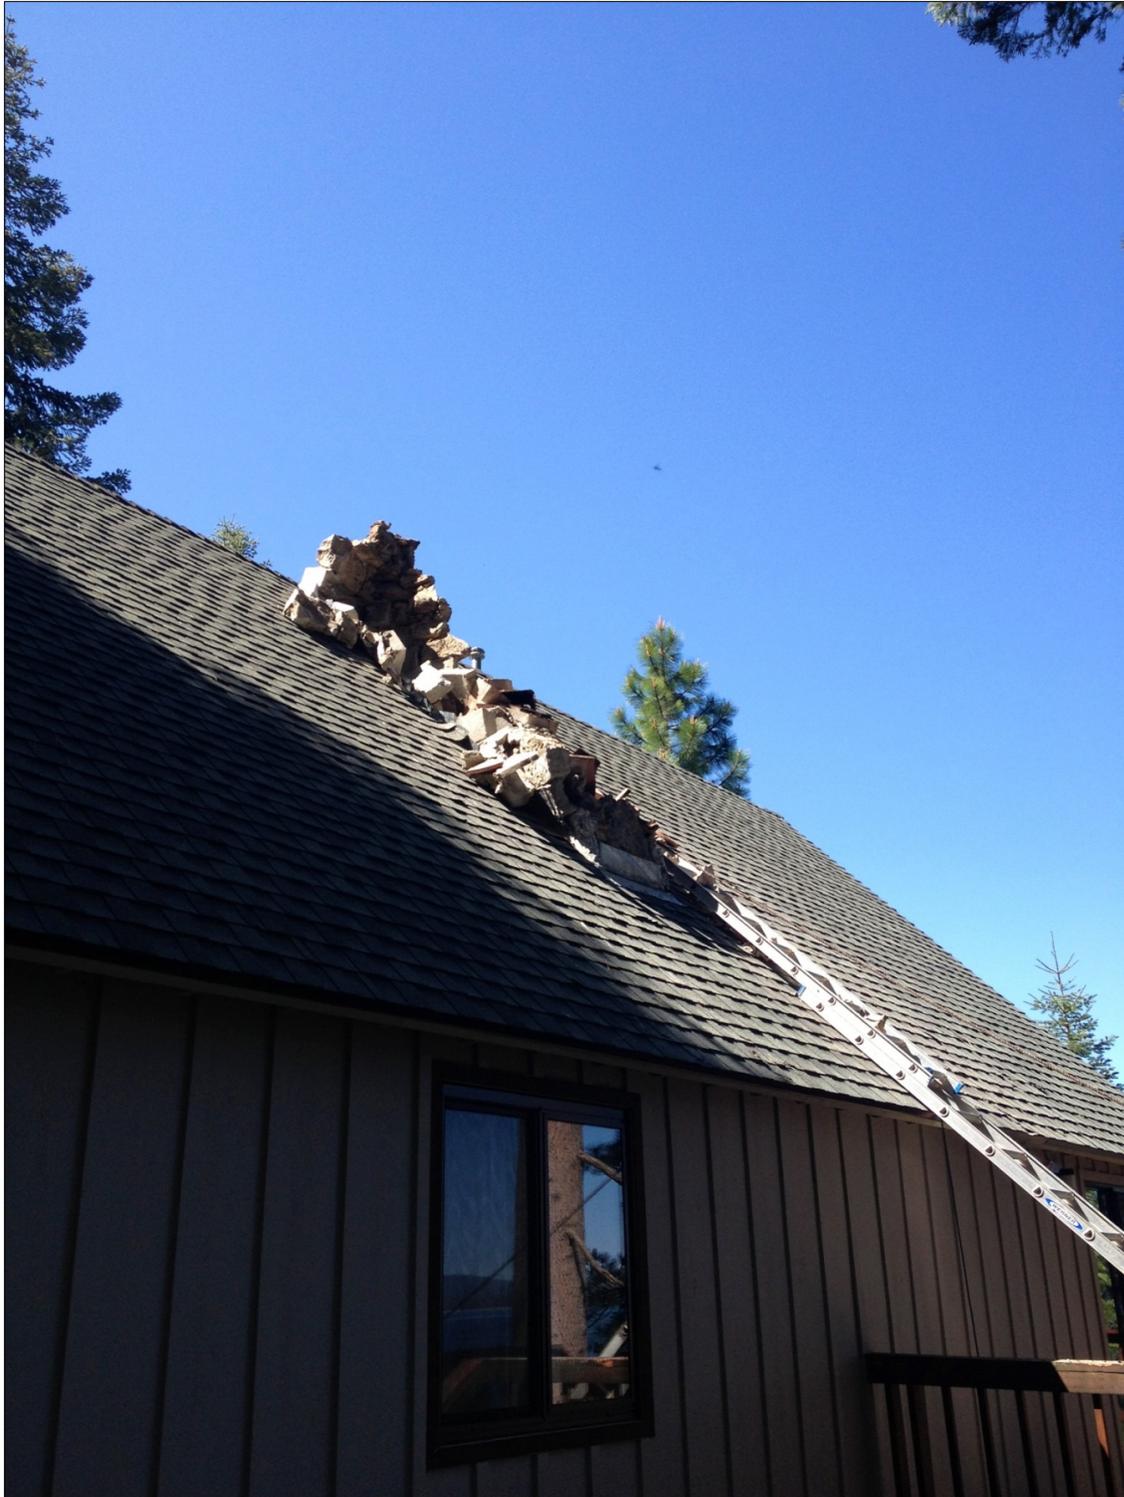
**Figure 2-6.** Chimney damage at site 1.1.22 in LACC. Remains of chimney immediately after collapse. Roof was damaged where the bricks fell. Photo courtesy of homeowner.

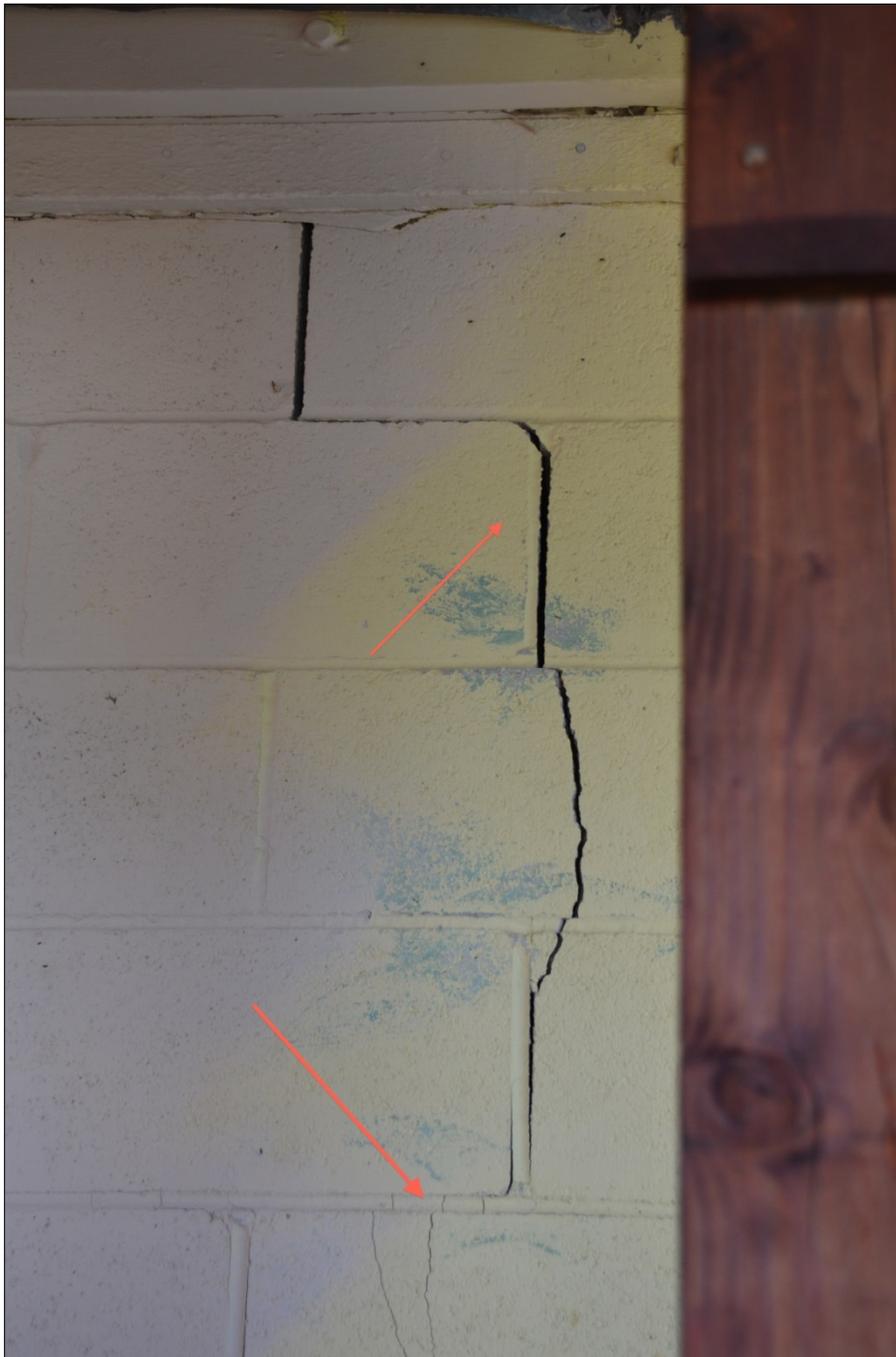
**Figure 2-7.** Foundation cracking at site 1.1.21 in LACC.

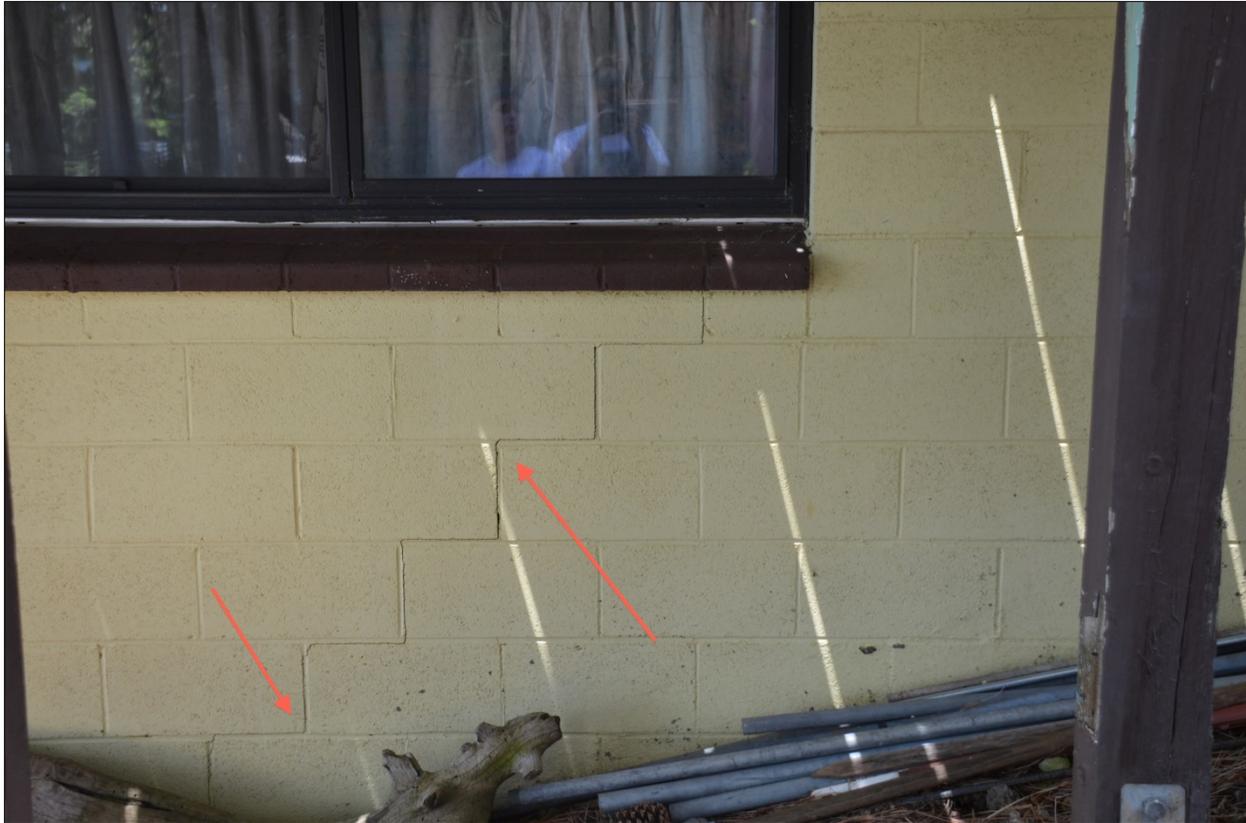
**Figure 2-8.** Stepwise foundation cracking at site 1.1.22 in LACC.

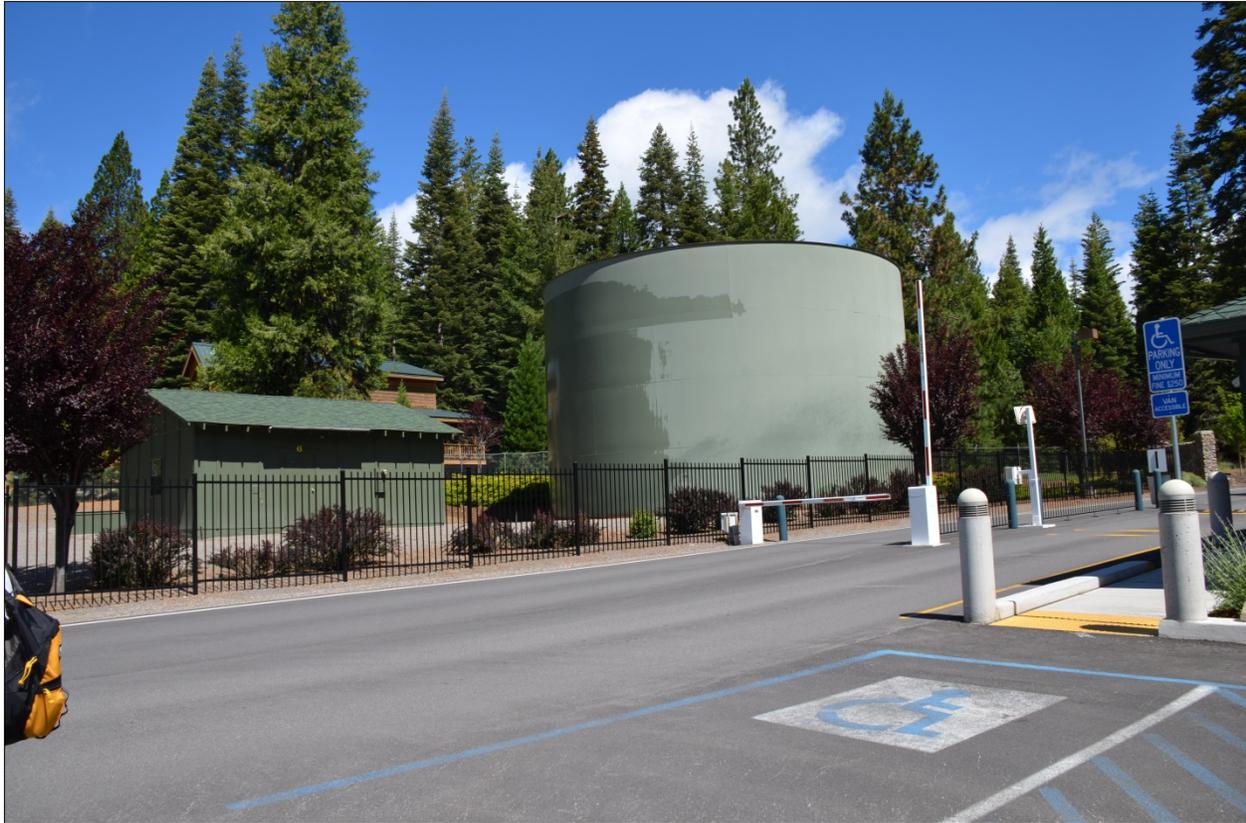
**Figure 2-9.** Water tank in LACC, at site 1.1.28. The earthquake caused a coupling to break, and 50,000 gallons of water were spilled before LACC Mutual Water Company shut off the leak.

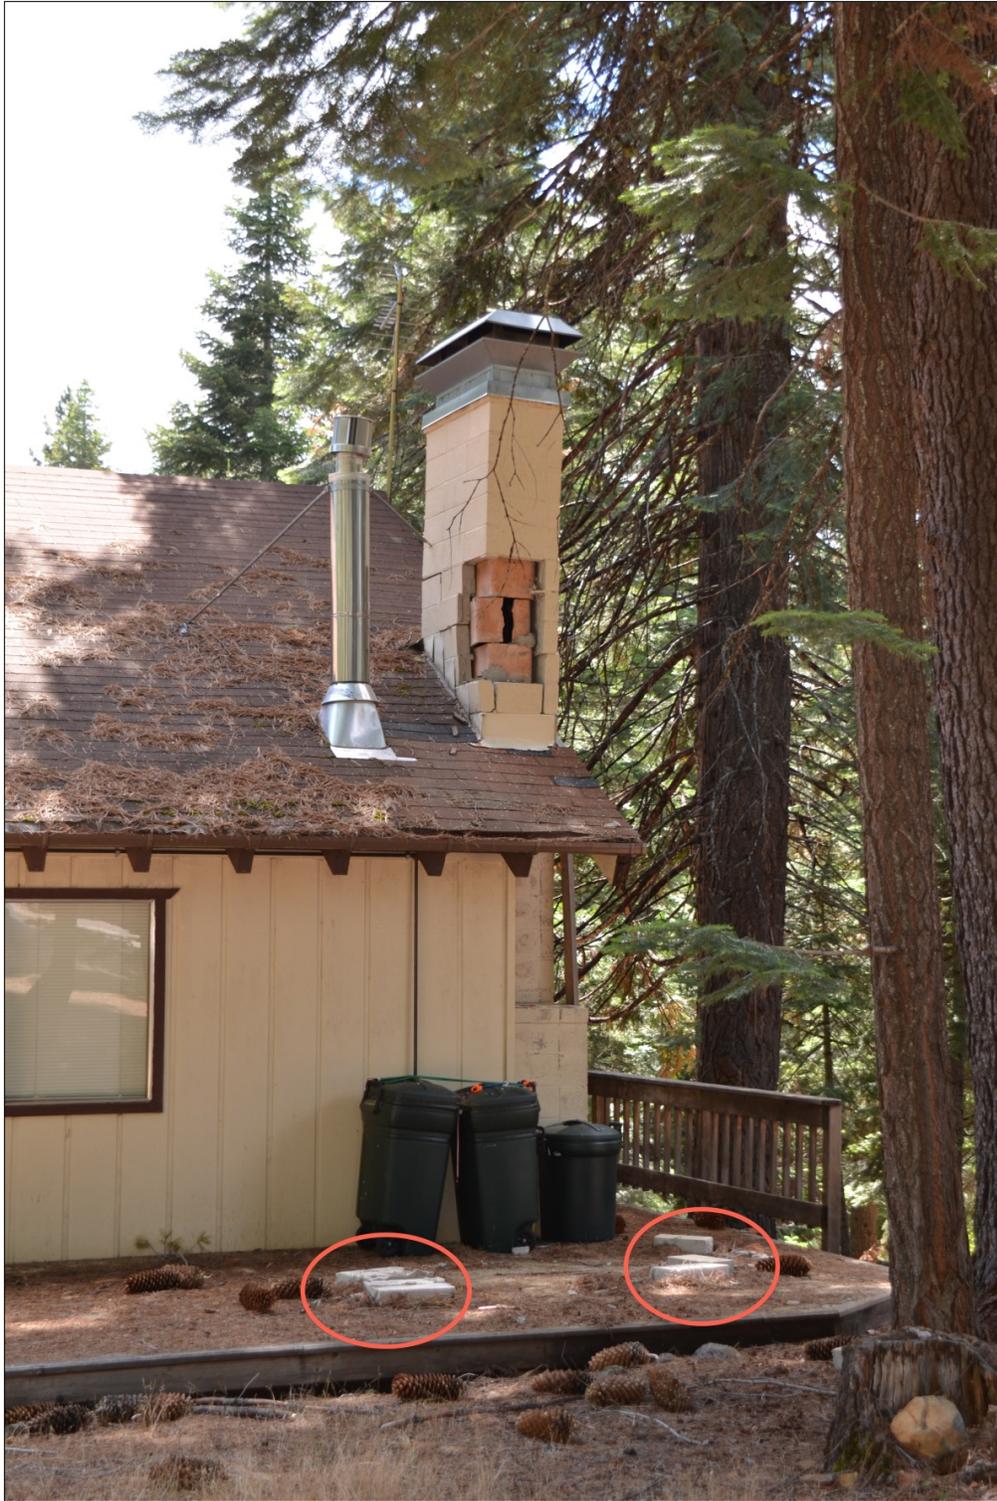
Figure 2-10. Chimney damage at site 1.1.19 in LACC.

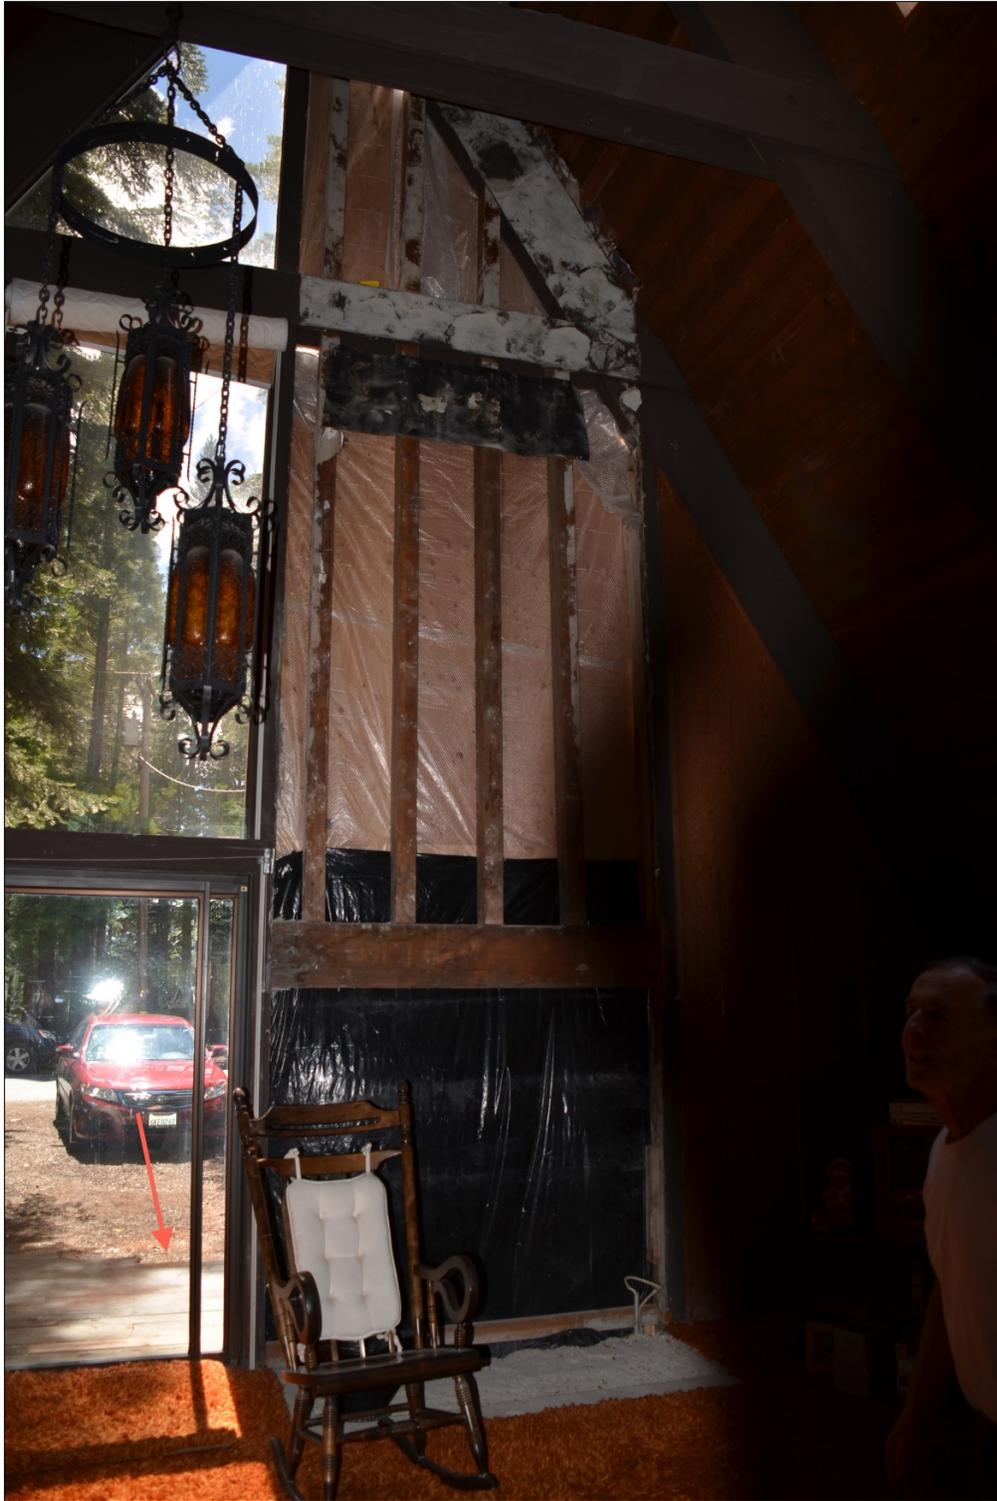
**Figure 2-11.** Chimney damage at site 1.1.26 in LACC. Chimney collapsed both internally and externally. Falling bricks and stones damaged deck and floor.

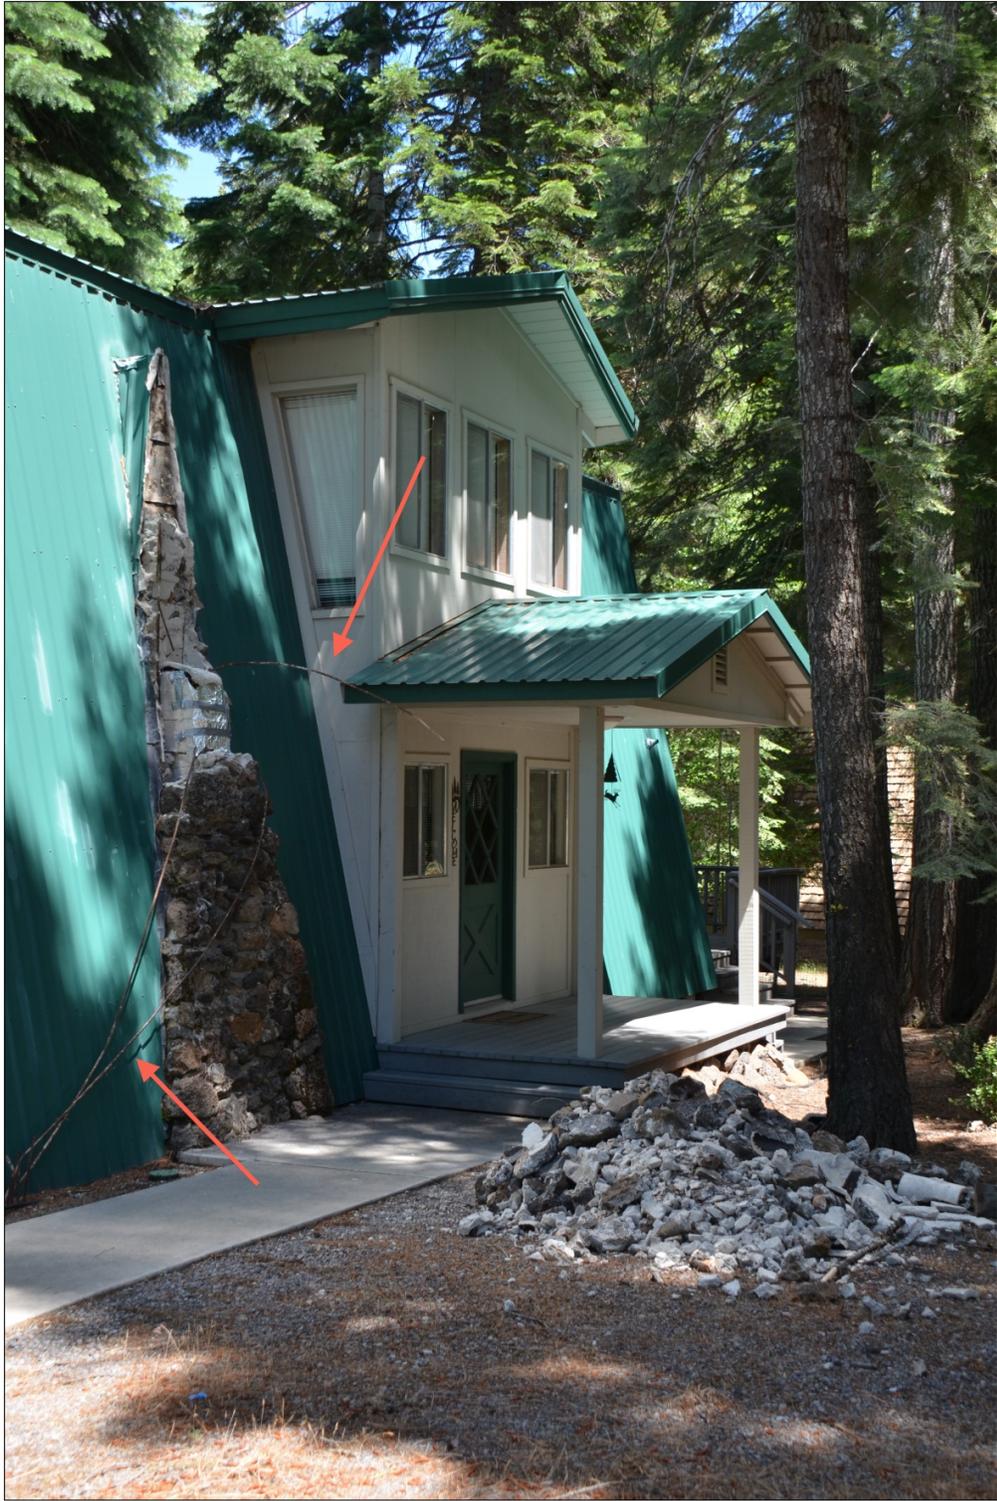
**Figure 2-12.** Chimney collapse at site 1.1.23 in LACC. Exposed rebar indicates the chimney was “reinforced.”

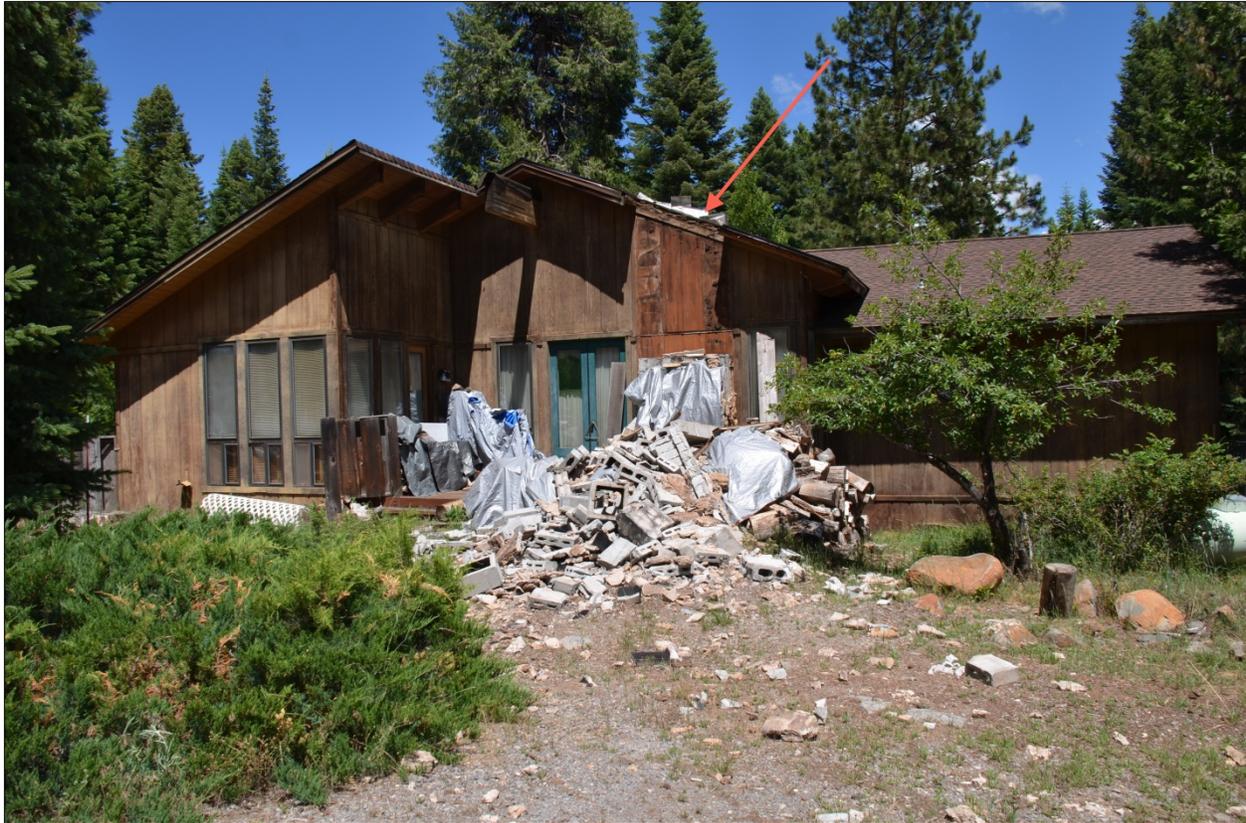
**Figure 2–13.** Chimney collapse at site 1.1.24 in LACC.

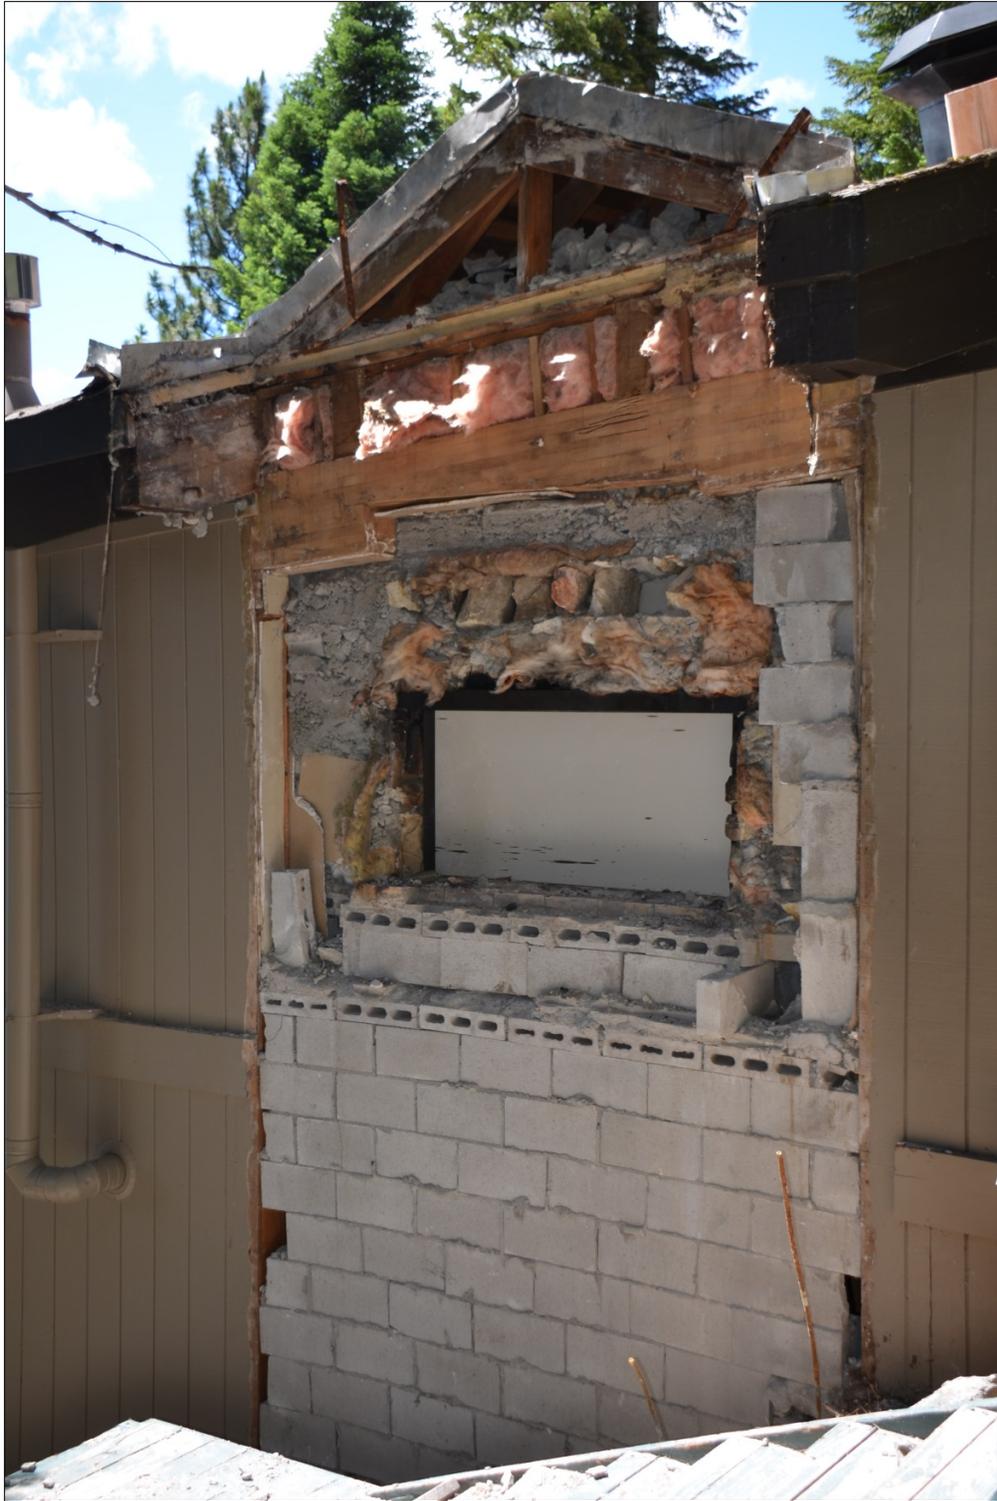
**Figure 2-14.** Chimney collapse at site 1.1.25 in LACC. Homeowners had cleaned up chimney pieces before the photo was taken.

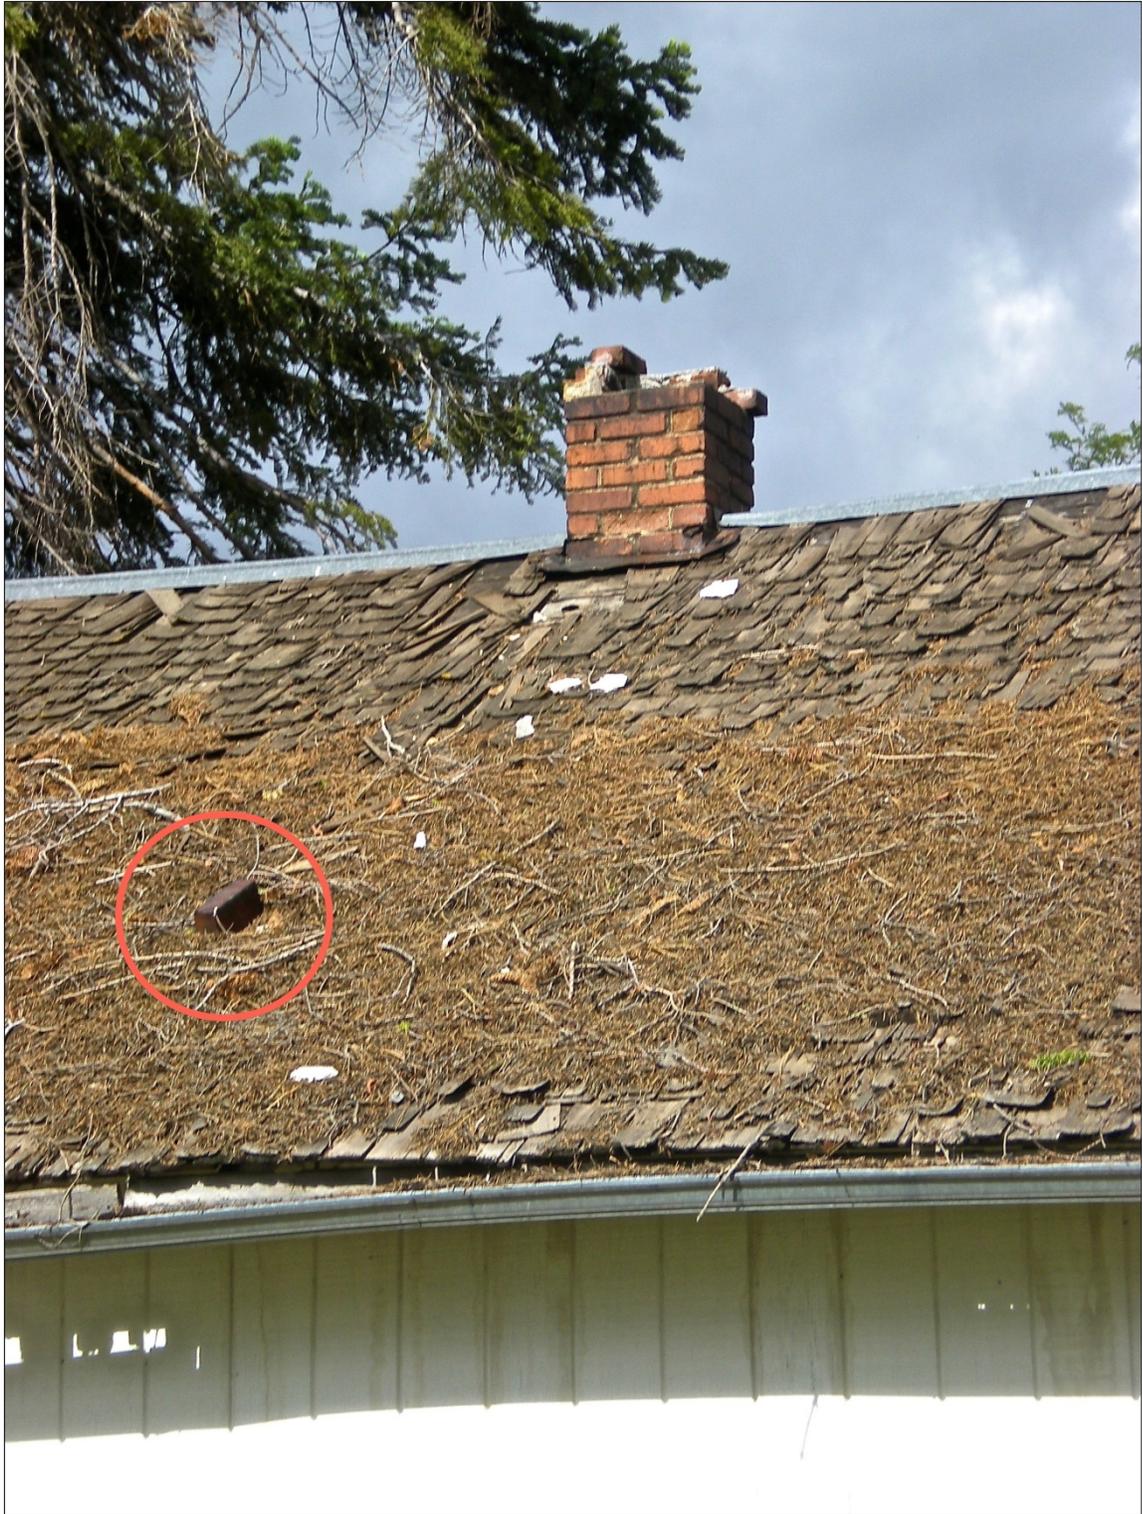
**Figure 2-15.** Chimney damage to house (site 1.1.35) in Westwood.

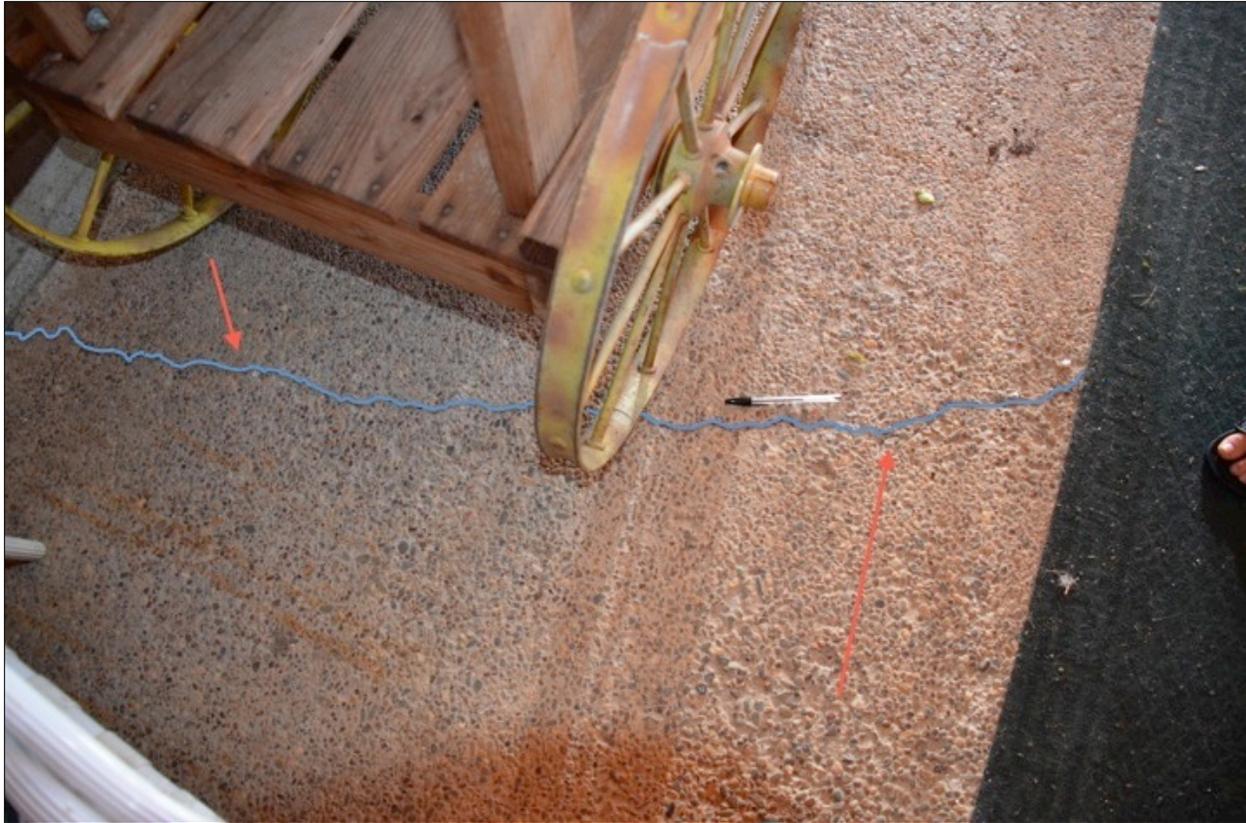
On Kokanee Trail, near the tip of the Almanor West Peninsula, one house was displaced on its cripple wall (table 1–2, item 62). At a neighboring house (table 1–1, item 41), there were several 2-m-long cracks along a paved walkway, as well as a cracked foundation, shifted doorframes, cracked sheet rock around the fireplace, and a broken pipe in the basement that caused flooding at the time of the earthquake (fig. 2–16).

**Figure 2-16.** Cracked pavement in walkway of site 1.1.41 in LAW. House also suffered cracked foundation, shifted doorframes, cracked sheetrock, and a broken water pipe in the basement.
