# Faulting, Damage, and Intensity in the Canyon Dam Earthquake of May 23, 2013

By K. Chapman, M.B. Gold, John Boatwright, J. Sipe, V. Quitoriano, D. Dreger, and Jeanne Hardebeck

Open-File Report 2016-1145

U.S. Department of the Interior  
U.S. Geological Survey

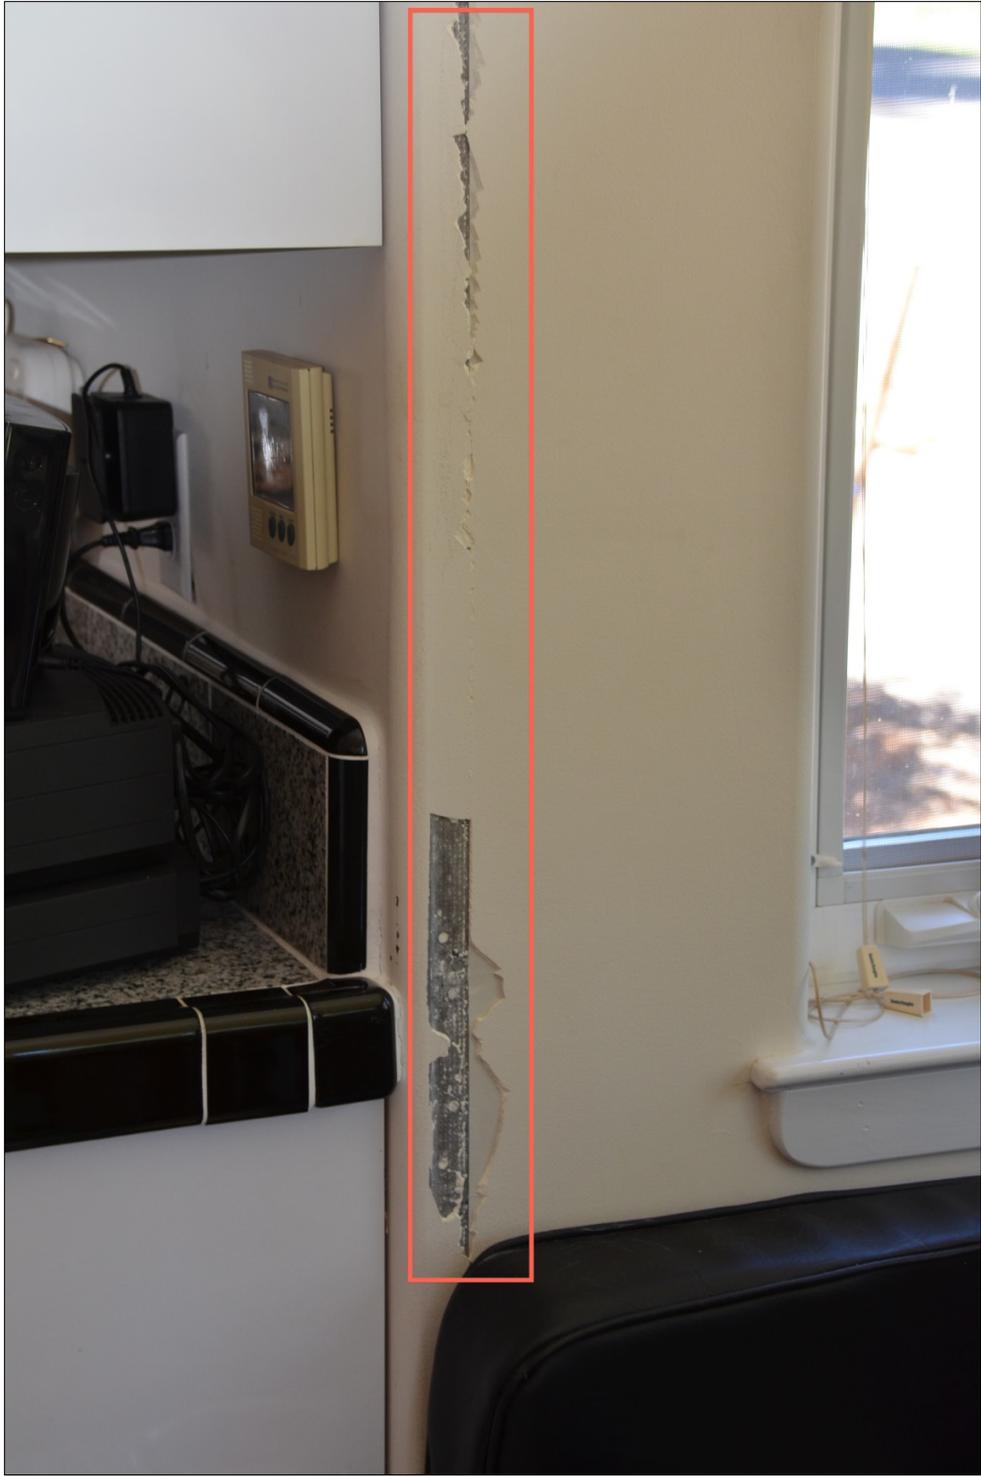
On Lake Almanor West Drive, we found one house with displaced or racked cripple walls, and we were told of two others. The homeowner showed us the damage her house sustained as it settled (table 1–1, item 40). There was significant drywall cracking on the first floor, caused by settling of the upper story on the lower story. Two load-bearing laminated wooden roof beams were partially separated

**Figure 2-17.** Cracked drywall in site 1.1.40 in LAW. Many locations throughout the first story of the house had similar drywall. Drywall in the second story was mostly undamaged.

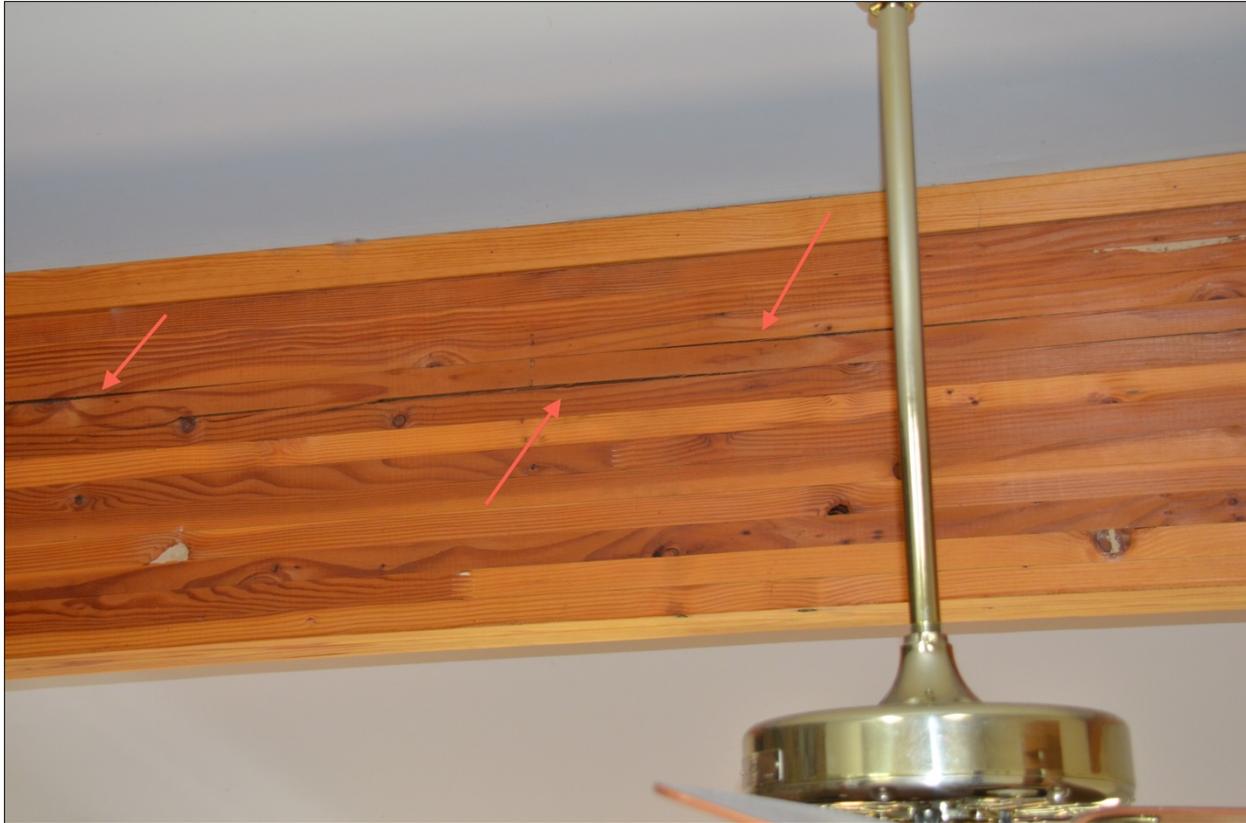
**Figure 2-18.** Cracks in laminated wooden ceiling beams in site 1.1.40 in LAW. Cracks were present in beams oriented both north-south and east-west.

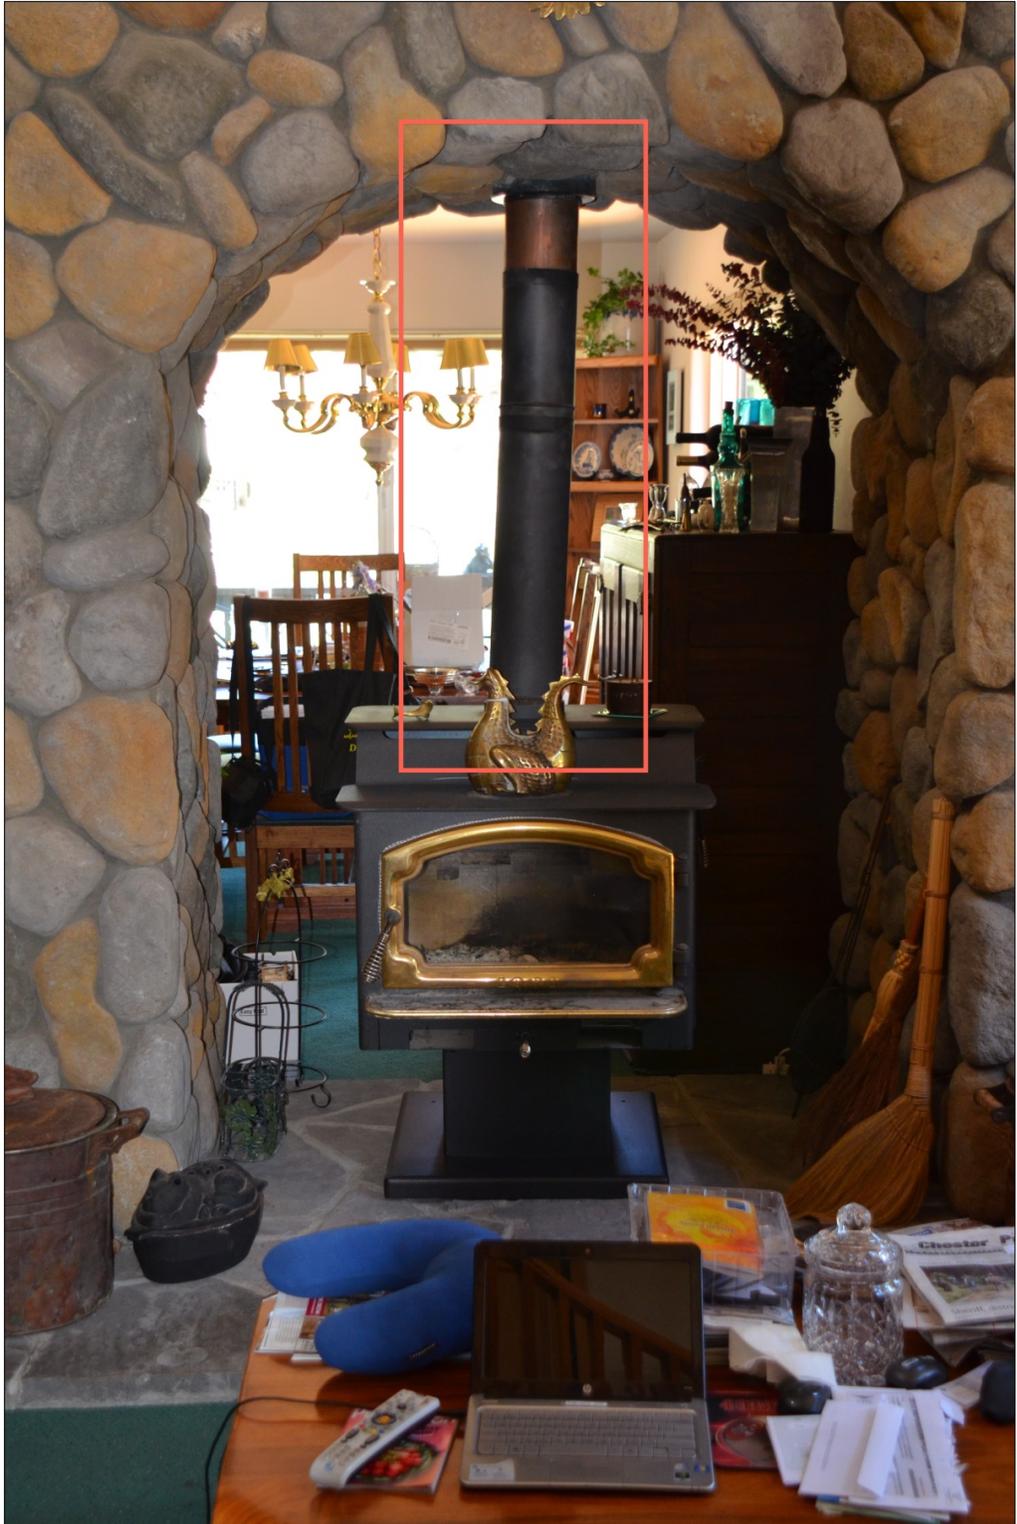
from the wall and cracked. The 640-pound freestanding fireplace shifted, causing the flue to bend and cracking the stone archway that housed it. Figures 2–17 to 2–20 show photographs of this damage.

Figure 2-19. Shifted fireplace and chimney flue in site 1.1.40 in LAW.

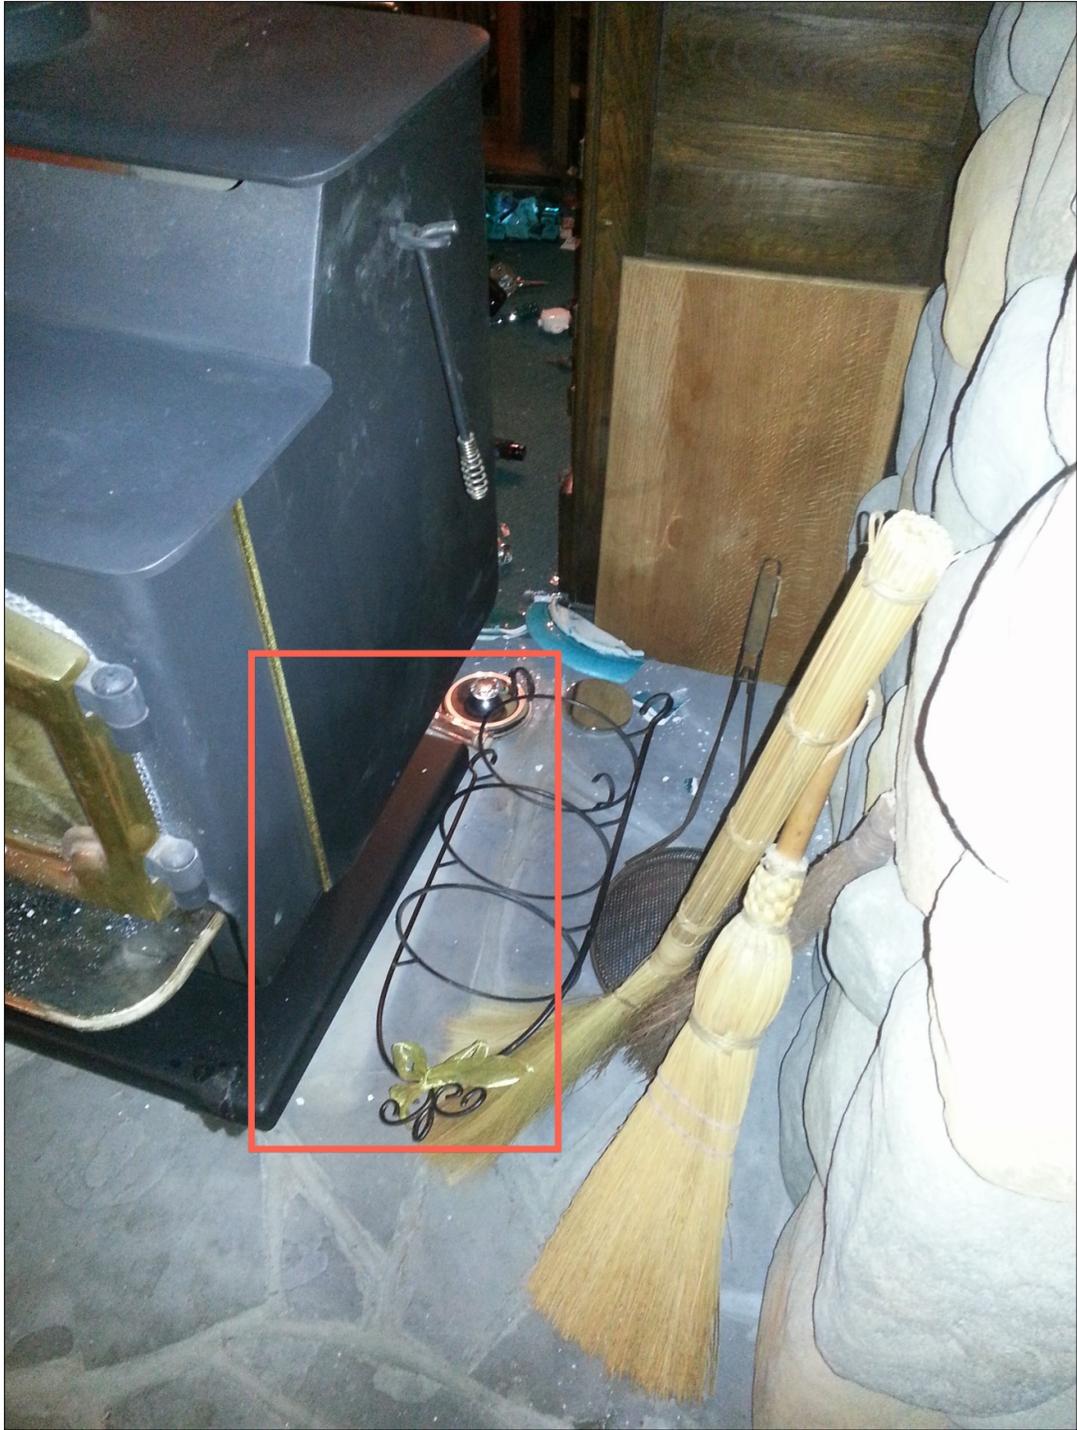
Figure 2-20. Shifted fireplace in site 1.1.41 in LAW.

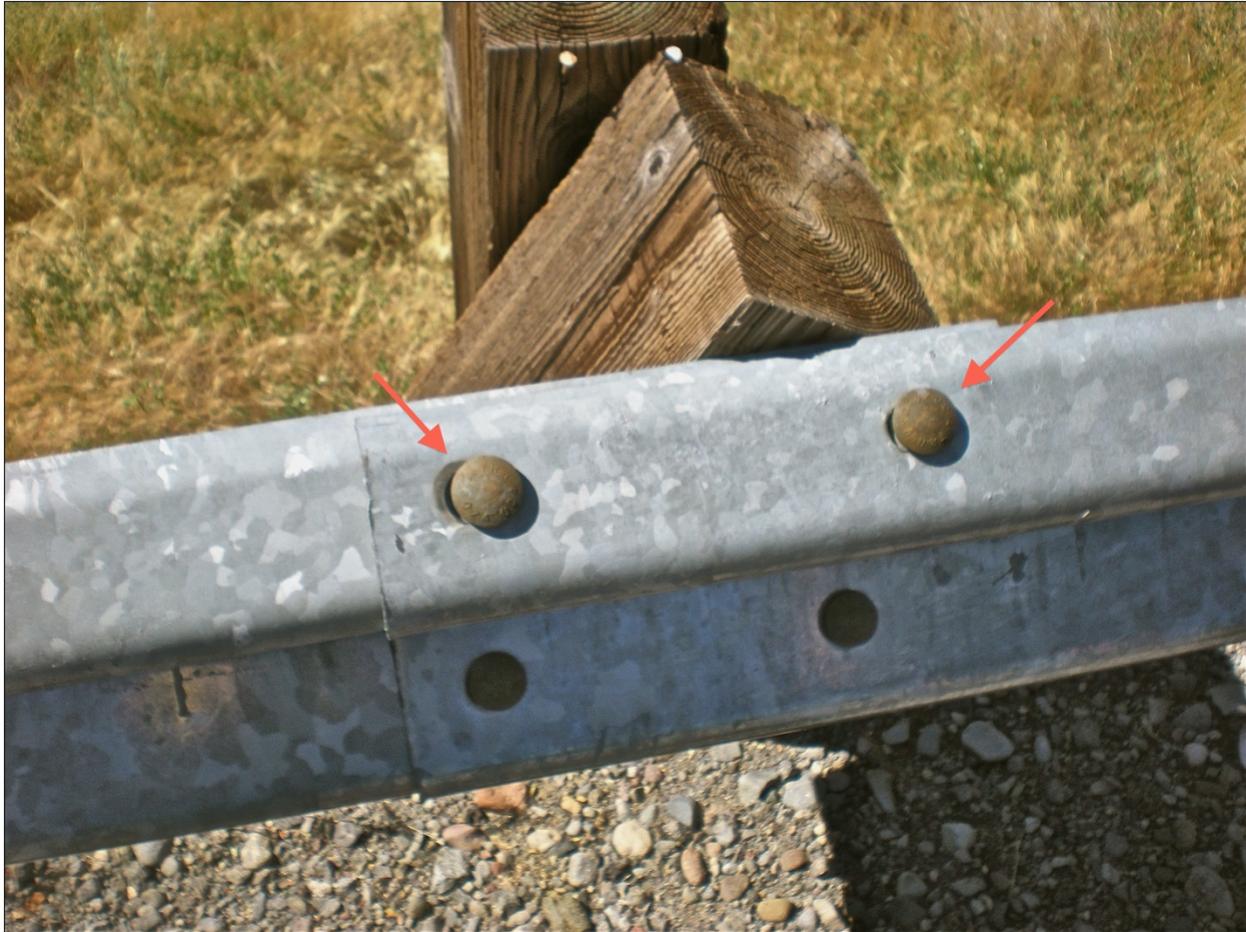
We also went to Butt Valley Dam to look for damage or shaking effects (table 1–1, item 49). Butt Valley Dam is located at the southern end of the Butt Valley Reservoir, 11 km southwest of the epicenter. Along the crest of the dam, we found a possible right-lateral offset of the bolts on the guardrail (fig. 2–21), consistent with the strong (30 percent g) east-west motion recorded by the PG&E accelerometer sited on the dam crest. Bolts were displaced in the middle of the dam, while those at either end did not appear to be affected. PG&E reported that their field crew found the road to Butt Valley Dam blocked by rock falls after the earthquake.

**Figure 2–21.** Shifted bolts in Butt Valley Dam guardrail, site 1.1.49. Guardrail runs the length of Butt Valley Dam, located at the southern end of Butt Valley Reservoir, approximately 11 km southwest of the epicenter. The PG&E accelerometer located on the dam recorded a PGA (peak ground acceleration) of 0.3 g.

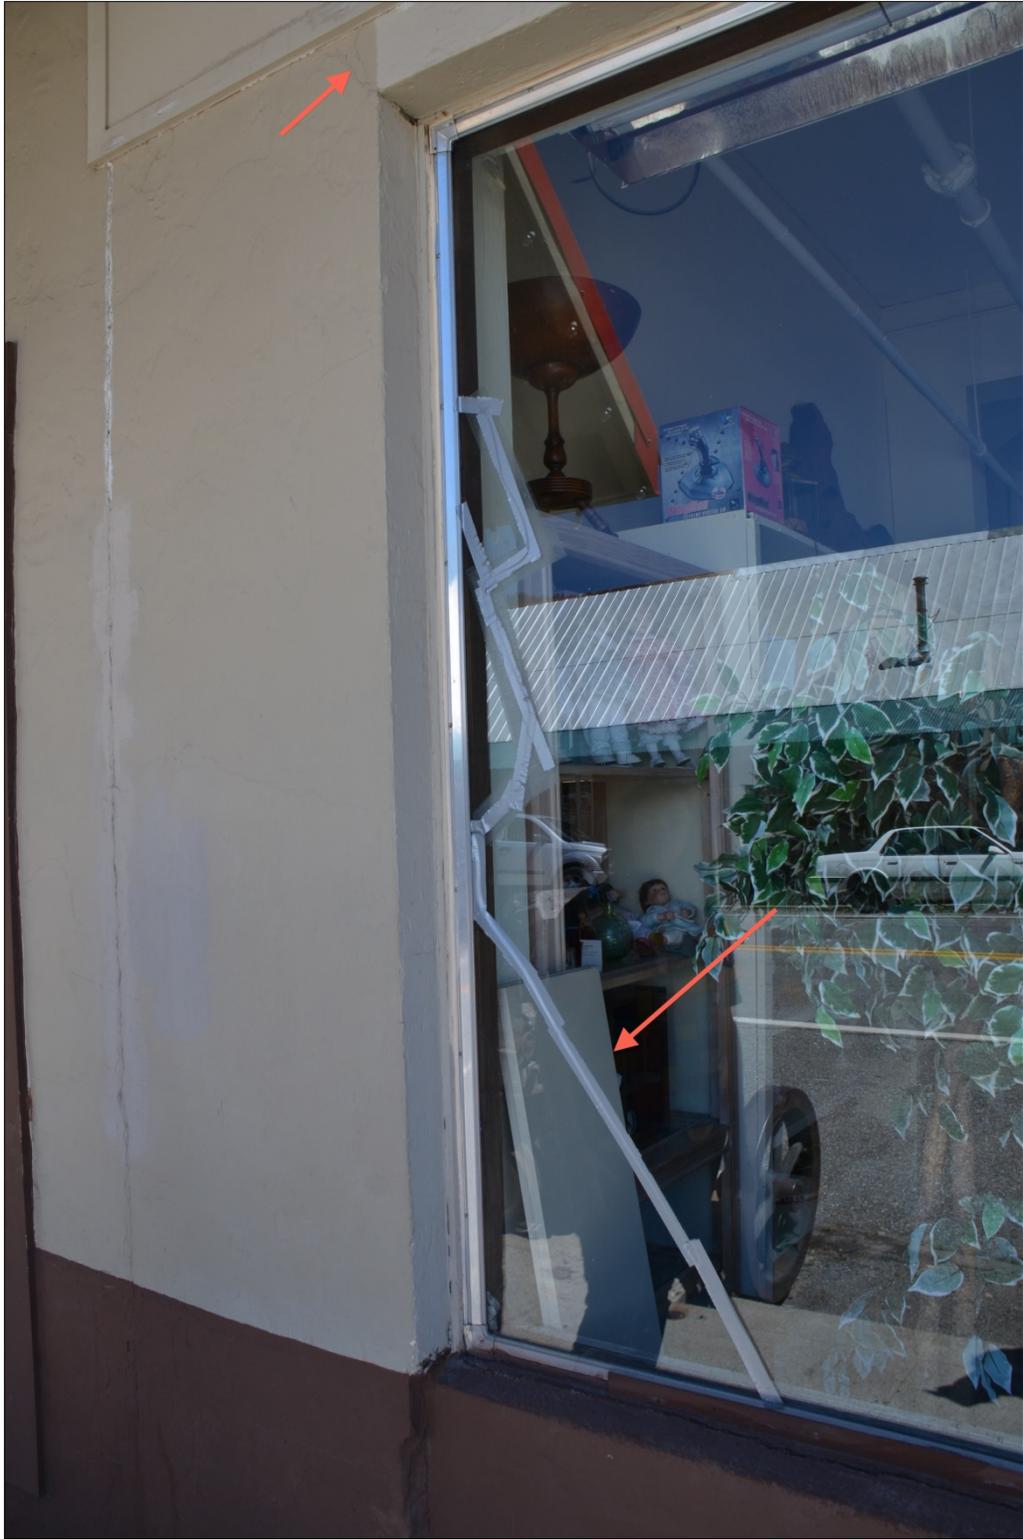
There were 16 DYFI reports from Greenville of varying intensity (CDI 2.2–6.7). Greenville is about 11 km southeast of Canyon Dam. The Sierra Lodge (table 1–1, item 51) had a cracked window and cracked drywall (fig. 2–22), and the Evergreen Supermarket had items fall off the shelves (table 1–1, item 52). The damage in the Evergreen Supermarket corresponds to a mild disturbance in Nason's (1984) food store intensity scale. One resident reported fireplace damage and a collapsed outbuilding to PCOES (table 1–2, item 64). Greenville is underlain by Quaternary sediments.

Figure 2-22. Cracked window in Sierra Lodge, site 1.1.51 in Greenville.
