The M_w 6.0 South Napa Earthquake of August 24, 2014—Observations of Surface Faulting and Ground Deformation, with Recommendations for Improving Post-Earthquake Field Investigations

By Daniel J. Ponti, Carla M. Rosa, and James Luke Blair

Open-File Report 2019–1018

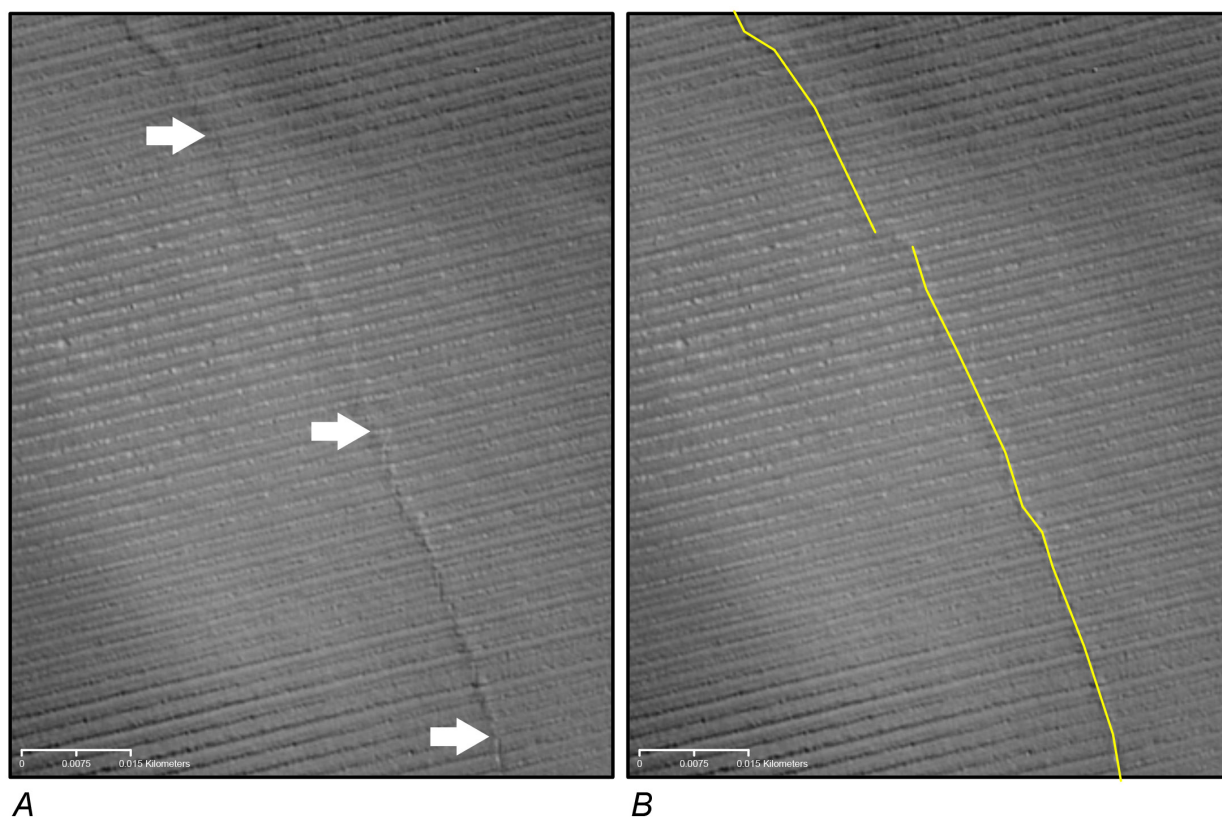
Figure 6. Lidar mole track showing expression of fault rupture on Trace A of the West Napa Fault System from a vineyard about 450 m north of State Route 12/121, located just north of stations 218–221 (appendix 2, figs. 2.3 and 2.4). A, The rupture is clearly expressed as a positive topographic feature (white arrows) in this USGS/Towill airborne lidar shaded relief image (light source from the northeast [55°], 20° above the horizon), defining a zone about 3 m wide. Strike-slip displacement here was about 30 cm when lidar was flown on September 9, 2014 (Lienkaemper and others, 2016), and offset of the vine rows is clearly visible. B, Same image as A, with interpreted linework from our rupture compilation. In most cases, we did not attempt to replicate fine-scale rupture details from the lidar.

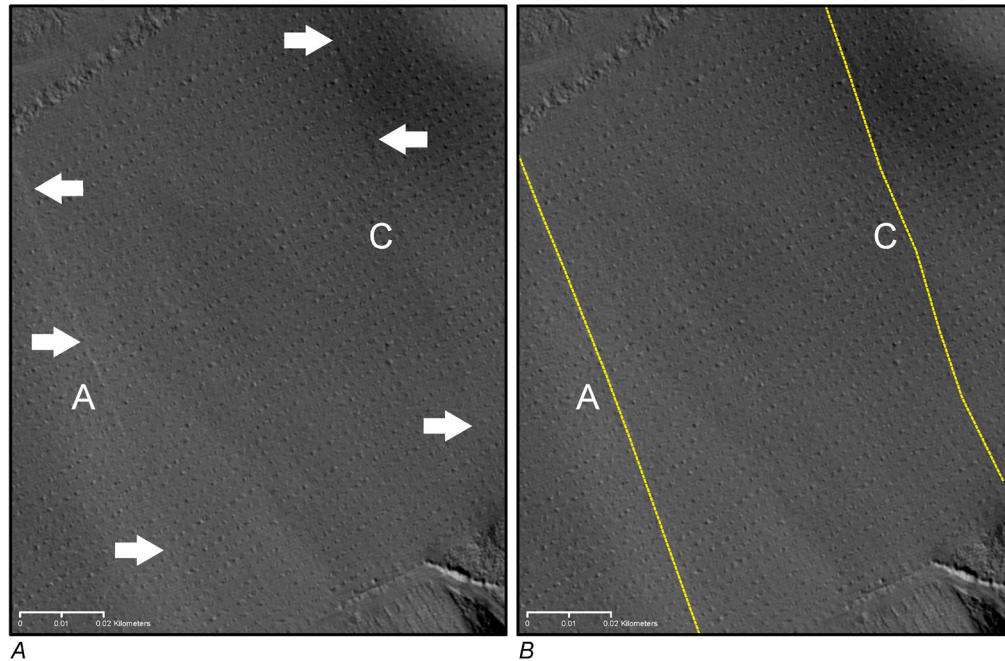
Figure 7. Lidar lineament showing expression of fault rupture on traces A and C (labeled) of the West Napa Fault System, at Hendry Winery, near the northern end of the rupture (near station 469, appendix 2, fig. 2.7, and near stations 699–702, appendix 4, fig. 4.3). A, Rupture is expressed as tonal lineaments (white arrows) in this USGS/Towill airborne lidar shaded relief image (light source from the northeast [55°, 20° above the horizon] that results from a small amount of west-side up vertical offset on Trace A, and east-side up vertical offset on Trace C, producing a graben between the two traces. Vertical offset was not noted or measured in the field; strike-slip displacement on Trace A in this area is negligible, but more than 4 cm on Trace C. B, Same image as A, with interpreted linework.

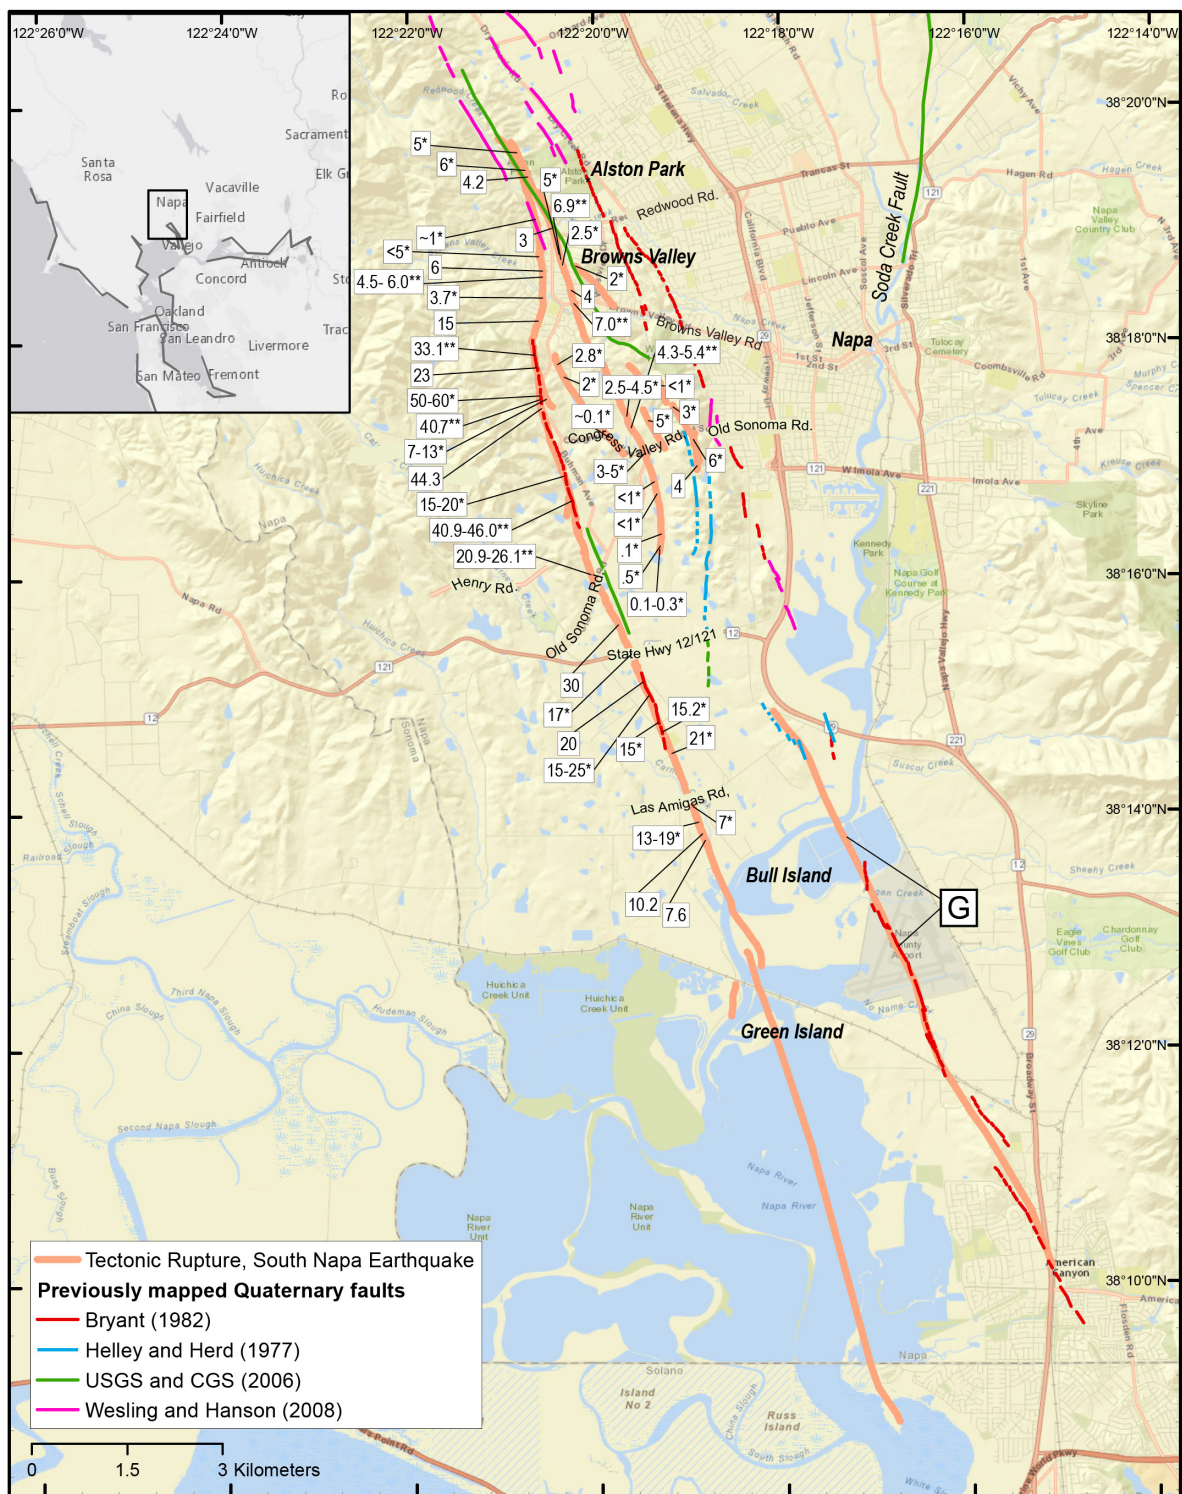
The largest surface displacements are confined to Trace A south of Browns Valley and north of the epicenter (fig. 9). This observation is consistent with rupture models derived from inversion of seismic waveforms, GPS data, and InSAR data (Dreger and others, 2015; Floyd and others, 2016) that indicate that seismogenic rupture likely propagated upward and to the north from the hypocenter along this trace. These same studies also conclude that some slip occurred 5–10 km southeast of the hypocenter at a depth shallower than 2 km (Dreger and others, 2015; Floyd and others, 2016). Although ground observations are largely lacking or equivocal south of the Napa River, both coseismic and postseismic UAVSAR lineaments support the conclusion that dextral slip along Trace A extended as far south as Slaughterhouse Point (fig. 1; DeLong and others, 2016), for a total rupture length of more than 21 km.

On secondary traces B–G dextral slip does not exceed 8 cm (fig. 9). Field measurements of strike-slip displacement taken shortly after the event generally show that the largest displacements on traces B–E are near their northern ends (fig. 9), closest to Trace A, north of the slip maximum observed on Trace A. The proximity of traces B–E to Trace A indicates that these faults may connect at shallow depths, and the larger displacements in the north suggest that a small amount of seismogenic slip may have transferred to these structures from Trace A. Trace F, where the largest observed displacements are along its southern half farthest from Trace A, is an exception. Trenches excavated across Trace F show evidence for significantly larger fault separation during several prior Holocene events (Seitz and others, 2015) and suggest that Trace F may act independently from Trace A. Although the question of triggered versus primary slip on the secondary faults remains unresolved, overall it appears that slip transfer from Trace A to the secondary traces, if any, was limited.

Figure 9. Map of tectonic surface faulting produced by the August 24, 2014, South Napa earthquake, showing selected sites of maximum right-lateral strike-slip displacement (in centimeters) obtained from field measurements (white boxes), and previously mapped Quaternary-age strands of the West Napa Fault System. Only a selected set of previously mapped faults are shown for clarity; where different reports map the same feature, the earliest mapping is shown. Labels with asterisks are either approximate values or a

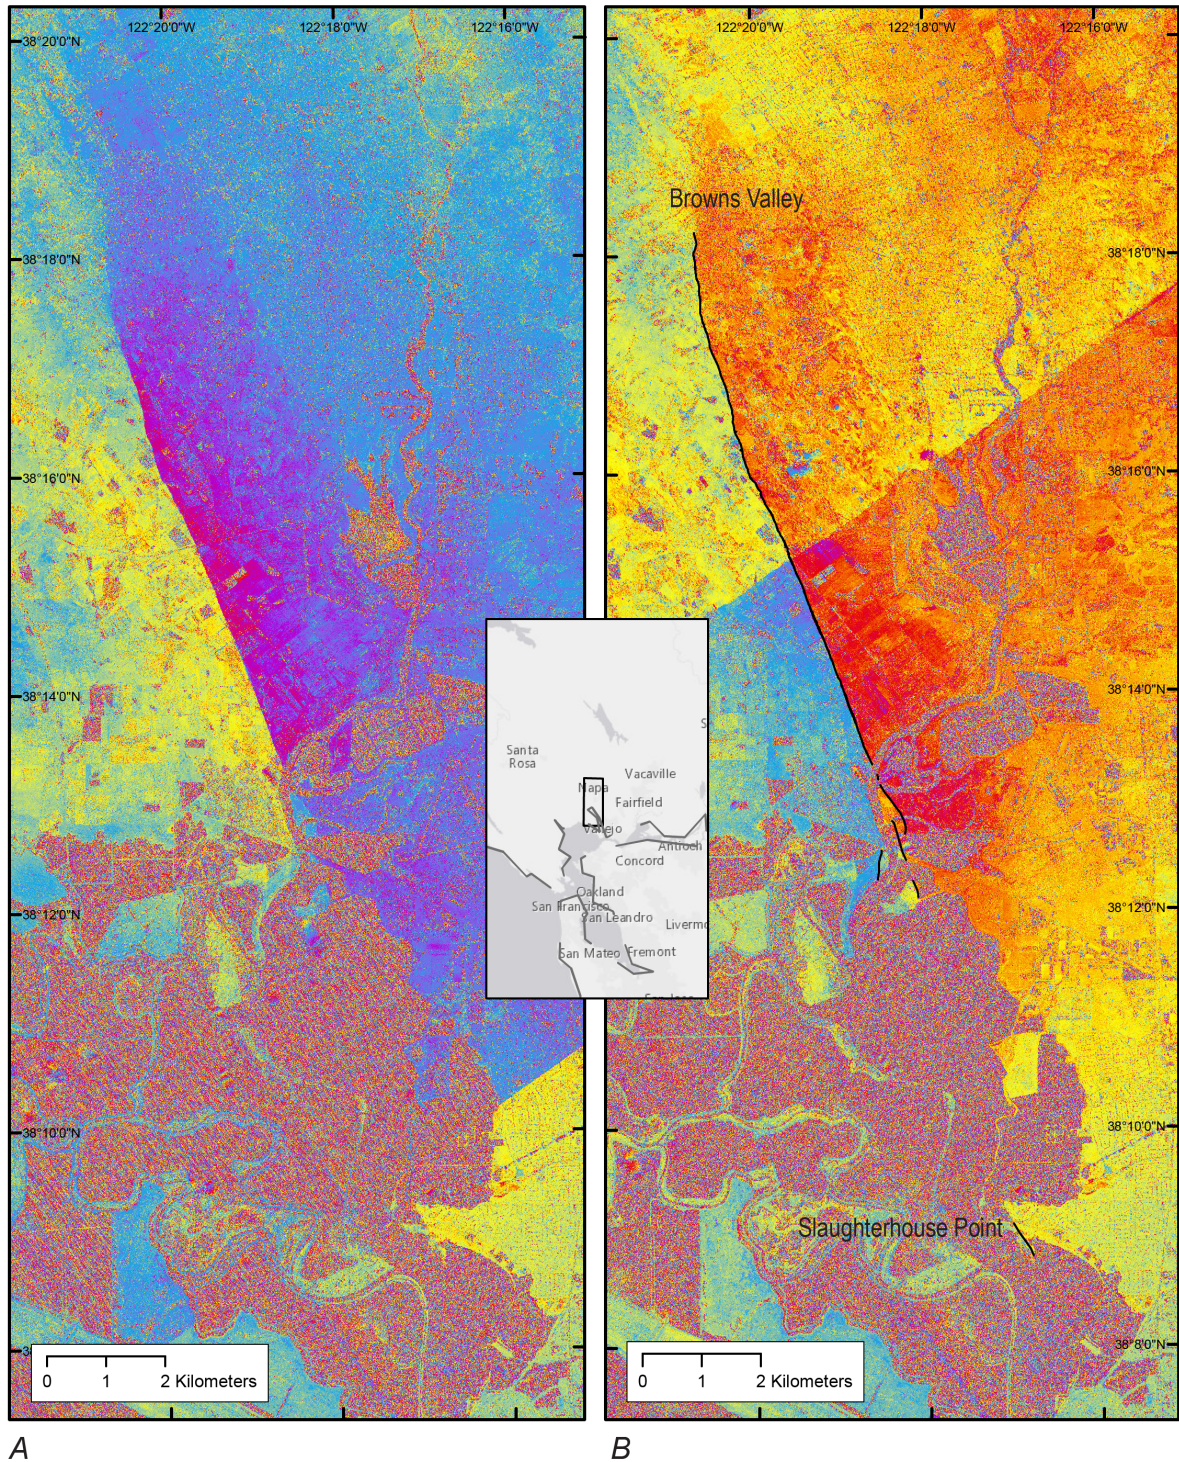
Figure 10. UAVSAR wrapped phase interferograms from the postseismic interval of the August 24, 2014, South Napa earthquake, between August 29 and October 22, 2014 (Interval 3). Inset shows area of figure. *A*, images from flight lines 23511 (north) and 05510 (south). *B*, images from flight lines 05512 (north) and 05510 (south). Black lines show the extent of the rupture and evidence for afterslip, as interpreted from the UAVSAR interferograms. Afterslip is confined to Trace A south of Browns Valley and apparently extends as far south as Slaughterhouse Point.

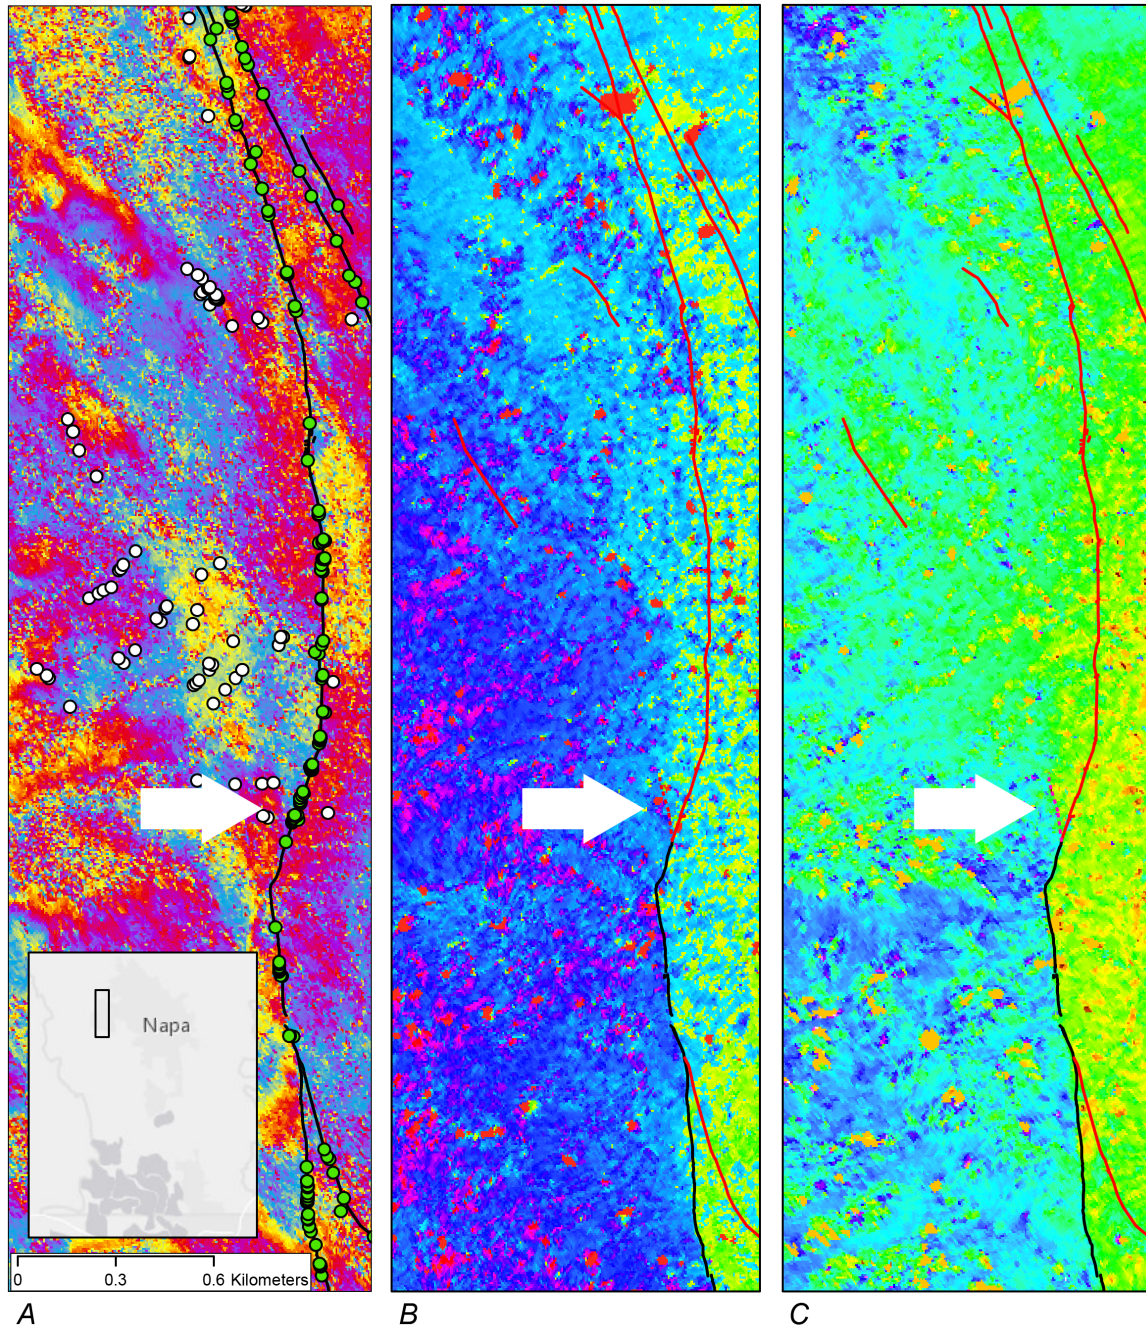
Both InSAR and ground observations show that afterslip did not extend north into Browns Valley (fig. 11). The northern terminus of afterslip is several hundred meters north of where the strike of Trace A shifts abruptly to a northeast azimuth. Possible afterslip may occur along a faint, approximately 200-m-long UAVSAR lineament that appears to intersect Trace A precisely where afterslip on Trace A ceases. No observations of faulting exist precisely along this trend, but the area near and north of this faint lineament experienced substantial distributed pavement and sidewalk damage, possibly related to distributed deformation or focused, intense ground motions. These observations are suggestive of a possible set of structures in this area that serve to distribute and accommodate Trace A slip and pose questions as to how slip may propagate to faults to the north.

Figure 11. UAVSAR interferograms, mapped fault rupture, and observation stations near Browns Valley, California. Inset shows area of figure. A, Fault rupture (black) and observations of surface rupture of tectonic (green circles) and uncertain (white circles) origins, are overlain on the UAVSAR wrapped phase interferogram that contains the coseismic signal from the South Napa earthquake from flight line 05512 (Interval 2). Color spectrum from red to violet represents a 2π change in phase. Arrow points to a possible approximately 200-m-long lineament that branches off of Trace A about 200 m north of where the strike of Trace A shifts abruptly to the northeast. Near this lineament, white circles represent sites of damaged hardscape. B, Fault rupture overlain on the postseismic-interval (Interval 3) UAVSAR unwrapped phase interferogram from flight line 23511. Color spectrum from red to violet represents range change from 8.9 to -11.1 cm. Fault rupture line color indicates whether afterslip occurred along the trace (black, afterslip; red,

no afterslip), as interpreted from postseismic UAVSAR interferograms. Afterslip appears to cease along Trace A where the short coseismic (Interval 2) UAVSAR lineament intersects (arrow). A faint lineament (dotted), consistent with dextral slip along this trend, possibly indicates that afterslip continues along this short lineament west of Trace A. C, Fault rupture overlain on the postseismic-interval (Interval 3) UAVSAR unwrapped phase interferogram from flight line 05512. Color spectrum from red to violet represents range change from 9.7 to -16.4 cm. A faint lineament as in B (dotted line) is seen in this interferogram as well. Sharp gradations not annotated are likely due to vegetation and other cultural features.

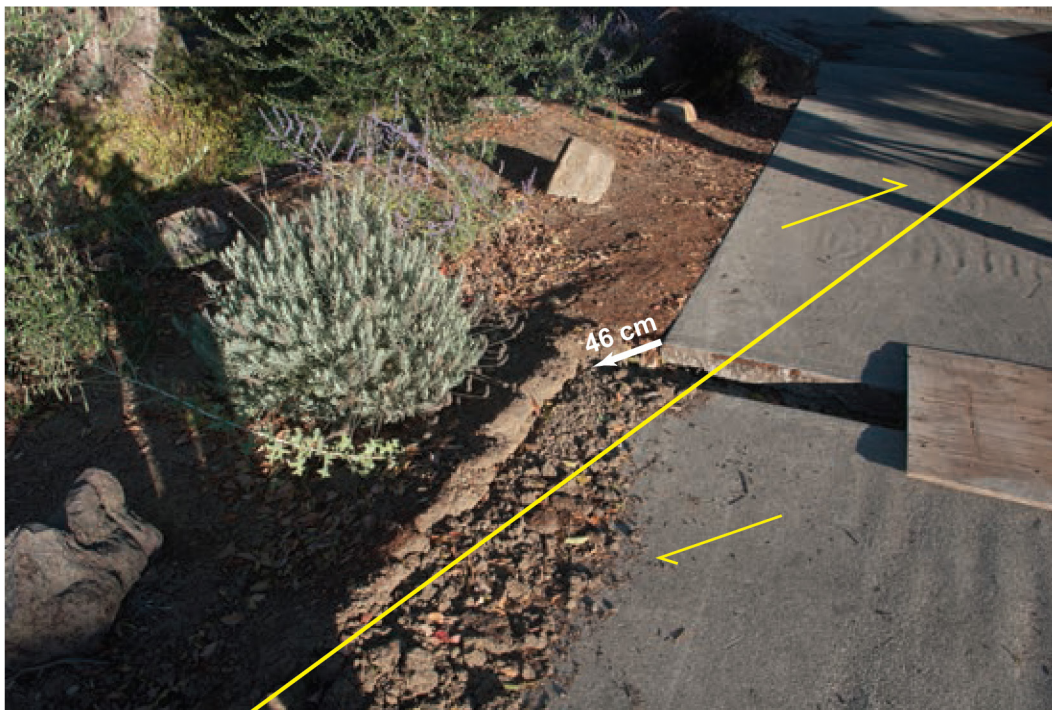
At 0.5 km north of Henry Road, fault slip is observed to increase to more than 40 cm (station 270, appendix 2, fig. 2.4), but farther north, for about 1 km between stations 291 and 292 (appendix 2, figs. 2.4 and 2.5) fault slip may decrease or be distributed over a broad zone as the rupture is intermittently difficult to follow, especially where parts of it are likely obscured beneath landslide deposits. North of station 292, fault strike changes to a northerly trend ($\sim 355^\circ$), and for about 1 km to Leaning Oak Drive (stations 337–354, appendix 2, fig. 2.5), fault rupture occurs as very well developed, connected en echelon fractures, prominent mole tracks, and common transpressive deformation with up-to-the-west vertical displacement consistent with the local topography (stations 301–330, appendix 2, fig. 2.5). Transpressive deformation along with a change in fault strike to the north implies a substantial clockwise rotation of the fault slip vector in this region (from northwest to north-northeast), which may be an indication of interaction with another fault at depth. The largest fault displacements (>30 cm) were measured along this stretch of the rupture. The best constrained measurement (fig. 12, station 298, appendix 2, fig. 2.5) had a total slip of 46 cm (44.3 cm of strike-slip displacement, 10 cm of vertical displacement, and 7 cm of compression), with nearby estimates of slip of as great as 60 cm (station 328, appendix 2, fig. 2.5).

Figure 12. Photograph showing offset driveway at station 298 (appendix 2, fig. 2.5) where the maximum coseismic slip on Trace A (46 cm) of the West Napa Fault System was measured on August 25, 2014; view is to the southeast. Orientation of the driveway relative to the fault strike (yellow line) was such that two adjacent concrete slabs moved opposite to each other on either side of the fault, separating at a joint with

no rotation. The slip vector (white arrow) is slightly oblique to the fault strike producing compression that can be seen in the soil near the left edge of the lower slab where that slab “plowed” into the adjacent soil.

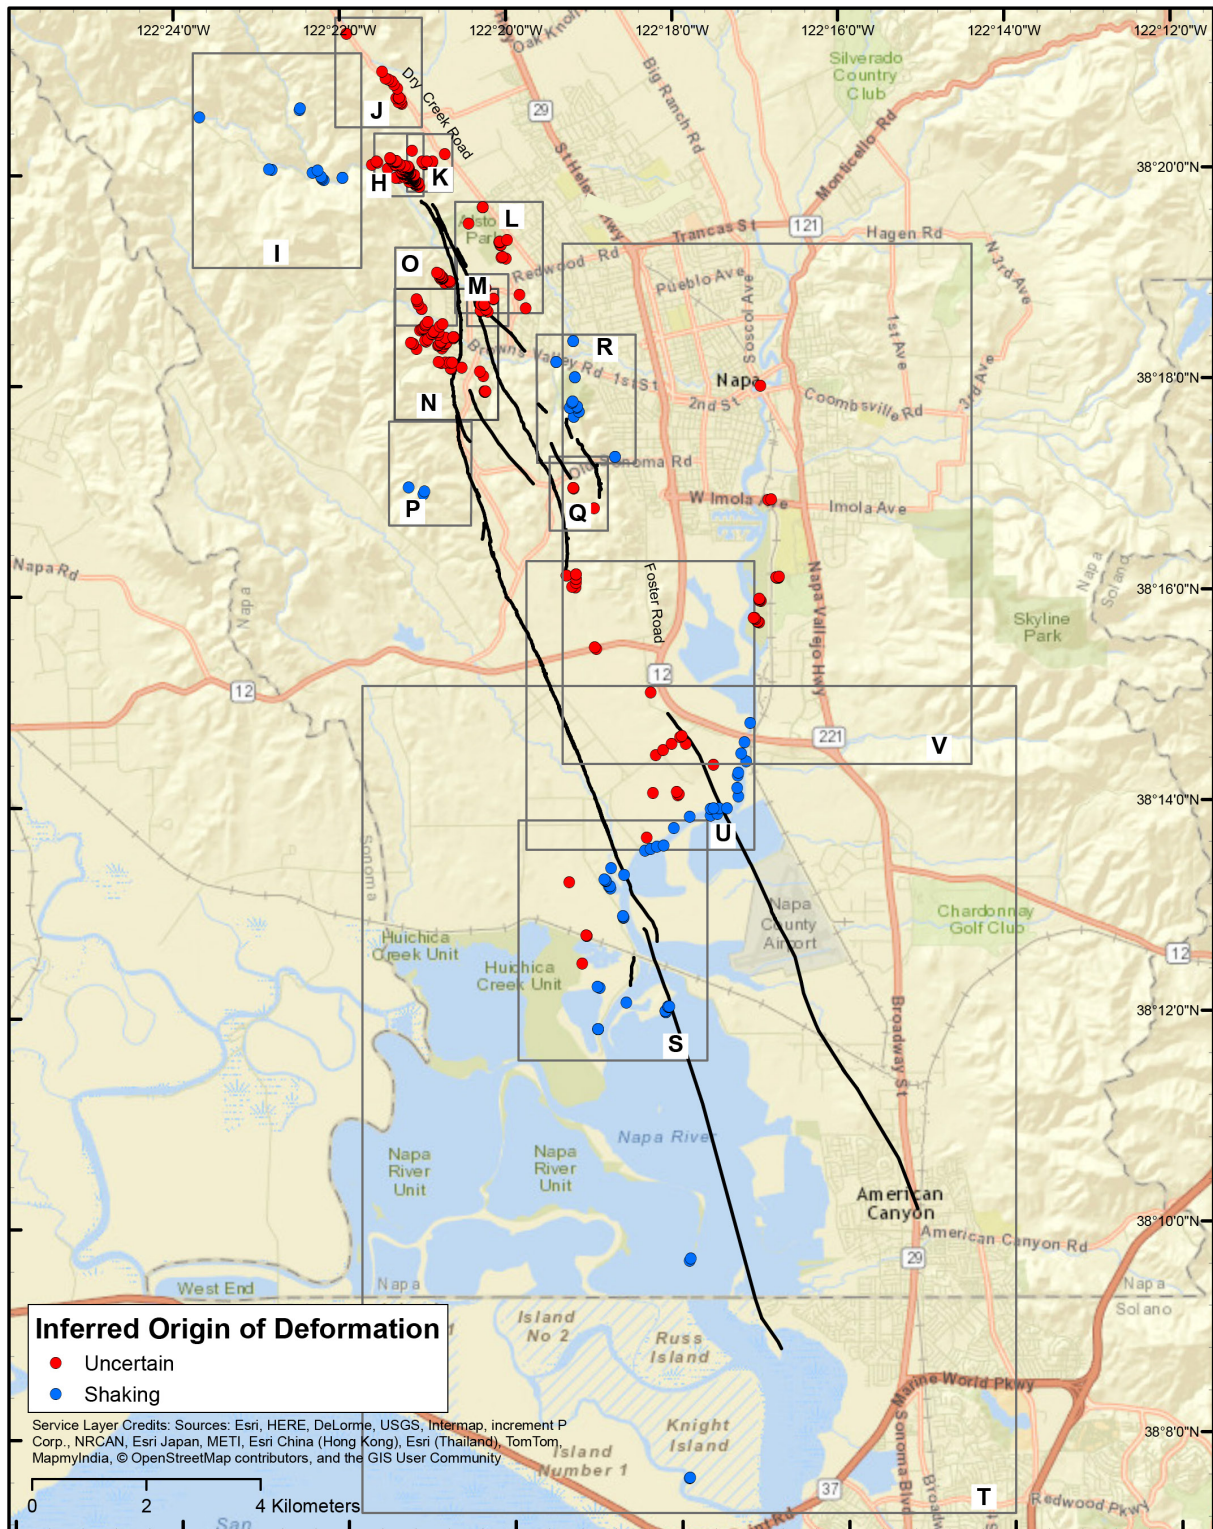
In addition to surface faulting produced by the South Napa earthquake, the event also caused widespread ground disturbance that was not along fault zones. This is true even though the earthquake produced only a limited amount of liquefaction and landslide-induced ground failure (Brocher and others, 2015). Of the more than 1,200 observation sites compiled for this report, more than 40 percent are not located anywhere near the tectonic fault traces (fig. 13). Of these anomalous sites, less than 20 percent of the stations had deformation that could readily be attributed to seismically induced, shallow slope failure (for example, slumps, soil and rock falls) or to lateral spreading from liquefaction or soft clay failure. The remaining sites of ground deformation cannot be readily attributed to either shaking-induced ground failure or faulting and have been classified as being of uncertain origin. Some of these features may be indicative of faulting or bedrock control and are located along UAVSAR lineaments, whereas others have no mappable extent. Observations for these features are organized in the appendixes by geographic regions that isolate sites with similar ground deformation characteristics (fig. 13).

Figure 13. Map showing locations of ground deformation produced by the August 24, 2014, South Napa earthquake that are not located on known tectonic fault traces (black lines). Blue circles, deformation clearly related to lateral spreading or shallow slope failure; red circles, origin of deformation is uncertain; H–V, regions (rectangles).
