Appendix 3. Tabulated Observations and Photographs of Surface Faulting and Ground Deformation Produced by the M_w 6.0 South Napa Earthquake of August 24, 2014—Trace B

Trace B

Figure 3.1. Rupture map showing locations of observation stations 500–514 along Trace B of the West Napa Fault System, California, from intersection of Sunset Road and Congress Valley Road north to Twin Oaks Drive. Inset shows location of fig. 3.1 relative to full extent of rupture. Shaded relief base from U.S. Geological Survey National Map <https://viewer.nationalmap.gov/advanced-viewer/>.

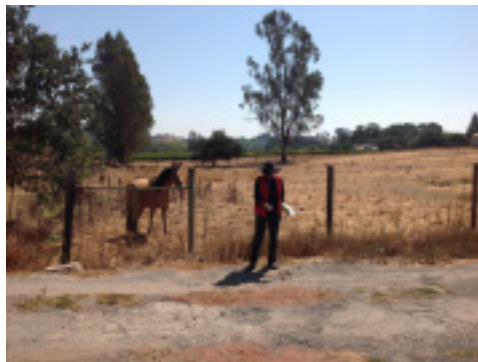
Station ID: 501			Observer: Prentice/Sickler			
Observation date	Latitude	Longitude	Offset feature	Inferred origin		
2014:09:11	38.29011	122.33483	Pavement	Tectonic		
Description						
Sunset Road at end of public access. Cracks across road trend N50W. Water meter box recently dug up—new repair? Another water meter box has lid popping up, related to earthquake?						
Fault azimuth	Strike slip	Strike-slip sense	Extension	Compression	Vertical	Upthrown side
310						
Photographer	Camera coordinates		Photograph date			
Prentice	38.29012	122.33480	2014:09:11	12:22:14

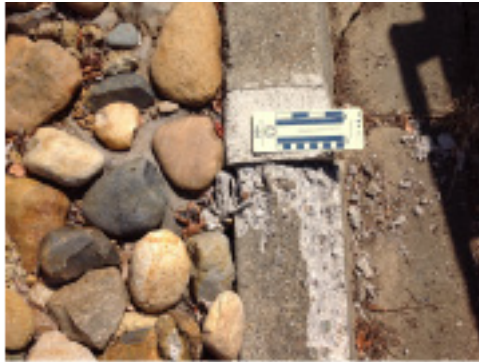
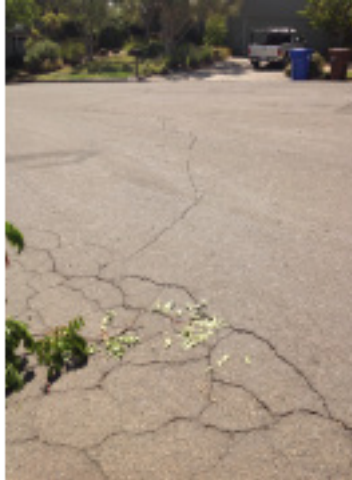
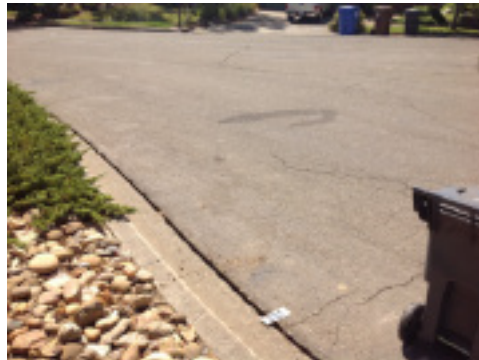
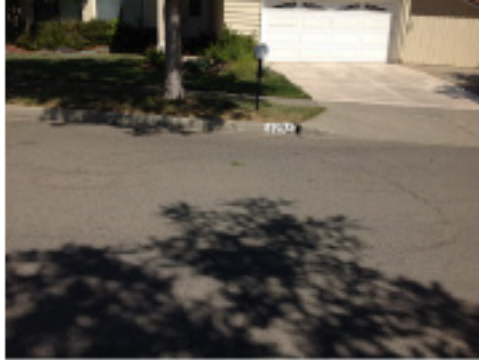
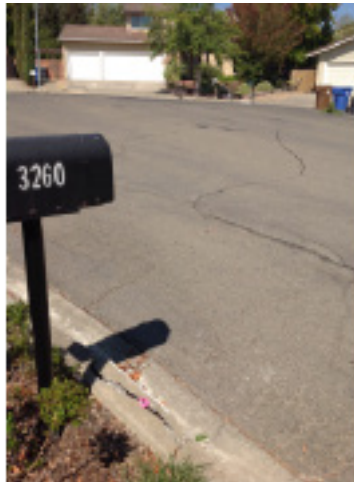
Station ID: 503		Observer: Prentice/Sickler				
Observation date	Latitude	Longitude	Offset feature	Inferred origin		
2014:09:11	38.29447	122.33857	Curb/Sidewalk	Tectonic		
Description						
Curb in Stonebridge Court is damaged and very small left-lateral offset. Cracks continue across asphalt to south (trend N24W). Asphalt pulled away, 3 cm opening. Multiple curbs fractured.						
Fault azimuth	Strike slip	Strike-slip sense	Extension	Compression	Vertical	Upthrown side
336		LL	3*			
Photographer	Camera coordinates		Photograph date			
Prentice	38.29450	122.33852	2014:09:11 11:50:32

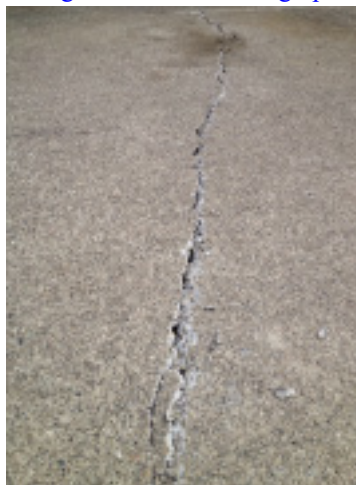
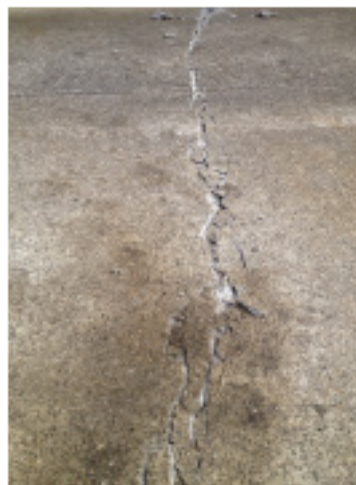
Station ID: 504		Observer: Rubin/Seitz				
Observation date	Latitude	Longitude	Offset feature	Inferred origin		
2014:09:16	38.29504	122.33894	Curb/Sidewalk	Tectonic		
Description						
Many cracks in asphalt street. Most look preexisting with no obvious preferred orientation but have opened. Permissible RL offset at driveway curb joint. Fresh cracking in cement driveway trends 338.						
Fault azimuth	Strike slip	Strike-slip sense	Extension	Compression	Vertical	Upthrown side
338		RL				
Photographer	Camera coordinates		Photograph date			
Seitz	38.29504	122.33892	2014:09:16 15:40:41

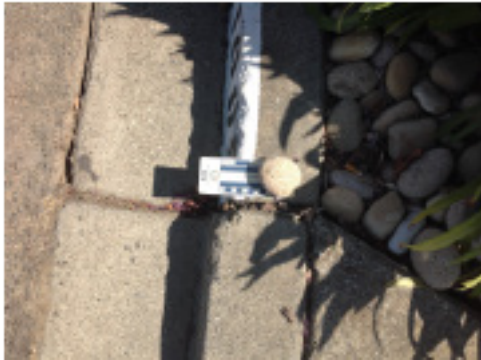
Station ID: 505		Observer: Prentice/Sickler				
Observation date	Latitude	Longitude	Offset feature	Inferred origin		
2014:09:11	38.29507	122.33896	Curb/Sidewalk	Tectonic		
Description						
Fresh curb cracks in front of house at curb joint, 20mm right-lateral.						
Fault azimuth	Strike slip	Strike-slip sense	Extension	Compression	Vertical	Upthrown side
	2*	RL				
Photographer	Camera coordinates		Photograph date			
Prentice	38.29510	122.33900	2014:09:11 11:26:30			
High Resolution Photograph

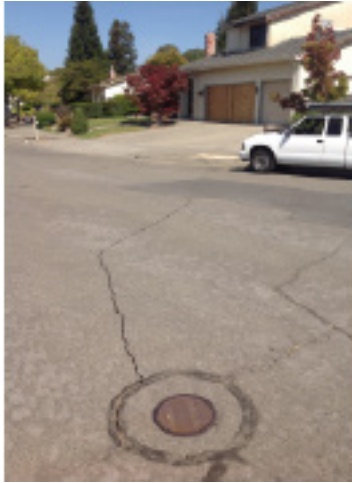
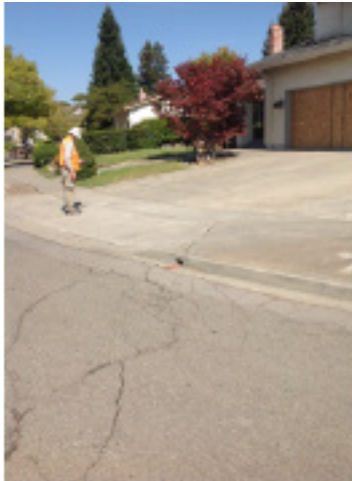
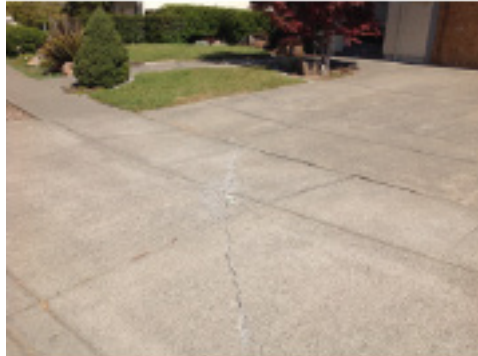
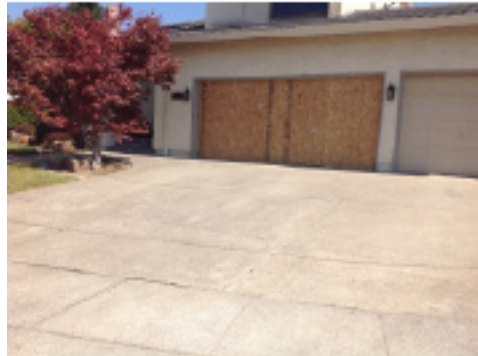
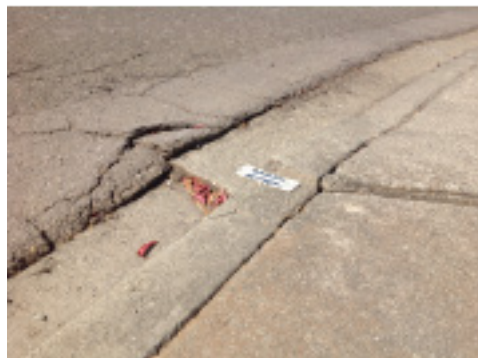
Station ID: 506**Observer: Prentice/Sickler**

Station ID: 506		Observer: Prentice/Sickler		
Observation date	Latitude	Longitude	Offset feature	Inferred origin
2014:09:11	38.29527	122.33912	Pavement	Tectonic
Description				
Driveway cracks and en echelon cracks across road. Garage door recently removed and has temporary repair. Curb and asphalt popped up.				
Photographer	Camera coordinates		Photograph date	
Prentice	38.29516	122.33910	2014:09:11 11:26:54

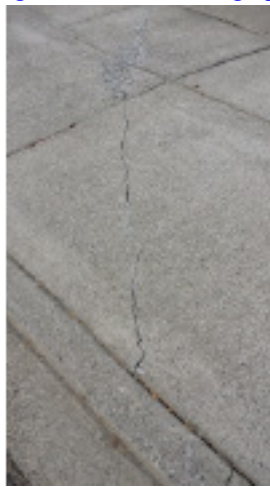
Station ID: 507				Observer: Rubin		
Observation date	Latitude	Longitude	Offset feature	Inferred origin		
2014:09:16	38.29530	122.33914	Curb/Sidewalk	Tectonic		
Description						
Fresh cracking in cement sidewalk and driveway. Crack trends N17W.						
Fault azimuth	Strike slip	Strike-slip sense	Extension	Compression	Vertical	Upthrown side
343						
Photographer	Camera coordinates			Photograph date		
Rubin				2014:09:16 15:41:00

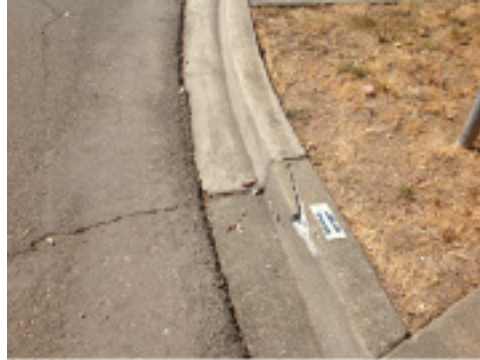
Station ID: 510 **Observer: Prentice/Sickler**

Station ID: 510		Observer: Prentice/Sickler				
Observation date	Latitude	Longitude	Offset feature	Inferred origin		
2014:09:11	38.29617	122.33975	Curb/Sidewalk	Tectonic		
Description						
Intersection of Alpine Court and Twin Oaks; damaged curb. Crossing intersection heading south is zone of fresh left-stepping en echelon cracks amid many old random cracks in asphalt. House at Alpine Court shows minor damage of garage and cracks through driveway pavement.						
Fault azimuth	Strike slip	Strike-slip sense	Extension	Compression	Vertical	Upthrown side
RL

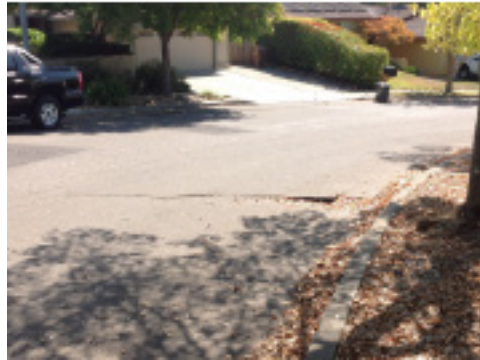
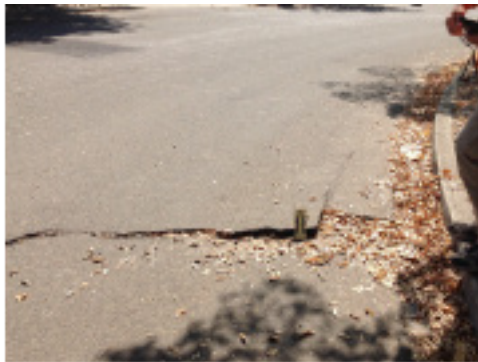
Station ID: 511 **Observer: Prentice/Sickler**

Compressional pavement damage. Vertical scarp <5 cm. Compiler note: Upthrown side inferred from photo.

Fault azimuth	Strike slip	Strike-slip sense	Extension	Compression	Vertical	Upthrown side
					5*	E

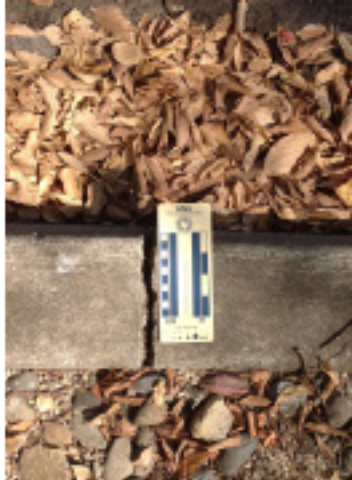
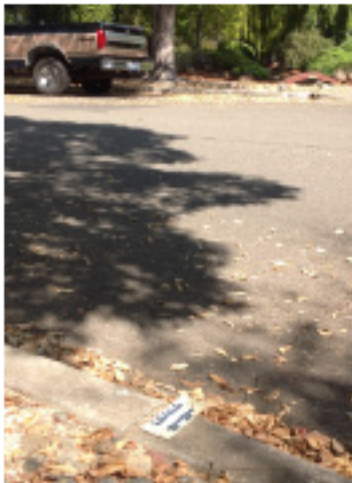
Station ID: 513

Curb on south side of street shows about 3 mm right-lateral. Crack trends N11E.

Fault azimuth	Strike slip	Strike-slip sense	Extension	Compression	Vertical	Upthrown side
	0.3*	RL

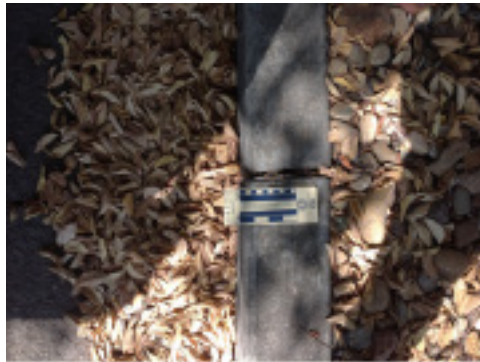
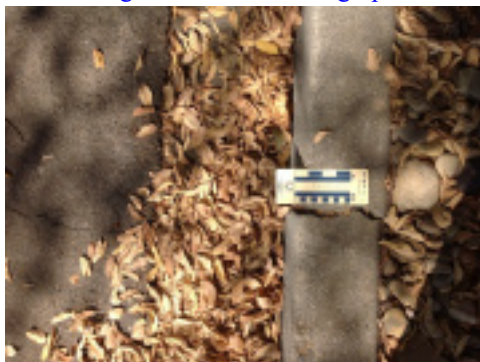
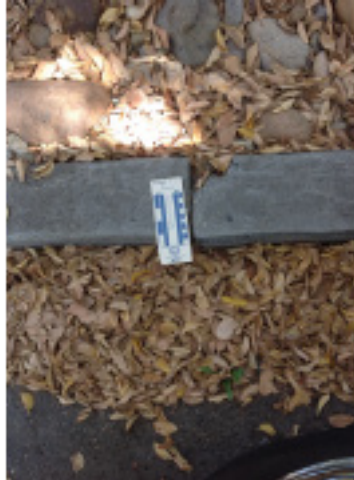
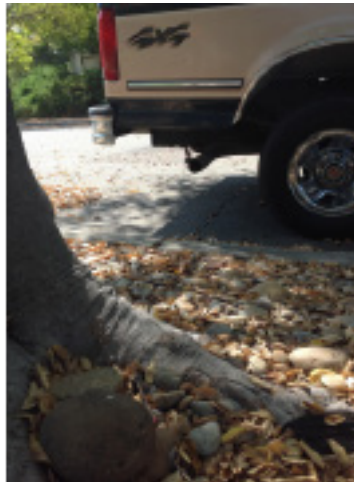
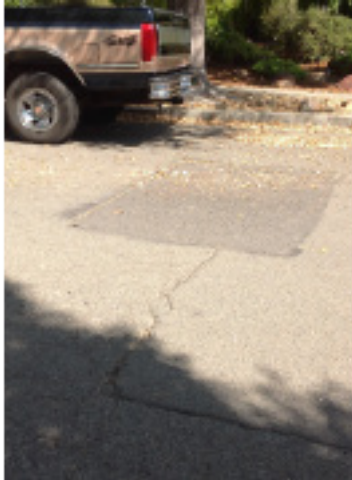
Station ID: 514

Alpine Court. Two cracks in curb on north side of street show small right-lateral, about 1 cm each. Cracks are 93 cm apart. Eastern crack trends N16E, western crack trends N5E. Other curb cracks and damage occur within a zone about 20 m wide, including another curb crack with about 8 mm right-lateral, crack trends N4W. Left-stepping en echelon zone of cracks crosses street to the south. Zone trends N22W.

Fault azimuth	Strike slip	Strike-slip sense	Extension	Compression	Vertical	Uprthrown side
	2.8*	RL
