## **Appendix 4. Tabulated Observations and Photographs of Surface Faulting and Ground Deformation Produced by the $M_w$ 6.0 South Napa Earthquake of August 24, 2014—Trace C**

## Trace C

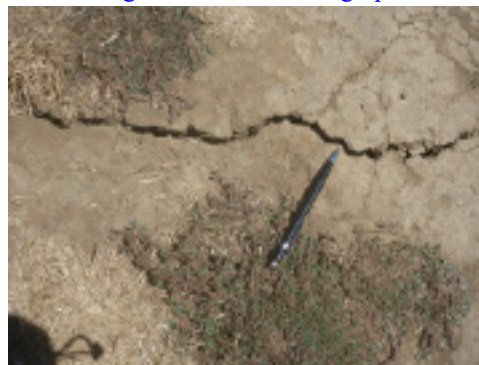
| Station ID: 552 | | | | Observer: Hecker/Pickering | | |
|---|---|---|---|---|---|---|
| ~20 m long zone of cracks crossing from vines toward road intersection. Trend ~345-350. 3mm right-lateral. | | | | | | |

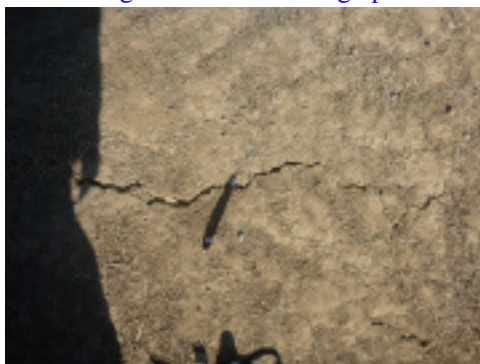
| Station ID: 553 | | | Observer: Pickering/Hecker | | | |
|---|---|---|---|---|---|---|
| Prominent, open fractures forming polygonal-type pattern through two vineyard rows. 0.5cm extension with some left-lateral. | | | | | | |

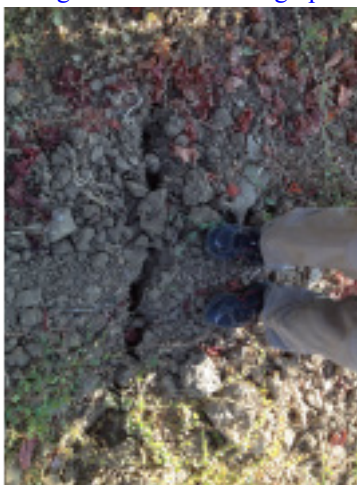
| Station ID: 562 | | | | Observer: Seitz |
|---|---|---|---|---|
| North oriented ground cracking in vineyard. | | | | |

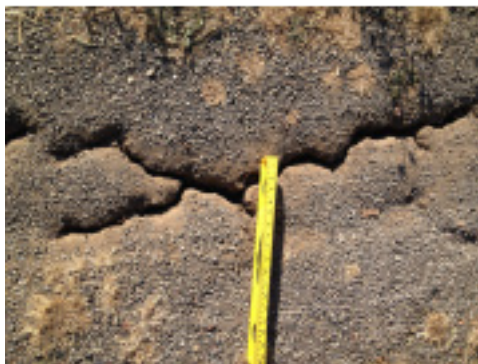
| Water pipe break in line with rupture. | | | | |

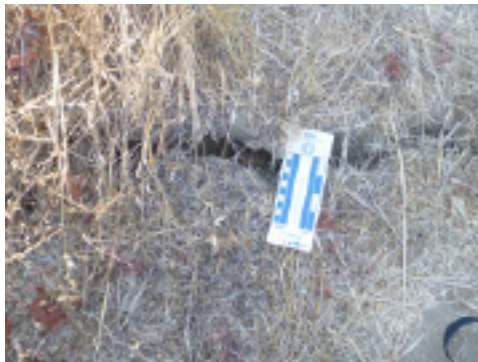
| Station ID: 573 | | | | Observer: Hecker | | |
|---|---|---|---|---|---|---|
| Fractures intersect north end of retention pond. Two primarily extensional cracks up to 3 cm opening. South side of pond (below embankment) - one main fracture, mainly extensional. Slight apparent right-lateral deflection of fence line. | | | | | | |

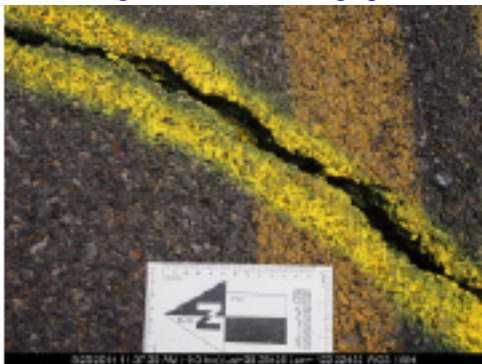
| Station ID: 587 | | | | Observer: Brossy | | |
|---|---|---|---|---|---|---|
| Photograph showing approximately 3.5 cm of right lateral separation of NW margin of yellow centerline on Congress Valley Rd. | | | | | | |

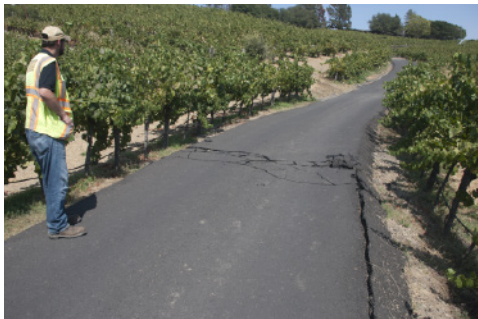
Shattering of asphalt along southern part of trace C on driveway near Thompson Road. Rupture was difficult to see in soil on either side of driveway, but obvious on asphalt. Right-lateral offsets were around 5 cm in this area, although difficult to measure at this location

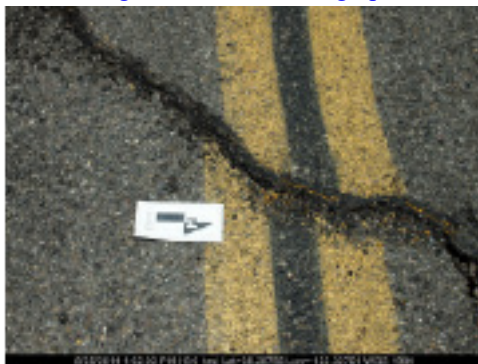
Photograph showing approximately 5 cm apparent right lateral separation of eastern margin of Thompson Ave. centerline.

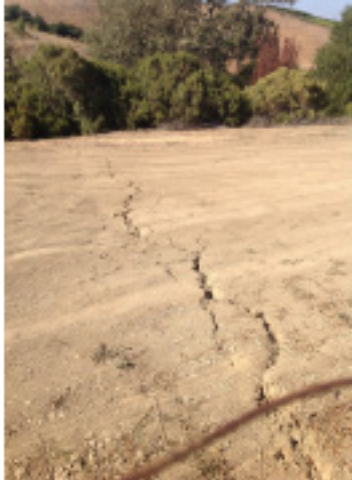
Surface rupture near northern boundary of Alston Park. Note left-stepping pattern of extensional cracking, suggestive of right-lateral displacement, which was about 4-5 cm at this location. [
