Appendix 5. Tabulated Observations and Photographs of Surface Faulting and Ground Deformation Produced by the M_w 6.0 South Napa Earthquake of August 24, 2014—Trace D

Trace D

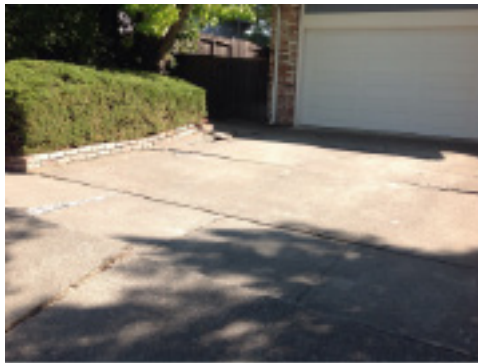
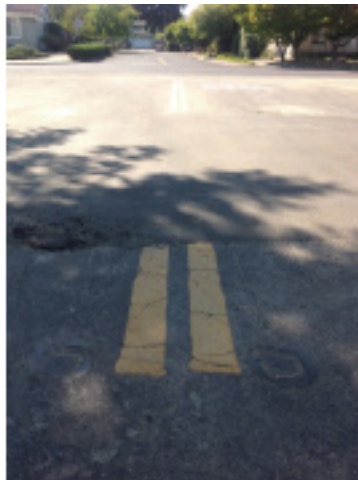
Station ID: 768		Observer: Prentice/Sickler				
Observation Date	Latitude	Longitude	Offset Feature	Inferred Origin		
2014:09:11	38.30793	122.33271	Pavement	Tectonic		
Description						
Craigie Court, cracks in driveway and buckled concrete; right-lateral cracks crossing road, N38W. Center line, now repaired, appears to have right-lateral offset. Right-lateral curb offset across street to north.						
Fault Azimuth	Strike Slip	Strike-slip Sense	Extension	Compression	Vertical	Upthrown Side
322	3*	RL				
Photographer	Camera Coordinates		Photograph Date			
Prentice	38.30799	122.33268	2014:09:11	15:28:10

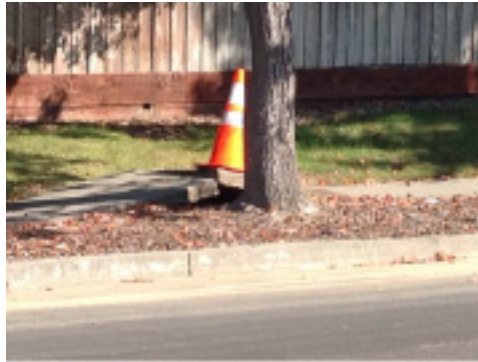
Station ID: 769		Observer: Prentice/Sickler		
Observation Date	Latitude	Longitude	Offset Feature	Inferred Origin
2014:09:11	38.30822	122.33287	Curb/Sidewalk	Tectonic
Description				
Tented sidewalk. Other fresh sidewalk damage in area.				
Photographer	Camera Coordinates		Photograph Date	
Prentice	38.30829	122.33304	2014:09:11 15:34:52

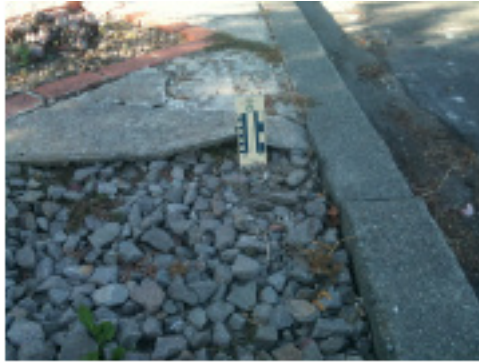
Station ID: 773		Observer: Prentice/Sickler		
Observation Date	Latitude	Longitude	Offset Feature	Inferred Origin
2014:09:11	38.30983	122.33543	Pavement	Tectonic
Description				
Linda Mesa and Scenic. Tented concrete. Asphalt thrust over curb apron at corner, extensional cracks, possible water line break on Scenic and multiple small curb cracks.				
Photographer	Camera Coordinates		Photograph Date	
Prentice			2014:09:11 16:52:11

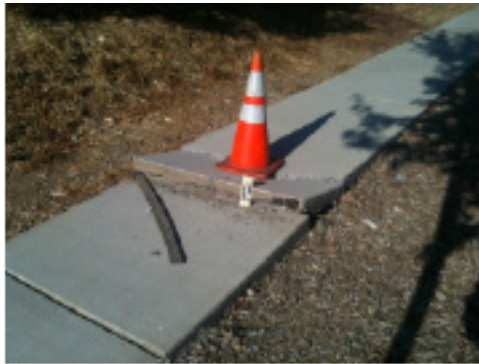
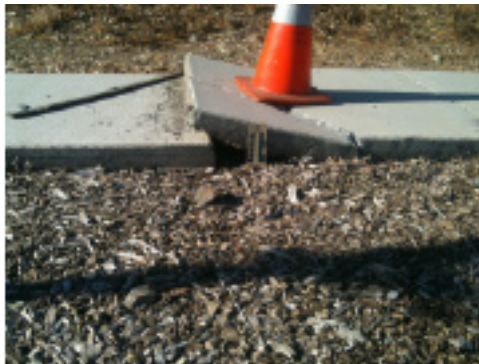
Station ID: 776		Observer: Prentice/Sickler				
Observation Date	Latitude	Longitude	Offset Feature	Inferred Origin		
2014:09:11	38.30996	122.33459	Curb/Sidewalk	Uncertain		
Description						
Scenic Drive. Pavement damaged, overthrust at joint and extended at two joints to the east. Trend N15W.						
Fault Azimuth	Strike Slip	Strike-slip Sense	Extension	Compression	Vertical	Upthrown Side
345						
Photographer	Camera Coordinates		Photograph Date			
Prentice			2014:09:11 16:59:11

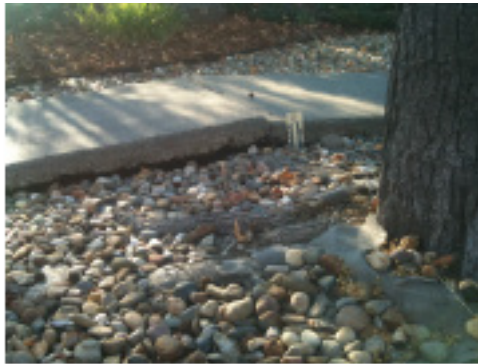
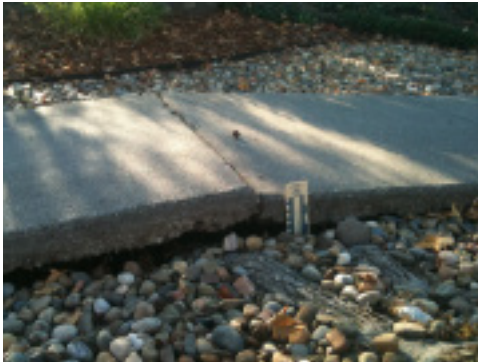
Station ID: 778				Observer: Prentice/Sickler
Observation Date	Latitude	Longitude	Offset Feature	Inferred Origin
2014:09:11	38.31078	122.33627	Curb/Sidewalk	Uncertain
Description				
Linda Mesa Way, sidewalk tented.

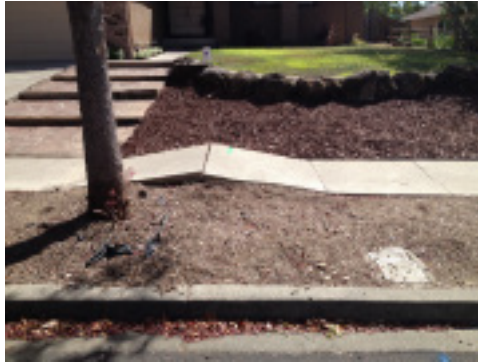
Station ID: 779				Observer: Seitz
Observation Date	Latitude	Longitude	Offset Feature	Inferred Origin
2014:09:16	38.31078	122.33627	Curb/Sidewalk	Uncertain
Description				
Compiler note: Google street image from 5/2014 shows similar pop up of concrete panel. Appears to be related to root action - not earthquake related.				
Photographer	Camera Coordinates		Photograph Date	
Seitz	38.31081	122.33632	2014:09:16 14:48:18

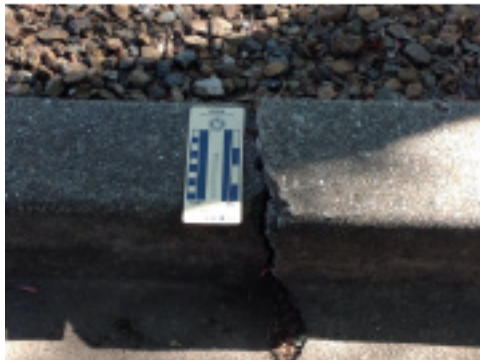
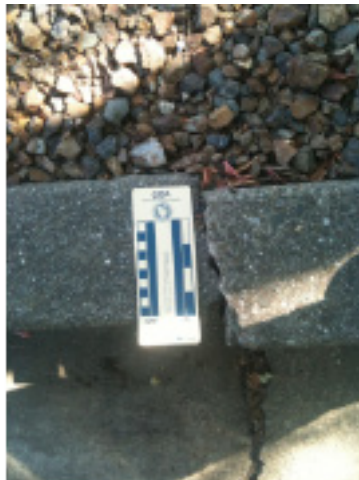
Station ID: 781		Observer: Prentice/Sickler				
Observation Date	Latitude	Longitude	Offset Feature	Inferred Origin		
2014:09:11	38.31081	122.33673	Curb/Sidewalk	Tectonic		
Description						
Linda Mesa Way, damaged curb, small curb and driveway cracks across street. Curb displaced right-lateral 20 mm, 26 mm vertical on N10W trending crack. Compiler note: upthrown side inferred from photo.						
Fault Azimuth	Strike Slip	Strike-slip Sense	Extension	Compression	Vertical	Upthrown Side
	2*	RL			2.6*	W
Photographer	Camera Coordinates		Photograph Date			
Prentice	38.31080	122.33675	2014:09:11	16:43:34
