Appendix 6. Tabulated Observations and Photographs of Surface Faulting and Ground Deformation Produced by the M_w 6.0 South Napa Earthquake of August 24, 2014—Trace E

Trace E

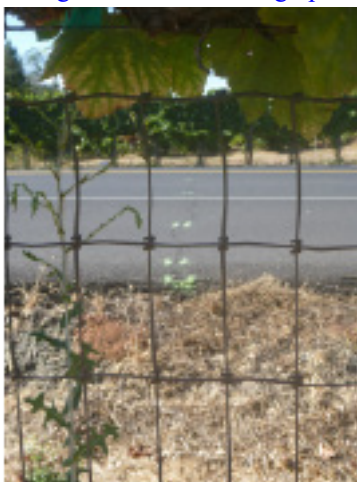
Station ID: 786				Observer: Hecker
Observation Date	Latitude	Longitude	Offset Feature	Inferred Origin
2014:09:12	38.28551	122.32113	Pavement	Tectonic
Description				
East end of distributed zone of road-spanning fractures crossing Old Sonoma.				
Photographer	Camera Coordinates		Photograph Date	
Hecker			2014:09:12 17:25:48

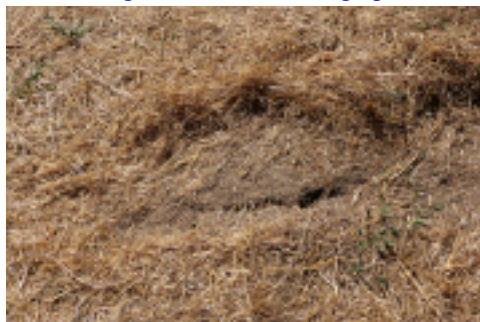
Station ID: 787			Observer: Prentice/Hecker/Sickler	
Observation Date	Latitude	Longitude	Offset Feature	Inferred Origin
2014:08:27	38.28629	122.32197	Soil	Tectonic
Description				
Cracks east of winery parking area.				
Photographer	Camera Coordinates		Photograph Date	
Prentice			2014:08:27 15:38:42

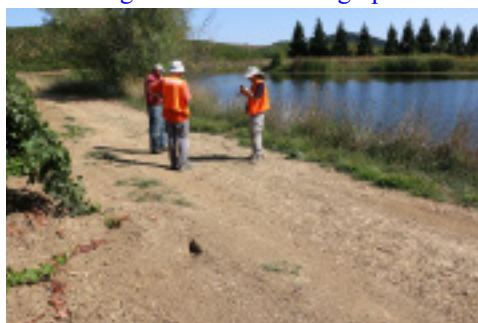
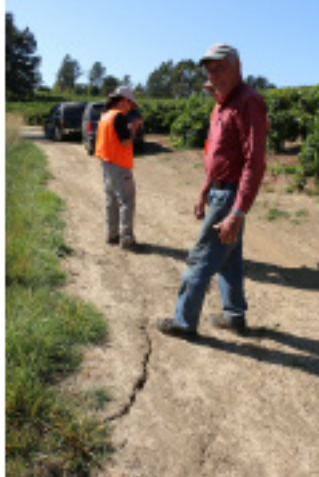
Station ID: 788				Observer: Prentice/Hecker/Sickler		
Observation Date		Latitude	Longitude	Offset Feature		Inferred Origin
2014:08:27		38.28746	122.32283	Soil		Tectonic
Description						
Left-stepping en echelon cracks near reservoir in vineyard, small left-lateral.						
Fault Azimuth	Strike Slip	Strike-slip Sense	Extension	Compression	Vertical	Upthrown Side
LL						
Photographer		Camera Coordinates		Photograph Date		
Prentice				2014:08:27 15:45:03

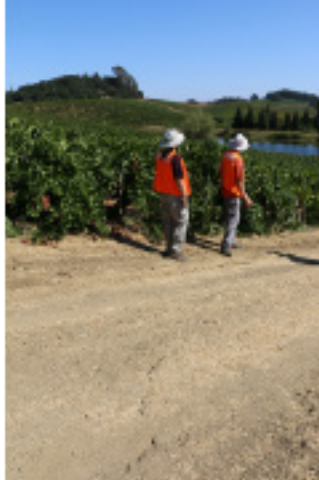
Station ID: 789				Observer: Prentice/Hecker/Sickler		
Observation Date		Latitude	Longitude	Offset Feature	Inferred Origin	
2014:08:27		38.28822	122.32344	Soil	Tectonic	
Description						
Left-stepping en echelon cracks across vineyard road north of reservoir.						
Fault Azimuth	Strike Slip	Strike-slip Sense	Extension	Compression	Vertical	Upthrown Side
RL

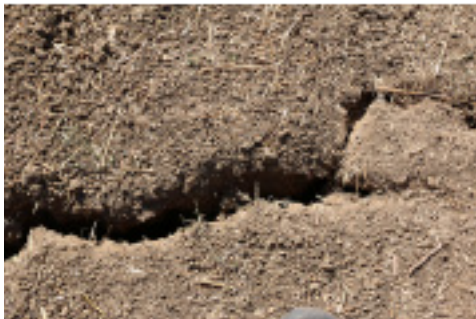
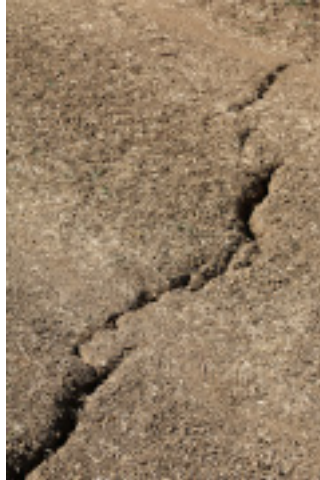
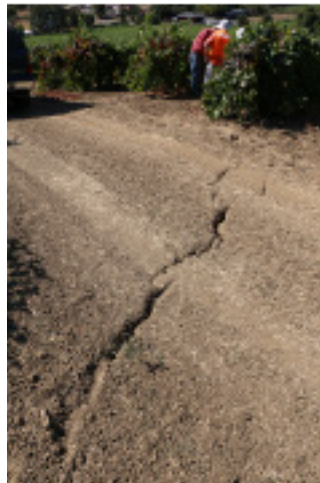
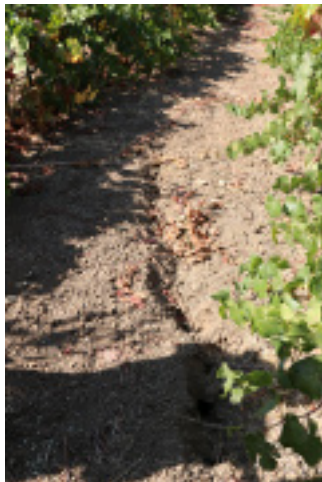
Station ID: 790				Observer: Prentice/Hecker/Sickler		
Observation Date		Latitude	Longitude	Offset Feature		Inferred Origin
2014:08:27		38.28887	122.32392	Soil		Tectonic
Description						
Cracks across vineyard road, right-lateral estimate about 5 cm.						
Fault Azimuth	Strike Slip	Strike-slip Sense	Extension	Compression	Vertical	Upthrown Side
	5*	RL				
Photographer		Camera Coordinates		Photograph Date		
Prentice				2014:08:27 15:56:42

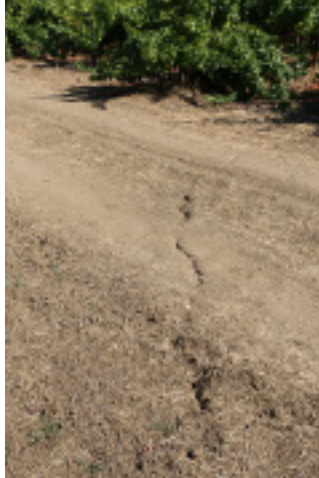
Station ID: 791				Observer: Prentice/Hecker/Sickler		
Observation Date		Latitude	Longitude	Offset Feature		Inferred Origin
2014:08:27		38.29044	122.32475	Soil		Tectonic
Description						
Cracks across vineyard road, small right-lateral.						
Fault Azimuth	Strike Slip	Strike-slip Sense	Extension	Compression	Vertical	Upthrown Side
RL

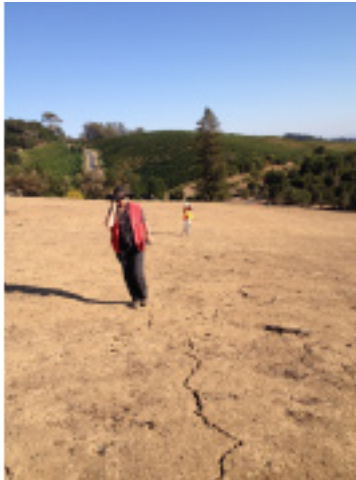
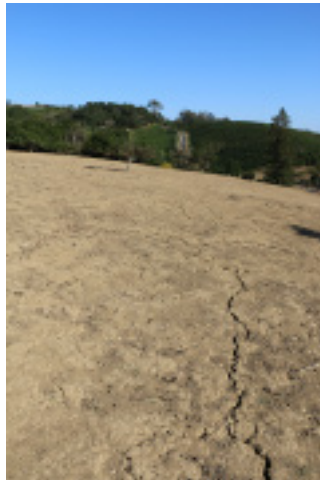
Station ID: 793				Observer: Prentice/Hecker/Sickler		
Observation Date		Latitude	Longitude	Offset Feature		Inferred Origin
2014:08:27		38.29583	122.32615	Soil		Tectonic
Description						
Right-lateral cracks up hill.						
Fault Azimuth	Strike Slip	Strike-slip Sense	Extension	Compression	Vertical	Upthrown Side
RL

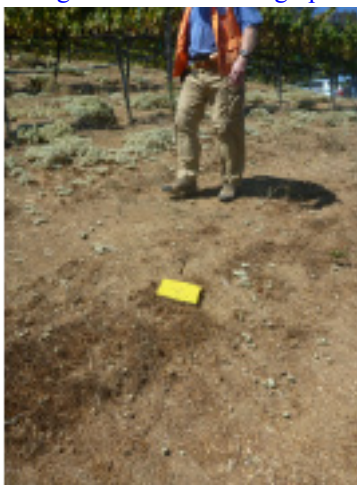
Station ID: 795						Observer: Hecker
Observation Date		Latitude	Longitude	Offset Feature		Inferred Origin
2014:09:12		38.29869	122.32950	Soil		Uncertain
Description						
1-2 meter-wide zone of extensional cracks (~						
Fault Azimuth	Strike Slip	Strike-slip Sense	Extension	Compression	Vertical	Upthrown Side
312			<1 *			
Photographer		Camera Coordinates		Photograph Date		
Hecker				2014:09:12 14:43:11

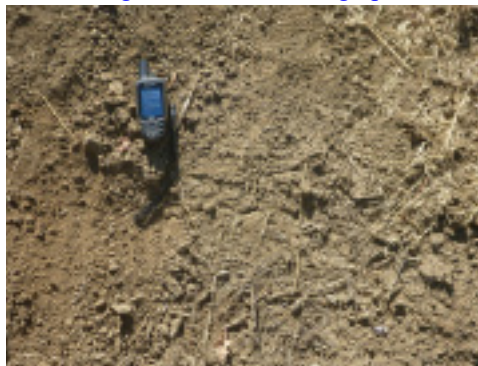
Station ID: 797					Observer: Hecker	
Observation Date		Latitude	Longitude	Offset Feature	Inferred Origin	
2014:09:12		38.29919	122.33008	Soil	Uncertain	
Description						
Very short (~0.5 m) isolated crack in dirt with ~2 mm opening. Trend 297.						
Fault Azimuth	Strike Slip	Strike-slip Sense	Extension	Compression	Vertical	Upthrown Side
297			0.2*			
Photographer		Camera Coordinates		Photograph Date		
Hecker				2014:09:12 15:22:55

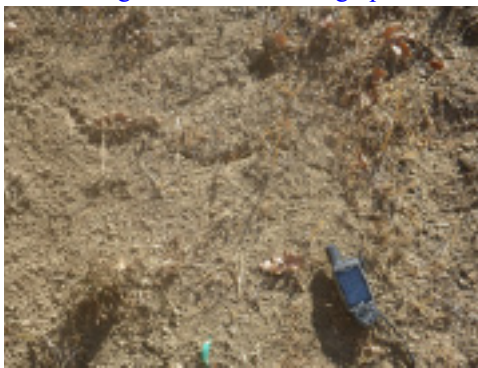
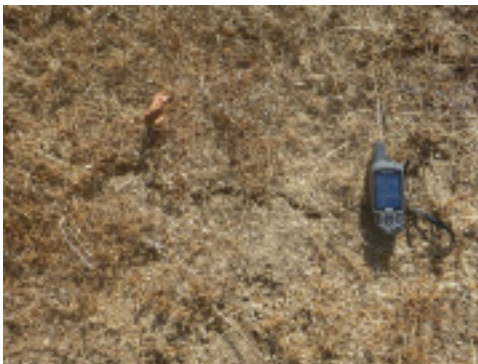
Station ID: 800					Observer: Hecker	
Observation Date		Latitude	Longitude	Offset Feature	Inferred Origin	
2014:09:12		38.29983	122.33100	Soil	Uncertain	
Description						
Few, meter-long zone of cracks (with a few mm wide openings) crossing open hillside, trend 297. South end of ~10-m-long crack upslope.						
Fault Azimuth	Strike Slip	Strike-slip Sense	Extension	Compression	Vertical	Upthrown Side
297						
Photographer		Camera Coordinates		Photograph Date		
Hecker				2014:09:12 16:12:07
