Appendix 7. Tabulated Observations and Photographs of Surface Faulting and Ground Deformation Produced by the M_w 6.0 South Napa Earthquake of August 24, 2014—Trace F

Trace F

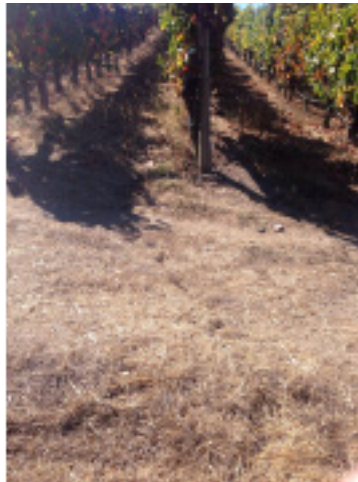
Station ID: 803				Observer: Dawson
Observation Date	Latitude	Longitude	Offset Feature	Inferred Origin
2014:09:16	38.28195	122.31516	Soil	Tectonic
Description				
At property boundary.				
Photographer	Camera Coordinates		Photograph Date	
Dawson	38.28194	122.31502	2014:09:16

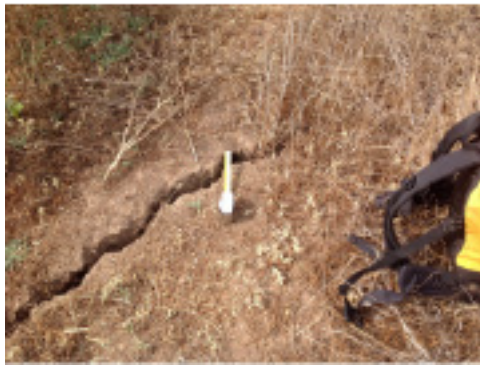
Station ID: 805				Observer: Ponti		
Observation Date	Latitude	Longitude	Offset Feature	Inferred Origin		
2014:10:15	38.28245	122.31515	Soil	Tectonic		
Description						
Vector length 6 cm, vector azimuth 130, fracture azimuth overall is 358. Plunge is 5. Normal oblique, up on the west side.						
Fault Azimuth	Strike Slip	Strike-slip Sense	Extension	Compression	Vertical	Upthrown Side
358	4	RL	4.5		0.5	W
Photographer	Camera Coordinates			Photograph Date		
Ponti	38.28245	122.31512	2014:10:15	14:31:04

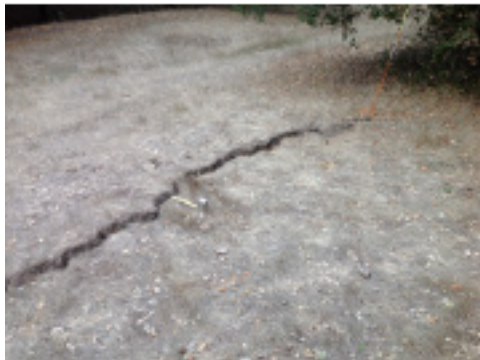
Station ID: 810				Observer: Ponti		
Observation Date	Latitude	Longitude	Offset Feature	Inferred Origin		
2014:10:15	38.28428	122.31524	Soil	Tectonic		
Description						
Prominent uphill facing scarp here. No apparent lateral offset, about 6 cm of vertical offset and 3 to 4 cm extension.						
Fault Azimuth	Strike Slip	Strike-slip Sense	Extension	Compression	Vertical	Upthrown Side
			3-4*		6*	W
Photographer	Camera Coordinates		Photograph Date			
Ponti	38.28429	122.31527	2014:10:15	15:18:49

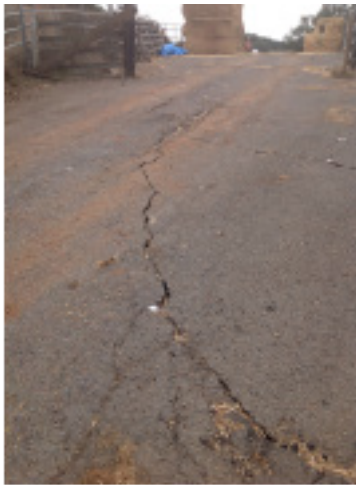
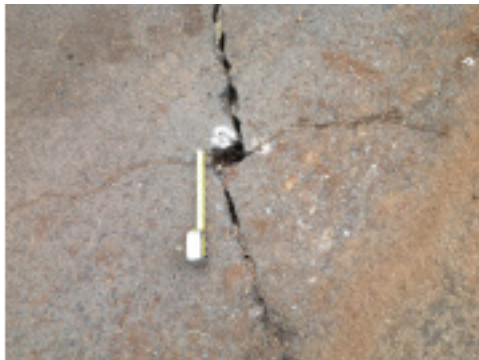
Station ID: 816				Observer: Ponti		
Observation Date	Latitude	Longitude	Offset Feature	Inferred Origin		
2014:10:15	38.28619	122.31580	Soil	Tectonic		
Description						
Fractures cut across road here. Offsets on fractures indicate approximately 5 cm of right-lateral motion parallel to fault.						
Fault Azimuth	Strike Slip	Strike-slip Sense	Extension	Compression	Vertical	Upthrown Side
	5*	RL				
Photographer	Camera Coordinates		Photograph Date			
Ponti	38.28626	122.31579	2014:10:15	15:41:17

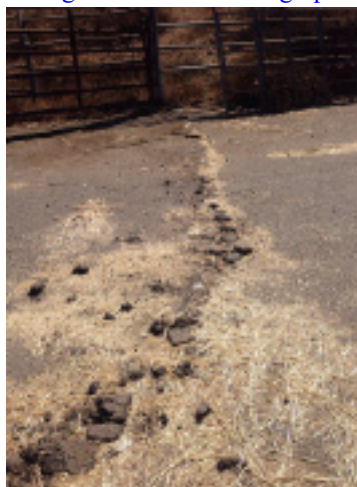
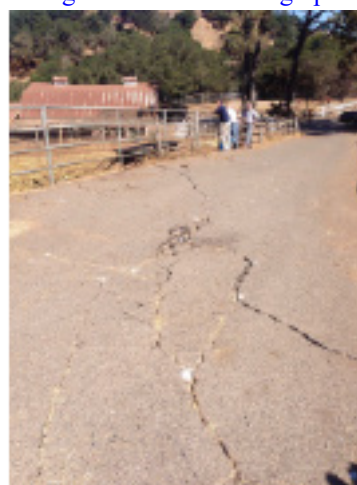
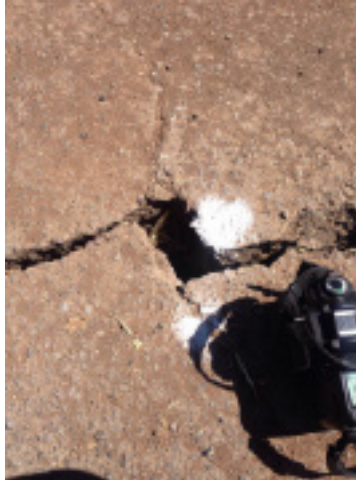
Description
About 5 cm right-lateral.

Fault Azimuth	Strike Slip	Strike-slip Sense	Extension	Compression	Vertical	Upthrown Side
	5*	RL

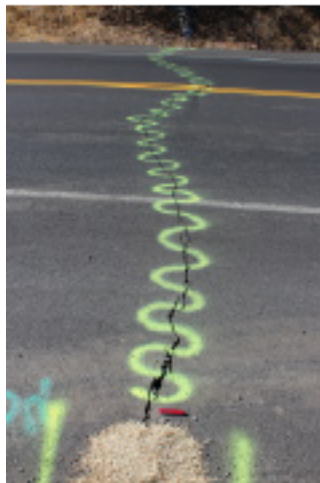
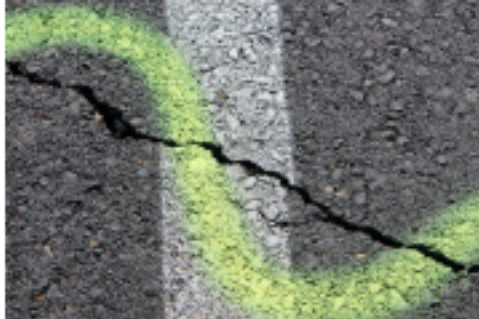
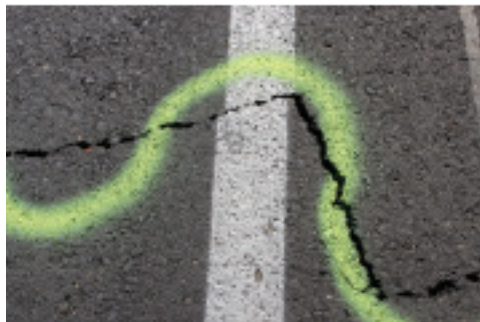
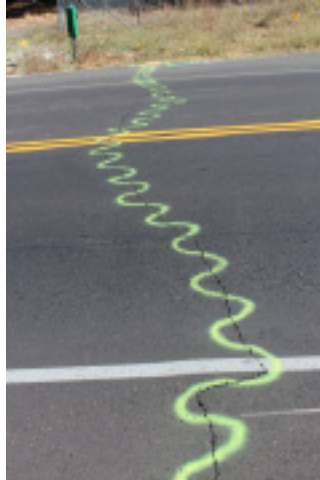
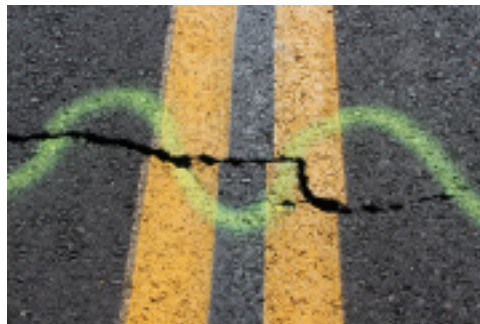
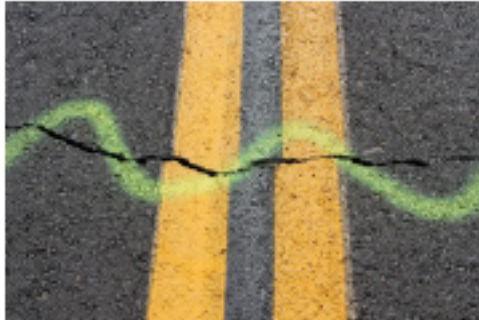
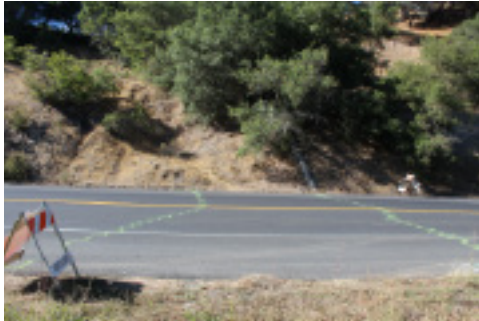
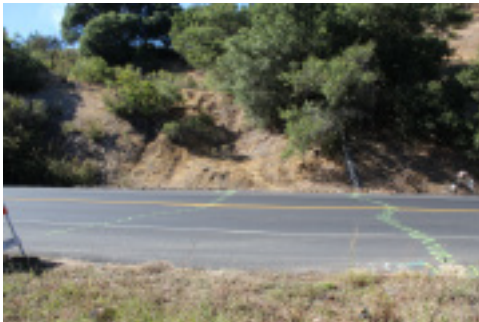
Old Sonoma Road west of city limits.

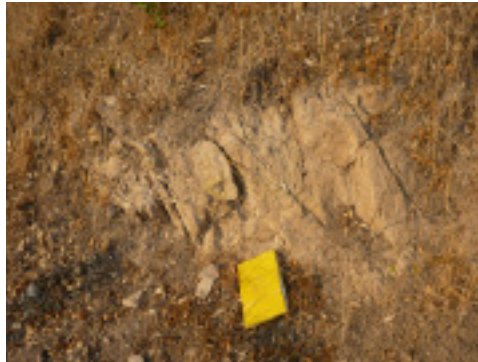
Station ID: 820					Observer: Hecker
Observation Date	Latitude	Longitude	Offset Feature	Inferred Origin	
2014:09:19	38.28897	122.31783	Soil	Tectonic	
Description					
Bedrock outcropping along road with fresh fractures and nearby small extensional crack in non-expansive soil between vines.					
Photographer	Camera Coordinates		Photograph Date		
Hecker			2014:09:19 18:43:57

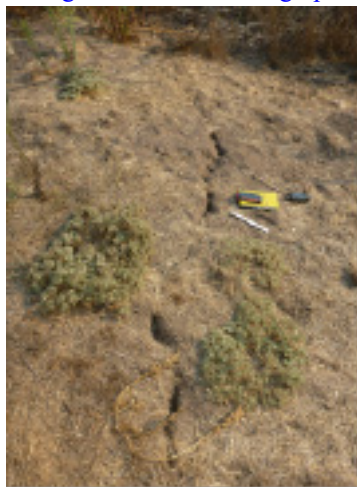
Station ID: 822				Observer: Hecker		
Observation Date	Latitude	Longitude	Offset Feature	Inferred Origin		
2014:09:19	38.29032	122.31962	Soil	Uncertain		
Description						
Separate fracture alignment subparallel and west of main zone. Extensional crack across path with slight down to west (downhill) vertical displacement and slight inflection in slope.						
Fault Azimuth	Strike Slip	Strike-slip Sense	Extension	Compression	Vertical	Upthrown Side
						E
Photographer		Camera Coordinates		Photograph Date		
Hecker				2014:09:19 17:59:34

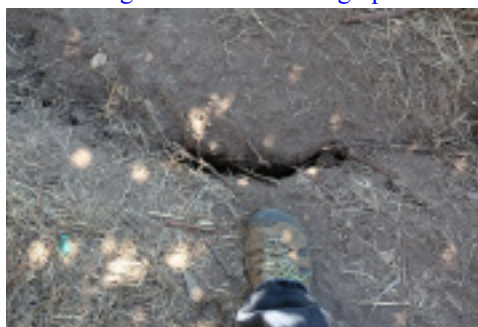
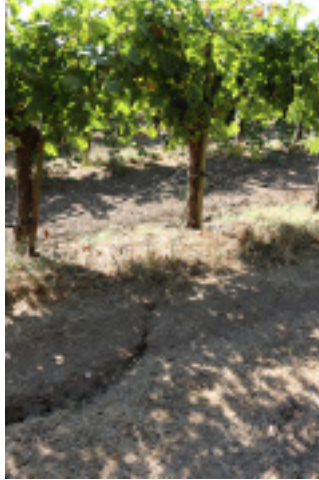
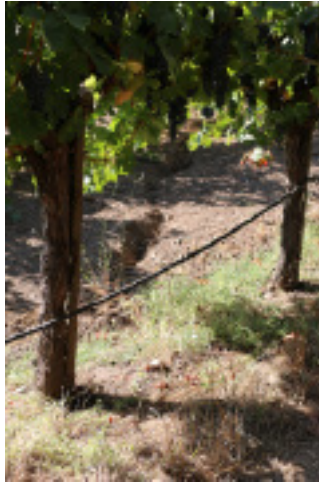
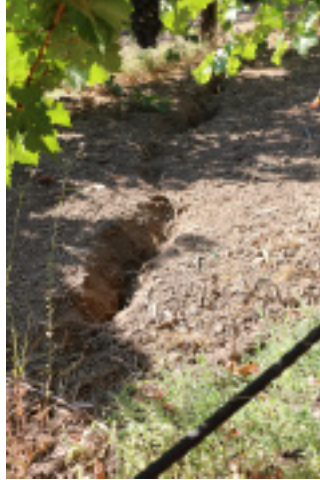
Station ID: 838				Observer: Prentice/Hecker/Sickler		
Observation Date	Latitude	Longitude	Offset Feature	Inferred Origin		
2014:08:27	38.29161	122.32078	Soil	Tectonic		
Description						
Cracks near eastern edge of vineyard, near edge of forest. Water line break here; small right-lateral.						
Fault Azimuth	Strike Slip	Strike-slip Sense	Extension	Compression	Vertical	Upthrown Side
		RL				
Photographer	Camera Coordinates			Photograph Date		
Prentice				2014:08:27 16:25:47

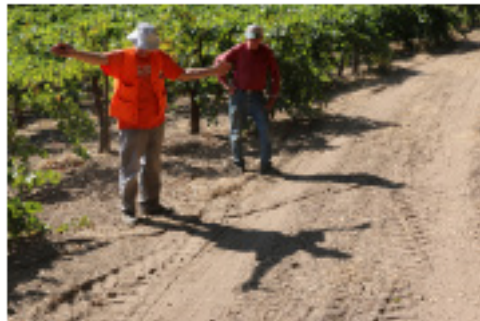
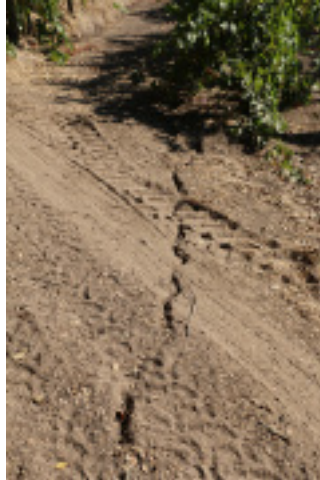
Water line break along zone of cracks. Cracks across vineyard road, small right-lateral.

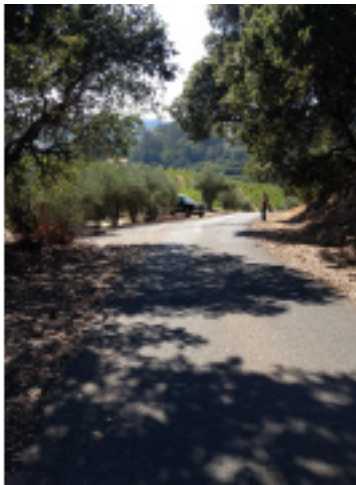
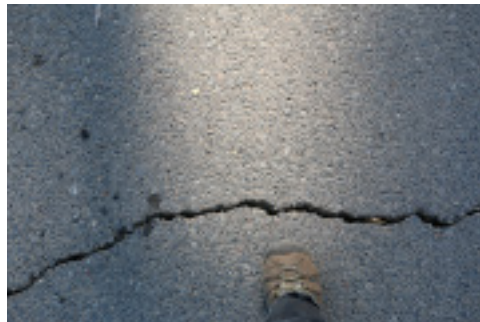
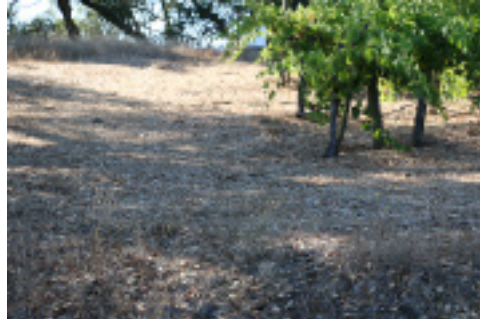
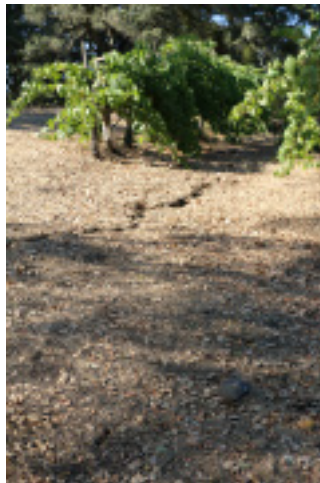
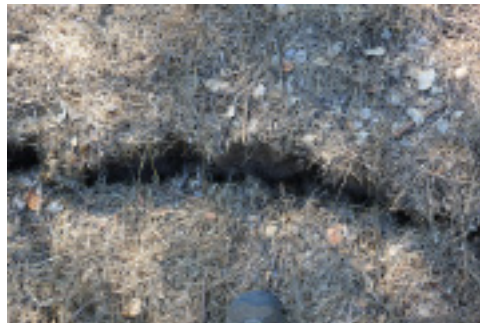
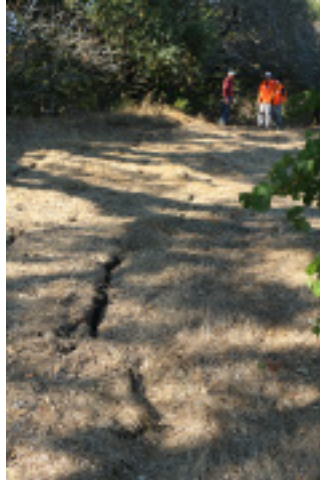
Station ID: 842		Observer: Prentice/Hecker/Sickler				
Observation Date	Latitude	Longitude	Offset Feature	Inferred Origin		
2014:08:27	38.29338	122.32157	Soil	Tectonic		
Description						
Cracks across asphalt road, small right-lateral, 1-3 cm of west-side-up. Left-stepping en echelon cracks in vineyard north of road.						
Fault Azimuth	Strike Slip	Strike-slip Sense	Extension	Compression	Vertical	Upthrown Side
		RL			1-3*	W
Photographer	Camera Coordinates		Photograph Date			
Prentice			2014:08:27 16:42:28

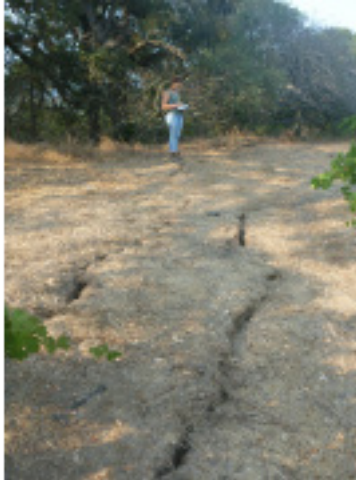
Station ID: 847				Observer: Hecker		
Observation Date	Latitude	Longitude	Offset Feature	Inferred Origin		
2014:09:19	38.29372	122.32167	Soil	Tectonic		
Description						
Several extensional cracks straddle row of vines. Somewhat left-stepping across 3-m-wide zone; small up on west component (~5-10 cm).						
Fault Azimuth	Strike Slip	Strike-slip Sense	Extension	Compression	Vertical	Upthrown Side
		RL			5-10*	W
