Appendix 9. Tabulated Observations and Photographs of Ground Deformation Produced by the M_w 6.0 South Napa Earthquake of August 24, 2014—Shaking-Induced Deformation Owing to Landslide Reactivation or Fill Settlement

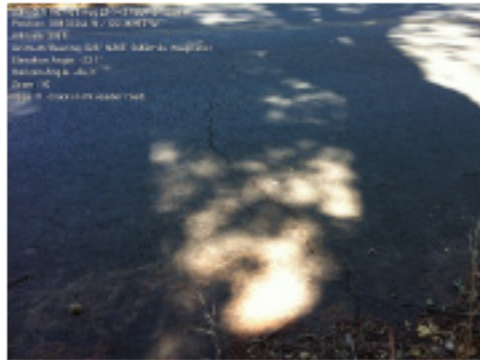
Station ID: 1146		Observer: Haydon/Wiegers		
Observation Date	Latitude	Longitude	Offset Feature	Inferred Origin
2014:08:26	38.33245	122.36995	Pavement	Shaking
Description				
Crack in Mt. Veeder Road.				
Photographer	Camera Coordinates		Photograph Date	
Haydon/Wiegers	38.33244	122.36993	2014:08:26 14:31:45

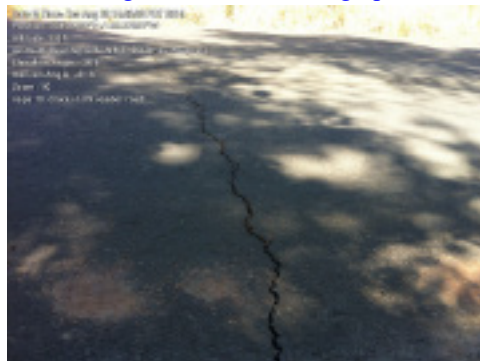
Station ID: 1147		Observer: Haydon/Wiegers		
Observation Date	Latitude	Longitude	Offset Feature	Inferred Origin
2014:08:26	38.33259	122.37028	Pavement	Shaking
Description				
Crack in Mt. Veeder Road.				
Photographer	Camera Coordinates		Photograph Date	
Haydon/Wiegers	38.33258	122.37027	2014:08:26 14:28:46

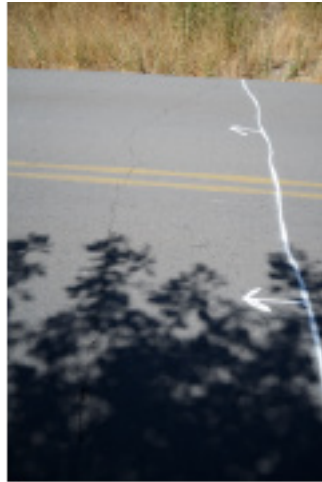
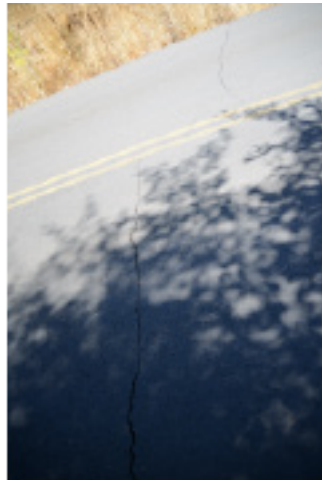
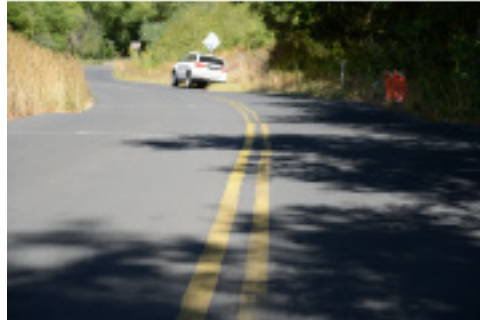
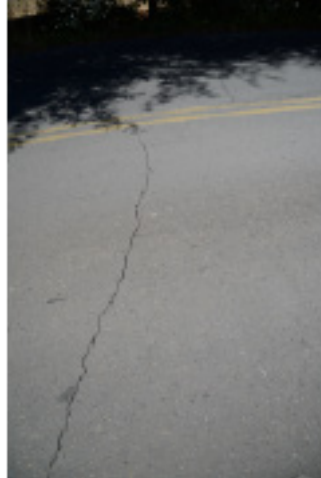
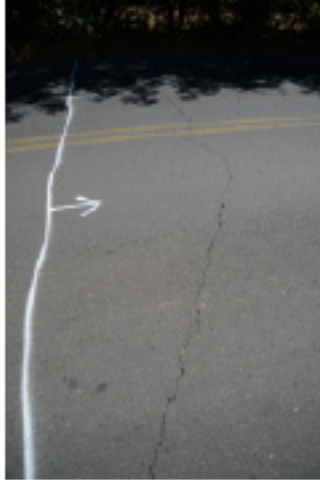
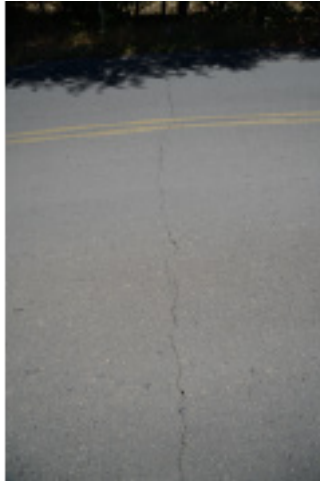
Station ID: 1148				Observer: Hudnut
Observation Date	Latitude	Longitude	Offset Feature	Inferred Origin
2014:08:28	38.33270	122.36622	Pavement	Shaking
Description				
Fractures in paved road; non-tectonic; road has sag/bump with cracks on both sides of it.				
Photographer	Camera Coordinates		Photograph Date	
Hudnut	38.33279	122.36610	2014:08:28 13:43:17

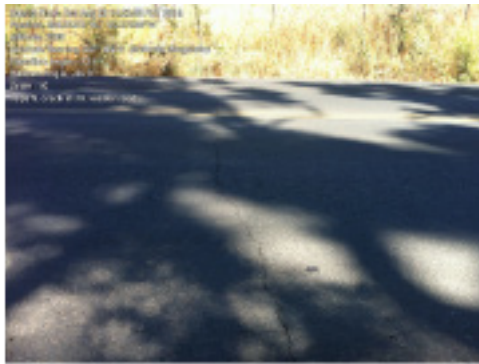
Station ID: 1149		Observer: Haydon/Wiegers		
Observation Date	Latitude	Longitude	Offset Feature	Inferred Origin
2014:08:26	38.33273	122.37037	Pavement	Shaking
Description				
Crack in Mt. Veeder Road.				
Photographer	Camera Coordinates		Photograph Date	
Haydon/Wiegers	38.33273	122.37035	2014:08:26 14:24:33

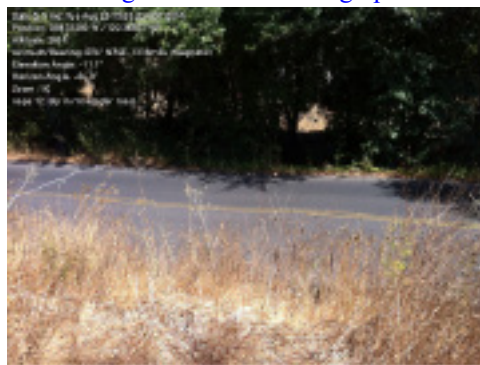
Station ID: 1150		Observer: Haydon/Wiegers		
Observation Date	Latitude	Longitude	Offset Feature	Inferred Origin
2014:08:26	38.33276	122.36616	Pavement	Shaking
Description				
Dip in Mt. Veeder Road.				
Photographer	Camera Coordinates		Photograph Date	
Haydon/Wiegers	38.33279	122.36621	2014:08:26 15:06:29

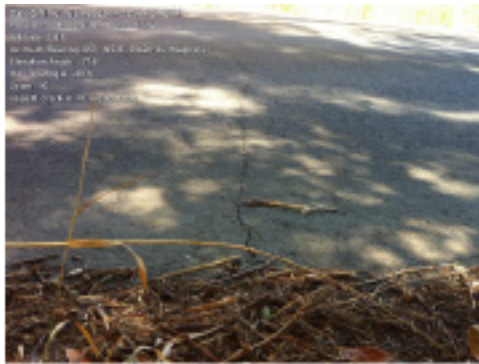
Station ID: 1151		Observer: Haydon/Wiegers		
Observation Date	Latitude	Longitude	Offset Feature	Inferred Origin
2014:08:26	38.33294	122.37053	Pavement	Shaking
Description				
Crack in Mt. Veeder Road.				
Photographer	Camera Coordinates		Photograph Date	
Haydon/Wiegers	38.33294	122.37051	2014:08:26 14:19:52

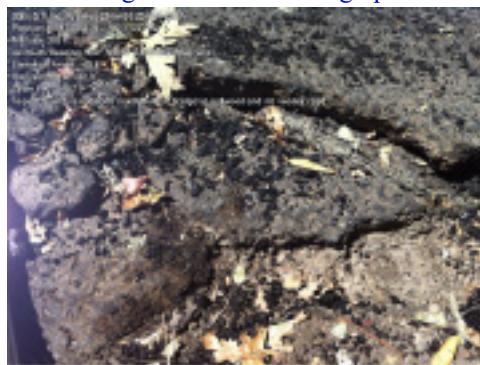
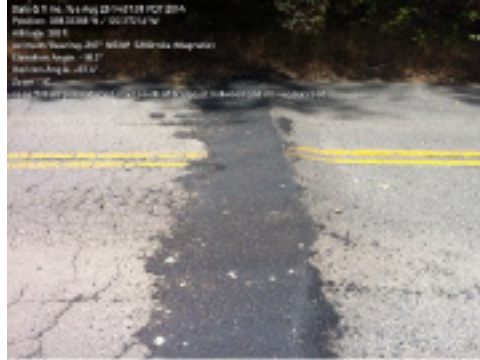
Station ID: 1152		Observer: Haydon/Wiegers		
Observation Date	Latitude	Longitude	Offset Feature	Inferred Origin
2014:08:26	38.33359	122.37217	Pavement	Shaking
Description				
Bump in Redwood Road south of bridge at Redwood and Mt Veeder Road.				
Photographer	Camera Coordinates		Photograph Date	
Haydon/Wiegers	38.33344	122.37221	2014:08:26 14:01:10

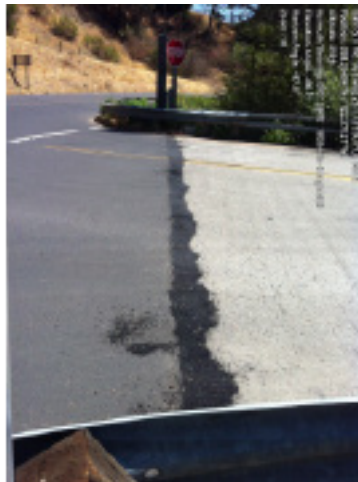
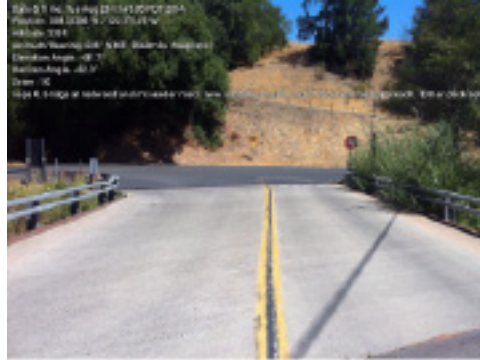
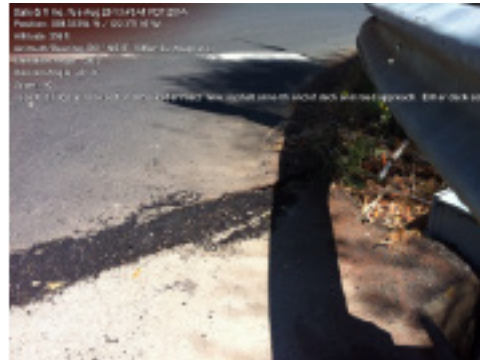
Bridge at Redwood and Mt Veeder road. New asphalt on north end of deck and road approach.

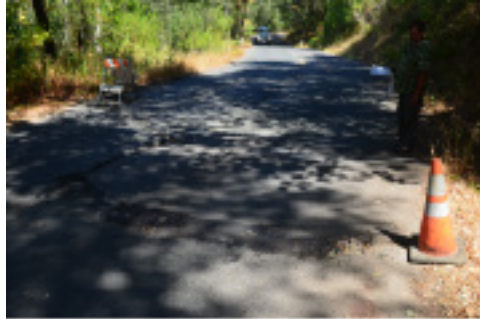
Pavement with right-lateral offset.

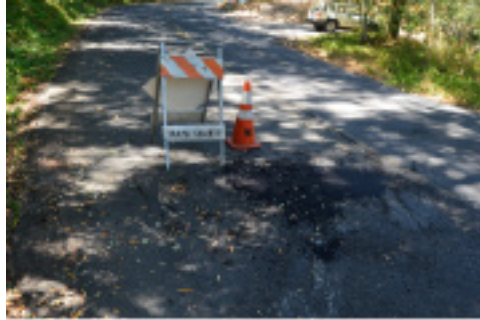
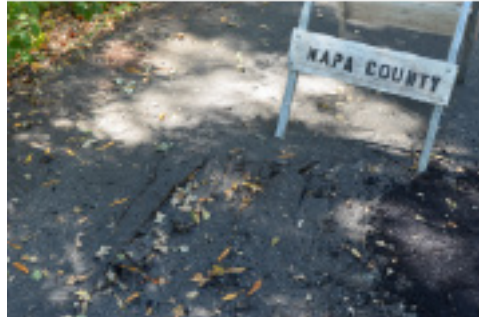
Deformation of pavement.

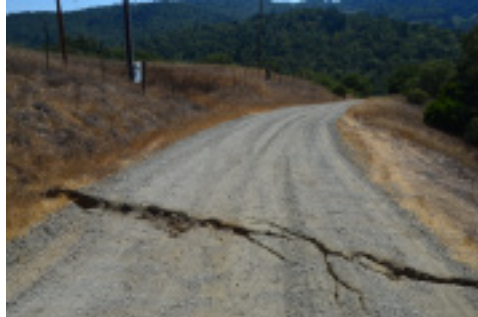
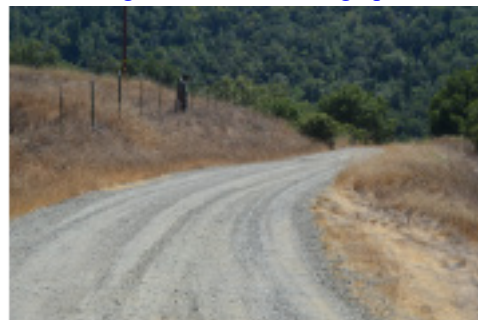
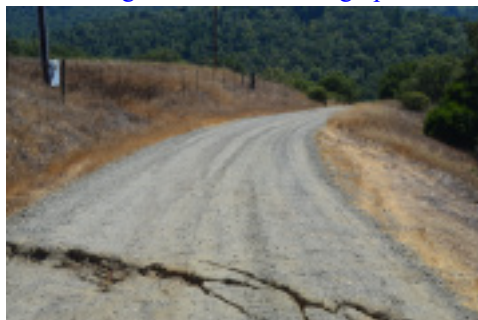
Extensional crack across road about 5 cm open; downslope side of road wider. Up 2 in. to south and open 2 ft. deep on upslope side of road.

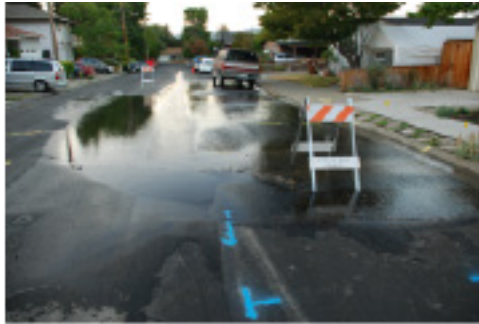
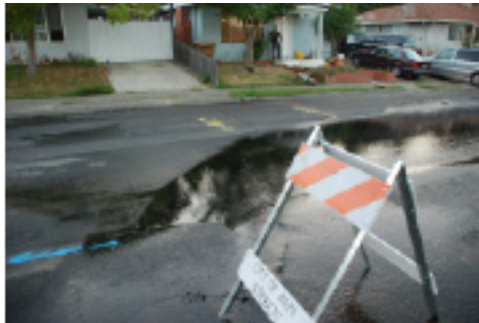
Station ID: 1038				Observer: Holzer
Observation Date	Latitude	Longitude	Offset Feature	Inferred Origin
2014:08:25	38.28834	122.31190	Pavement	Uncertain
Description				
Lilienthal Avenue: water line break; hairline crack in and orthogonal to street.				
Photographer	Camera Coordinates		Photograph Date	
Holzer			2014:08:25 19:40:56

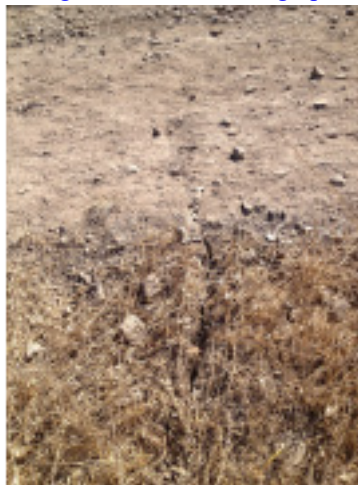
Station ID: 1040				Observer: Seitz		
Observation Date	Latitude	Longitude	Offset Feature	Inferred Origin		
2014:09:03	38.29545	122.31917	Soil	Uncertain		
Description						
Minor cracking across dirt road appears to be gravity-induced. N71E orientation; open about 1.5 cm.						
Fault Azimuth	Strike Slip	Strike-slip Sense	Extension	Compression	Vertical	Upthrown Side
71			1.5*			
Photographer	Camera Coordinates		Photograph Date			
Seitz	38.29546	122.31915	2014:09:03	11:07:00

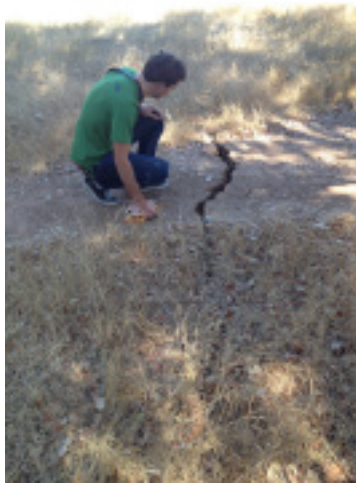
Station ID: 1041				Observer: Seitz		
Observation Date	Latitude	Longitude	Offset Feature	Inferred Origin		
2014:09:03	38.29608	122.31952	Soil	Shaking		
Description						
Ground crack with opening and extension trend N15W. 8 cm maximum opening extension direction N68E.						
Fault Azimuth	Strike Slip	Strike-slip Sense	Extension	Compression	Vertical	Upthrown Side
345	1	LL	8			
Photographer	Camera Coordinates		Photograph Date			
Seitz	38.29608	122.31951	2014:09:03 10:53:11

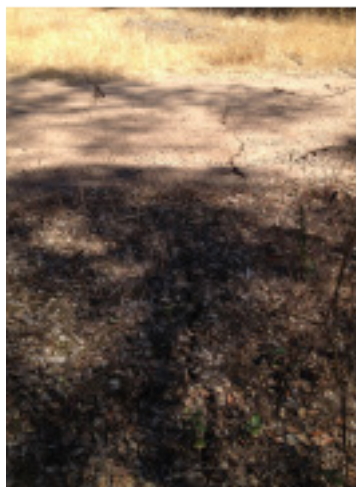
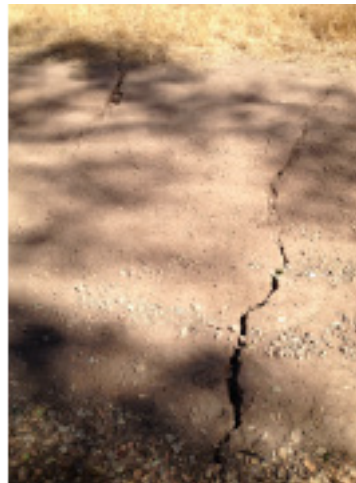
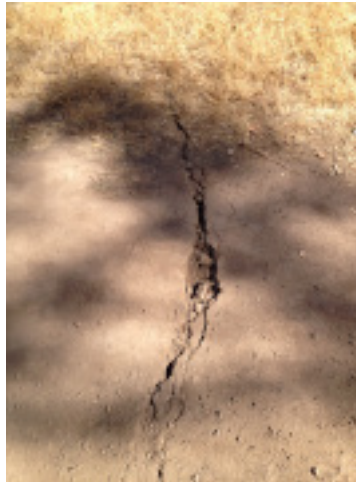
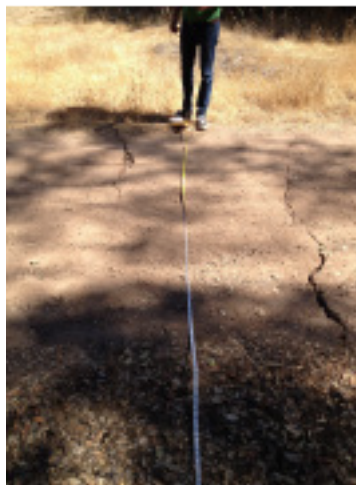
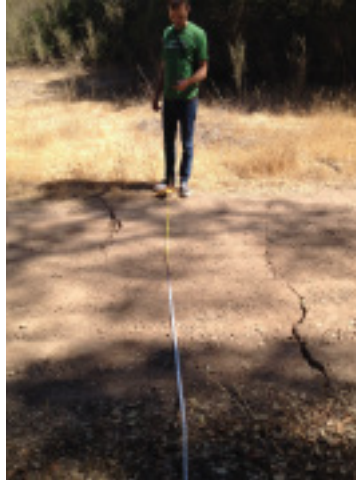
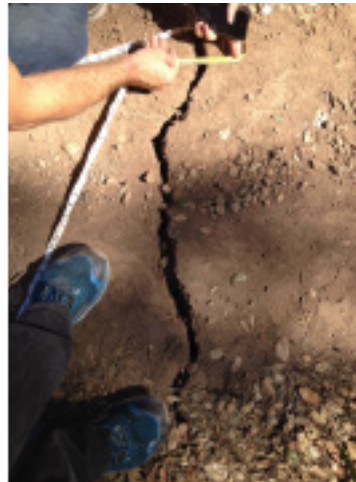
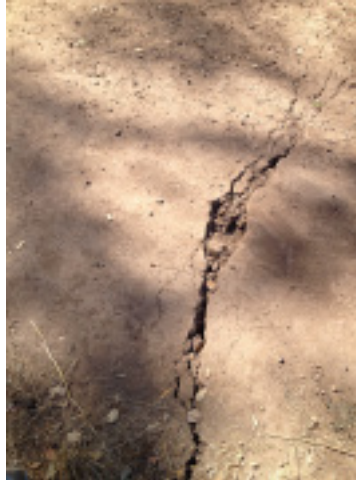
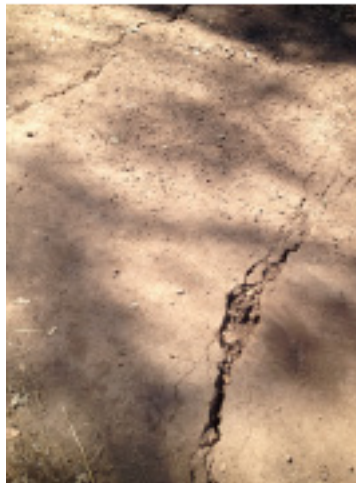
Station ID: 1042				Observer: Seitz		
Observation Date	Latitude	Longitude	Offset Feature	Inferred Origin		
2014:09:03	38.29610	122.32089	Soil	Shaking		
Description						
Two cracks across path N11E. Orientation cracks are open, spaced about 1.5 m apart; trend N80E. Opening about 2 cm can be traced about 15 m.						
Fault Azimuth	Strike Slip	Strike-slip Sense	Extension	Compression	Vertical	Uprthrown Side
11			2*			
Photographer	Camera Coordinates		Photograph Date			
Seitz	38.29612	122.32085	2014:09:03 11:29:53

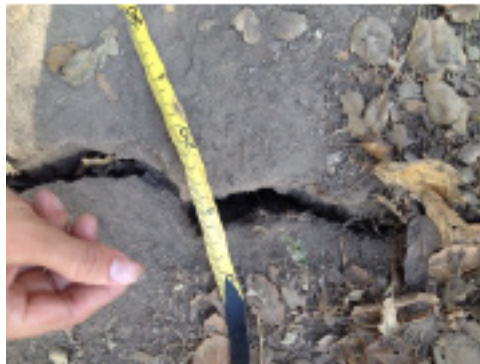
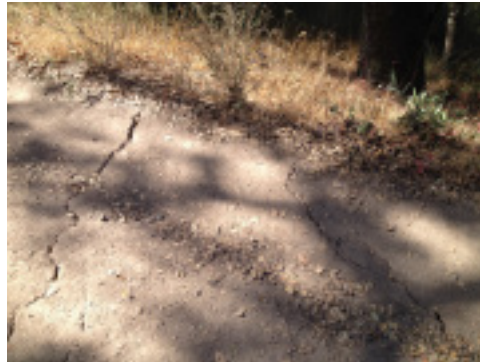
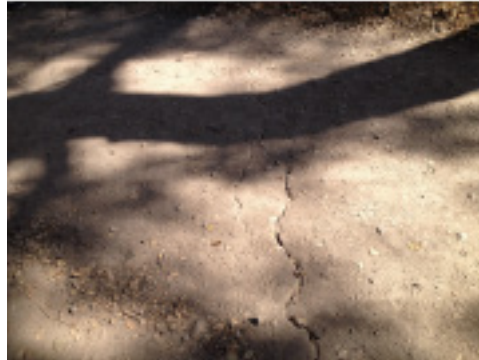
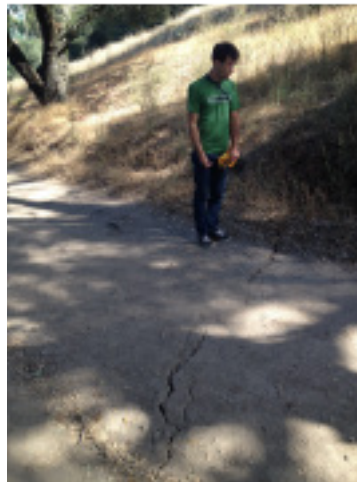
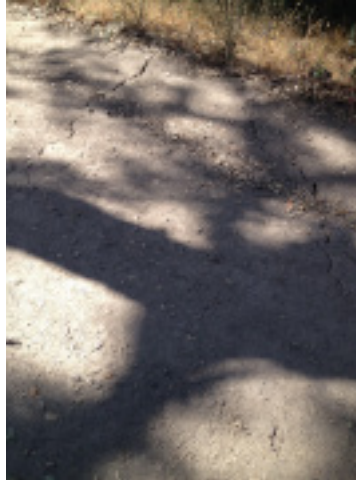
Station ID: 1044				Observer: Seitz		
Observation Date	Latitude	Longitude	Offset Feature	Inferred Origin		
2014:09:03	38.29692	122.32045	Soil	Shaking		
Description						
Two cracks across dirt road open 1 to 2 cm. Trend N60E; 2 cm separation.						
Fault Azimuth	Strike Slip	Strike-slip Sense	Extension	Compression	Vertical	Upthrown Side
60			1-2*			
Photographer	Camera Coordinates		Photograph Date			
Seitz	38.29693	122.32042	2014:09:03 10:41:57
