Appendix 12. Tabulated Observations and Photographs of Ground Deformation Produced by the M_w 6.0 South Napa Earthquake of August 24, 2014—Isolated Cracking on Slopes

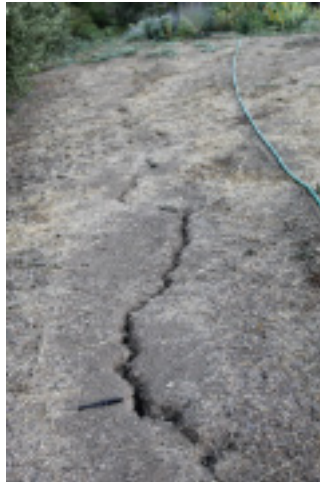
Station ID: 1159		Observer: Pickering/Crewdson		
Observation Date	Latitude	Longitude	Offset Feature	Inferred Origin
2014:09:10	38.34439	122.35415	Soil	Uncertain
Description				
Fracture continues (property boundary).				
Photographer	Camera Coordinates		Photograph Date	
Pickering/Crewdson			2014:09:10 05:41:47

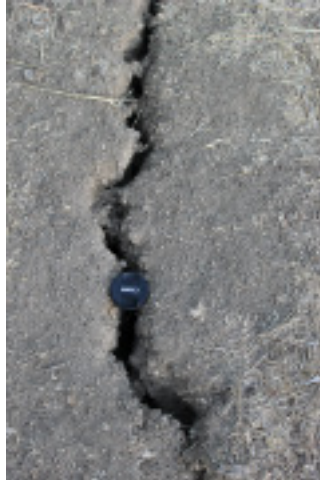
Station ID: 1160	Observer: Pickering/Crewdson	
Photographer	Camera Coordinates	Photograph Date
Pickering/Crewdson		2014:09:10 05:20:08

Station ID: 1160		Observer: Pickering/Crewdson				
Observation Date	Latitude	Longitude	Offset Feature	Inferred Origin		
2014:09:10	38.34458	122.35436	Soil	Uncertain		
Description						
3-6 cm extension fracture.						
Fault Azimuth	Strike Slip	Strike-slip Sense	Extension	Compression	Vertical	Upthrown Side
			3-6*

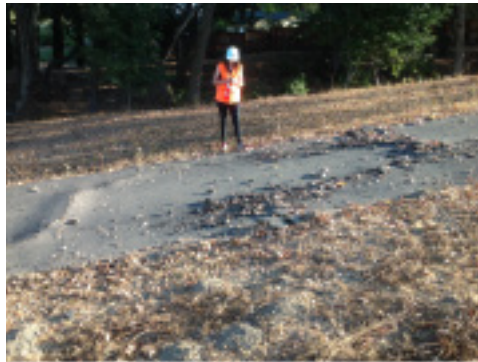
Station ID: 1168		Observer: Ponti				
Observation Date	Latitude	Longitude	Offset Feature	Inferred Origin		
2014:09:12	38.34537	122.35472	Pavement	Uncertain		
Description						
Compressional deformation on road. Trend 345.						
Fault Azimuth	Strike Slip	Strike-slip Sense	Extension	Compression	Vertical	Upthrown Side
345						
Photographer	Camera Coordinates		Photograph Date			
Ponti	38.34538	122.35471	2014:09:11 17:39:00

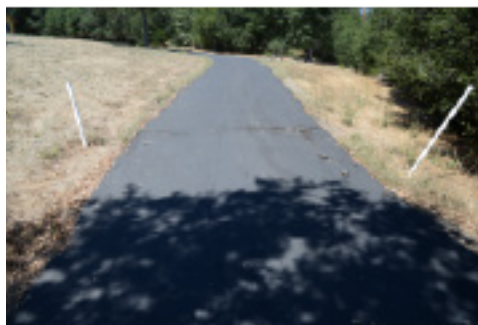
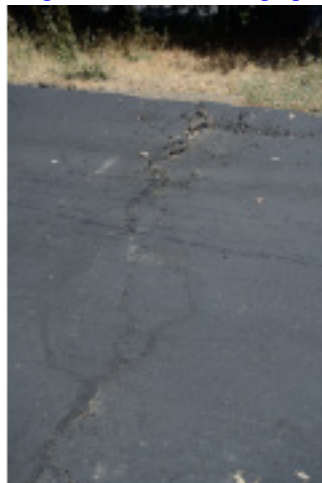
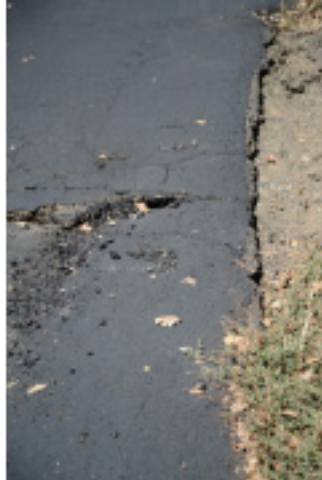
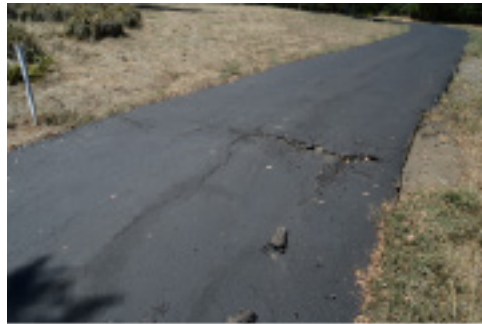
Station ID: 1170				Observer: Hudnut		
Observation Date	Latitude	Longitude	Offset Feature	Inferred Origin		
2014:08:28	38.34738	122.35576	Pavement	Uncertain		
Description						
Fracture across paved driveway. Cracks next to tree stump located by side of asphalt driveway. Side-hill slump. Crack crossing driveway in N35W but no displacement; tent feature.						
Fault Azimuth	Strike Slip	Strike-slip Sense	Extension	Compression	Vertical	Upthrown Side
325						
Photographer	Camera Coordinates			Photograph Date		
Hudnut	38.34743	122.35566	2014:08:28	12:16:05

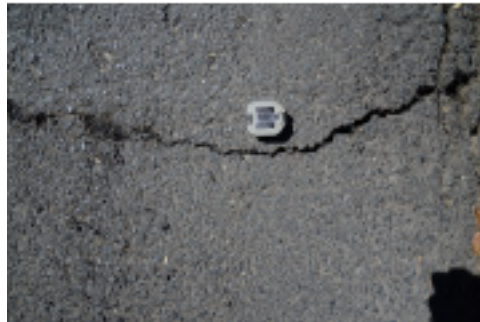
Station ID: 1171				Observer: Hudnut
Observation Date	Latitude	Longitude	Offset Feature	Inferred Origin
2014:08:28	38.34792	122.35619	Pavement	Uncertain
Description				
Fractures in paved road.				
Photographer	Camera Coordinates		Photograph Date	
Hudnut	38.34789	122.35621	2014:08:28	12:08:06

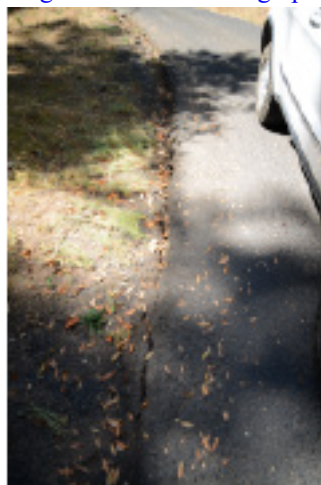
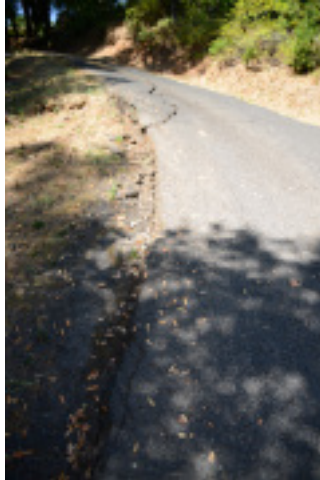
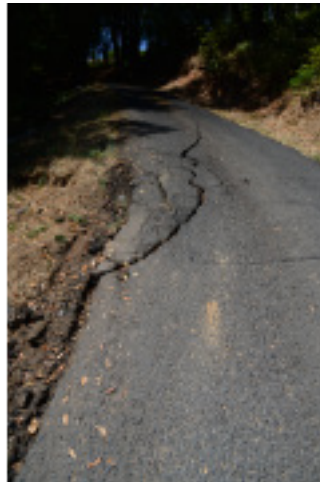
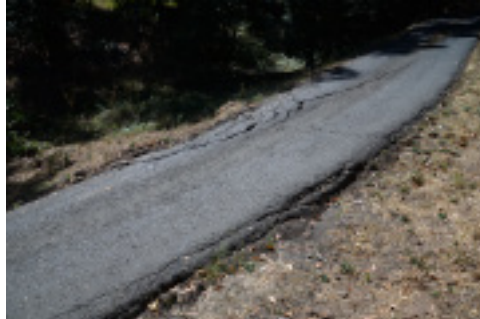
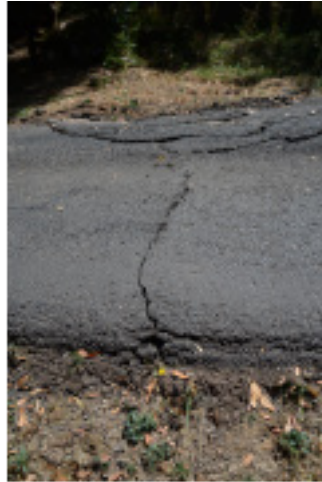
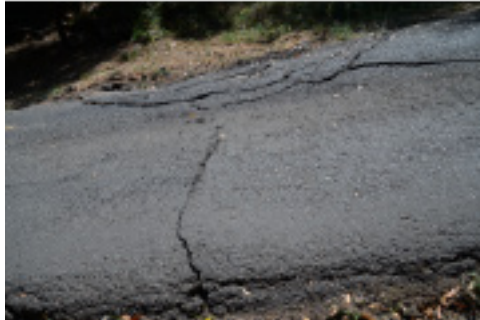
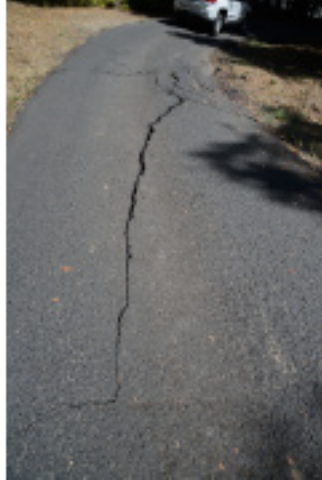
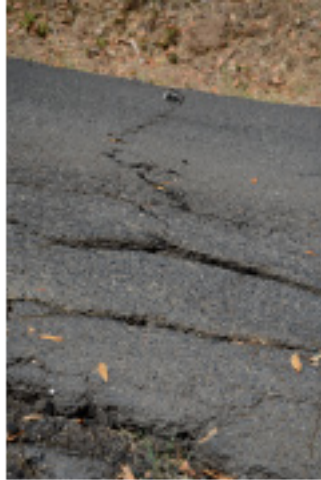
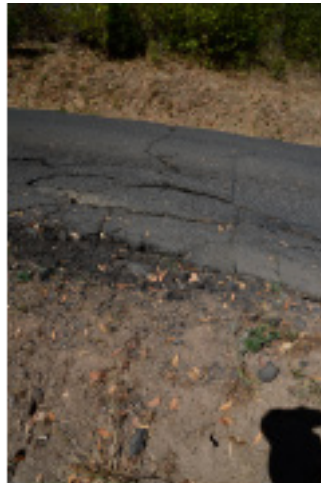
Station ID: 1172				Observer: Hudnut
Observation Date	Latitude	Longitude	Offset Feature	Inferred Origin
2014:08:28	38.34828	122.35681	Pavement	Uncertain
Description				
Fractures in paved road.				
Photographer	Camera Coordinates		Photograph Date	
Hudnut			2014:08:28	12:05:19

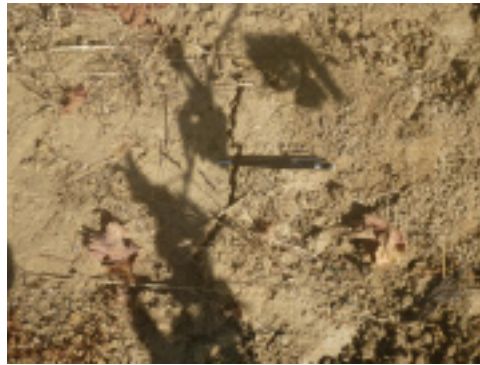
Station ID: 1035				Observer: Hecker		
Observation Date	Latitude	Longitude	Offset Feature	Inferred Origin		
2014:09:12	38.28340	122.32020	Soil	Uncertain		
Description						
Isolated 0.5-cm-wide crack between vines (only ~0.3 m long).						
Fault Azimuth	Strike Slip	Strike-slip Sense	Extension	Compression	Vertical	Upthrown Side
			0.5*			
Photographer	Camera Coordinates		Photograph Date			
Hecker			2014:09:12 18:12:31
