# Appendix 13. Tabulated Observations and Photographs of Ground Deformation Produced by the $M_w$ 6.0 South Napa Earthquake of August 24, 2014—Fractures Associated with UAVSAR Lineaments

## Introduction

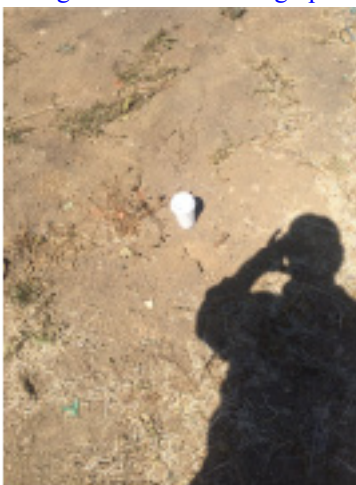
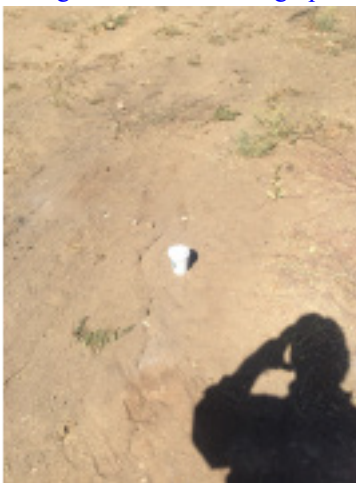
| Station ID: 1191 | | | | | Observer: Schwartz | |

| Station ID: 1191 | | | | | Observer: Schwartz | |
|---|---|---|---|---|---|---|
| Four linear cracks with primarily left stepping, en echelon traces. General trend 293. Can only trace for 8 m north. | | | | | | |

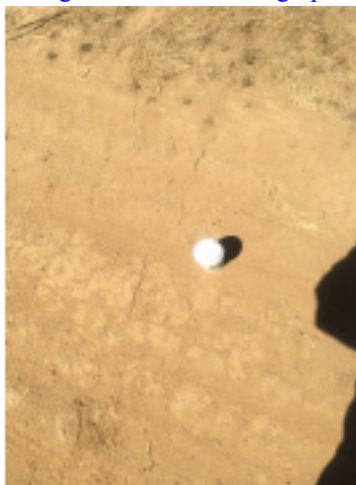
| Station ID: 1192 | | | | Observer: Schwartz | | |
|---|---|---|---|---|---|---|
| Crack almost perpendicular to road and can be traced to north into natural ground. Cannot trace completely across road, may actually tie into cracks that are parallel to road. May be shaking related. Orientation of cracks is 173. | | | | | | |

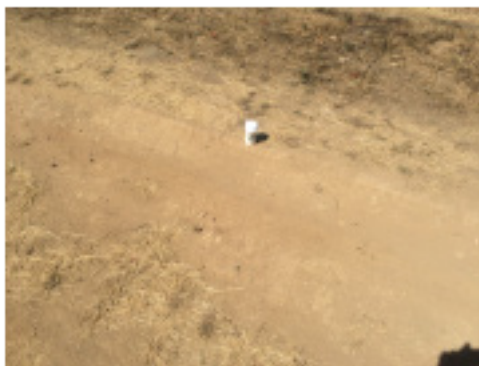
| Station ID: 1193 | | | | Observer: Schwartz | | |

| Station ID: 1193 | | | | Observer: Schwartz | | |
|---|---|---|---|---|---|---|
| Two short left stepping cracks in compacted road surface. Cannot clearly trace into native dirt and cannot extend across road into vineyard to south. Orientation of individual cracks is 272. | | | | | | |

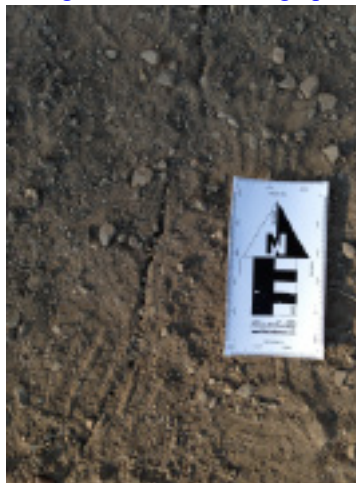
| Station ID: 1194 | | | Observer: Morelan/Trexler | |

| Station ID: 1194 | | | Observer: Morelan/Trexler | |
|---|---|---|---|---|
| Site name: alston_1 - Measurement: None - Measurement azimuth: None - Feature azimuth: None - Displacement sense: opening; halfway up scarp. | | | | |

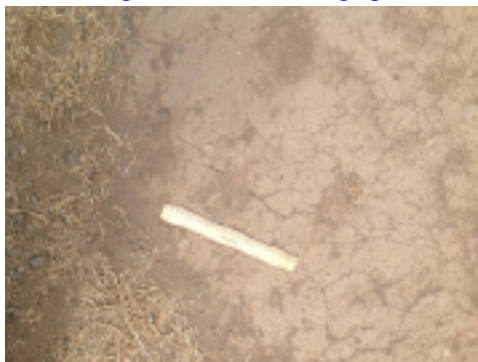
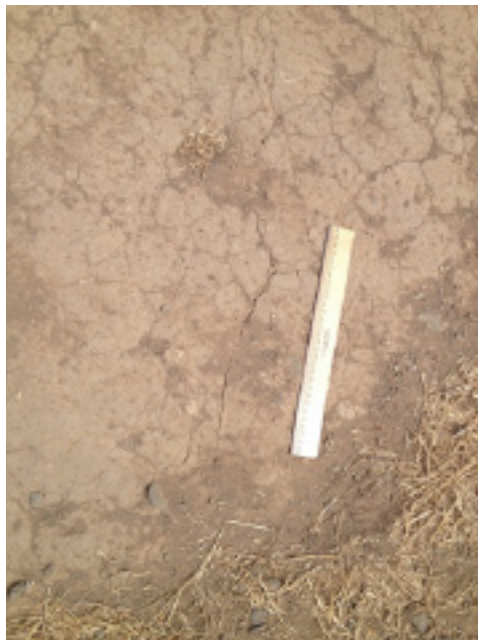
| Station ID: 1196 | | Observer: Seitz/Rubin | |

| Station ID: 1196 | | | | Observer: Seitz/Rubin | | |
|---|---|---|---|---|---|---|
| Location of reported rupture. | | | | | | |

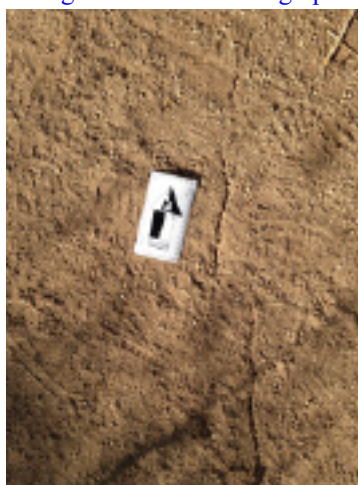
| Station ID: 1197 | | Observer: Morelan/Trexler | | |

Displacement sense: opening; halfway up scarp.

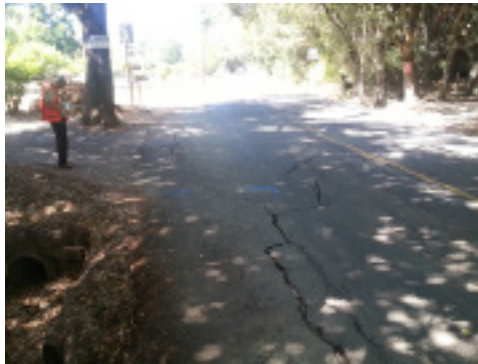
| Station ID: 1285 | | | | Observer: Lancaster |

| Station ID: 1285 | | | | Observer: Lancaster |
|---|---|---|---|---|
| Fractures in pavement and soil appear to be mostly horizontal. Zone of separation up to 25 ft. Eastern most cracking along roadway. Mostly horizontal separation. | | | | |

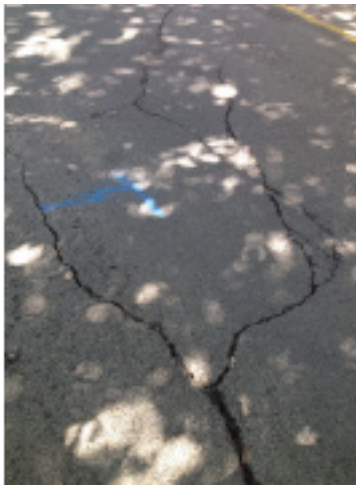
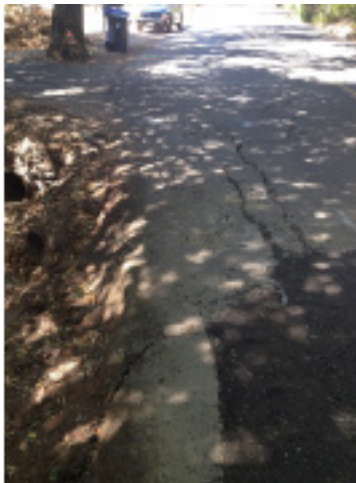
| Station ID: 1286 | | | | Observer: Seitz | | |
|---|---|---|---|---|---|---|
| Zone of cracks across asphalt seem to be related to slumping into adjacent drainage ditch. Quite extensive, about 50 m long, parallel to the roadway and it seems to be related to weak pavement. Direction roughly N45W. | | | | | | |

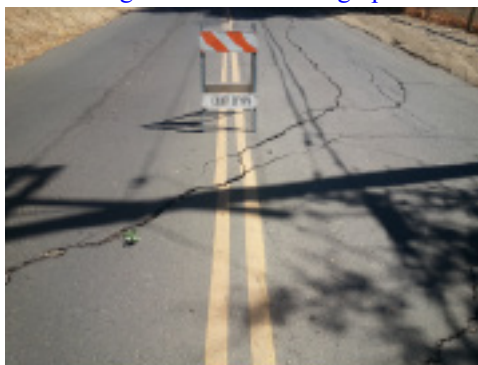
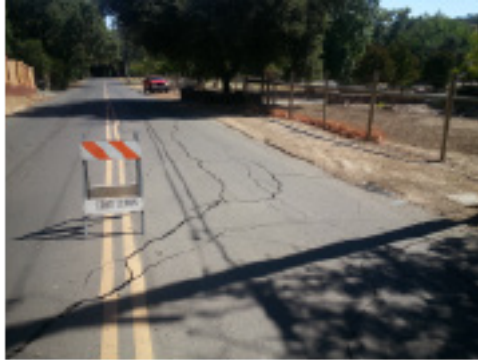
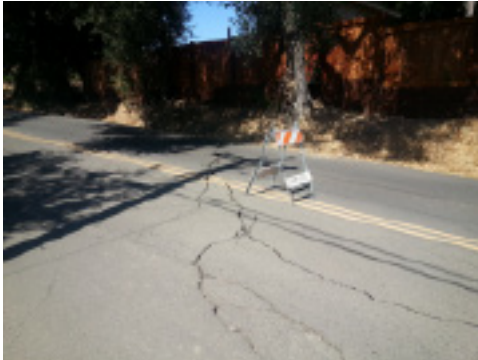
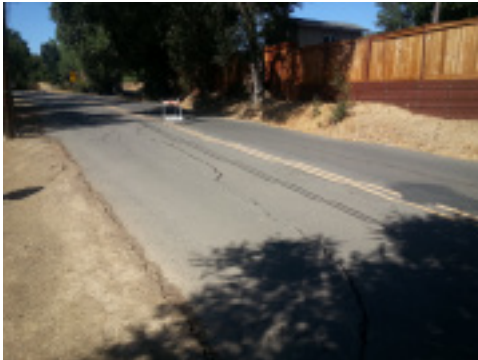
| Station ID: 1288 | | | Observer: Lancaster | |

| Station ID: 1288 | | | Observer: Lancaster | |
|---|---|---|---|---|
| Deformation on Partrick Rd. Cracks show predominantly horizontal separation. | | | | |

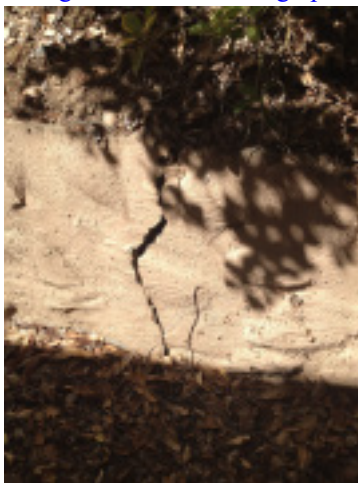
| Station ID: 1290 | | | | Observer: Lancaster |

| Station ID: 1290 | | | | Observer: Lancaster |
|---|---|---|---|---|
| Western most extent of cracking in roadway. | | | | |

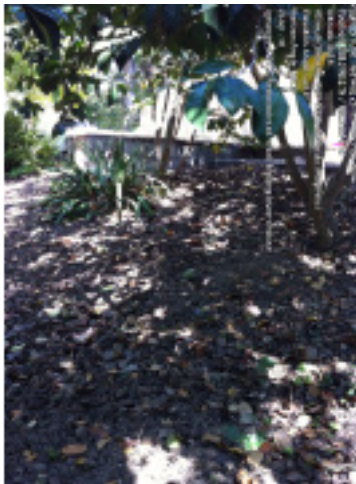
| Station ID: 1292 | | | Observer: Haydon/Wiegers | |

| Station ID: 1292 | | | Observer: Haydon/Wiegers | |
|---|---|---|---|---|
| Crack leading toward house. | | | | |

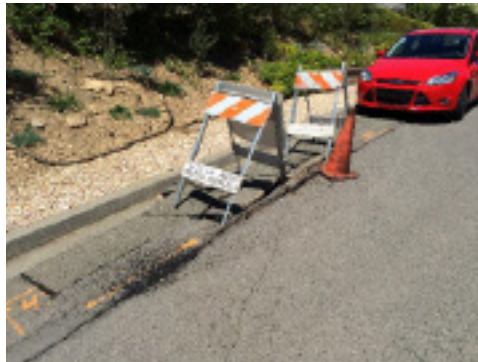
| Station ID: 1293 | | | Observer: Haydon/Wiegers | |

| Station ID: 1293 | | | Observer: Haydon/Wiegers | |
|---|---|---|---|---|
| Broken pavement (6 month old pavement) on west side of house. | | | | |

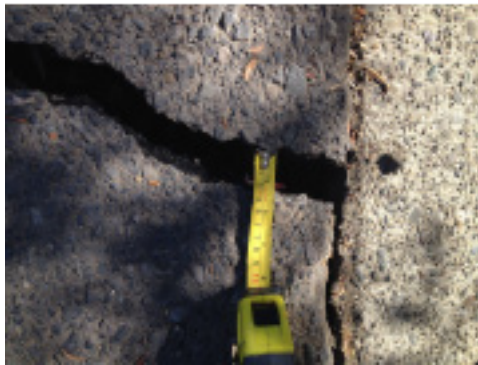
| Station ID: 1295 | | | | Observer: Seitz/Rubin | | |
|---|---|---|---|---|---|---|
| Open crack across street 3.5 cm. Extends across soil and beneath house into backyard. Foundation damaged. No lateral displacement observed. Crack along crest of local ridgeline, possibly gravity related. | | | | | | |

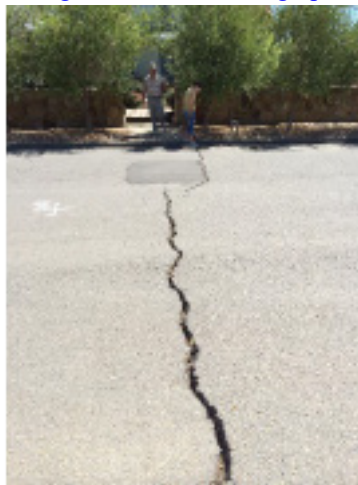
| Station ID: 1296 | | | | Observer: Wells |
|---|---|---|---|---|
| Cracks on bedrock fault. | | | | |

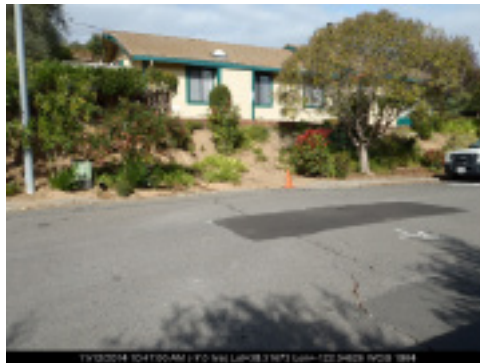
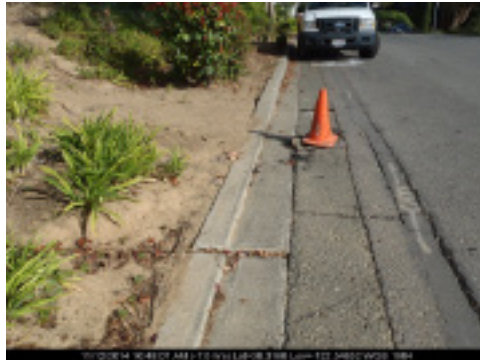
| Station ID: 1298 | | | | Observer: Brossy | | |
|---|---|---|---|---|---|---|
| Cracking in the street that extended across the whole paved section and into the soil adjacent, projecting under the house along ~335 degrees. No cracking or deformation of the property to the south was apparent. | | | | | | |

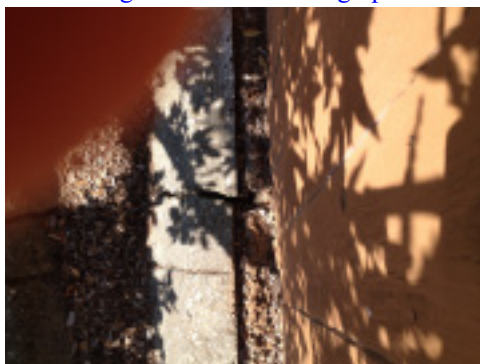
| Station ID: 1305 | | | | Observer: Seitz/Rubin | | |
|---|---|---|---|---|---|---|
| On trend with cracks in street and through house. Crack open 2 cm in dirt, not continuous to tank access road. Opening in downslope direction. Right-lateral offset ~ 2 cm in v-ditch up slope of house. Possibly gravity related. | | | | | | |

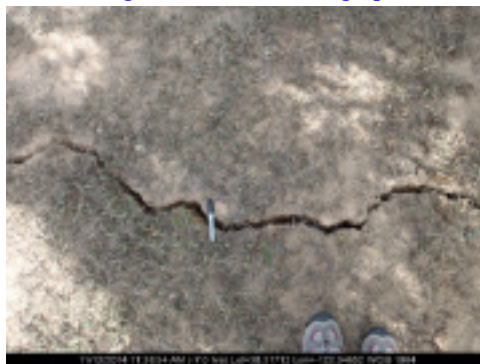
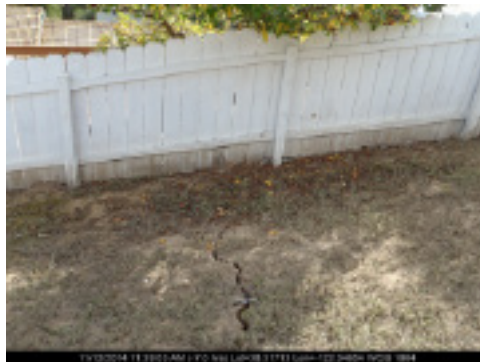
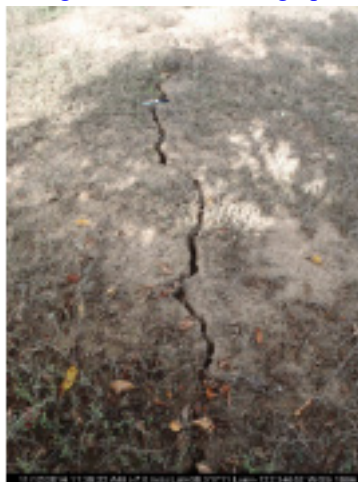
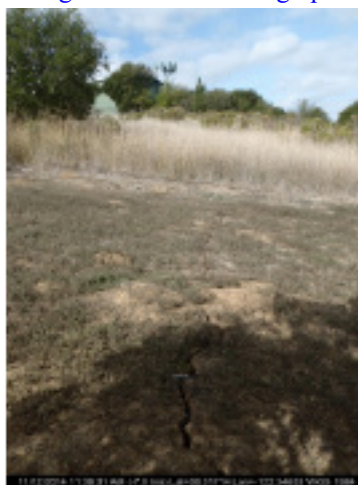
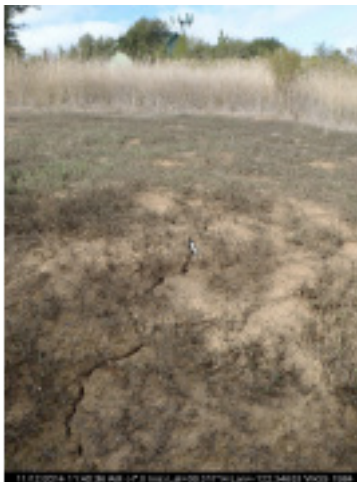
| Station ID: 1308 | | | | Observer: Brossy | | |
|---|---|---|---|---|---|---|
| Observed two co-linear cracks in soil about 2 m apart with ~1-2.5 cm of separation. These trended ~325 degrees and did not have any apparent lateral or vertical displacement. One of the panels of the fence had also pulled apart by about 1.5 inches. | | | | | | |

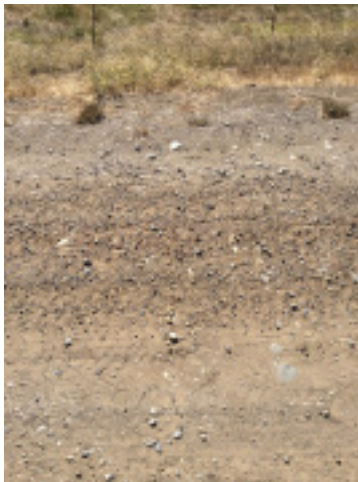
Fresh cracks in dirt road, both parallel and normal to the road alignment.

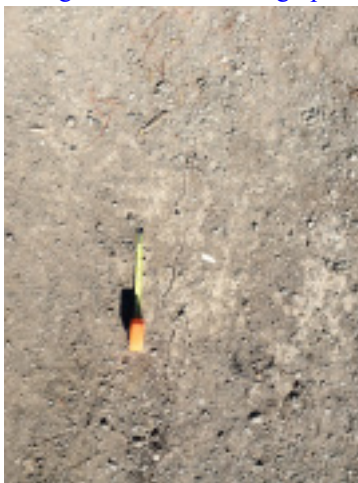
| <b>Station ID: 1115</b> | | <b>Observer: Hitchcock/Lutz</b> | | |

Fresh cracks, some in left-stepping en echelon pattern. No detectable displacement.

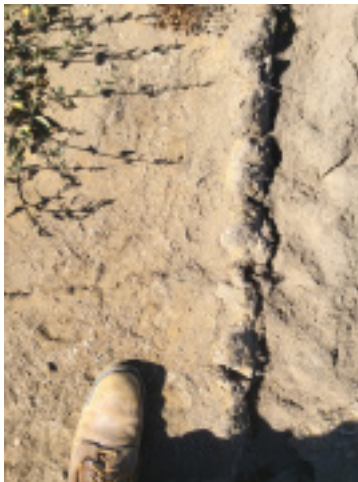
| Station ID: 1116 | | | | Observer: Hitchcock/Lutz | | |
|---|---|---|---|---|---|---|
| Possibly right-lateral offset of tire track 0.5 inches. Cracks are fresh, distinguishable from desiccation cracking, and continuous up to about 10 ft in length. | | | | | | |

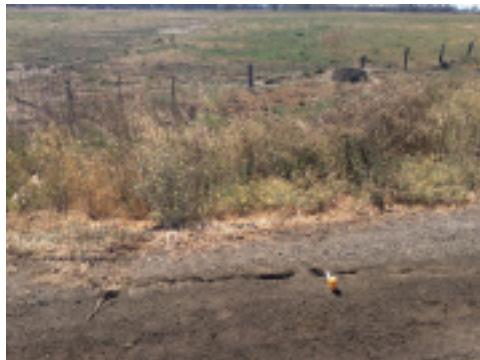
| <b>Station ID: 1117</b> | | <b>Observer: Hitchcock/Lutz</b> | | |

Fissures along southeast edge of road embankment. Likely fresh based on absence of infilling or vegetation growth.

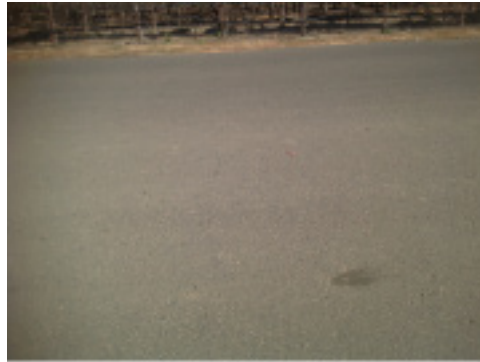
| Station ID: 1119 | | | Observer: Hitchcock/Lutz | |
|---|---|---|---|---|
| Fresh hairline crack in asphalt, oriented roughly normal to road alignment. | | | | |

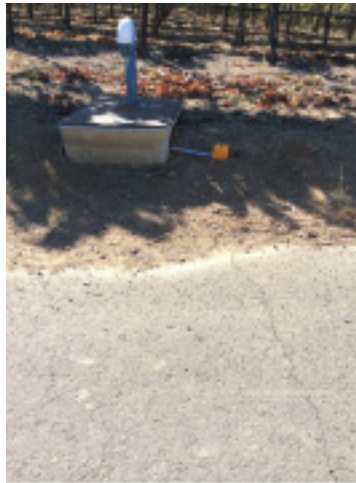
| Station ID: 1120 | | | Observer: Hitchcock/Lutz | |

| Station ID: 1120 | | | Observer: Hitchcock/Lutz | |
|---|---|---|---|---|
| 0.03 ft gap around blow off valve vault. Fresh crack in asphalt with no displacement, oriented roughly normal to road alignment. Possible hilltop fracturing. | | | | |

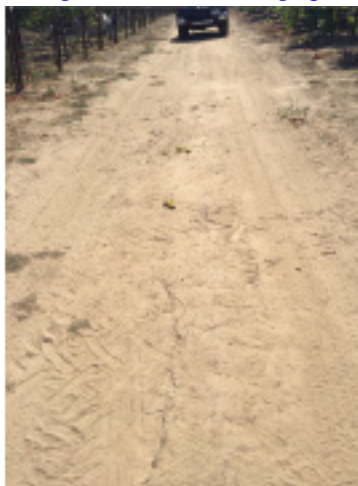
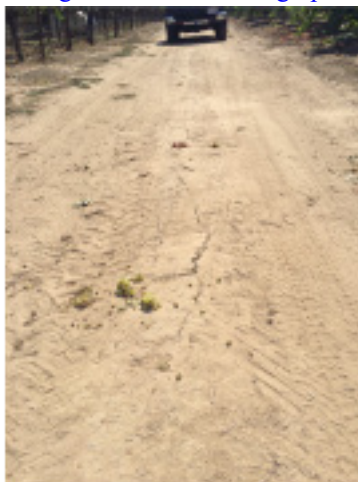
| Station ID: 1121 | | | | Observer: Pratt |
|---|---|---|---|---|
| Surface cracking possibly from expansive soil/utility. | | | | |

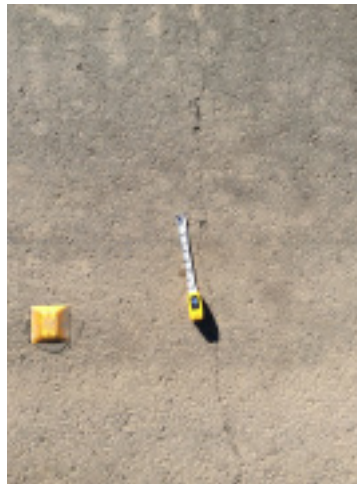
| Station ID: 1122 | | | Observer: Hitchcock/Lutz | |
|---|---|---|---|---|
| Fresh hairline crack in asphalt, oriented roughly subparallel to road alignment. | | | | |

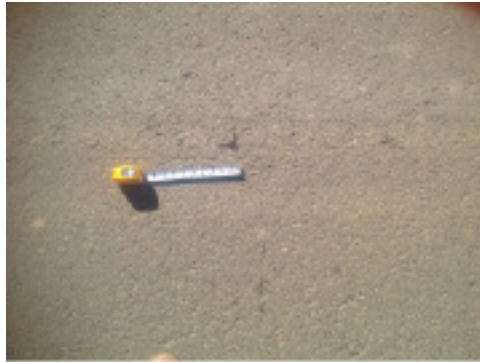
| Station ID: 1123 | | | Observer: Hitchcock/Lutz | |
|---|---|---|---|---|
| Fresh hairline crack in asphalt, oriented roughly subparallel to road alignment. | | | | |

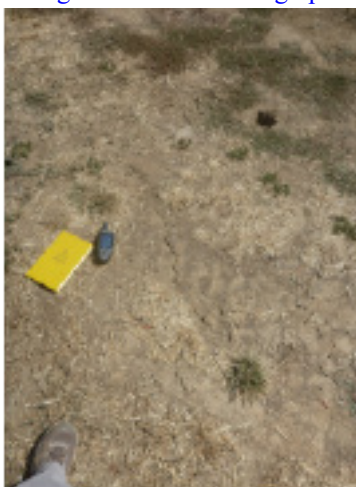
| Station ID: 1127 | | | | Observer: Hecker/Pickering | | |
|---|---|---|---|---|---|---|
| Minor extensional cracks. Vaguely left-stepping across road, oblique to creek, ~5-10 m from creek. Trend ~314 (Small fractures that do not appear aligned to. previous fractures). | | | | | | |

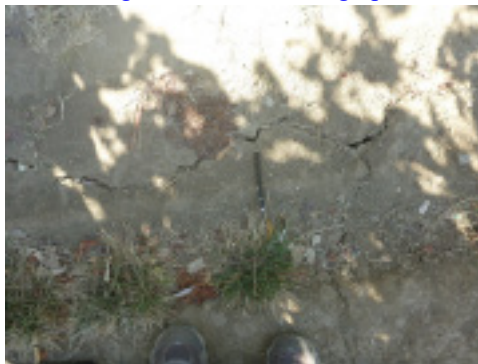
| Station ID: 1131 | | | | Observer: Hecker | |
|---|---|---|---|---|---|
| Grid-like (polygonal) pattern of open cracks down dirt road with suggestion of 1- 2mm right-lateral in places.<br>Can't trace into vines (recently plowed) to west or into roadside to east. | | | | | |
