# Appendix 14. Tabulated Observations and Photographs of Ground Deformation Produced by the $M_w$ 6.0 South Napa Earthquake of August 24, 2014—Areas of Extensive Curb and Sidewalk Damage

## Introduction

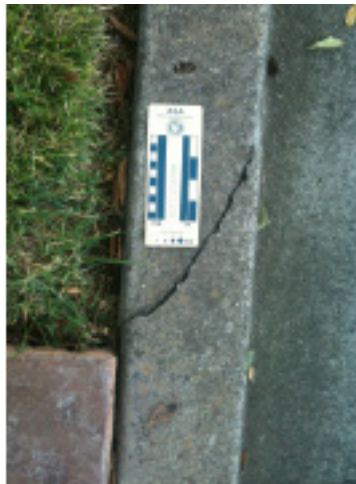
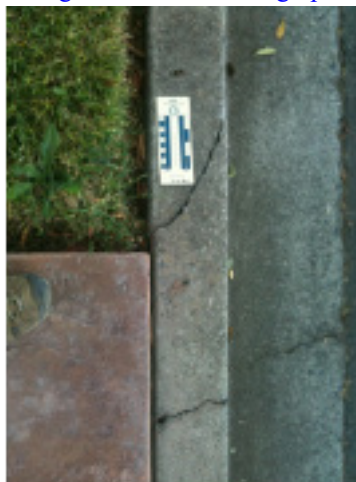
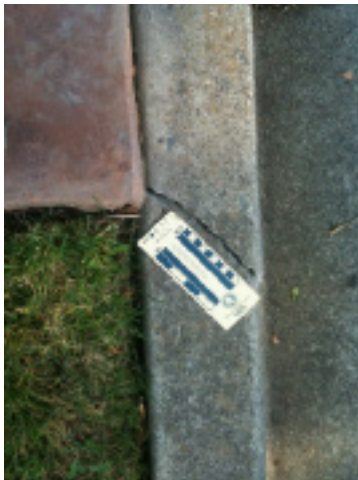
| Station ID: 1210 | | | Observer: Prentice/Sickler | |

| Station ID: 1210 | | | Observer: Prentice/Sickler | |
|---|---|---|---|---|
| Regal Drive. Small cracks in curb. | | | | |

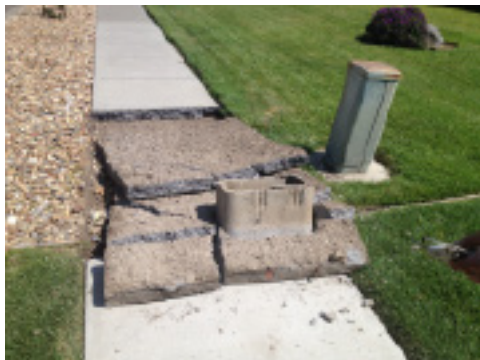
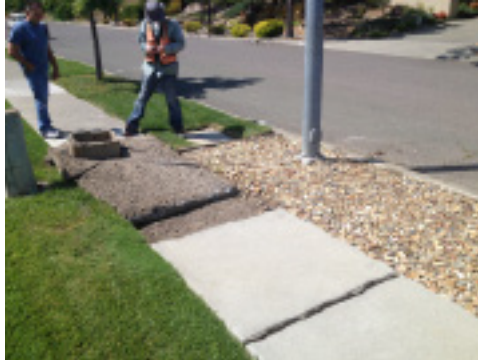
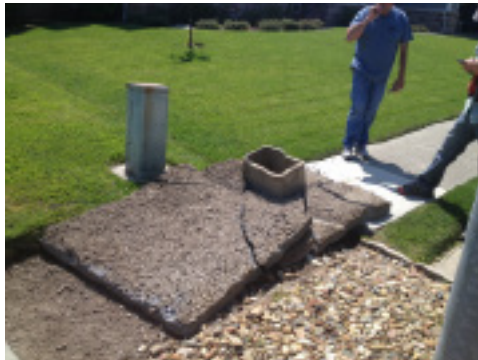
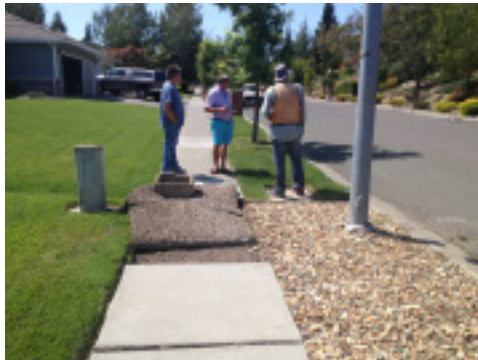
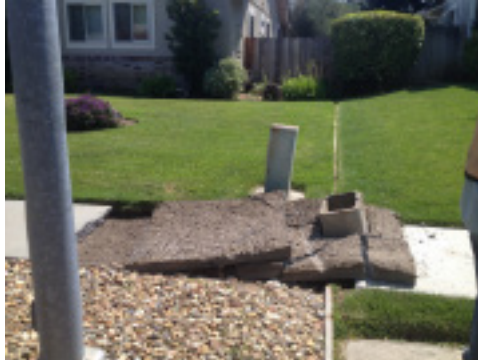
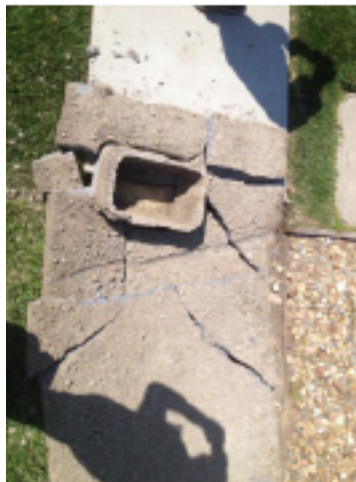
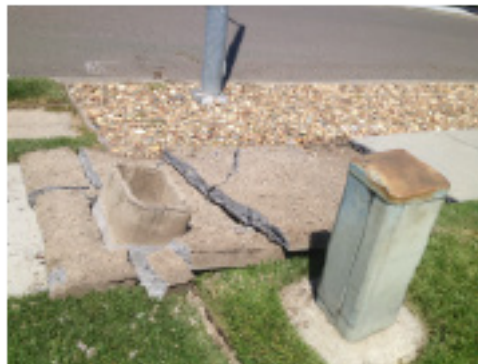
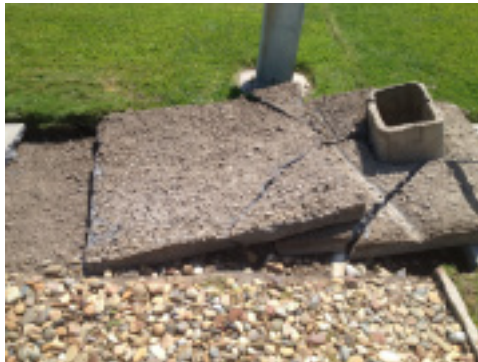
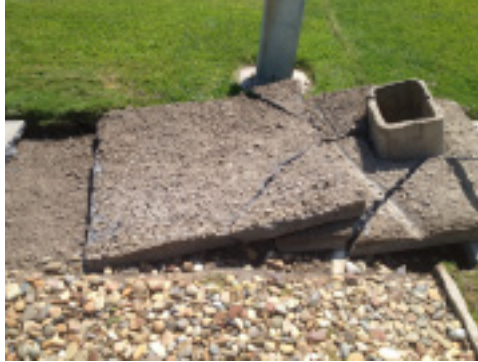
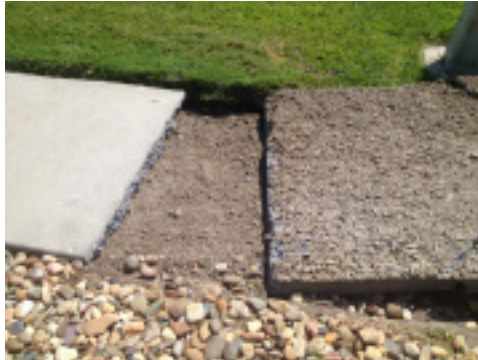
| <b>Station ID: 1211</b> | | <b>Observer: Seitz/Rubin</b> | | |

Two sidewalk panels upside down. Possibly shaking related. Does not appear to be related to rupture based on distance from observed rupture locations.

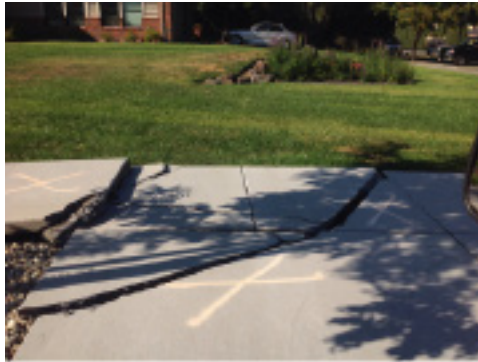
| Station ID: 1213 | | | Observer: Prentice/Sickler | |

| Station ID: 1213 | | | Observer: Prentice/Sickler | |
|---|---|---|---|---|
| Westminster and Regal, damaged sidewalk. | | | | |

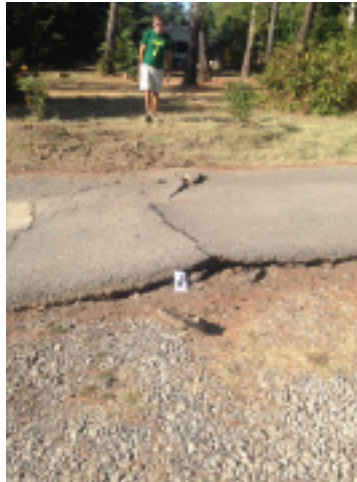
| <b>Station ID: 1215</b> | | <b>Observer: Morelan/Trexler</b> |

| Station ID: 1215 | | | | Observer: Morelan/Trexler | | |
|---|---|---|---|---|---|---|
| Site name: camilla - Measurement: None - Measurement azimuth: None - Feature azimuth: 3 - Displacement sense: RL; compressed road. | | | | | | |

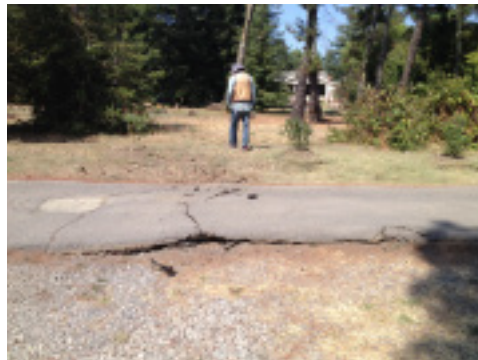
| <b>Station ID: 1216</b> | | <b>Observer: Seitz/Rubin</b> | | |

| Cracking and deformed asphalt. Cracks do not extend into soil. No lateral displacement. Appears to be shaking related rather than tectonic. | | | | |

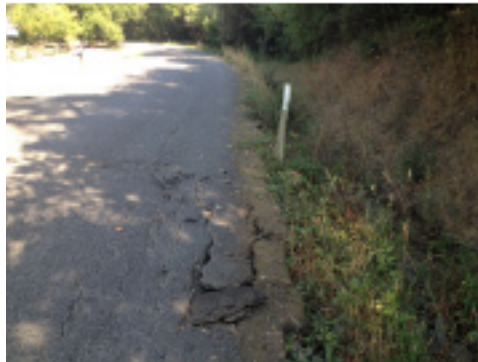
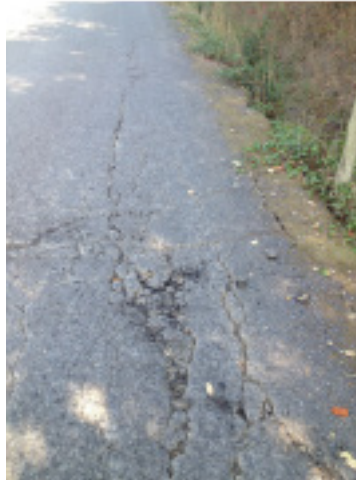
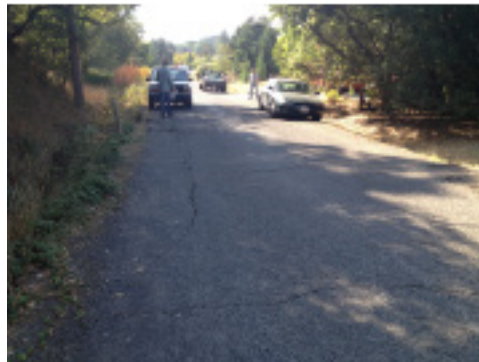
| Station ID: 1218 | | | Observer: Rubin/Seitz | |

| Station ID: 1218 | | | Observer: Rubin/Seitz | |
|---|---|---|---|---|
| Many pre-existing cracks in old asphalt. Some open. Longest cracks are related to creep into drainage ditch adjacent to road. Many other irregular cracks. | | | | |

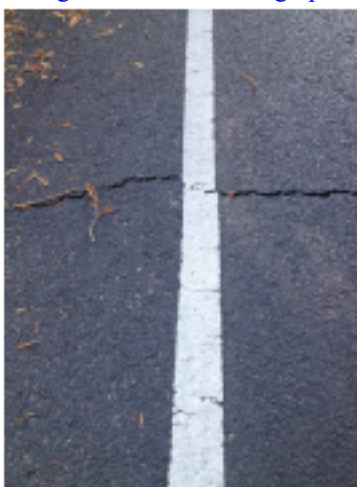
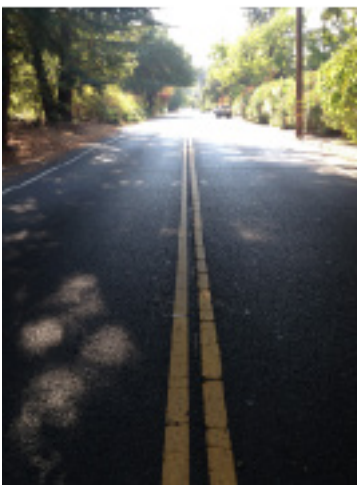
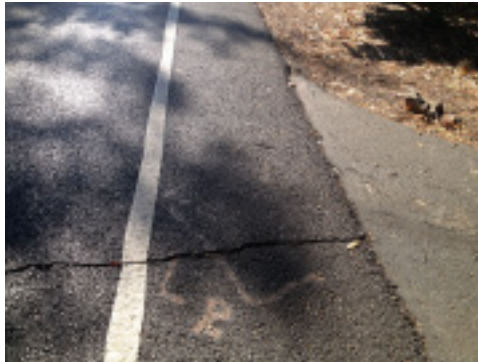
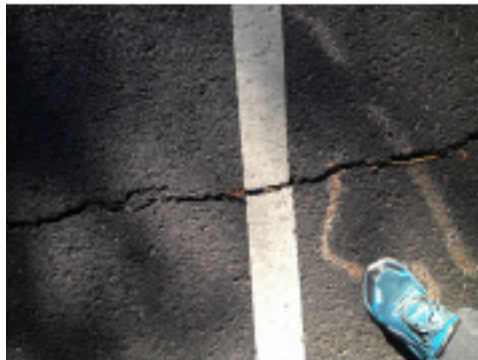
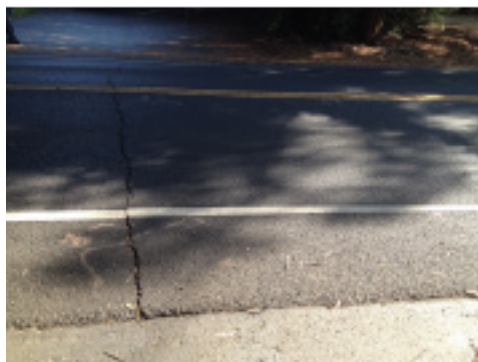
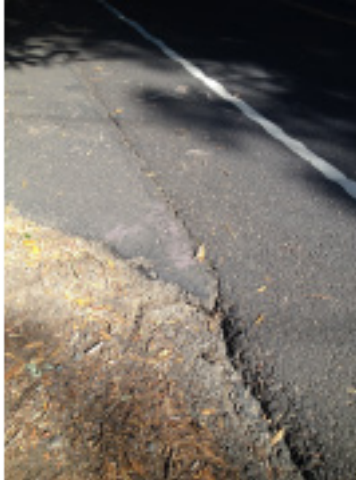
| Station ID: 1220 | | | | Observer: Seitz/Rubin | | |
|---|---|---|---|---|---|---|
| Apparent 1 cm left-lateral offset of double yellow and white lane lines. Many irregular cracks in driveway.<br>Uncertain origin but difficult to understand as tectonic based on distance from observed rupture. | | | | | | |

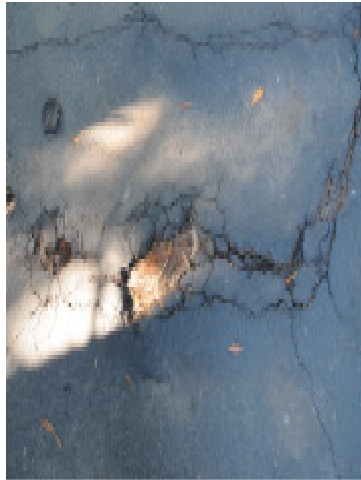
| <b>Station ID: 1221</b> | | <b>Observer: Schwartz</b> |

| Station ID: 1221 | | | | Observer: Schwartz | | |
|---|---|---|---|---|---|---|
| Left-lateral offset of road striping. | | | | | | |

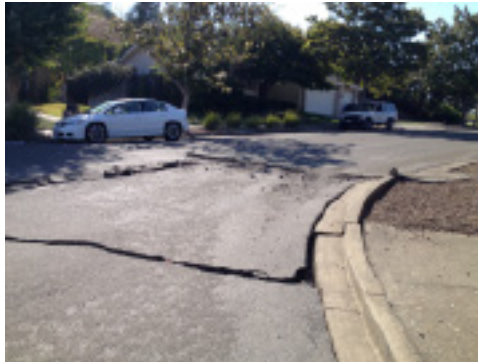
| Station ID: 1229 | | | | Observer: Rubin/Seitz |

| Station ID: 1229 | | | | Observer: Rubin/Seitz |
|---|---|---|---|---|
| Irregular cracks in road and shifted sidewalk slabs. No obvious throughgoing pattern. | | | | |
