# **Appendix 15. Tabulated Observations and Photographs of Ground Deformation Produced by the $M_w$ 6.0 South Napa Earthquake of August 24, 2014—Pavement Cracks South of the Soda Creek Fault, Napa, California**

## Region V

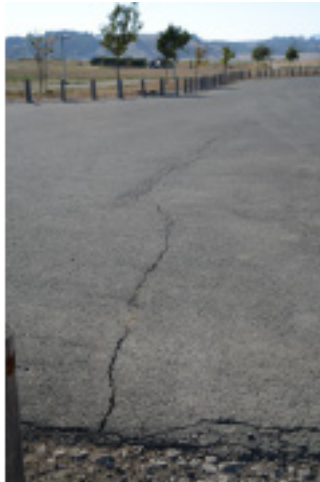
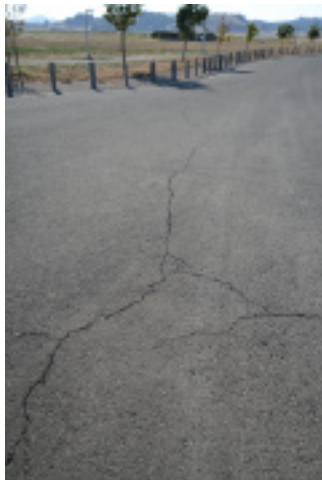
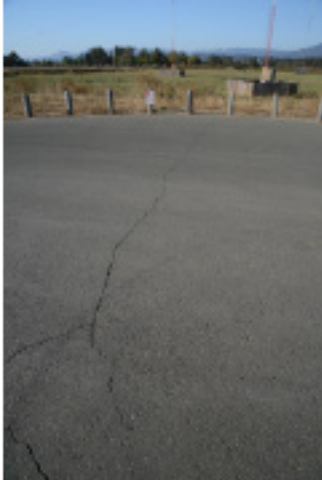
| Station ID: 1320 | | | | Observer: Hudnut |

| Station ID: 1320 | | | | Observer: Hudnut |
|---|---|---|---|---|
| Fracture in pavement. | | | | |

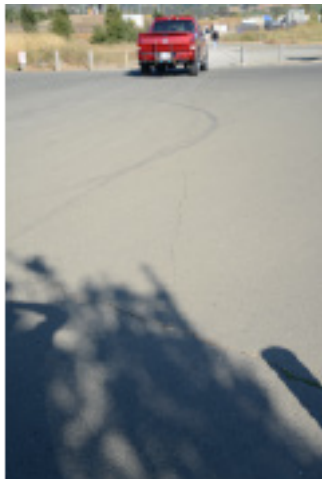
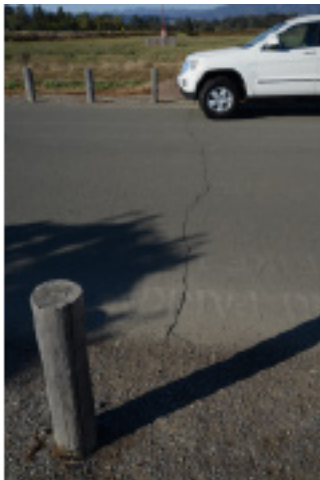
| Station ID: 1321 | | | | Observer: Hudnut |

| Station ID: 1321 | | | | Observer: Hudnut |
|---|---|---|---|---|
| Fracture in pavement. | | | | |

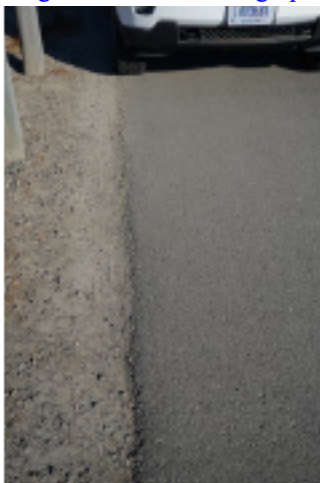
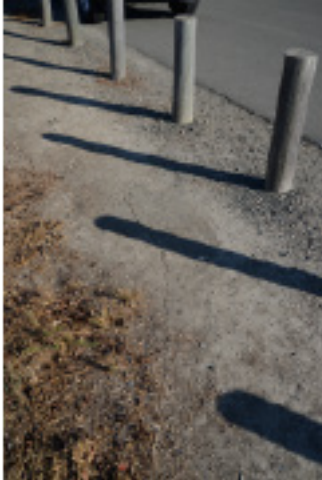
| <b>Station ID: 1322</b> | <b>Observer: Hudnut</b> |

Fracture in gravel.

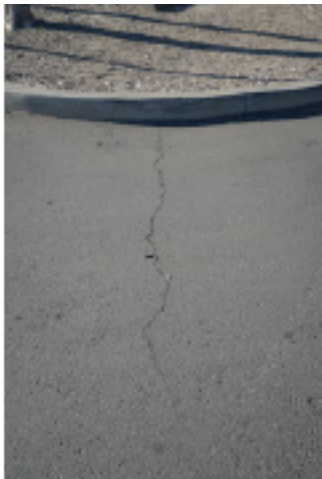
| Station ID: 1323 | | | | Observer: Hudnut |

| Station ID: 1323 | | | | Observer: Hudnut |
|---|---|---|---|---|
| Fracture in pavement. | | | | |

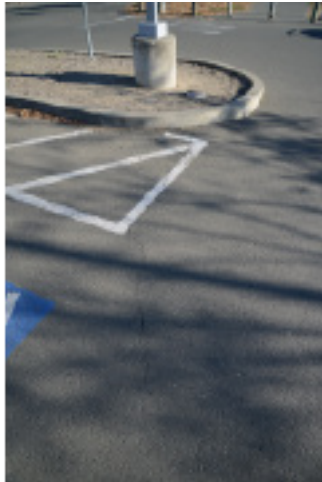
| Station ID: 1324 | | | | Observer: Hudnut |

| Station ID: 1324 | | | | Observer: Hudnut |
|---|---|---|---|---|
| Fracture in pavement. | | | | |

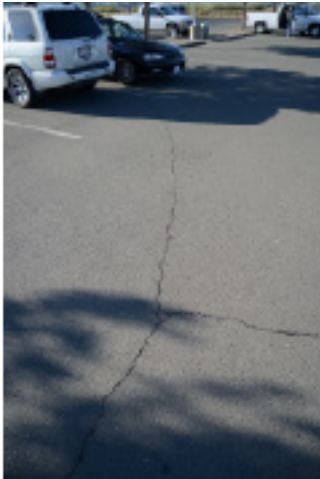
| Station ID: 1325 | | | | Observer: Hudnut |

| Station ID: 1325 | | | | Observer: Hudnut |
|---|---|---|---|---|
| Fracture in pavement. | | | | |

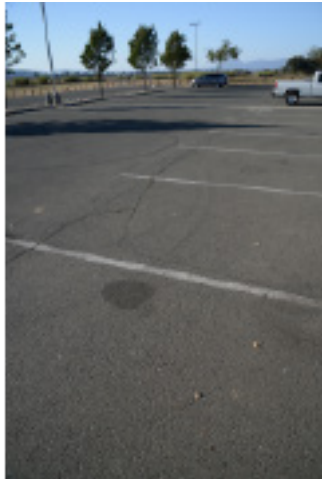
| Station ID: 1326 | | | | Observer: Hudnut |

| Station ID: 1326 | | | | Observer: Hudnut |
|---|---|---|---|---|
| Fracture in pavement. | | | | |

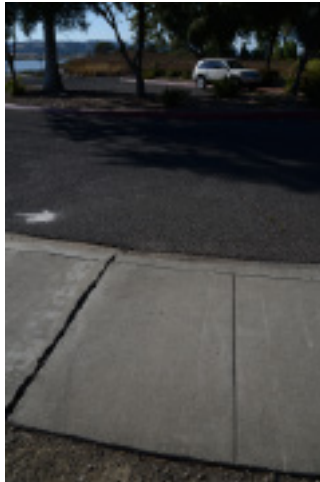
| Station ID: 1327 | | | | Observer: Hudnut |

| Station ID: 1327 | | | | Observer: Hudnut |
|---|---|---|---|---|
| Expansion in sidewalk. | | | | |

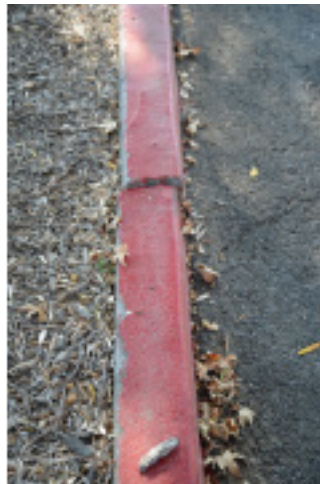
| Station ID: 1328 | | | | Observer: Hudnut |

| Station ID: 1328 | | | | Observer: Hudnut |
|---|---|---|---|---|
| Curb offset. | | | | |

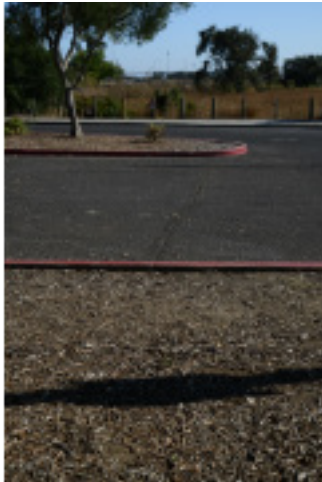
| Station ID: 1329 | | | | Observer: Hudnut |

| Station ID: 1329 | | | | Observer: Hudnut |
|---|---|---|---|---|
| Fracture in pavement. | | | | |

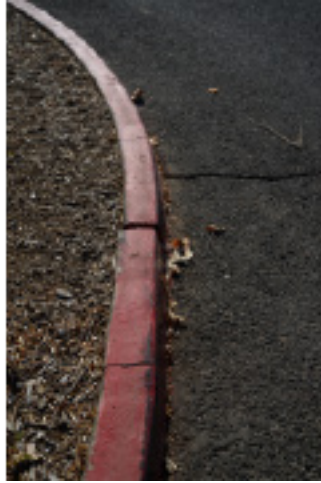
| Station ID: 1330 | | | | Observer: Hudnut |

| Station ID: 1330 | | | | Observer: Hudnut |
|---|---|---|---|---|
| Fracture in pavement. | | | | |

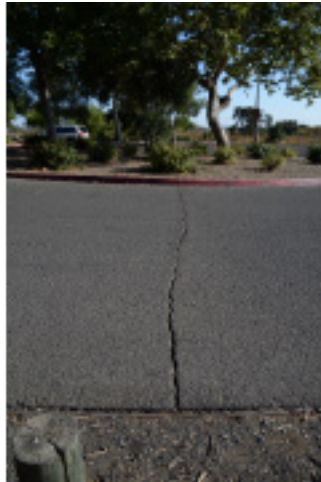
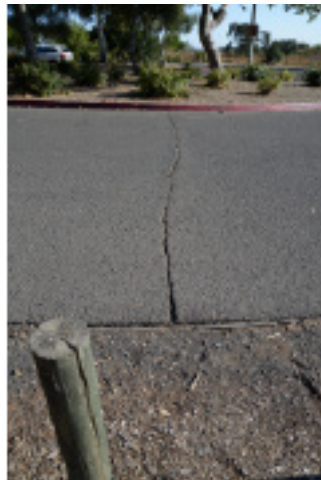
| Station ID: 1331 | | | | Observer: Hudnut |

| Station ID: 1331 | | | | Observer: Hudnut |
|---|---|---|---|---|
| Fracture in pavement. | | | | |

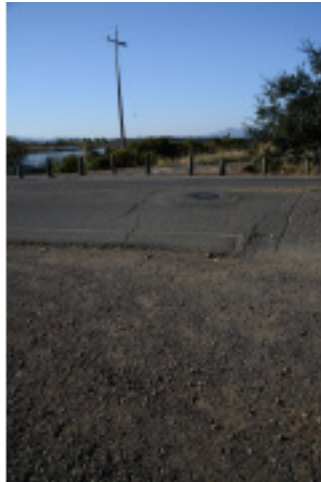
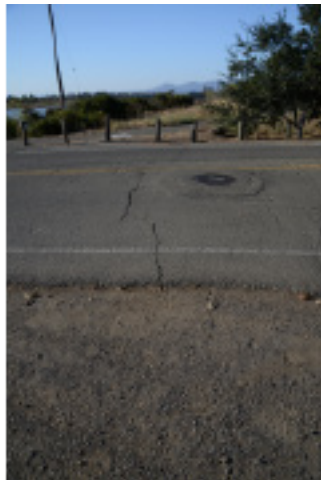
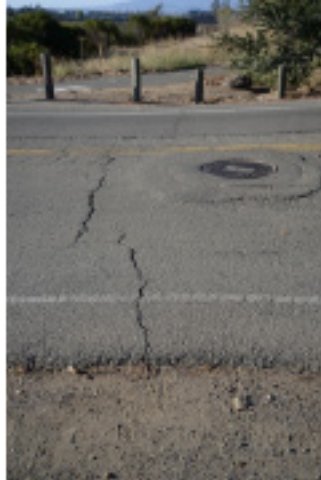
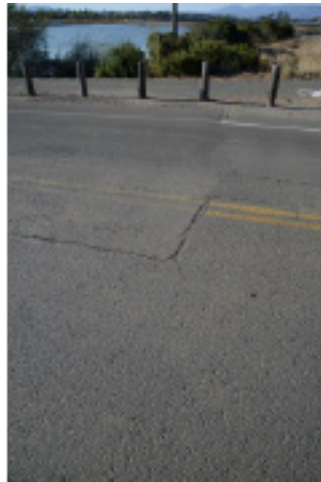
| Station ID: 1332 | | | | Observer: Hudnut |

| Station ID: 1332 | | | | Observer: Hudnut |
|---|---|---|---|---|
| Fracture in pavement. | | | | |

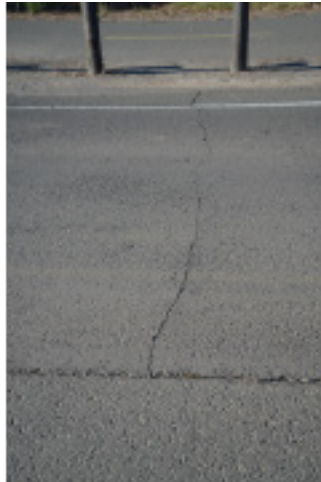
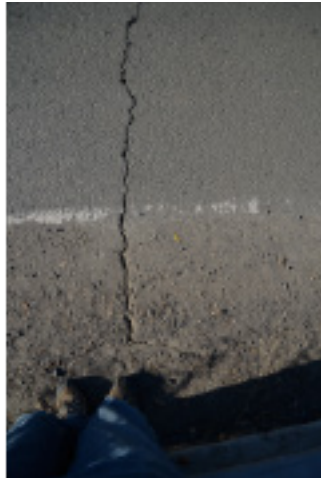
| Station ID: 1333 | | | | Observer: Hudnut |

| Station ID: 1333 | | | | Observer: Hudnut |
|---|---|---|---|---|
| Fracture in pavement. | | | | |

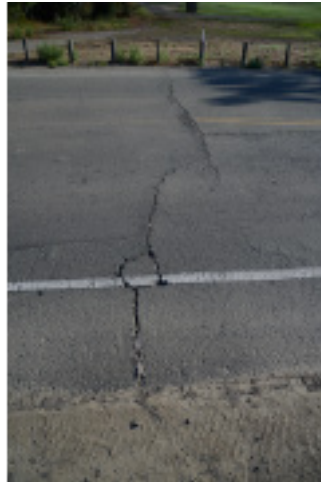
| Station ID: 1334 | | | | Observer: Hudnut |

| Station ID: 1334 | | | | Observer: Hudnut |
|---|---|---|---|---|
| Fracture in pavement. | | | | |

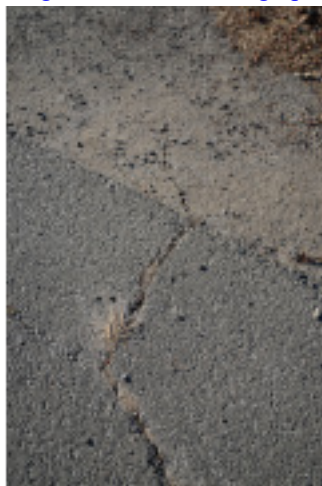
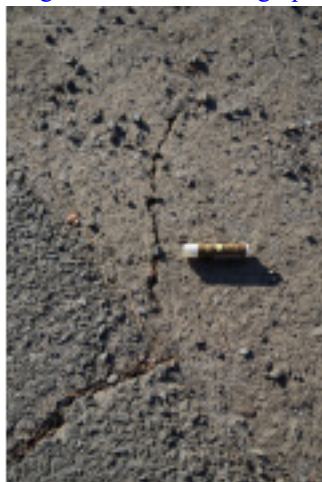
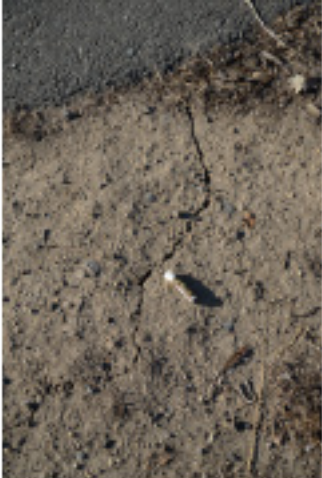
| Station ID: 1335 | | | | Observer: Hudnut |

| Station ID: 1335 | | | | Observer: Hudnut |
|---|---|---|---|---|
| Fracture in gravel. | | | | |

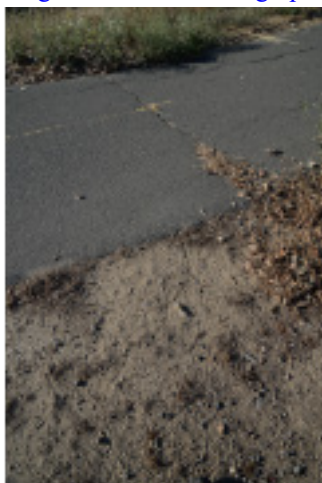
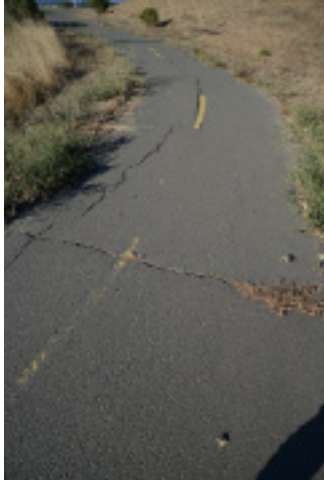
| Station ID: 1336 | | | | Observer: Hudnut |

| Station ID: 1336 | | | | Observer: Hudnut |
|---|---|---|---|---|
| Fracture in pavement; extends to dirt. | | | | |

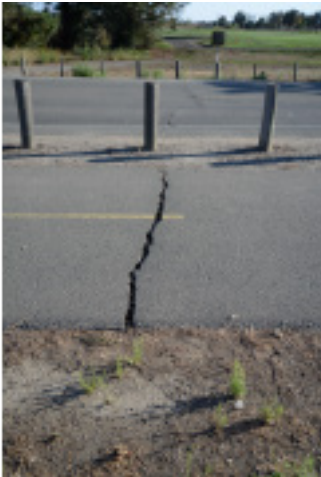
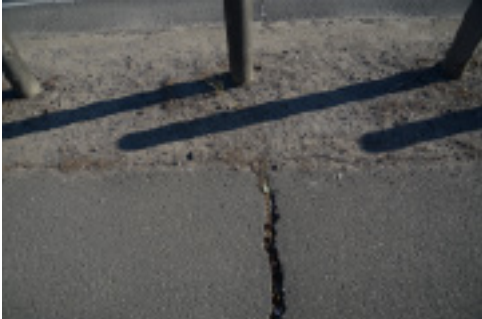
| Station ID: 1337 | | | Observer: Hudnut | |

| Station ID: 1337 | | | Observer: Hudnut | |
|---|---|---|---|---|
| Fracture crossing paved path; extensional. | | | | |

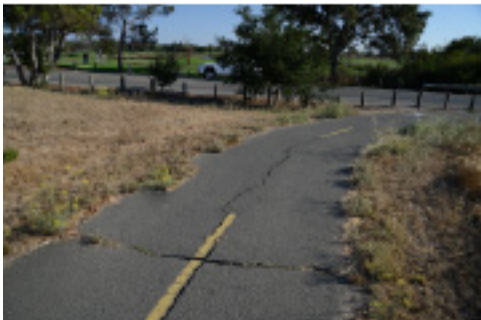
| Station ID: 1338 | | | | Observer: Hudnut |

| Station ID: 1338 | | | | Observer: Hudnut |
|---|---|---|---|---|
| Fractures across and along paved path. | | | | |

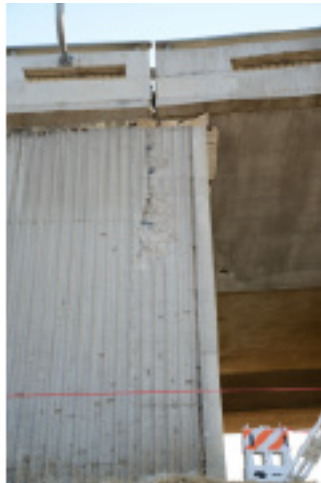
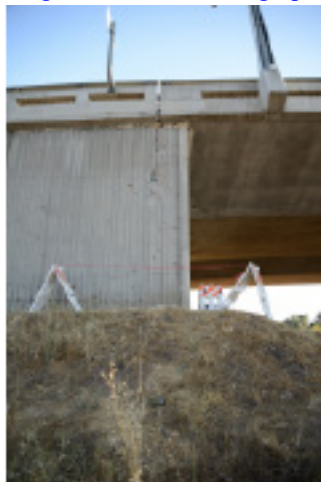
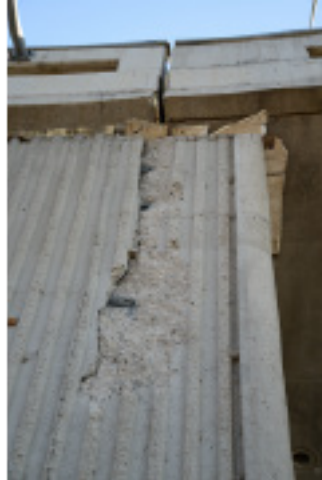
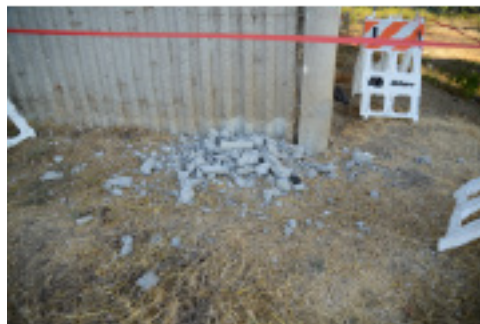
| Station ID: 1339 | | | | Observer: Hudnut |

| Station ID: 1339 | | | | Observer: Hudnut |
|---|---|---|---|---|
| Extensional feature in elevated road/highway. Crack in abutment of bridge along InSAR line; slab of concrete spalled off north side of bridge. | | | | |

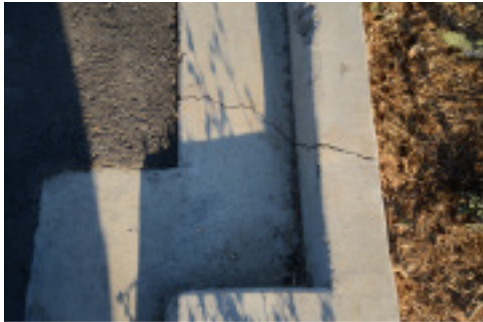
| Station ID: 1340 | | | | Observer: Hudnut |

| Station ID: 1340 | | | | Observer: Hudnut |
|---|---|---|---|---|
| Crack in curb at parking lot. | | | | |

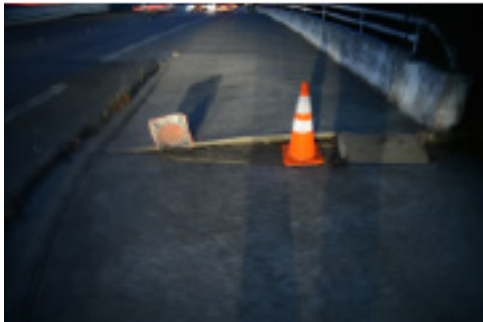
| Station ID: 1341 | | | | Observer: Hudnut | | |

| Station ID: 1341 | | | | Observer: Hudnut | | |
|---|---|---|---|---|---|---|
| Uplifted sidewalk. Bridge damage on south abutment along Soscol Ave.; along InSAR lineament. Compression consistent with clockwise rotation of bridge deck in right-lateral shear. | | | | | | |
