Landscape Change Associated with the Upper Scenic Drive Landslide, La Honda, California, January 10–June 28, 2017

By Alexandra J. Pickering, Carol S. Prentice, and Stephen B. DeLong

Open-File Report 2019–1024

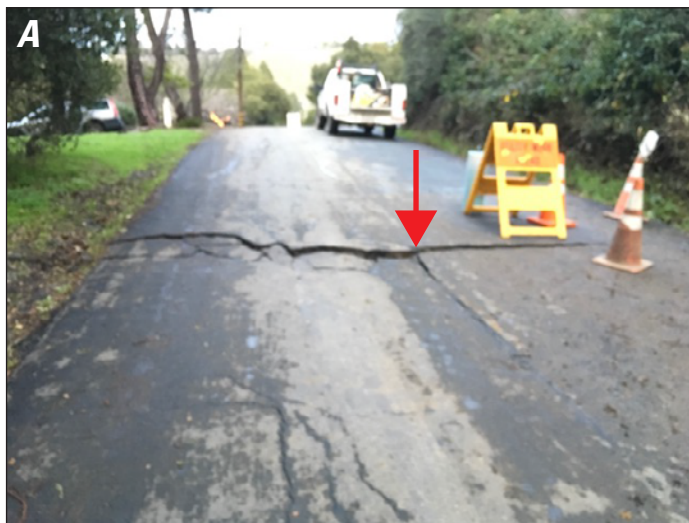
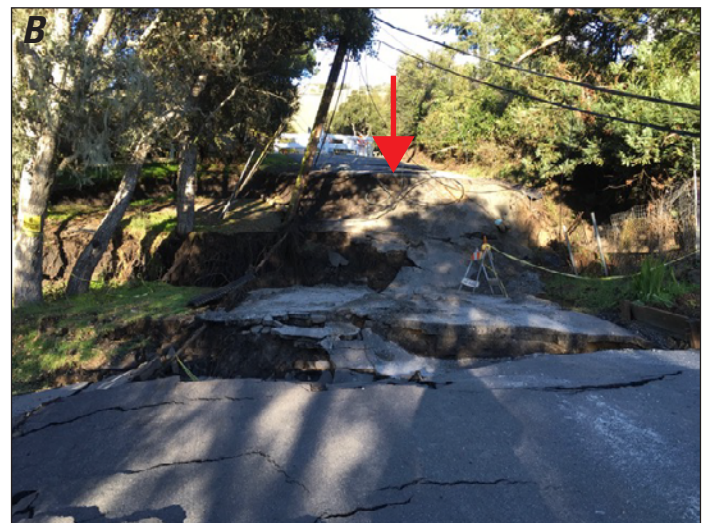
Movement of the USDL in 2017 began on or just before January 10, 2017, as was reported by the residents of 345 Scenic Drive (structure #3; see fig. 3 [on map sheet]), who noticed new cracks in their driveway and garage floor. Early in the morning of January 11, 2017, the residents observed a water-line break in front of their home on upper Scenic Drive, caused by landslide motion; they notified authorities, and the water line was shut off at around 3 a.m. Figure 5, which shows two photographs taken (on January 11 and 25, 2017) of the road in front of 345 Scenic Drive, illustrates the development of the northern lateral boundary (right flank) of the landslide. Between January 20 and 23, 2017, additional

Figure 5. Photographs to north-northeast of upper part of Scenic Drive, showing development of right flank (northern margin) of 2017 upper Scenic Drive landslide (USDL), which crosses roadway. Red arrow points to same location in both photographs. Photographs by Carol Prentice. See figure 3 (on map sheet) for location. *A*, Photograph taken on January 11, 2017, showing initiation of landslide movement. Note that this low-resolution image is only photograph available that shows early landslide movement. *B*, Photograph taken on January 25, 2017, showing advanced movement (4-m vertical displacement) along right flank of 2017 USDL. Note white barricade across road above right flank.

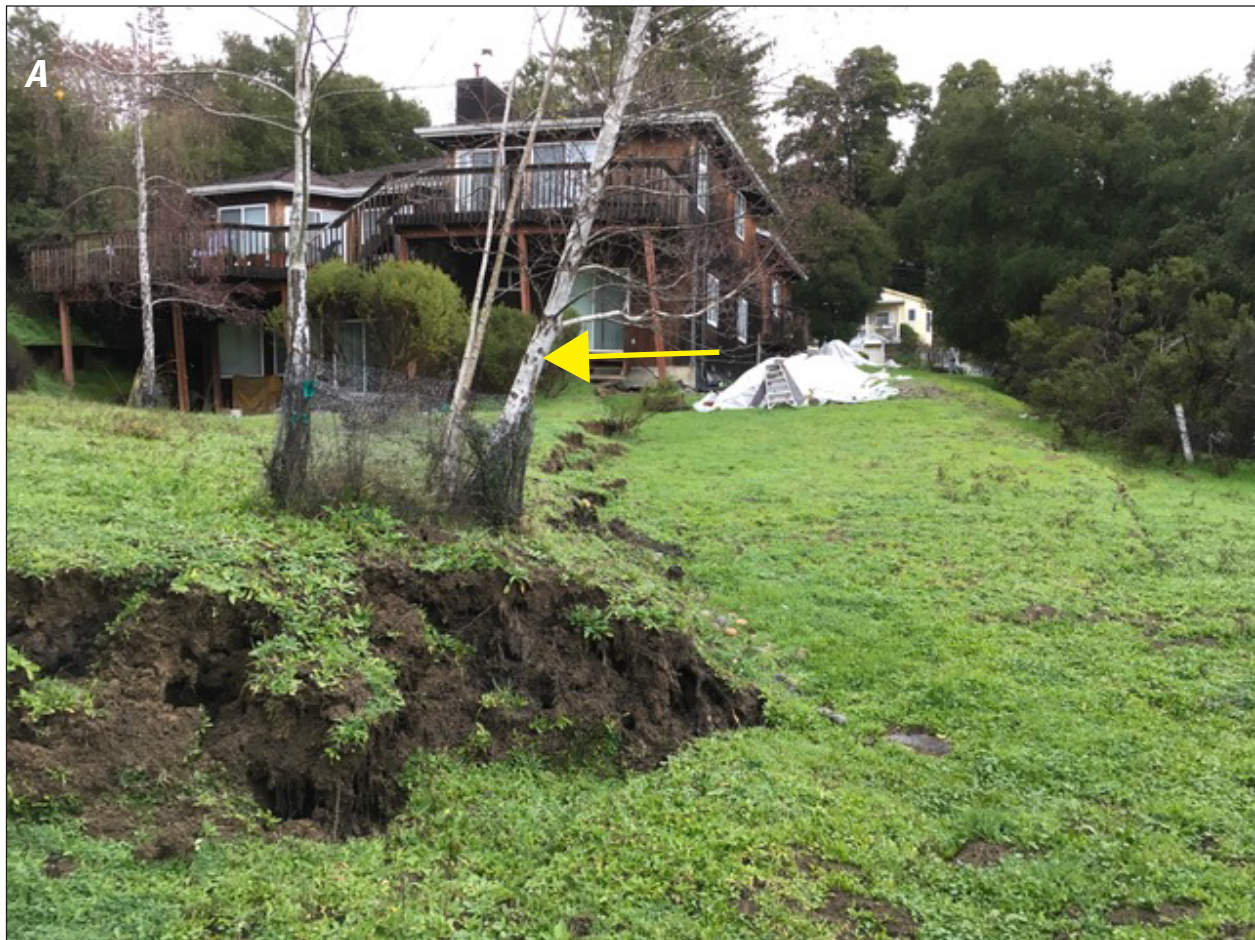
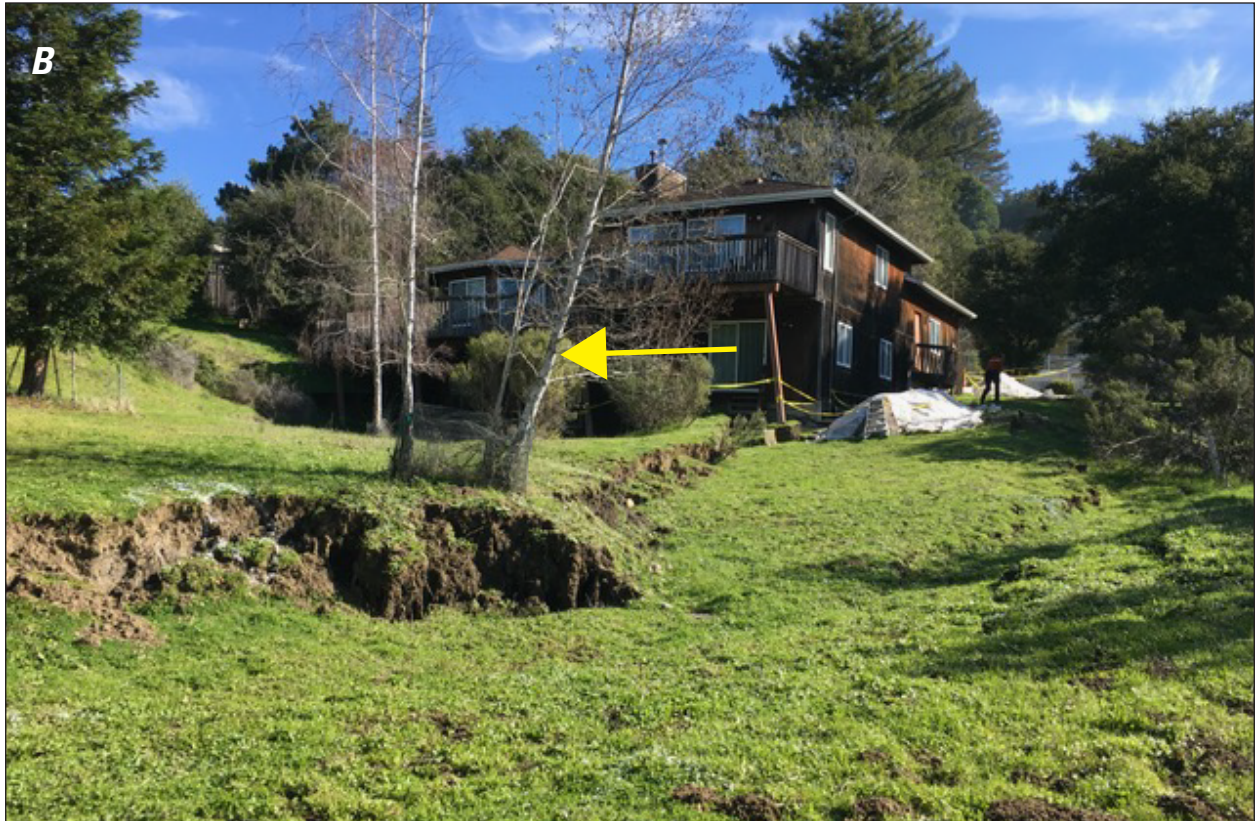
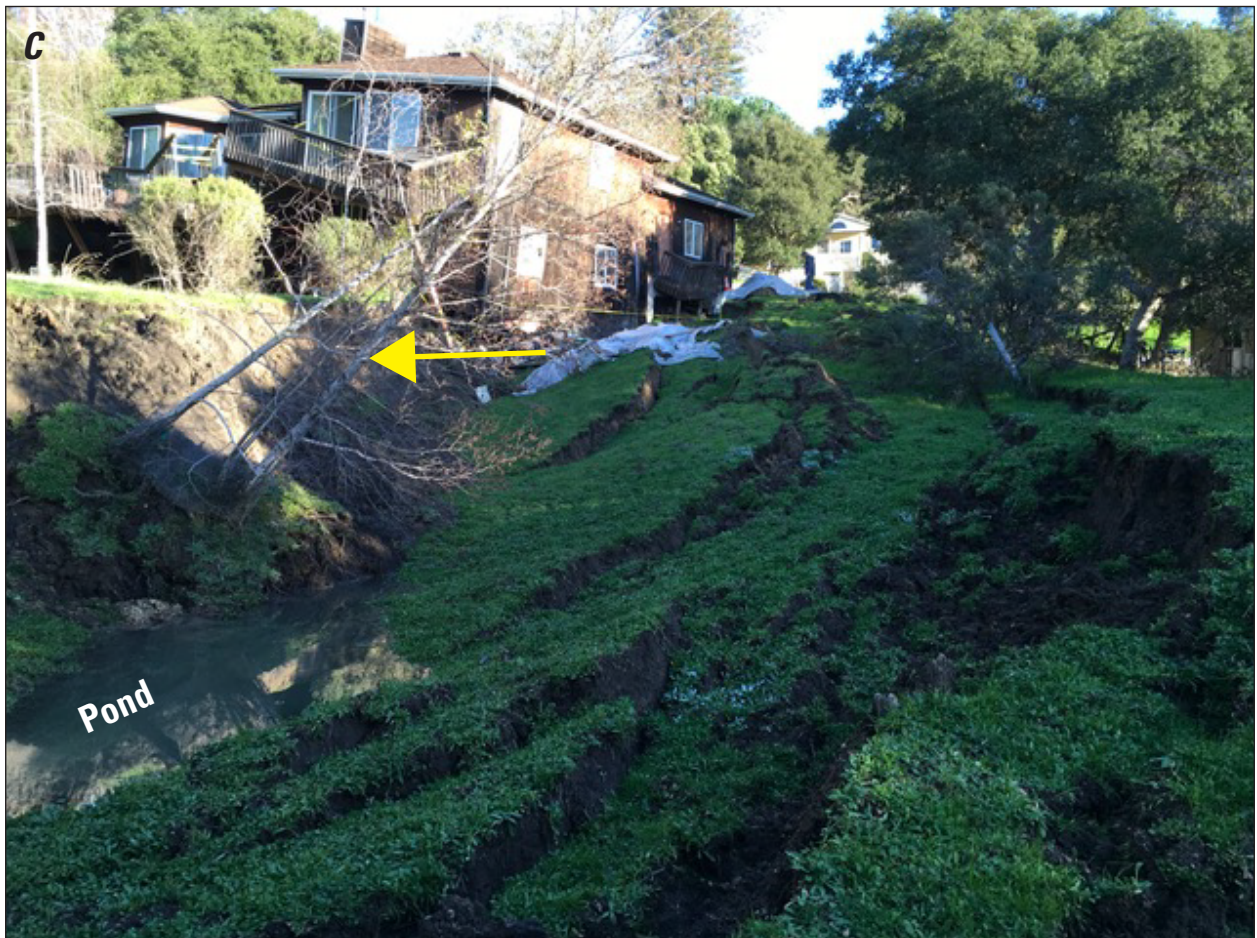
landslide motion occurred as a result of storms that brought additional rainfall to the already wetted region. Figure 6 illustrates the development of a graben along the northern lateral boundary of the slide behind (west of) the residence at 345 Scenic Drive between January 11 and 24, 2017. The pond that formed within the graben was intentionally breached to provide drainage of the area. Aerial views (figs. 7, 8, 9) show development of landslide features between January 11 and 31, 2017.

Figure 6. Photographs to east taken in backyard of home at 345 Scenic Drive (structure #3 on fig. 3 [on map sheet]), showing development of graben along right flank of 2017 upper Scenic Drive landslide (USDL). Yellow arrow points to same tree in all three photographs. Photographs by Carol Prentice. *A*, Photograph taken on January 11, 2017, showing early movement of 2017 USDL. *B*, Photograph taken on January 16, 2017, showing further movement and graben development of 2017 USDL. *C*, Photograph taken on January 24, 2017, showing pond that accumulated in well-developed landslide graben.

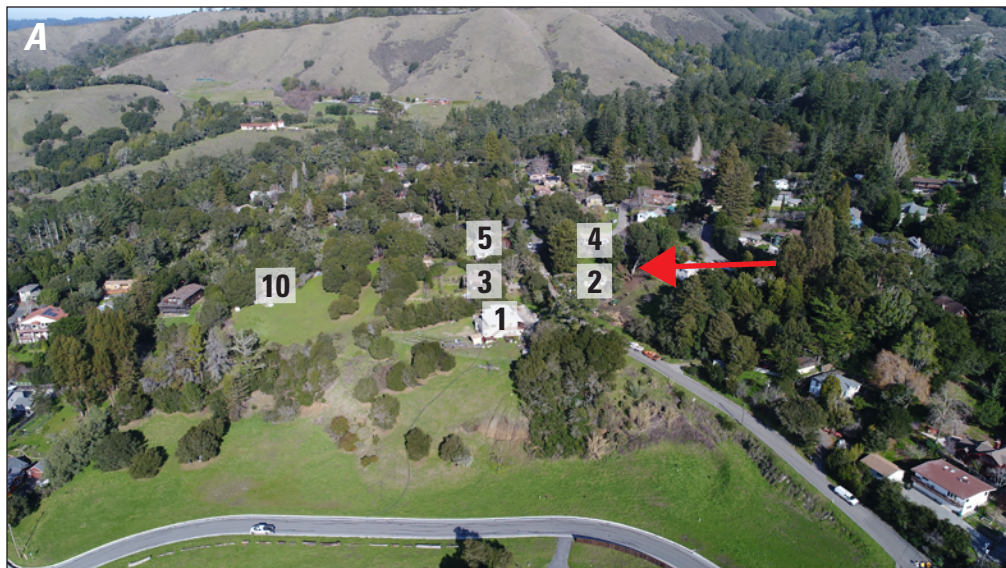
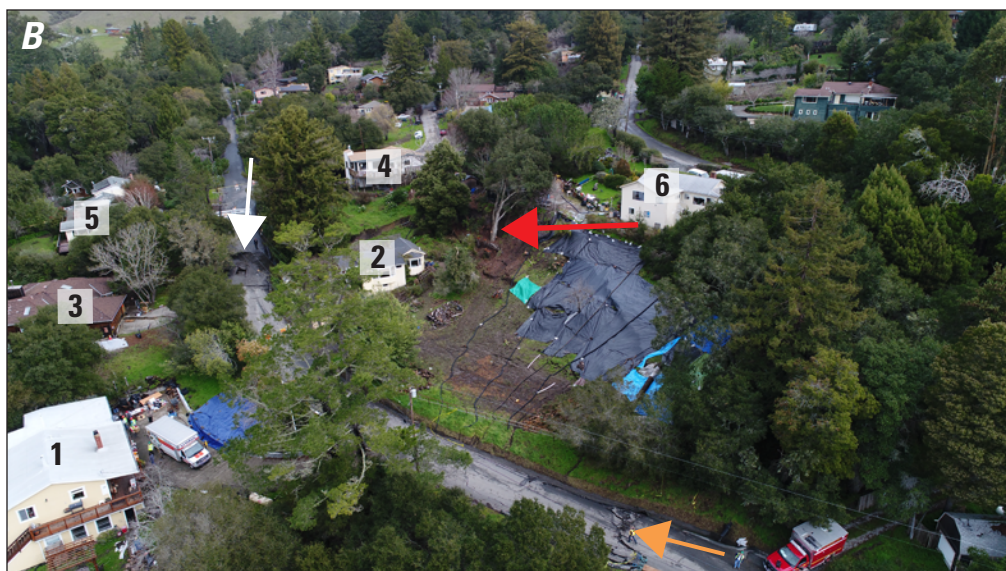
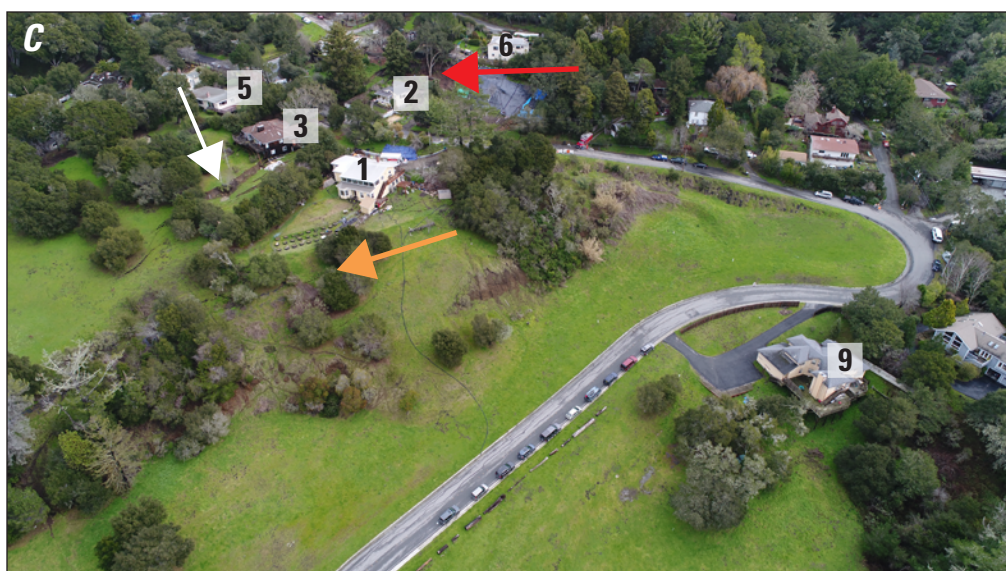
Figure 7. Oblique aerial photographs of Scenic Drive area, showing features of 2017 upper Scenic Drive landslide (USDL). See figure 3 (on map sheet) for locations of numbered structures. In all three photographs, red arrow points to same oak tree below headscarp of 2017 USDL (also shown in figures 8A, 9B, and 9D). Photographs by Ari Delay, La Honda Fire Brigade. *A*, Photograph to northeast, taken on January 17, 2017, showing overview of 2017 USDL. *B*, Photograph to northeast, taken on January 21, 2017. White arrow points to right flank (northern margin) of 2017 USDL where it crosses Scenic Drive (also depicted in fig. 5); note white barricade across road above right flank (just above white arrow), which also is visible in figures 5B, 9B, and 9D. Orange arrow points to left flank (southern margin) of 2017 USDL where it crosses Scenic Drive. Note blue and black tarps set out by homeowner over parts of landslide to prevent infiltration of rainwater. *C*, Photograph to east, taken on January 21, 2017. White arrow points to graben and pond (also depicted in fig. 6C) that formed along right flank of 2017 USDL behind structure #3. Orange arrow points to landslide toe (see fig. 8) in its early stage of development.

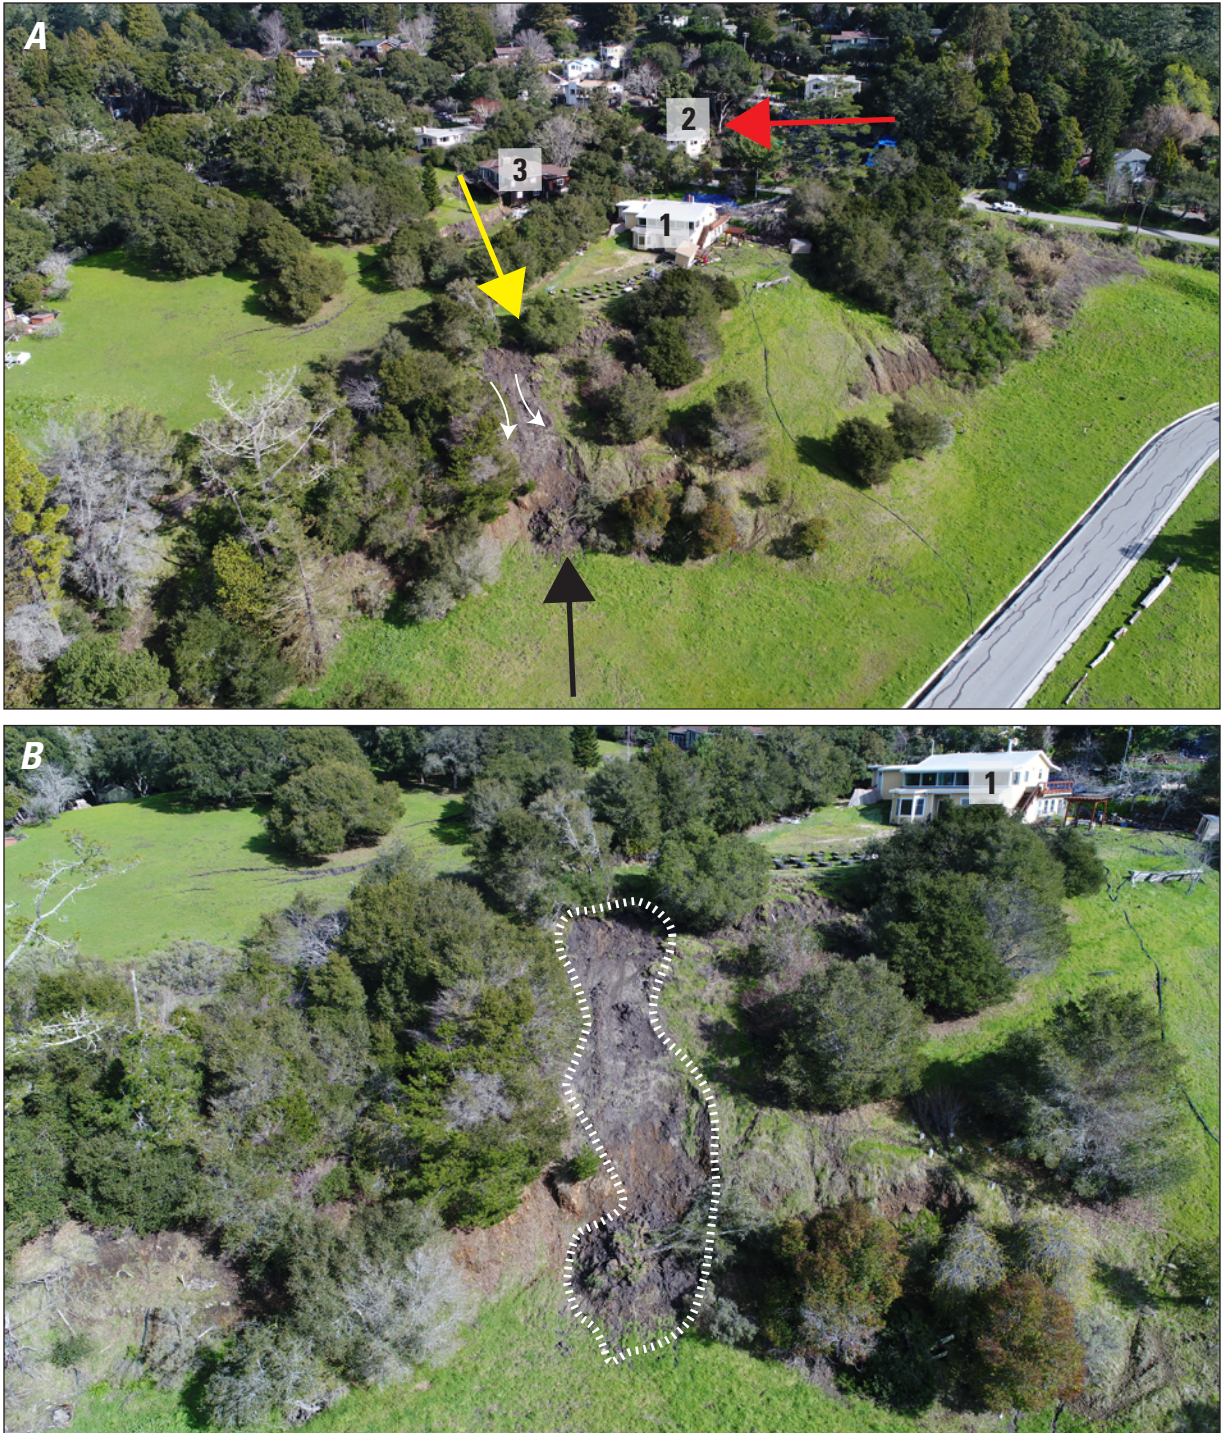
Figure 3 (on map sheet) shows a map of landslide features as they appeared January 27 and 28, 2017. The 2017 USDL is roughly triangular in shape, measuring approximately 150 by 80 m, and covering about 8,000 m². The headscarp extends along the northeastern part of the landslide for approximately 60 m; the toe is near the top of an ancient headscarp associated with the SDL. As the 2017 USDL moved, the toe, because it was near the top of the ancient headscarp, became oversteepened and unstable; as

a result, it spawned several small, secondary, catastrophic failures in late January and February 2017 (figs. 2, 3 [on map sheet]; see also, fig. 8). This process likely will continue if landslide motion resumes.

Figure 8. Oblique aerial photographs to northeast, showing localized failure along toe of 2017 upper Scenic Drive landslide (USDL). Photographs taken on January 25, 2017, by Ari Delay, La Honda Fire Brigade. See figure 3 (on map sheet) for locations of numbered structures. *A*, Overview of 2017 USDL. Yellow arrow points to source of toe collapse; black arrow points to deposit at base of Scenic Drive landslide headscarp. Paired curved white arrows indicate direction of downslope movement. Red arrow points to same oak tree (below headscarp of landslide) that is shown in figures 7A–C, 9B, and 9D. *B*, Closer view of localized failure along toe of 2017 USDL. White hachures outline toe collapse.

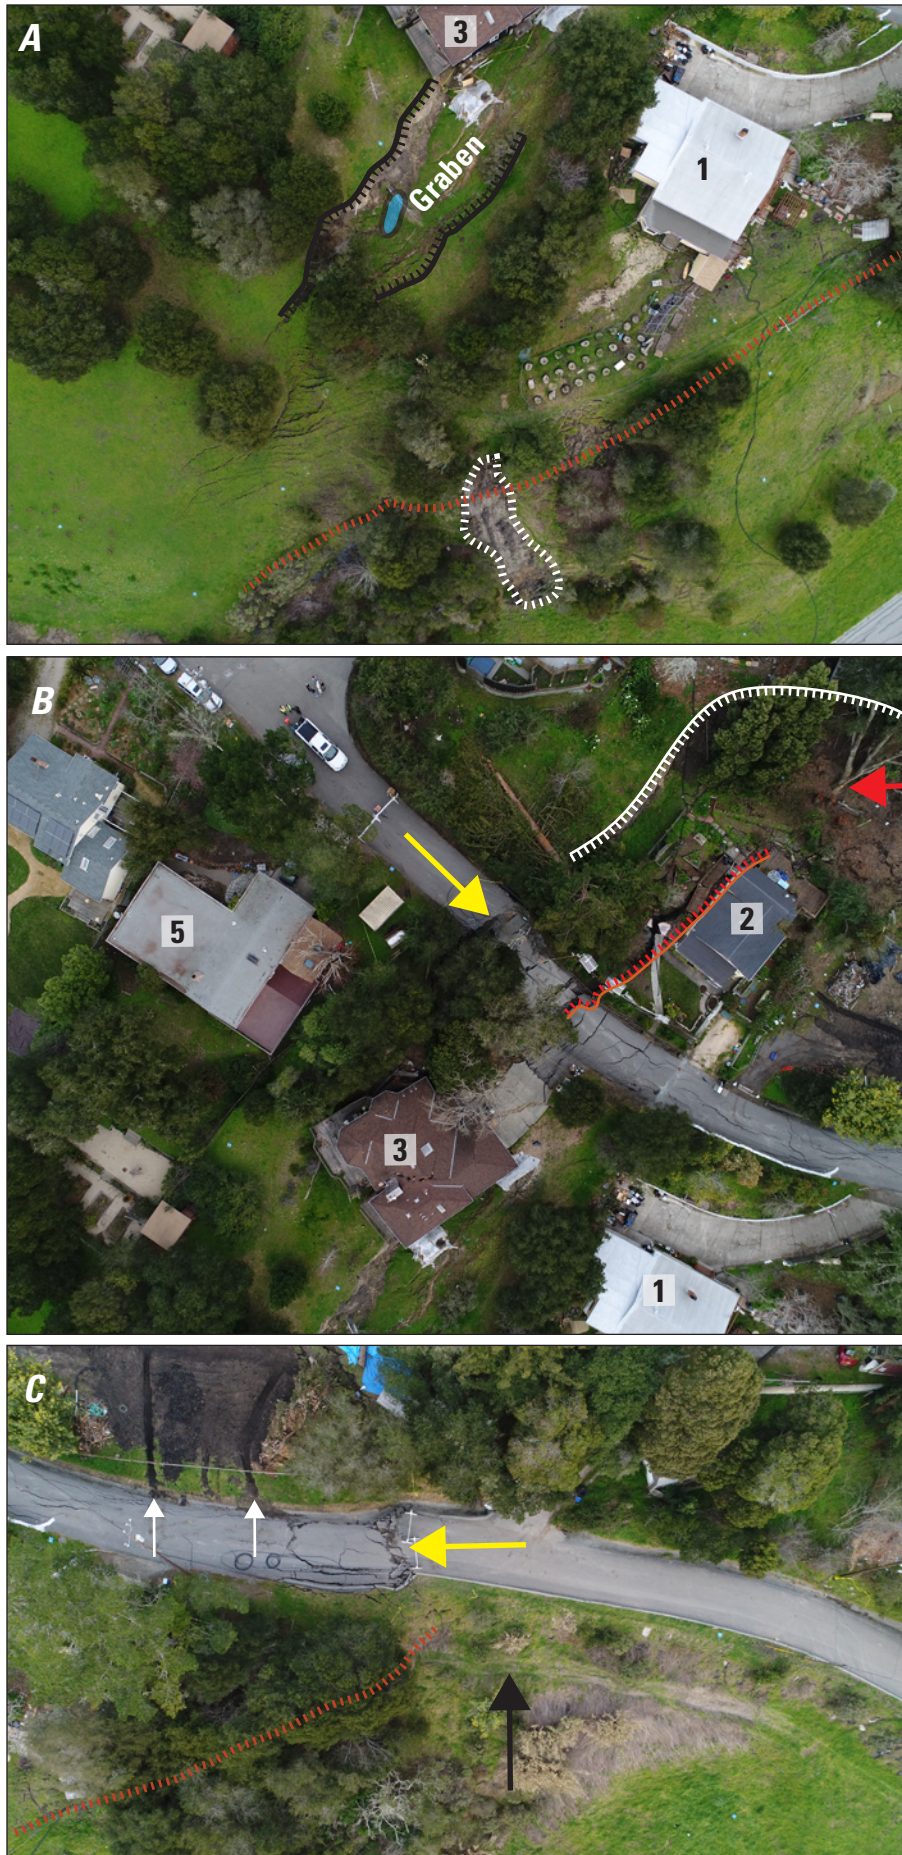
Figure 9. Oblique aerial photographs of upper Scenic Drive area, showing features of 2017 upper Scenic Drive landslide (USDL). Photographs taken on January 31, 2017, by Ari Delay, La Honda Fire Brigade. See figure 3 (on map sheet) for locations of numbered structures. Red arrows in *B* and *D* point to same oak tree (below headscarp of USDL) that is shown in figures 7A–C and 8A. *A*, Black hachured lines mark boundaries of graben developed along right flank of 2017 USDL behind structure #3; hachures point into graben. Blue shading highlights pond that formed in graben. White hachures outline area of collapse due to oversteepening of landslide toe (also shown in figures 8B and 9D); red hachures mark base of landslide toe. *B*, White hachured line marks headscarp of 2017 USDL; hachures point into landslide. Yellow arrow points to where right flank of 2017 USDL crosses Scenic Drive (also shown in figures 5B and 7B; note white barricade across road above right flank). Red hachured line marks uphill-facing scarp that forms south boundary of graben; hachures point upscarp. *C*, Yellow arrow points to left flank (southern margin) of 2017 USDL where it crosses Scenic Drive. Smaller white arrows point to channels that were excavated to help drain surface water within landslide mass. Red hachures mark approximate location of landslide toe. Black arrow points to approximate location of northernmost tie-back anchor installed as part of 2011 project to stabilize previous Scenic Drive landslides. *D*, White arrow points to channel that was excavated to help drain surface water in graben behind structure #3. Red hachures mark approximate location of landslide toe. White hachures outline locations of debris flows due to local collapse of oversteepened toe (also shown in figures 8B and 9A). Black arrow points to headscarp of previous (2005, 2006) Scenic Drive landslides.

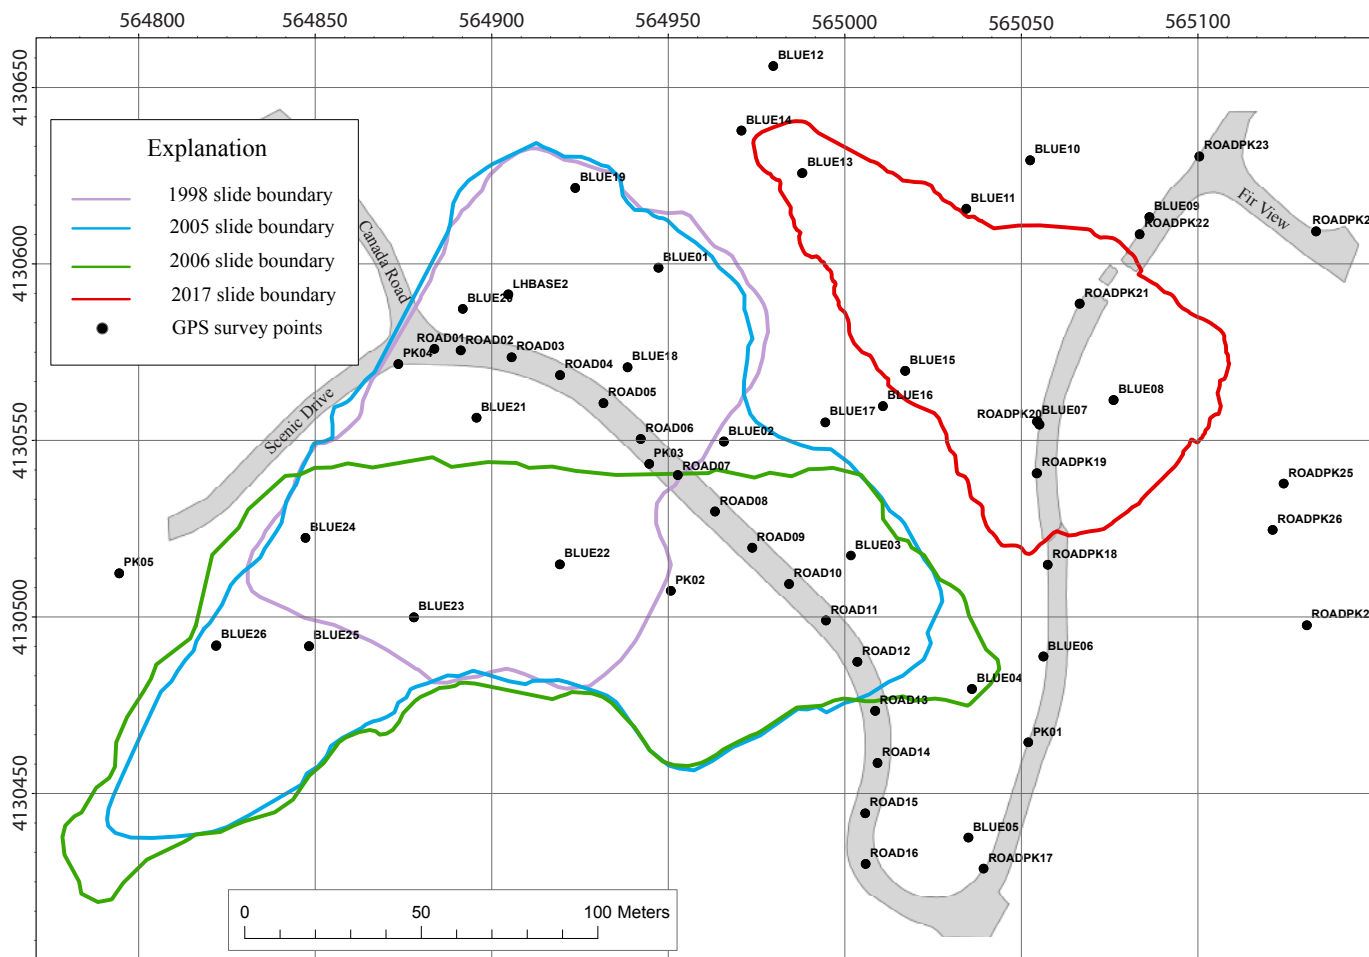
Figure 10. Schematic map showing boundaries of previous (1998, 2005, 2006) Scenic Drive landslides, compared to that of 2017 upper Scenic Drive landslide (USDL; see fig. 1 for location). USDL, which is located above headscarps of previous Scenic Drive landslides, encompasses about 8,000 m². Black dots indicate locations of 58 survey points and one local base station (labeled LHBASE2) used to monitor landslide activity: points labeled PK01–05 are survey nails embedded in Scenic Drive roadway used for 2016 and 2017 real-time kinematic global positioning system and terrestrial laser scanner surveys; points labeled ROADPK17–27, survey nails placed in pavement on January 27, 2018, to monitor ongoing 2017 landslide activity; points labeled ROAD01–12, reflective lane markers along Scenic Drive; points labeled BLUE05–17, other survey markers placed throughout study area.

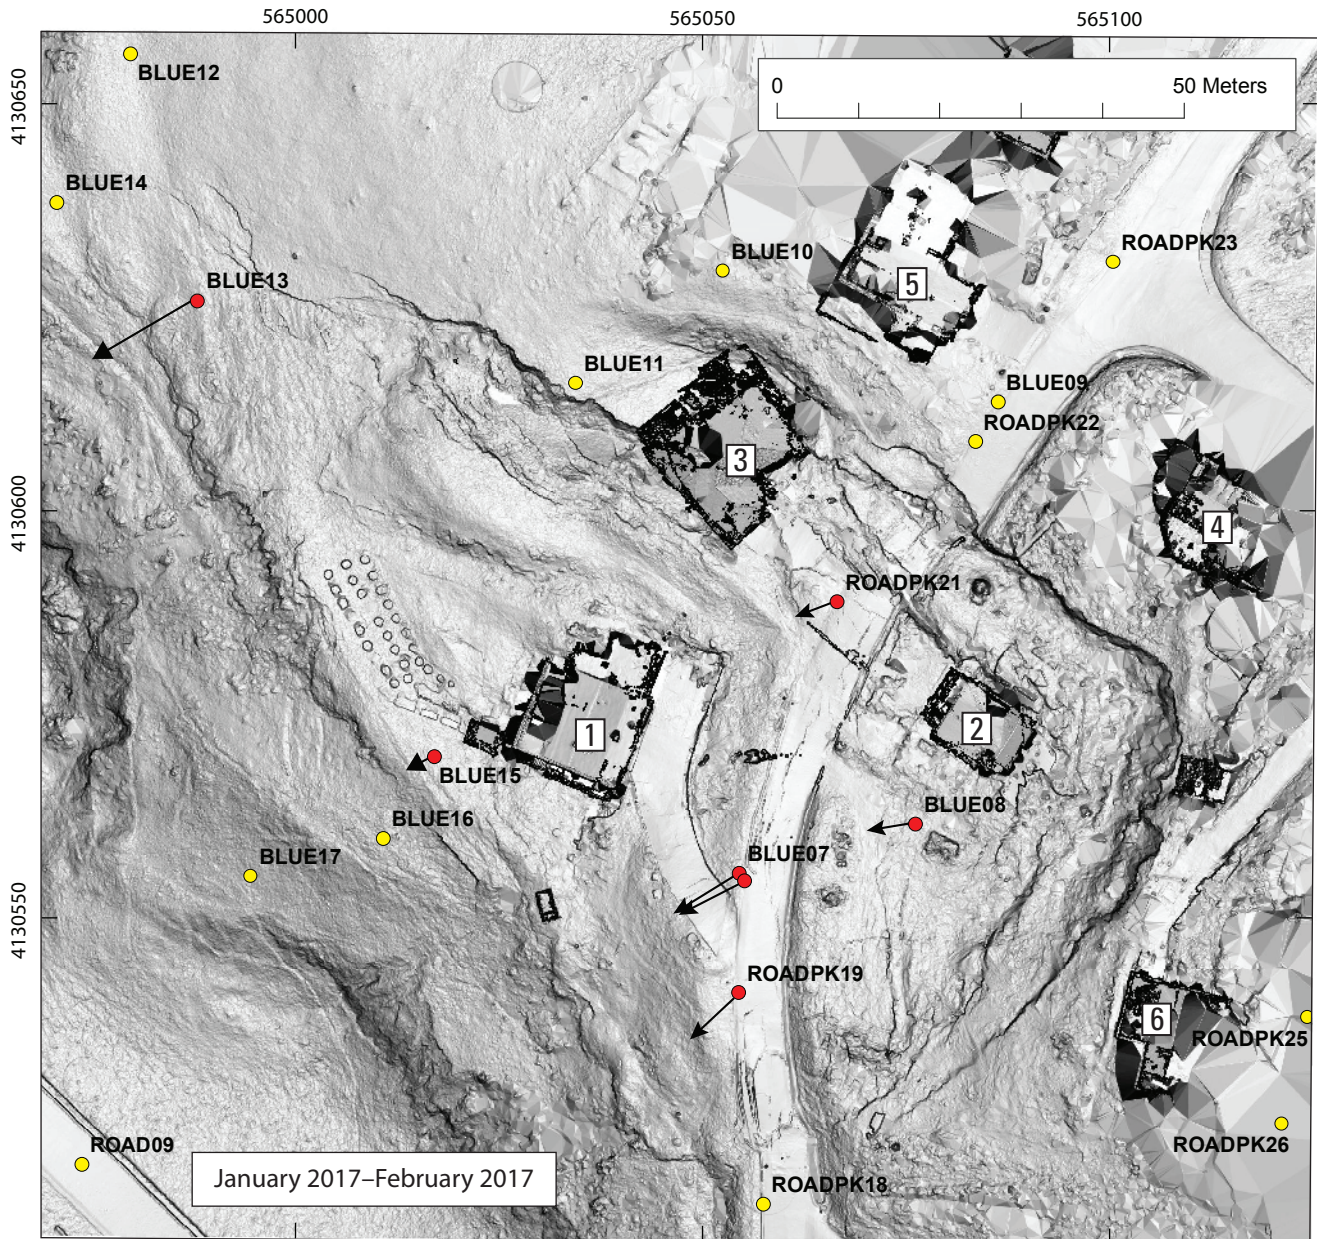
(figs. 10, 11; see also, table 1). Total horizontal movement between January 28 and February 23 was at least 5 cm (station BLUE15) and no more than 28 cm (BLUE13). No measurable landslide motion occurred after February 23, and none of the monuments outside of the current 2017 USDL

boundaries moved within the limits of our measurement error (horizontal, about 2 cm; vertical, 3 cm).

Figure 11. Slope-shade map of 2017 upper Scenic Drive landslide (USDL), showing real-time kinematic global positioning system and terrestrial laser scanner survey points (red dots, points within 2017 USDL; yellow dots, points outside of 2017 USDL) used for repeat surveys. Arrows on red dots are horizontal displacement vectors that indicate magnitude (distance relative to 10-cm arrow shown in lower right corner) and direction of movement from January 27–February 23, 2017; see table 1 for values of magnitude and directions of displacement. Yellow dots depict survey points that showed no displacement (within error of surveys). See figure 3 (on map sheet) for locations of numbered structures.

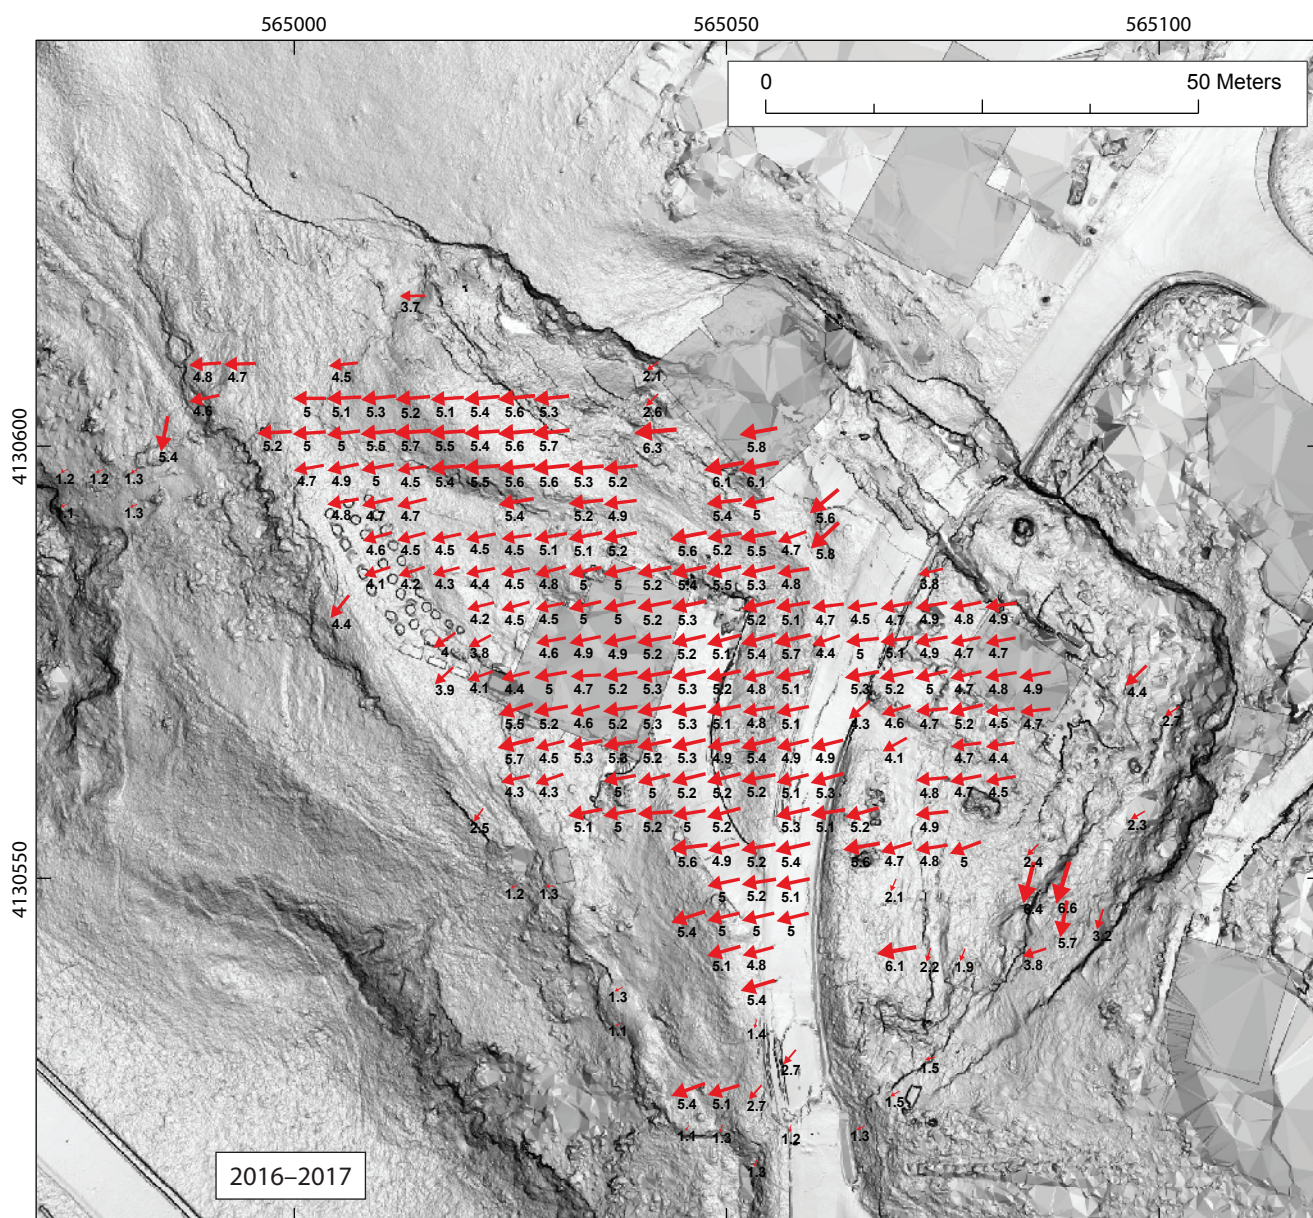
Figure 12. Shaded-relief map of 2017 upper Scenic Drive landslide (USDL), showing magnitudes (distance values, in meters) and directions (red arrows) of total horizontal displacement of 2017 USDL between 2016 and 2017, as measured by optical image correlation (see Leprince and others, 2007). Size of each arrow is scaled to distance value labeled below arrow. Displacements of less than 1 meter are not shown.

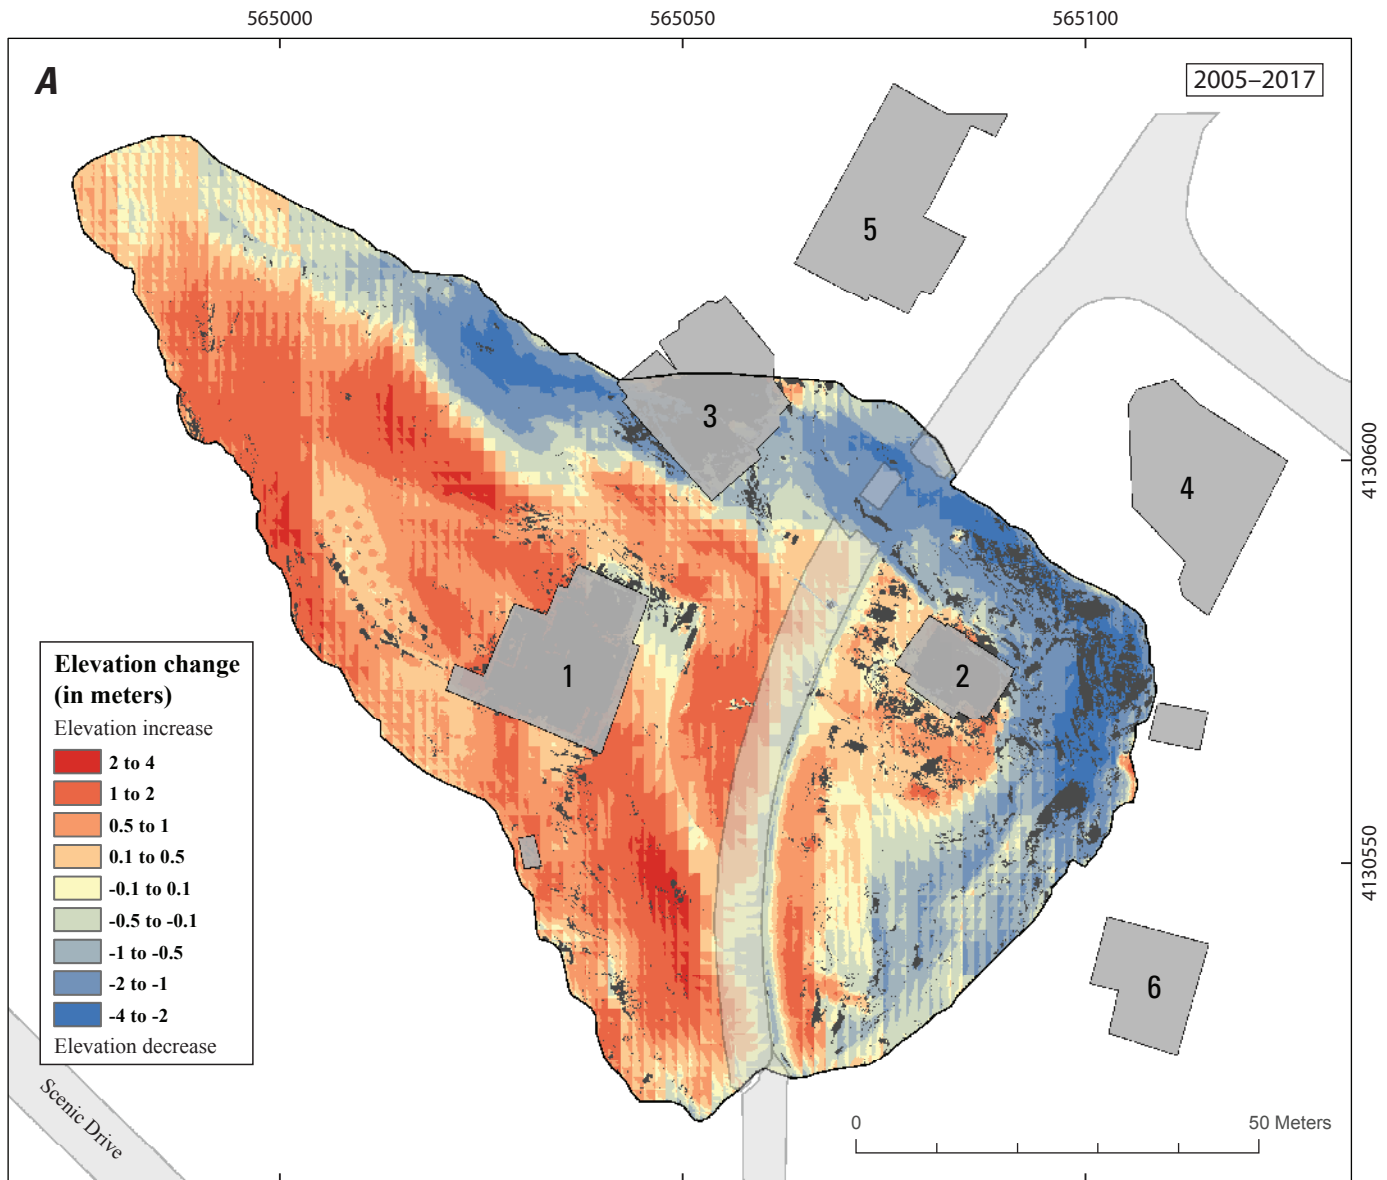
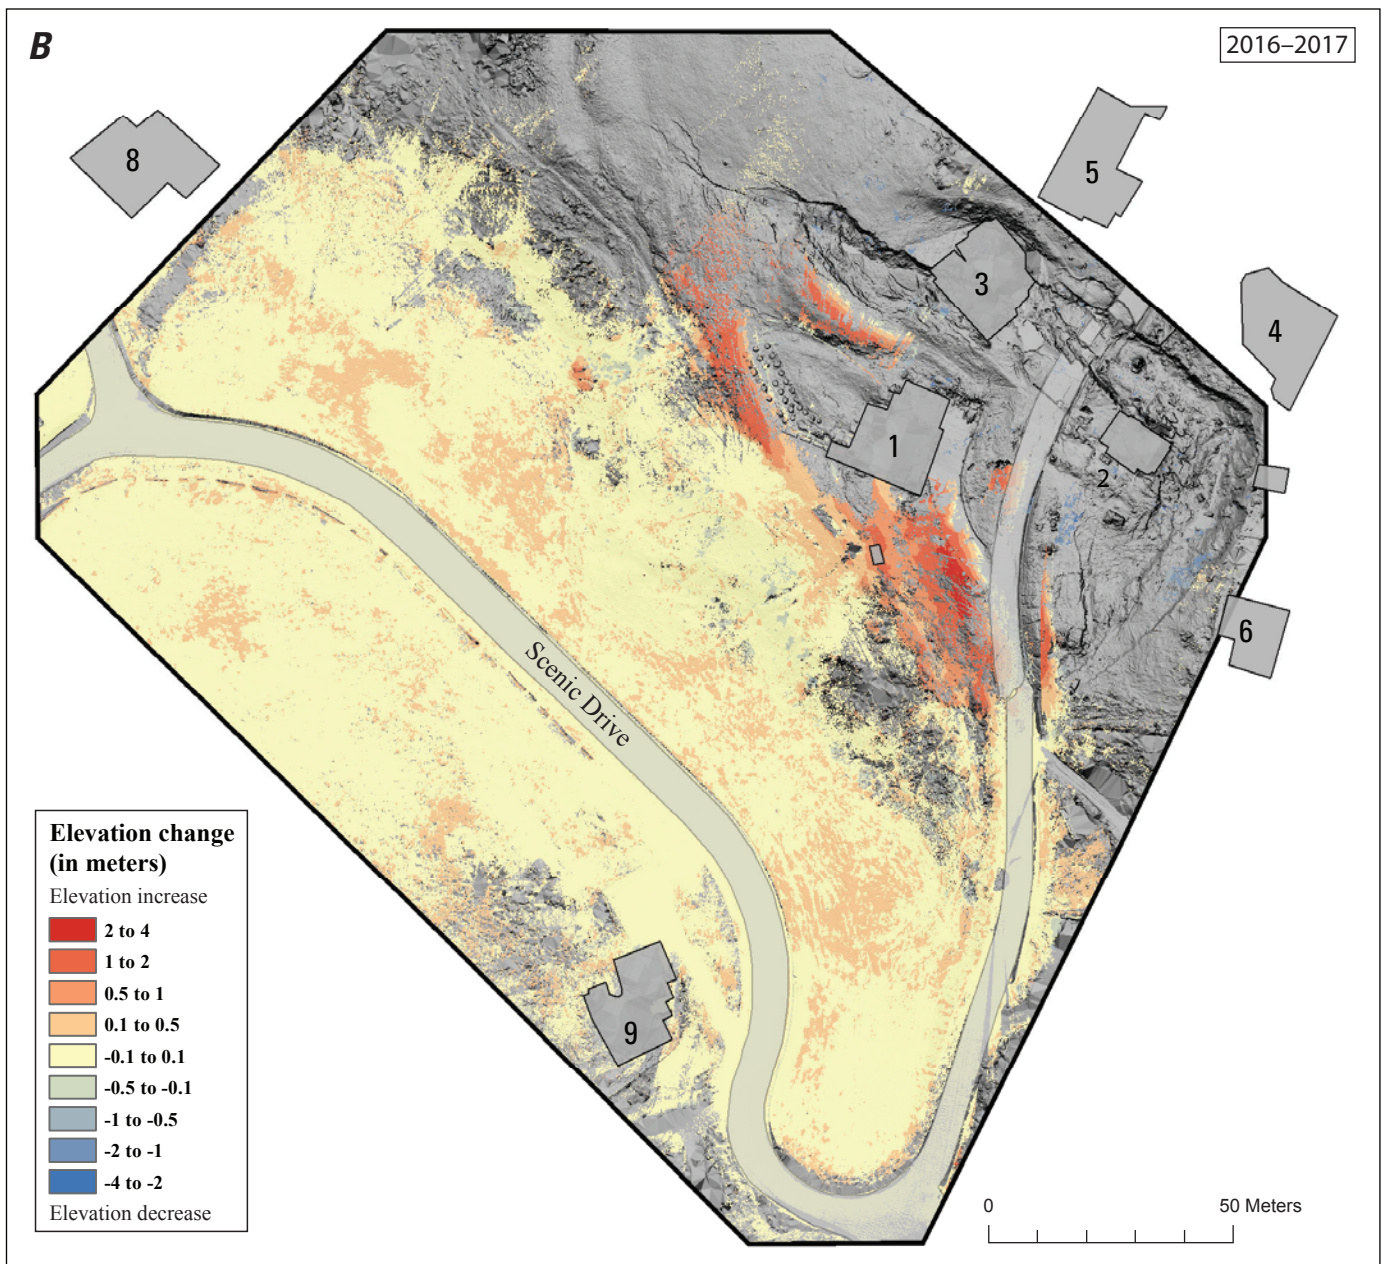
Differencing the 2017 TLS data with 2005 airborne-lidar data provides an estimate of total vertical elevation changes within the 2017 USDL (fig. 13A). The part of the

landslide that is adjacent to the headscarp and within the graben behind 345 Scenic Drive subsided between 2 and 4 m. Most of the remaining landslide uplifted from 0.5 to 2 m, with a few areas uplifting 2 to 4 m. Differencing the 2016 and 2017 TLS scans shows that the SDL remained stable, in contrast to the part of the 2017 USDL that is within the overlap area of the two TLS scans, which uplifted (fig. 13B).

Figure 13. Maps showing changes in elevation within 2017 upper Scenic Drive landslide (USDL) and in surrounding area. Lighter gray areas are roads; numbered darker gray polygons are footprints of structures (see figure 3 [on map sheet] for locations). **A**, Changes in elevation within 2017 USDL between 2005 and 2017, as determined from terrestrial laser scanner (TLS) and airborne lidar (ALS) surveys. Elevation changes are calculated at 5-cm resolution; jagged color pattern is due to resolution difference between TLS and ALS surveys. Data types and sources: 2005 data, ~1.4-m-resolution ALS, acquired from San Mateo County; 2017 data, 5-cm-resolution TLS, from Pickering and others (2018). **B** (on facing page), Changes in elevation within 2017 USDL and in surrounding area between 2016 and 2017, as determined from repeat TLS surveys. Map shows stability of repaired Scenic Drive landslide area, which moved in 1998, 2005 and 2006, as well as positive elevation changes in parts of 2017 USDL. Note that most of 2017 USDL area does not show elevation change because it was not surveyed in 2016; area where overlap between 2016 and 2017 TLS surveys exists is primarily near toe of 2017 USDL. Also note that minor elevation changes (pale-orange shading, 0.1–0.5 m) on either side of Scenic Drive do not indicate actual changes in elevation but, rather, are data-collection artifacts caused by inability of 2017 survey to penetrate tall grass.
