Landscape Change Associated with the Upper Scenic Drive Landslide, La Honda, California, January 10–June 28, 2017

By Alexandra J. Pickering, Carol S. Prentice, and Stephen B. DeLong

Open-File Report 2019–1024

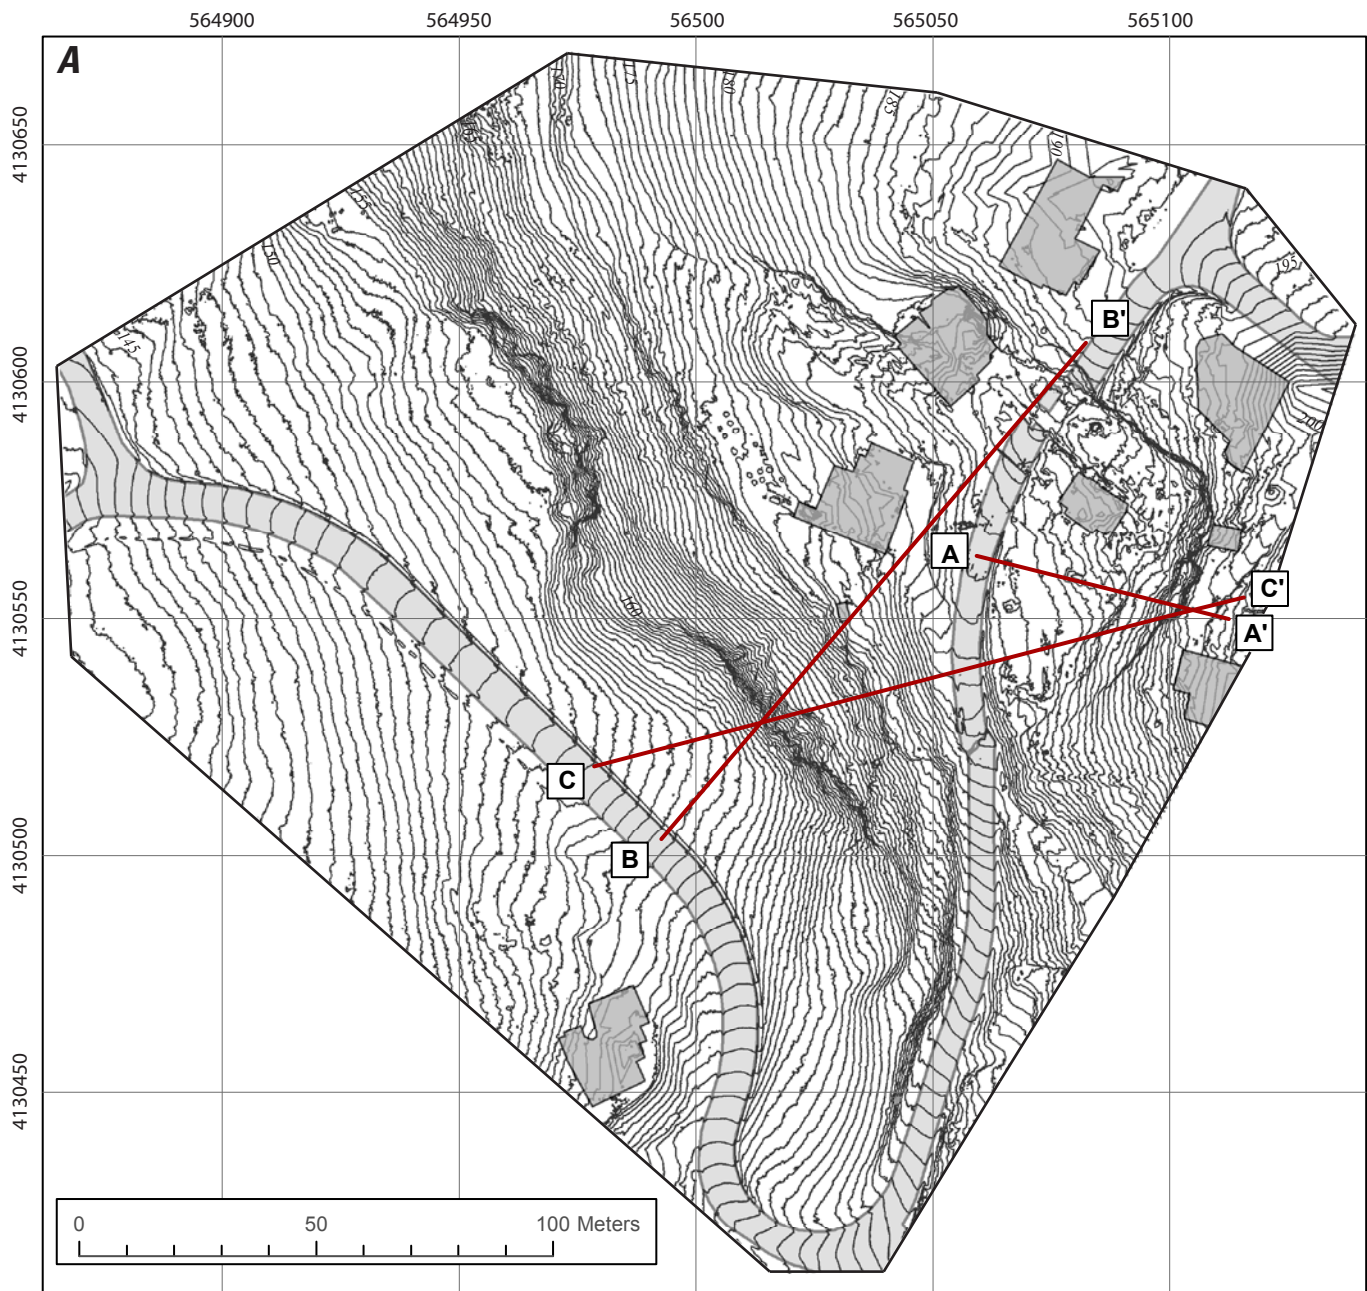
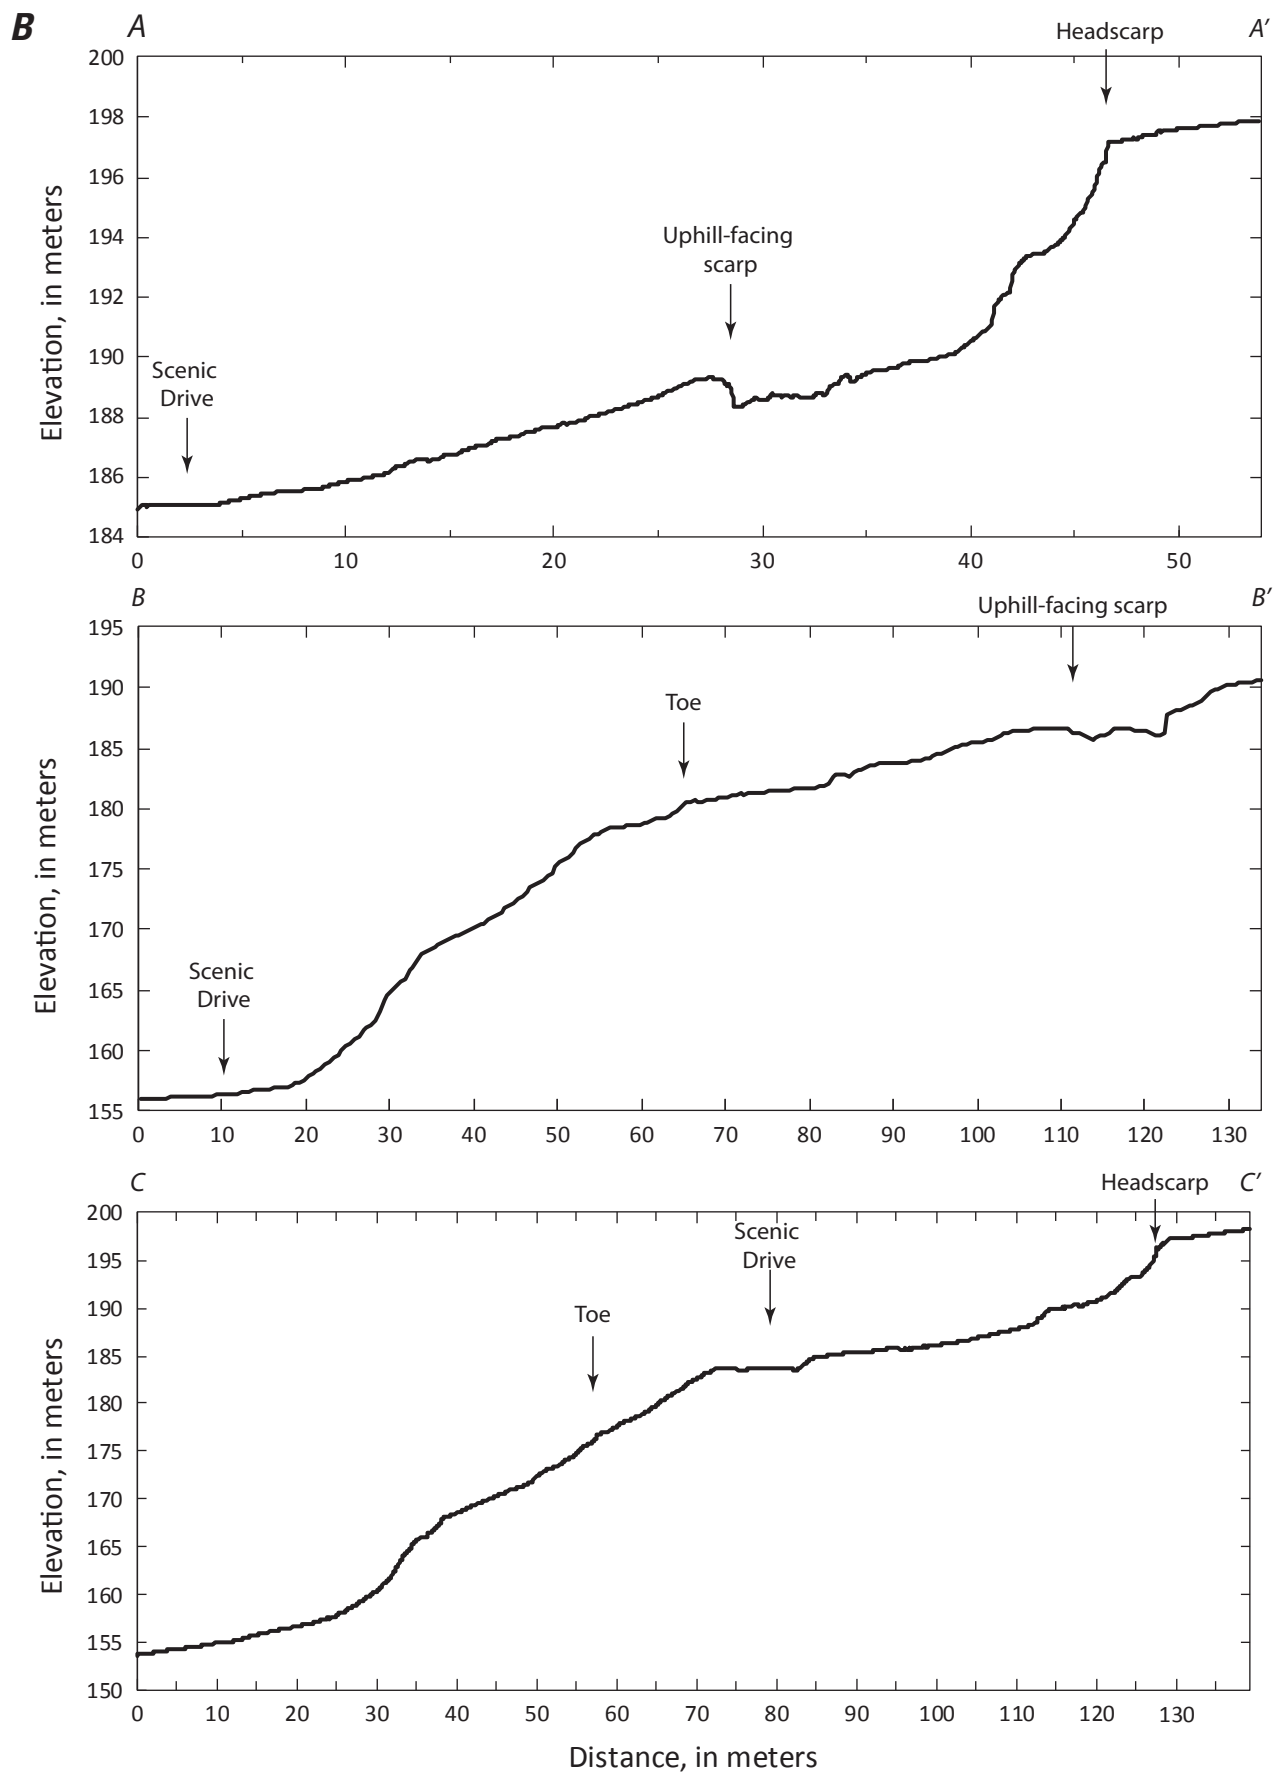
Figure 14. Contour map and topographic profiles of 2017 upper Scenic Drive landslide (USDL) and surrounding area. *A*, Contour map of same area as figure 13*B*, showing location of profiles in figure 14*B* (on facing page). Lighter gray areas are roads; darker gray polygons are footprints of structures. Generated from 5-cm-resolution terrestrial laser scanner digital elevation model (NAD83, zone 10N), from Pickering and others (2018); contour interval, 0.5 m. *B*, Topographic profiles illustrating prominent features of 2017 USDL (see figure 14*A* for locations of profiles). All three topographic profiles are scaled so that they have uniform vertical exaggeration.

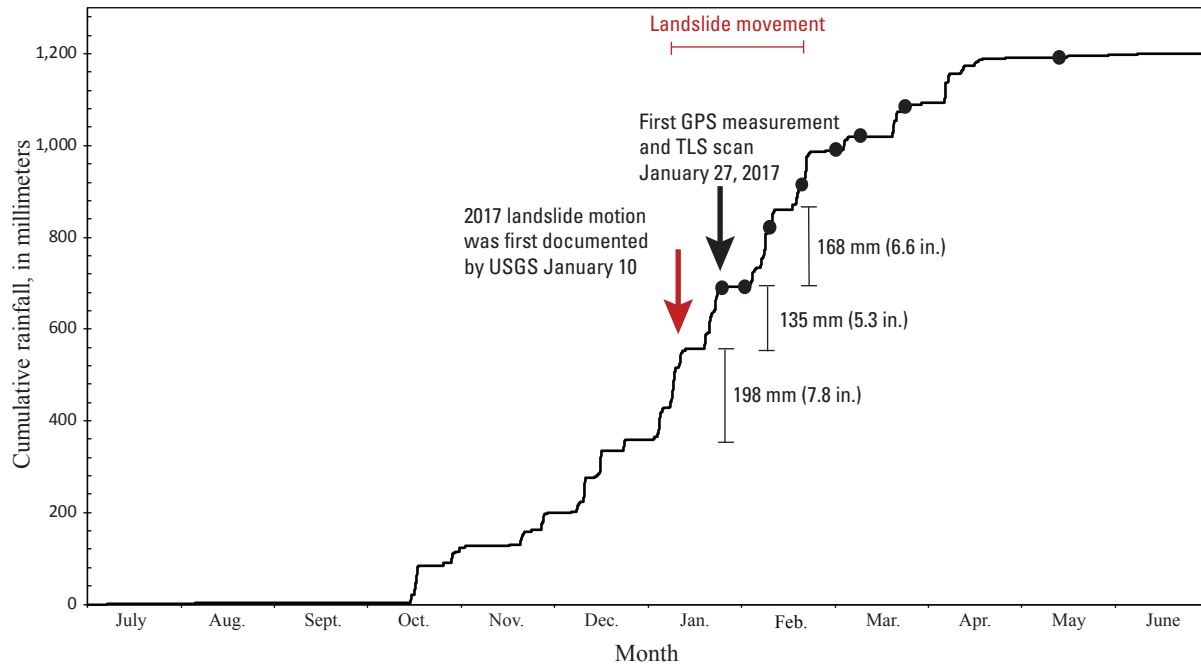
and continued through December when several storms contributed 159 mm of rainfall, likely leading to an elevated water table (fig. 15). Long-term rainfall-year records show a precipitation average of 715 mm/year for the area, which had been under drought conditions during the previous few years (fig. 16). La Honda received 516 mm of rainfall

prior to the landslide movement that occurred on January 10, 2017, and a total of 1,201 mm of rainfall for the entire 2017 rainfall year. The landslide motion in January 2017 occurred in response to a series of closely spaced storms between January 7 and 10, which produced 121 mm of rainfall; a peak rainfall intensity of 5.6 mm/hr occurred

overnight on January 8 into January 9. The highest rainfall intensity, 11.7 mm/hr, occurred on January 18, and most of the landslide motion occurred in response to this storm, as well as to the storms that occurred between January 20 and 23. Similar to past SDL episodes, the landslide responded to changes in rainfall rate, most of the movement occurring

during or after large storms. Minor horizontal movement (as much as 28 cm in the western part of the landslide) occurred between January 28 and February 23. Between February 23 and June 28, coincident with decreasing rainfall, we measured no additional horizontal landslide motion.

Figure 15. Plot showing cumulative rainfall for rainfall year 2016–2017, at La Honda, Calif. Rainfall data is from rain gauge LAH, located at Log Cabin Camp, about 1.9 km southwest of 2017 upper Scenic Drive landslide (USDL) (see fig. 1). Movement of 2017 USDL was first documented by USGS on January 10, 2017, after heavy rainfall from series of closely spaced storms that produced nearly 200 mm of rainfall in 10 days; most movement occurred between January 18 and 27, 2017, prior to terrestrial laser scanner (TLS) and real-time kinematic global positioning system (RTK GPS) surveys and coincident with several storms that added 135 mm of rainfall. After January 27, 2017, movement of 2017 USDL slowed significantly, and it had stopped by February 23, 2017. Black dots indicate dates of RTK GPS surveys.

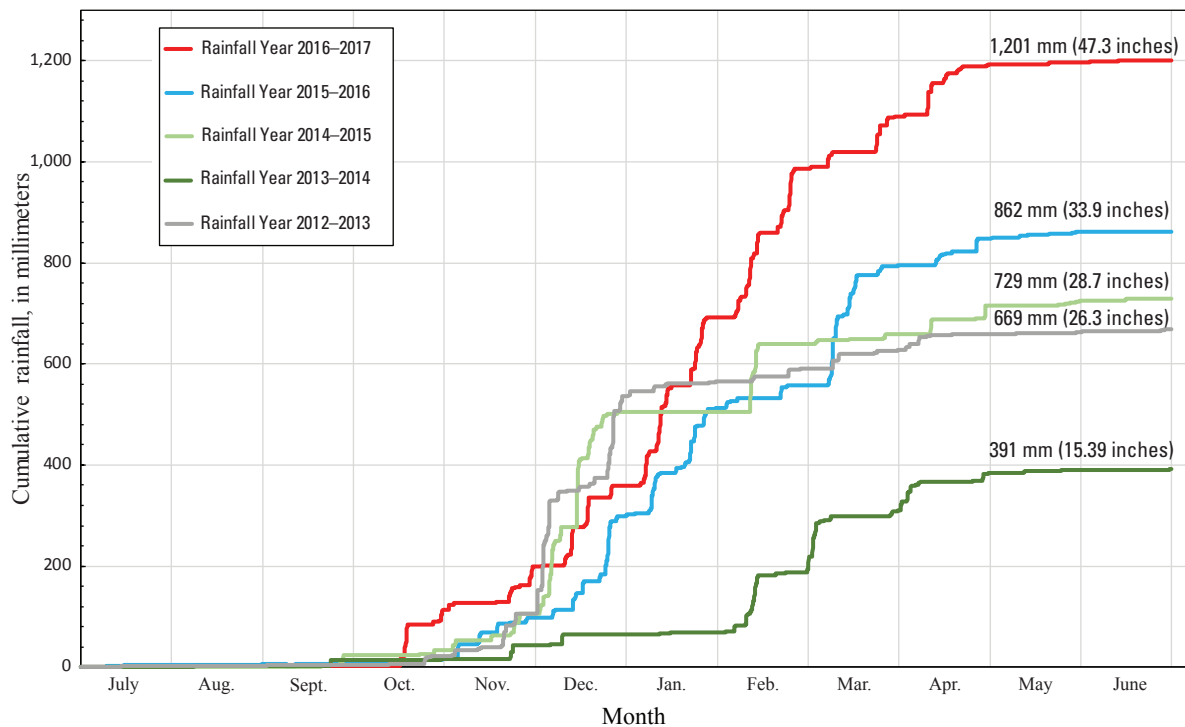
Figure 16. Plot showing cumulative rainfall for rainfall year 2016–2017 and four preceding rainfall years, at La Honda, Calif. Rainfall data is from rain gauge LAH, located about 1.9 km southwest of 2017 upper Scenic Drive landslide (see fig. 1 for location). Rainfall year 2016–2017 was among wettest on record, when a total of 1,201 mm of rainfall fell following several years of drought conditions. According to long-term (20 yr) records, normal rainfall averages 715 mm/yr. Previous years of movement of Scenic Drive landslides (1998, 2005, and 2006) all received above-average rainfall (1,017, 850, and 769 mm/yr, respectively).
