Measurement of Long-Term Channel Change Through Repeated Cross-Section Surveys at Bridge Crossings in Alaska

Open-File Report 2019–1028

By Karenth L. Dworsky and Jeffrey S. Conaway

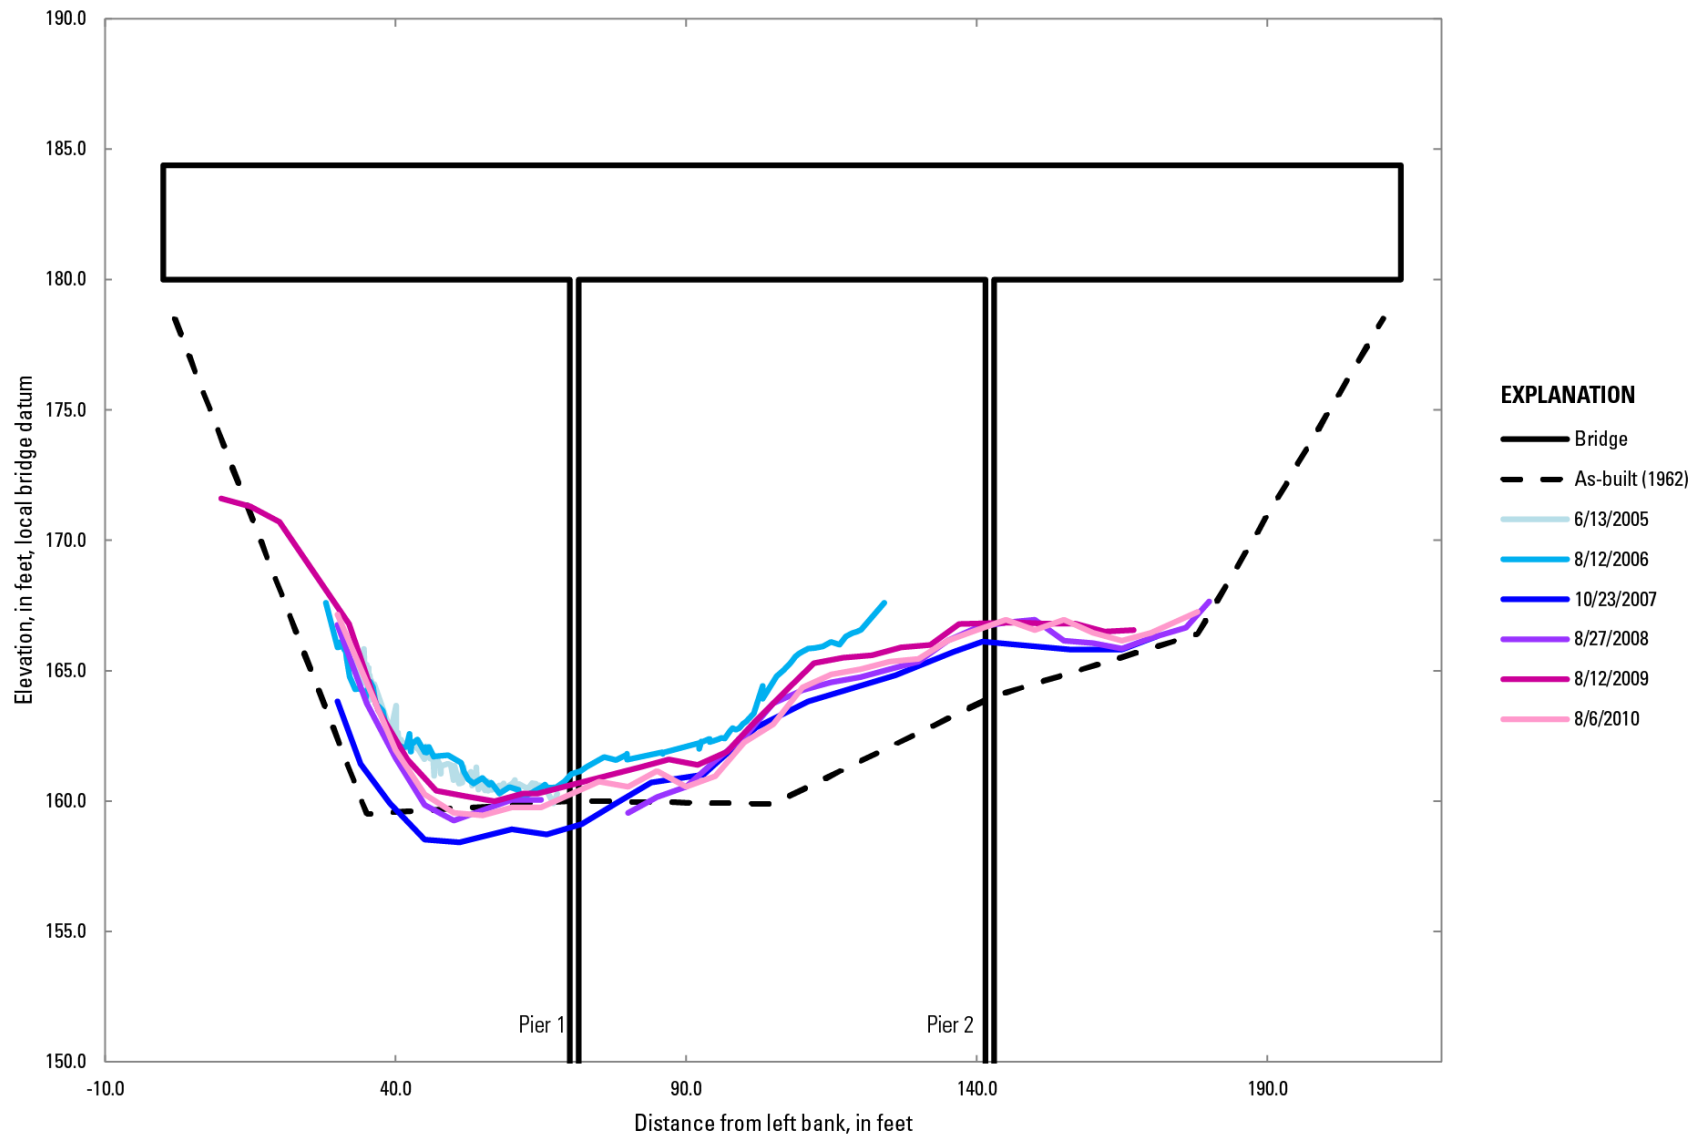
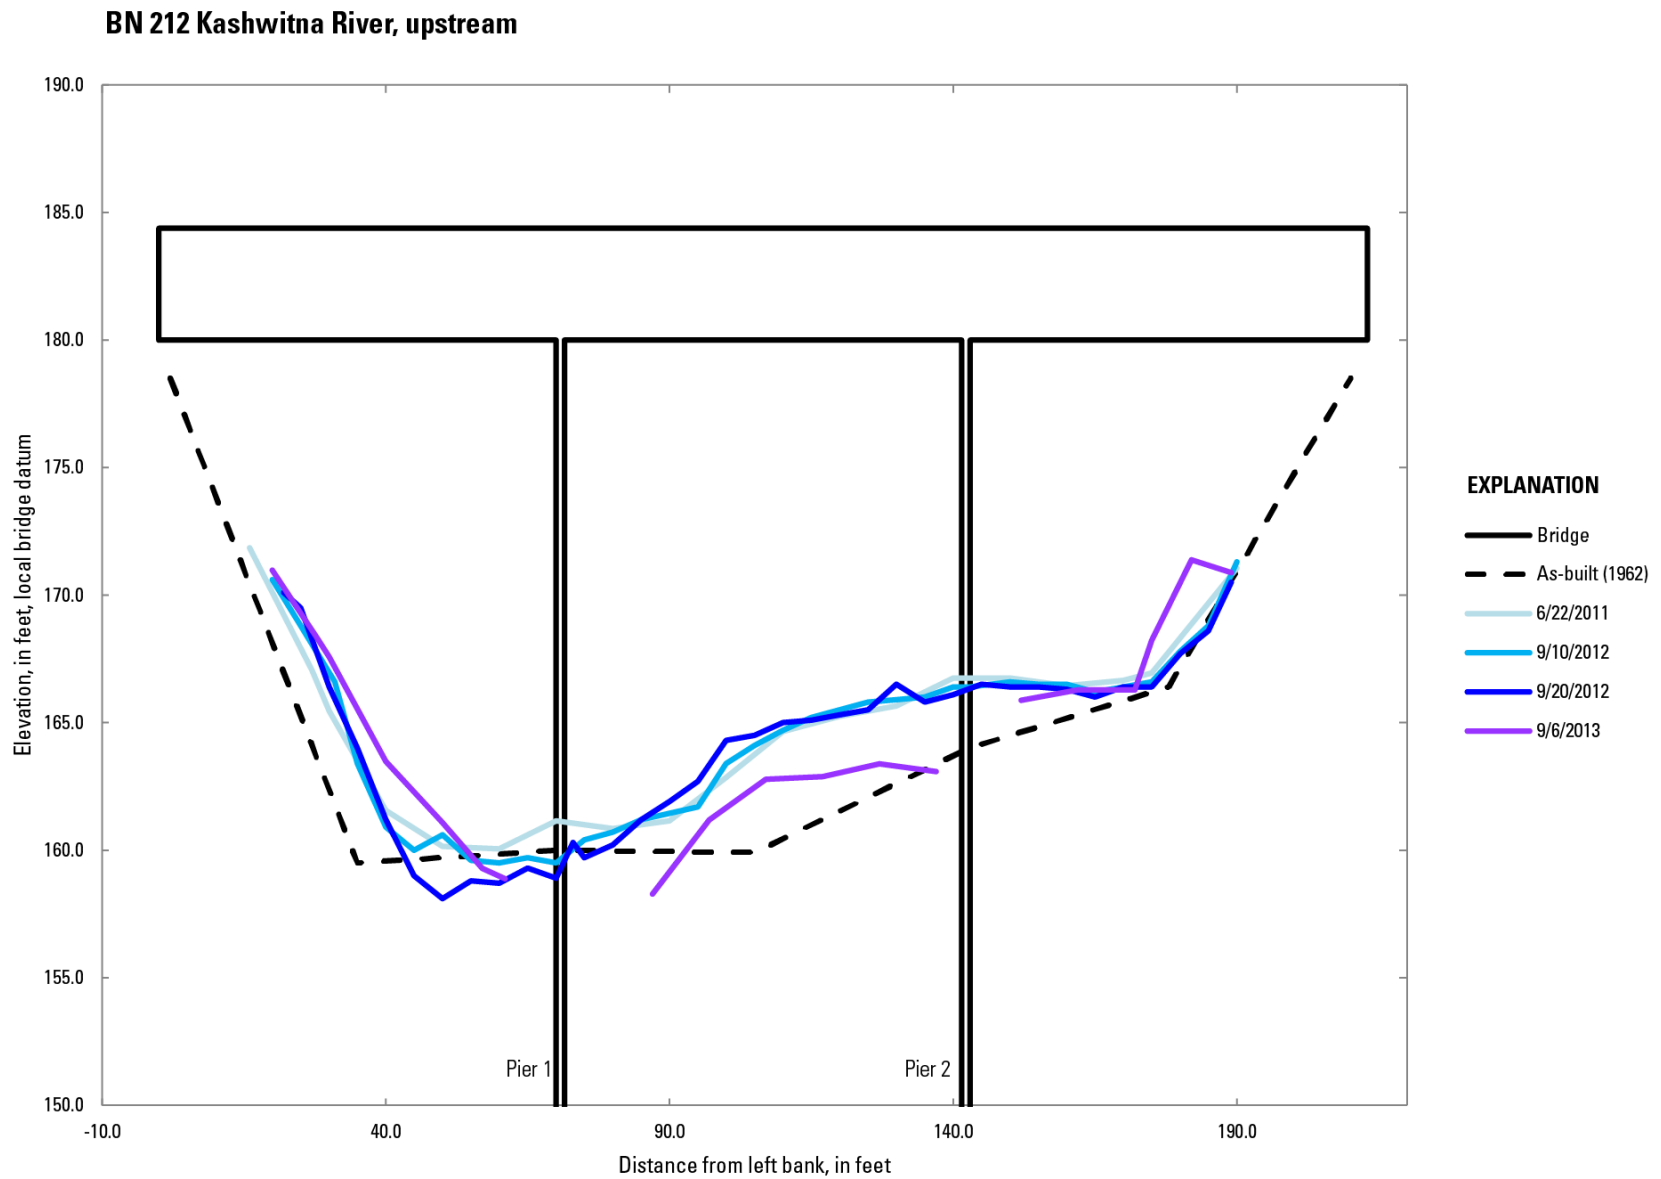
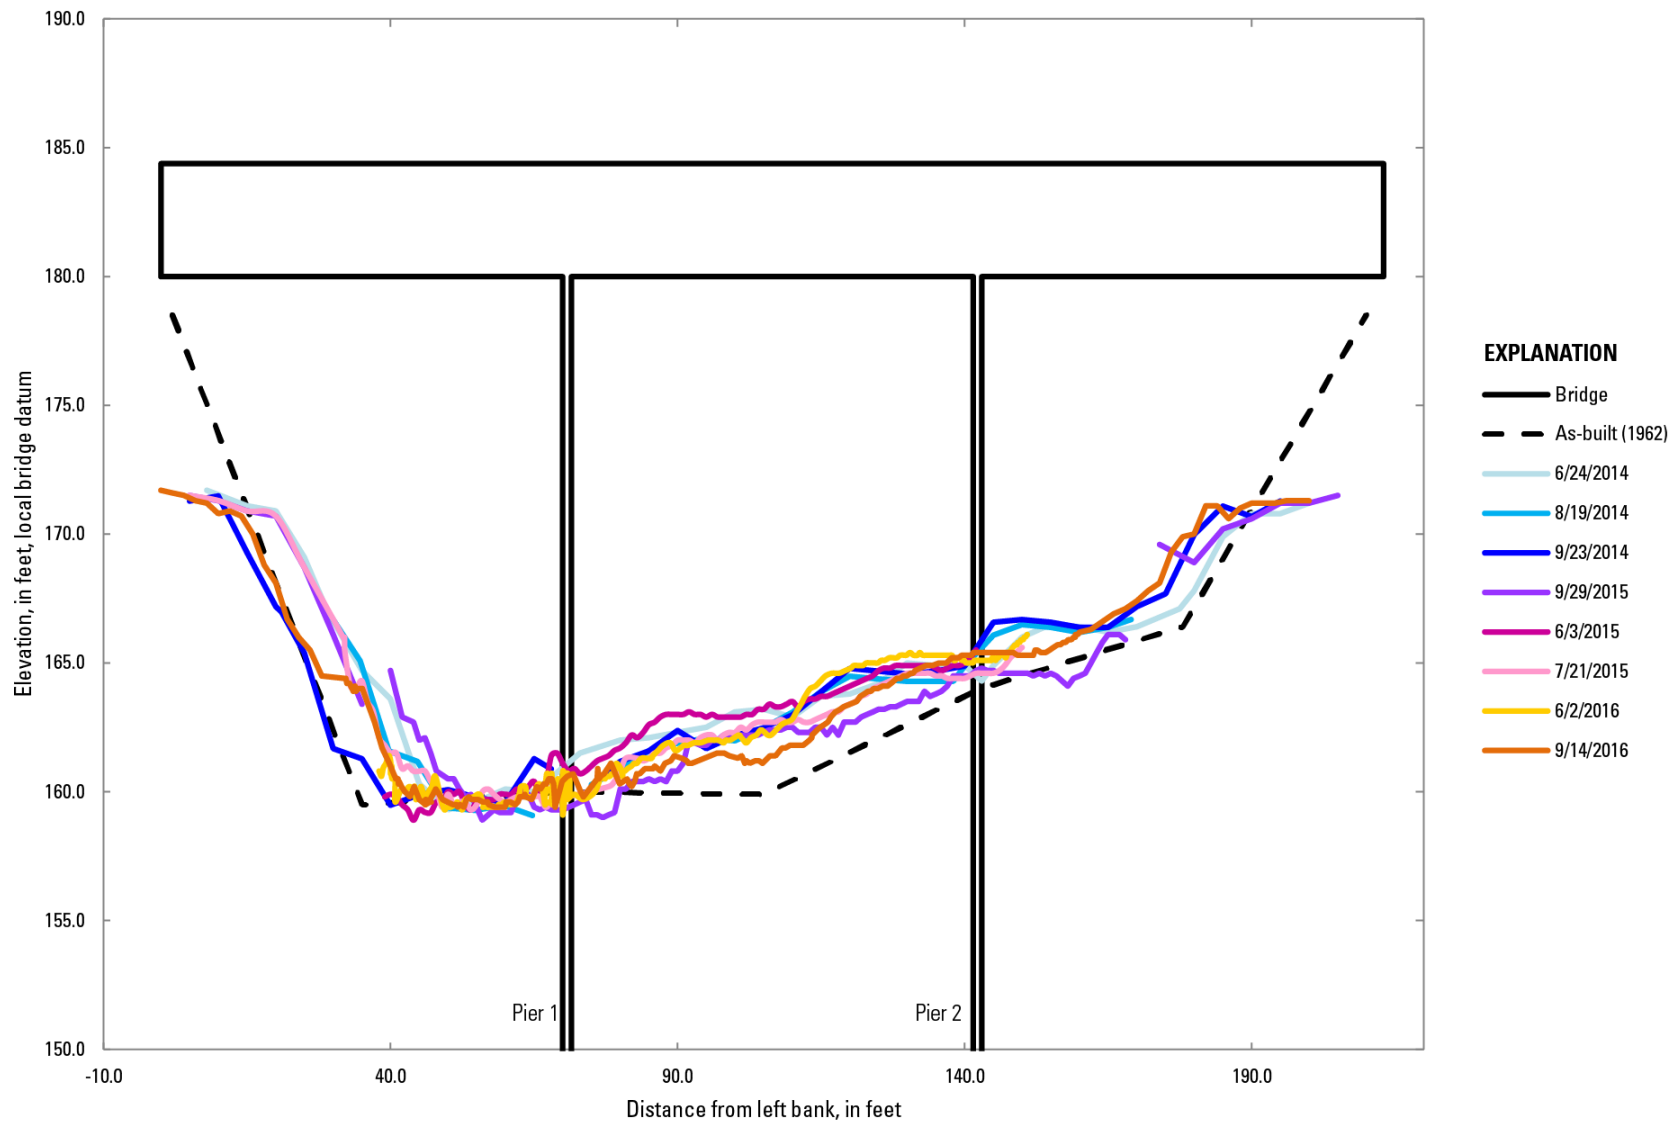
Cross sections are collected from a pedestrian bridge 30 ft upstream of the highway bridge and are considered representative of the channel at the highway bridge owing to the proximity of the bridges and the uniformity of the channel between the bridges. Cross sections were collected from 2005 to 2016 (figs. 8–10) with a maximum streambed scour of 3 ft observed in the left part of the channel. The remainder of the channel has aggraded 3 ft since the as-built survey. Despite relatively consistent debris accumulation on the piers, localized pier scour is not evident.

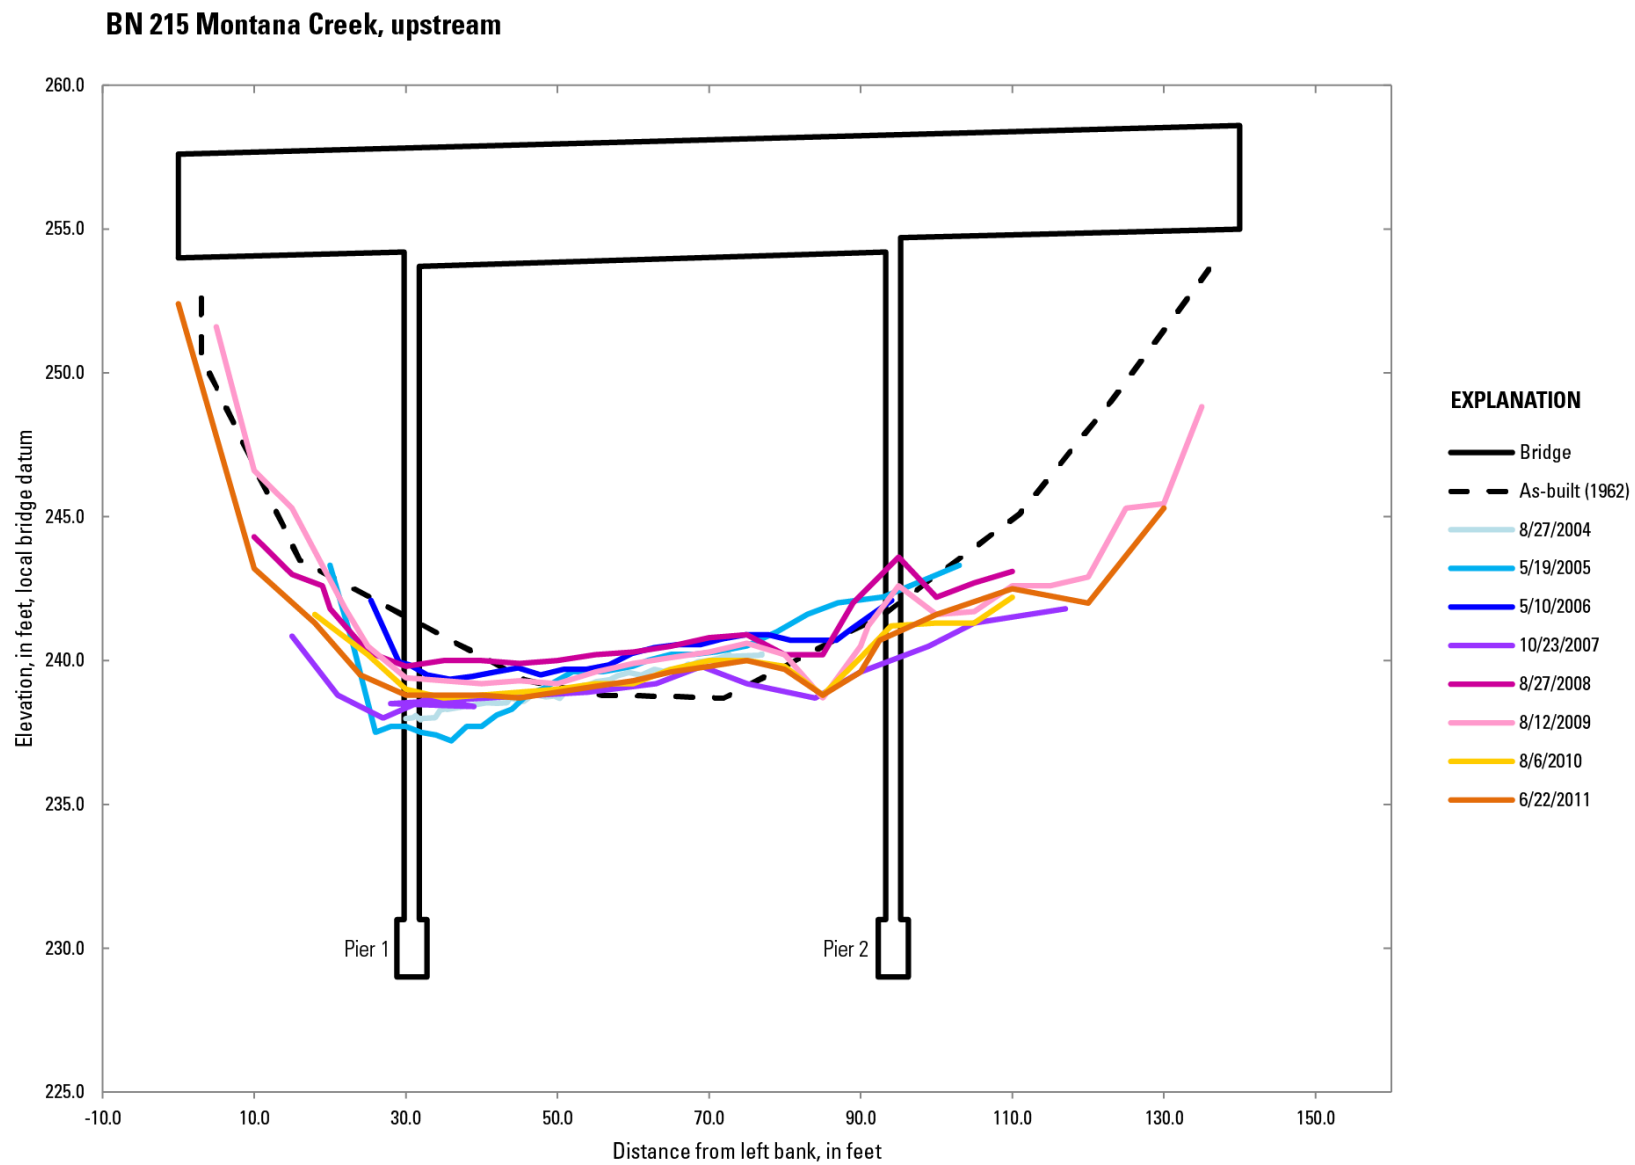
Figure 11. Cross sections showing upstream soundings at bridge 215, Montana Creek, Alaska, 2004–11.

Montana Creek originates in the Talkeetna Range, but is not glacially fed. The channel curves right upstream of the bridge but is straight through the bridge reach. The channel constricts slightly at the highway bridge. Overbank flow is confined to the right side of the channel, which is vegetated with small to medium bushes and a few trees, whereas the left bank is armored in riprap. Both bridge piers are prone to debris accumulation. Cross sections were measured along the upstream side of the bridge from 2004 to 2016 (figs. 11–13). Channel elevations are stable in the center of the channel with less than 2 ft of scour. Maximum local scour at the piers of as much as 5 ft was observed, and channel width has increased 10 ft along the right bank since the as-built survey.

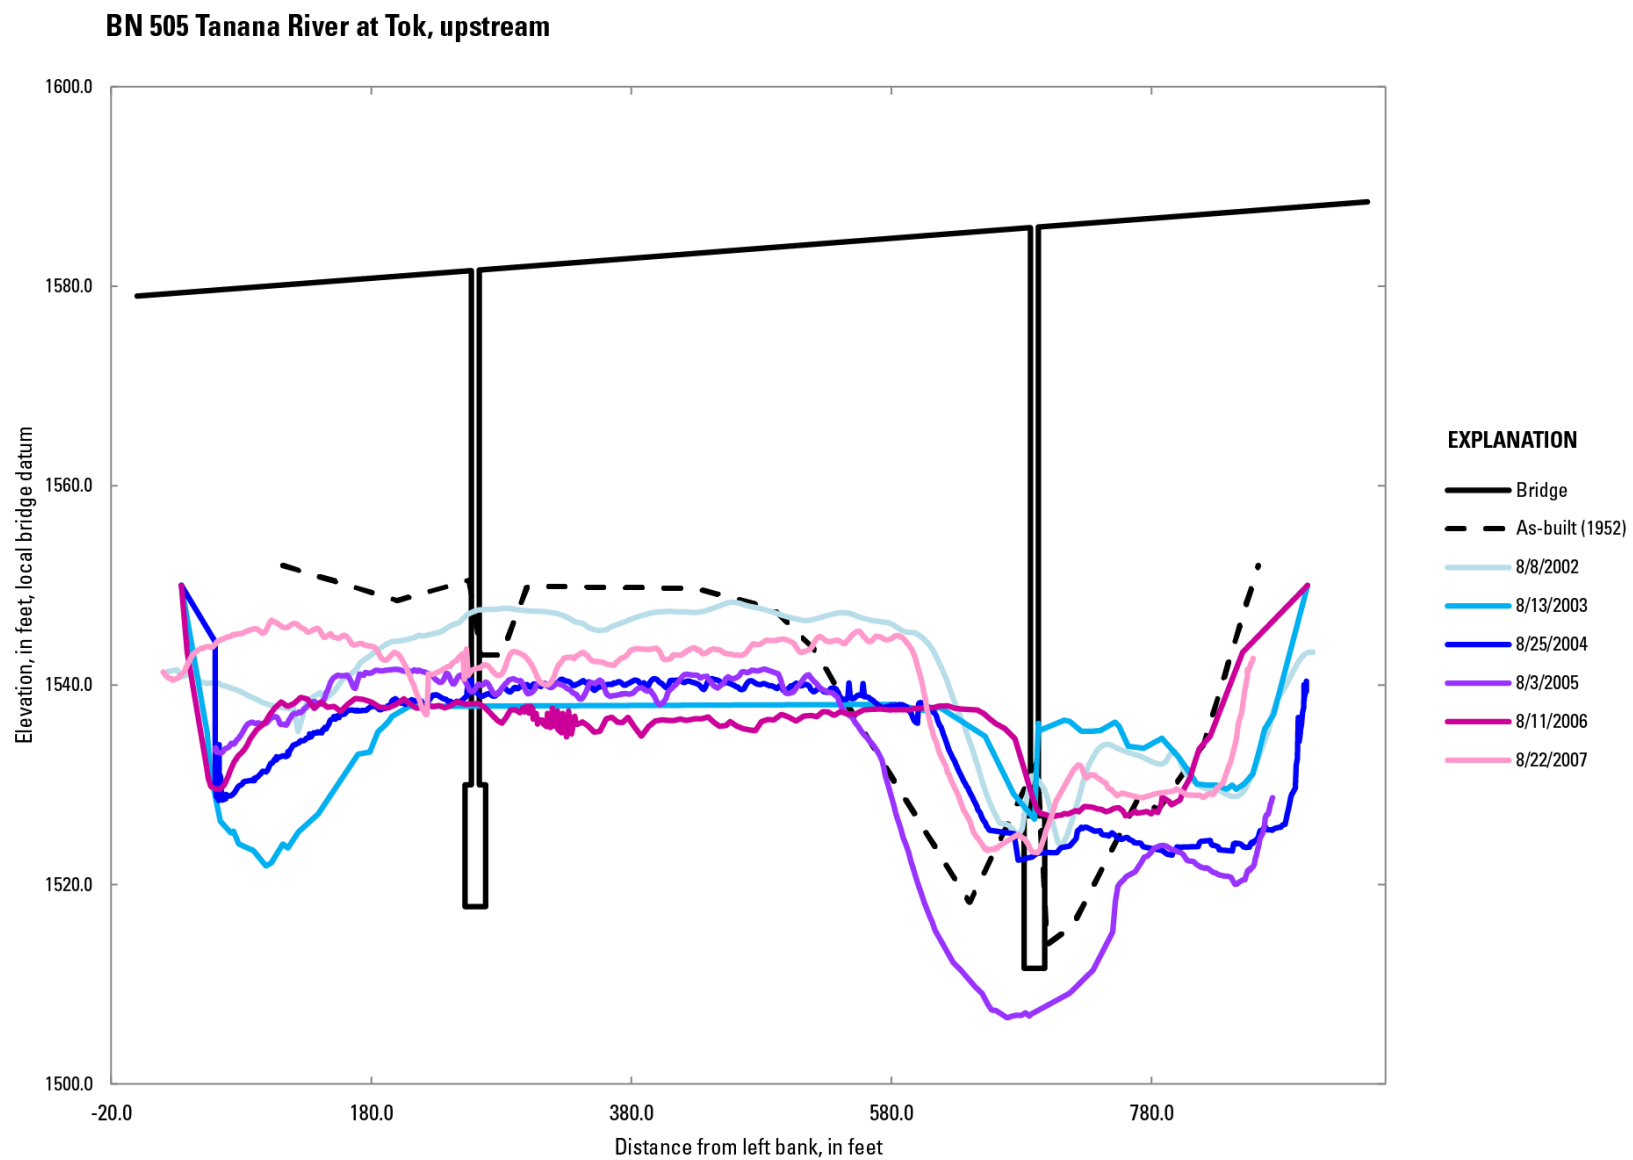
Figure 44. Cross sections showing upstream soundings at bridge 505, Tanana River at Tok, Alaska, 2002–07.

The bridge is located where the Tanana River enters a natural constriction that is controlled by bedrock along the right bank and is a single channel at all but low flows. The river has migrated in the direction of the right bank since the bridge was built and is directed by the bedrock into the bridge reach at an angle. This flow angle of attack on the pier was observed to be about 40–45 degrees (Conaway and Moran, 2004). The high angle of attack on the pier and position of the bridge at the head of a natural constriction, where flow velocities and sediment transport capacity are the highest, made this structure particularly susceptible to streambed scour (Conaway and Moran, 2004). An extensive bathymetric survey was done at Bridge 505 in 2003 (Conaway and Moran, 2004) to build a two-dimensional hydrodynamic model. Annual cross-sectional surveys were done from 2002 to 2010 (figs. 44 and 45). Scour of as much as 22 ft was concentrated at the right-bank pier. Some lesser contraction scour of 9 ft also was noticed at this crossing. The bridge was ultimately replaced in 2010, 250 ft downstream of the original bridge (Conaway, 2010).

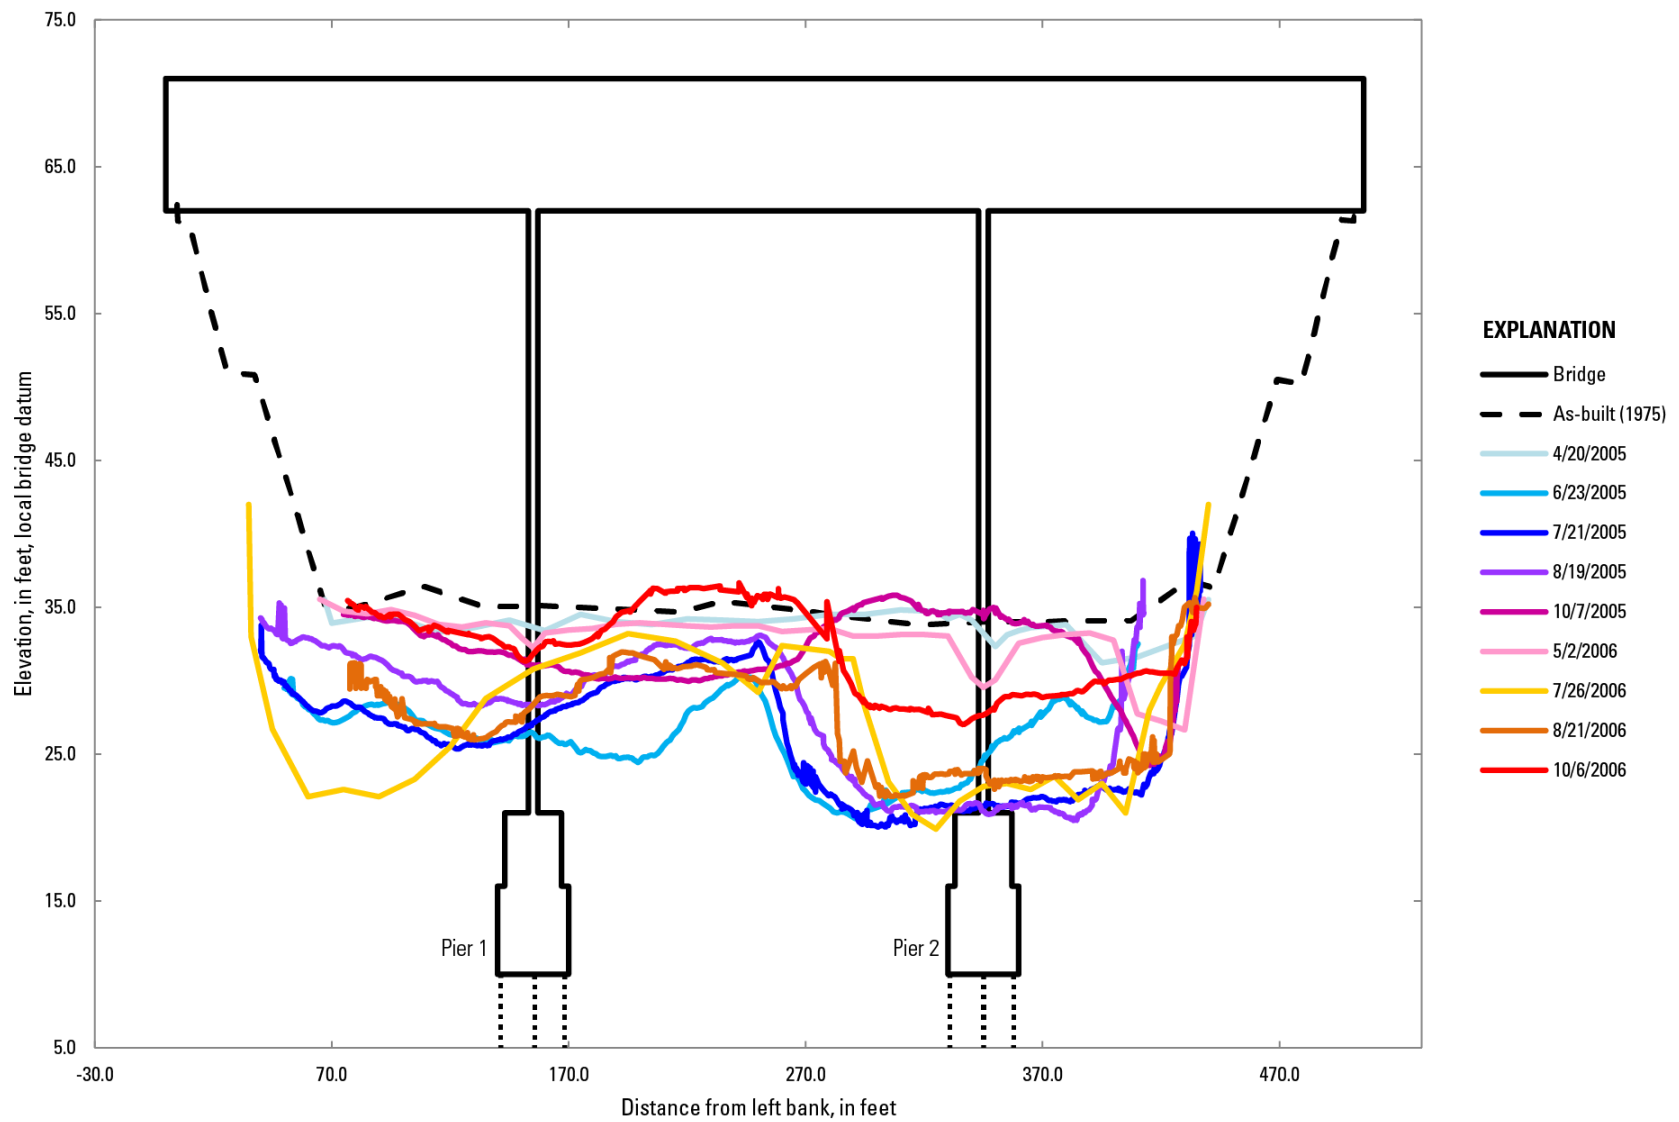
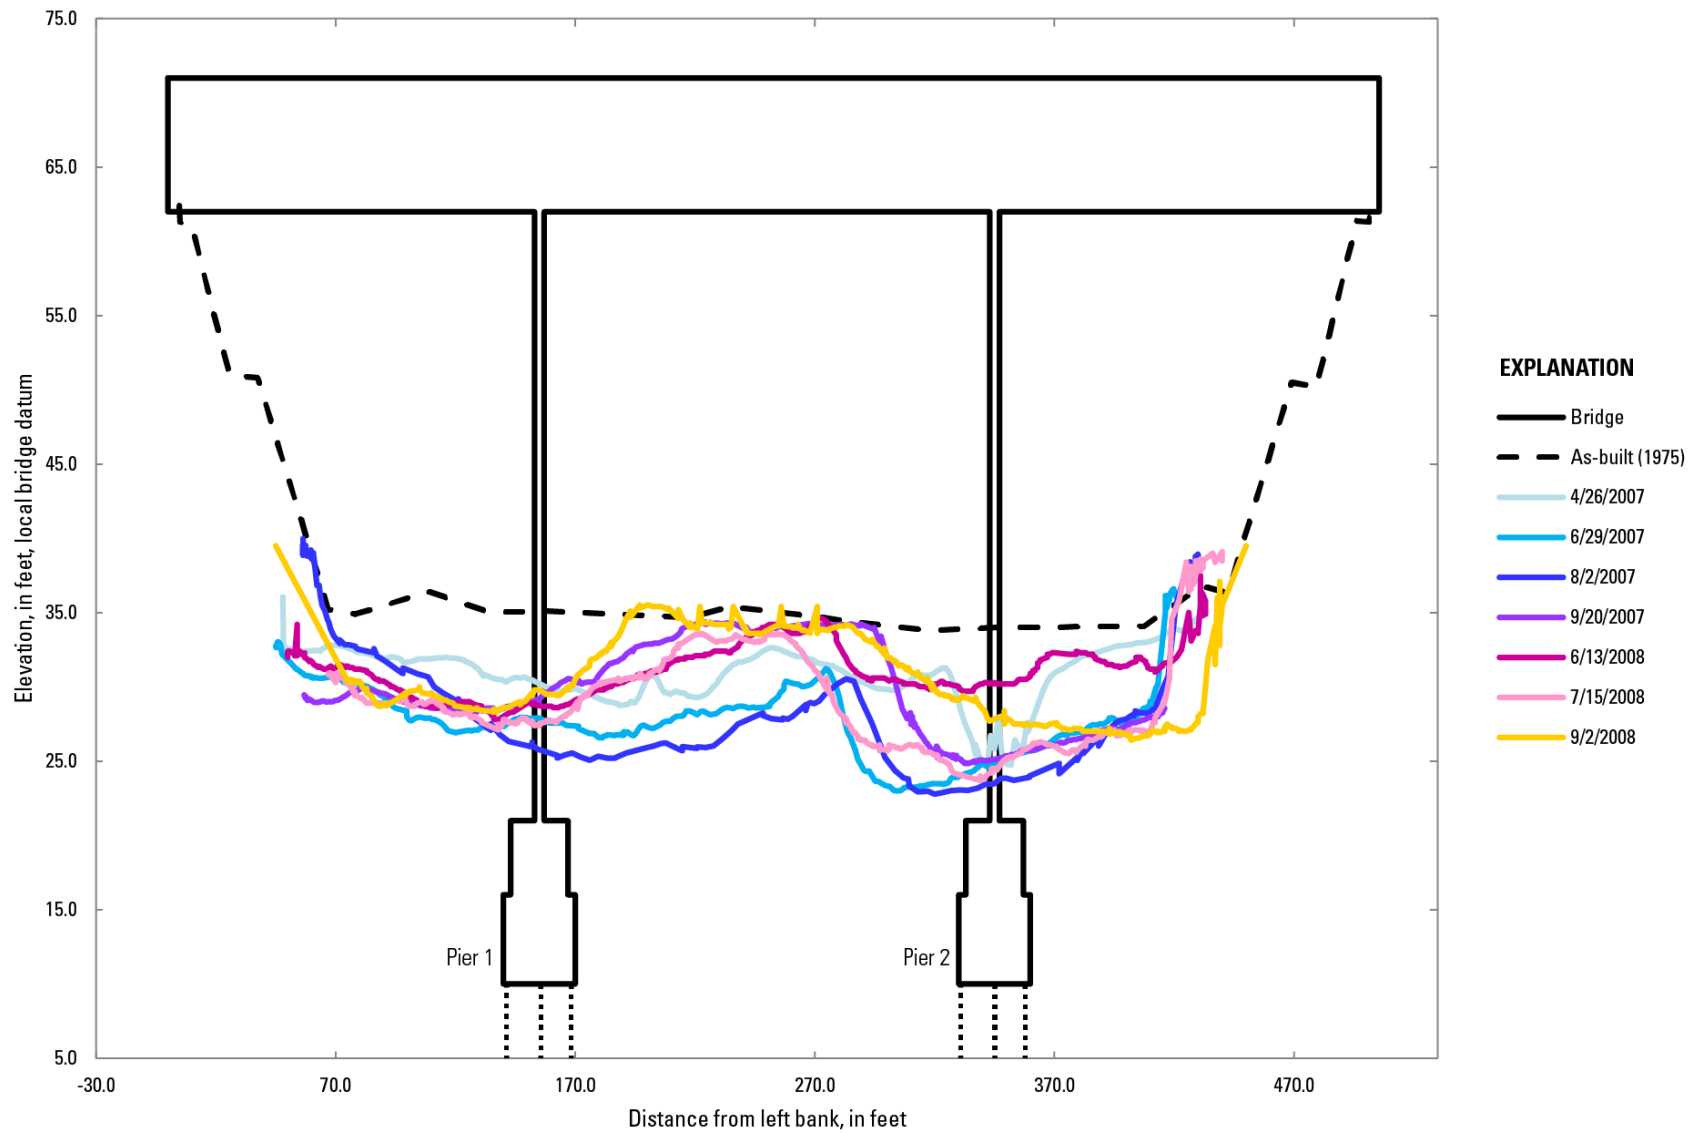
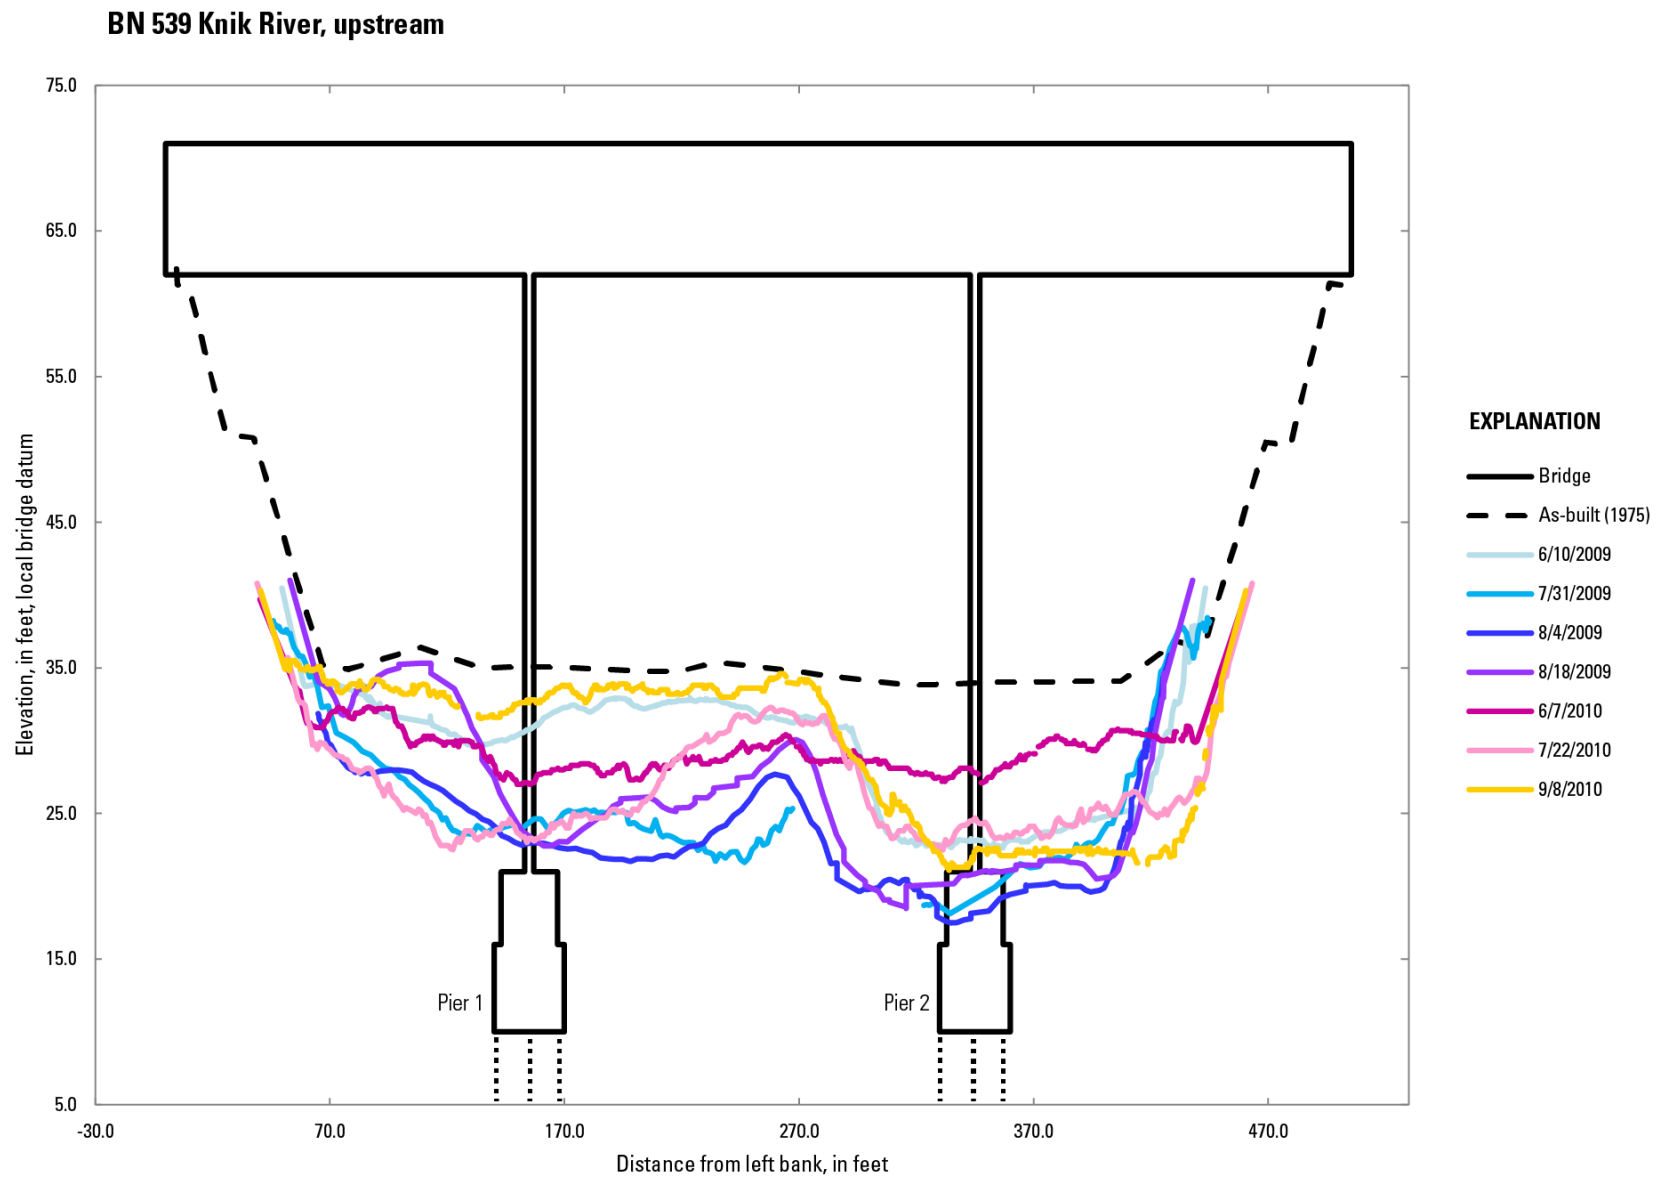
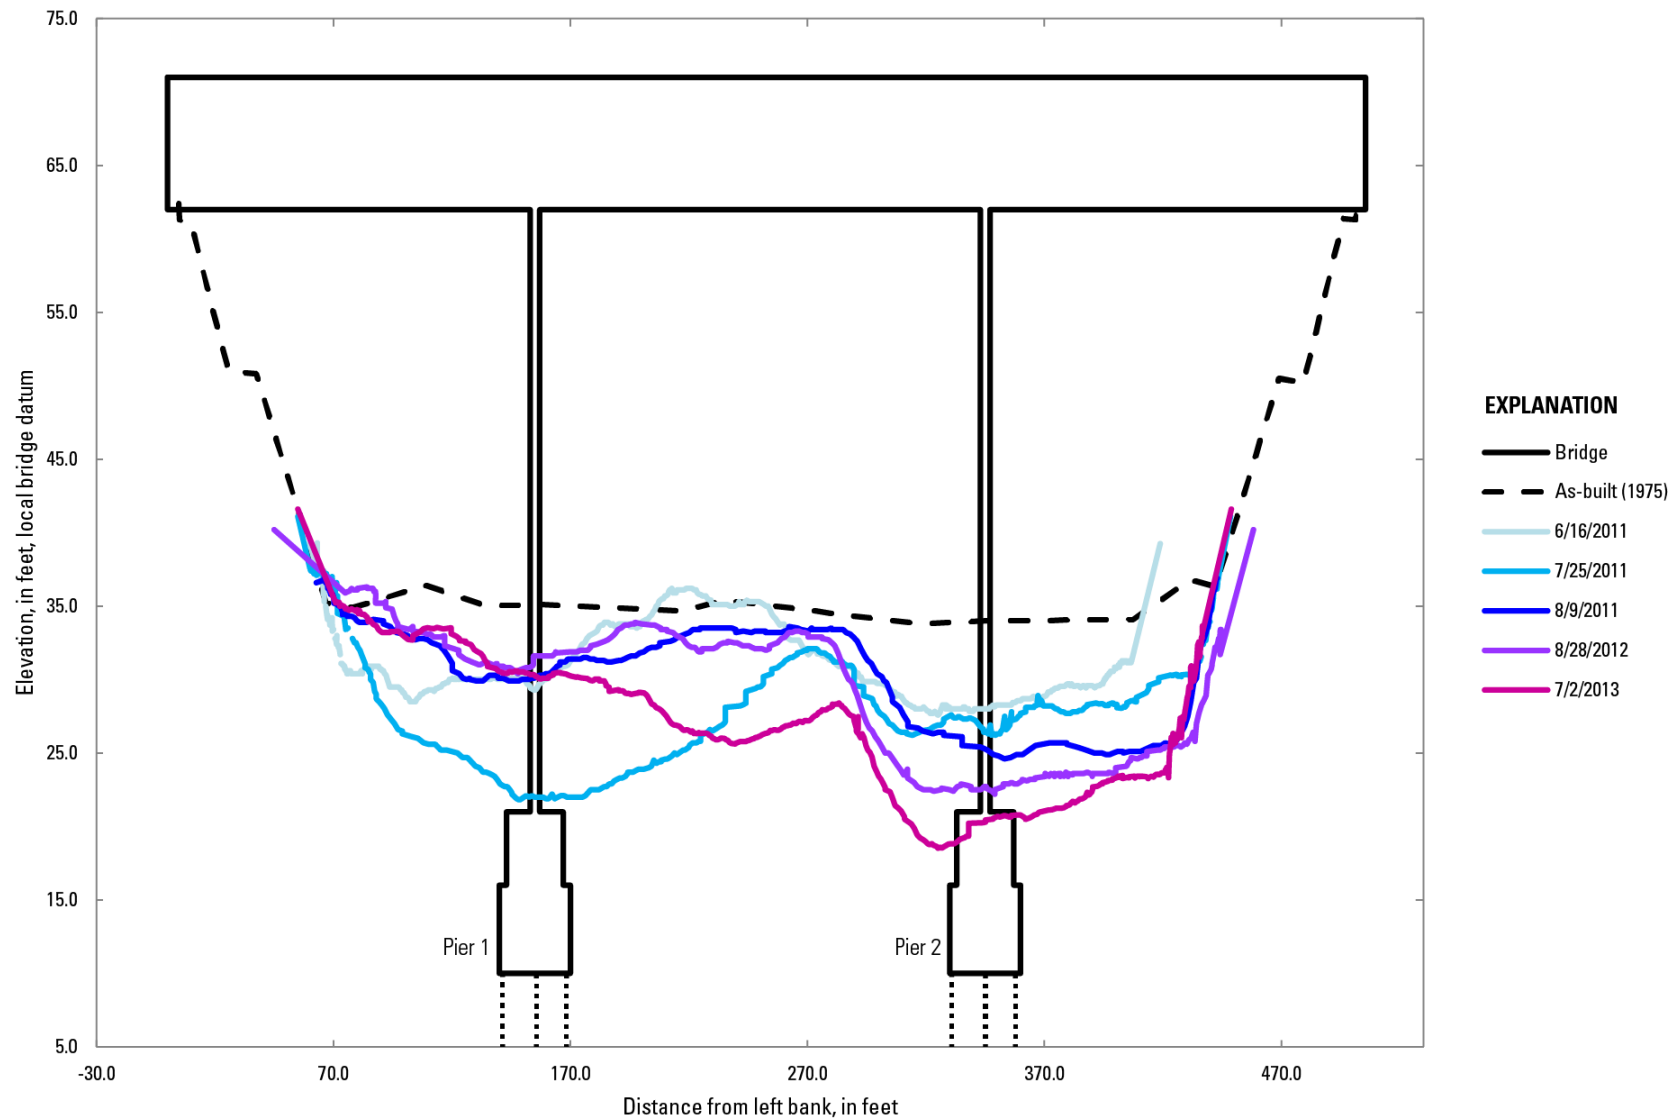
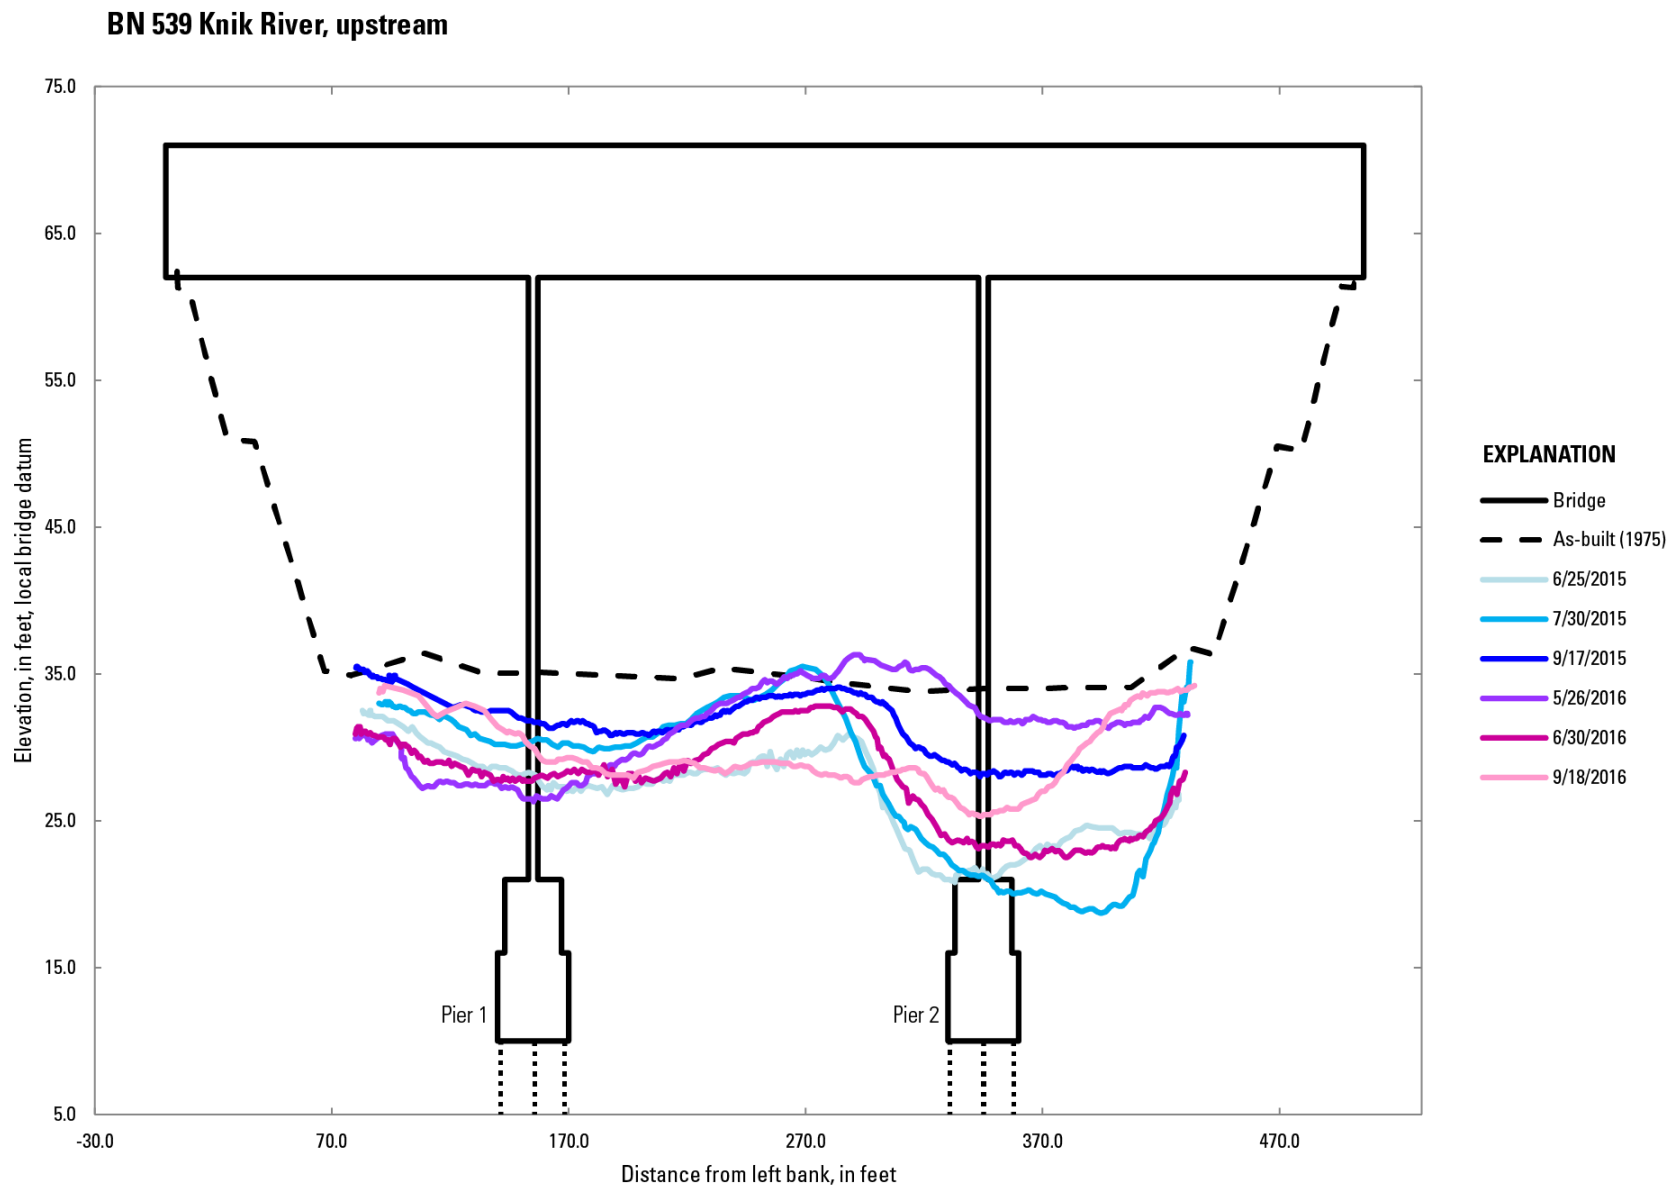
The Knik River is a braided, sand-and-gravel channel that transports large quantities of sediment from the Knik Glacier, which is about 6 mi upstream. Pier-mounted sonar data record an annual pattern of channel aggradation and degradation punctuated by shorter periods of scour and fill related to high flows and the complex pier geometry (Conaway, 2007). Large annual changes in bed elevation across the channel are partially attributed to the nearly 4-to-1 channel contraction at the bridge during high flows. An older bridge and piers directly upstream of the bridge add to the complexity and extent of the scour. Other factors influencing scour at this site are the upstream guide banks and changes in sediment supply. Substantial scour has occurred during every year of monitoring from 2005 to 2013 and 2014 to 2016 (figs. 53–57). Conaway (2006) noted a pattern of increased scour during warm phases of the Pacific Decadal Oscillation due to increased discharge from glacial melt. At higher flows, scour occurs as flow is routed along both guide banks, although in more recent years increasingly more scour has been observed along the right bank. The most substantial scour (as much as 13 ft) tends to occur during July–August, whereas data collected in spring and later in autumn show that bed elevations across the channel return to about the same elevation of those in the as-built cross section. Scour reaches critical levels when the footing and sub-footing of the right bank pier are exposed by the cumulative effects of local scour at the pier and contraction scour.
