Measurement of Long-Term Channel Change Through Repeated Cross-Section Surveys at Bridge Crossings in Alaska

Open-File Report 2019–1028

By Karenth L. Dworsky and Jeffrey S. Conaway

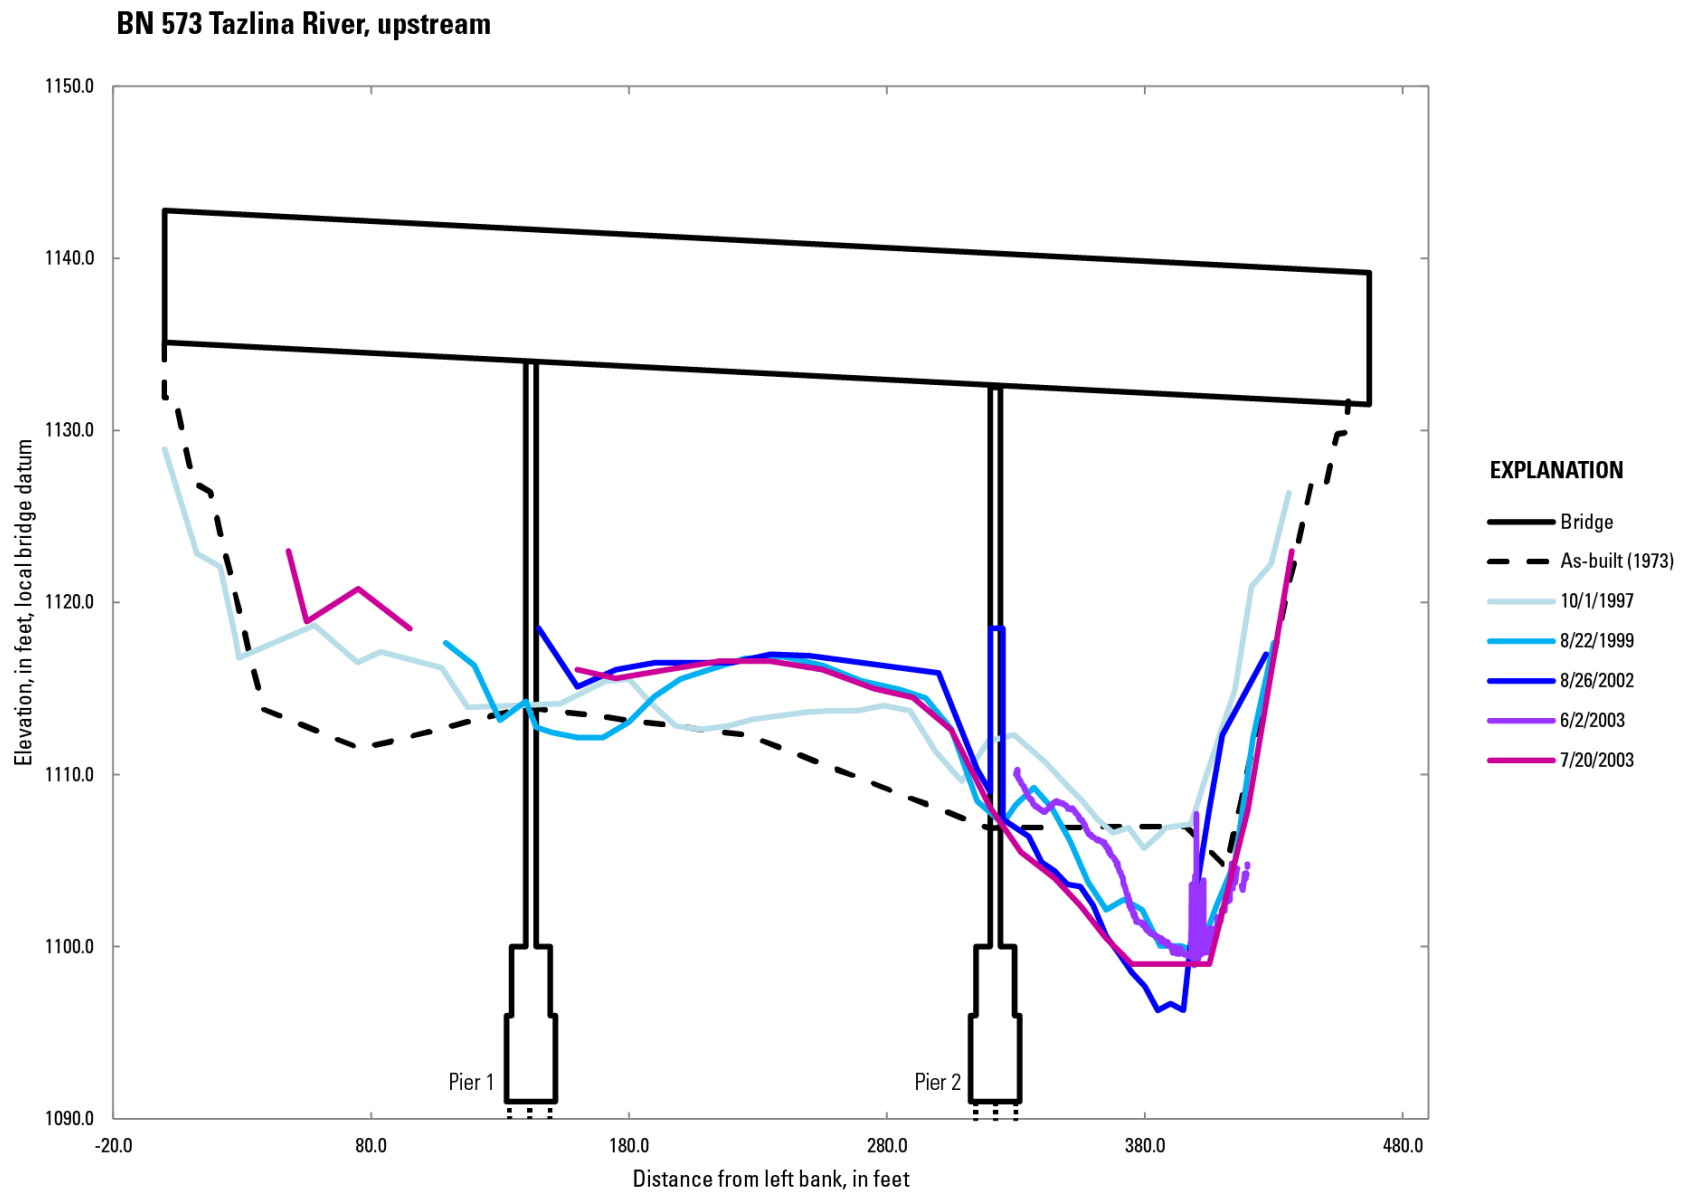
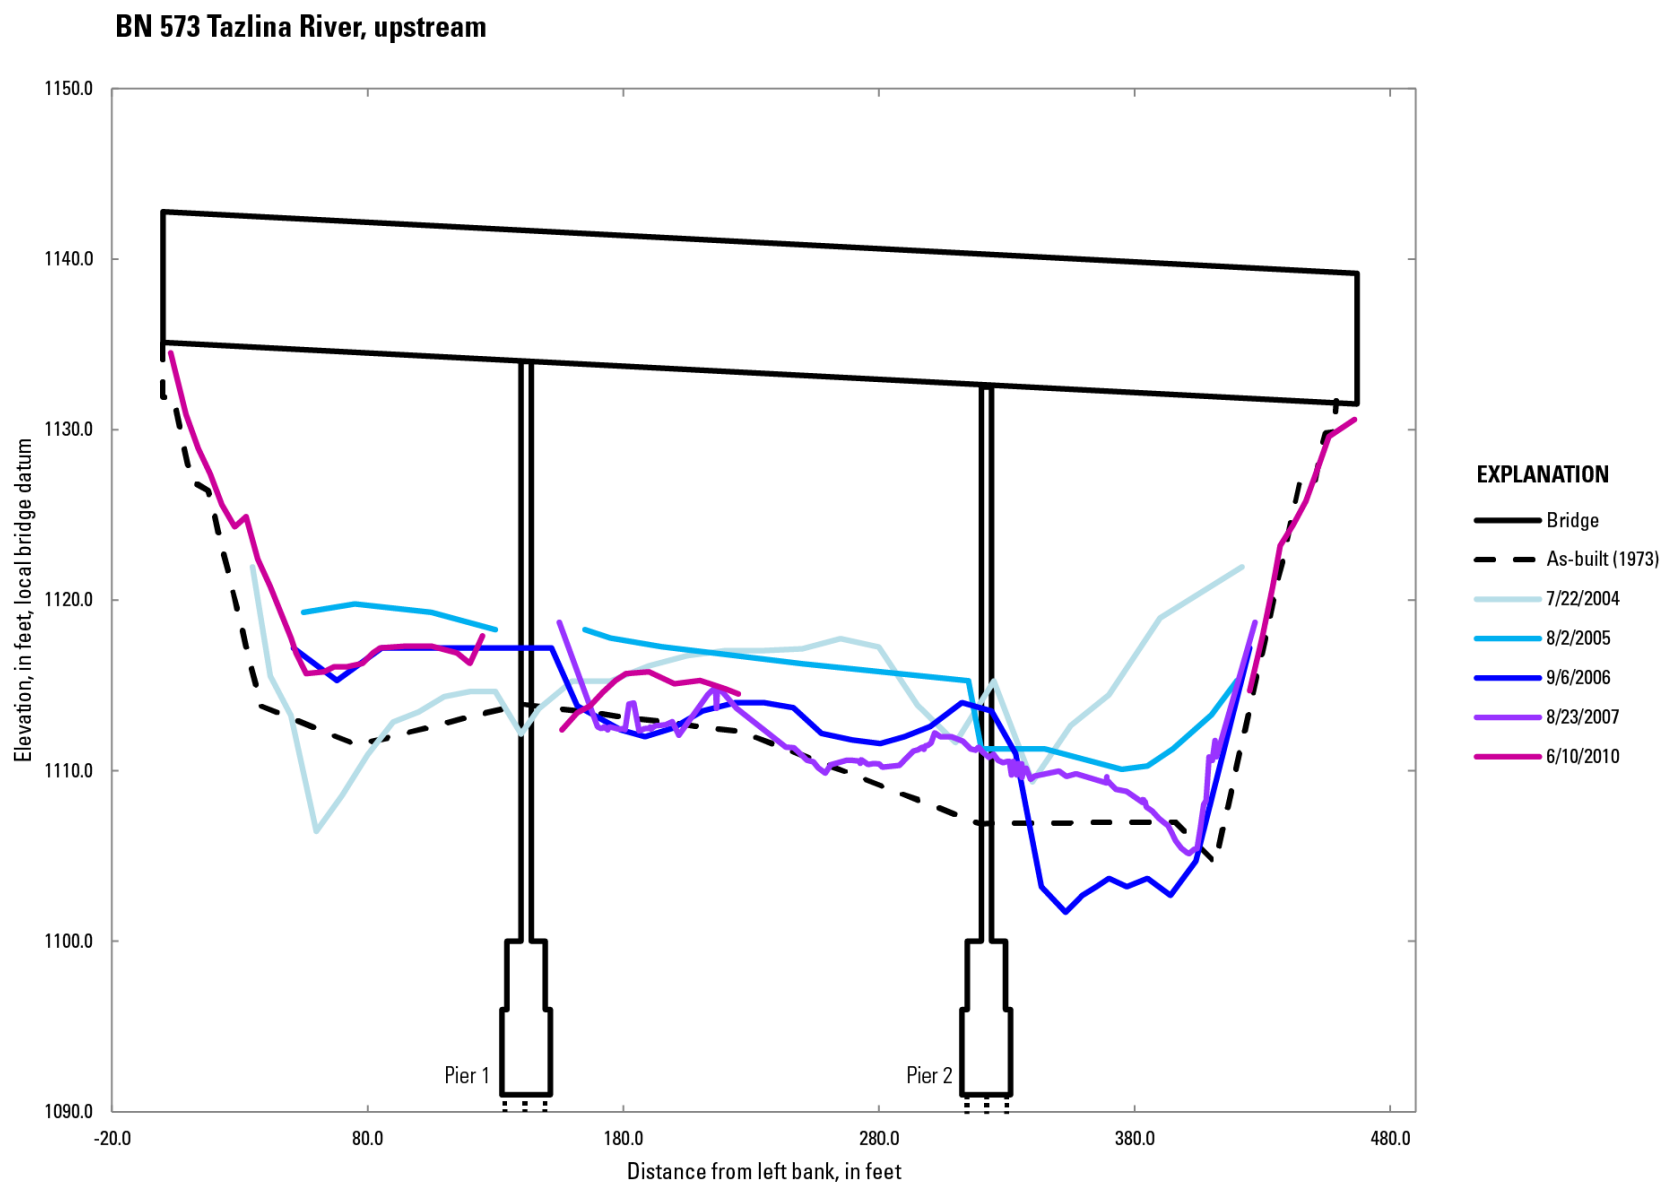
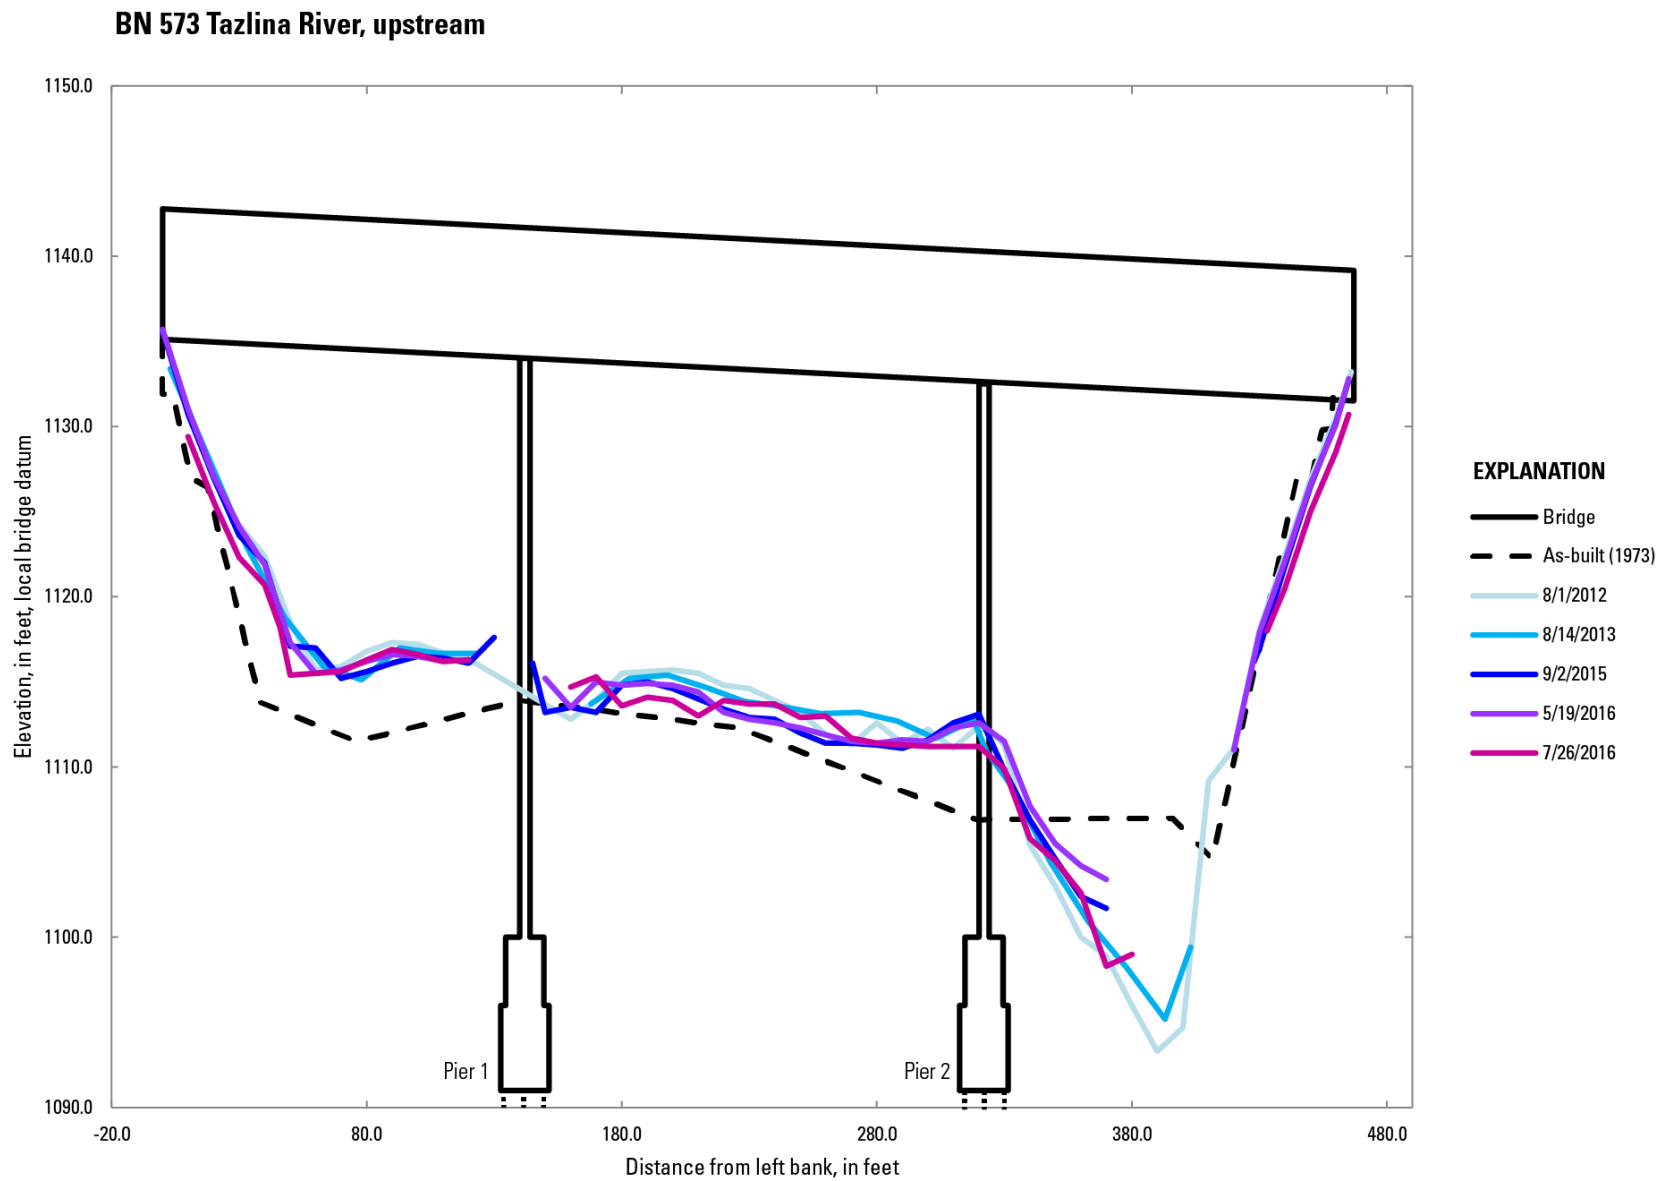
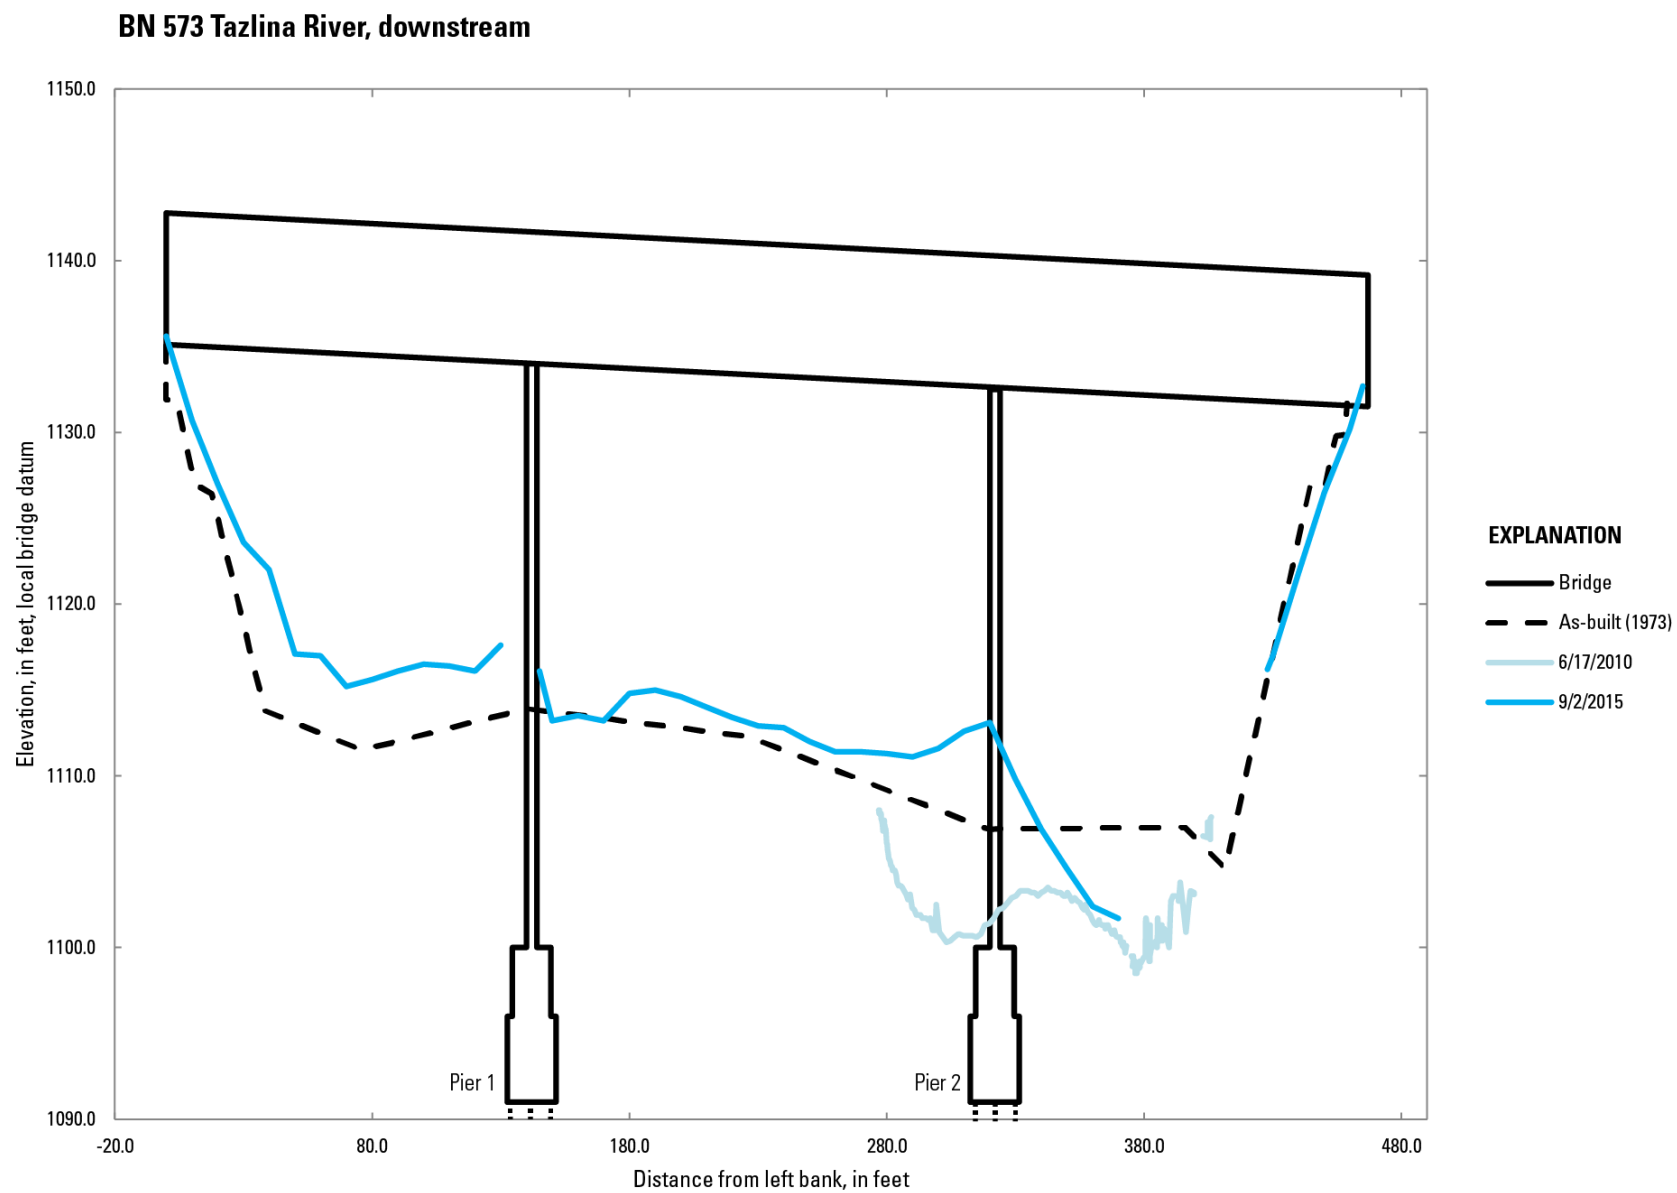
Cross sections were collected along the upstream side of the bridge during 1997, 1999, 2002–07, 2012, 2013, 2015, and 2016 (figs. 58–61). Maximum streambed scour of 14 ft was observed in the right side of the channel. The remainder of the channel has aggraded 6 ft since the as-built survey. Flow velocities greater than 13 ft/s have prohibited the measurement of accurate streambed depths in the right side of the channel for the past 3 years (2013–16).

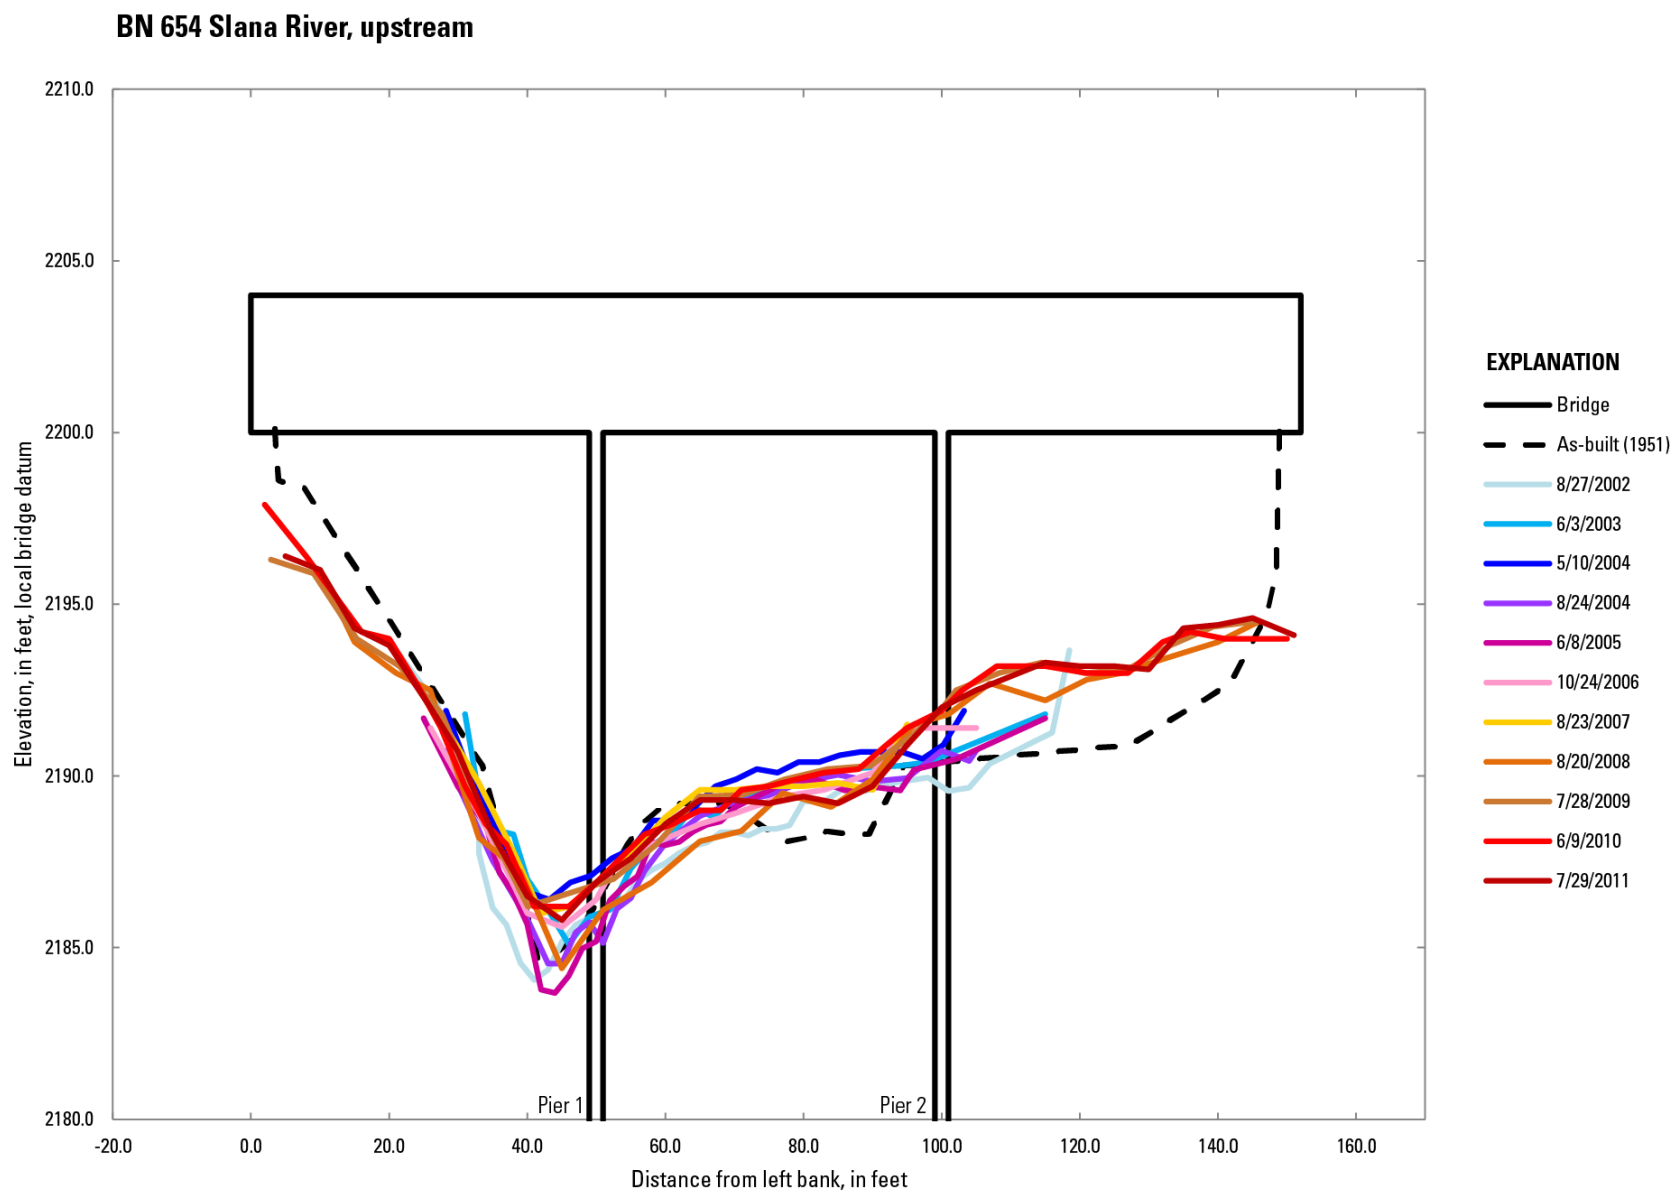
Figure 62. Cross sections showing upstream soundings at bridge 654, Slana River, Alaska, 2002–11.

The Slana River is a tributary of the Copper River, originating in the Alaska Range. It is a single meandering channel near the bridge. Cross sections were collected from 2002 to 2011 (fig. 62). The as-built cross section indicates a low streambed near the left most pier. Soundings indicate that an additional 3 ft of local scour occurred around the left pier, whereas as much as 3 ft of aggradation occurred across the right side of the channel.

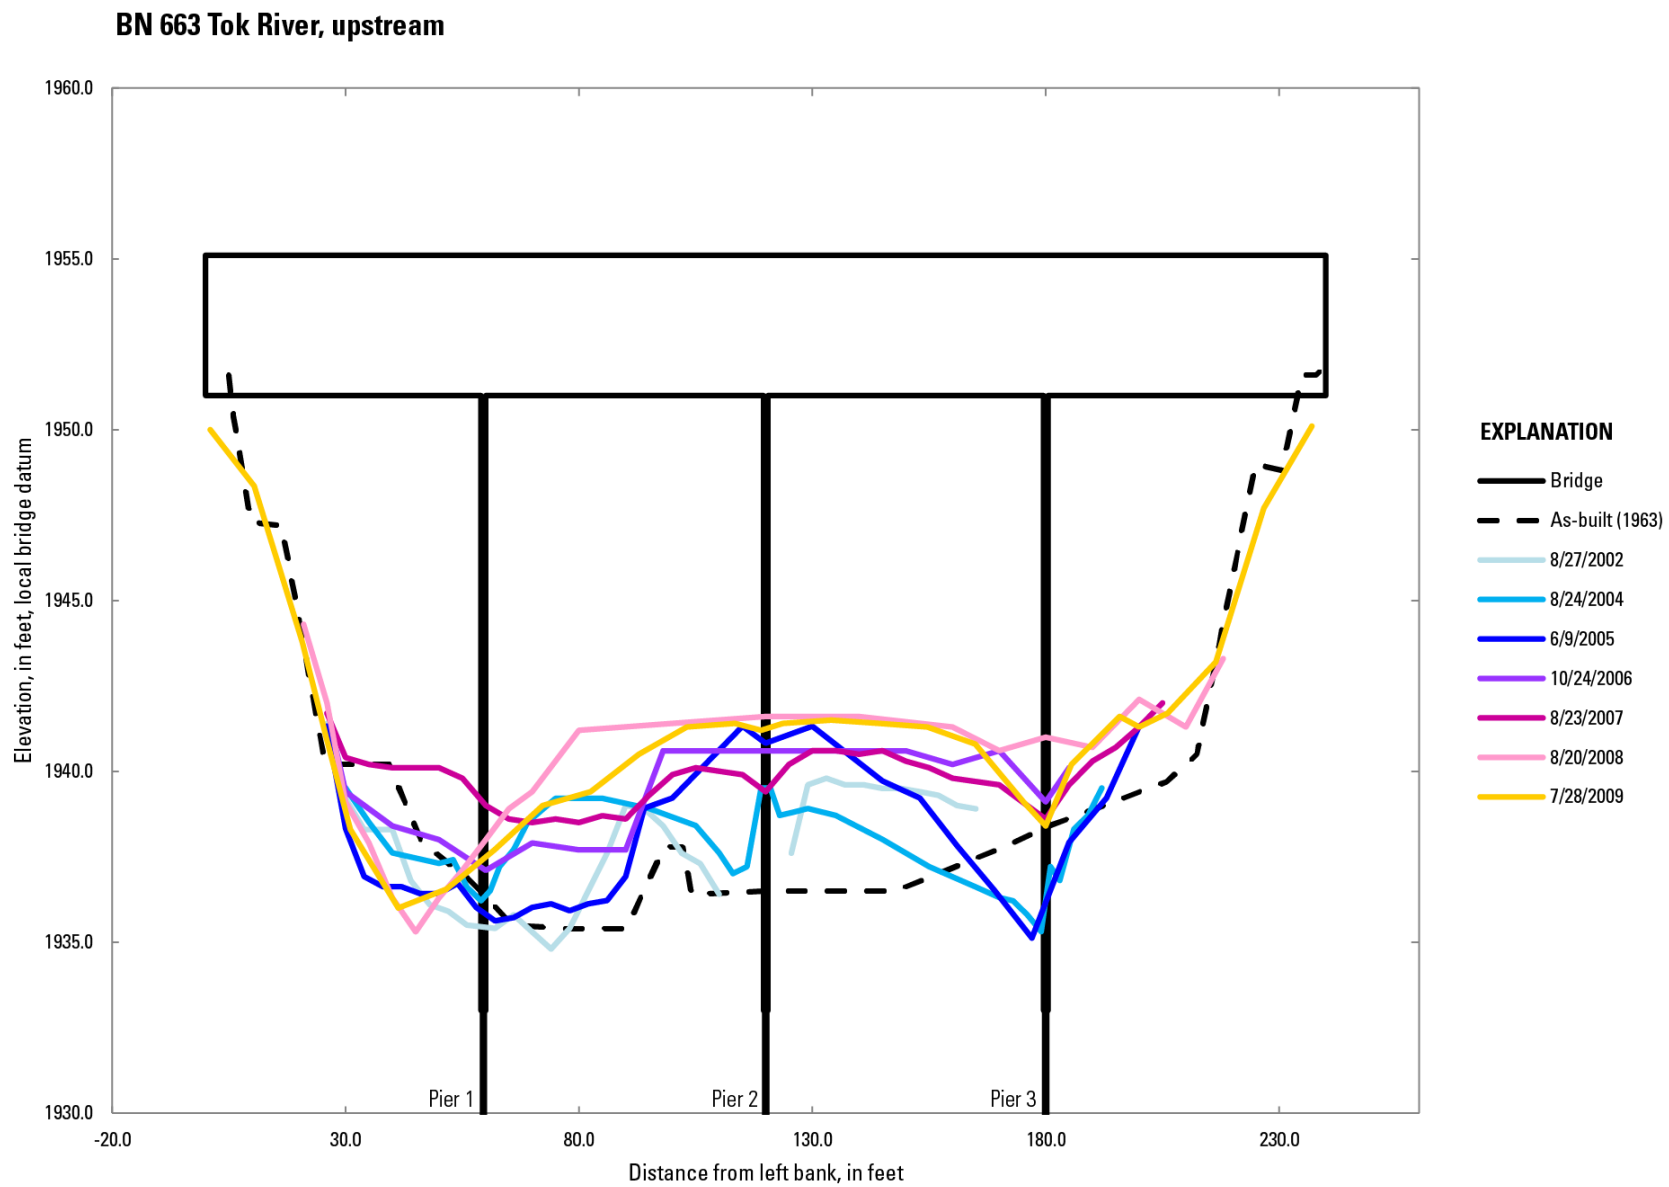
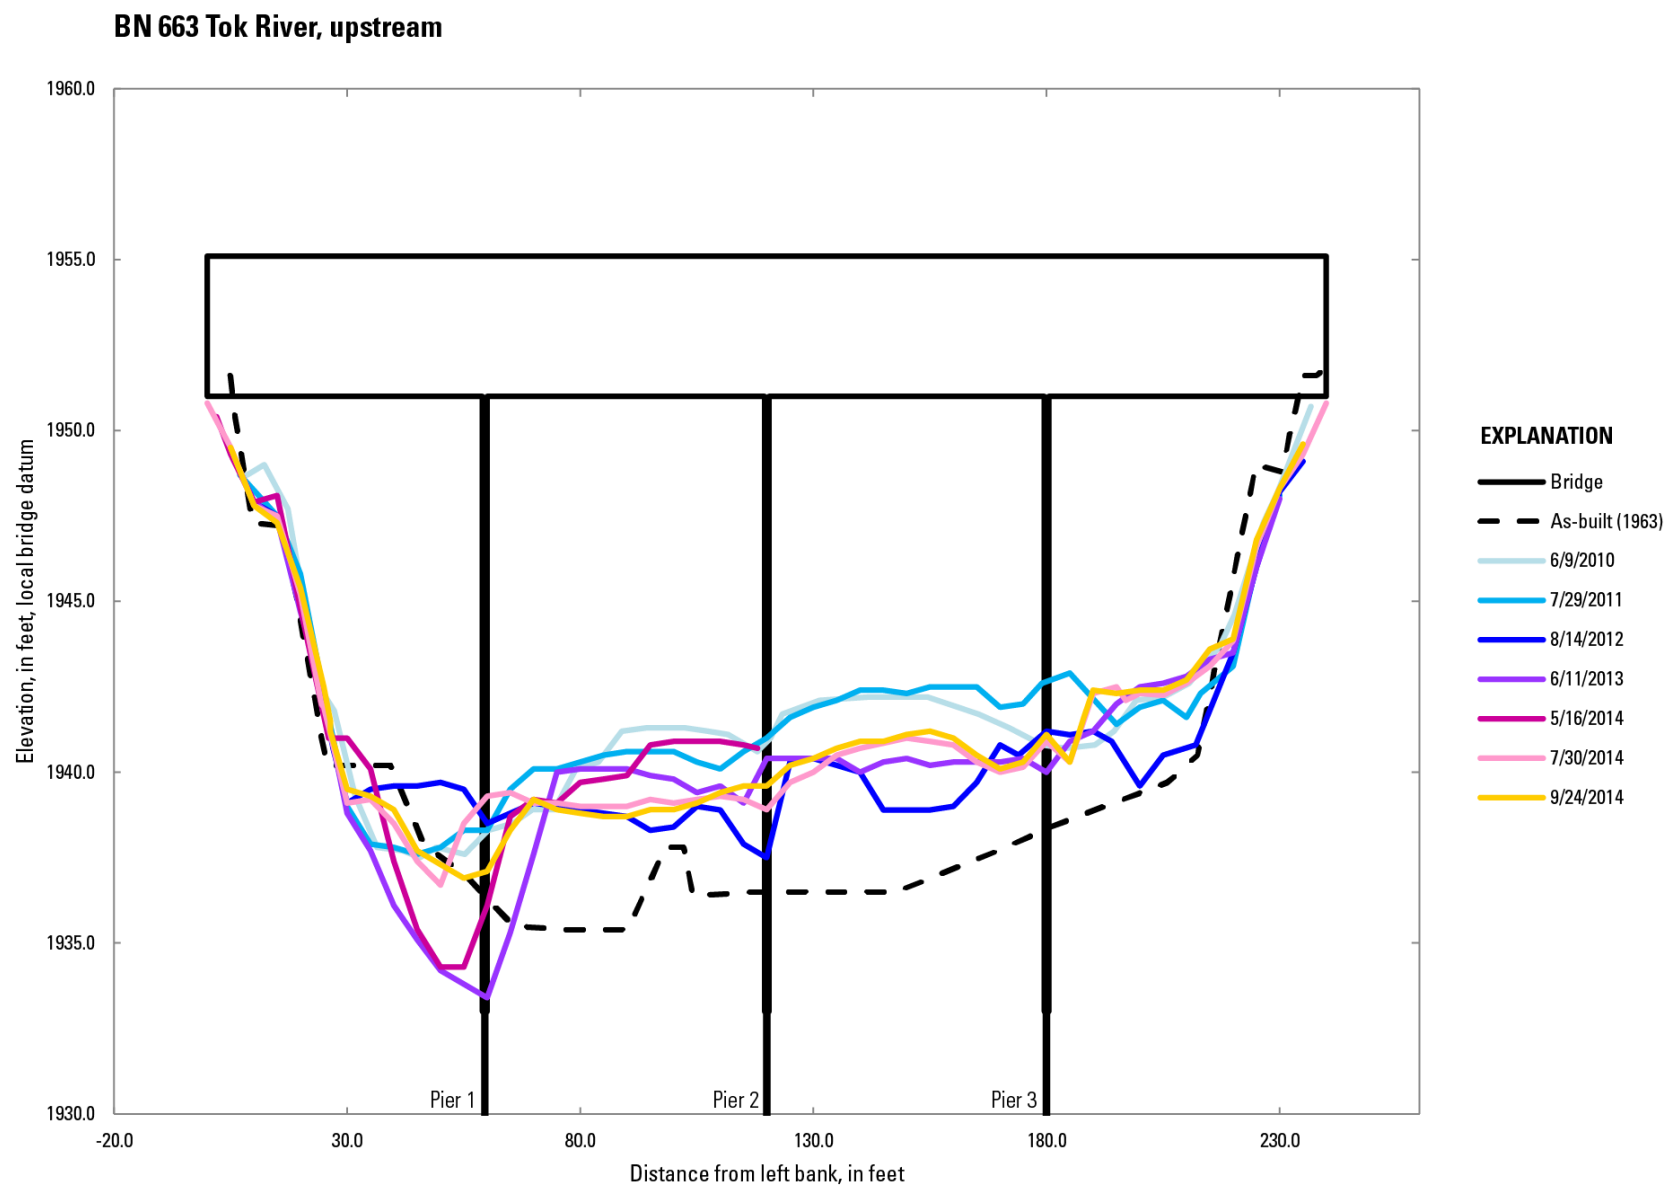
The Tok River is a wide, braided gravel-bed river originating in the Alaska Range and is a tributary of the Tanana River. Cross sections were measured in 2002 and from 2004 until the bridge was replaced in 2014 (figs. 63 and 64). The channel had an overall aggradation of 5 ft relative to the as-built cross-section. From 2004 to 2005, 6 ft of localized pier scour occurred on the rightmost pier, and from 2013 to 2014, 6 ft of scour occurred on the leftmost pier.

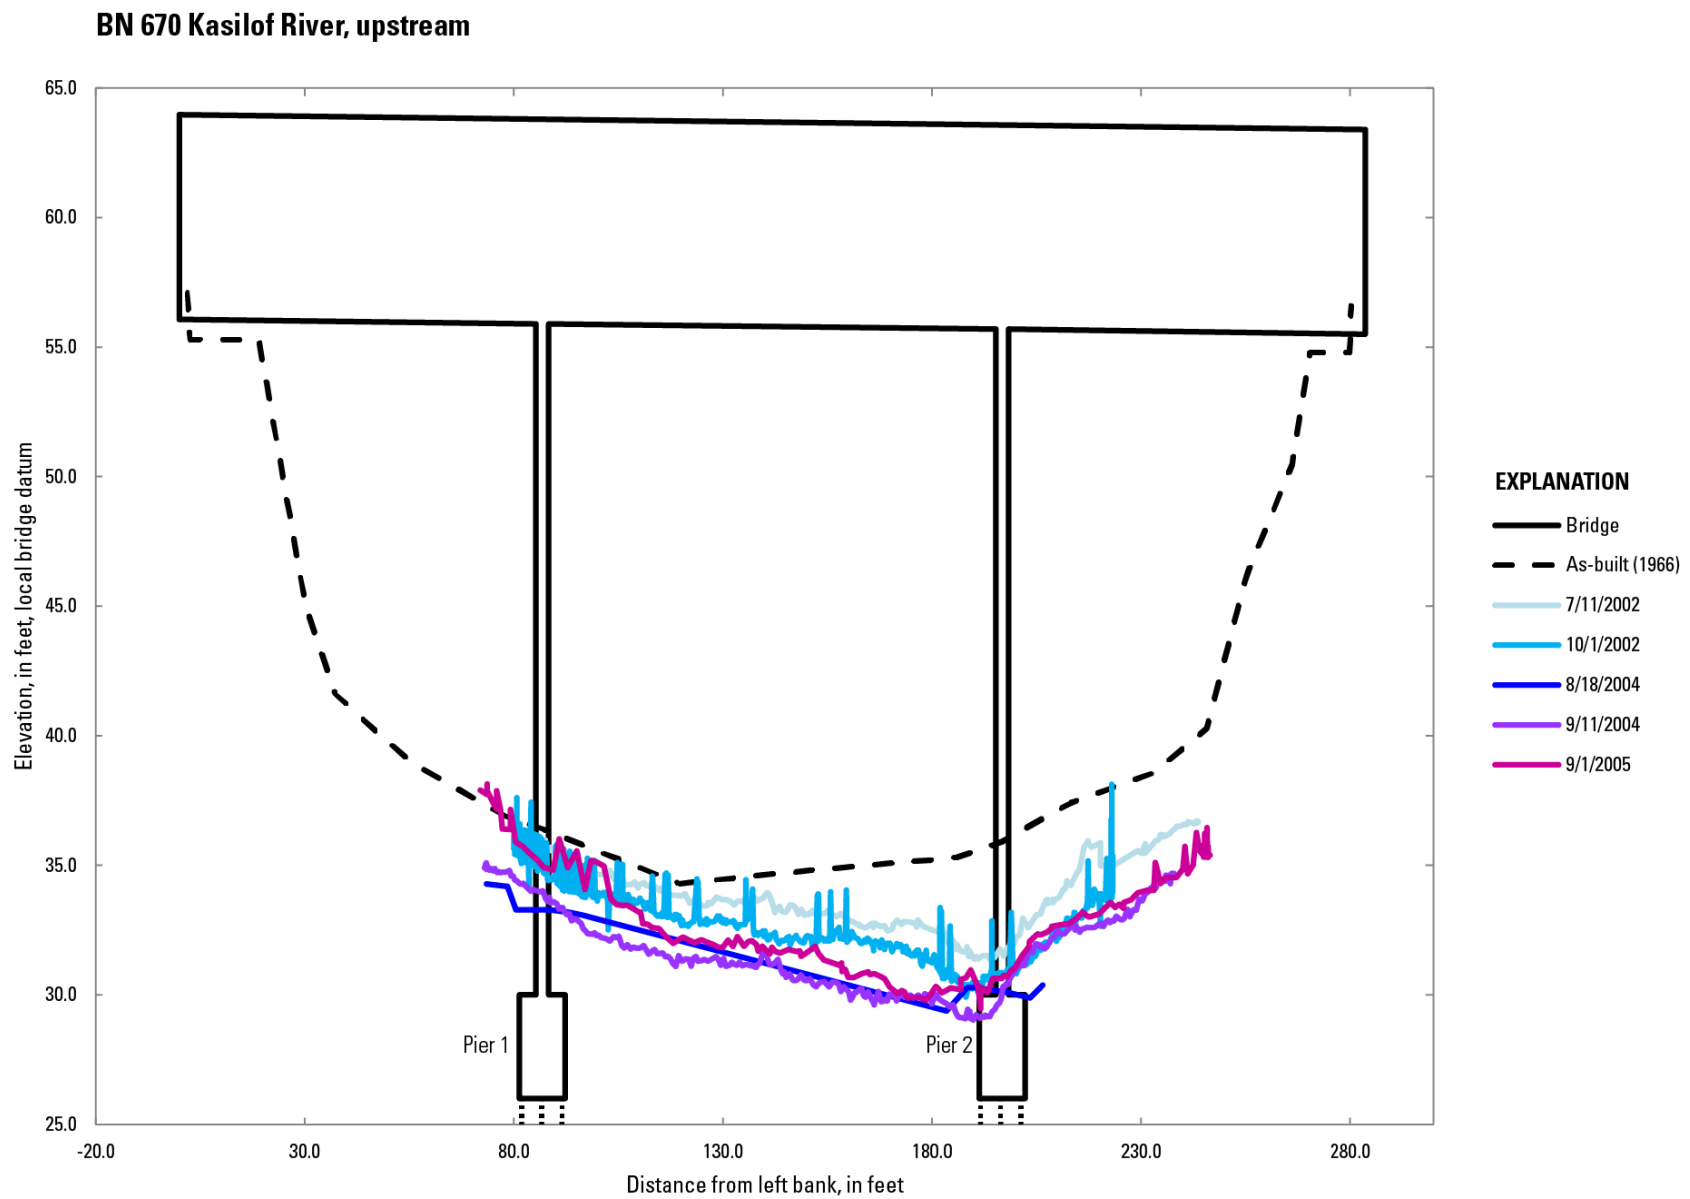
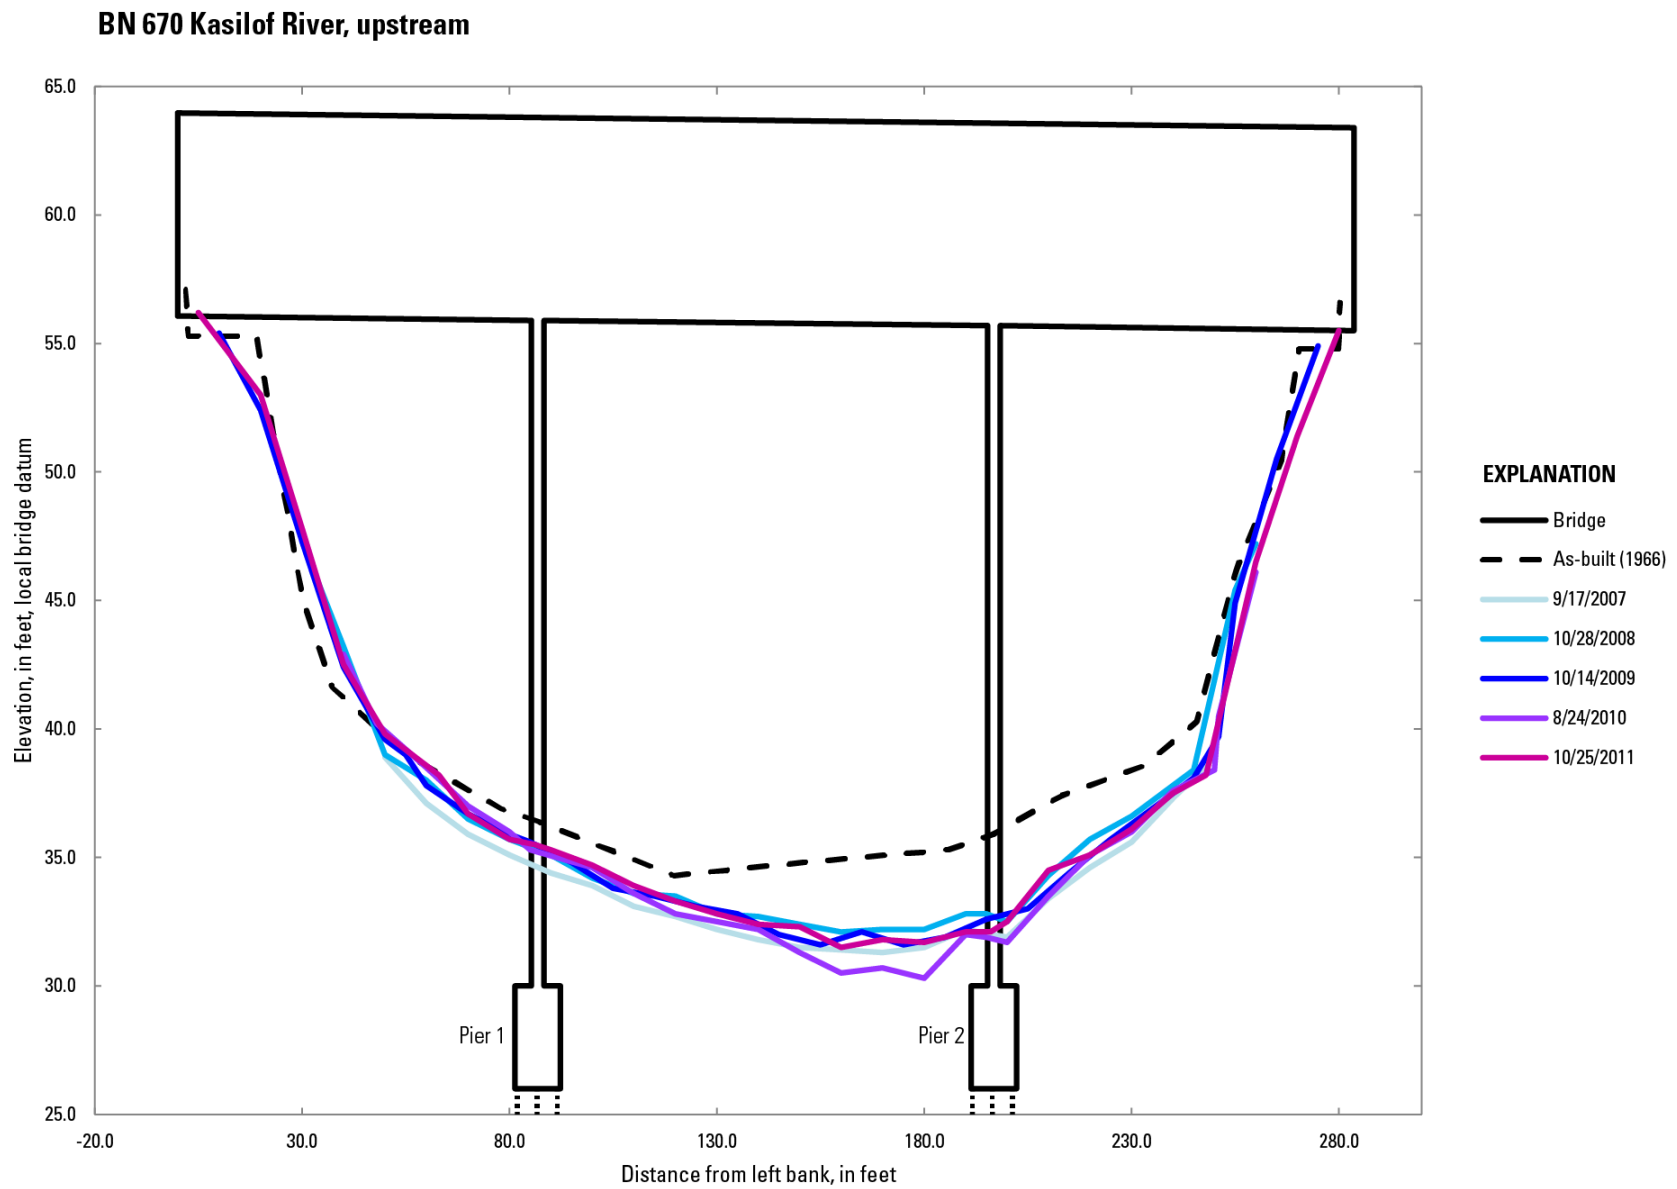
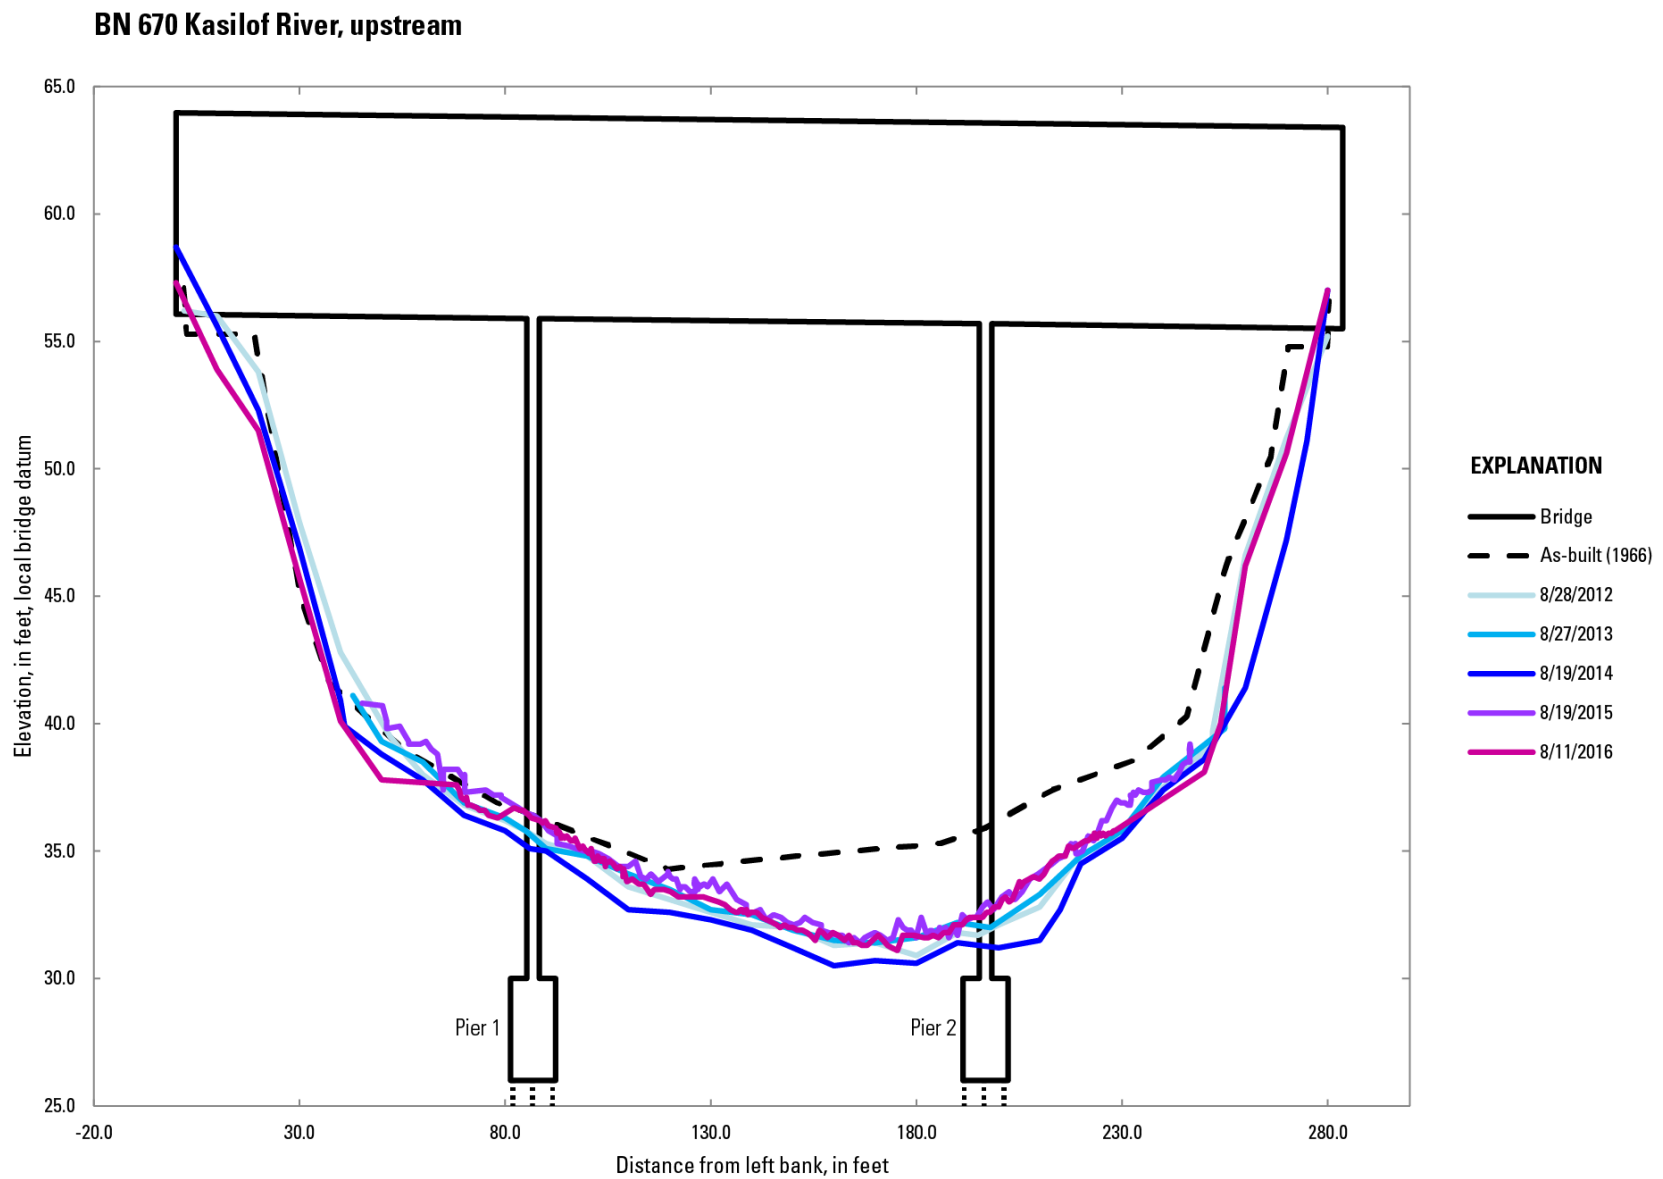
The Kasilof River is a silt-rich river that originates in Tustumena Lake, a large proglacial lake draining the Kenai Mountains. The lake naturally attenuates flow in the Kasilof River; discharge slowly increases throughout the summer, typically peaking between late July and mid-August, and then slowly decreases before freeze-up unless large autumn rainstorms maintain high lake levels. Cross sections were measured during 2002, 2004, 2005, and 2007–16 (figs. 65–67). At bridge 670, the channel generally is stable with very little change occurring in streambed elevation since monitoring first began. However, relative to the as-built, as much as 6 ft of degradation occurred on the right side of the channel. During the first few years of monitoring (2002–05), 6 ft of localized scour occurred around the rightmost pier. In 2004, soundings at the right-bank pier indicated that the pier footing was exposed.
