Measurement of Long-Term Channel Change Through Repeated Cross-Section Surveys at Bridge Crossings in Alaska

Open-File Report 2019–1028

By Karenth L. Dworsky and Jeffrey S. Conaway

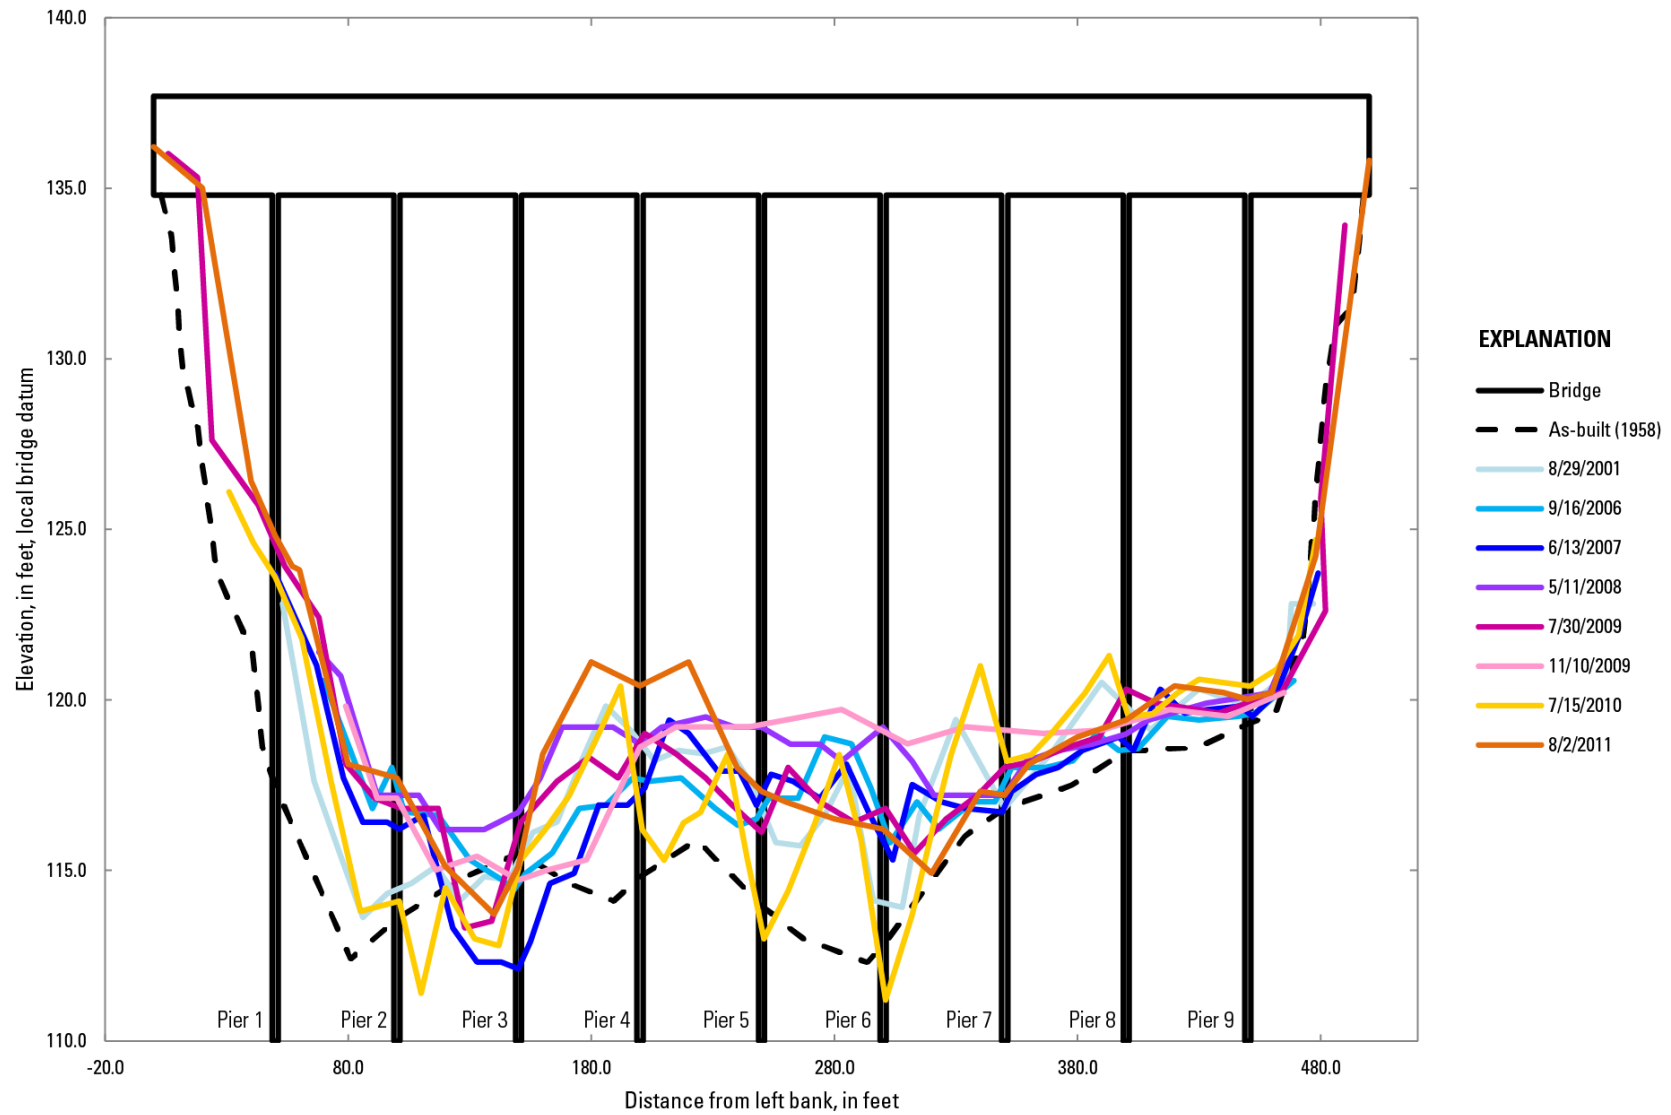
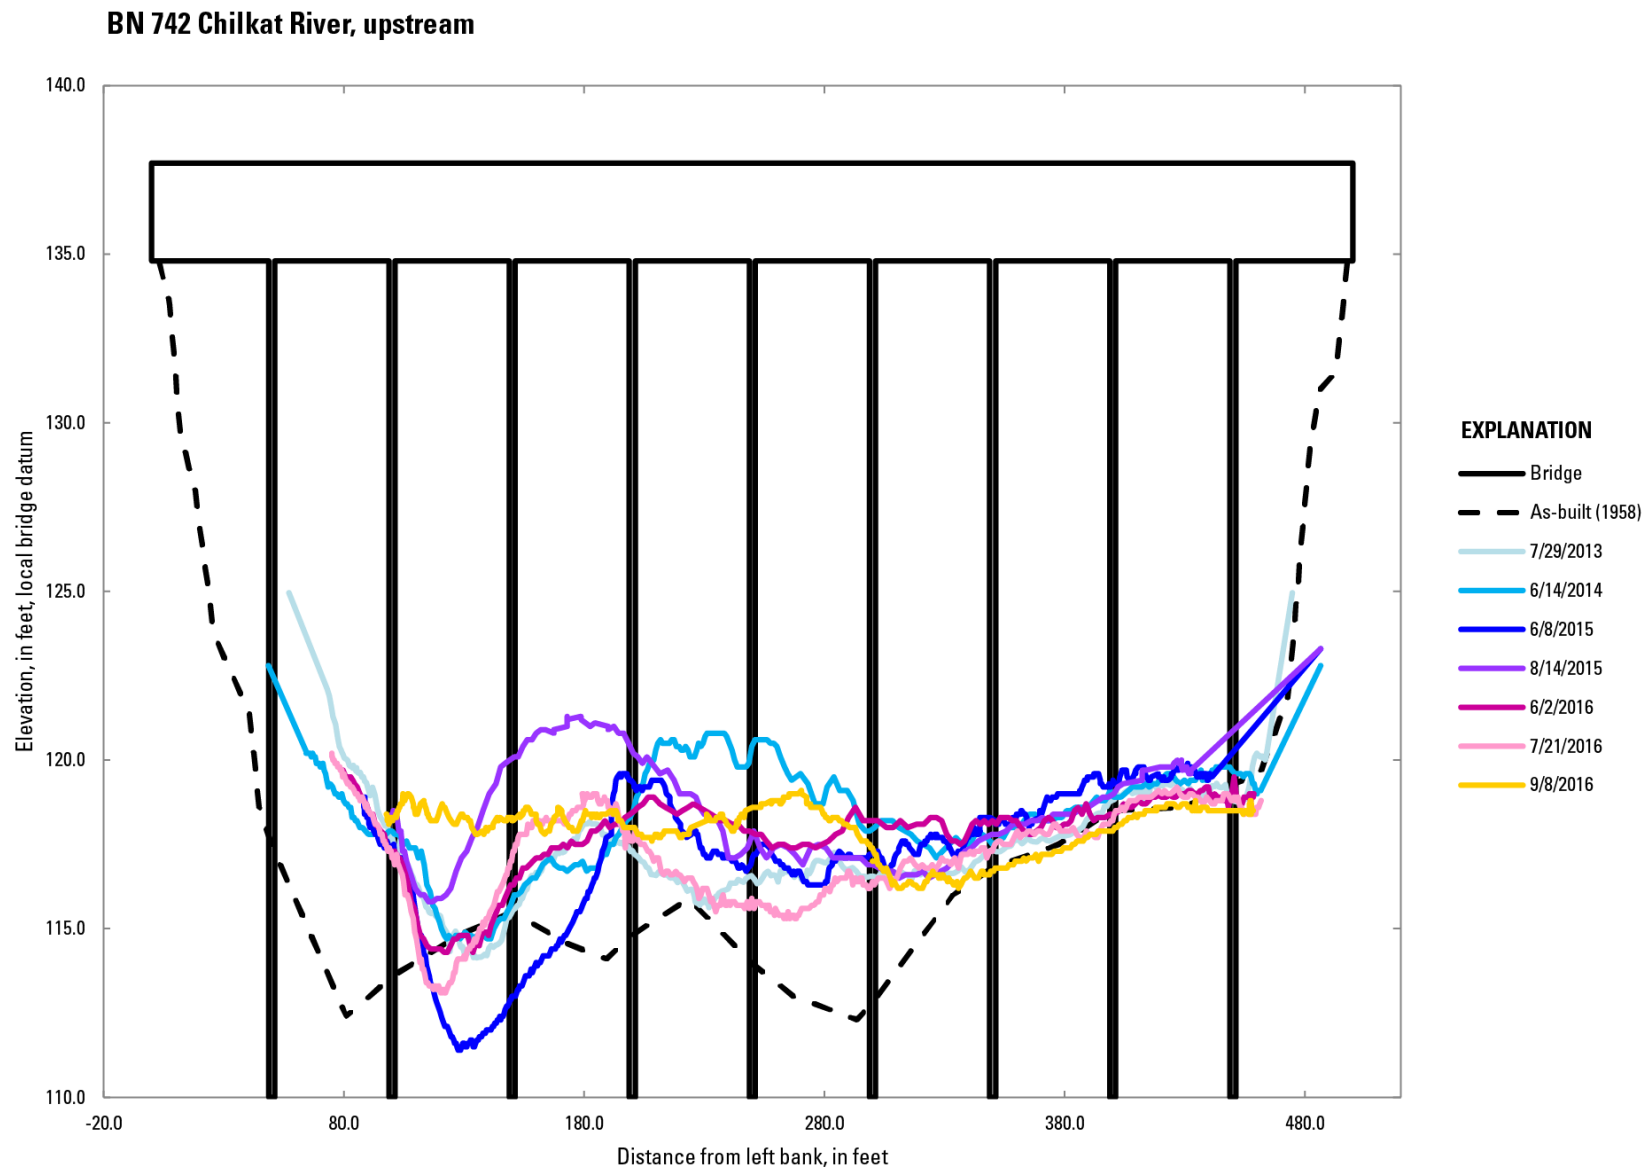
The Chilkat River originates at Chilkat Glacier in the Coast Range on the border of Alaska and British Columbia. The river flows in a single channel through the bridge, which crosses about 1 mi upstream of the Klehini River confluence. Cross sections were measured during 2001, 2004–11, and 2013–16 (figs. 68–70). Since the as-built survey, 7 ft of aggradation occurred on the left bank with little to no degradation on the right bank. From 2006 to 2010, the Chilkat River scoured as much as 7 feet locally around piers 2, 5, and 6 (pier numbering starts from the left side). From 2013 to 2016, as much as 8 ft of scour occurred between piers 2 and 4, and aggradation of as much as 6 ft occurred around the other piers.

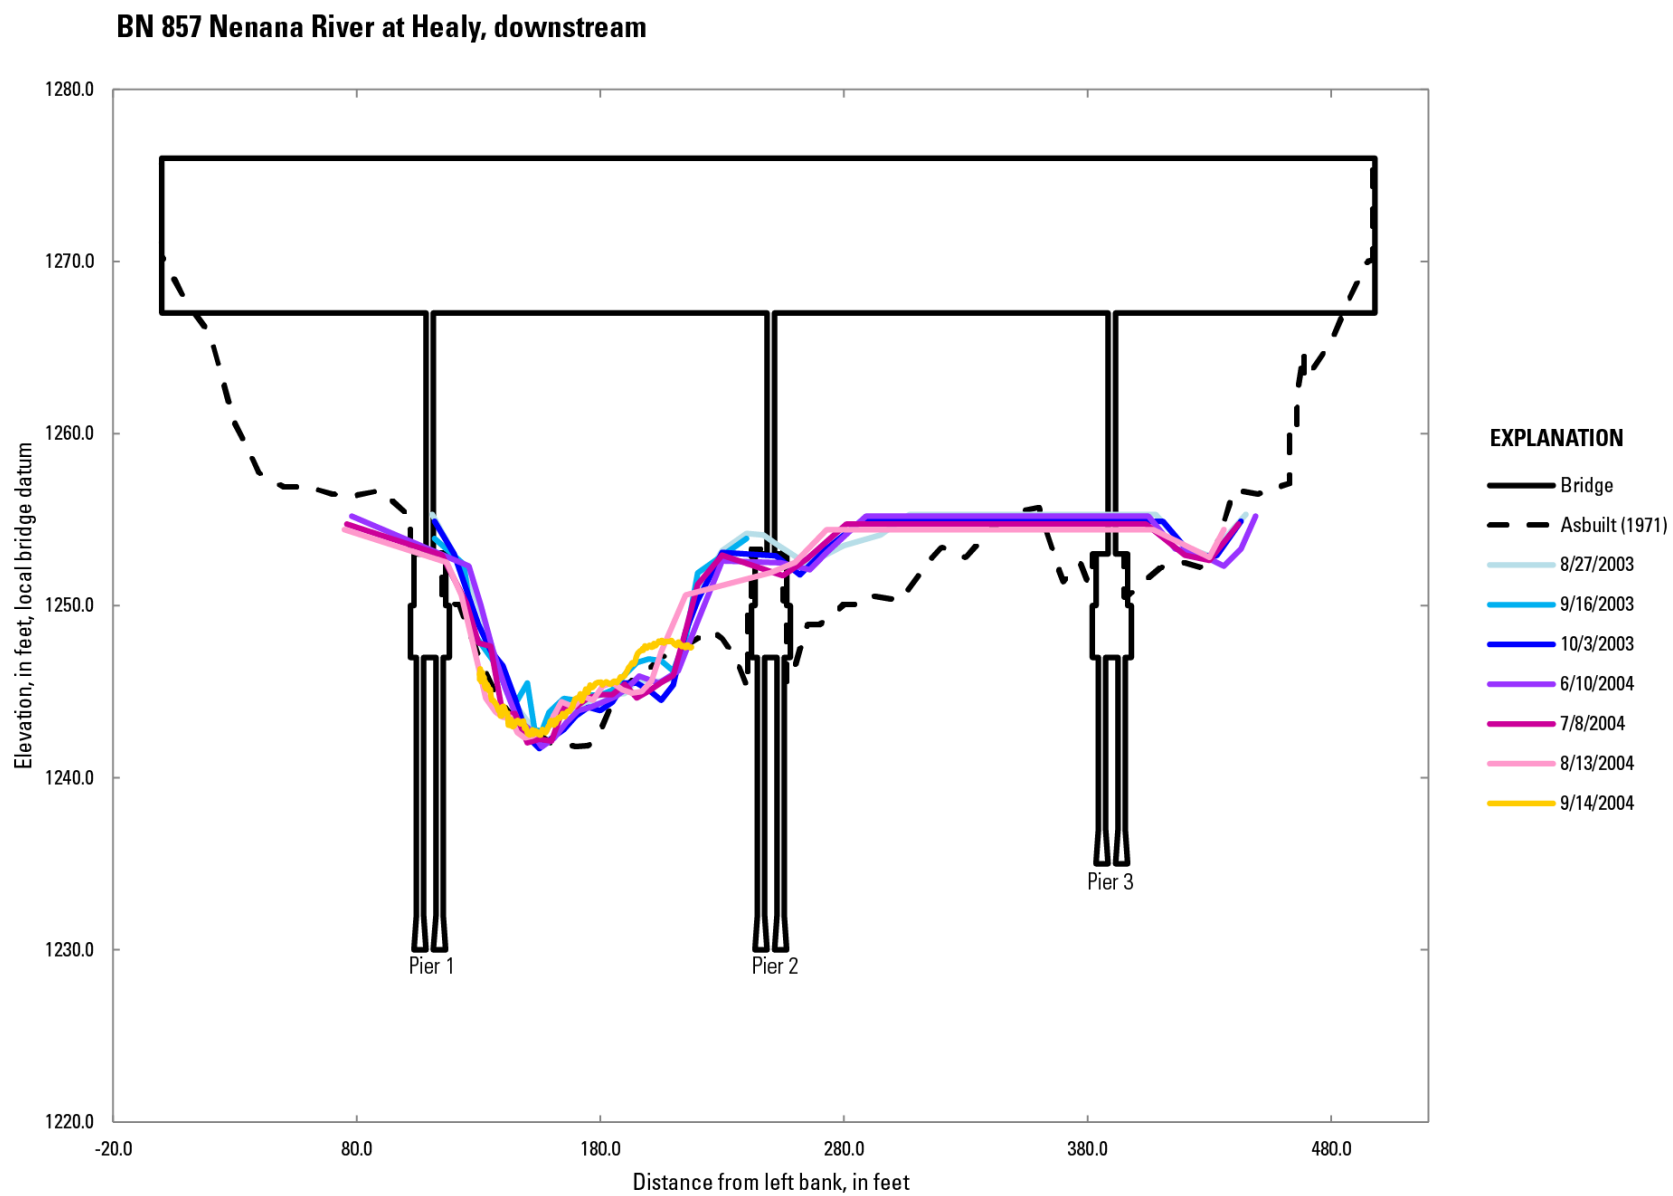
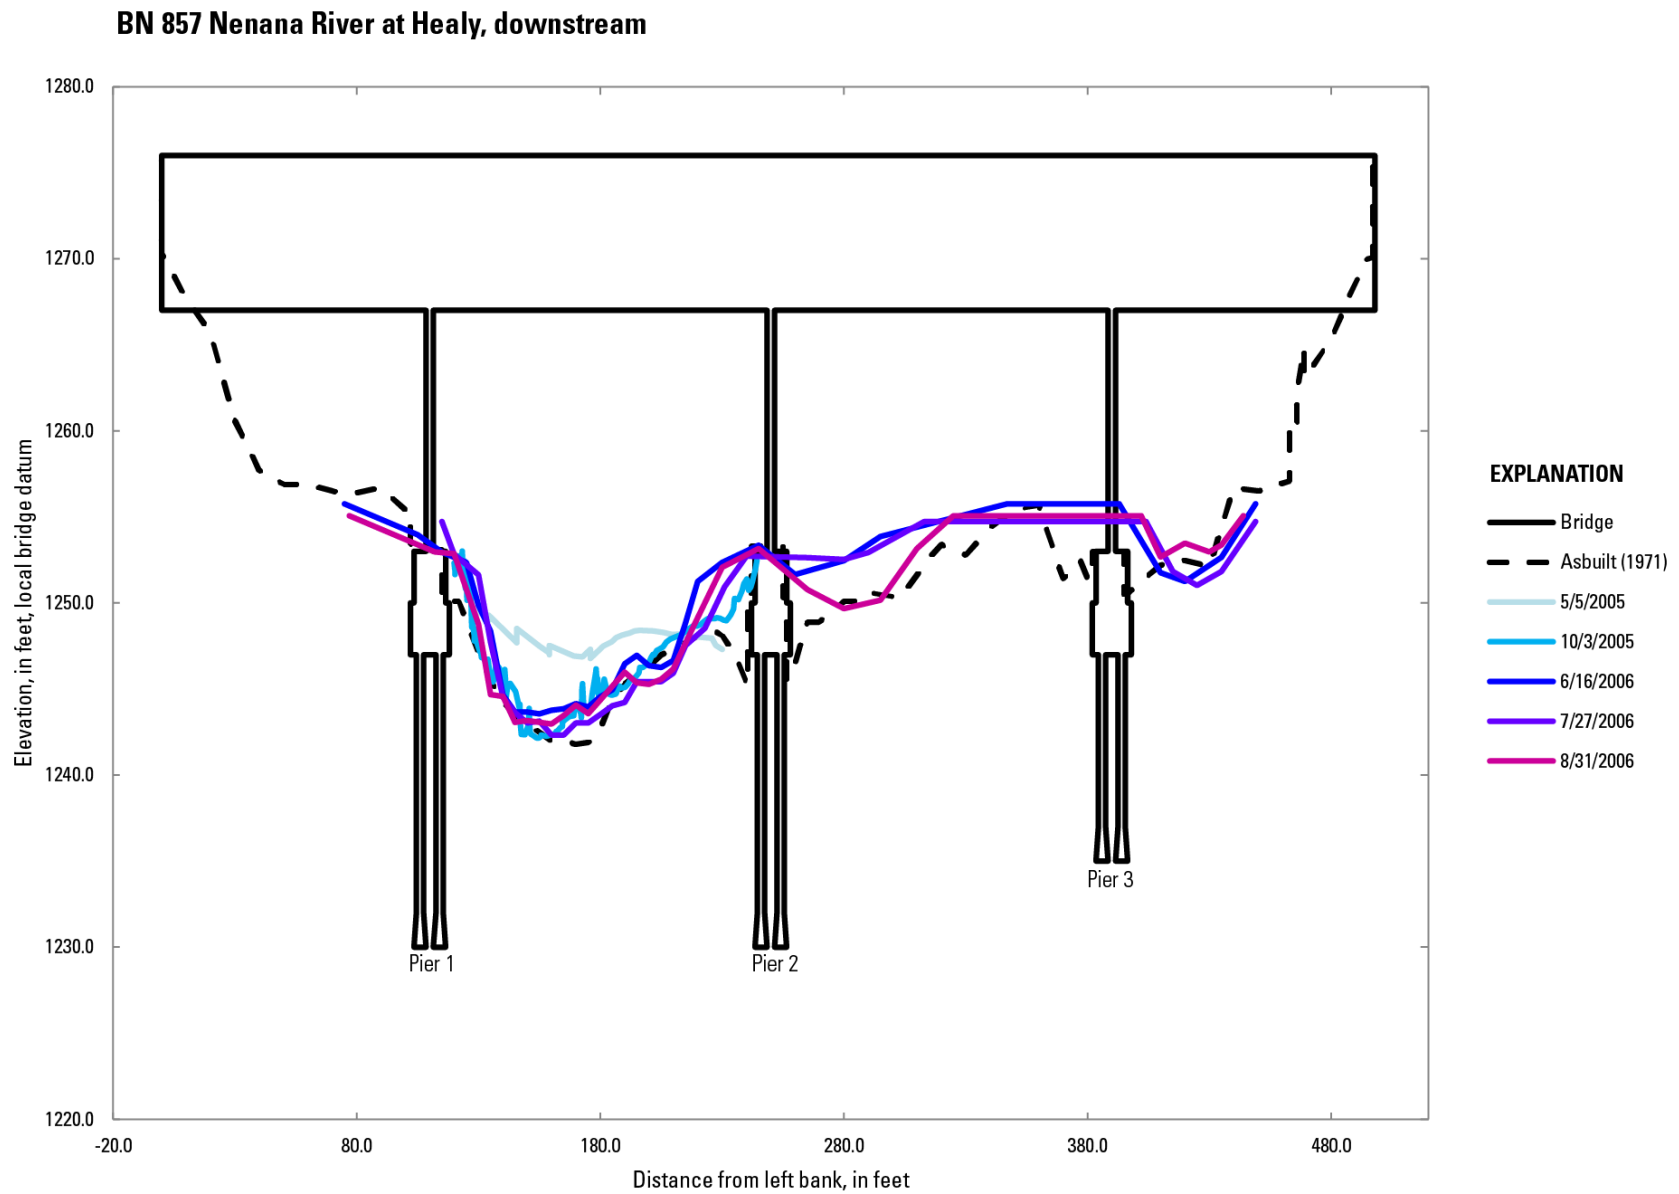
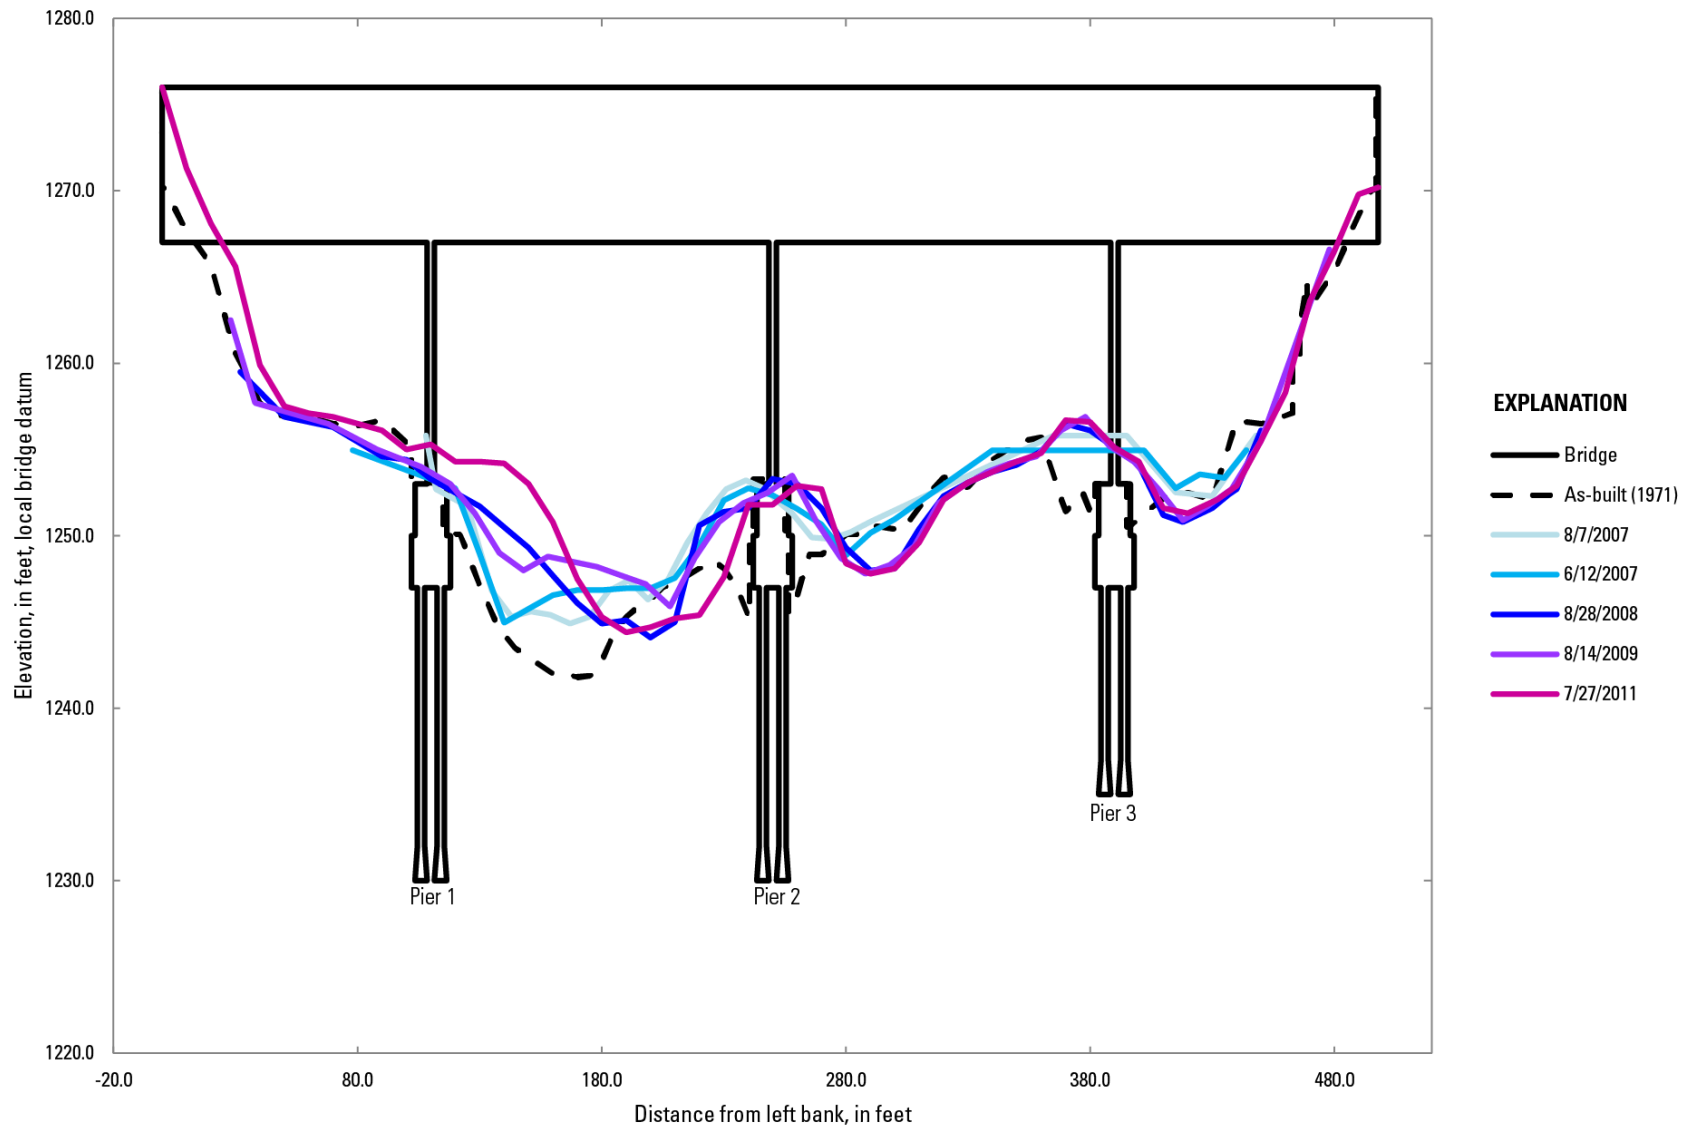
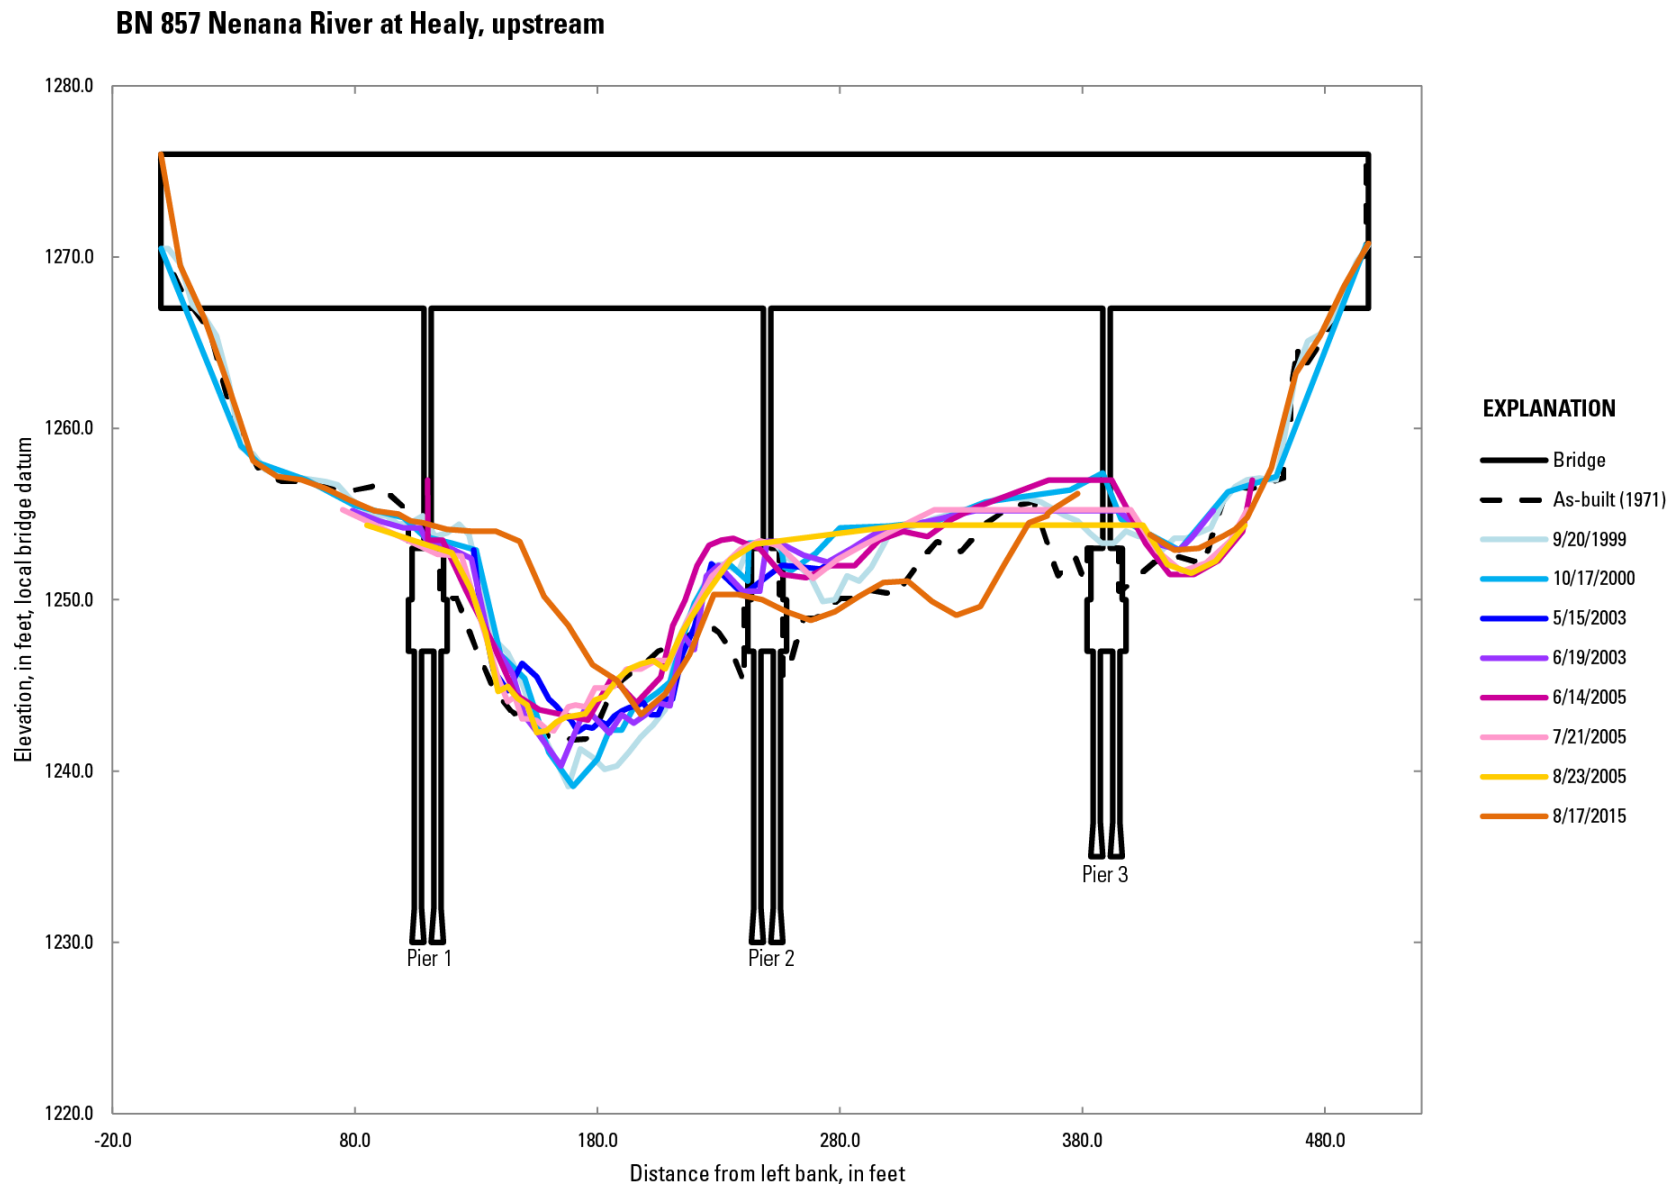
The Nenana River is a tributary of the Tanana River that originates at the Nenana Glacier on the southern side of the Alaska Range. Bridge 857 is about 500 ft downstream of a railroad bridge. During low-to-moderate flows, gravel bars are present upstream of the bridge and extend upstream of the railroad bridge dividing the approach flow into two separate channels. During high flows, there are no exposed gravel bars and standing waves are present throughout the reach. Cross sections were measured during 1999, 2000, 2003–09, 2011, and 2015 (figs. 71–74). The rightmost pier is subject to debris accumulation. Most of the flow has been confined to the left side of the channel since the bridge was constructed, and pier footings were exposed in this part of the channel in all the soundings. Most of the scour (as much as 4 ft) has been confined between the first and second piers. On the right side of the channel, aggradation of as much as 4 ft has occurred between the second and third pier.

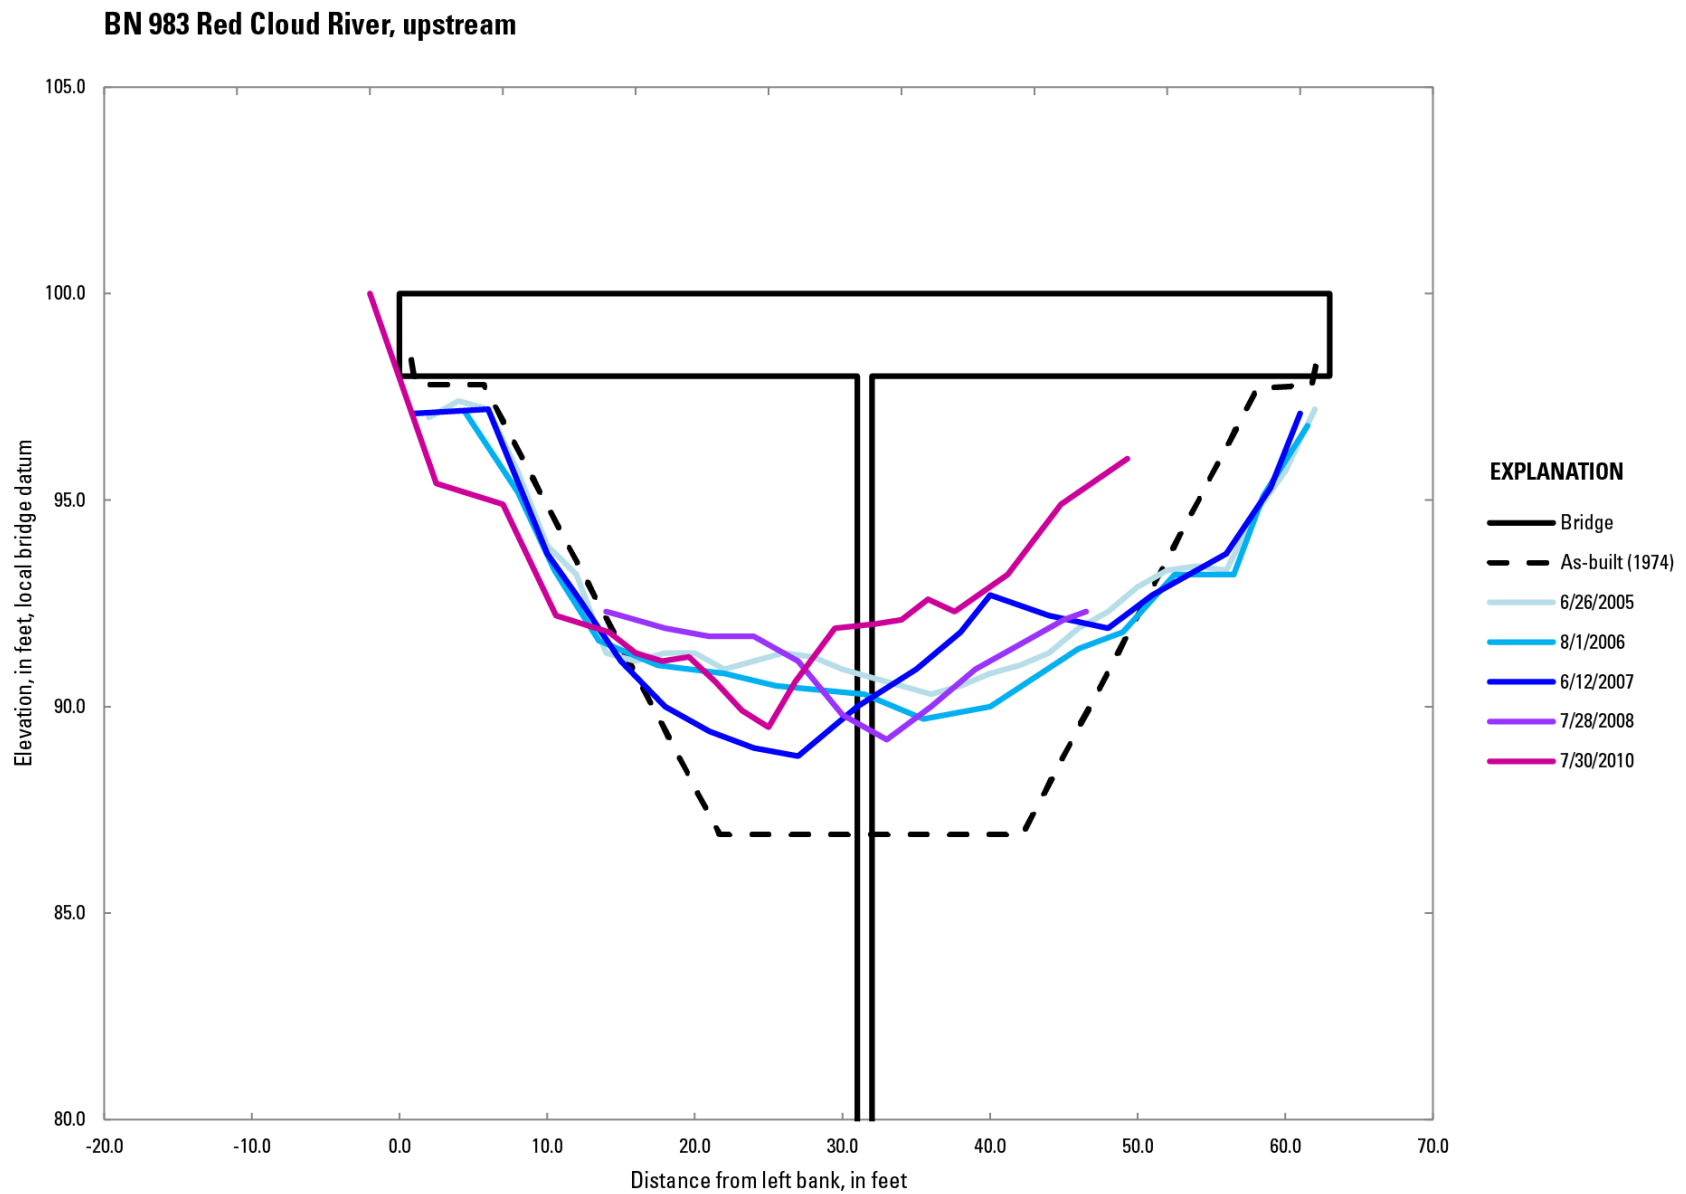
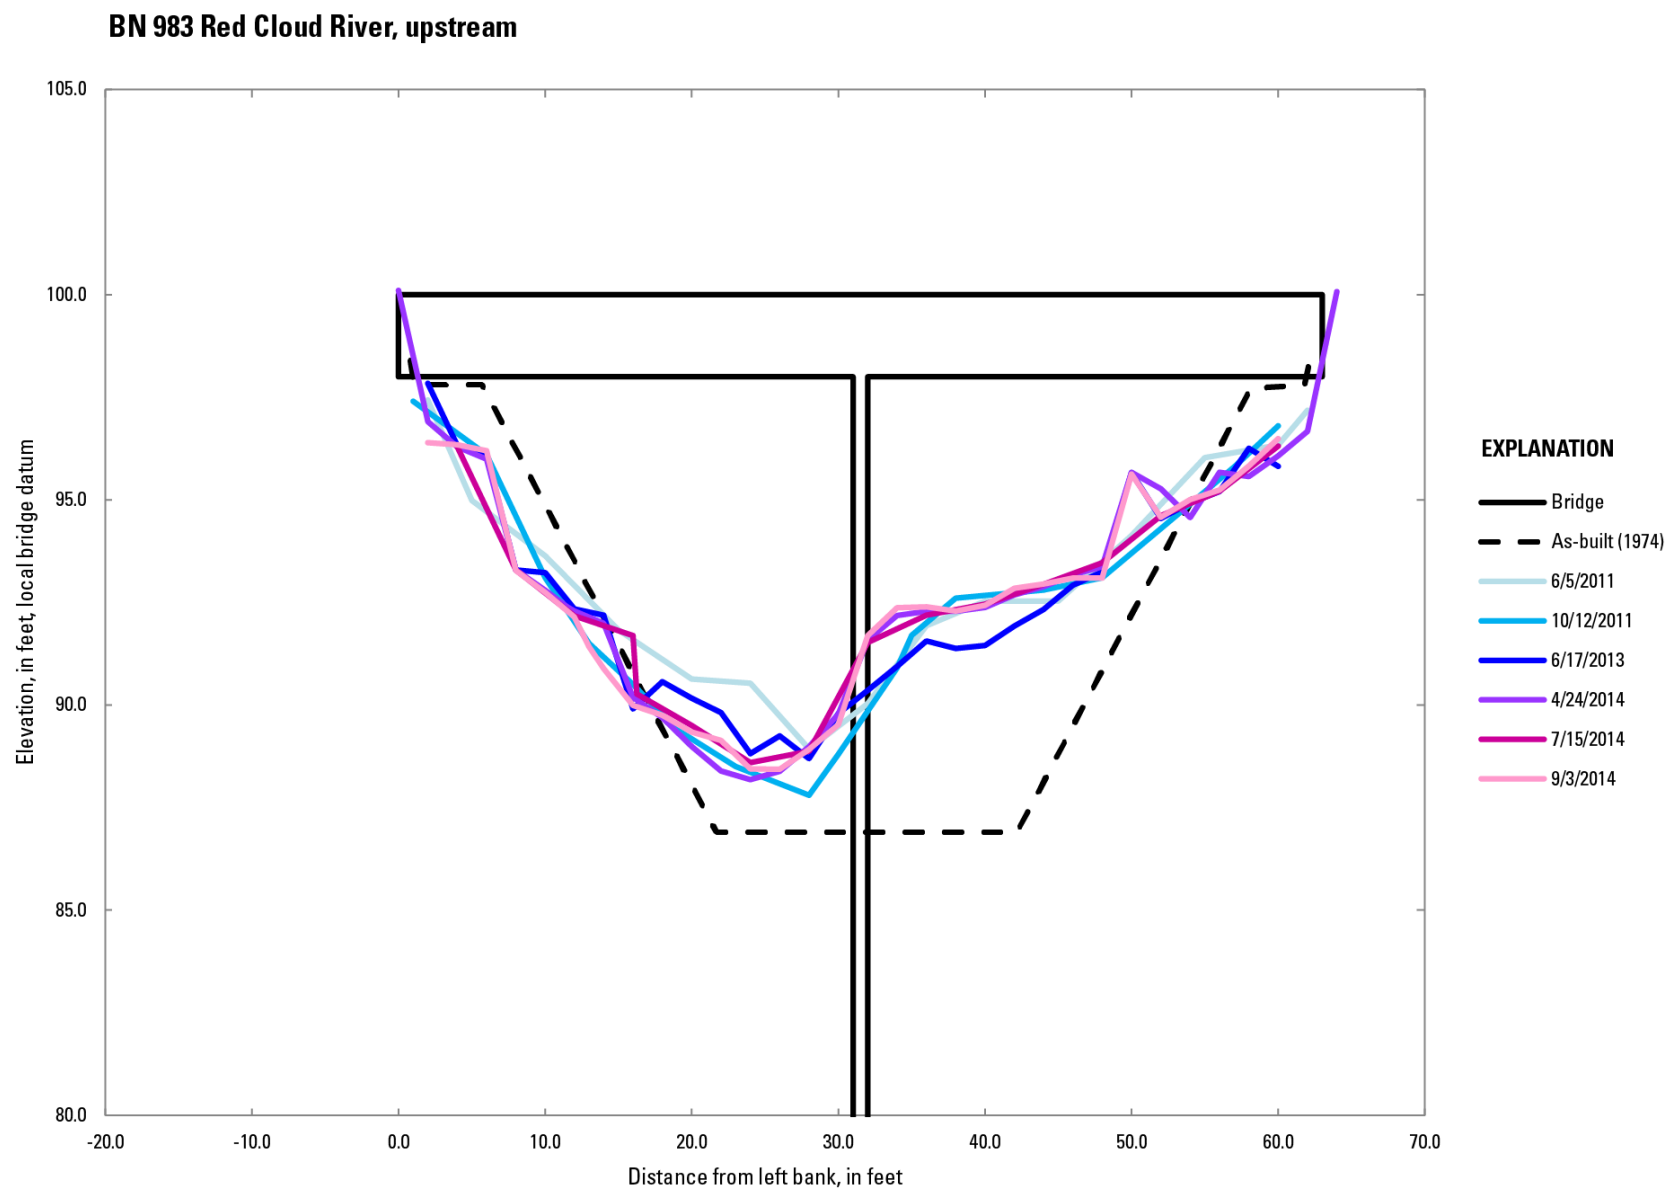
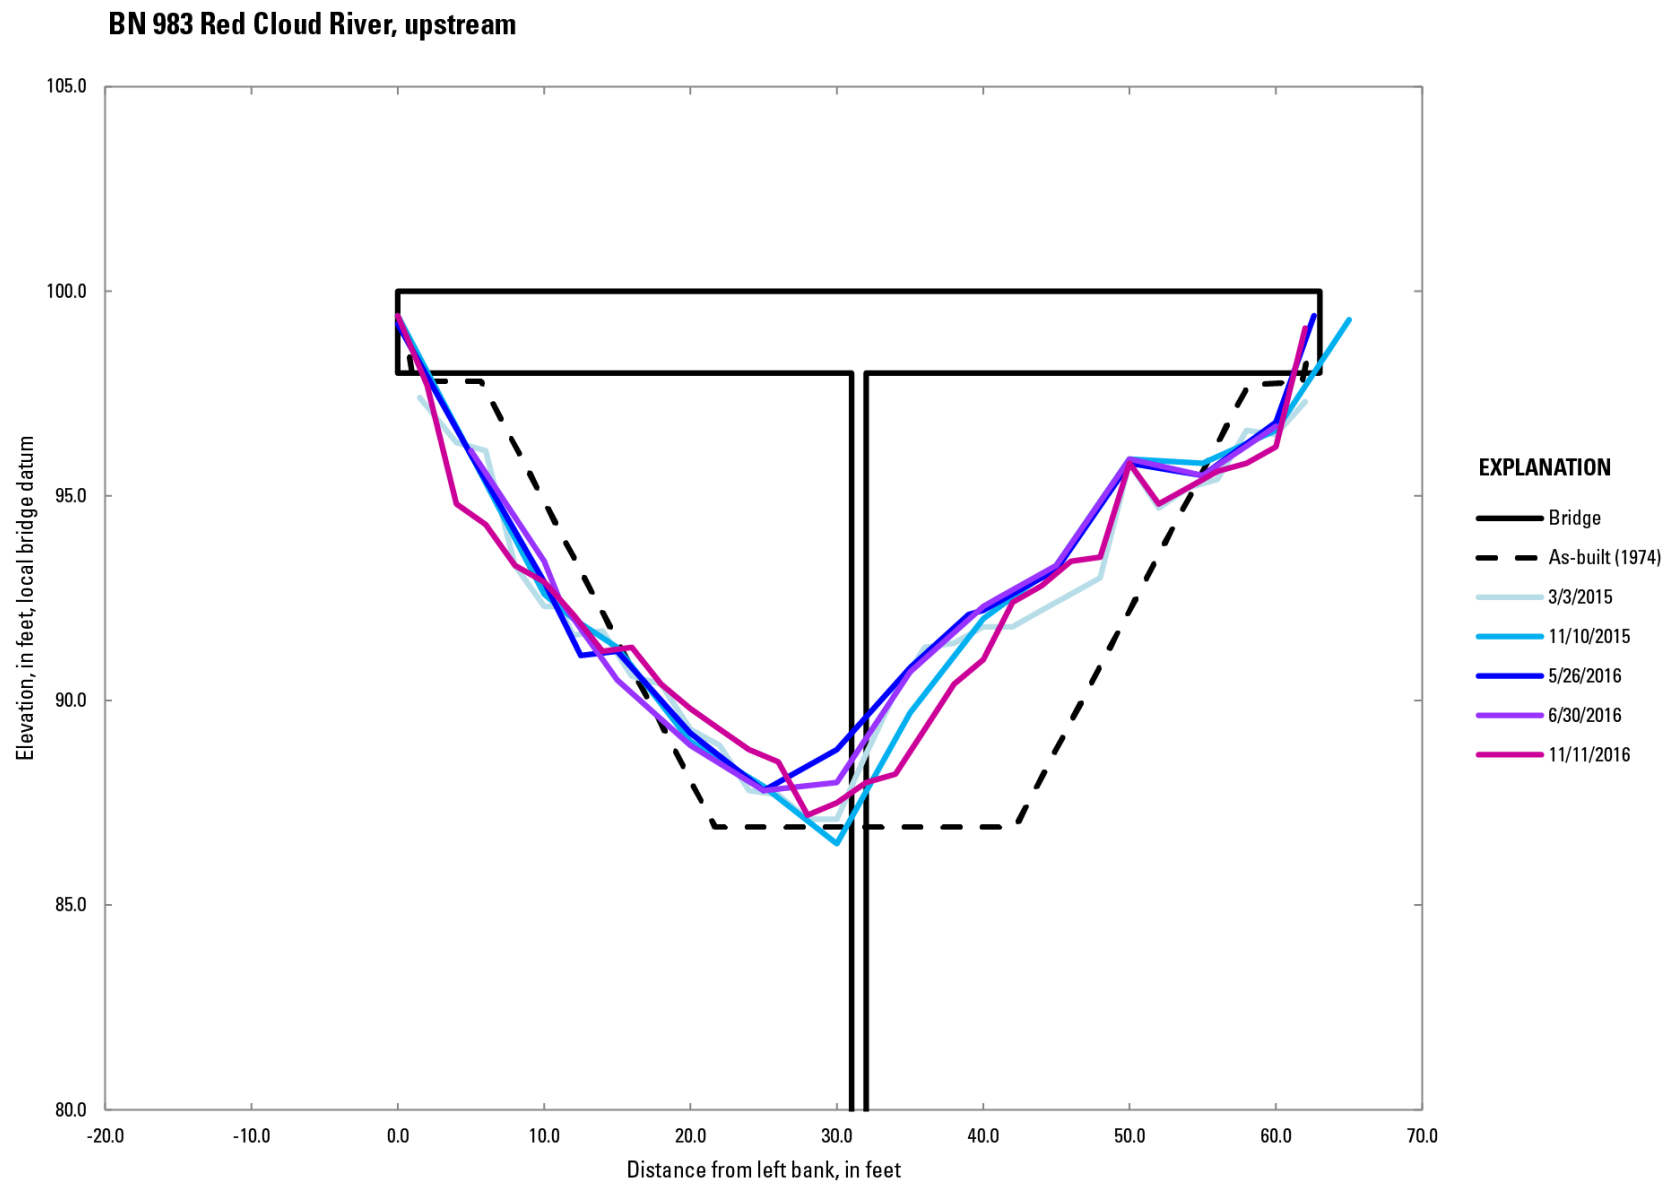
Red Cloud River is a steep mountain stream that originates on the eastern side of Sharatin Mountain on Kodiak Island. Directly upstream of the bridge is the confluence of the Red Cloud River and an unnamed creek that drains from the mountains on the southeastern side of the Red Cloud Basin. Red Cloud River is a cobble-rich river that is prone to flooding during heavy rains. Changes in discharge are rapid at this site owing to the small drainage area, high gradient of the stream, and intense precipitation. Cross sections were measured during 2005–11 and 2013–16 (figs. 75–78). Relative to the as-built cross section, about 3 ft of aggradation occurred across the channel. Soundings also indicate continuous lateral channel migration through the bridge. As much as 3 ft of local scour at the pier occurred since 2014, likely aggravated by debris lodged on the pier.
