## **Ground Failure Triggered by Shaking during the November 30, 2018, Magnitude 7.1 Anchorage, Alaska, Earthquake**

Open-File Report 2020–1043

By Alex R.R. Grant, Randall W. Jibson, Robert C. Witter, Kate E. Allstadt, Eric M. Thompson,  
and Adrian M. Bender

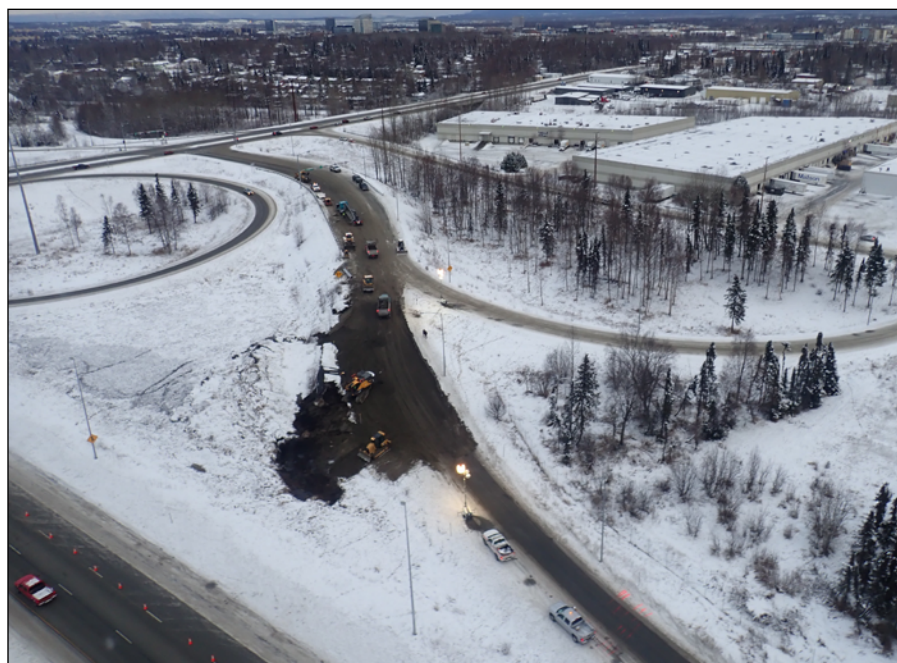
**Figure 5.** Photograph of ground failure of an engineered fill-slope embankment that damaged about 70 meters of the northbound offramp from Minnesota Drive to International Airport Road, in Anchorage, Alaska. On December 1, 2018, the day after the earthquake and time this photograph was taken, Alaska Department of Transportation crews had already begun repairs to the road. Location shown in figure 4.

The most damaging landslides triggered by this earthquake involved both natural and fill materials that developed complex, flow-like, landslide deposits. The most widely publicized were failures in engineered road fills at the north-bound Minnesota Drive offramp to International Airport Road in Anchorage (fig. 5) and along Vine Road south of Wasilla (fig. 11*A*). At Minnesota Drive, collapse of about 70 m of the offramp embankment appeared to occur from loss of bearing strength in underlying,

poorly drained silt and fine sand of glacioestuarine origin (Combellick, 1999). The Alaska Department of Transportation had already begun repairs by the time of our first overflight on December 1. A similar engineered embankment constructed across a saturated bog also failed during earthquake shaking caused by loss of bearing strength in underlying deposits, which caused damage to about 90 m of Vine Road (fig. 11A). At Vine Road, saturated silt, fine sand, and (or) organic deposits fill a bog, which occupies a poorly drained area in glacial terrain confined by drumlins. Similar types of failures occurred in the railroad grade along the coastal bluffs 3 km north of the town of Chugiak. These failures appeared to initiate as slumps and then transitioned into a more flow-like behavior (fig. 11B). Several such slides occurred along a few kilometers of the railroad in this area and were being repaired at the time of our aerial overflights.

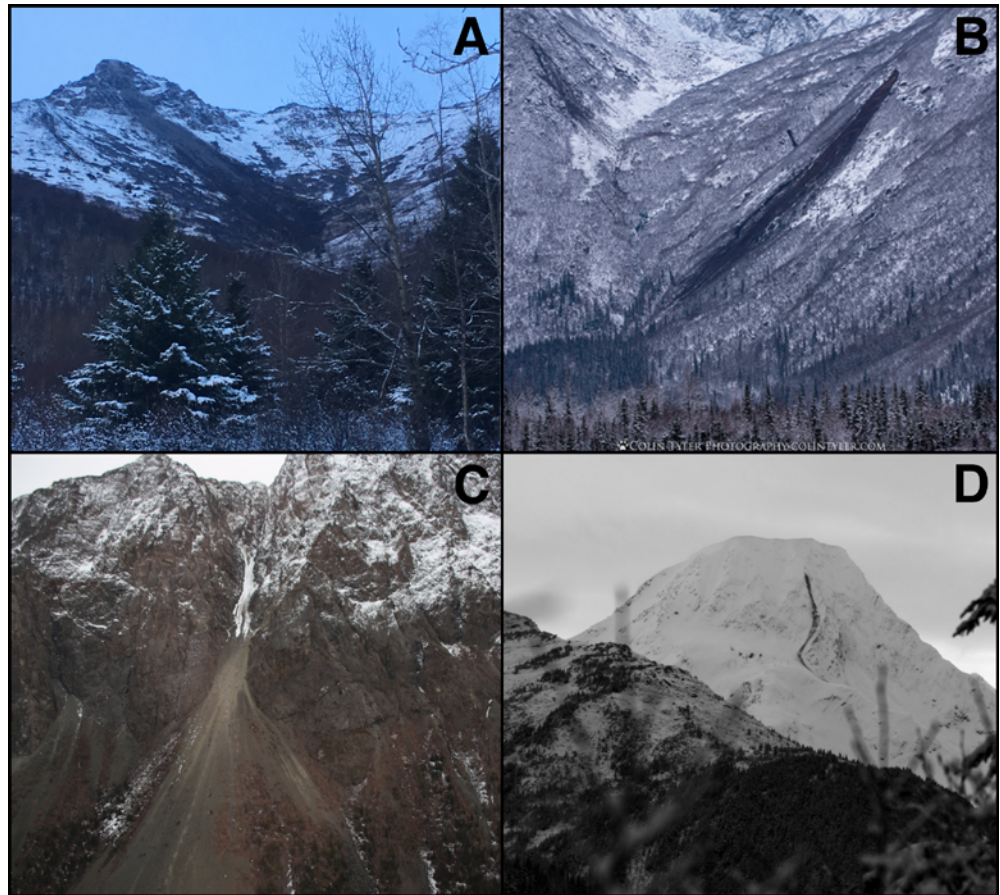
**Figure 6.** Photographs of rockslides, rock avalanches, and rockfalls. *A*, Rockslide on Rainbow Peak (photograph by Jeremiah Drage, resident). *B*, Rock avalanche below Eagle Peak (photograph by Colin Tyler, resident). *C*, Rockfall above Eagle River. *D*, Rockfall from Peak 4,710' (photograph by Heather Thamm, Chugach National Forest Avalanche Information Center). Locations shown in figure 4.

a small source area. Though this rockslide was obscured by snow by the time of our overflight, we noted numerous signs of additional rockfalls and rockslides farther up Eagle River valley that likely were triggered by the earthquake (fig. 6C). Most slope failures consisted of small detachments of rock onto existing talus slopes or long, thin, trailing deposits formed because of the steepness of these valleys. We saw no signs of major drainage blockages. Many of these slope failures started as falls and transitioned to flows as they reached shallower slopes, and most source areas were in bedrock. We noted a similar density and style of slope failures in the Eklutna River valley upstream from Eklutna Lake. Mountainous areas south of these two valleys showed no signs of similarly intense rockfall activity at the time of our December 5 overflight, but differences in snow cover could have biased our assessment. The Chugach National Forest Avalanche Information Center reported earthquake-triggered snow avalanches and rockfalls in mountainous terrain surrounding Girdwood (fig. 6D)

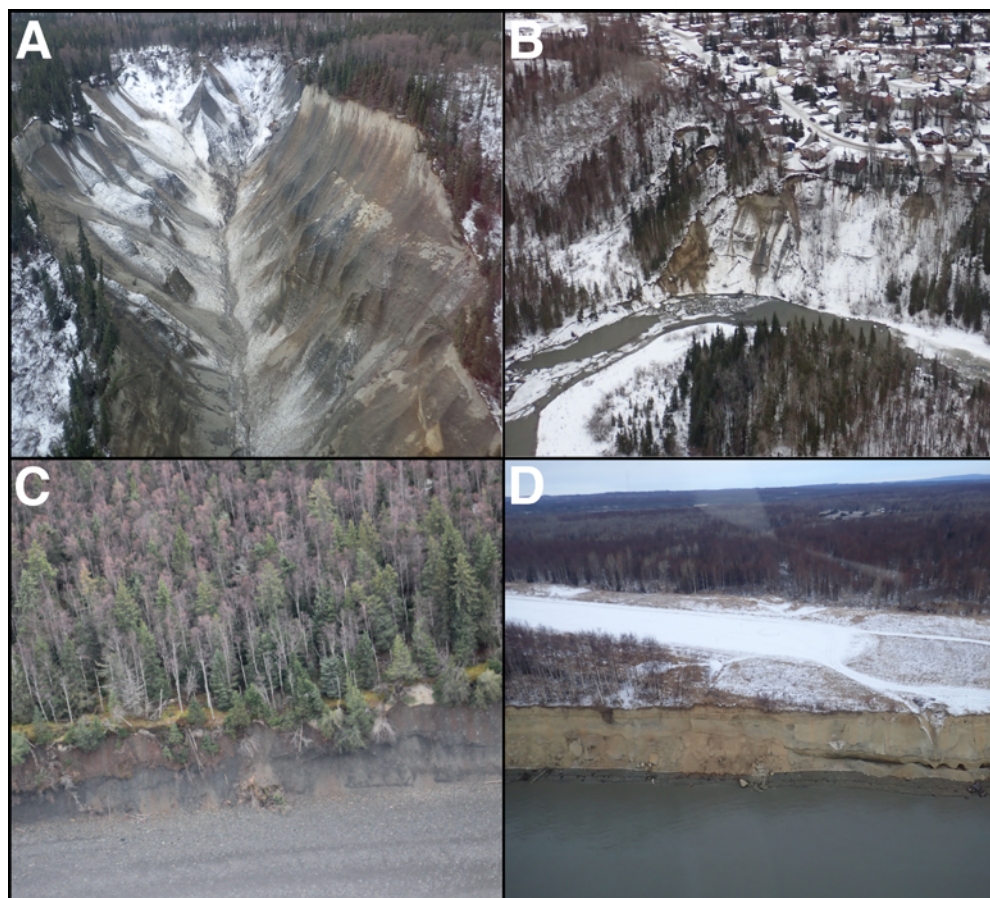
Other notable disrupted slides included raveling of new material from steep canyon walls cut into glacial drift by the Eklutna River downstream from the dam (fig. 7A) and failures in steep slopes along Eagle River between the Glenn Highway bridge and Eagle River Loop Road (fig. 7B). Preliminary comparisons of digital terrain models derived from lidar acquired before and after the earthquake show several shallow debris slides and avalanches in 40- to 50-m-high valley walls along Eagle River (fig. 8). These slope failures occurred in unstable colluvium, consisting of silt, sand, and gravel eroded from adjacent glacial drift that mantles

**Figure 7.** Photographs of disrupted landslides and coastal bluff collapses. *A*, Disrupted landslides in glacial drift along Eklutna River bluffs. *B*, Landslides in bluffs along the Eagle River west of Glenn Highway. *C*, Coastal bluff collapses along south side of Turnagain Arm. *D*, Coastal bluff collapses along west side of the Knik Arm. Locations shown in figure 4.

During helicopter overflights we also observed collapsed coastal bluffs along the south side of the Turnagain Arm (fig. 7C) and the west side of the Knik Arm (fig. 7D). Few rapid, disrupted slides directly impacted infrastructure, except for several rockfalls along the Seward Highway (fig. 9A) that caused a temporary road closure (removed prior to our field reconnaissance) and failures along steep coastal bluffs (fig. 9B).

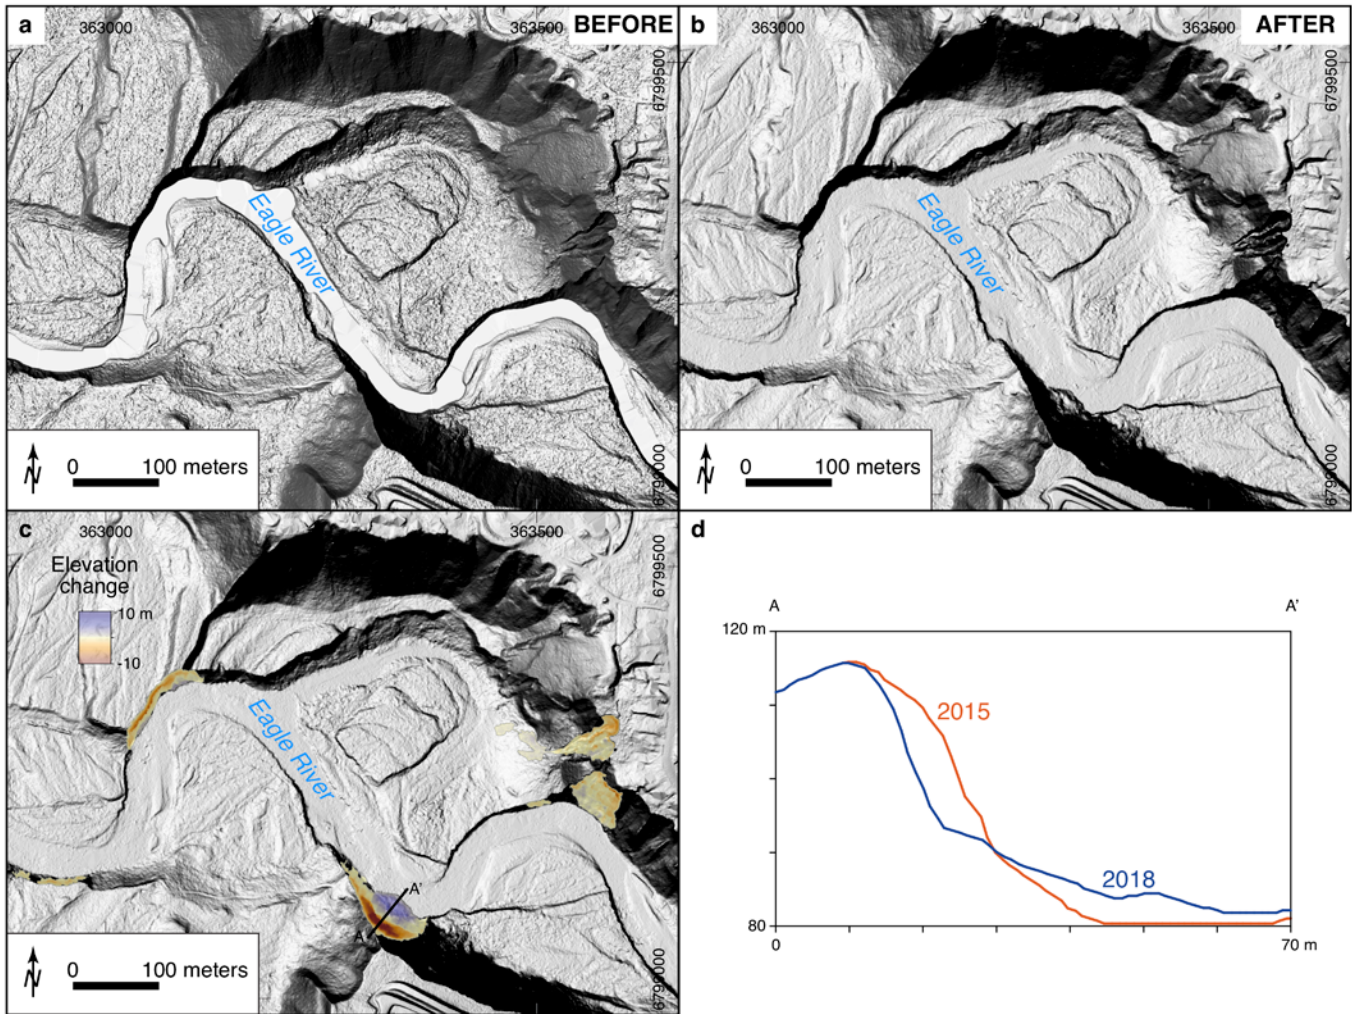
**Figure 8.** Digital terrain models (DTMs) derived from light detection and ranging (lidar) data acquired before and after the 2018 Anchorage earthquake used to estimate elevation changes induced by slope failure along the Eagle River (lidar available at <https://elevation.alaska.gov>). Maps use the North American Datum of 1983 (NAD83) Universal Transverse Mercator Zone 6 North coordinate system, in meters (m). *a*, Lidar DTM developed from data acquired for the Municipality of Anchorage in May 2015. *b*, Lidar DTM of the same area developed from data acquired in December 2018, after the earthquake. *c*, DTM showing elevation change between the 2015 and 2018 lidar data. Landslides occurred on steep slopes as much as 35 m high in the Eagle River canyon. Warm colors show negative elevation changes, greatest near landslide headscarps, and cool colors show positive elevation changes, where landslide deposits occur. The total range of elevation change varied from 4.6 to –12.7 m. *d*, Profile A–A' shows the elevation across a landslide before and after the earthquake. Location shown in *c*.

steep to very steep slopes (Schmoll and others, 1972; 1980). Schmoll and others (1980) specifically point out the susceptibility of the colluvium along Eagle River to slope failure, “Landslides and earthflows have been common in the past in these areas and may be reactivated, especially if the slope is disturbed.”

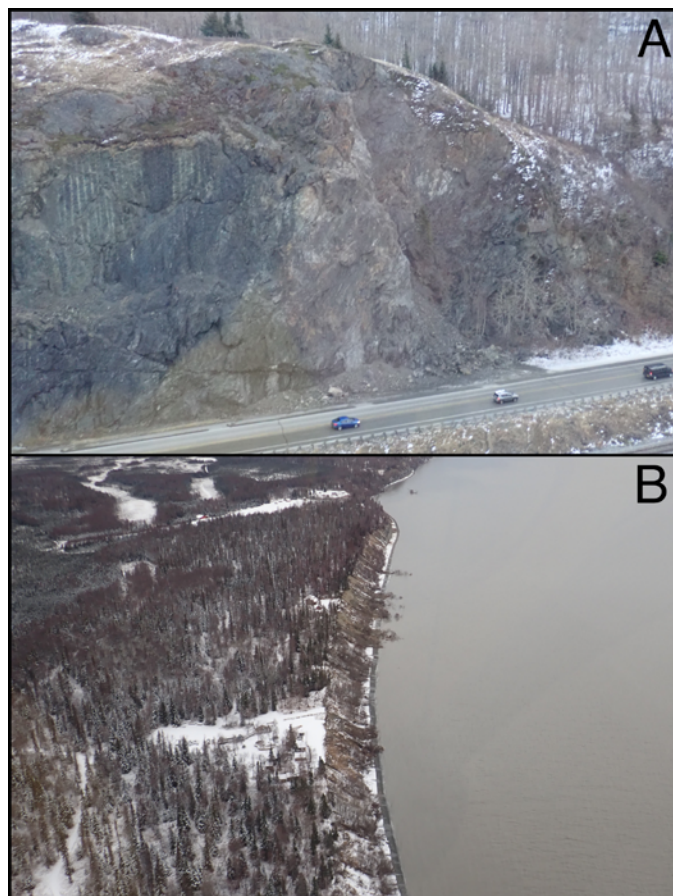
**Figure 9.** Photographs of rockfalls and coastal bluff landslides. *A*, Rockfall along Seward Highway. *B*, Coastal bluff landslides along Knik Arm west of Anchorage. Locations shown in figure 4.

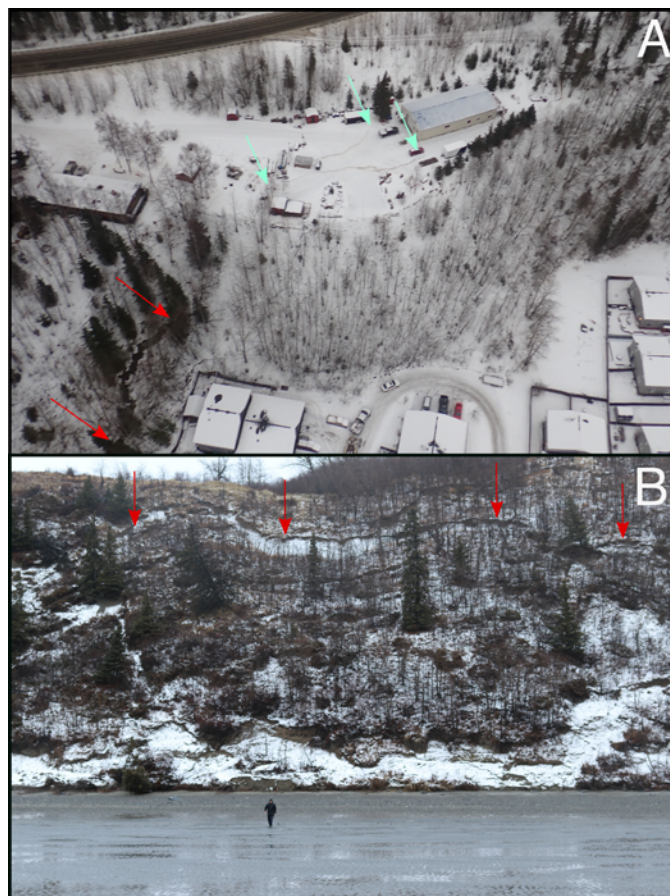
Few deep (>3 m) coherent landslides were observed after the earthquake, although at least one led to significant impact to the built environment. Eight homes in the River Heights neighborhood of Eagle River were red tagged (unsafe for occupation) because of landslide movement in the steep slope behind the houses (fig. 10A). Our observations indicate that the slide plane may have been several meters deep. The basal slip surface appeared parallel to the slope in the upper part of the slide, but it extended below the houses at the base of the slope and appears to have curved upward at the toe, indicating possible

rotational movement. Some of the houses were moved several decimeters off their foundations and were pushed toward the street by the landslide. Backyard patios, fences, and outbuildings were heavily damaged by tilting in different directions and differential uplift. Utility connections were severed or distressed in some homes. Additional homes not directly impacted by the landslide across the street were yellow tagged (restricted use) until further investigation could determine the extent of the landslide area and the potential for additional movement.

In the southwest corner of Anchorage, we documented additional evidence of coherent landslides along the southern coastal bluffs of Kincaid Park. We observed evidence of extensional cracks along the edge of the nearly 80-m-high bluffs in the southeastern corner of Kincaid Park, and a complex of cracks have as much as 1.5 m vertical and 1 m horizontal offsets

**Figure 10.** Photographs of coherent landslides. *A*, Coherent landslide that propagated into structures in the town of Eagle River; several structures below this slope were red tagged because of damage from deformation of this slope. Red arrows show the headscarp of the structure-impacting landslide, cyan arrows show additional extensional cracks above the slope. *B*, Landslide complex along the south-facing bluffs of Kincaid Park with many internal scarps. Primary scarp shown with red arrows. Locations shown in figure 4.

along the southwestern corner of Kincaid Park at the top of a ~70-m-high bluff (fig. 10*B*). Incipient cracks were also noted in several slopes near the Glenn Highway crossing of the Eagle River and along the tops of talus slopes along the lower Eklutna River.

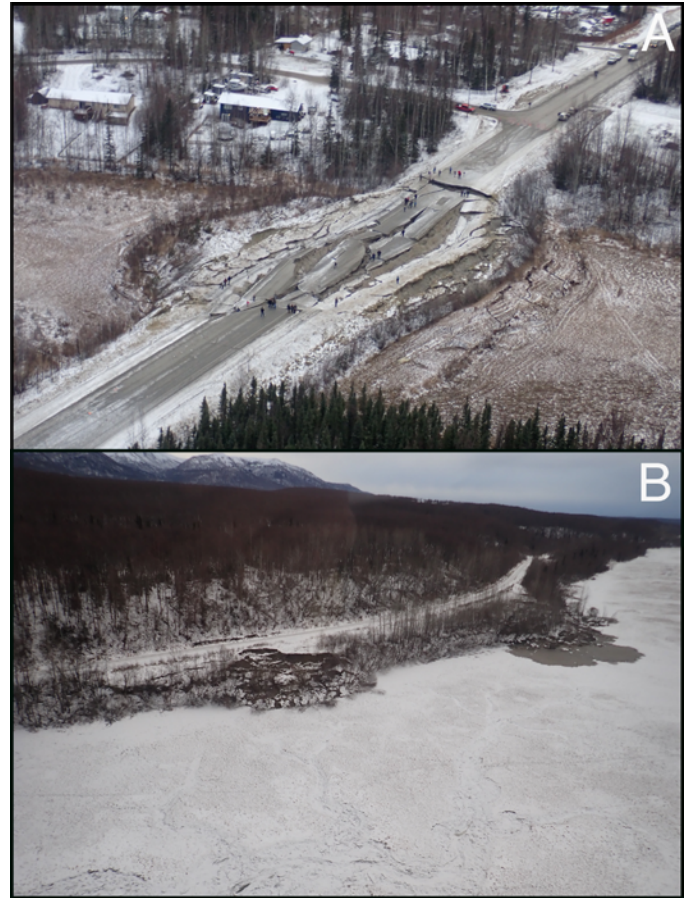
**Figure 11.** Photographs of roadway damage. *A*, Earthquake shaking caused loss of bearing strength in bog sediment that disrupted Vine Road in Wasilla, Alaska. *B*, Flow-slides along a railway alignment near Peters Creek. Locations shown in figure 4.

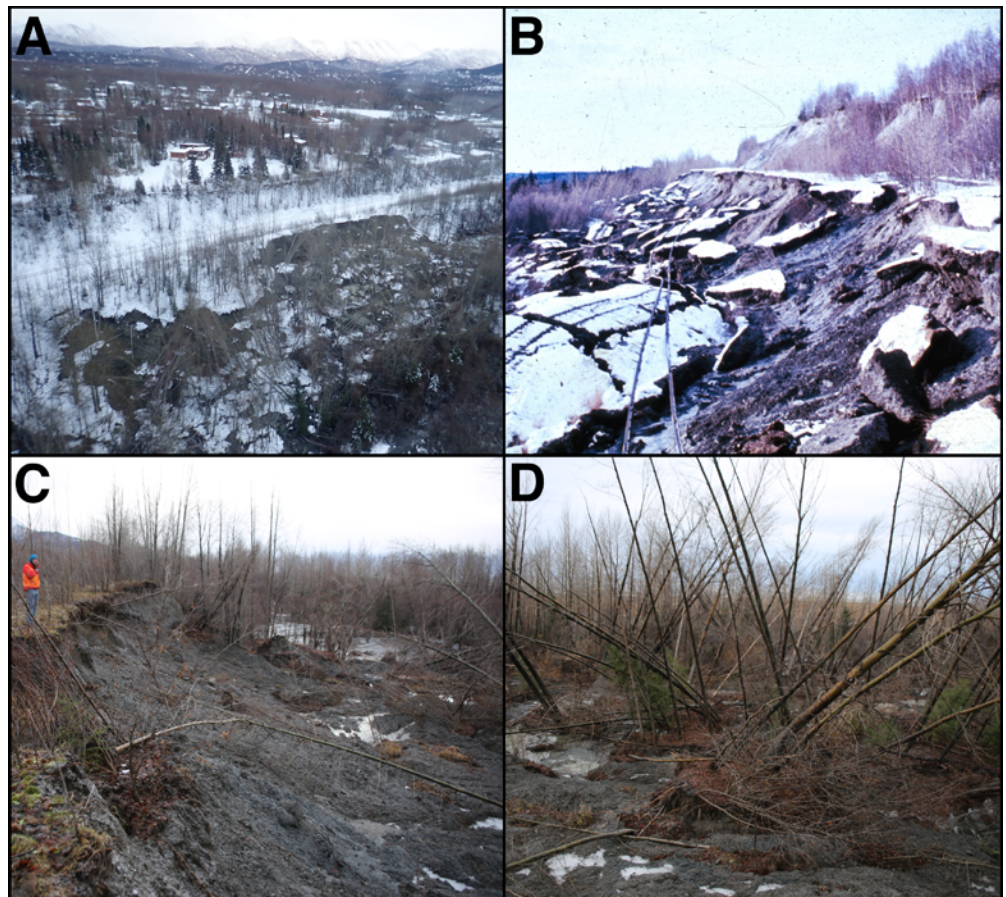
In the Potter Hill neighborhood of southern Anchorage, we observed several large flow slides (fig. 12). Near Potter Hill, a railroad grade has been cut approximately halfway up ~35-m-high coastal bluffs, creating a 15–20 m wide bench. The 1964 Alaska earthquake triggered destructive landsliding and ground cracking that extended about 3 km along this bluff (fig. 12B; Hansen, 1965; Hansen and others, 1966). The 1964 Potter Hill landslides

**Figure 12.** Photographs of the Potter Hill flow slides. *A*, Aerial photograph of two flow landslides near Potter Hill. *B*, Landslides triggered by the 1964 Alaska earthquake disrupting nearly a mile of the Alaska Railroad at Potter Hill (photograph by Reuben Kachadoorian of the U.S. Geological Survey, from Hansen and others, 1966). *C*, Main scarp of a slump/flow slide at Potter Hill. Railroad grade is to the left, tidal flat to the right. Disrupted slide material and ponded drainage are ubiquitous. *D*, Tilted trees on landslide deposits at Potter Hill indicate multiple modes of movement: slumping, siding, and toppling. Location shown in figure 4.

were described as having 5–10 m deep, steep slope-parallel slip surfaces and that they transitioned into flows after failure. Hansen (1965) documented several previous episodes of landsliding along this stretch of bluff from both previous earthquakes and heavy rainstorms. In 1964 and in some previous episodes of slope failure, segments of railroad track were damaged or destroyed. Hansen's (1965) description of the Potter Hill landslides indicates that they

“...consisted of elongate fragmented slump blocks rotated backward and broken into many pieces toward the base of the slope. In places at the toe, they turned into earth and mudflows derived partly from the intertidal silt of Turnagain Arm and partly, perhaps, from the clay-silt-sand sequence in the lower part of the bluff.”

This description perfectly matches our 2018 observations. The landslides we observed here extended along the same reach of bluff and had the same morphology as the Potter Hill landslides described in 1964 (figs. 12A, 12B, 13); they appear to have initiated as coherent slumps that then disaggregated and transitioned into flows (fig. 12C). Landslides occurred only on the lower part of the bluff below the railroad grade. Trees were askew and tilted in chaotic orientations (fig. 12D) indicating multiple movement geometries—slumping, sliding, and toppling. The 2018 landslides involved both failure of new bluff material and reactivation of some parts of the 1964 landslide deposits. The 2018 landslides were smaller, less extensive, and had shorter runout distances than those triggered in 1964. The railroad track was

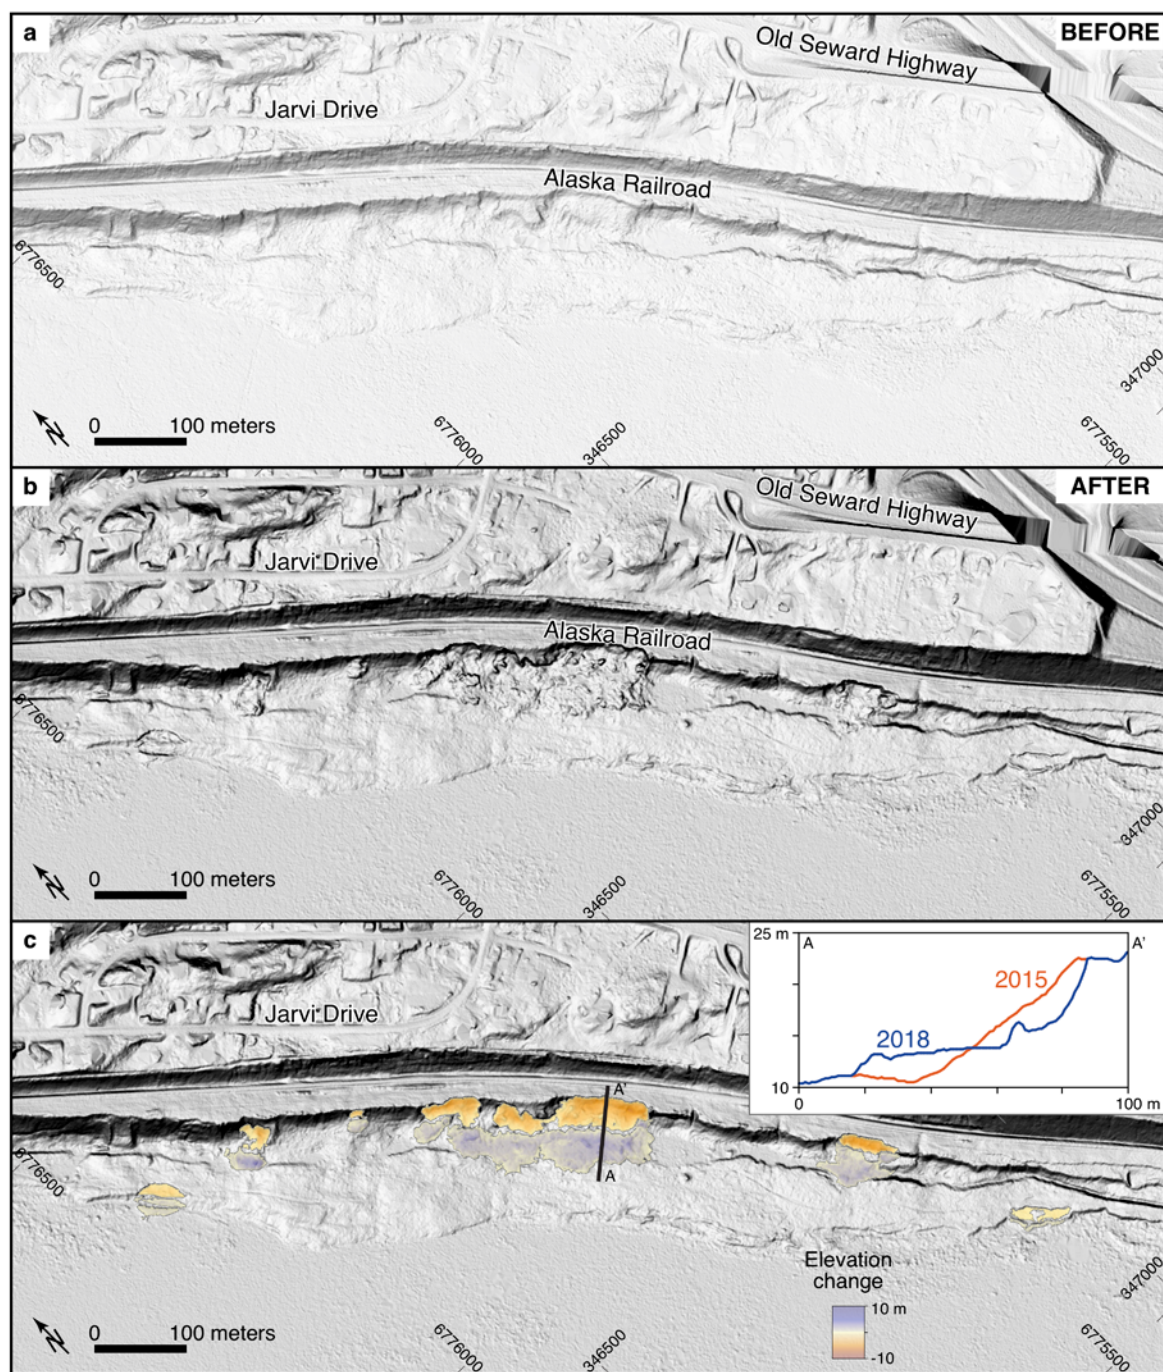
**Figure 13.** Digital terrain models (DTMs) derived from light detection and ranging (lidar) data acquired before and after the 2018 Anchorage earthquake used to estimate elevation changes caused by the Potter Hill landslides (lidar available at <https://elevation.alaska.gov>). Maps use the North American Datum of 1983 (NAD83) Universal Transverse Mercator Zone 6 North coordinate system, in meters (m). *a*, Lidar DTM developed from data acquired for the Municipality of Anchorage in May 2015. The Alaska Railroad runs along the road bed cut into the coastal bluff and showed no slumping in 2015 before the 2018 earthquake. *b*, Lidar DTM of the same area developed from data acquired in December 2018 after the earthquake. *c*, DTM showing the elevation change between the 2015 and 2018 lidar data. The Potter Hill landslides cut into the bench seaward of the railroad but did not damage the roadbed or tracks. Warm colors show negative elevation changes, greatest near landslide headscarps, and cool colors show positive elevation changes, where landslide deposits occur. The total range of elevation change varied from 3.7 to 6.0 m. Profile A–A' shows the elevation across a landslide before and after the earthquake.

not damaged in the 2018 earthquake largely because the railroad grade has been widened since 1964. However, future episodes of landsliding could pose a risk to the tracks with additional recession of the bluffs.

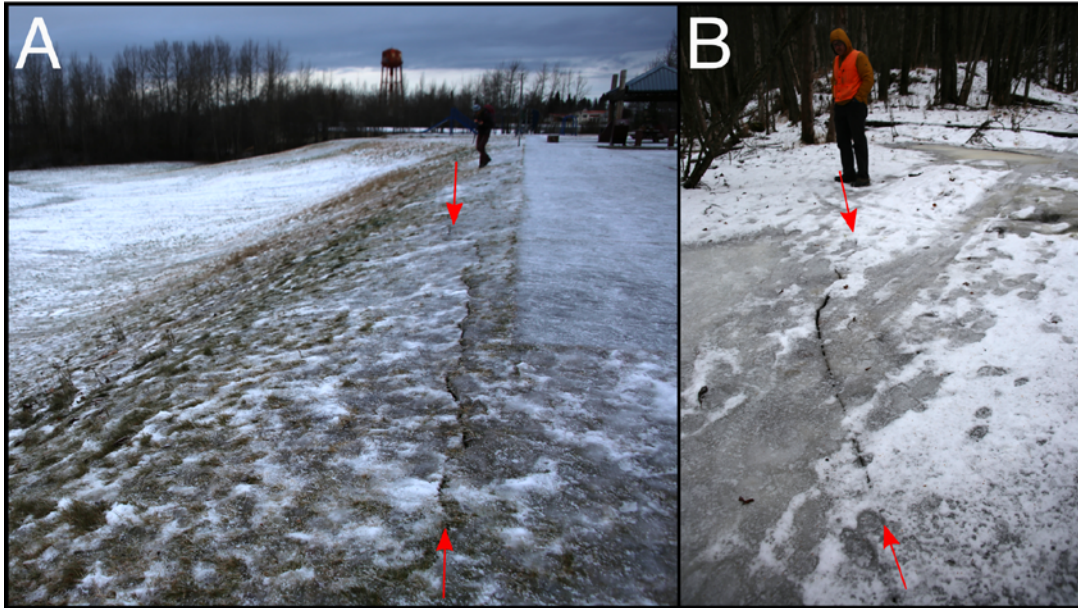
The 1964 Government Hill landslide is located about 1 km north of downtown Anchorage on the bluff that forms the northern edge of Ship Creek channel (figs. 4 and 14A). The original landslide formed as large blocks along the bluff translated outward along a subhorizontal basal shear surface and a broad, deep graben formed between the main scarp and the largest of the landslide blocks (Hansen, 1965). During our field investigation, we discovered a new continuous crack that extends about 30 m along the crown of the main scarp of the 1964 landslide at Sunset Park (fig. 14A). Additional discontinuous cracking no more than a few meters long was visible elsewhere along the old main scarp. Separation across the cracks was no more than 1–2 centimeters (cm), and we saw no downslope deformation, indicating no significant downslope movement.

**Figure 14.** Photographs of minor cracking along 1964 landslide grabens in Anchorage. *A*, Fresh crack along the main scarp of 1964 Government Hill landslide at Sunset Park. The crack that extends upward from the bottom center of the photograph is continuous for about 30 meters along the old scarp; it has 1–2 centimeters (cm) of extensional separation. No net downslope movement of the 1964 landslide mass is apparent. The 1964 landslide moved from right to left in the photograph. *B*, Crack extending along the edge of a graben that formed in the 1964 Turnagain Heights landslide. The crack is visible extending upward from the bottom left part of the photograph. This and several similar graben-bounding cracks on this landslide had about 1 cm of extensional separation. No evidence of net downslope movement of the 1964 landslide mass is apparent. Locations shown in figure 4.

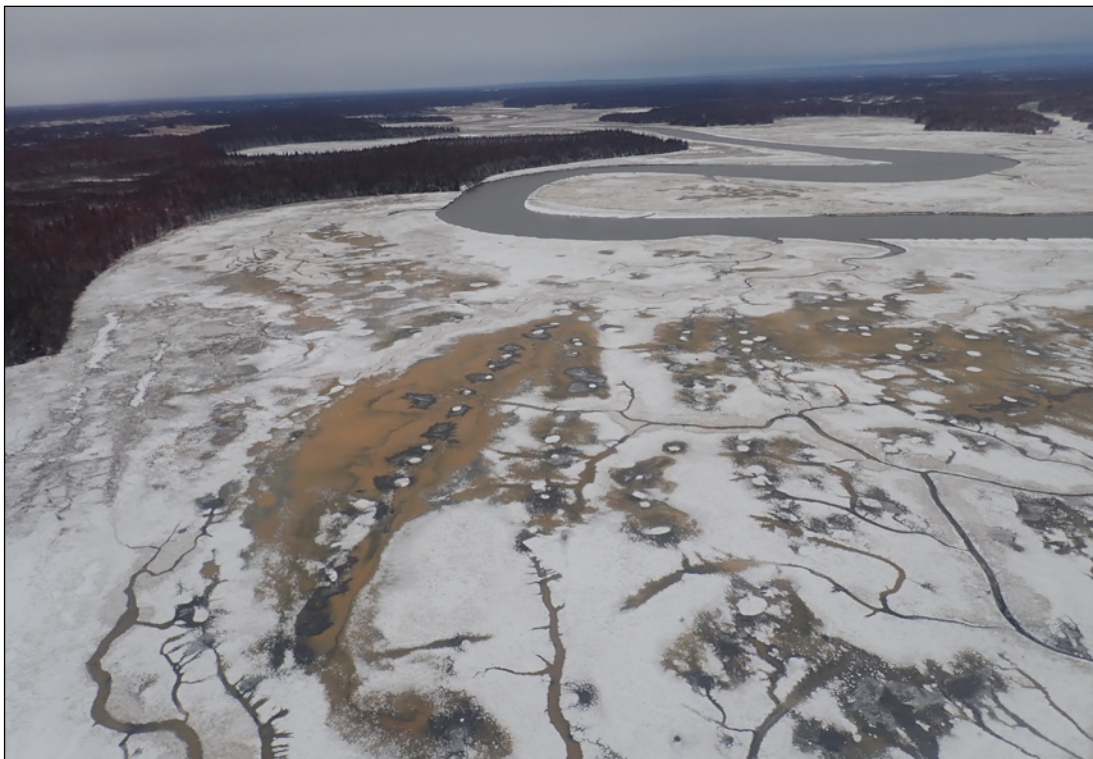
The most notable evidence of liquefaction was seen at the mouths of the Little Susitna River (fig. 15) and Ingram Creek (fig. 16A). Linear patterns in the observed sand boils at the Little Susitna River suggest liquefaction of paleochannels or recent channels, similar to paleochannel liquefaction observed following the 2011 Tohoku, Japan (Pradel and others, 2014), and 2016 Kaikoura, New Zealand (Bastin and others, 2018), earthquakes. A second dense field of sand boils was observed within the tidal mudflats of Ingram Creek near Portage during our overflight on December 5. Sand boils below Ingram Creek were spaced more irregularly than those observed at the Little Susitna River. An example of the ephemeral nature of much of the evidence of ground failure following earthquakes, these sand boils were unrecognizable during our ground-based reconnaissance of the Ingram Creek mudflats just 4 days later. However, we documented soft irregular depressions that likely represent relict sand-boil vents (fig. 16B) remaining after tidal erosion of loose sand ejecta. Additional possible relict sand boils were observed near Portage and along the north shore of the Knik Arm (figs. 16C, D). Features

**Figure 15.** Photograph of a complex of sand boils along the mouth of the Little Susitna River north of Anchorage. Linear patterns of sand boils may be related to liquefaction of paleochannels. Location shown in figure 4.

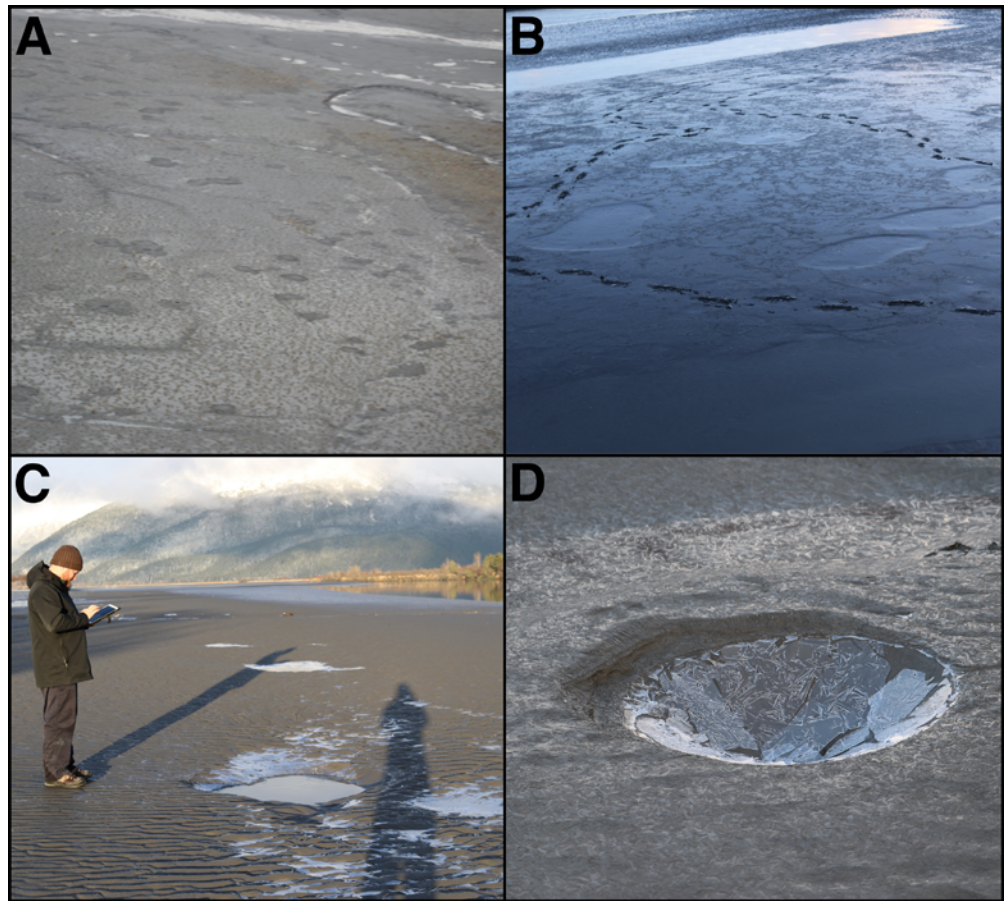
**Figure 16.** Photographs of sand boils and possible relict sand boils observed following the Anchorage earthquake. *A*, Well-defined sand boils near the outlet of Ingram Creek in Turnagain Arm on December 5, 2018. *B*, Possible relict sand boil vents at the mouth of Ingram Creek outlined by footprints. *C*, Possible relict sand boils near Portage. These steep-sided, water-filled voids in otherwise hard-packed riverbanks below high tide are believed to be the remnant vents from liquefaction during the earthquake. *D*, Close-up view of possible relict ~60-centimeter-diameter sand boil. Locations shown in figure 4.

interpreted as relict sand boils were all steep-sided circular depressions. The depressions were filled with disturbed, loose soil surrounded by stiffer and partly frozen soil. All noted relict sand boils were below high tide level, near zones of lateral spreading or previous observations of sand boils where sand ejecta could have been eroded by tidal action.

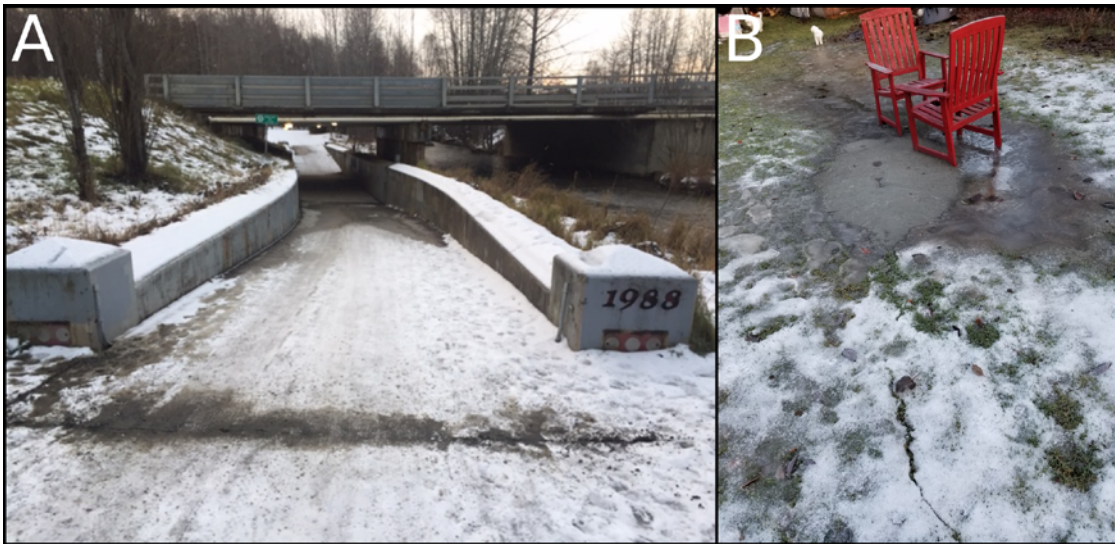
Scattered reports of ejected sand in crawl spaces and foundations cracked by settlement and a bridge abutment in downtown Anchorage (fig. 17*A*) indicate liquefaction caused significant damage in some Anchorage locations and residential dwellings. In southern Anchorage near Sand Lake, a sand boil and small fissure were observed following the earthquake (fig. 17*B*).

**Figure 17.** Photographs of evidence of liquefaction in Anchorage. *A*, Sand ejecta along the Chester Creek trail in Anchorage near the C Street overpass (photograph by Janet Curran, U.S. Geological Survey). Minor tilting of the bridge abutment was observed at this site. *B*, Sand boil in backyard of a house in southern Anchorage near Sand Lake. Sand boil is situated along a small fissure that propagated tens of meters through a house (located toward the top of the photograph). Settlement of part of the structure occurred close to the fissure (photograph by Roger D. Jones, resident). Locations shown in figure 4.

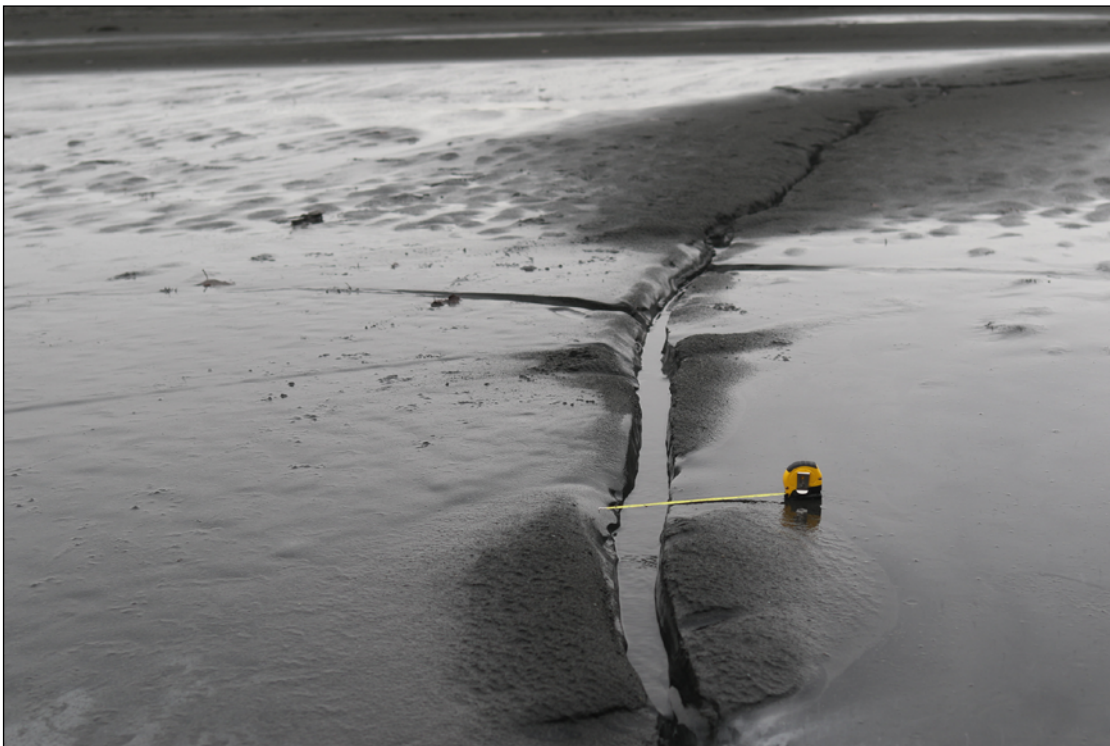
Extensional cracks with ejected sands where liquefaction-induced lateral spreading could be positively identified were observed near the north abutment of the Old Glenn Highway crossing of the Knik River (fig. 18). Extensional cracks within point-bar sands extended semicontinuously along a ~175 m stretch of the Knik River just downriver from a nearby highway bridge. Interestingly, we observed no displacements or damage to the bridge or lateral spreading just upriver. Typical crack widths downriver from the bridge were 10 cm, reaching a maximum of ~50 cm. Cracking was observed continuously through surficial

**Figure 18.** Photograph of extensional lateral-spread cracks on the north bank of the Knik River near the Old Glenn Highway. Sand ejecta are frozen on top of ~15 centimeters (cm) of clear ice that rests on clean river sands. Tape extended 30.5 cm. Location shown in figure 4.

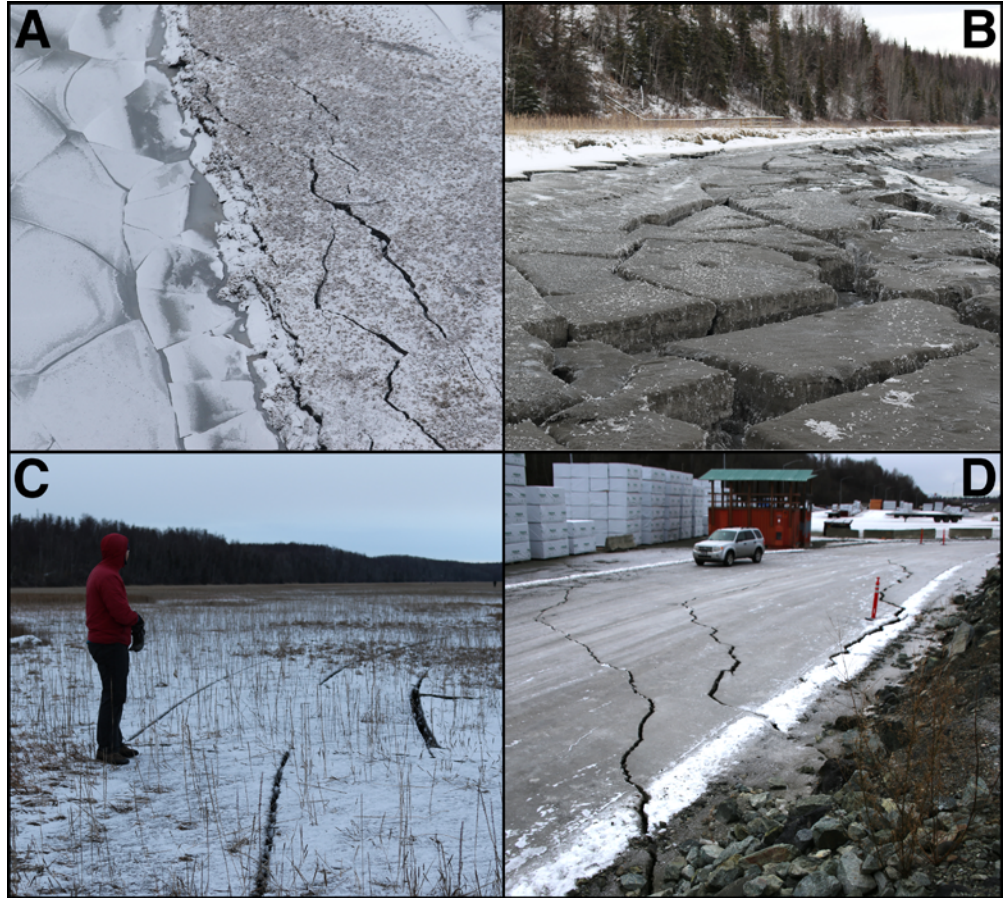
Most evidence of liquefaction from the 2018 Anchorage earthquake involved extensional cracking we associated with lateral spreading without clear evidence of sand ejecta. Notable examples include highly disrupted cracking and displacement on the banks of the Susitna River (fig. 19*A*) and along the shoreline of the Knik Arm (figs. 19*B*, *C*). Extensional cracks commonly were highly angular (for example, figs. 19*A*, *B*) and were preserved in a seasonally frozen crust of soils. Although we do not expect frozen surficial soils to have liquefied, we interpret their blocky and irregular displacements to reflect deeper subsurface deformation, likely caused by liquefaction of susceptible and unfrozen soils. Lateral spreading was also observed at the northern edge of the Port of Alaska (fig. 19*D*) as well as sand boils in the tidal flats at a nearby public boat launch.

**Figure 19.** Photographs of extensional lateral-spread cracks without obvious sand ejecta. *A*, Angular extensional cracks within a point bar island along the lower Susitna River with an associated set of compressional ice cracks caused by lateral displacement. *B*, Disrupted extensional cracks caused by liquefaction. Individual cracks are as wide as 60 centimeters (cm). Cumulative lateral displacement at this site was ~1.5 meters. *C*, Arcuate extensional cracks above mean high tide in Knik Arm. Individual cracks are 2.5–15 cm wide extended semicontinuously for several hundred meters parallel to the shore. *D*, Extensional lateral-spread cracks at the Port of Alaska.

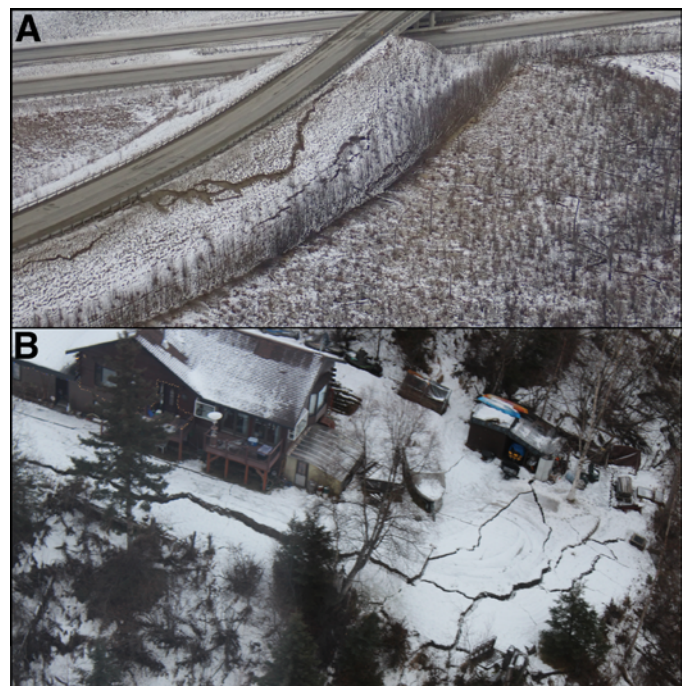
The most abundant and impactful style of ground failure triggered by this earthquake was extensional cracking not clearly associated with either landsliding or liquefaction. Many instances occurred adjacent to roads and residential structures near the edges of steep natural and fill slopes (fig. 20). In some instances, cracks propagated through existing buildings, or fill material moved downslope away from an existing structure on grade. This behavior was most common near the edges of graded building pads bounded by steep slopes. We noted widespread extensional cracking in the hilly residential areas of Peters Creek, Eagle River, and Chugiak (for example, fig. 20*B*). We did not make a comprehensive assessment, so other areas also may have been affected. Total horizontal and vertical offsets were typically tens of centimeters or less. The vast majority of cases we observed appeared to involve artificial fill and could be due simply to minor downslope slumping or settling, but we also observed cracking patterns in some locations that indicated potential incipient landsliding in both natural and fill slopes. Seismically generated cracking along the edges of slopes has been documented for other earthquakes (for example, Keefer and Manson, 1998; Jibson and others, 2018).

**Figure 20.** Photographs of extensional cracking. *A*, Extensional cracking in overpass embankment along the Glenn Highway. *B*, Extensional cracking and settling around a private residence in Chugiak. Locations shown in figure 4.

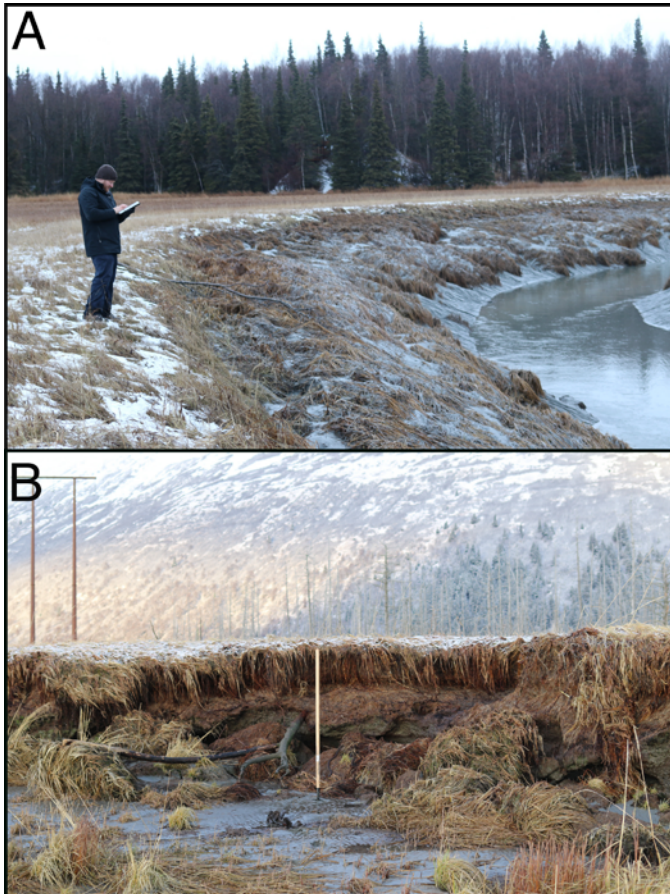
We also documented several river-bank collapses with vertical displacements as much as about 2 m. Bank collapse was typically observed along small creeks and streams at or near

mean high tide. Notable examples of this failure mode were along Campbell Creek (fig. 21A) within Anchorage and along Turnagain Arm below Girdwood (fig. 21B) in the remains of a forest that died because of tectonic subsidence in the 1964 Alaska earthquake. Marsh grasses covered in freshly deposited, unfrozen mud below the high tide line were the most common evidence of recent bank collapse. The bank collapses also were generally associated with recent extensional cracks. We did not observe ejecta of liquefiable materials at any bank-collapse sites. We suggest these bank collapses could either be lateral spreads caused by liquefaction that did not vent to the surface or simply slumping and (or) settlement of nonliquefiable material.

**Figure 21.** Photographs of examples of bank collapse following the Anchorage earthquake. *A*, Possible lateral spreading leading to partial bank collapse along lower Campbell Creek, Anchorage. Marsh grasses along the creeksides were freshly covered in soft, unfrozen muds. *B*, Bank collapse near Girdwood, Turnagain Arm. Multiple lateral spreads or bank collapses were observed within the tidal zone at this location. Locations shown in figure 4.

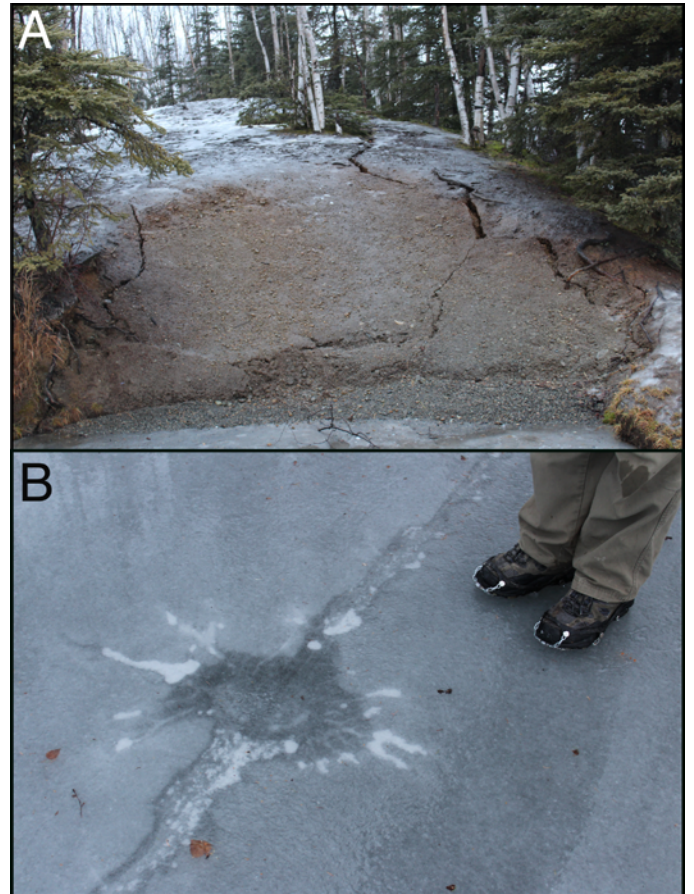
**Figure 22.** Photographs from Lower Fire Lake. *A*, Extensional cracks along a small island within Lower Fire Lake. *B*, Cracks in ice adjacent to the island showing clear evidence of movement and refreezing. Location shown in figure 4.
